## Expertise

Protocol number: 46277070  
Order No. / Reference: 26489791  
Inspection date: 23 Jun 2026

Manufacturer: Ford

Model: Transit Connect 230 L2 S&S Trend

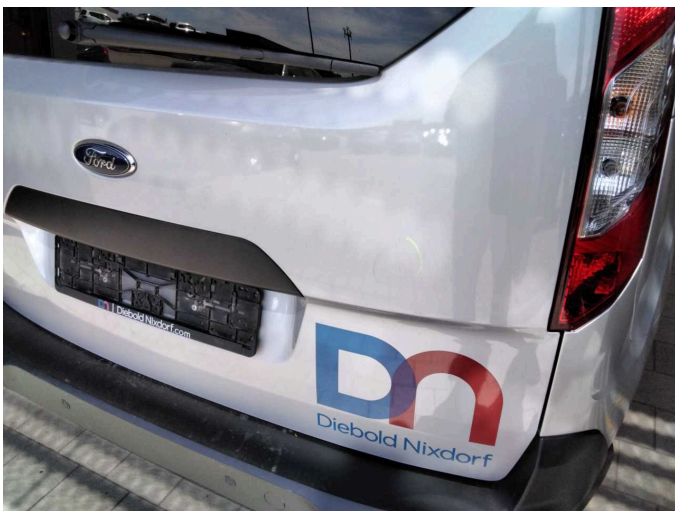
Damage 1: Boot lid / rear door: Boot lid - Dent / paintcoat damage - Smart repair

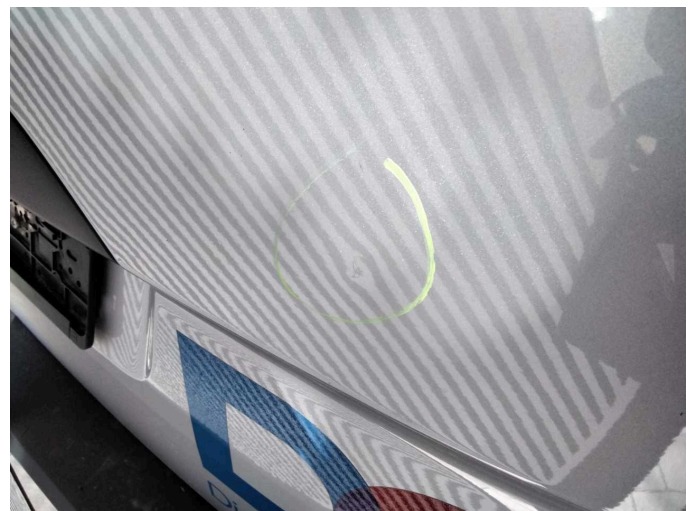
Damage 1: Boot lid / rear door: Boot lid - Dent / paintcoat damage - Smart repair

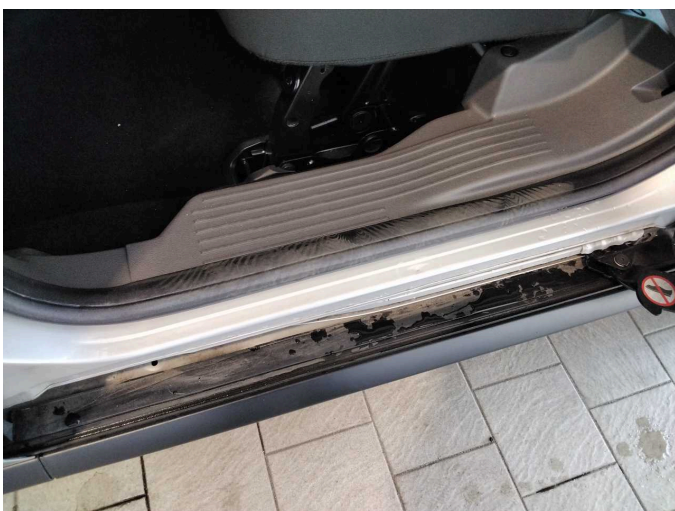
Damage 2: Side panel - rear left side: Sill - Dent / paintcoat damage - Smart repair

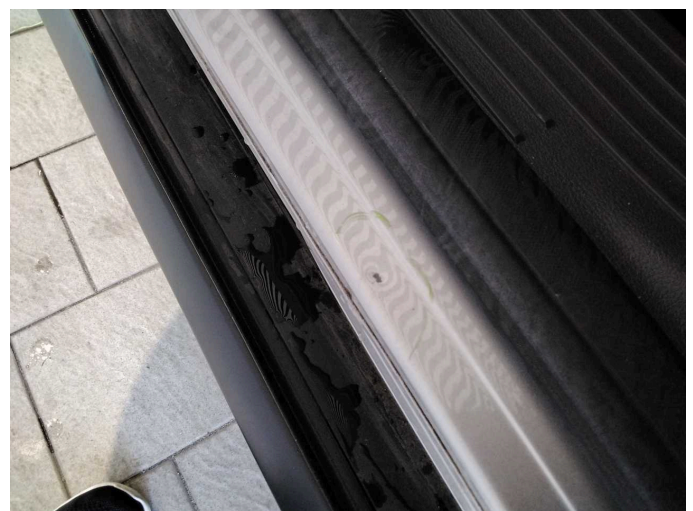
Damage 2: Side panel - rear left side: Sill - Dent / paintcoat damage - Smart repair

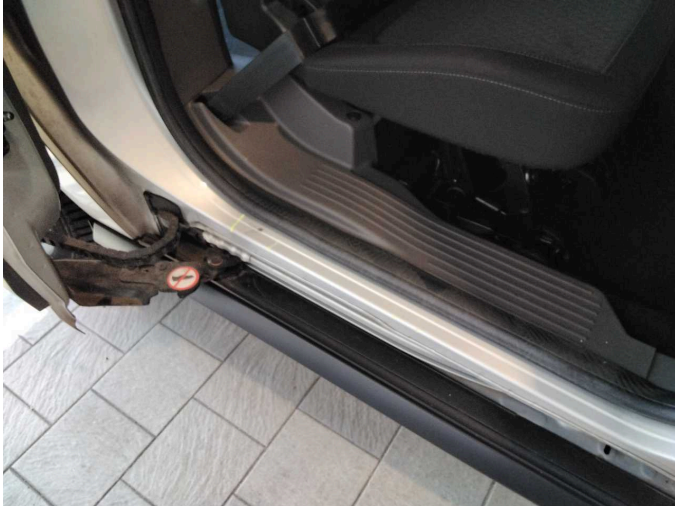
**Damage 3:** Side panel - rear right side: Sill - Dent / paintcoat damage - Smart repair

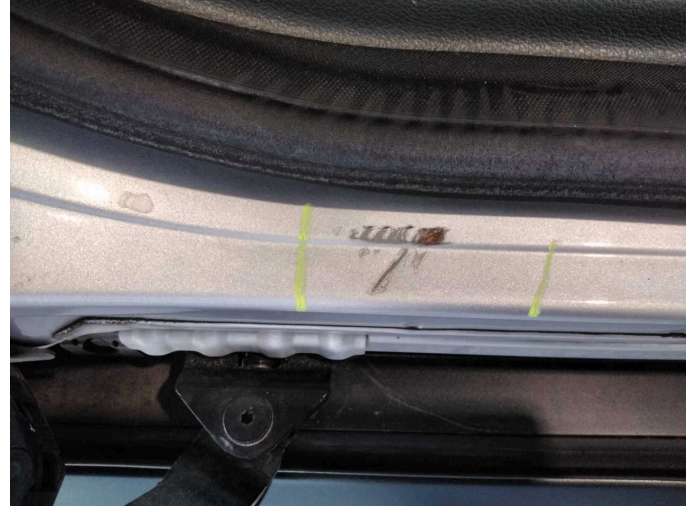
**Damage 3:** Side panel - rear right side: Sill - Dent / paintcoat damage - Smart repair

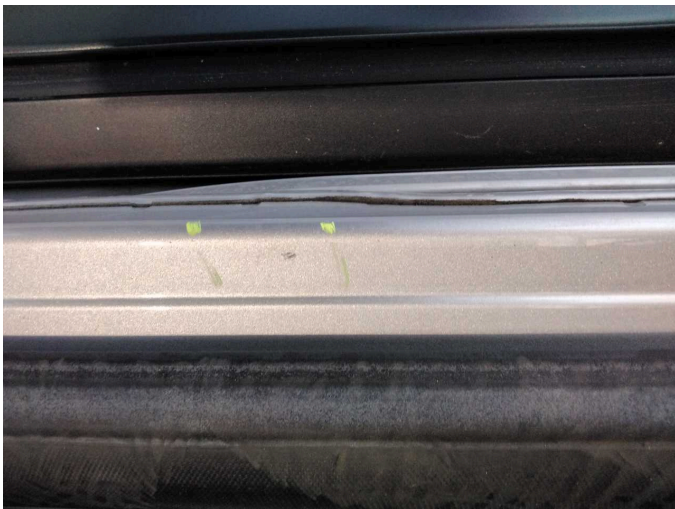
**Damage 3:** Side panel - rear right side: Sill - Dent / paintcoat damage - Smart repair

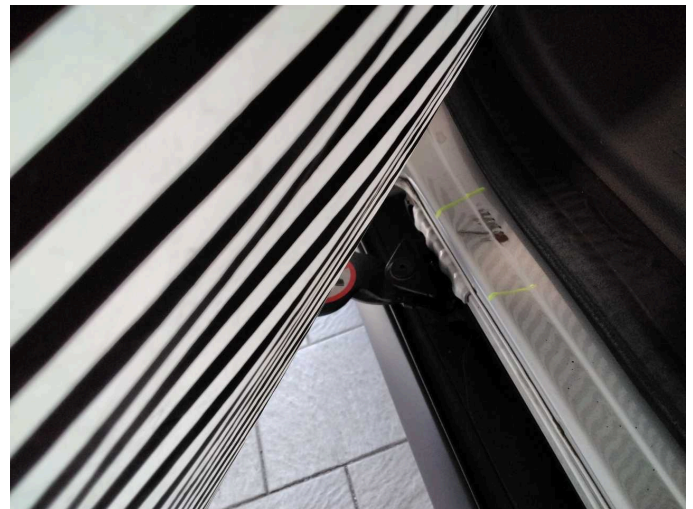
**Damage 3:** Side panel - rear right side: Sill - Dent / paintcoat damage - Smart repair

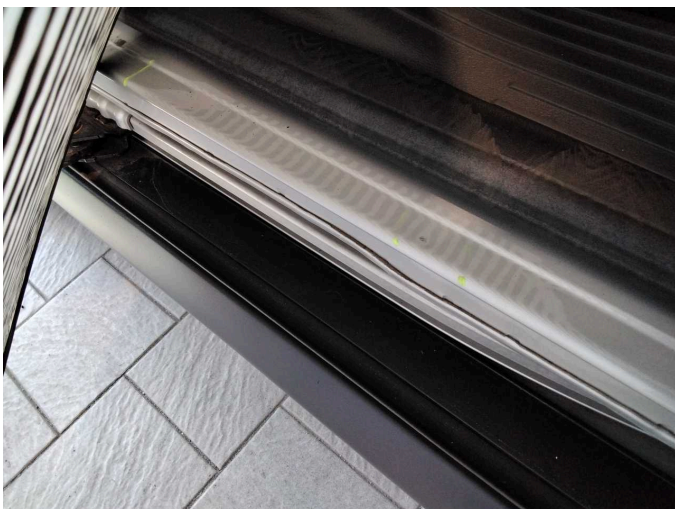
**Damage 3:** Side panel - rear right side: Sill - Dent / paintcoat damage - Smart repair

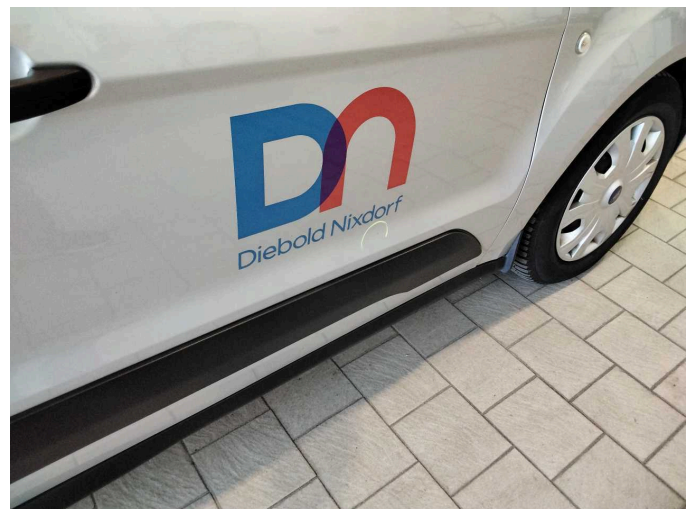
**Damage 4:** Door - front right side: Door - Scratch(es) - Smart repair

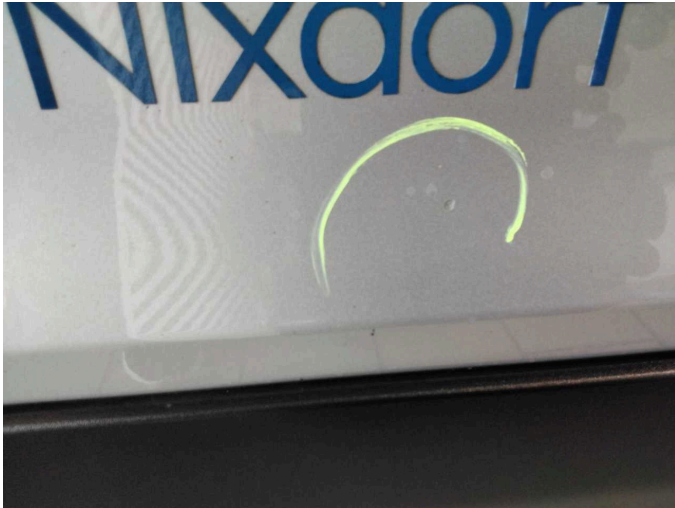
**Damage 4:** Door - front right side: Door - Scratch(es) - Smart repair

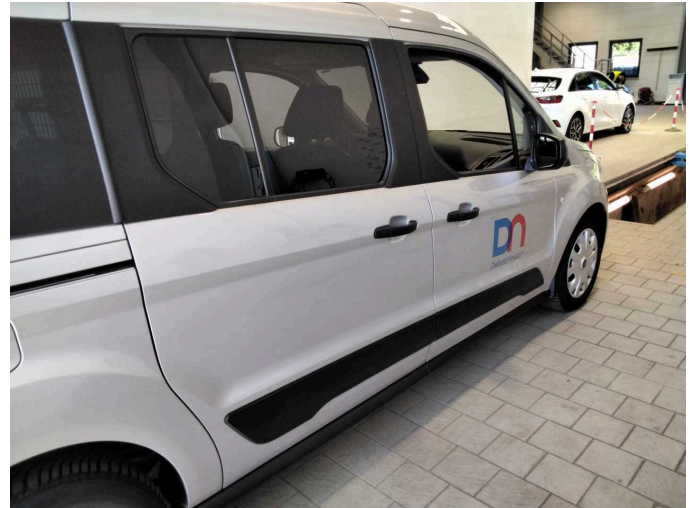
**Damage 5:** Body: Body - Glued / labelled - De-glue / neutralise

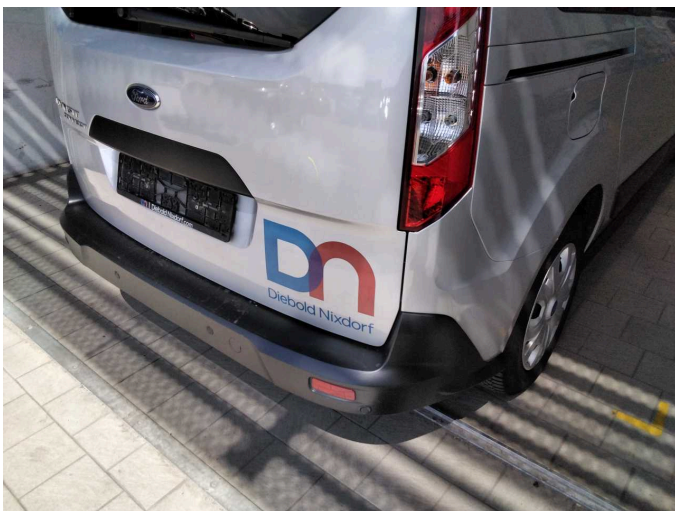
**Damage 5:** Body: Body - Glued / labelled - De-glue / neutralise

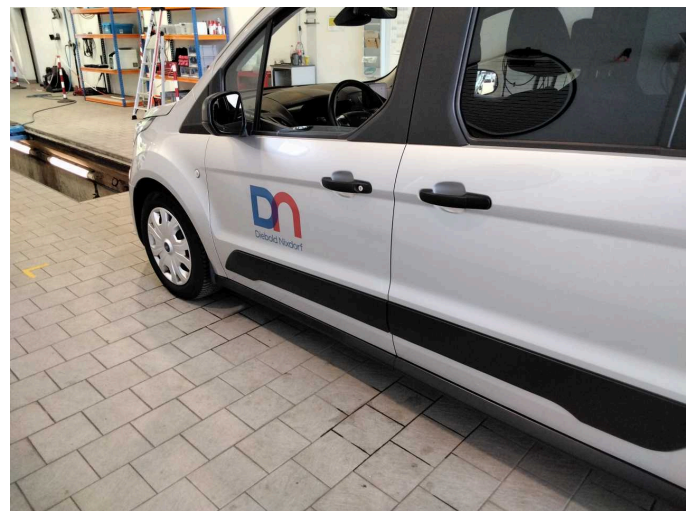
**Damage 5:** Body: Body - Glued / labelled - De-glue / neutralise

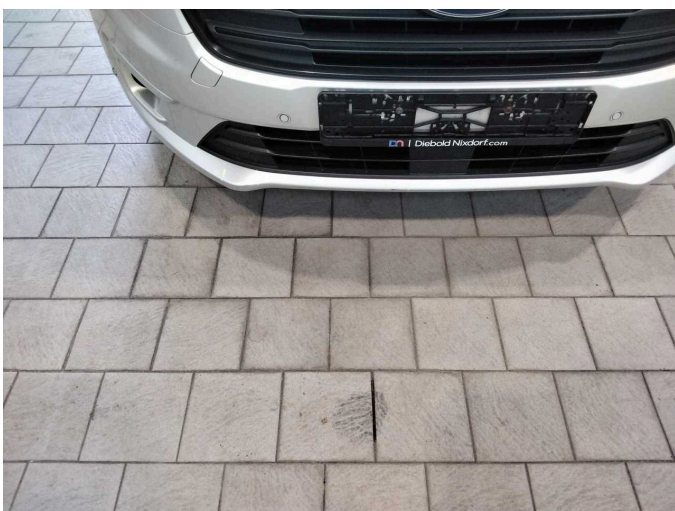
**Damage 7:** Front bumper: Front bumper - Dent / paintcoat damage - Repair and paint

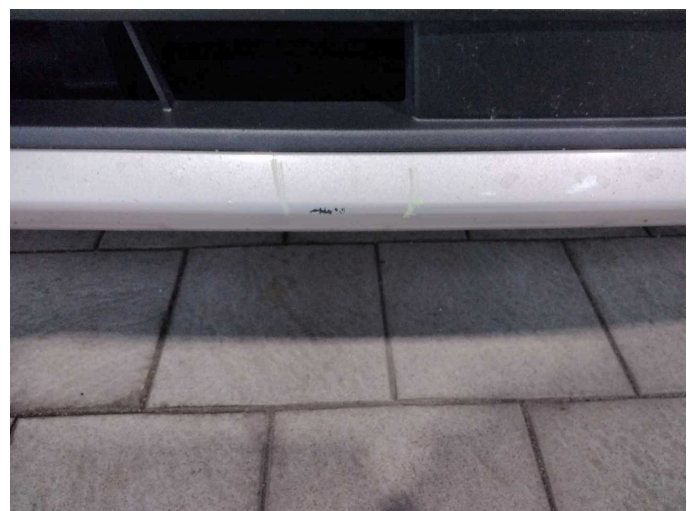
**Damage 7:** Front bumper: Front bumper - Dent / paintcoat damage - Repair and paint

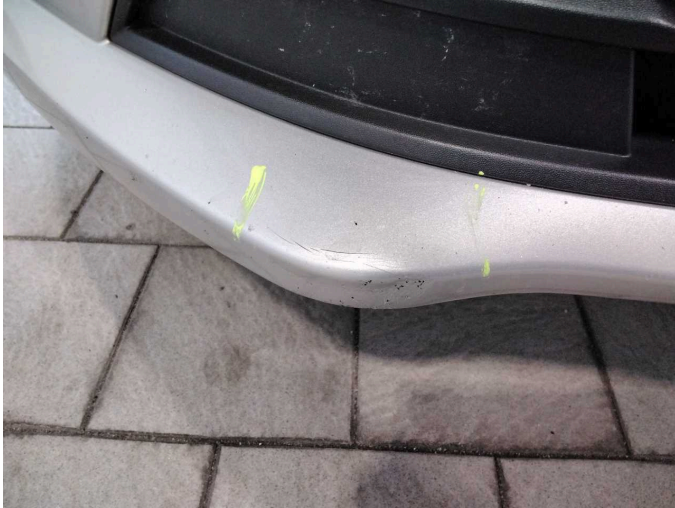
**Damage 7:** Front bumper: Front bumper - Dent / paintcoat damage - Repair and paint

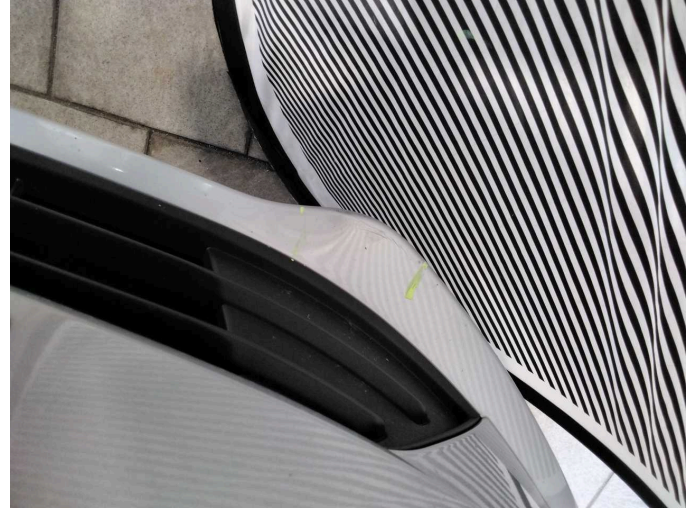
**Damage 7:** Front bumper: Front bumper - Dent / paintcoat damage - Repair and paint

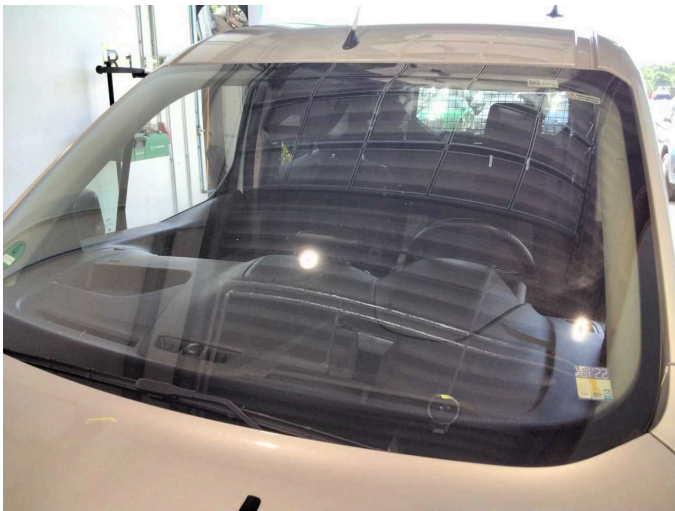
**Damage 8:** Vehicle glazing: Windscreen - Stone chips - Replace

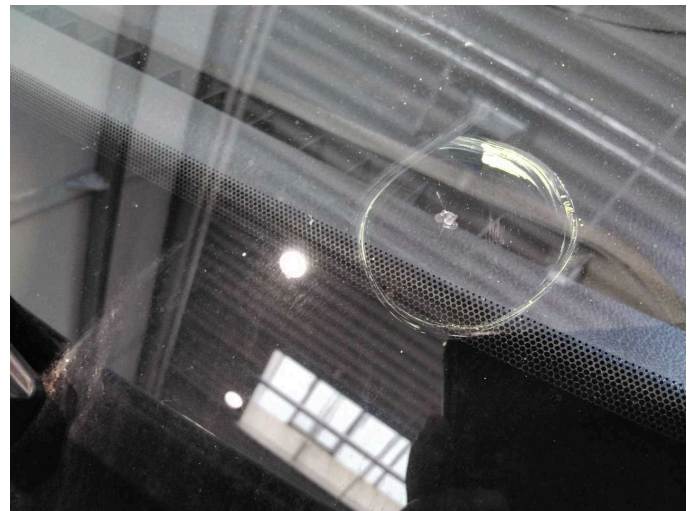
**Damage 8:** Vehicle glazing: Windscreen - Stone chips - Replace

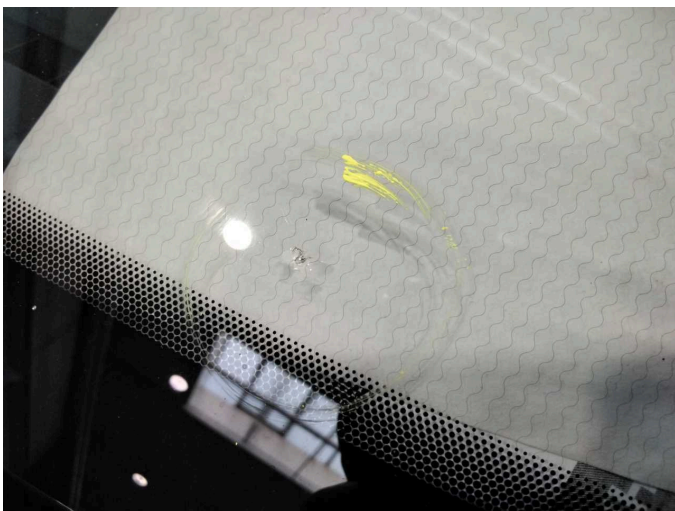
**Damage 8:** Vehicle glazing: Windscreen - Stone chips - Replace

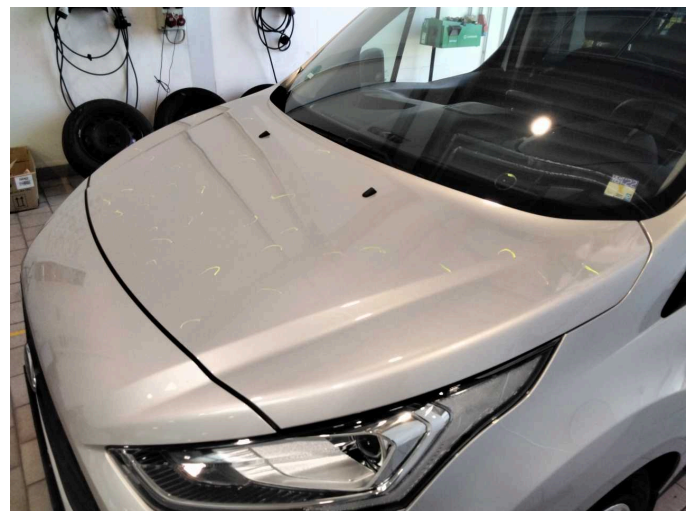
**Damage 9:** Body: Body - Damage by hail - Repair

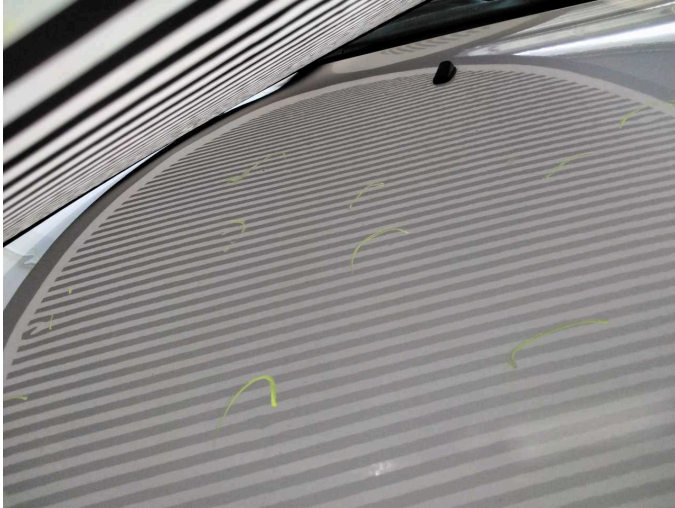
**Damage 9:** Body: Body - Damage by hail - Repair

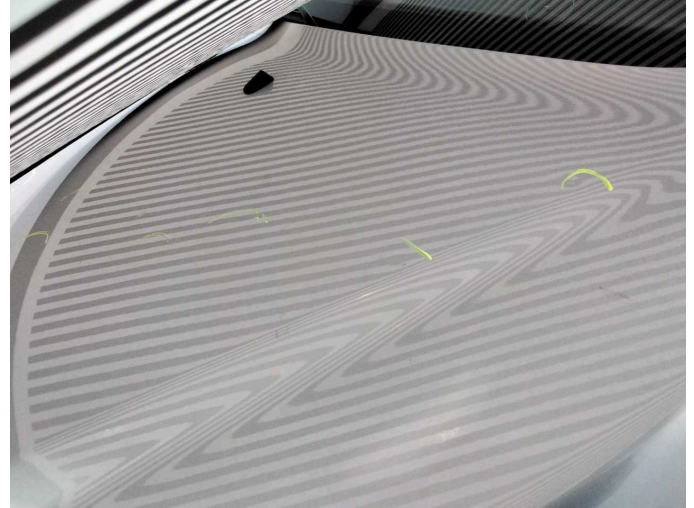
**Damage 9:** Body: Body - Damage by hail - Repair

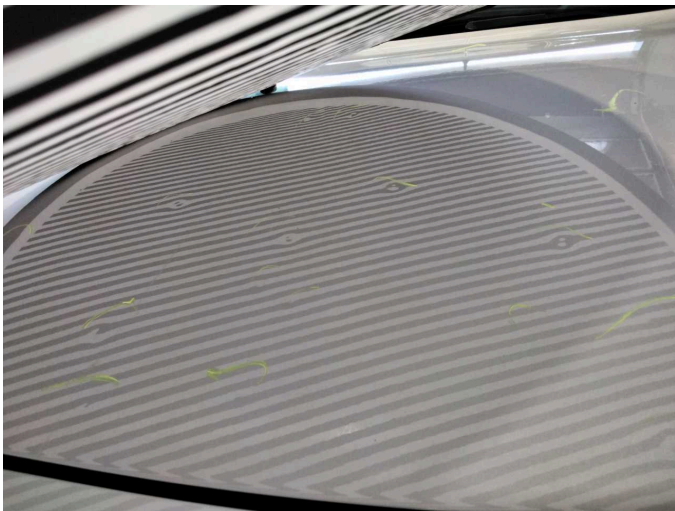
**Damage 9:** Body: Body - Damage by hail - Repair

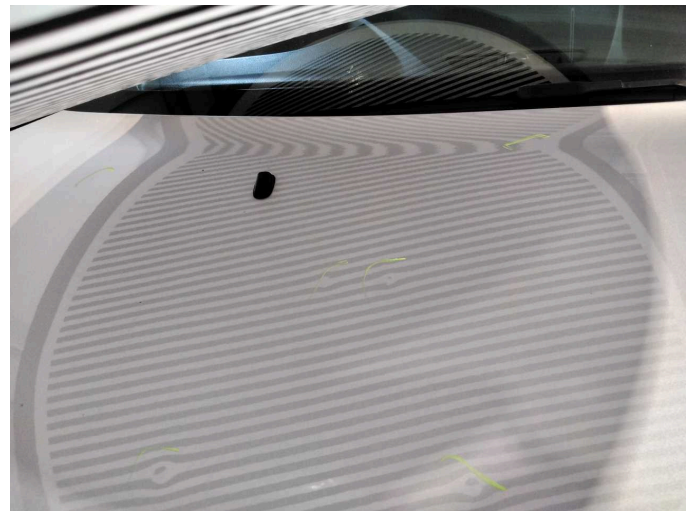
**Damage 9:** Body: Body - Damage by hail - Repair

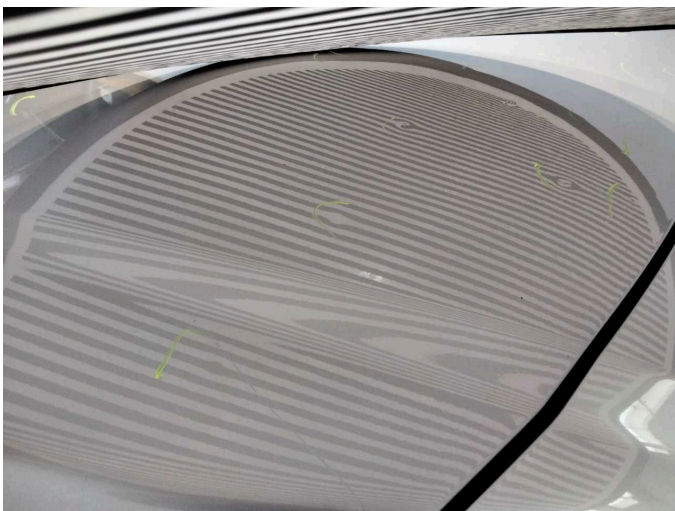
**Damage 9:** Body: Body - Damage by hail - Repair

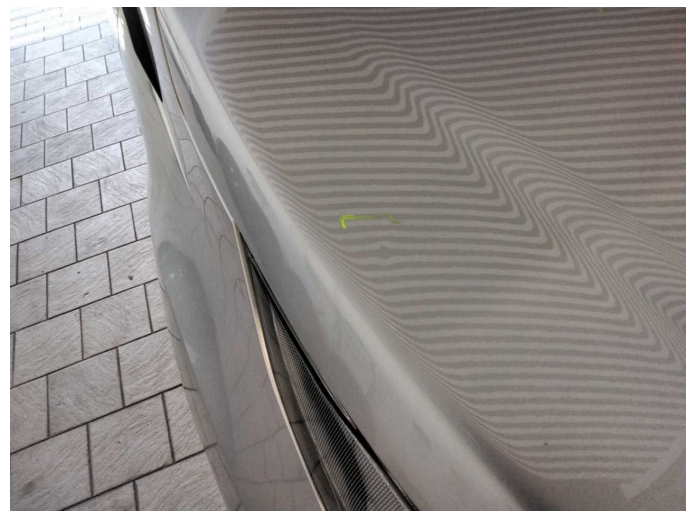
**Damage 9:** Body: Body - Damage by hail - Repair

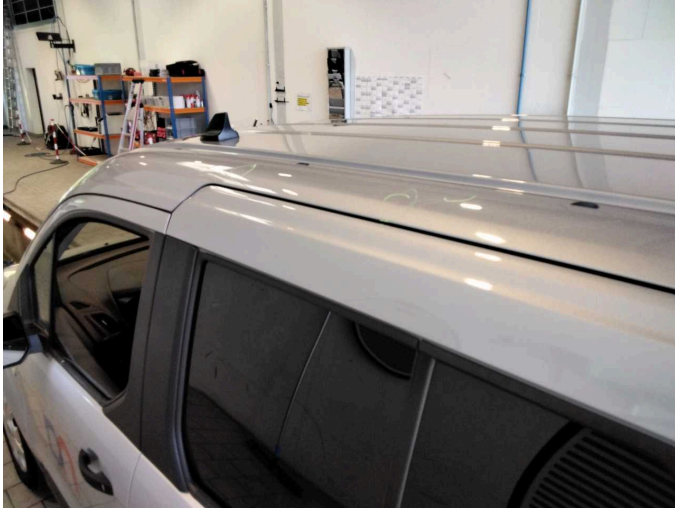
Damage 9: Body: Body - Damage by hail - Repair

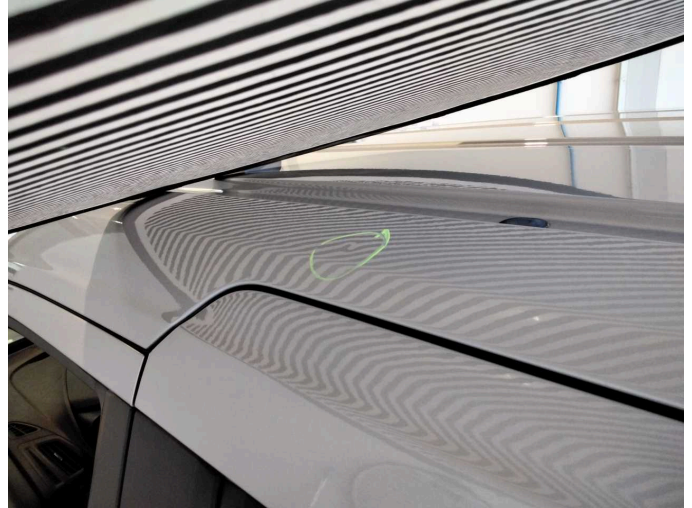
Damage 9: Body: Body - Damage by hail - Repair

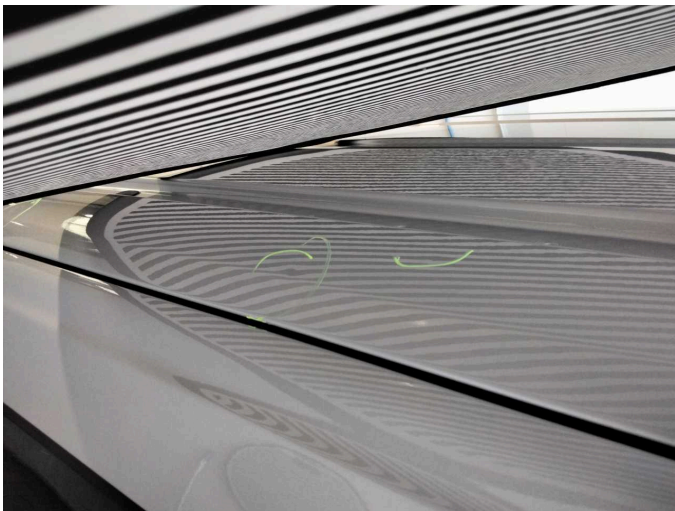
Damage 9: Body: Body - Damage by hail - Repair

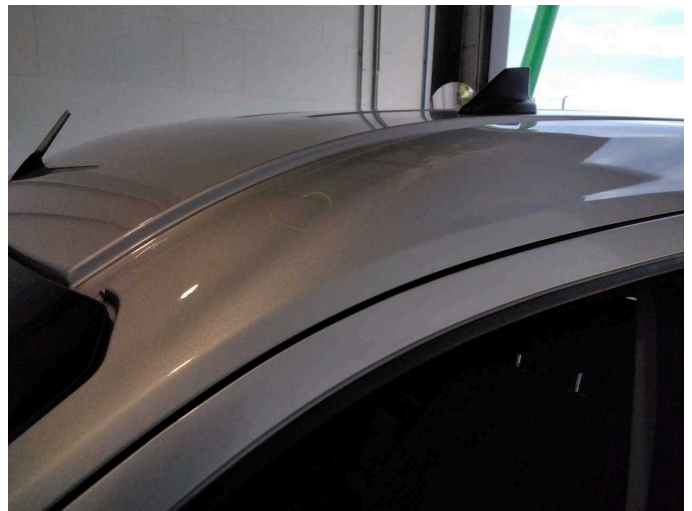
Damage 9: Body: Body - Damage by hail - Repair

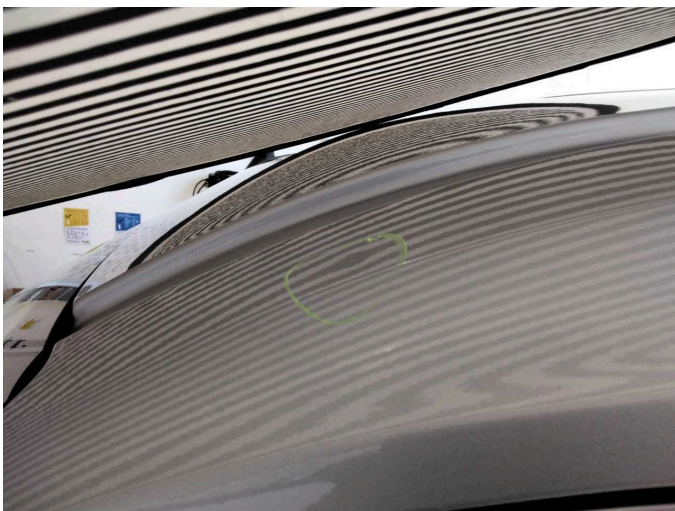
Damage 9: Body: Body - Damage by hail - Repair

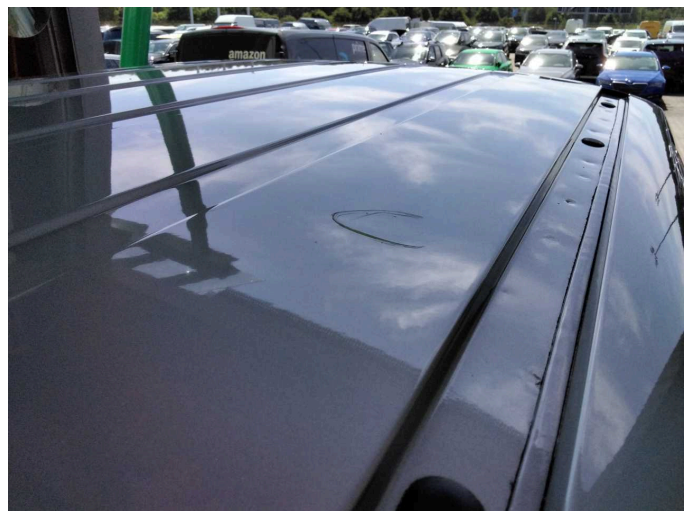
Damage 9: Body: Body - Damage by hail - Repair

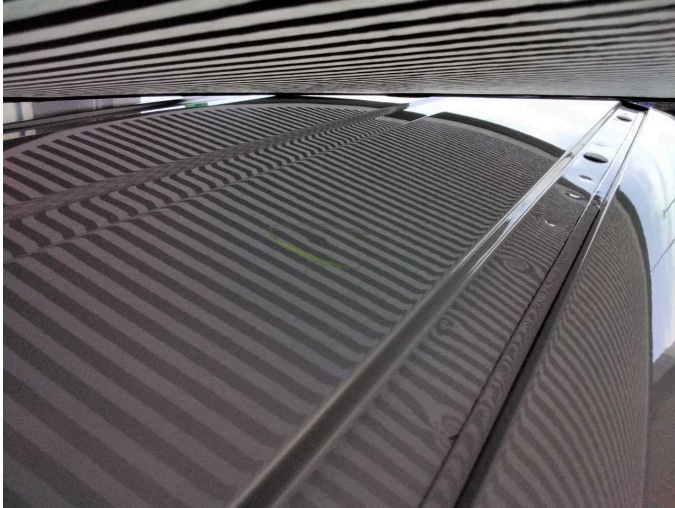
**Damage 9:** Body: Body - Damage by hail - Repair

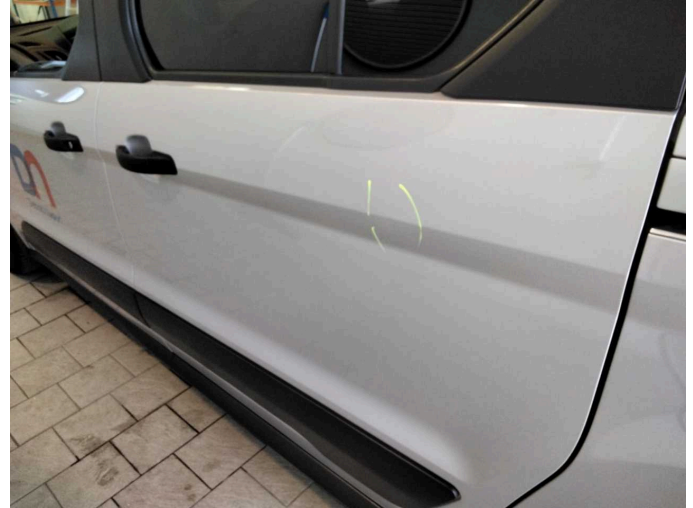
**Wear and tear 2:** Sliding door - left side: Sliding door with glass panel - dent(s) - No deduction

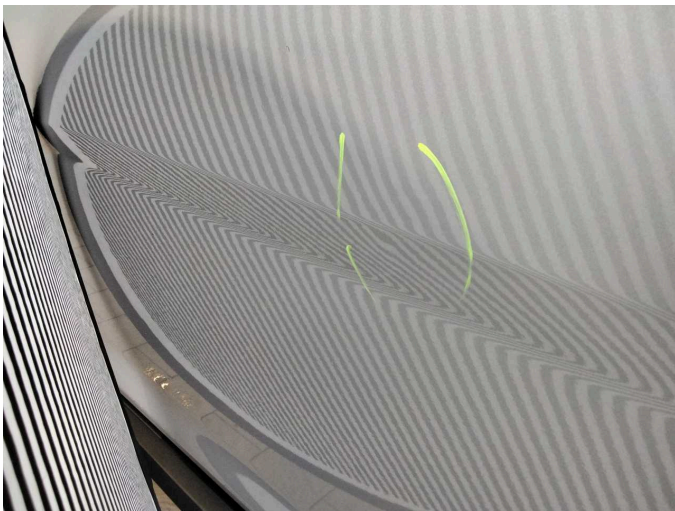
**Wear and tear 2:** Sliding door - left side: Sliding door with glass panel - dent(s) - No deduction

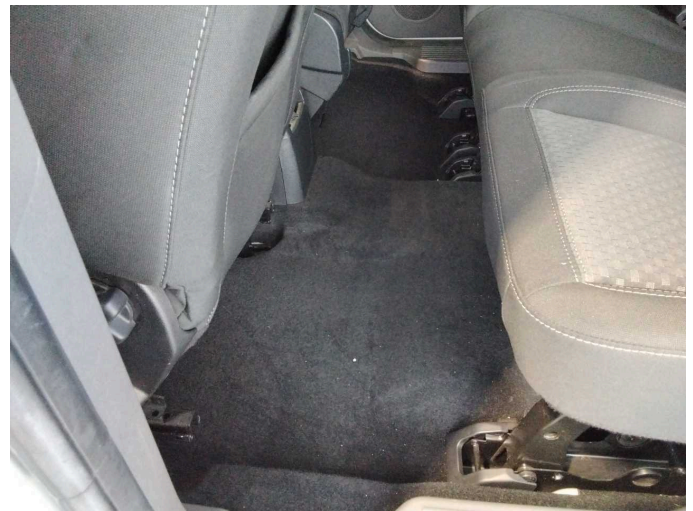
**Missing part 1:** Trim / covers: Floor mats (Hinten) - Missing - Replace
