Expertise

Protocol number: 46565989  
Order No. / Reference: 26716555  
Inspection date: 13 Jul 2026

Manufacturer: Volkswagen

Model: Caddy Cargo 2.0 TDI BMT

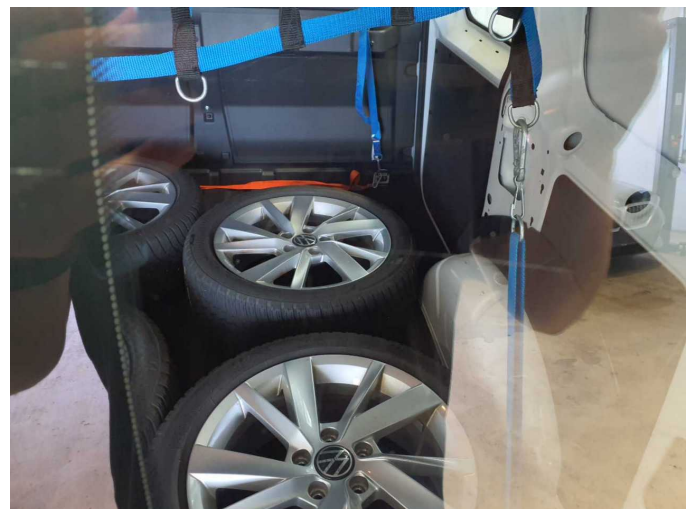
| No. | Component group | Description |
|---|---|---|
| 1 | Vehicle glazing | Rear window - Scratch(es) - Loss in value |

**Damage 1:** Vehicle glazing: Rear window - Scratch(es) - Loss in value

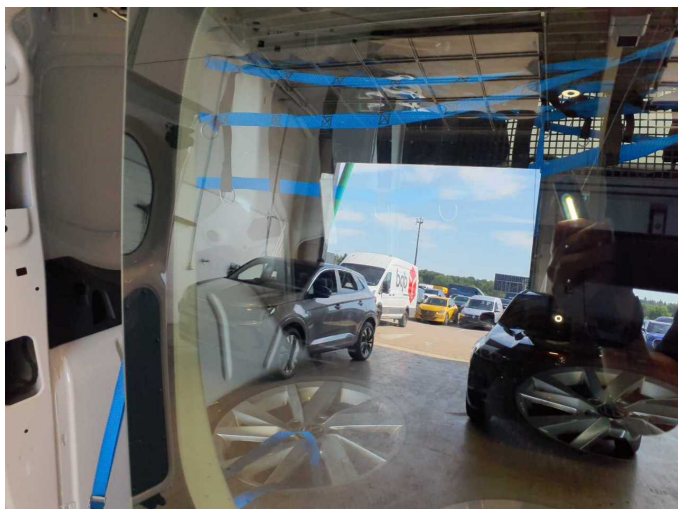
**Damage 1:** Vehicle glazing: Rear window - Scratch(es) - Loss in value

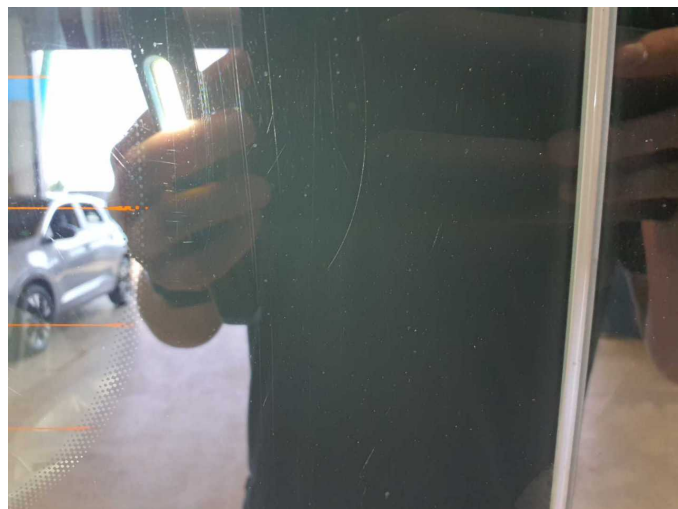
**Damage 1:** Vehicle glazing: Rear window - Scratch(es) - Loss in value

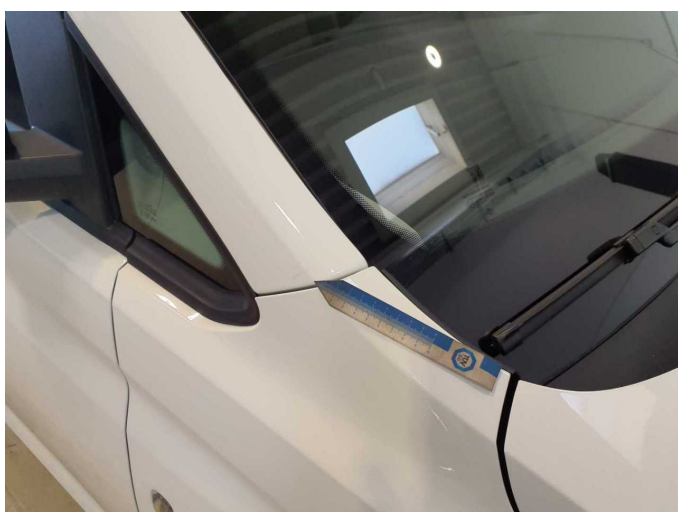
| No. | Component group | Description |
|---|---|---|
| 2 | Body | A-pillar - right side - Scratch(es) - Smart repair |

**Damage 2:** Body: A-pillar - right side - Scratch(es) - Smart repair

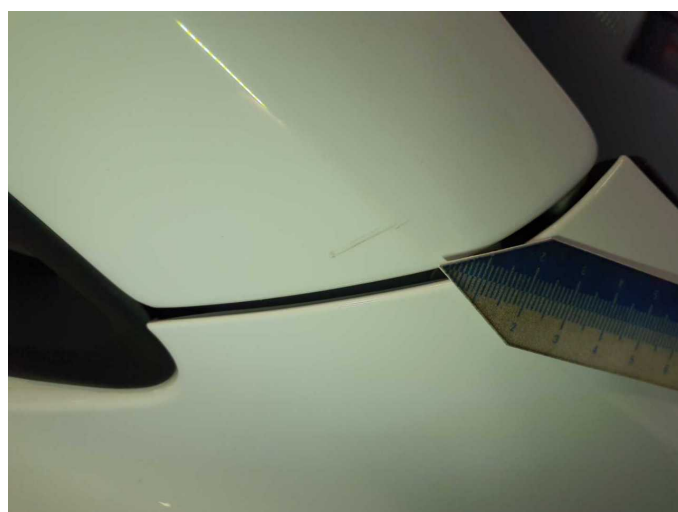
**Damage 2:** Body: A-pillar - right side - Scratch(es) - Smart repair

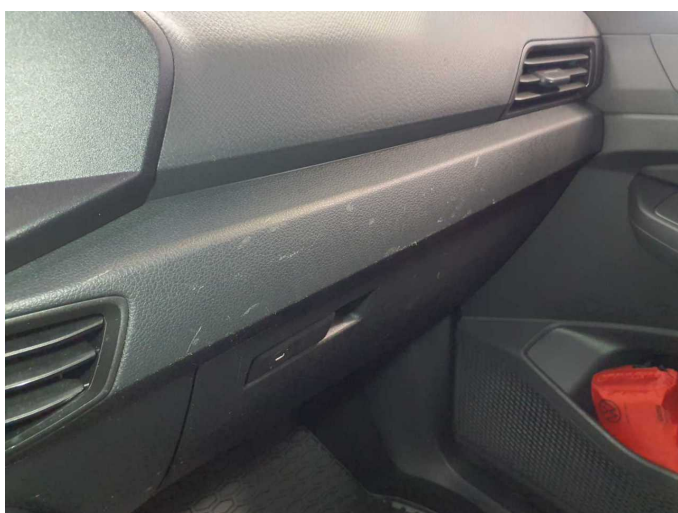
| No. | Component group | Description |
|---|---|---|
| 3 | Instrument panel | Centre console - front - Scratch(es) - Loss in value |

**Damage 3:** Instrument panel: Centre console - front - Scratch(es) - Loss in value

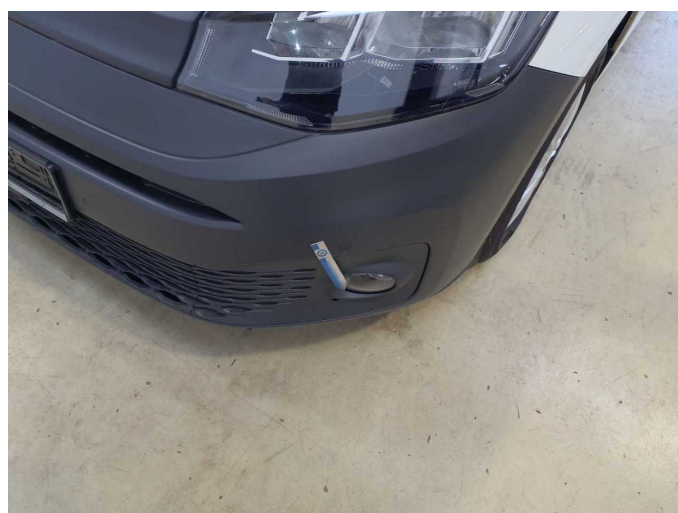
| No. | Component group | Description |
|---|---|---|
| 4 | Fog lamp | Fog lamp - front left side - Broken / torn - Replace |

**Damage 4:** Fog lamp: Fog lamp - front left side - Broken / torn - Replace

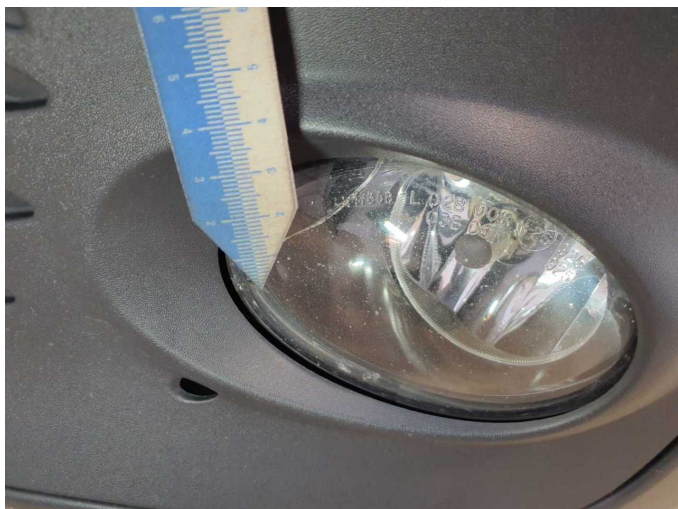
**Damage 4:** Fog lamp: Fog lamp - front left side - Broken / torn - Replace

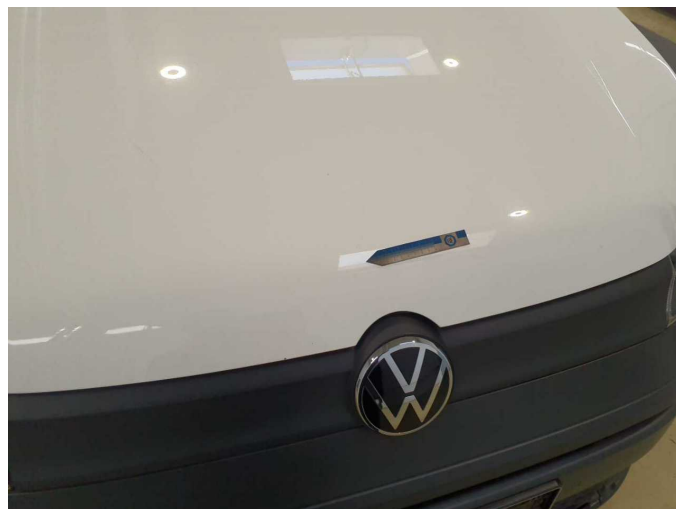
| No. | Component group | Description |
|---|---|---|
| 5 | Bonnet | Bonnet - Dent / paintcoat damage - Smart repair |

**Damage 5:** Bonnet: Bonnet - Dent / paintcoat damage - Smart repair

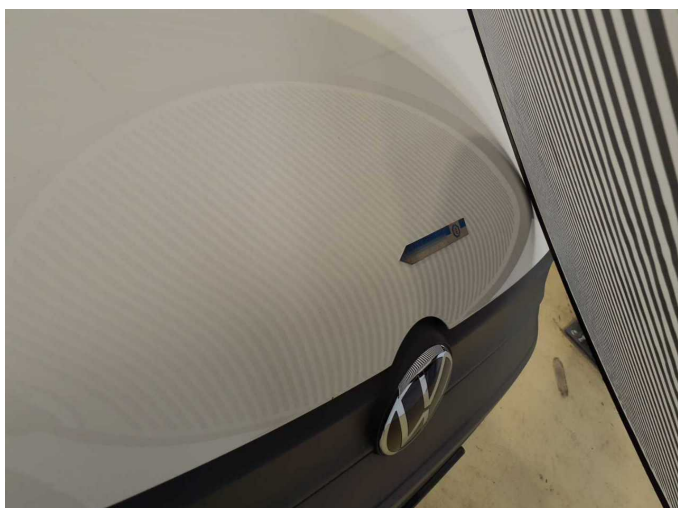
**Damage 5:** Bonnet: Bonnet - Dent / paintcoat damage - Smart repair

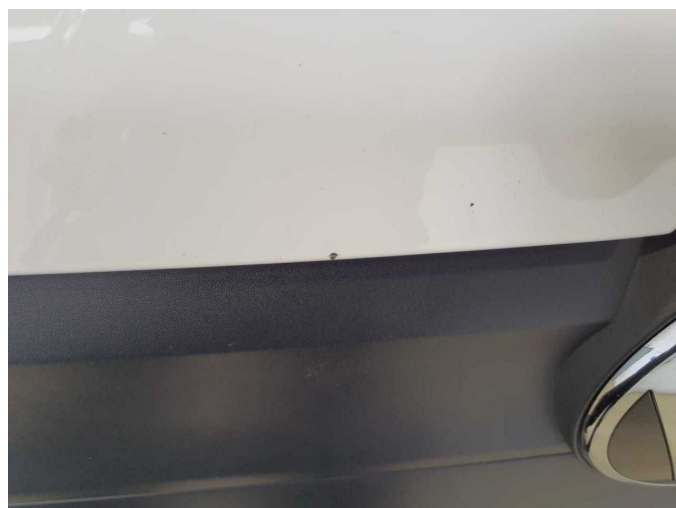
**Damage 5:** Bonnet: Bonnet - Dent / paintcoat damage - Smart repair

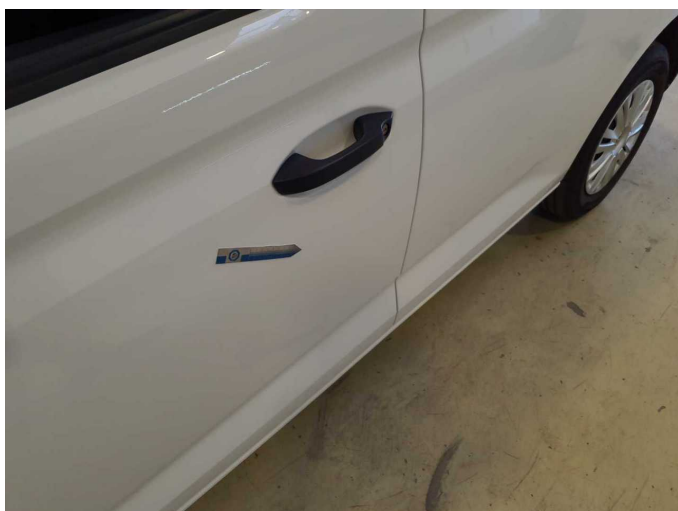
| No. | Component group | Description |
|---|---|---|
| 6 | Door - front left side | Door - Dent / paintcoat damage - Smart repair |

**Damage 6:** Door - front left side: Door - Dent / paintcoat damage - Smart repair

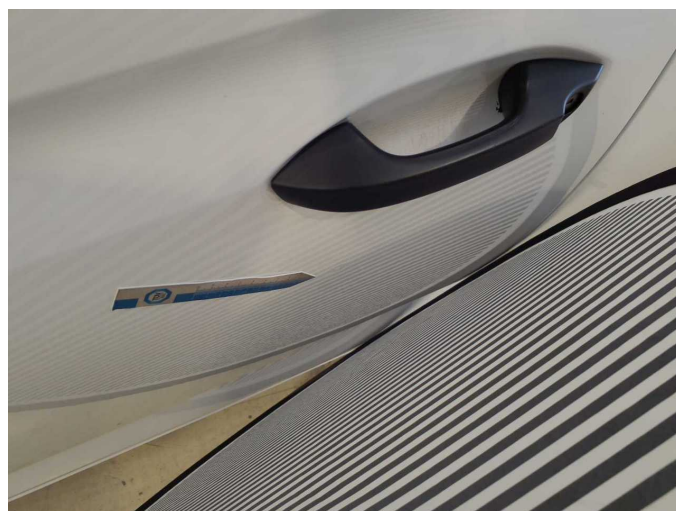
**Damage 6:** Door - front left side: Door - Dent / paintcoat damage - Smart repair

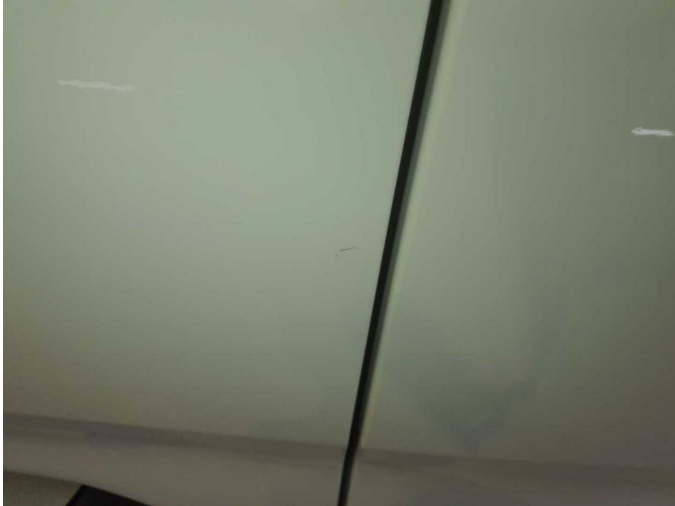
**Damage 6:** Door - front left side: Door - Dent / paintcoat damage - Smart repair

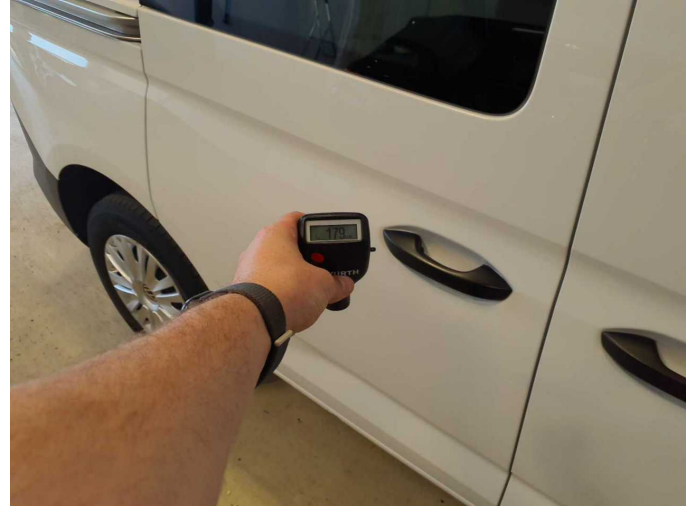
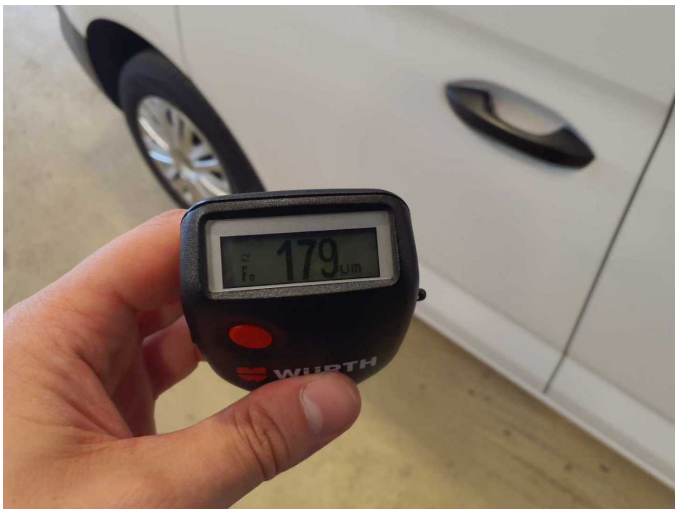
- 1 Door - rear right side, Professionally carried out, Invoice of repair done Non-existent
- 2 Door - front right side, Professionally carried out, Invoice of repair done Non-existent

| Door - rear right side | 179 µm | Door - front right side | 199 µm |

**Repainting 1:** Door - rear right side

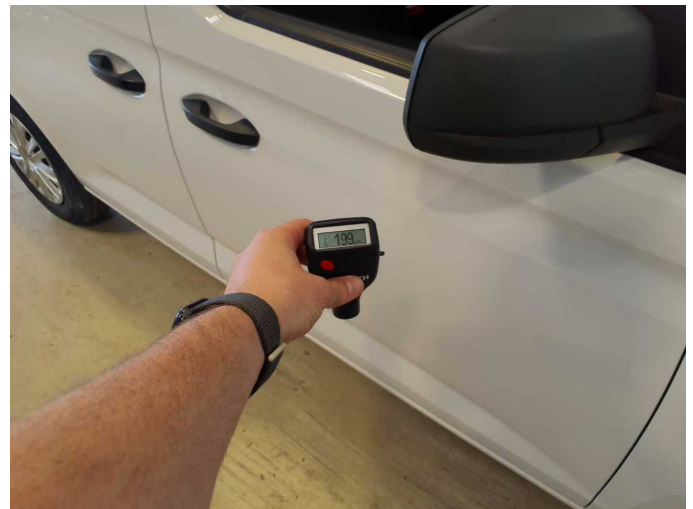
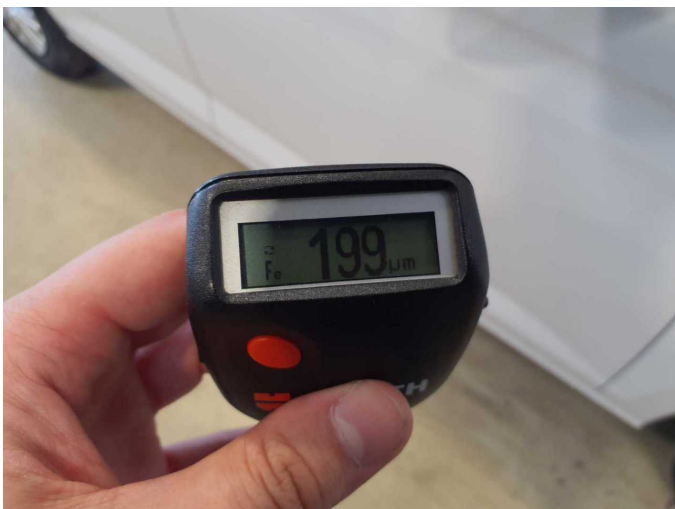
**Repainting 2:** Door - front right side
