## Expertise

Protocol number: 45831252  
Order No. / Reference: 26396912  
Inspection date: 1 Jun 2026

Model: Passat Variant 2.0 TDI SCR Business

VIN: WVVZZZ3CZME053714

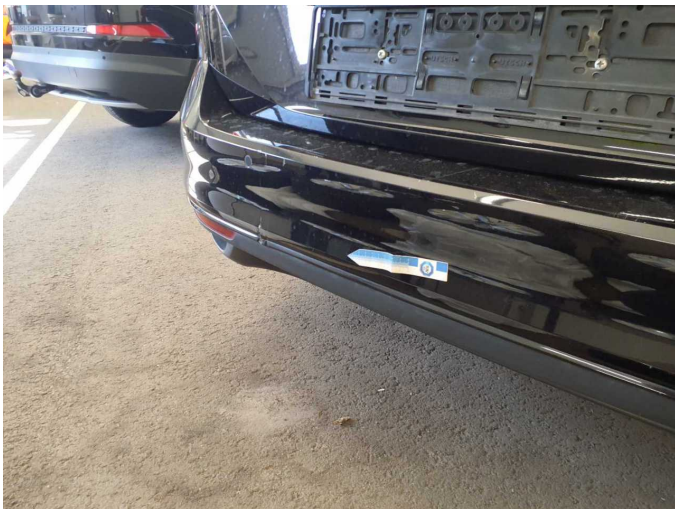
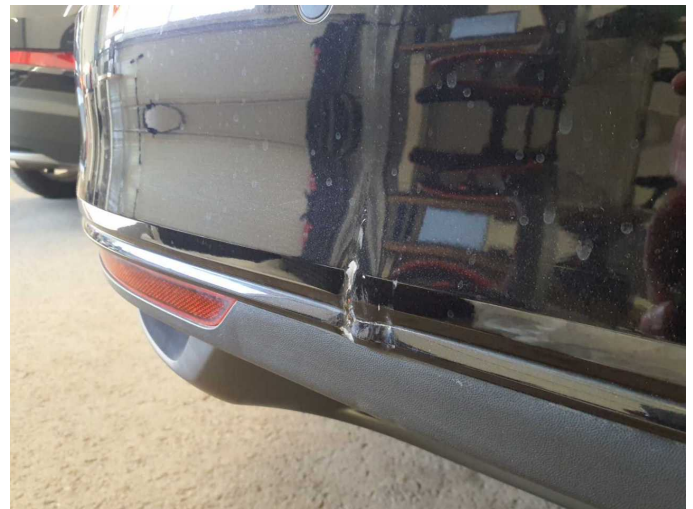
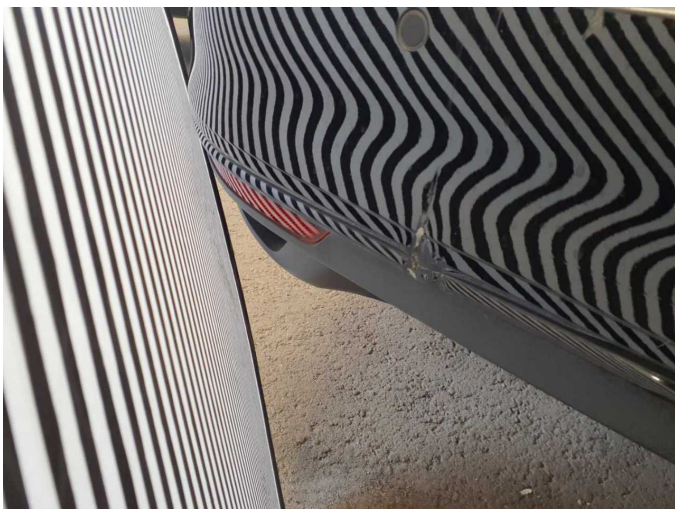
No.	Component group	Description
1	Rear bumper	Rear bumper (Verformung im Kantenbereich + Lackschaden) - Deformed - Replace

Damage 1: Rear bumper: Rear bumper (Verformung im Kantenbereich + Lackschaden) - Deformed - Replace

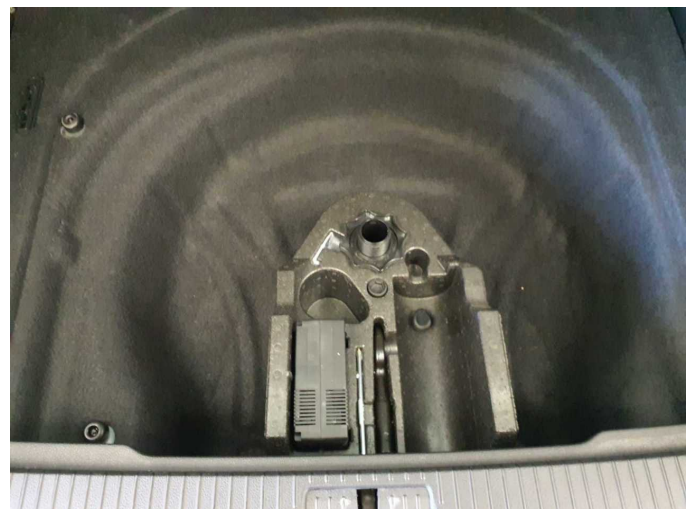
Equipment - Tirefit filler

Missing part 1: Equipment: Tirefit filler - Missing - Replace
