Expertise

Protocol number: 45918363
Order No. / Reference: 26416993
Inspection date: 11 Jun 2026

Manufacturer: Mercedes-Benz

Model: GLC-Coupe 220 d 4Matic 9G-TRONIC

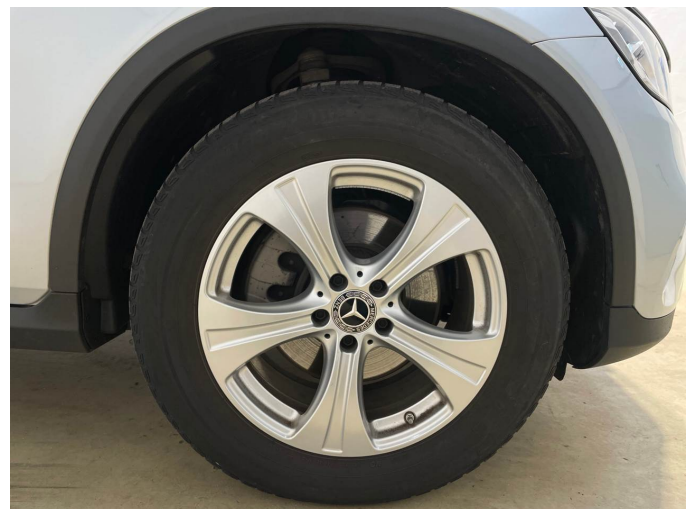
Figure 12: Mounted tyres

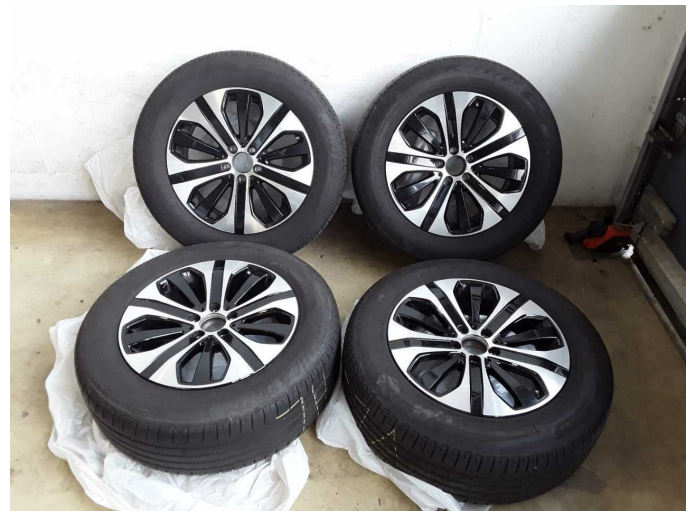
Figure 16: Additional tyres

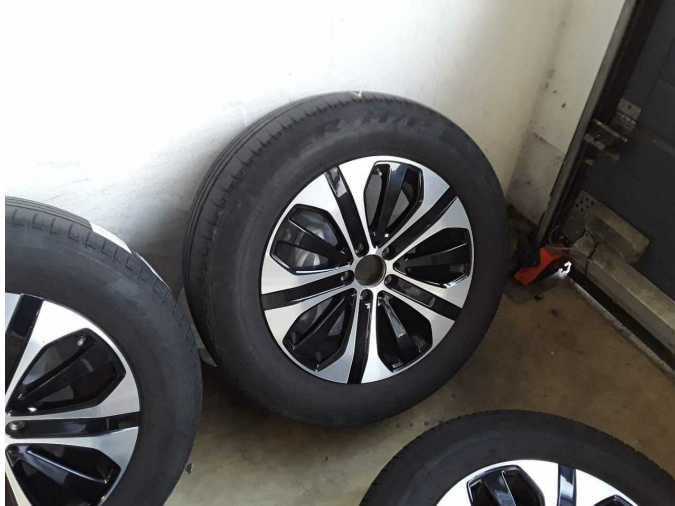
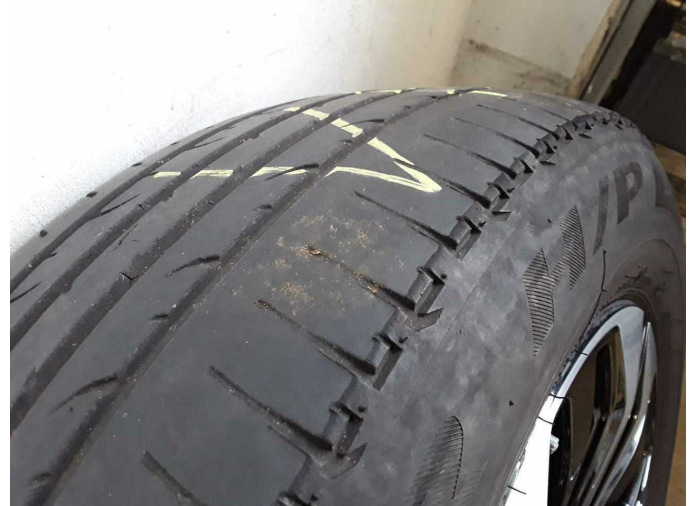
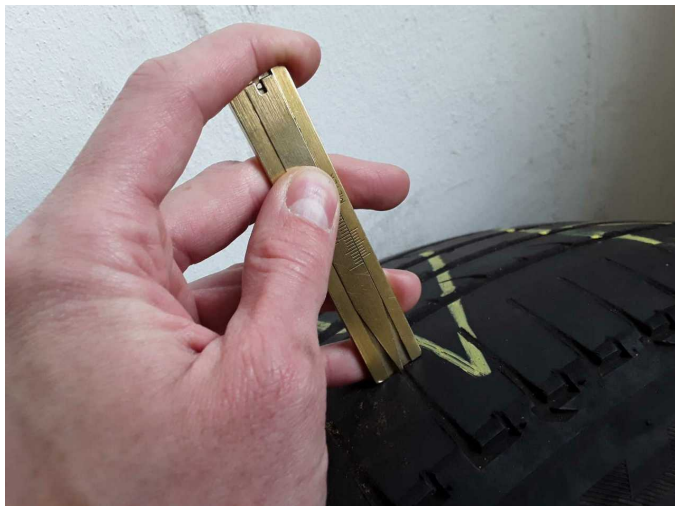
#	Tyre size	Type of tyre	Manufacturer	Tread depth
1)	235/60 R18 103V	Summer tyres on Light alloy	Bridgestone	4mm / 1mm
2)	235/60 R18 103V	Summer tyres on Light alloy	Bridgestone	6mm / 6mm

No.	Component group	Description
1	Misc.	Inspection / maintenance - No evidence - No deduction
2	Misc.	Main inspection - No evidence - No deduction
3	Documents	Service book - Incomplete - No deduction
4	2nd wheel set	1 tyre (Außen abgefahren) - Does not meet the leasing specifications - Replace

Damage 4: 2nd wheel set: 1 tyre (Außen abgefahren) - Does not meet the leasing specifications - Replace

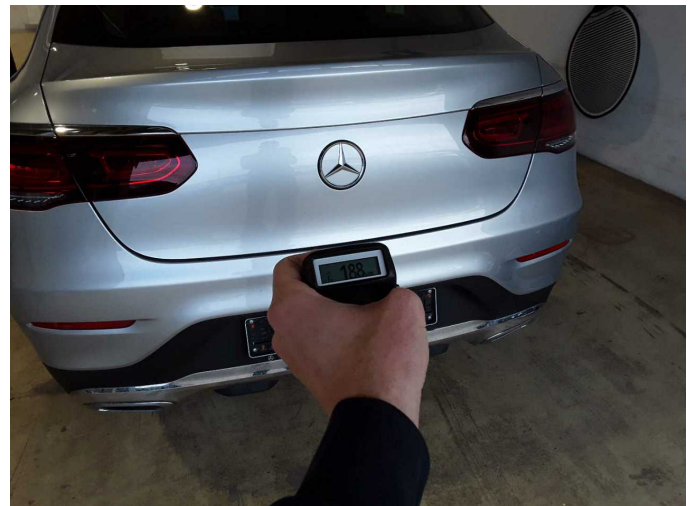
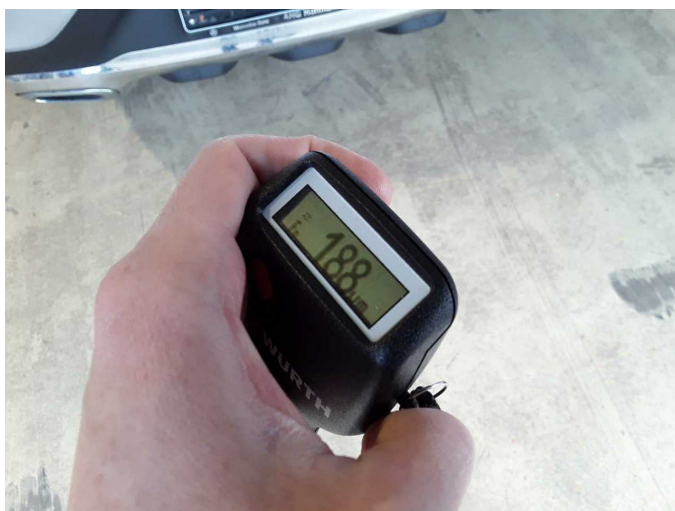
No.	Repainting
1	Boot lid / rear door, Professionally carried out, Invoice of repair done Non-existent
2	Side panel - rear right side, Professionally carried out, Invoice of repair done Non-existent

Repainting 1: Boot lid / rear door

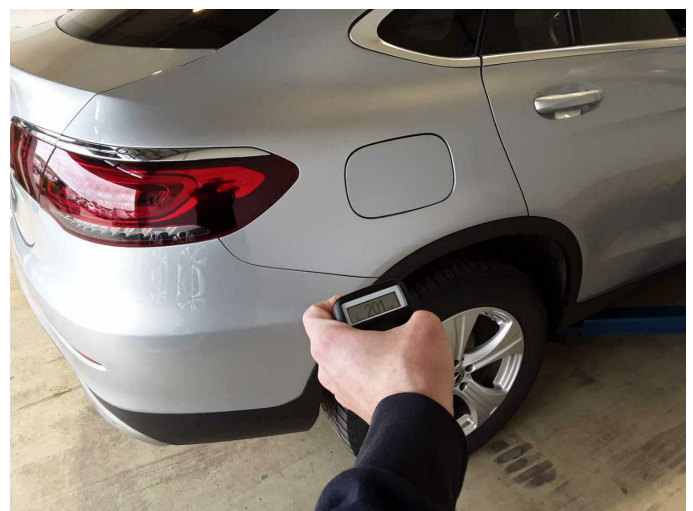
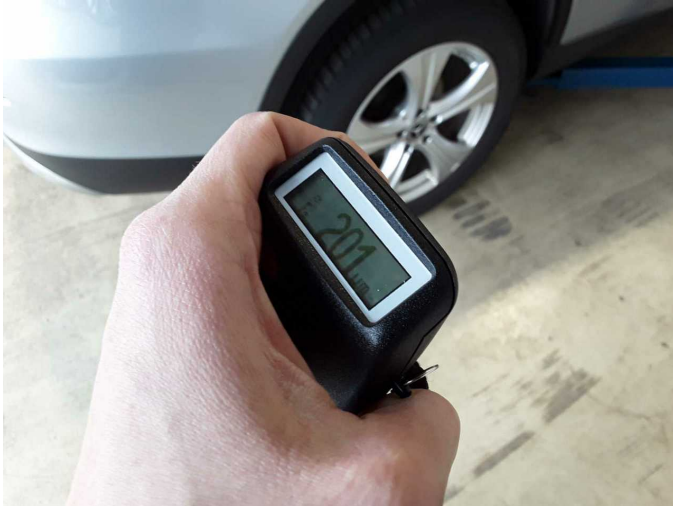
Repainting 2: Side panel - rear right side
