Expertise

Protocol number: 46595469  
Order No. / Reference: 26741758  
Inspection date: 14 Jul 2026

Manufacturer: Volkswagen  
VIN: WVGZZAAZMD000341

Model: up!

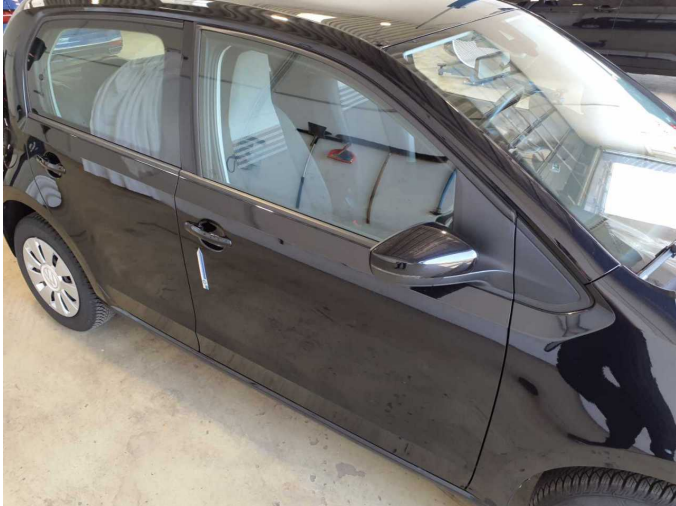
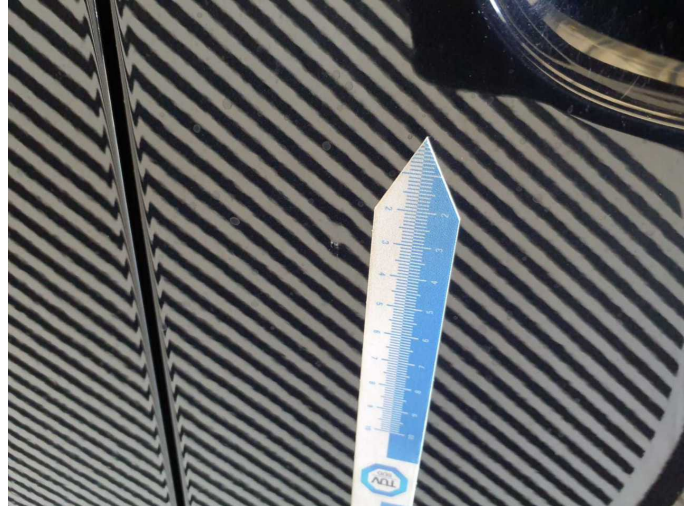
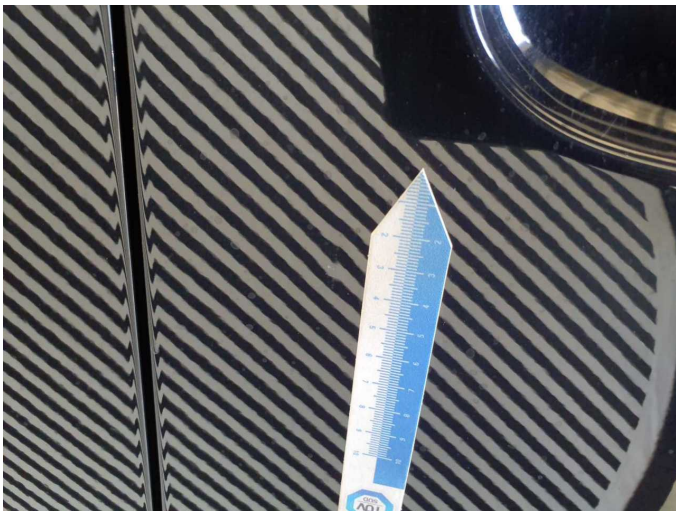
| No. | Component group | Description |
|---|---|---|
| 1 | Door - front right side | Door - dent(s) - Smooth repair work |

**Damage 1:** Door - front right side: Door - dent(s) - Smooth repair work

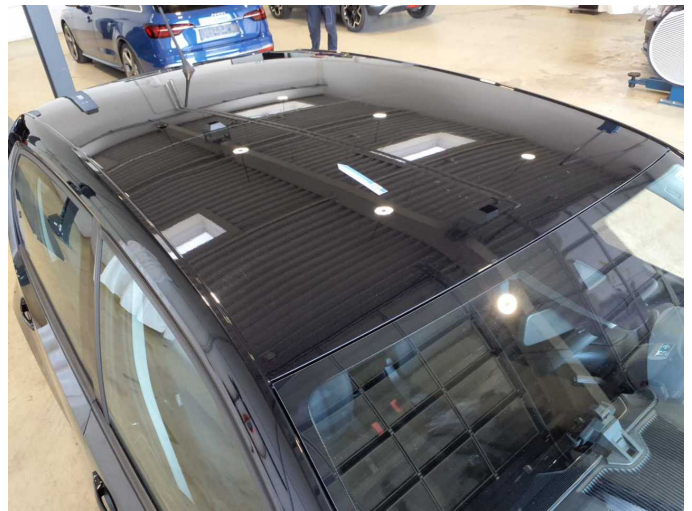
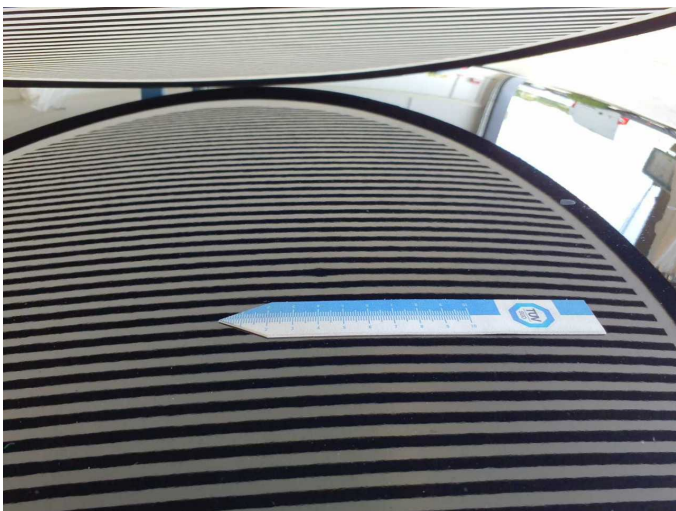
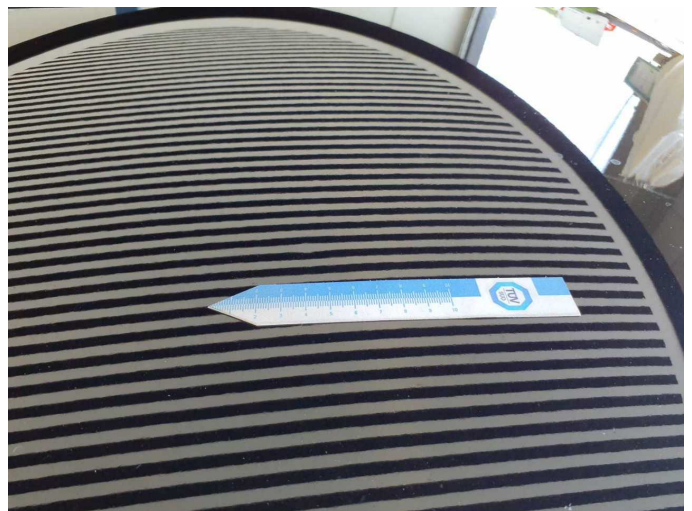
| No. | Component group | Description |
|---|---|---|
| 2 | Roof | Roof - dent(s) - Smooth repair work |

**Damage 2:** Roof: Roof - dent(s) - Smooth repair work

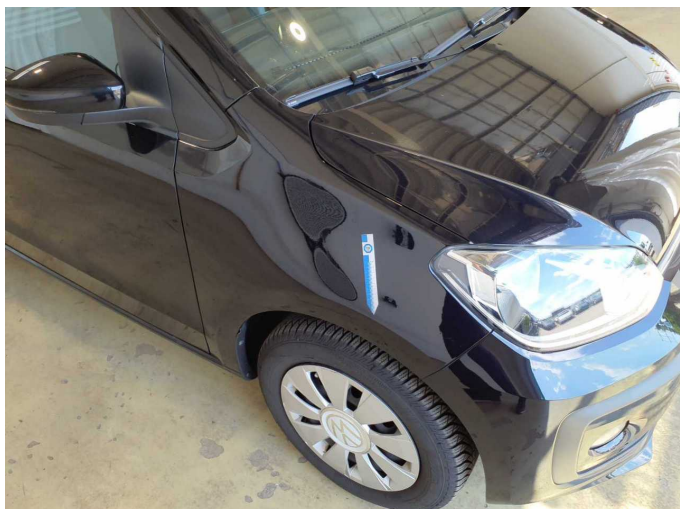
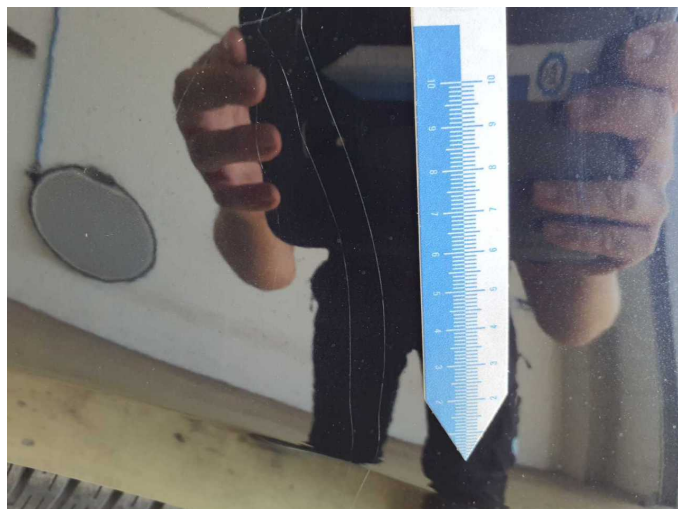
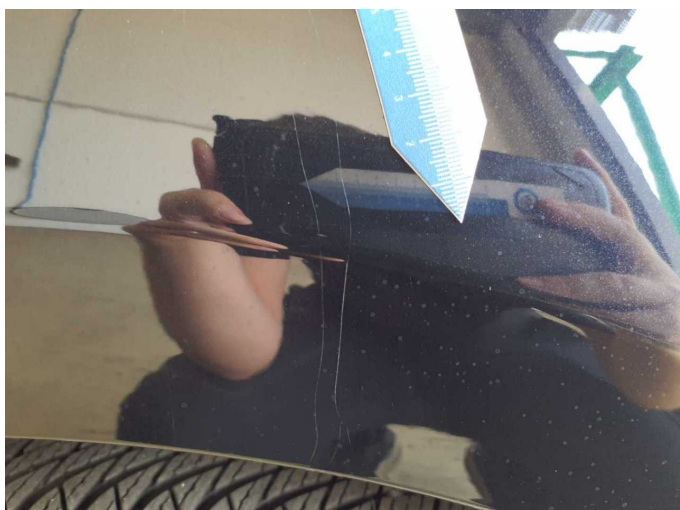
| No. | Component group | Description |
|---|---|---|
| 4 | Mudguard - right side | Mudguard - right side - Scratch(es) - Paint |

**Damage 4:** Mudguard - right side: Mudguard - right side - Scratch(es) - Paint

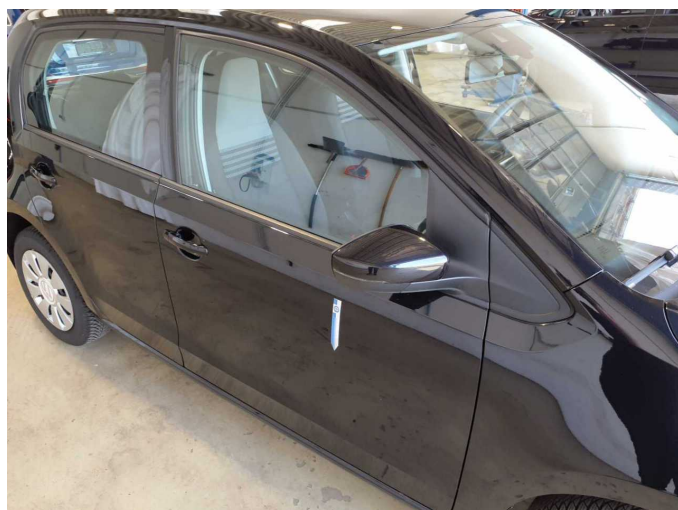
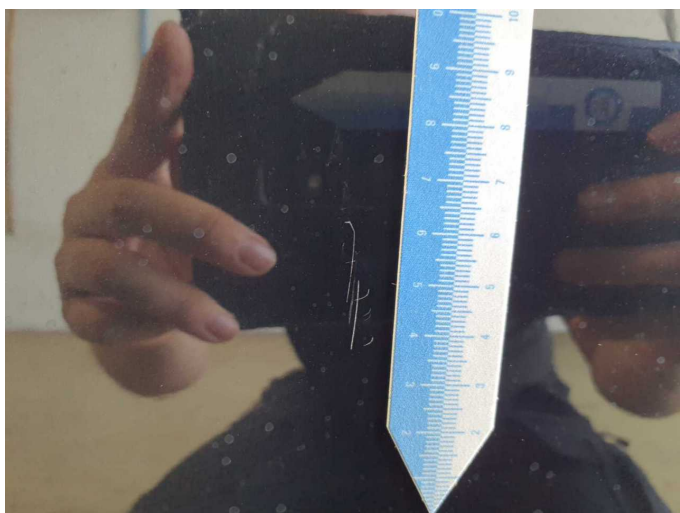
| No. | Component group | Description |
|---|---|---|
| 5 | Door - front right side | Door - Scratch(es) - Paint |

**Damage 5:** Door - front right side: Door - Scratch(es) - Paint
