Expertise

Protocol number: 45927319
Order No. / Reference: 26484450
Inspection date: 12 Jun 2026

Model: GLE 350 e 4Matic 9G-TRONIC AMG Line

VIN: W1N1671541A689840

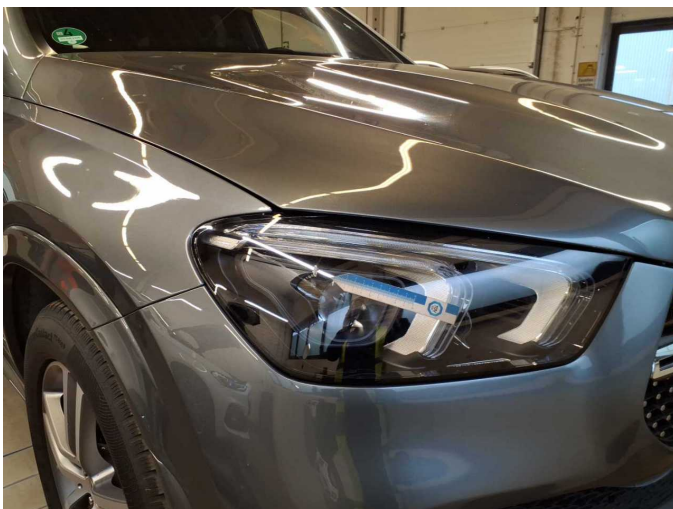
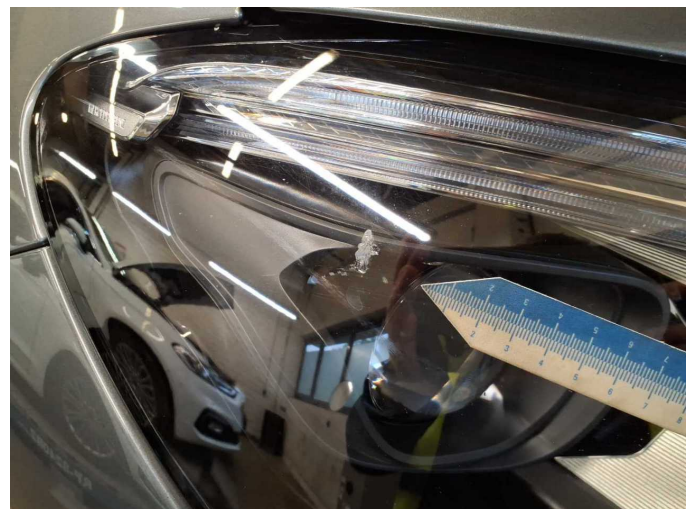
| No. | Component group | Description |
|---|---|--|
| 1 | Headlight | Headlight - right side (Harzflecken) - Paint defect - Smart repair |

Damage 1: Headlight: Headlight - right side (Harzflecken) - Paint defect - Smart repair

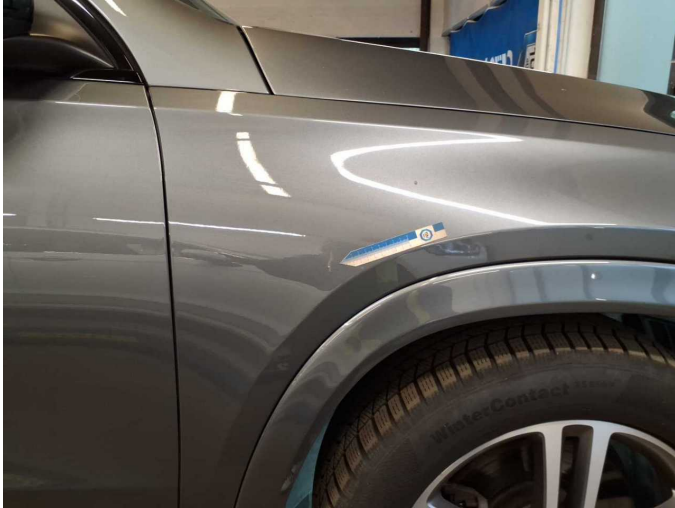
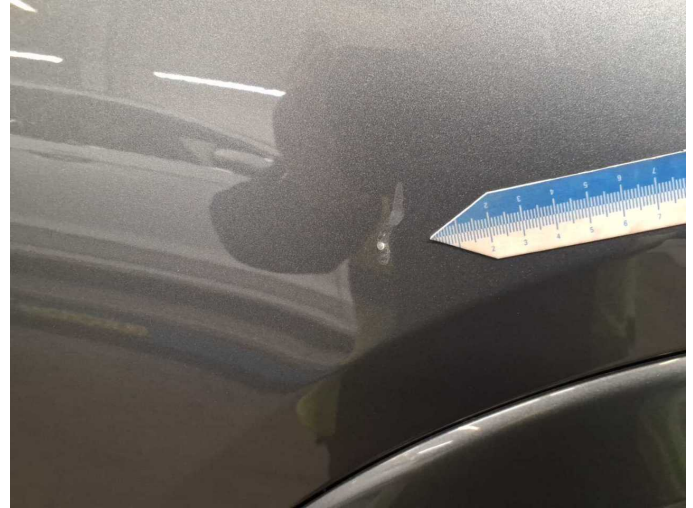
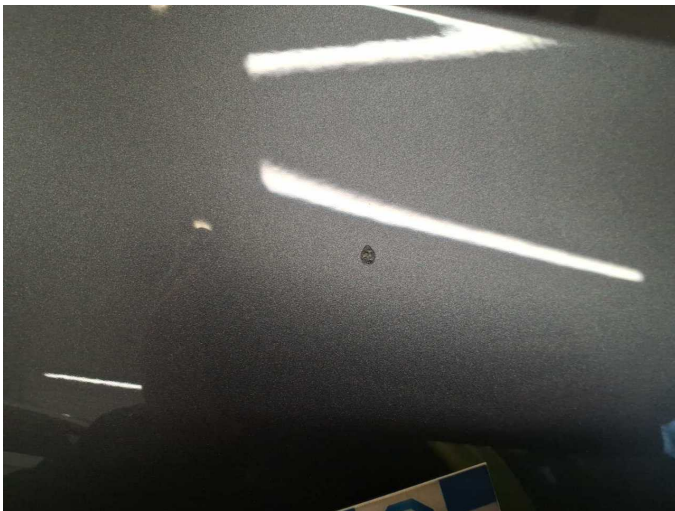
| No. | Component group | Description |
|---|---|--|
| 2 | Mudguard - right side | Mudguard - right side (Harzflecken-Mehrkosten möglich) - Paint defect - Conditioning |

Damage 2: Mudguard - right side: Mudguard - right side (Harzflecken-Mehrkosten möglich) - Paint defect - Conditioning

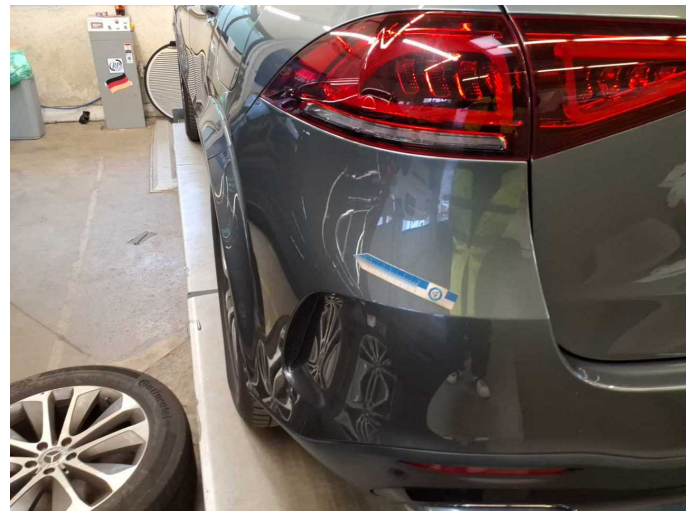
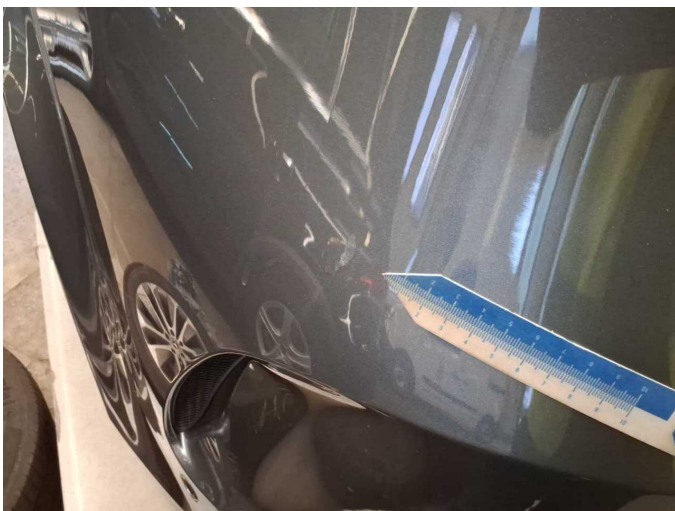
| No. | Component group | Description |
|---|---|--|
| 3 | Rear bumper | Rear bumper (Harzflecken-Mehrkosten möglich) - Paint defect - Conditioning |

Damage 3: Rear bumper: Rear bumper (Harzflecken-Mehrkosten möglich) - Paint defect - Conditioning

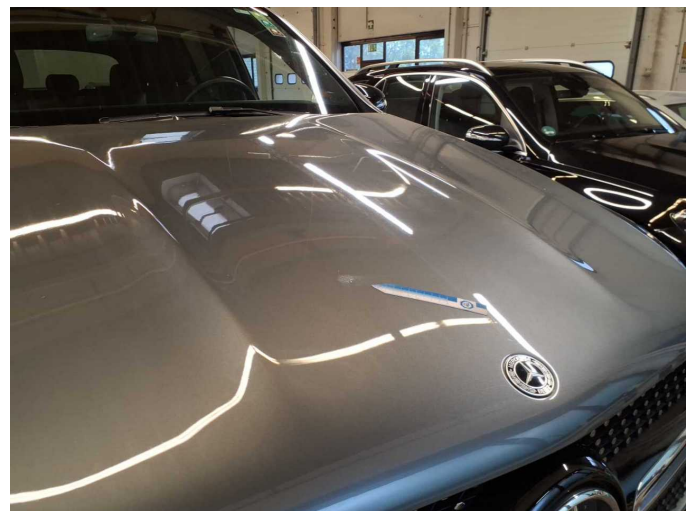
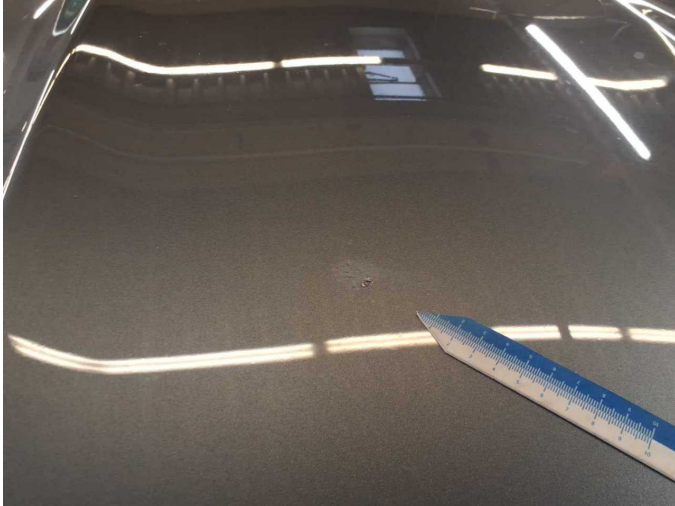
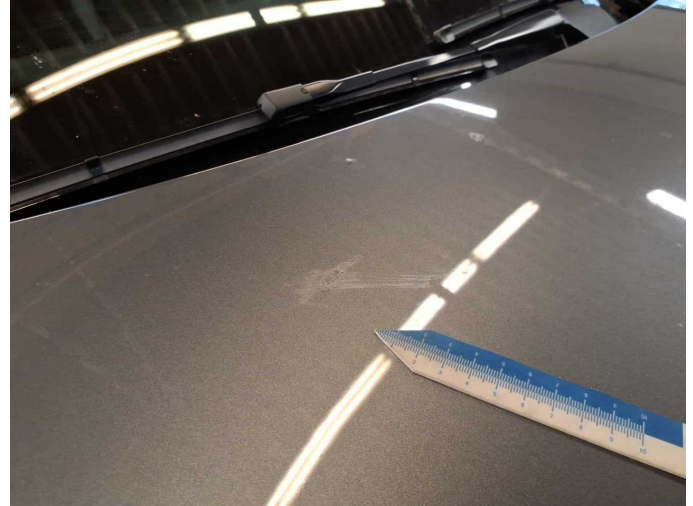
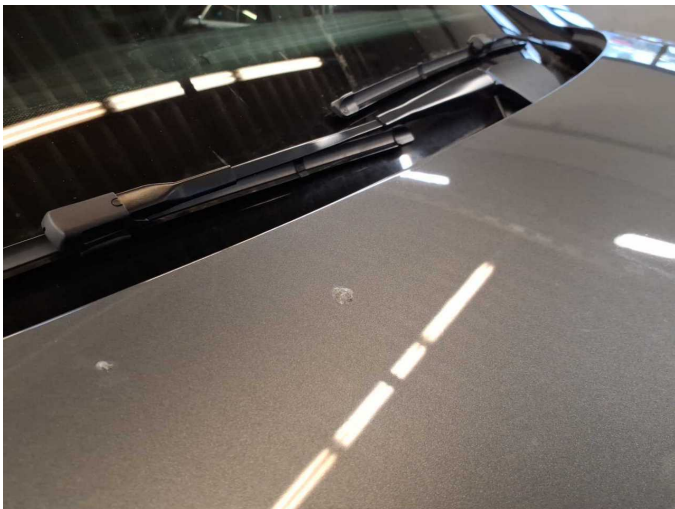
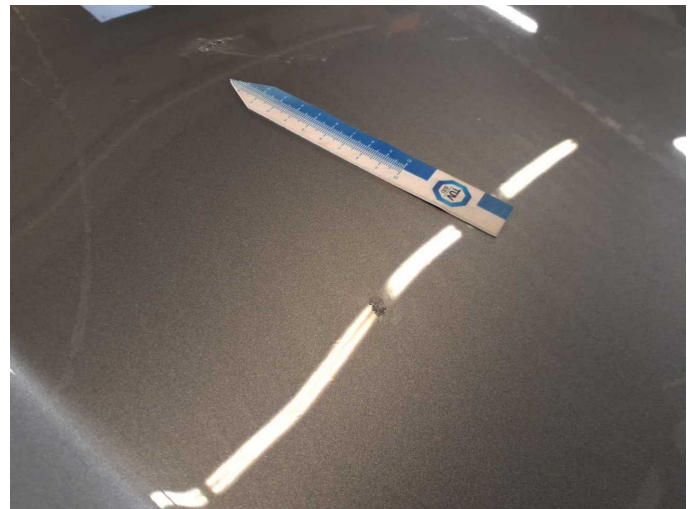
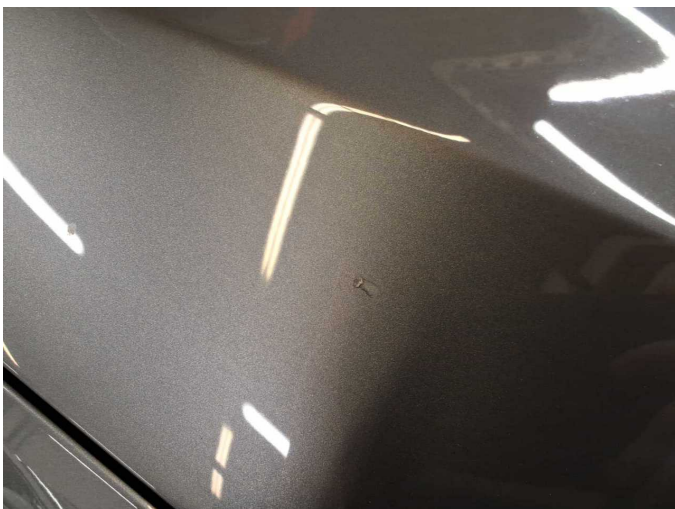
| No. | Component group | Description |
|---|---|--|
| 4 | Bonnet | Bonnet (Harzflecken-Mehrkosten möglich) - Paint defect - Conditioning |

Damage 4: Bonnet: Bonnet (Harzflecken-Mehrkosten möglich) - Paint defect - Conditioning

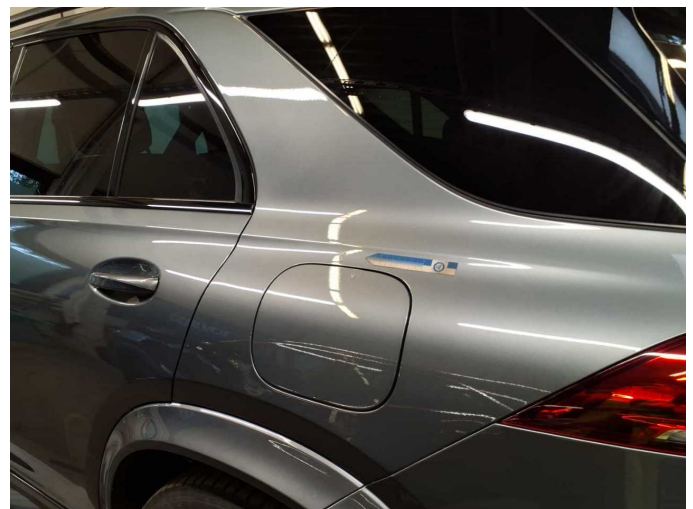
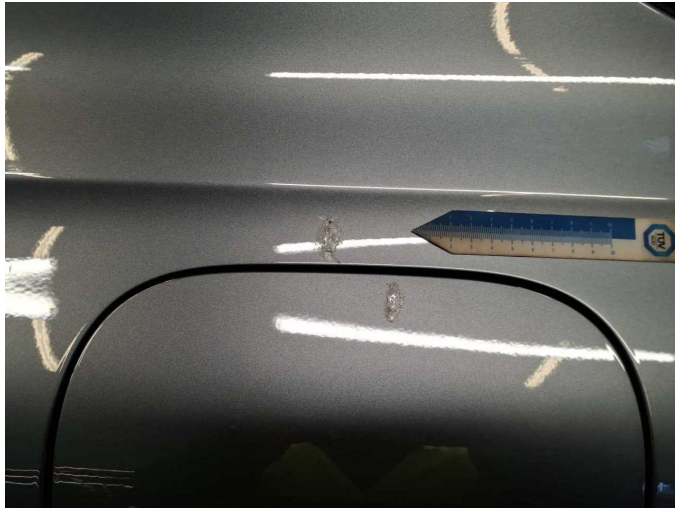
| No. | Component group | Description |
|---|---|--|
| 5 | Side panel - rear left side | Side panel (Harzflecken-Mehrkosten möglich) - Paint defect - Conditioning |

Damage 5: Side panel - rear left side: Side panel (Harzflecken-Mehrkosten möglich) - Paint defect - Conditioning

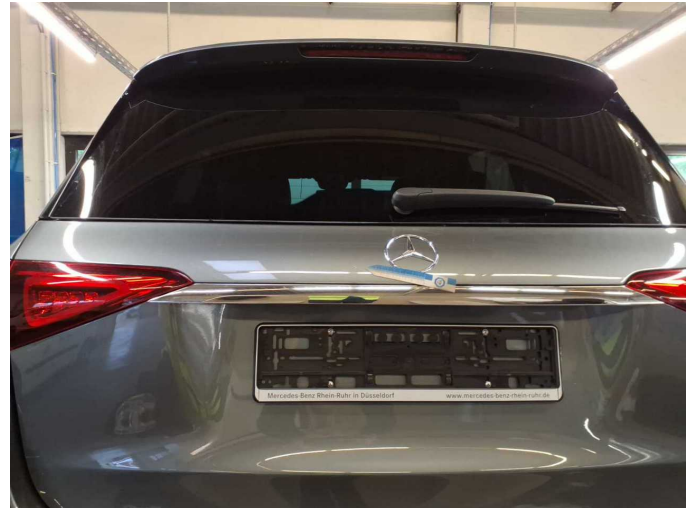
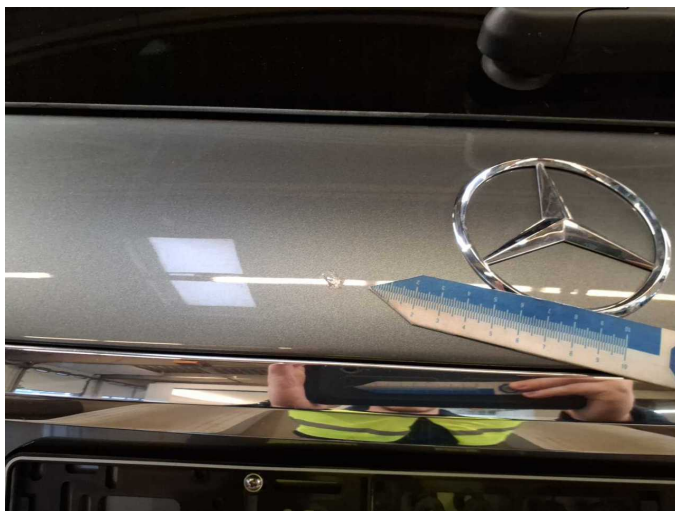
| No. | Component group | Description |
|---|---|--|
| 6 | Boot lid / rear door | Boot lid (Harzflecken-Mehrkosten möglich) - Paint defect - Conditioning |

Damage 6: Boot lid / rear door: Boot lid (Harzflecken-Mehrkosten möglich) - Paint defect - Conditioning

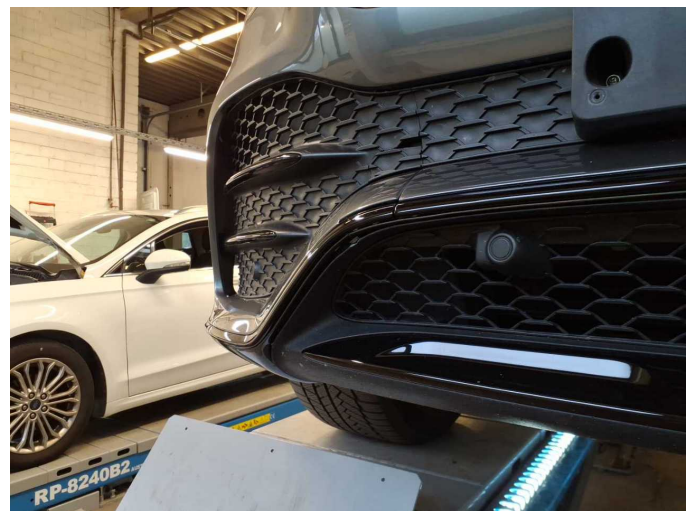
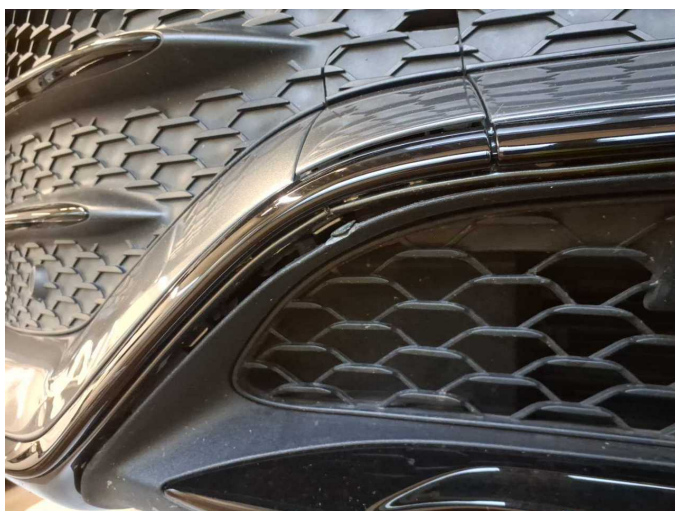
| No. | Component group | Description |
|---|---|--|
| 7 | Front bumper | Grille - Broken / torn - Replace |

Damage 7: Front bumper: Grille - Broken / torn - Replace

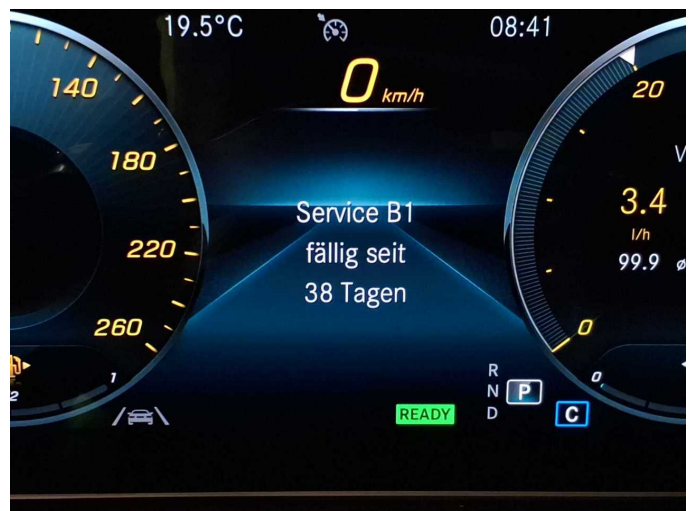
| No. | Component group | Description |
|---|---|--|
| 8 | Misc. | Inspection / maintenance - Due - Perform |

Damage 8: Misc.: Inspection / maintenance - Due - Perform

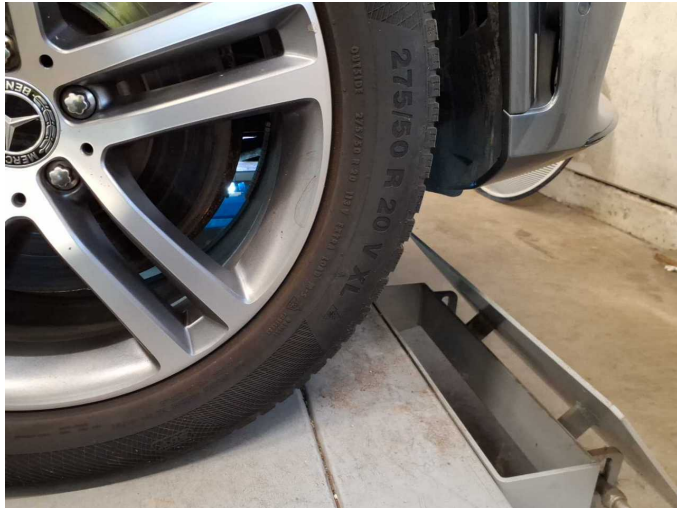
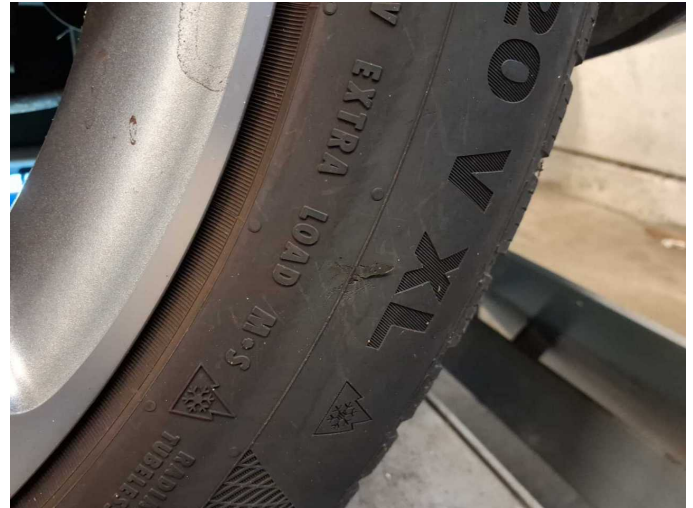
| No. | Component group | Description |
|---|---|---|
| 1 | Wheel / tyres | Tyre - front right side (nicht fahrbereit) - Broken / torn - No deduction |

Wear and tear 1: Wheel / tyres: Tyre - front right side (nicht fahrbereit) - Broken / torn - No deduction

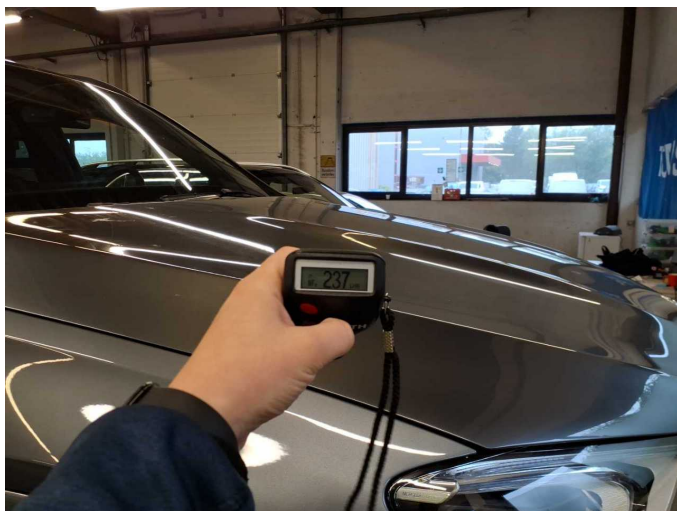
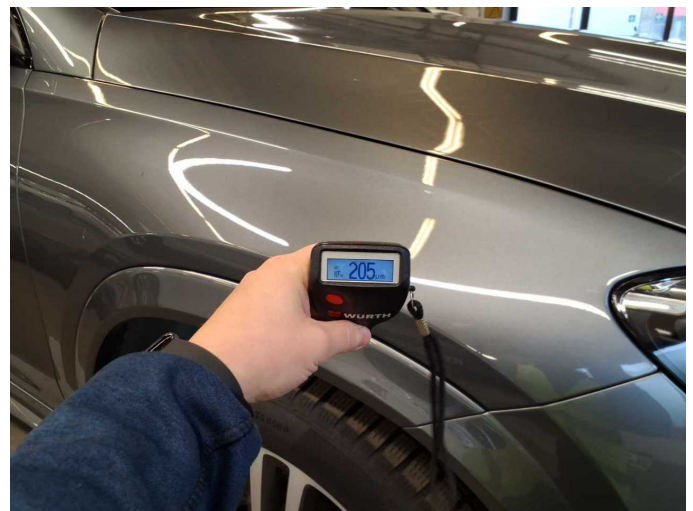
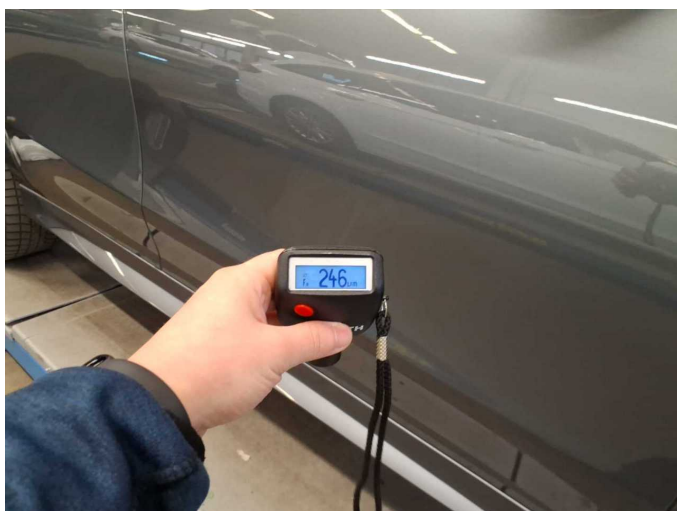
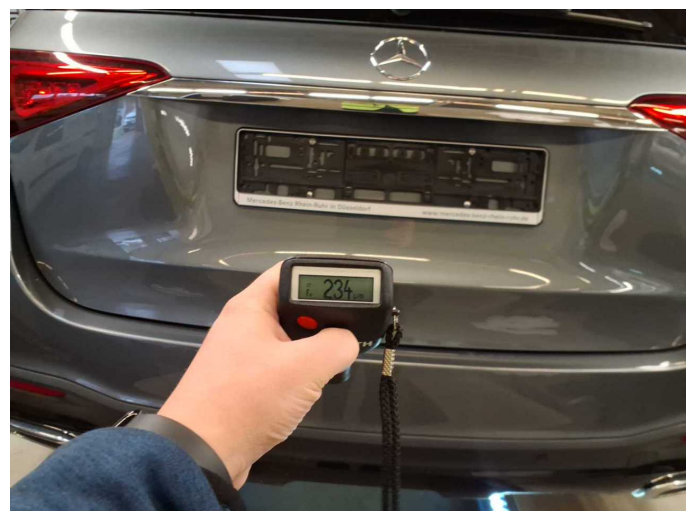
| No. | Repainting |
|---|---|
| 1 | Boot lid / rear door, Mudguard - right side, Bonnet, Door - front right side, Professionally carried out, Invoice of repair done Non-existent |

| Boot lid / rear door | 234 µm | Mudguard - right side | 205 µm |
| Bonnet | 237 µm | Door - front right side | 246 µm |

Repainting 1: Boot lid / rear door, Mudguard - right side, Bonnet, Door - front right side
