Expertise

Protocol number: 46183048  
Order No. / Reference: 26616884  
Inspection date: 25 Jun 2026

Manufacturer: Ford

Model: Focus Turnier 1.5 EcoBlue Start-Stopp-System Aut.  
COOL&CONNECT

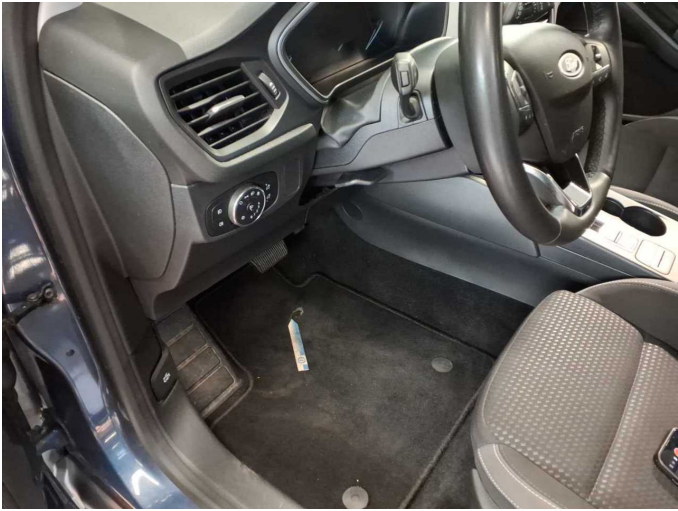
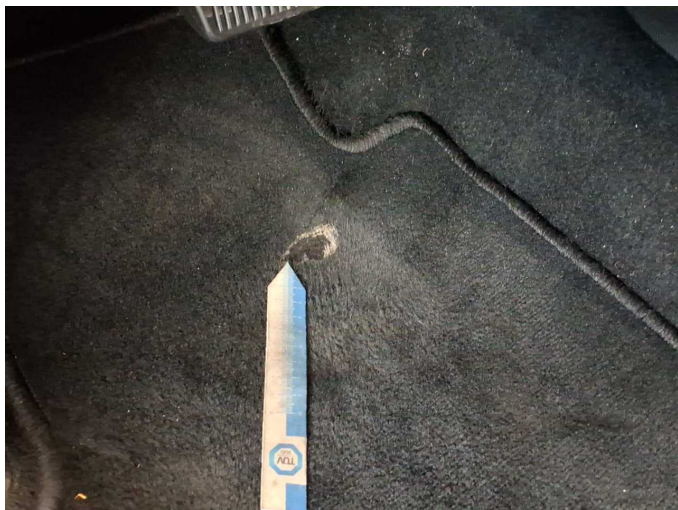
| No. | Component group | Description |
|---|---|---|
| 1 | Trim / covers | Floor mats - Holes - Replace |

Damage 1: Trim / covers: Floor mats - Holes - Replace

**Damage 1:** Trim / covers: Floor mats - Holes - Replace

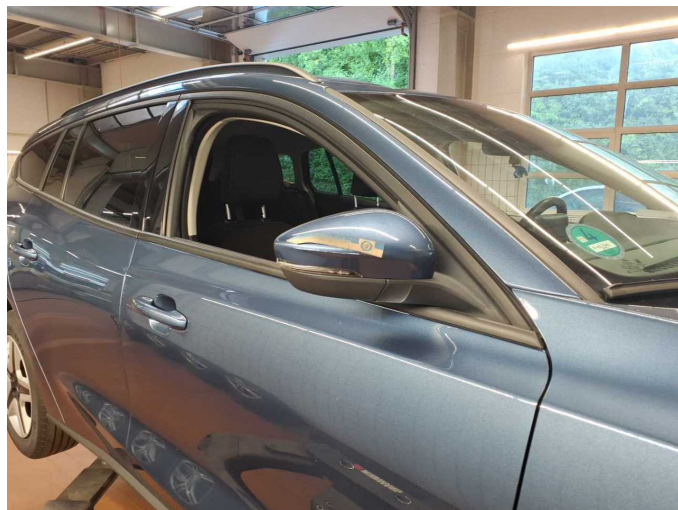
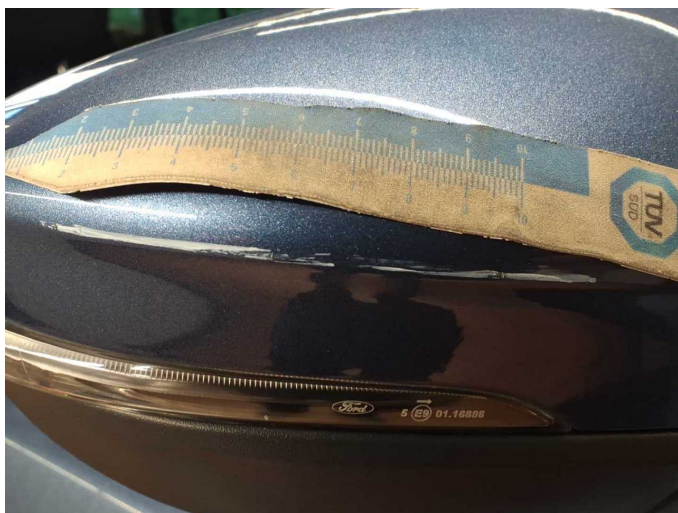
| No. | Component group | Description |
|---|---|---|
| 2 | Wing mirror - right side | Cap - Scratch(es) - Smart repair |

**Damage 2:** Wing mirror - right side: Cap - Scratch(es) - Smart repair

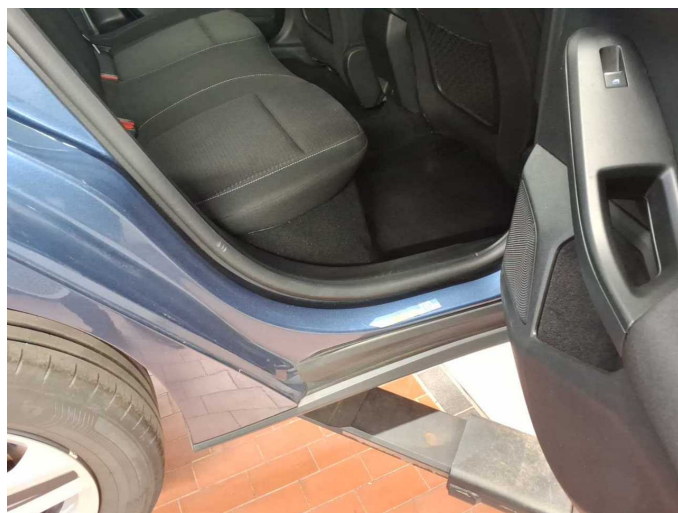
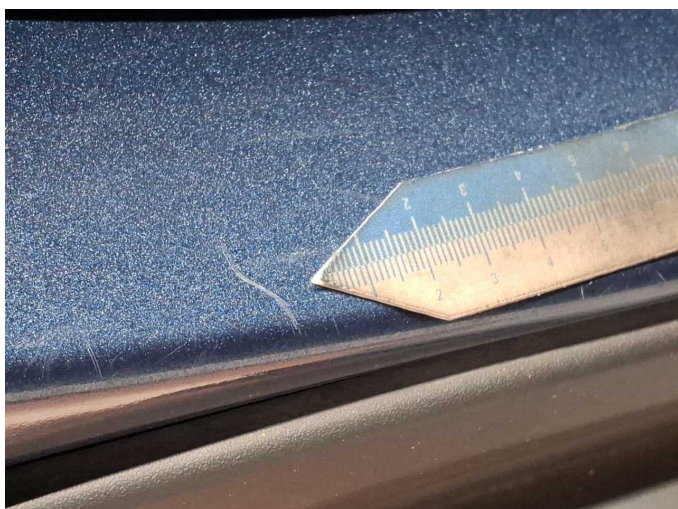
| No. | Component group | Description |
|---|---|---|
| 3 | Side panel - rear right side | Sill - Scratch(es) - Smart repair |

**Damage 3:** Side panel - rear right side: Sill - Scratch(es) - Smart repair

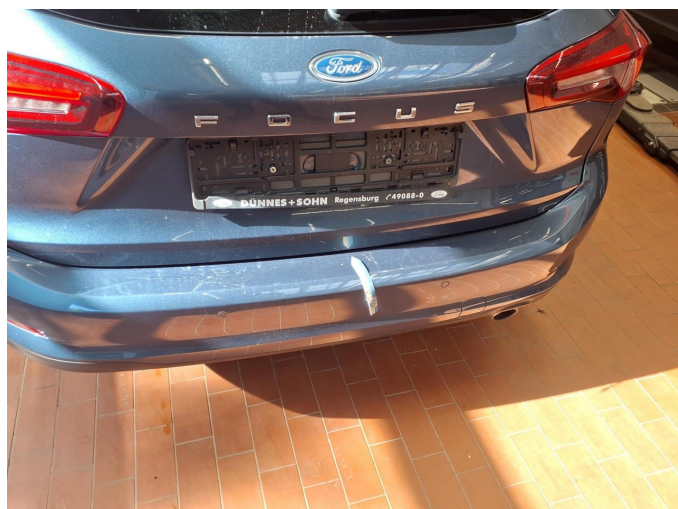
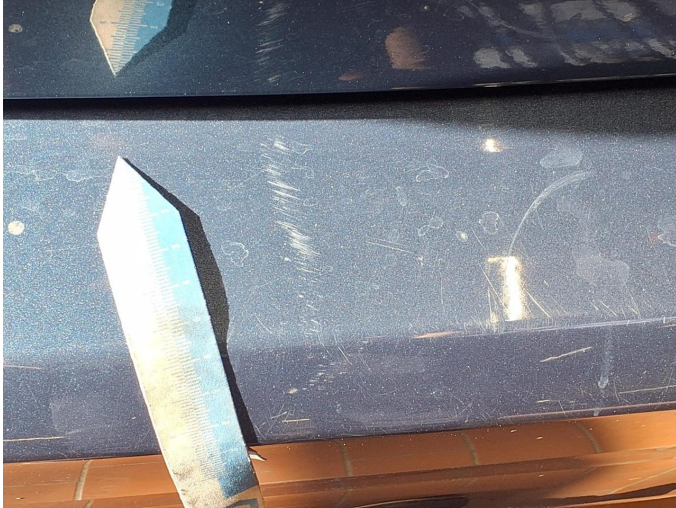
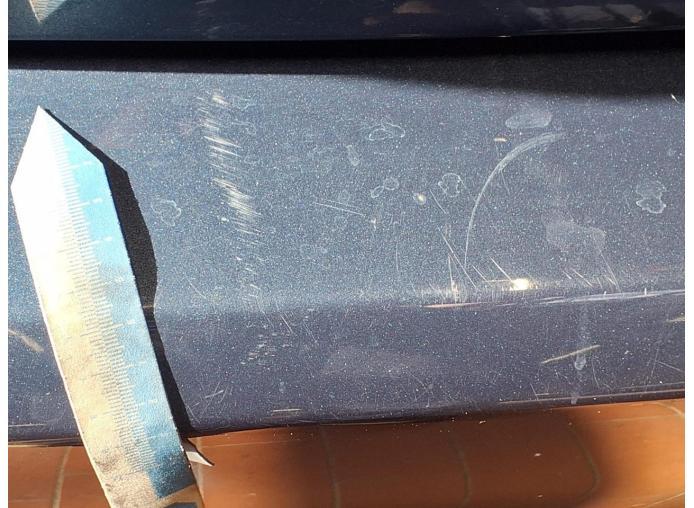
| No. | Component group | Description |
|---|---|---|
| 4 | Rear bumper | Rear bumper - Scratch(es) - Smart repair |

**Damage 4:** Rear bumper: Rear bumper - Scratch(es) - Smart repair

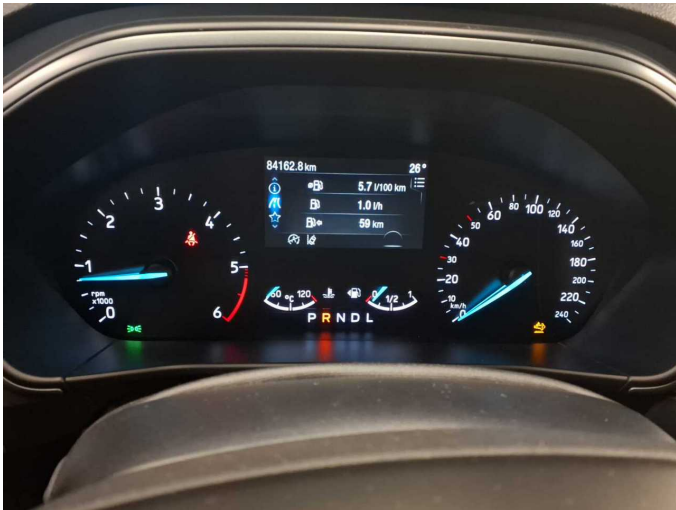
| Engine function test | An engine test run was performed, problem has been detected<br>This is due to the following reason.:<br>Kontrollleuchte Abgasnachbehandlung aktiv |

| No. | Component group | Description |
|---|---|---|
| 5 | Instrument panel | Indicator light (Abgasnachbehandlung) - Electrical fault - Perform diagnosis |

**Damage 5:** Instrument panel: Indicator light (Abgasnachbehandlung) - Electrical fault - Perform diagnosis

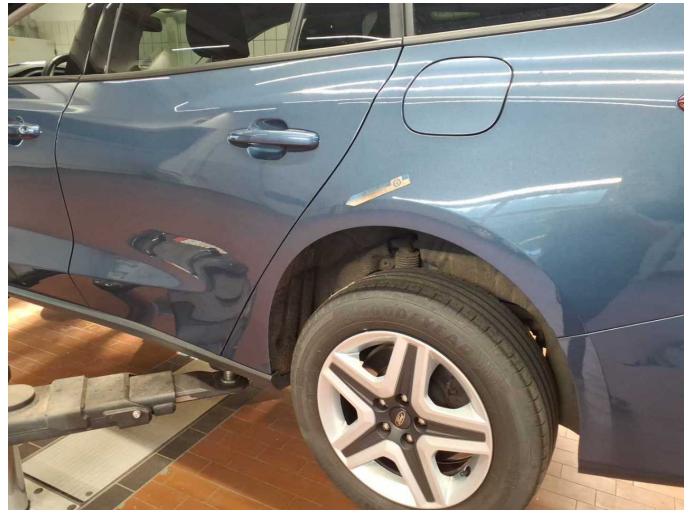
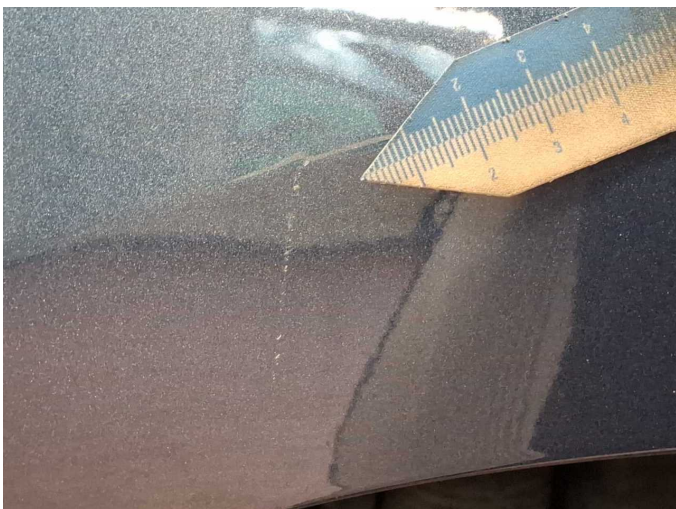
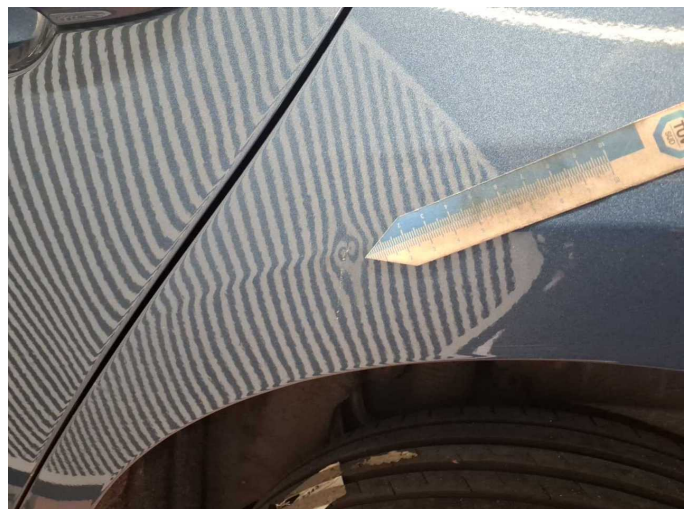
| No. | Component group | Description |
|---|---|---|
| 6 | Side panel - rear left side | Side panel - Dent / paintcoat damage - Smart repair |

**Damage 6:** Side panel - rear left side: Side panel - Dent / paintcoat damage - Smart repair

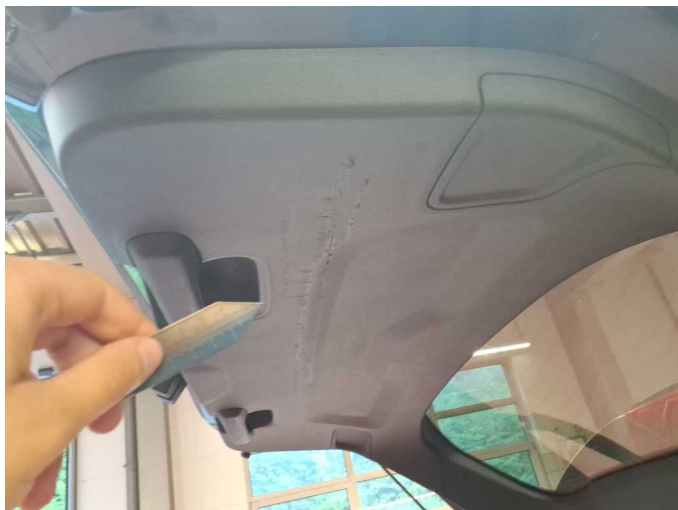
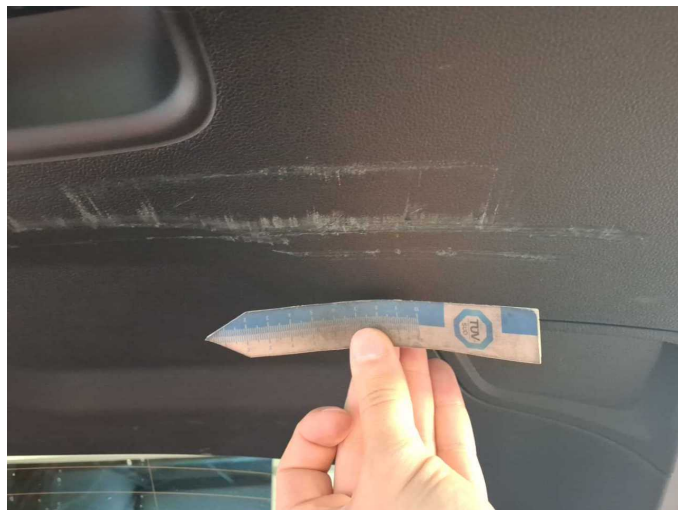
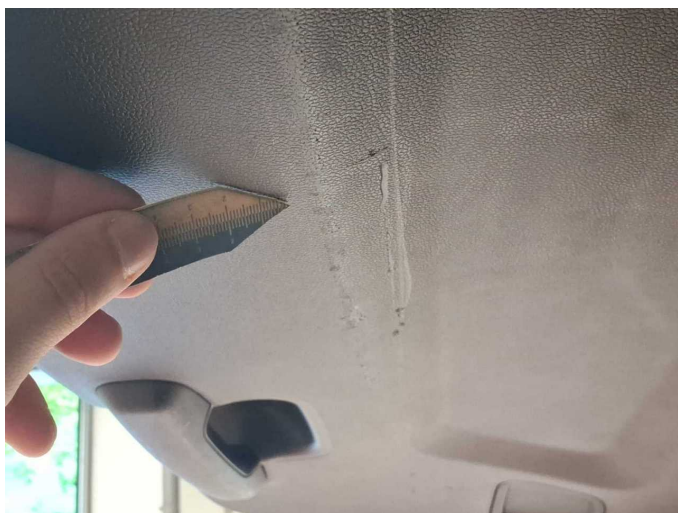
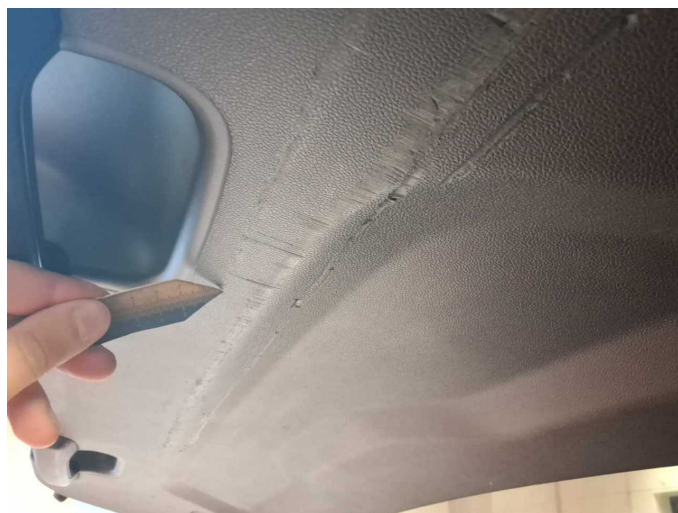
| No. | Component group | Description |
|---|---|---|
| 7 | Trim / covers | Boot lid - interior trim - Scratched - Replace |

**Damage 7:** Trim / covers: Boot lid - interior trim - Scratched - Replace

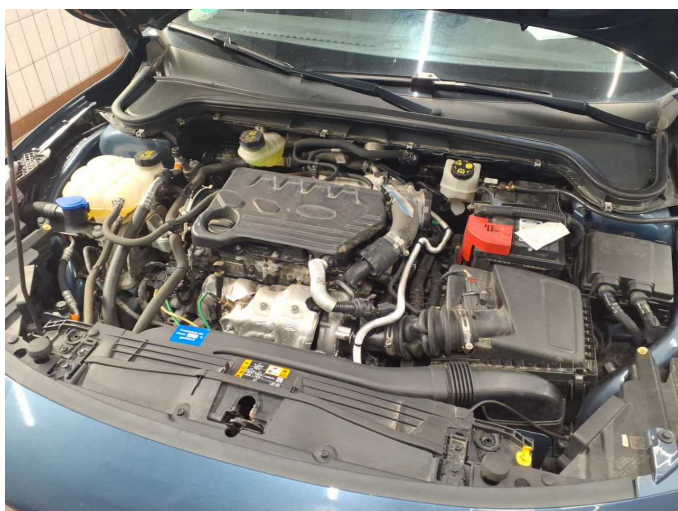
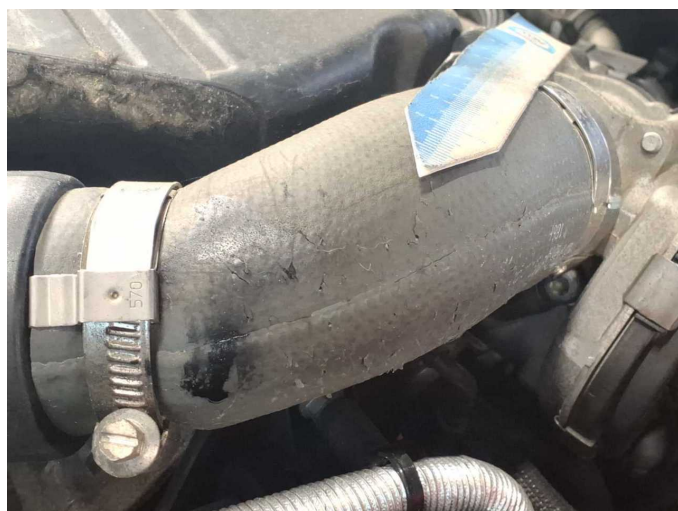
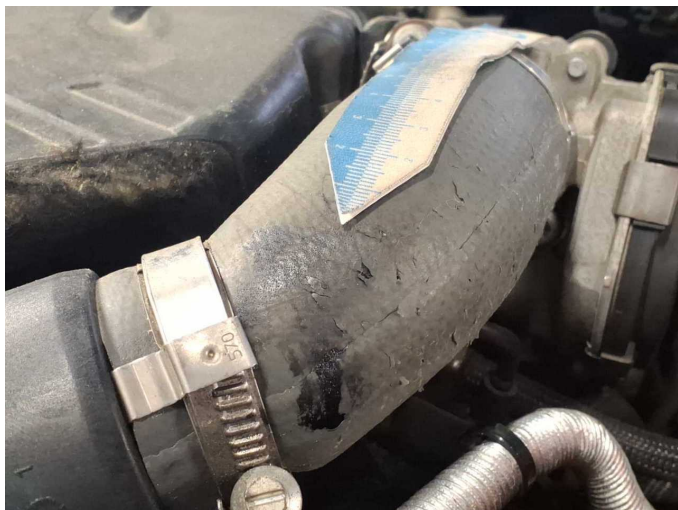
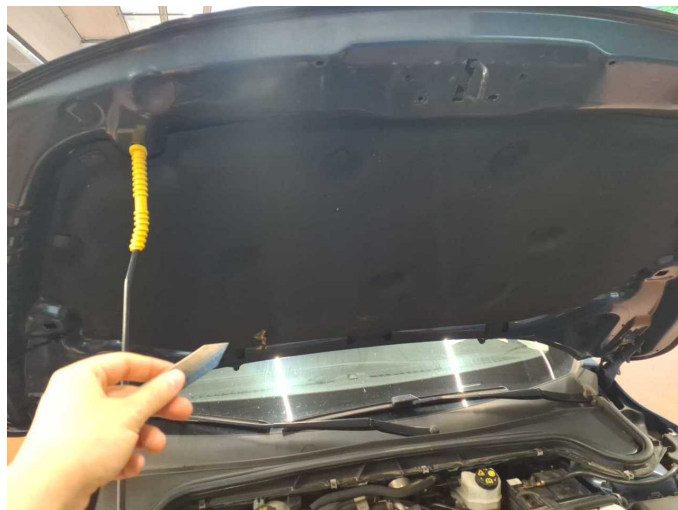
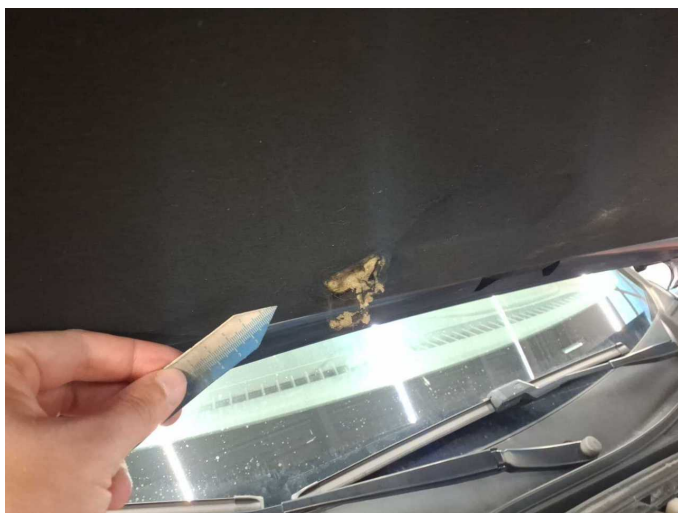
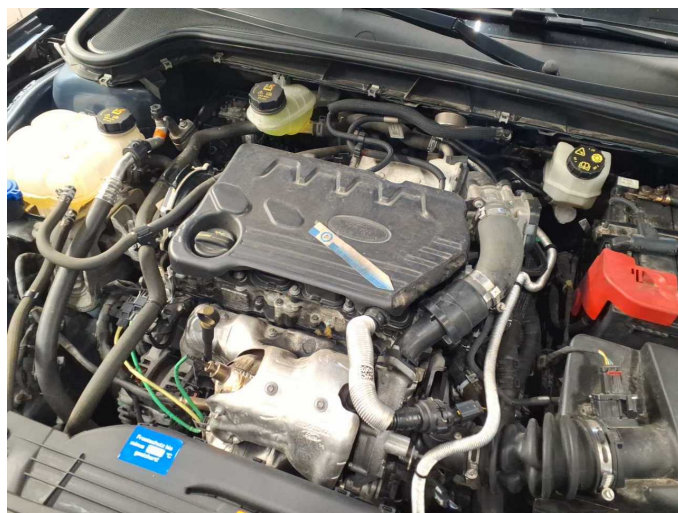
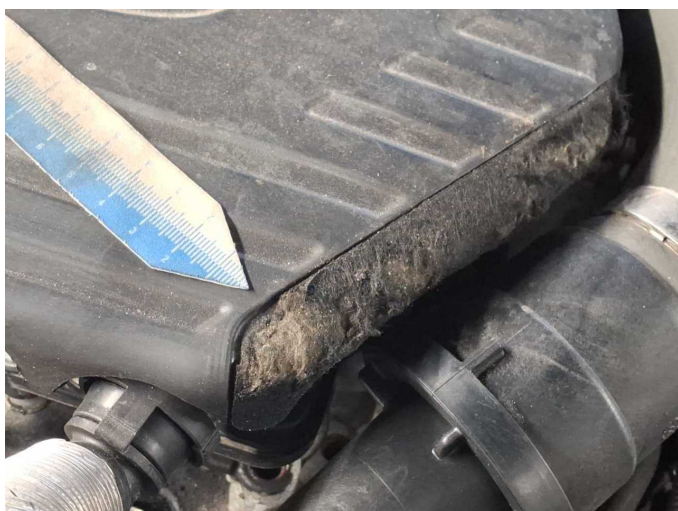
| No. | Component group | Description |
|---|---|---|
| 8 | Engine | Hose turbocharger (+ Dämmmatte Motorhaube, Motorabdeckung) - Damage caused by marten / rodent - Replace |

**Damage 8:** Engine: Hose turbocharger (+ Dämmmatte Motorhaube, Motorabdeckung) - Damage caused by marten / rodent - Replace

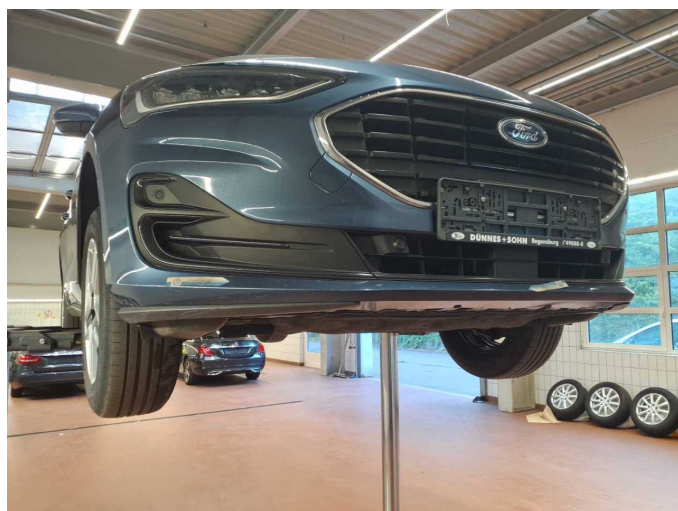
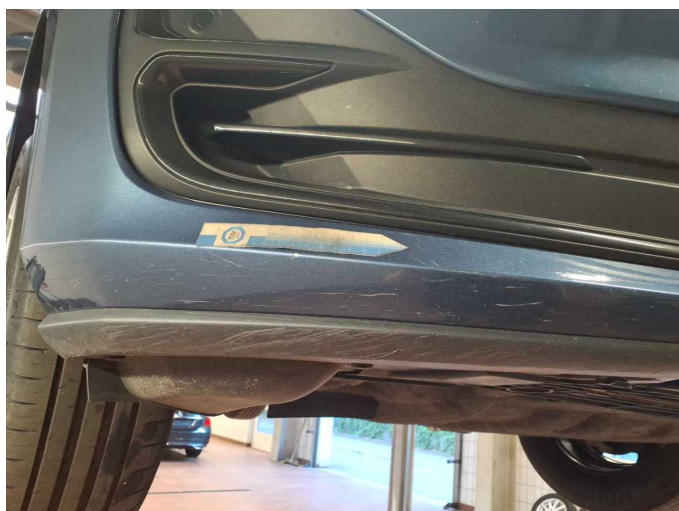
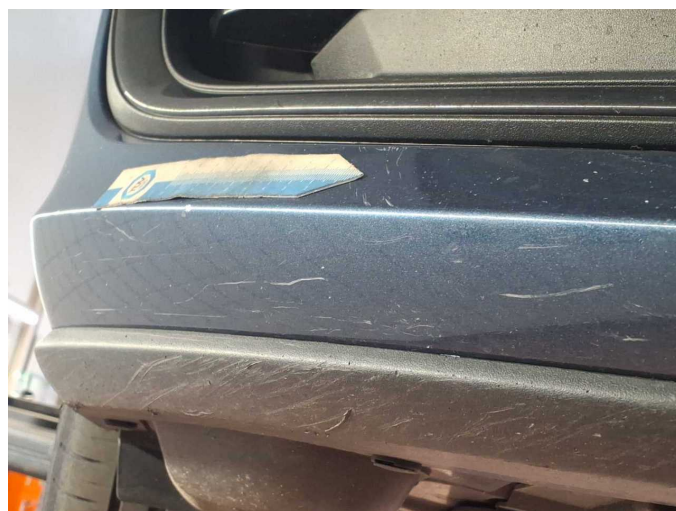
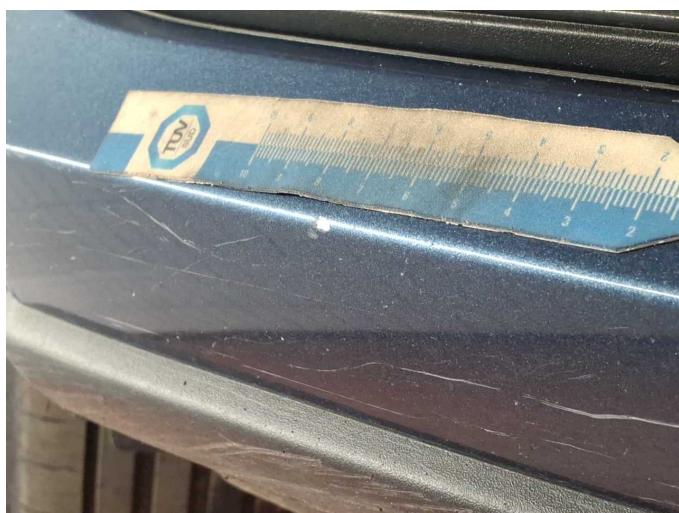
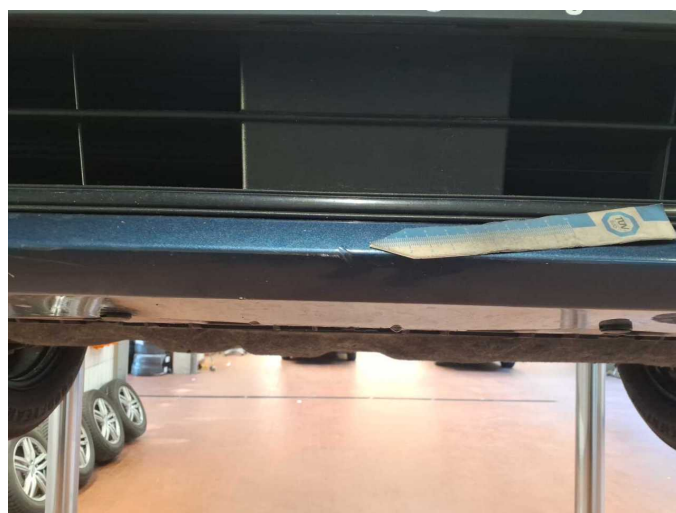
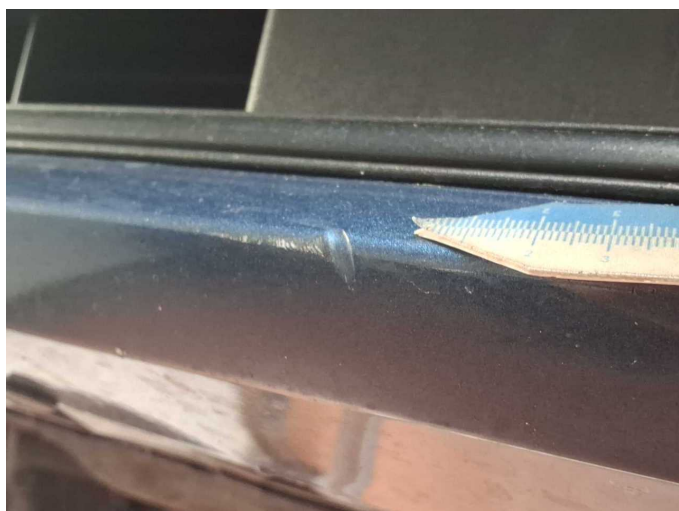
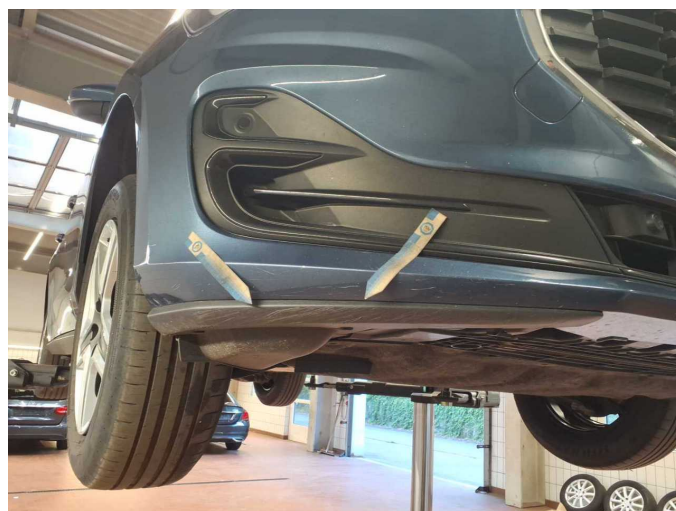
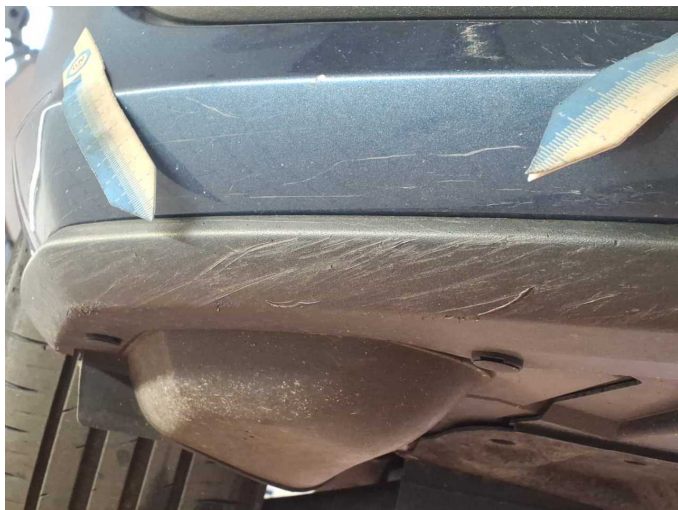
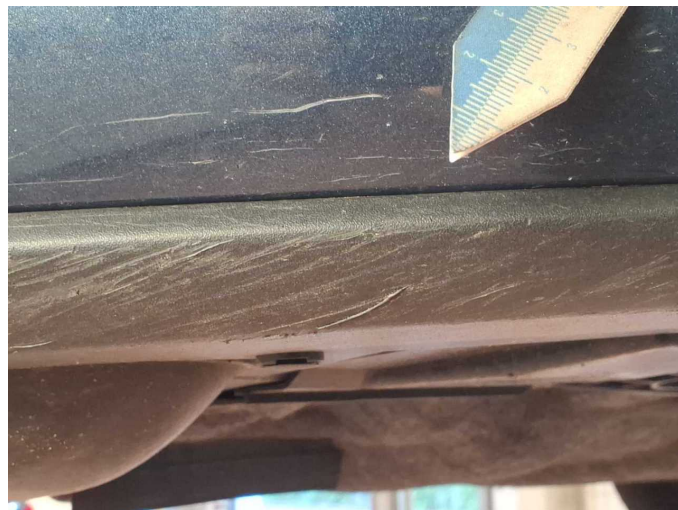
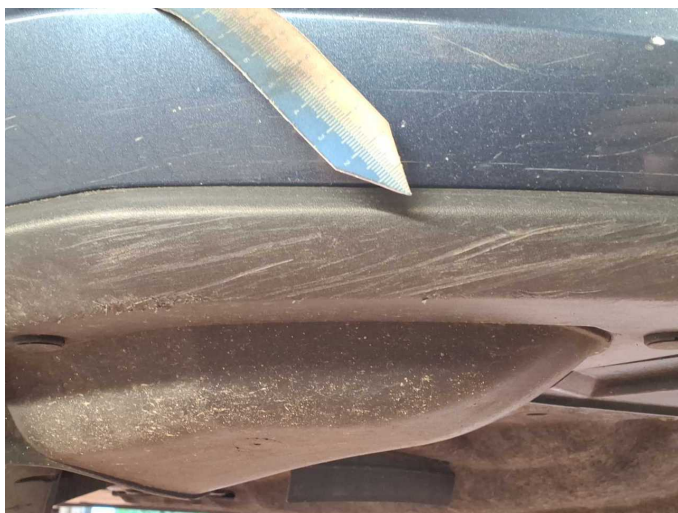
| No. | Component group | Description |
|---|---|---|
| 9 | Front bumper | Front bumper (+ Spoiler rechts verschürft erneuern) - Scratched - Repair and paint |

**Damage 9:** Front bumper: Front bumper (+ Spoiler rechts verschürft erneuern) - Scratched - Repair and paint

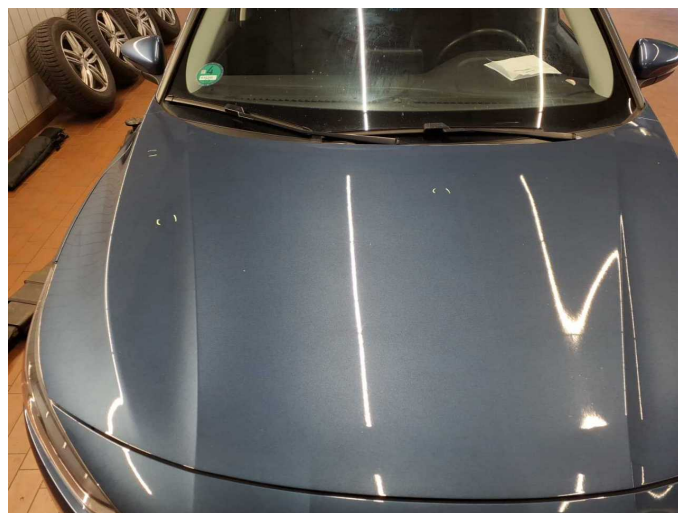
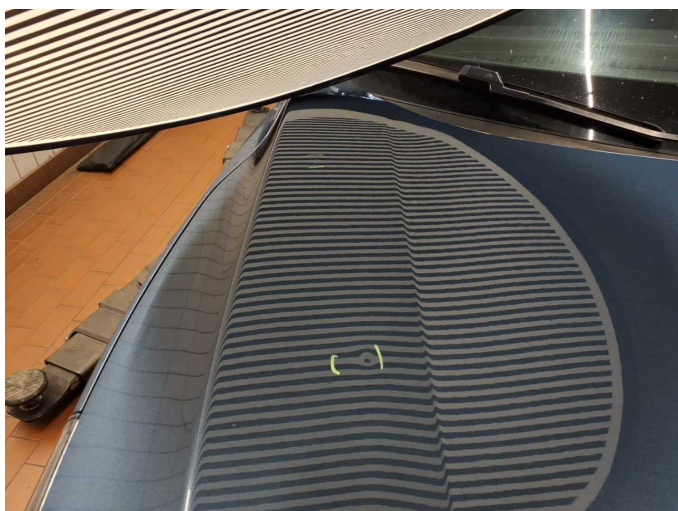
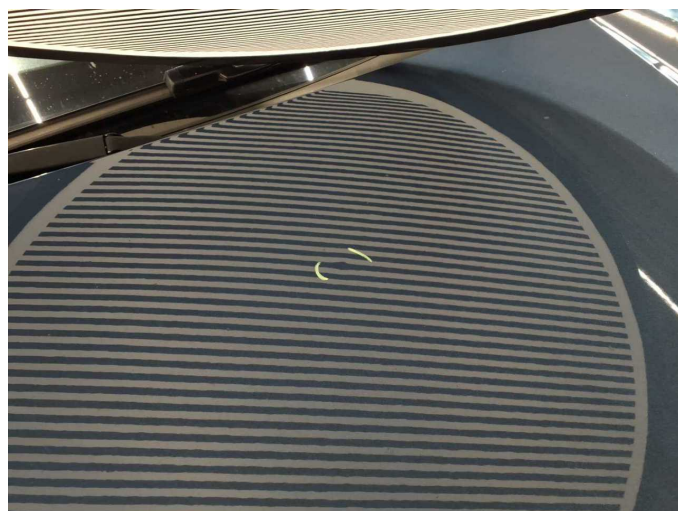
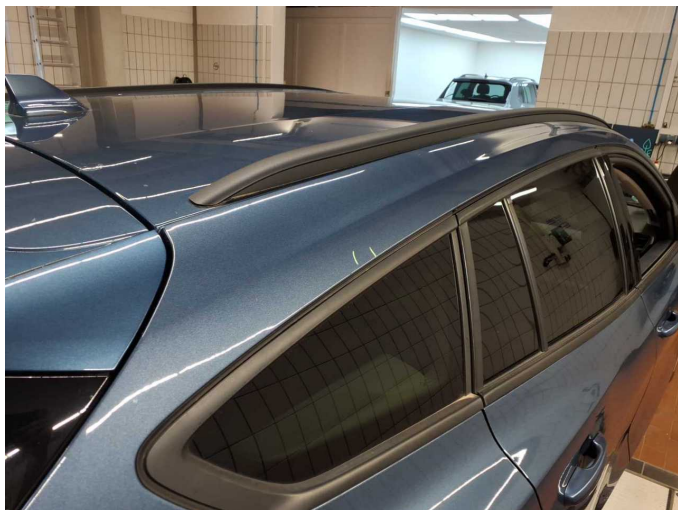
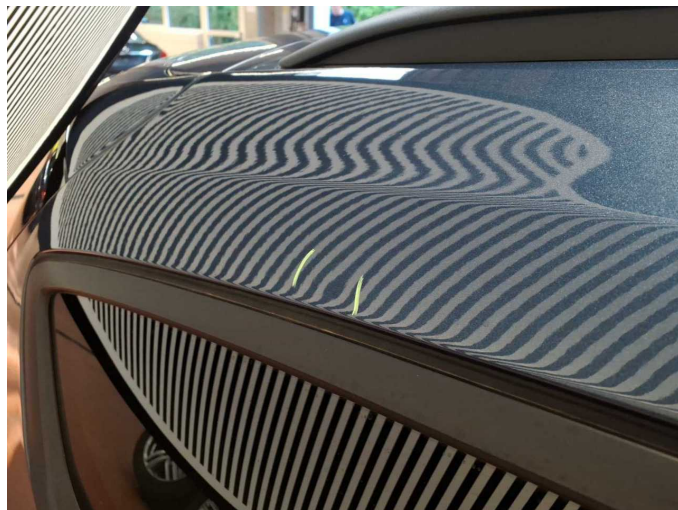
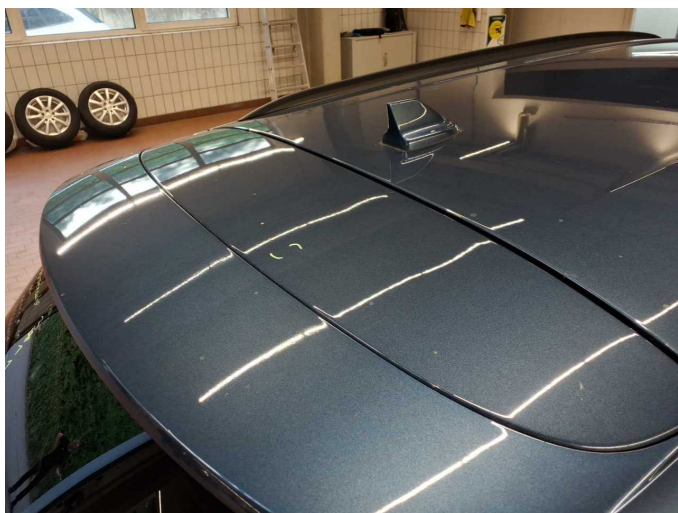
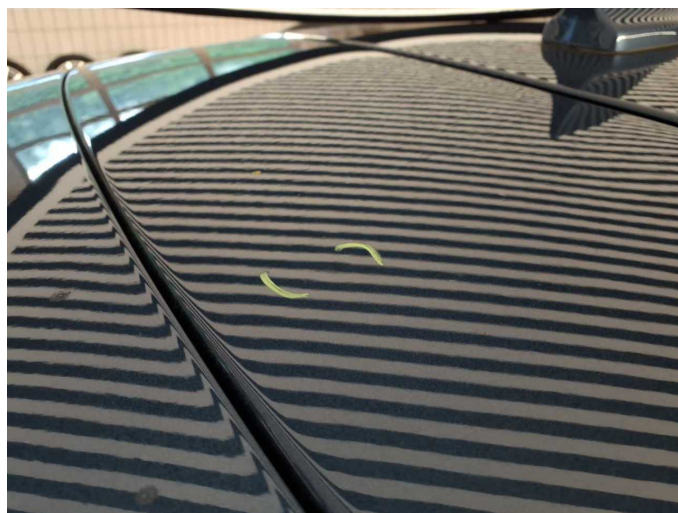
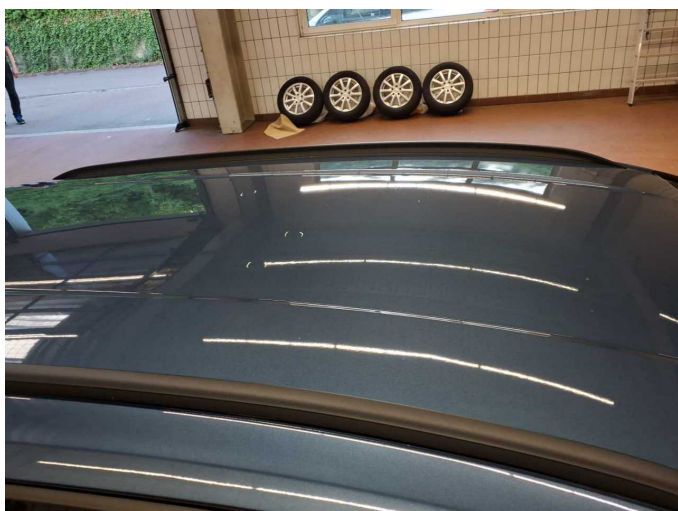
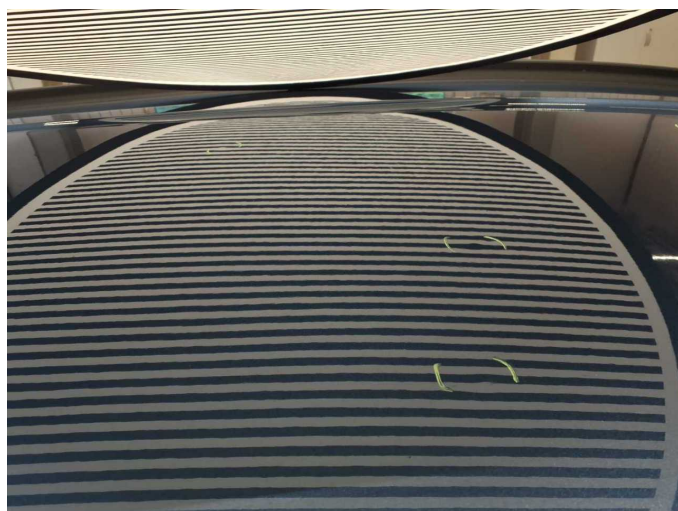
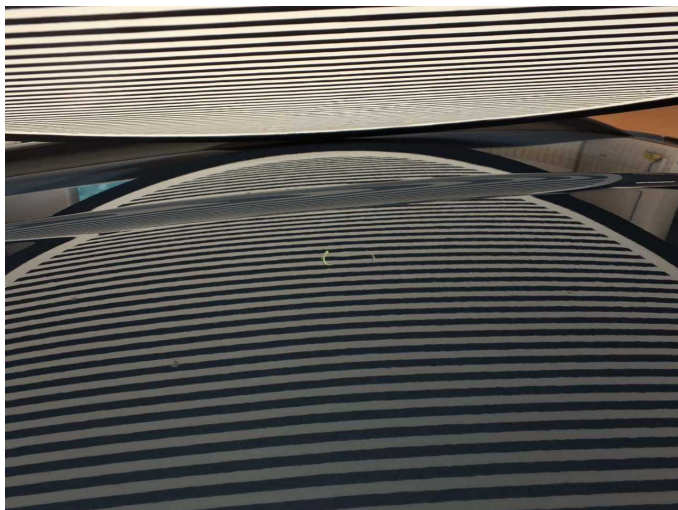
| No. | Component group | Description |
|---|---|---|
| 10 | Body | Body - Damage by hail - Smooth repair work |

**Damage 10:** Body: Body - Damage by hail - Smooth repair work

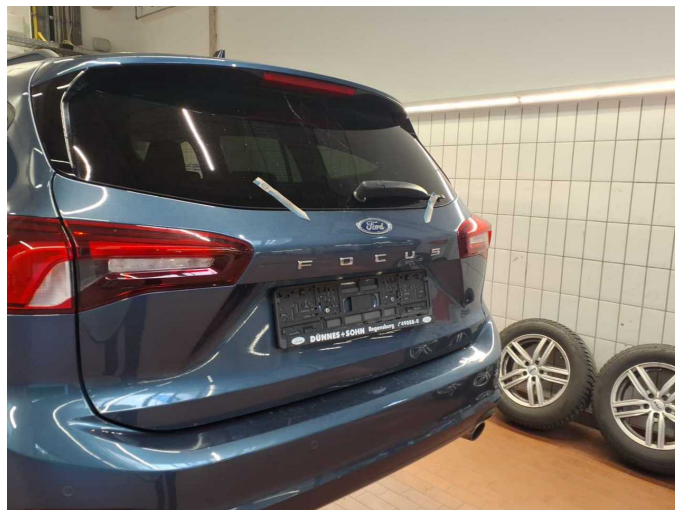
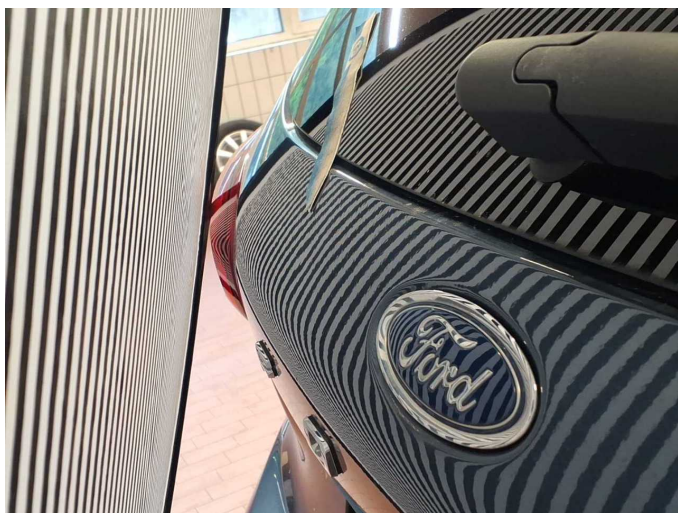
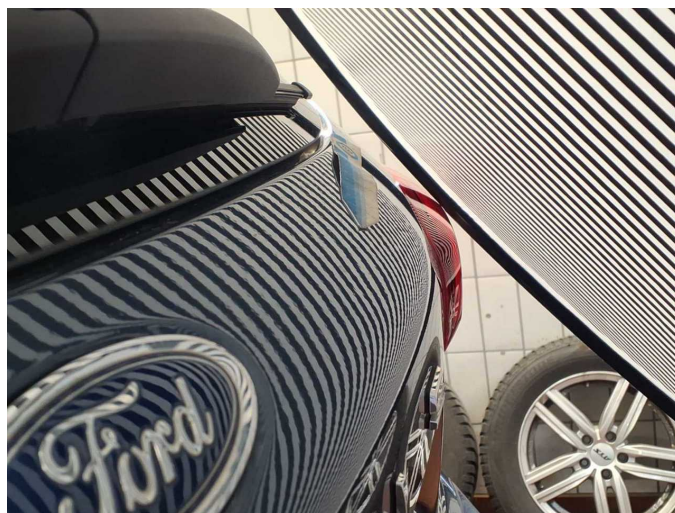
| No. | Component group | Description |
|---|---|---|
| 1 | Boot lid / rear door | Boot lid - dent(s) - No deduction |

**Wear and tear 1:** Boot lid / rear door: Boot lid - dent(s) - No deduction

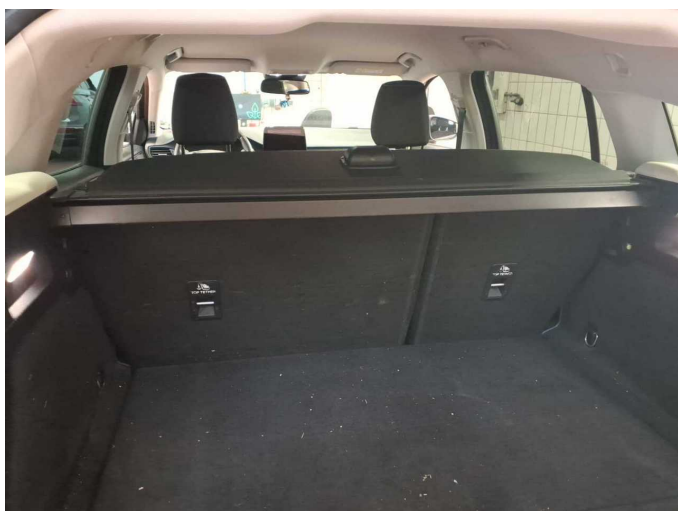
**Missing part 1:** Interior: Separation net - Missing - Replace
