Expertise

Protocol number: 46548076  
Order No. / Reference: 26534963  
Inspection date: 16 Jul 2026

Manufacturer: Ford

Model: Grand Tourneo Connect 1.5 EcoBlue Aut. Start/Stop Titanium

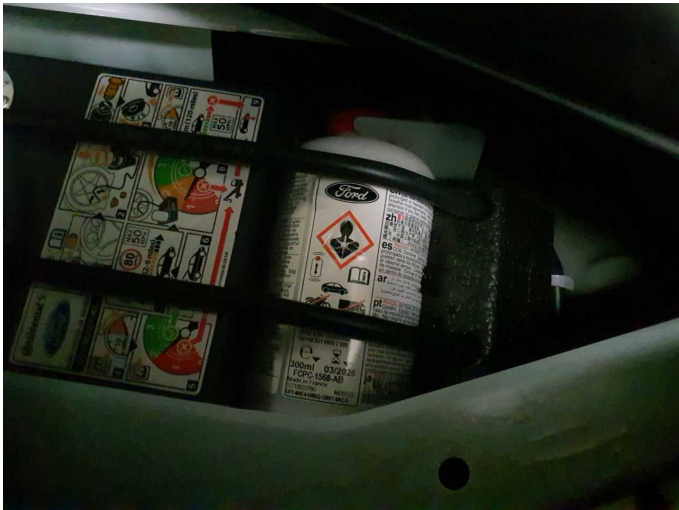
| No. | Component group | Description |
|---|---|---|
| 1 | Equipment | Tirefit filler - Expired - Replace |

Damage 1: Equipment: Tirefit filler - Expired - Replace

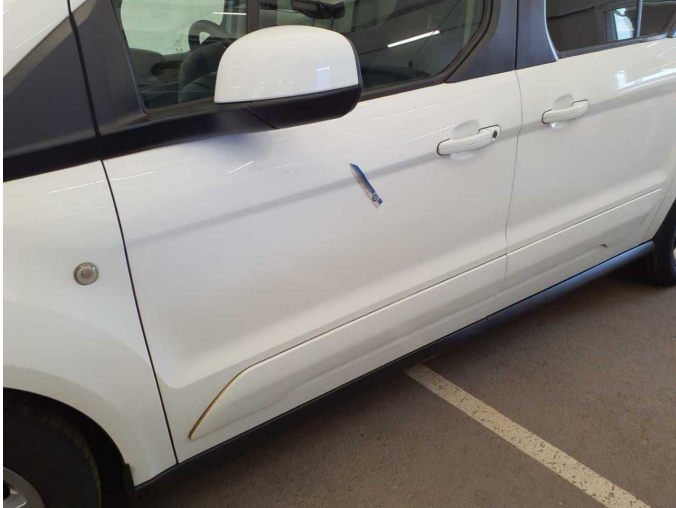
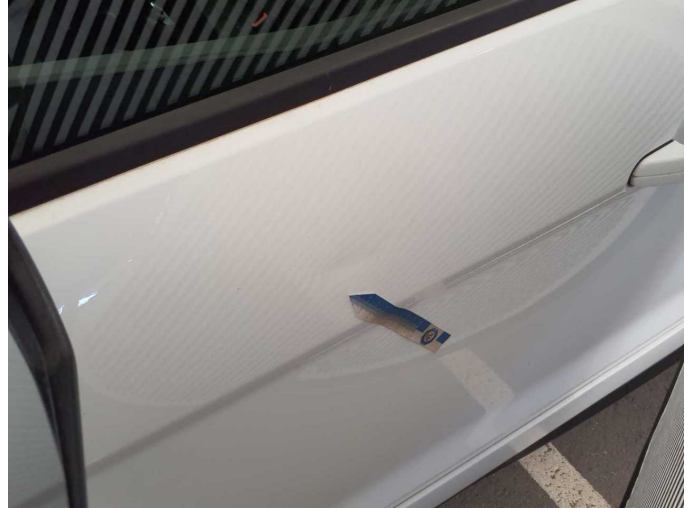
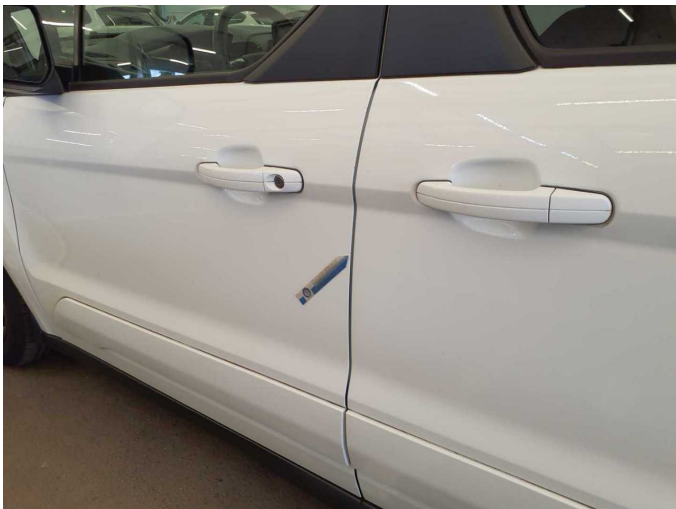
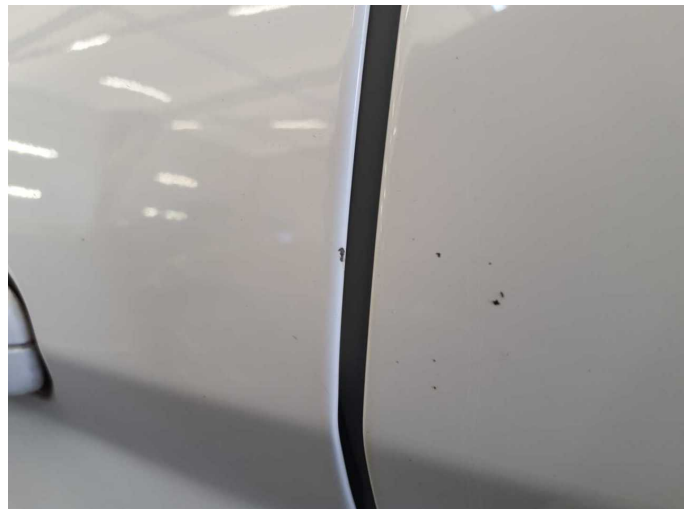
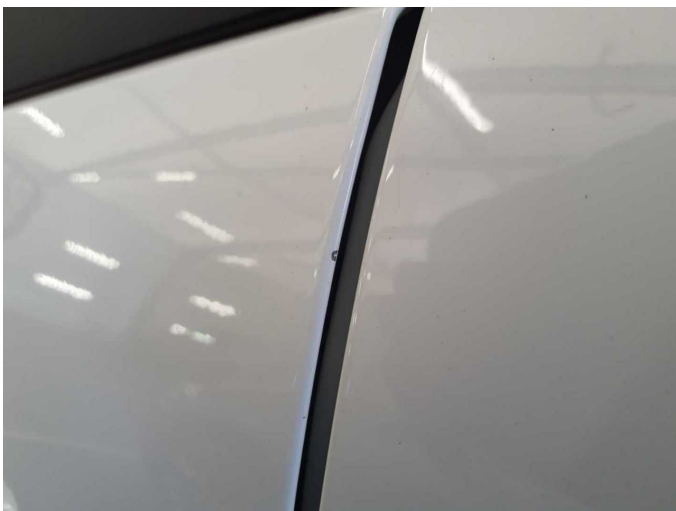
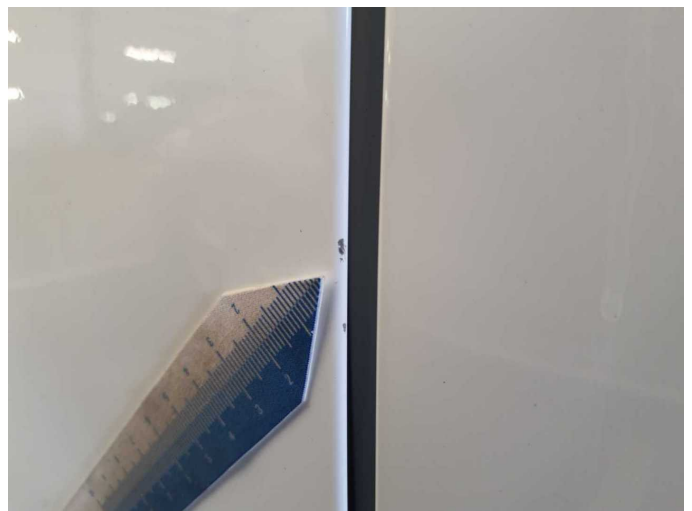
| No. | Component group | Description |
|---|---|---|
| 2 | Door - front left side | Door - Dent / paintcoat damage - Smart repair |

**Damage 2:** Door - front left side: Door - Dent / paintcoat damage - Smart repair

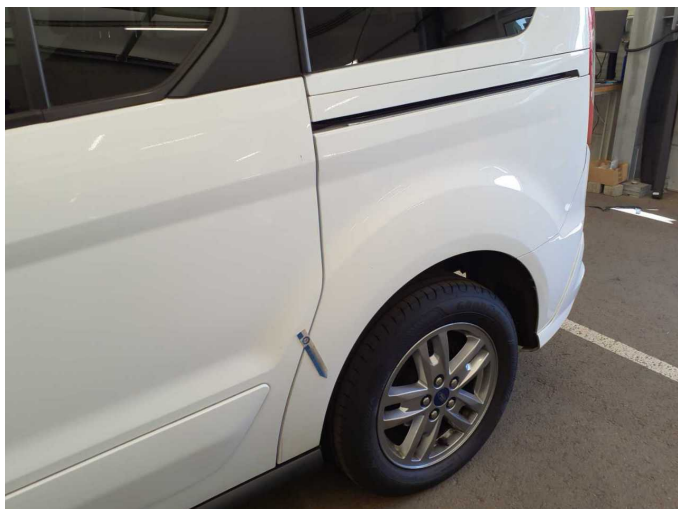
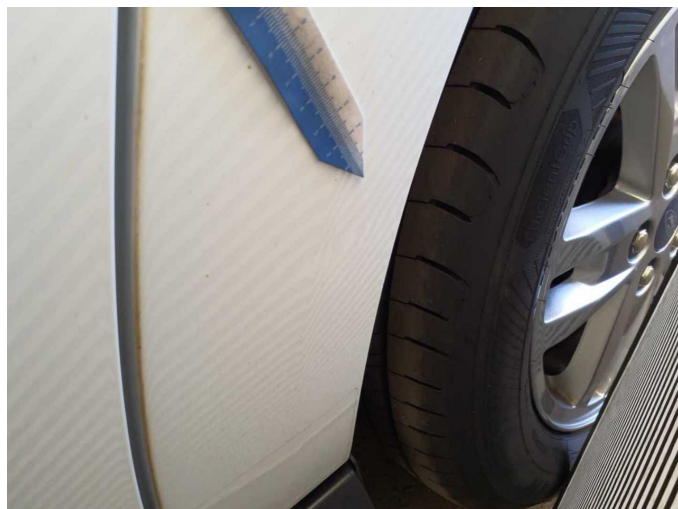
| No. | Component group | Description |
|---|---|---|
| 3 | Side panel - rear left side | Side panel - dent(s) - Smart repair |

**Damage 3:** Side panel - rear left side: Side panel - dent(s) - Smart repair

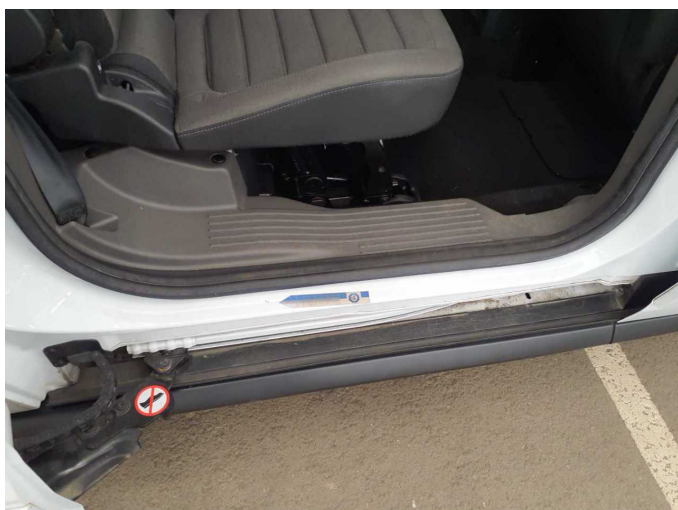
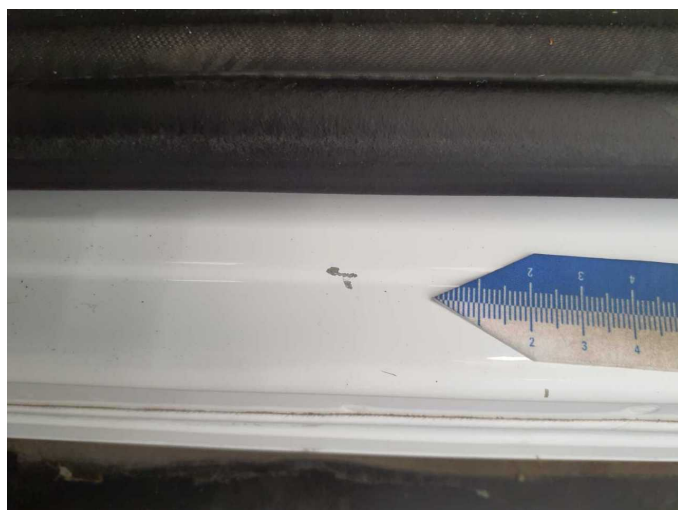
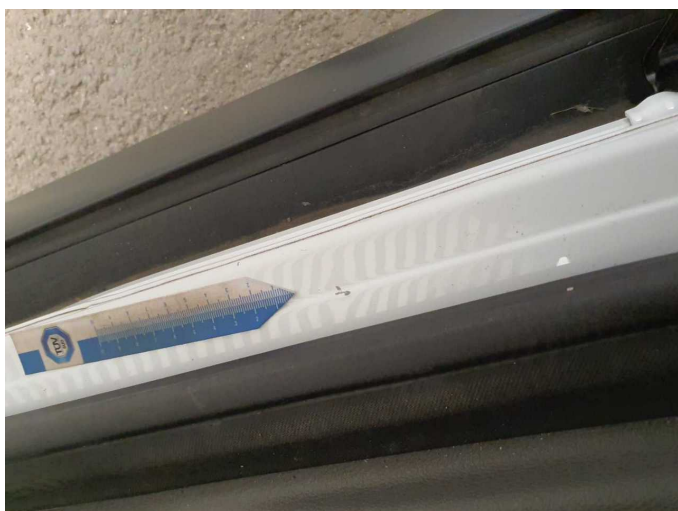
| No. | Component group | Description |
|---|---|---|
| 4 | Side panel - rear right side | Sill - dent(s) - Smart repair |

**Damage 4:** Side panel - rear right side: Sill - dent(s) - Smart repair

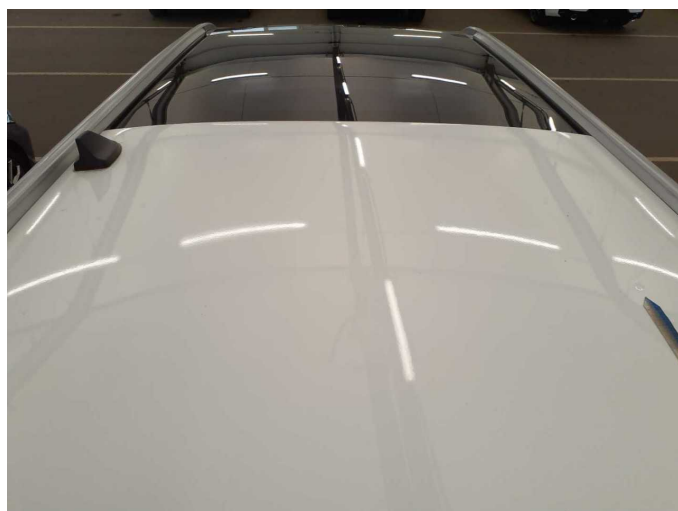
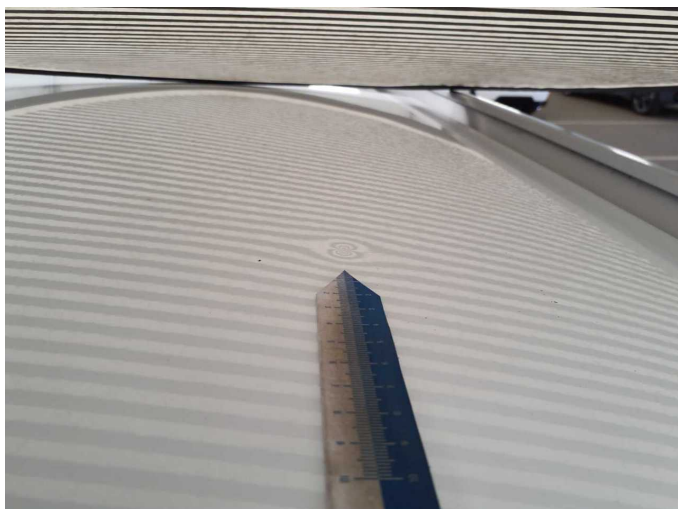
| No. | Component group | Description |
|---|---|---|
| 5 | Roof | Roof - dent(s) - Smart repair |

**Damage 5:** Roof: Roof - dent(s) - Smart repair

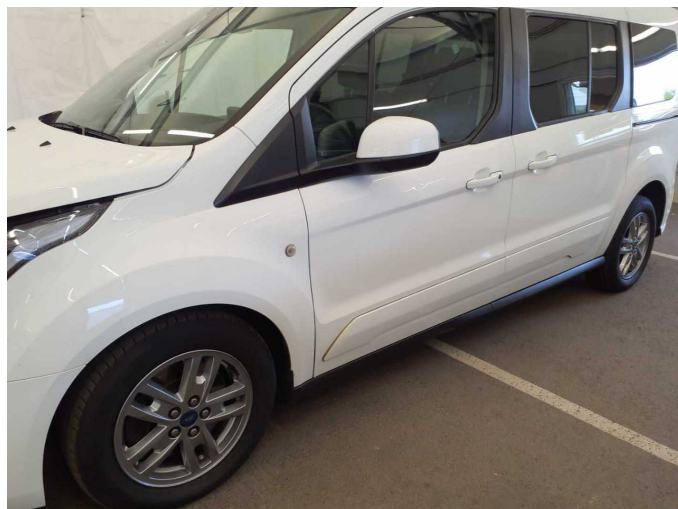
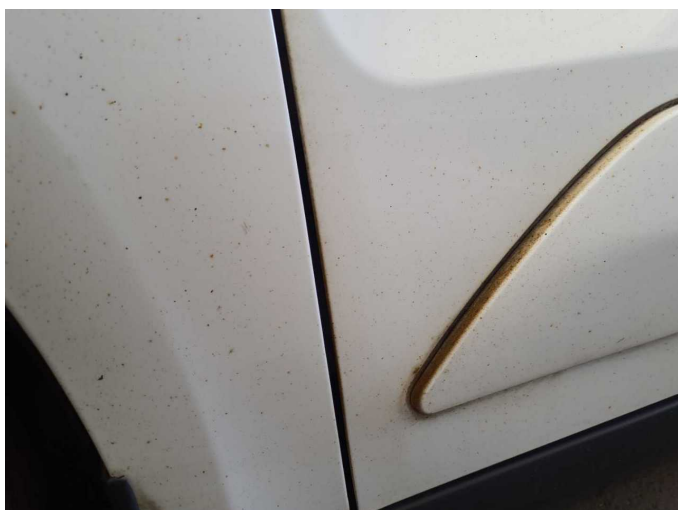
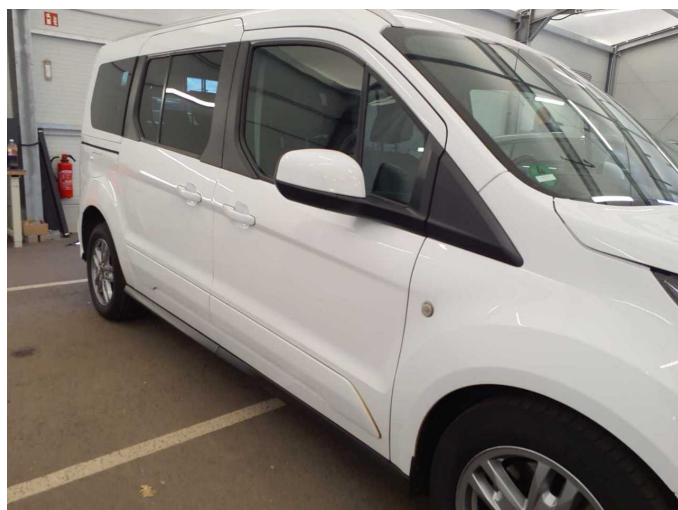
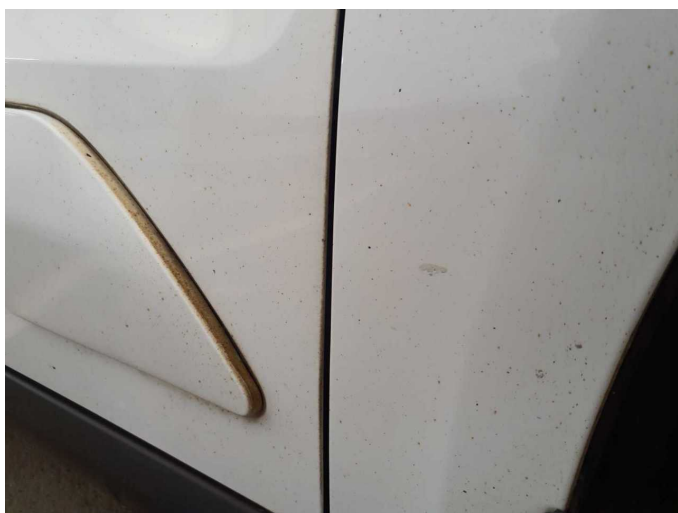
| No. | Component group | Description |
|---|---|---|
| 6 | Body | Body (Flugrost) - Soiled - Conditioning |

**Damage 6:** Body: Body (Flugrost) - Soiled - Conditioning

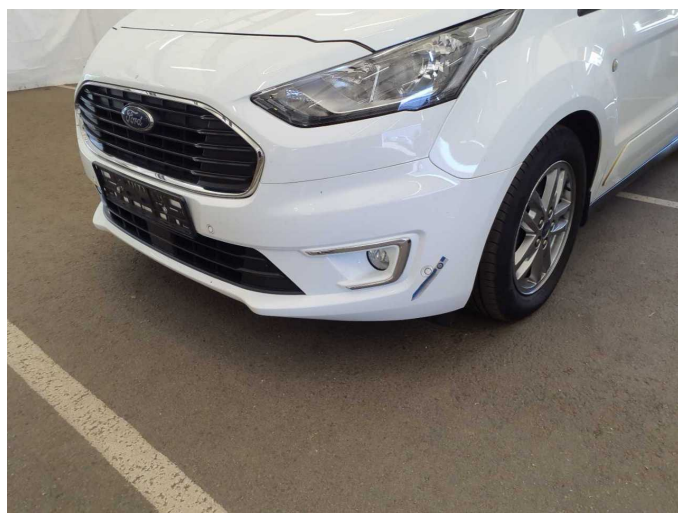
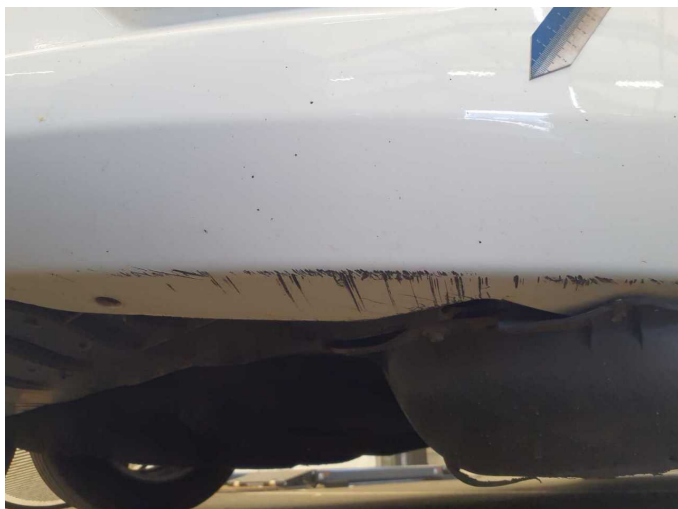
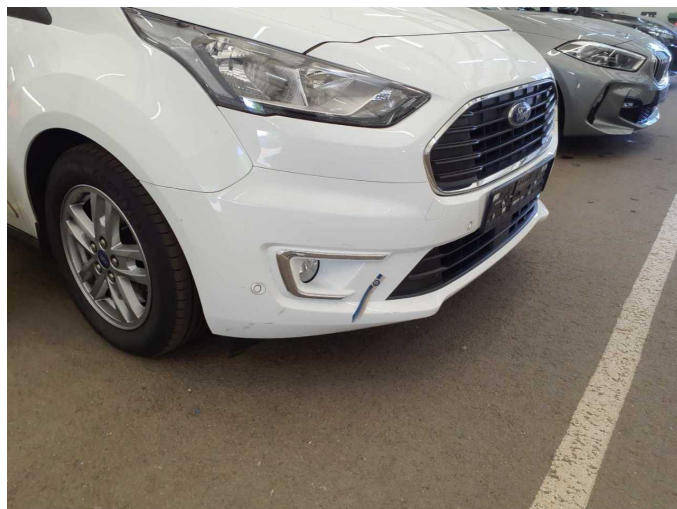
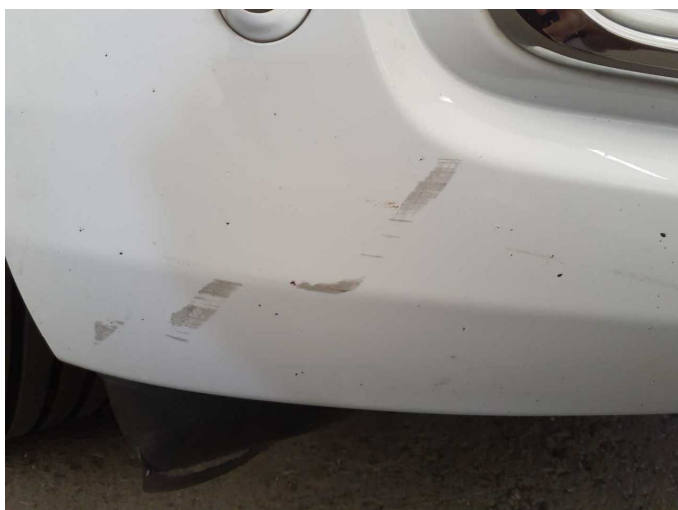
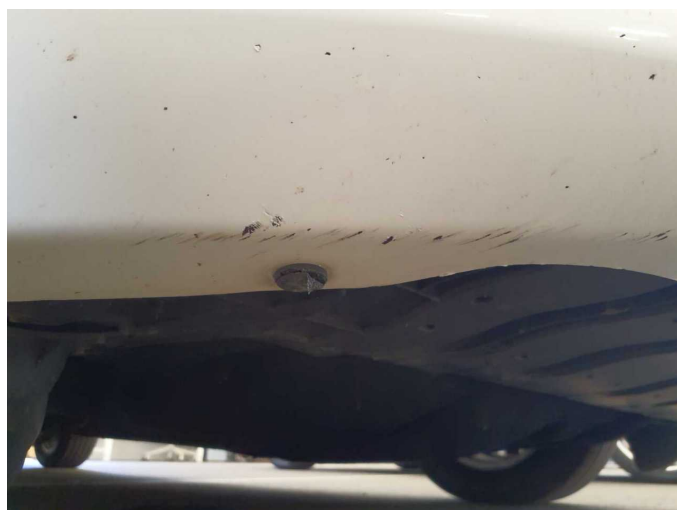
| No. | Component group | Description |
|---|---|---|
| 7 | Front bumper | Front bumper - Scratch(es) - Paint |

**Damage 7:** Front bumper: Front bumper - Scratch(es) - Paint

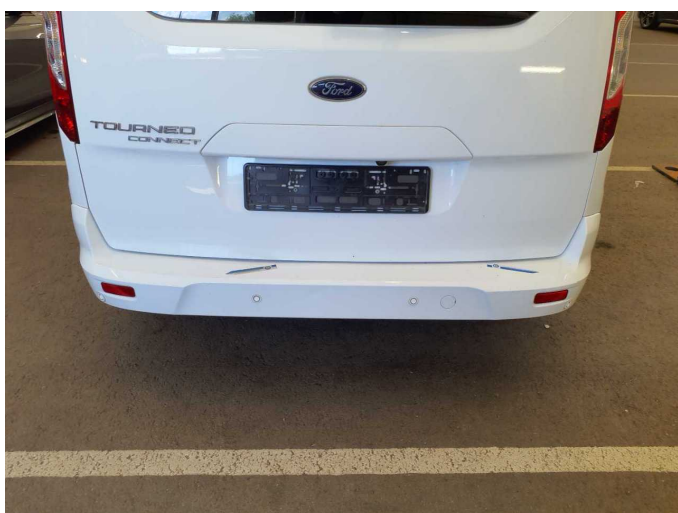
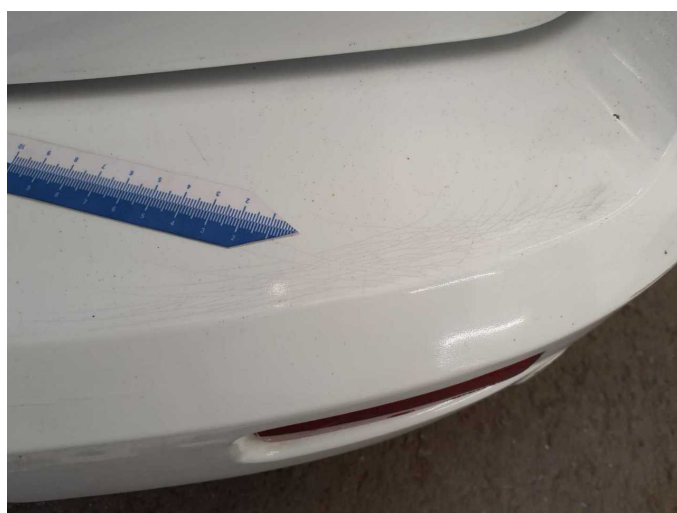
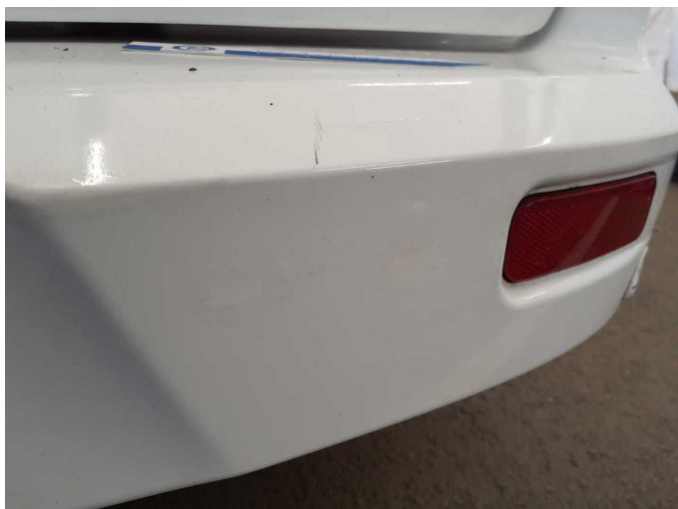
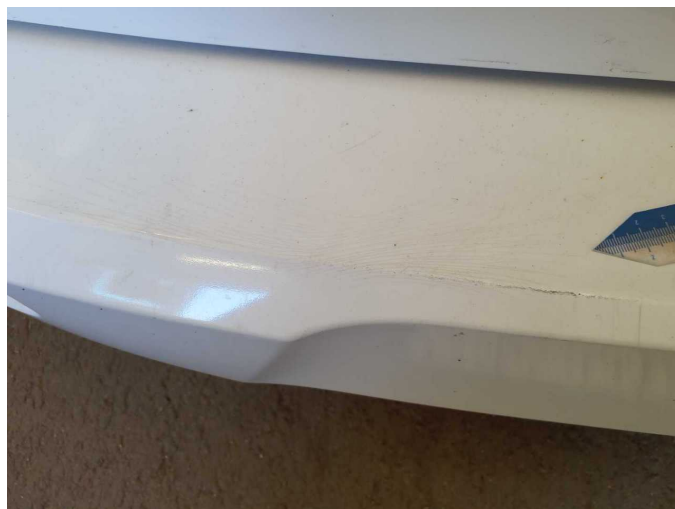
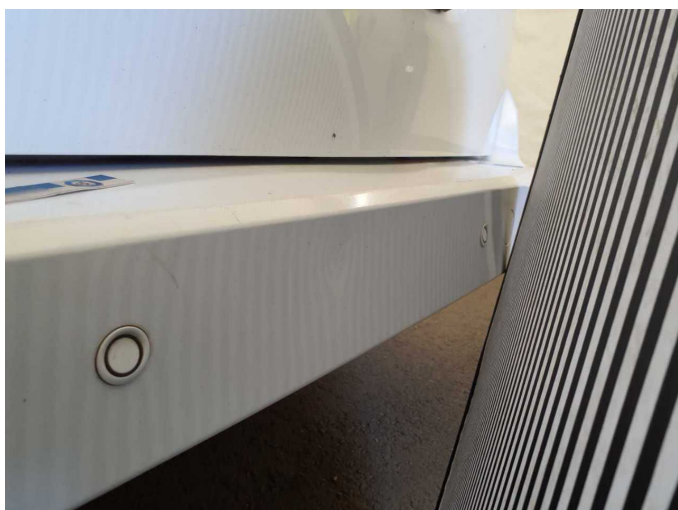
| No. | Component group | Description |
|---|---|---|
| 8 | Rear bumper | Rear bumper - Dent / paintcoat damage - Repair and paint |

**Damage 8:** Rear bumper: Rear bumper - Dent / paintcoat damage - Repair and paint

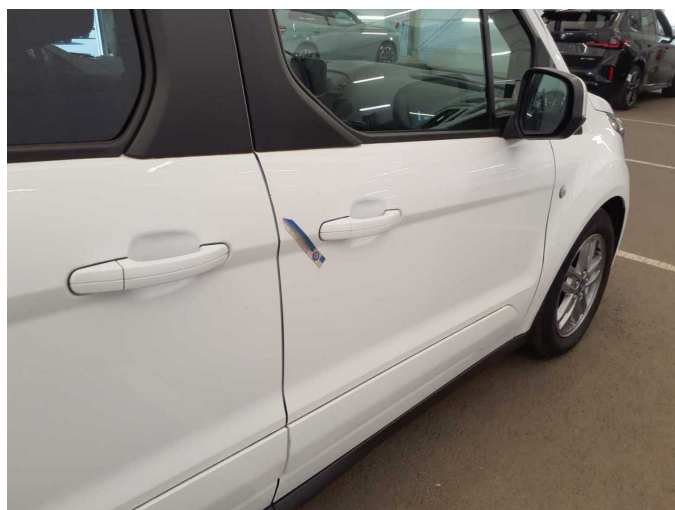
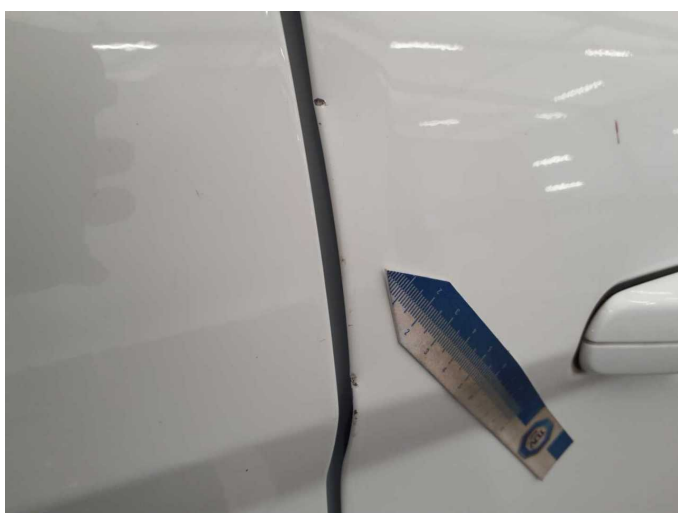
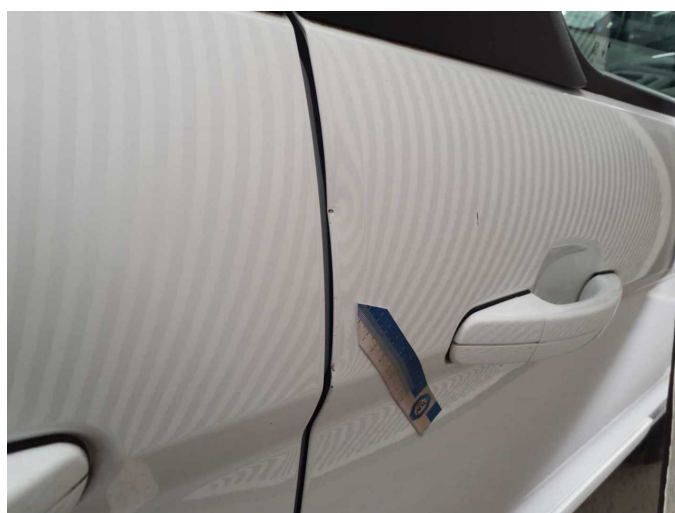
| No. | Component group | Description |
|---|---|---|
| 9 | Door - front right side | Door - Dent / paintcoat damage - Repair and paint |

**Damage 9:** Door - front right side: Door - Dent / paintcoat damage - Repair and paint
