## Expertise

Protocol number: 46184464  
Order No. / Reference: 26587997  
Inspection date: 25 Jun 2026

Manufacturer: Renault

Model: Espace TCe 225 EDC GPF LIMITED

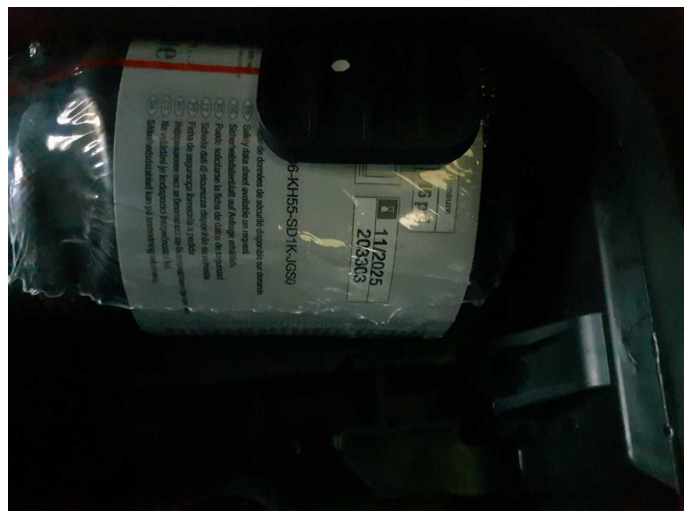
Damage 1: Equipment: Tirefit filler - Expired - Replace

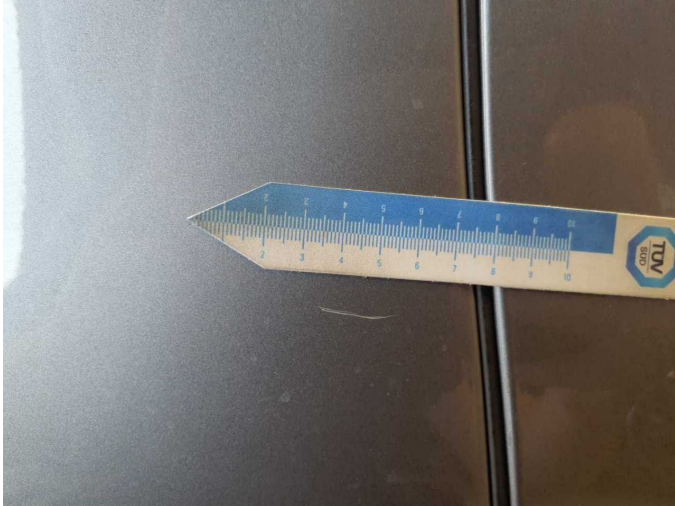
**Damage 2:** Door - rear right side: Door - Scratch(es) - Smart repair

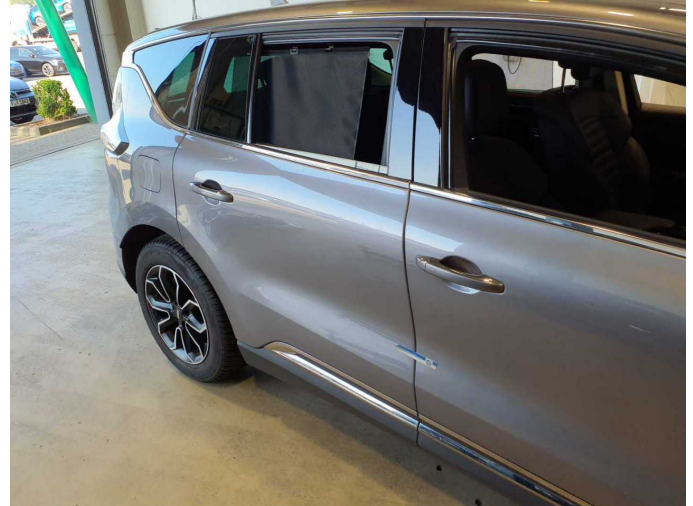
**Damage 2:** Door - rear right side: Door - Scratch(es) - Smart repair

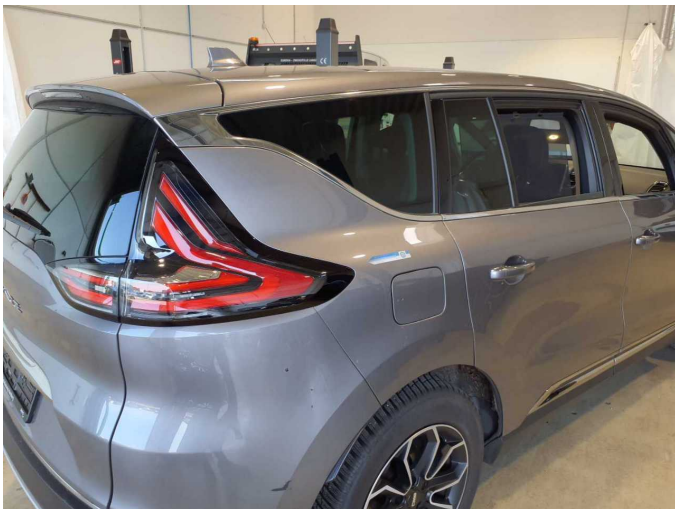
**Damage 3:** Side panel - rear right side: Side panel - dent(s) - Smart repair

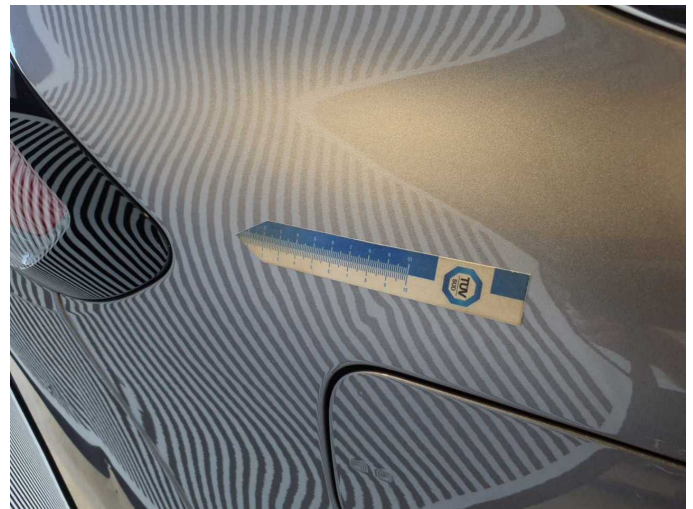
**Damage 3:** Side panel - rear right side: Side panel - dent(s) - Smart repair

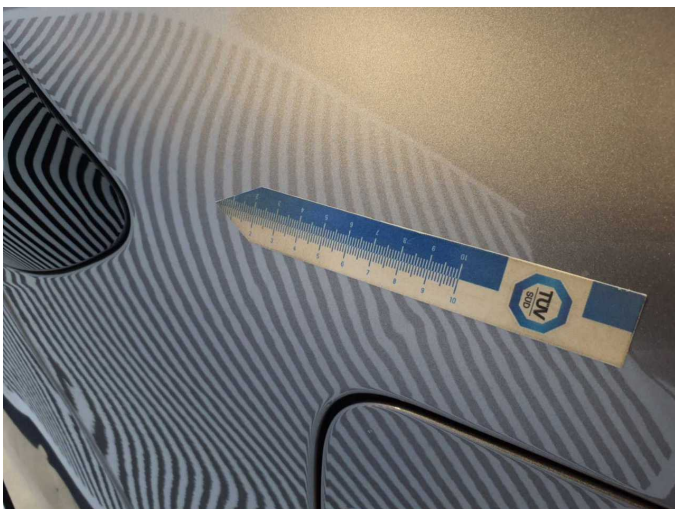
**Damage 3:** Side panel - rear right side: Side panel - dent(s) - Smart repair

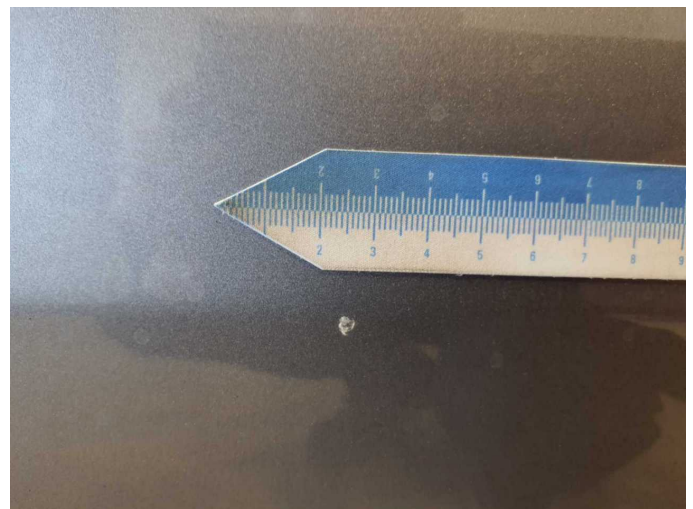
**Damage 4:** Door - front right side: Door - Scratch(es) - Smart repair

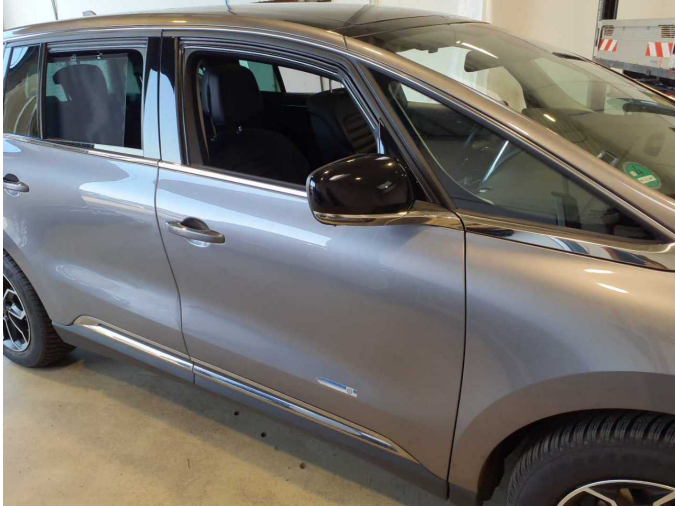
**Damage 4:** Door - front right side: Door - Scratch(es) - Smart repair

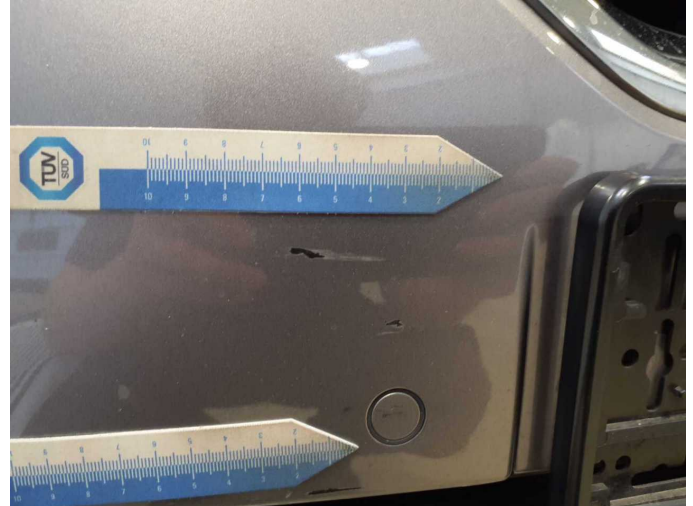
**Damage 5:** Front bumper: Front bumper - Scratch(es) - Paint

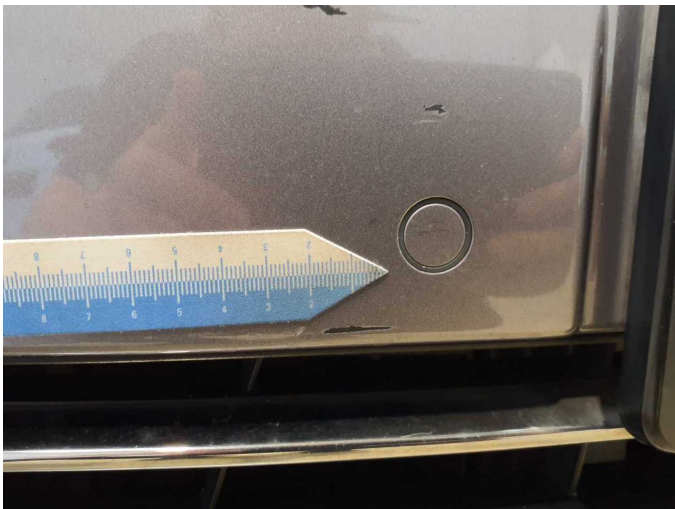
**Damage 5:** Front bumper: Front bumper - Scratch(es) - Paint

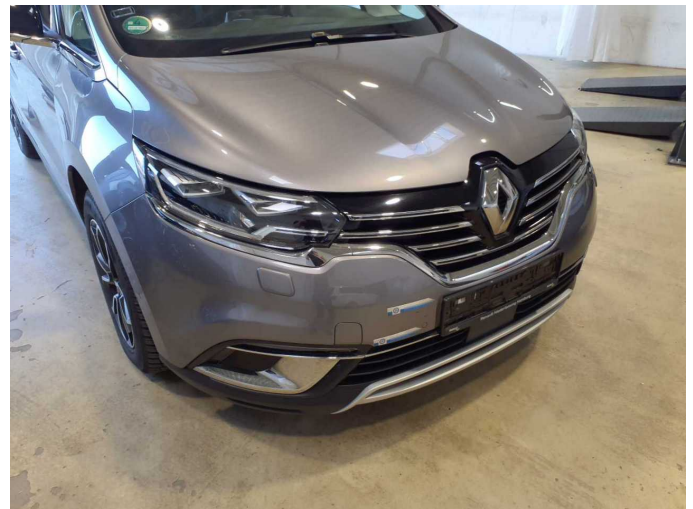
**Damage 5:** Front bumper: Front bumper - Scratch(es) - Paint

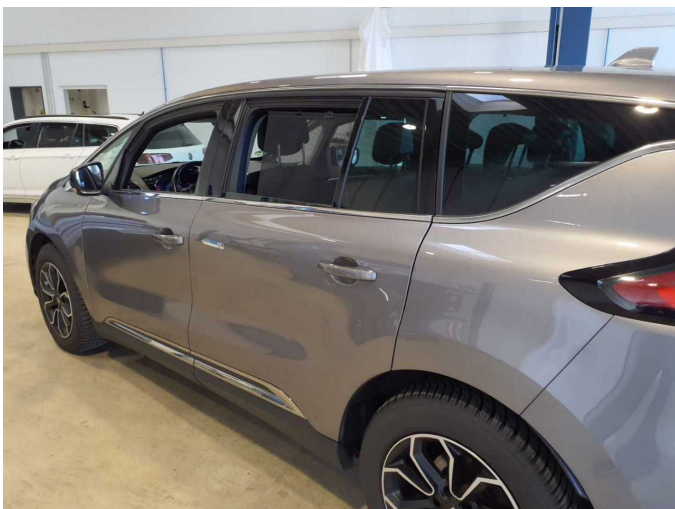
**Damage 6:** Door - rear left side: Door - Dent / paintcoat damage - Repair and paint

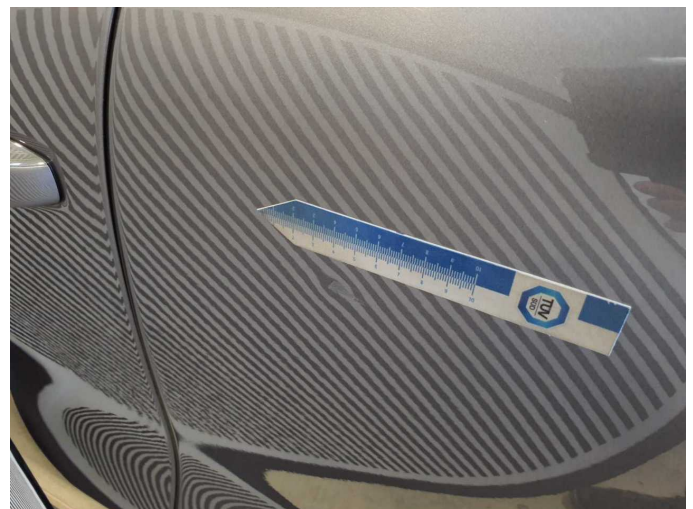
**Damage 6:** Door - rear left side: Door - Dent / paintcoat damage - Repair and paint

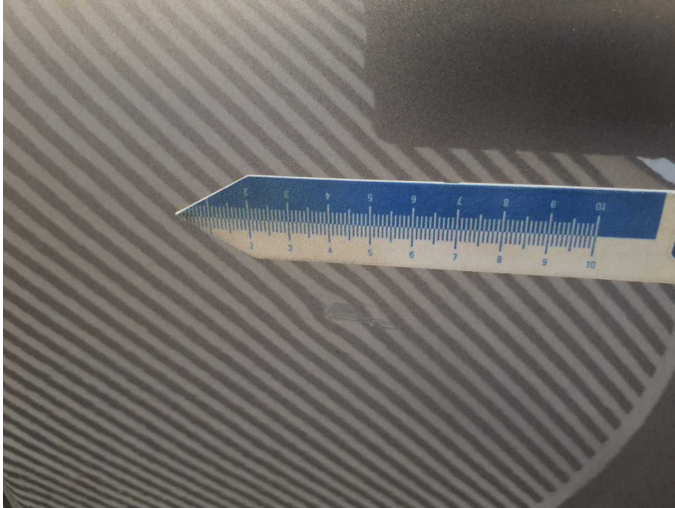
**Damage 6:** Door - rear left side: Door - Dent / paintcoat damage - Repair and paint

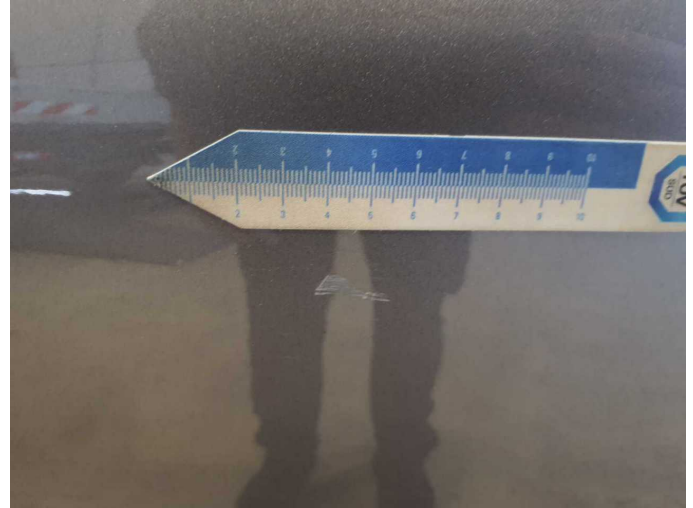
**Damage 6:** Door - rear left side: Door - Dent / paintcoat damage - Repair and paint

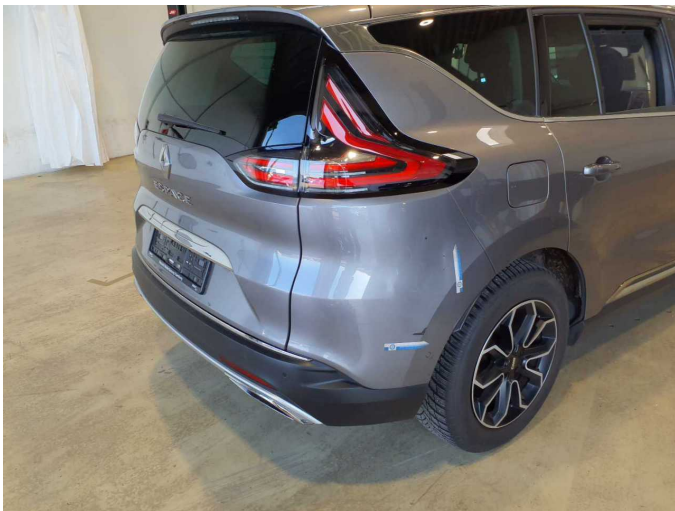
**Damage 7:** Rear bumper: Rear bumper - Dent / paintcoat damage - Replace

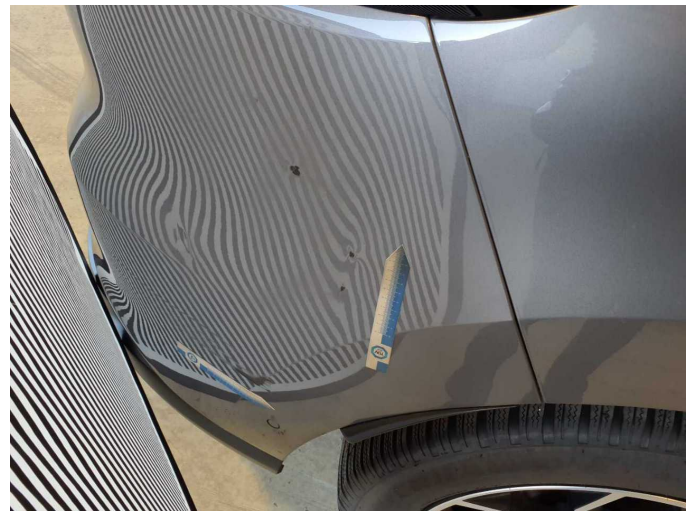
**Damage 7:** Rear bumper: Rear bumper - Dent / paintcoat damage - Replace

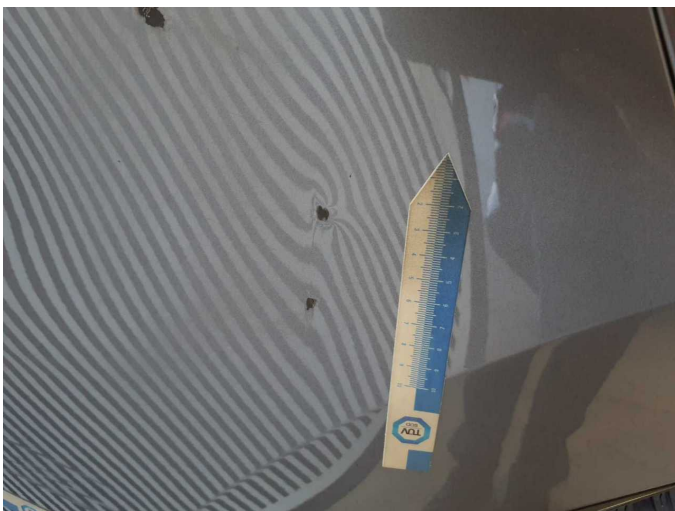
**Damage 7:** Rear bumper: Rear bumper - Dent / paintcoat damage - Replace

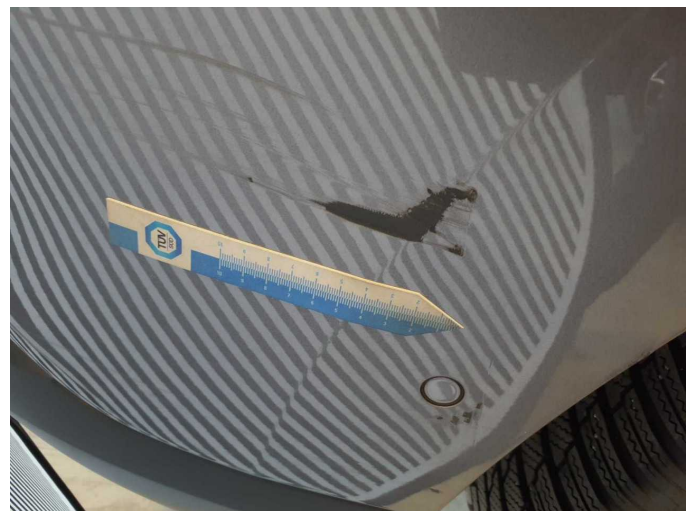
**Damage 7:** Rear bumper: Rear bumper - Dent / paintcoat damage - Replace

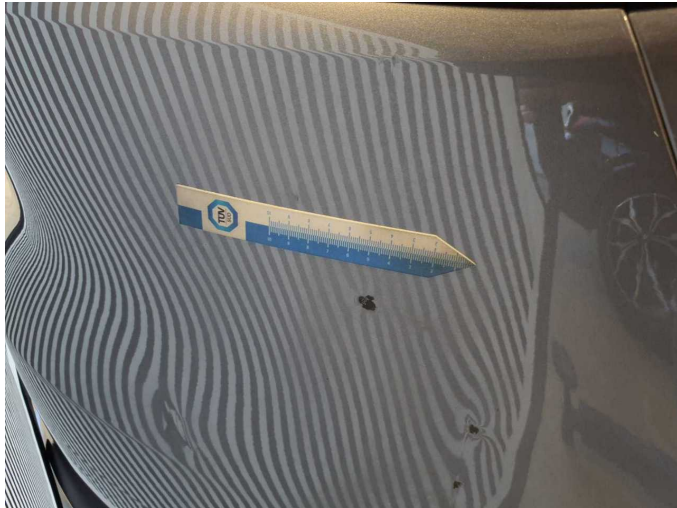
**Damage 7:** Rear bumper: Rear bumper - Dent / paintcoat damage - Replace

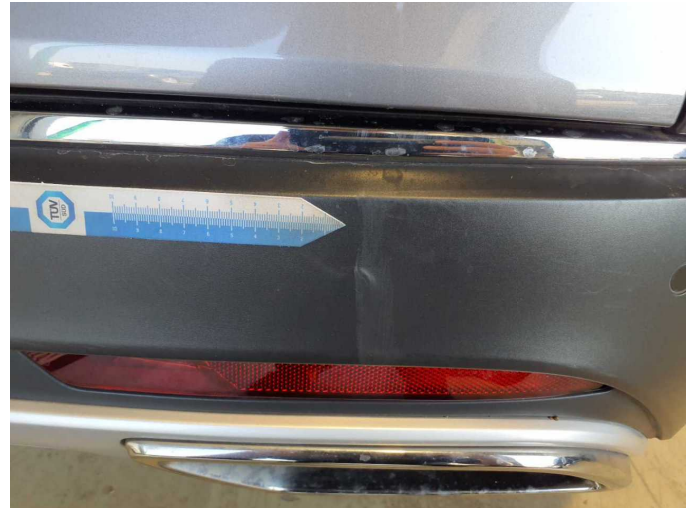
**Damage 7:** Rear bumper: Rear bumper - Dent / paintcoat damage - Replace

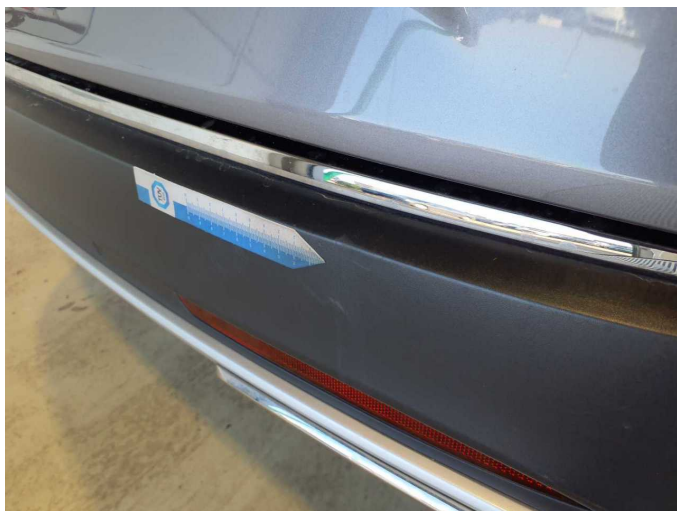
**Damage 7:** Rear bumper: Rear bumper - Dent / paintcoat damage - Replace

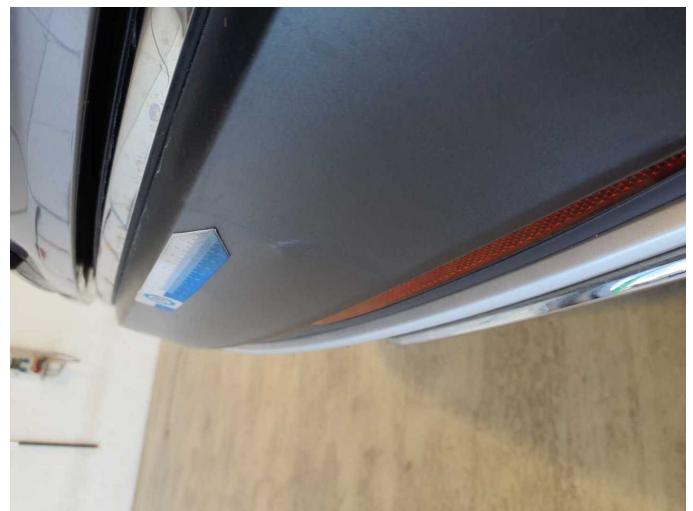
**Damage 7:** Rear bumper: Rear bumper - Dent / paintcoat damage - Replace

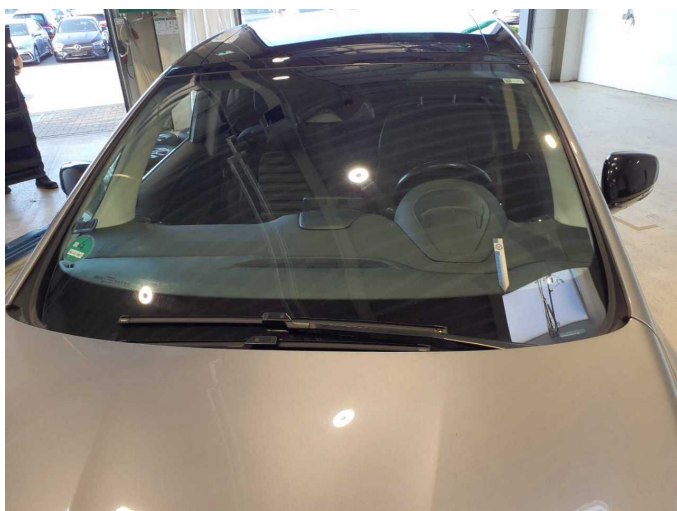
**Damage 8:** Vehicle glazing: Windscreen - Broken / torn - Replace

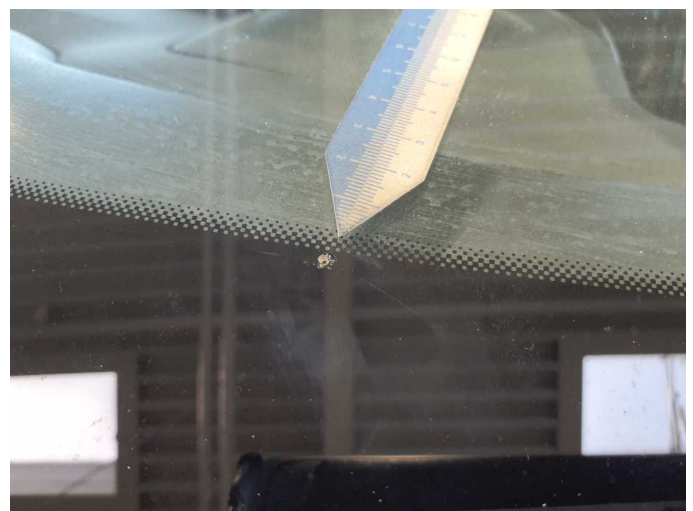
**Damage 8:** Vehicle glazing: Windscreen - Broken / torn - Replace

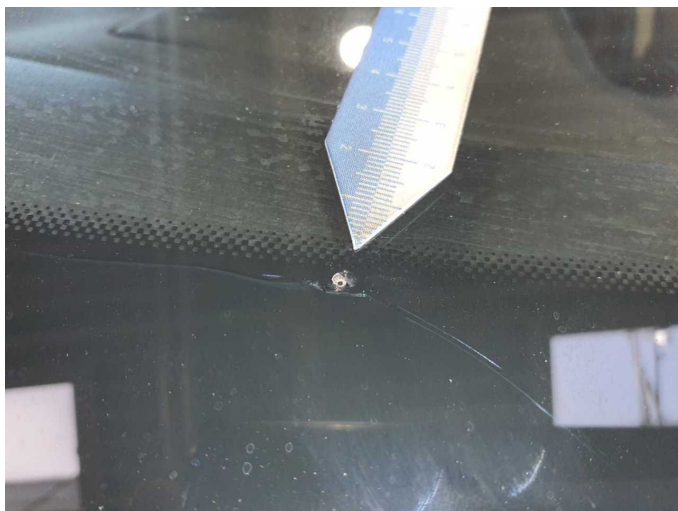
**Damage 8:** Vehicle glazing: Windscreen - Broken / torn - Replace
