Expertise

Protocol number: 46442243  
Order No. / Reference: 25930006  
Inspection date: 7 Jul 2026

Manufacturer: Mercedes-Benz

Model: Vito 116 CDI Tourer Lang Aut. SELECT

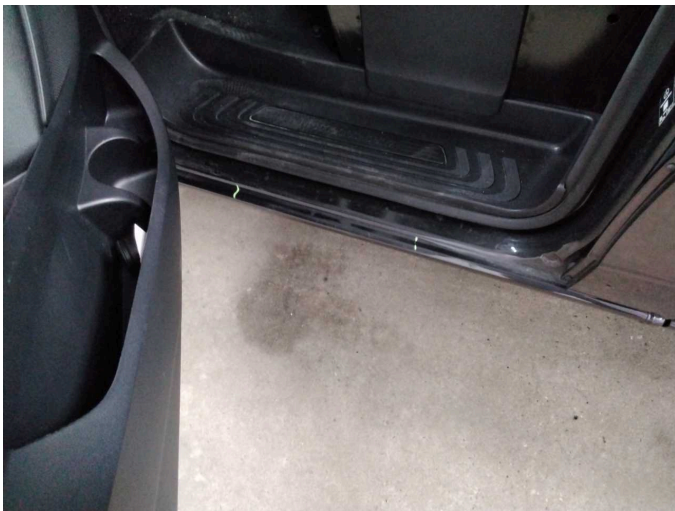
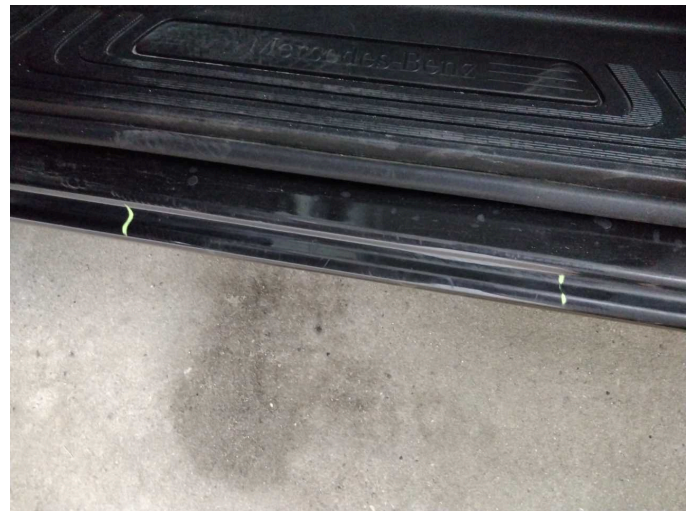
| No. | Component group | Description |
|---|---|---|
| 2 | Sill - left side | Sill - Scratch(es) - Smart repair |

**Damage 2:** Sill - left side: Sill - Scratch(es) - Smart repair

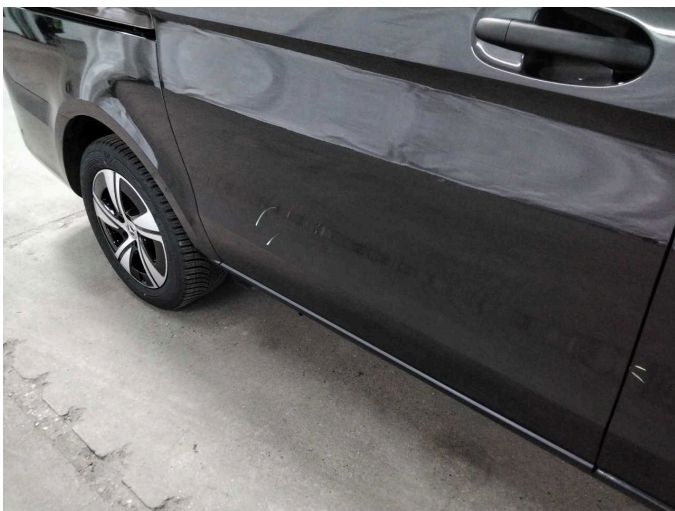
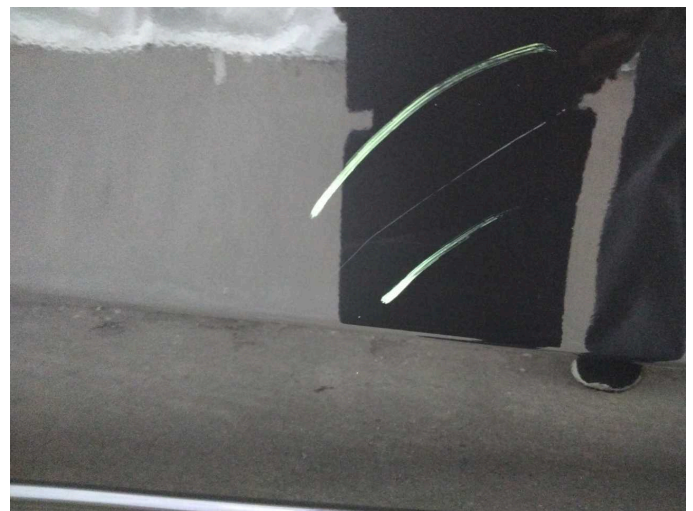
| No. | Component group | Description |
|---|---|---|
| 4 | Sliding door, right | Sliding door with glass panel - Scratch(es) - Smart repair |

**Damage 4:** Sliding door, right: Sliding door with glass panel - Scratch(es) - Smart repair

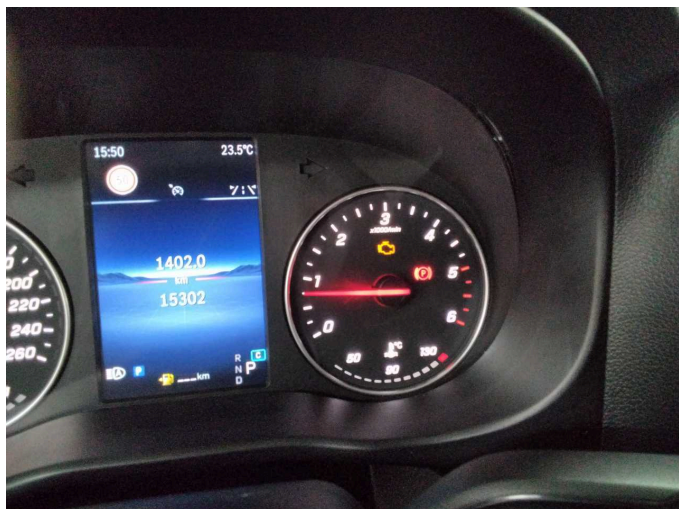
| No. | Component group | Description |
|---|---|---|
| 5 | Instrument panel | Indicator light (Motorkontrolle, nicht fahrbereit) - on - Perform diagnosis |

**Damage 5:** Instrument panel: Indicator light (Motorkontrolle, nicht fahrbereit) - on - Perform diagnosis

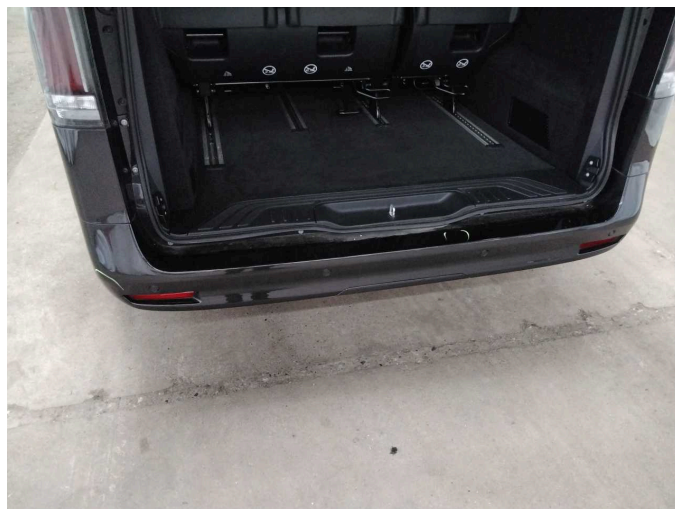
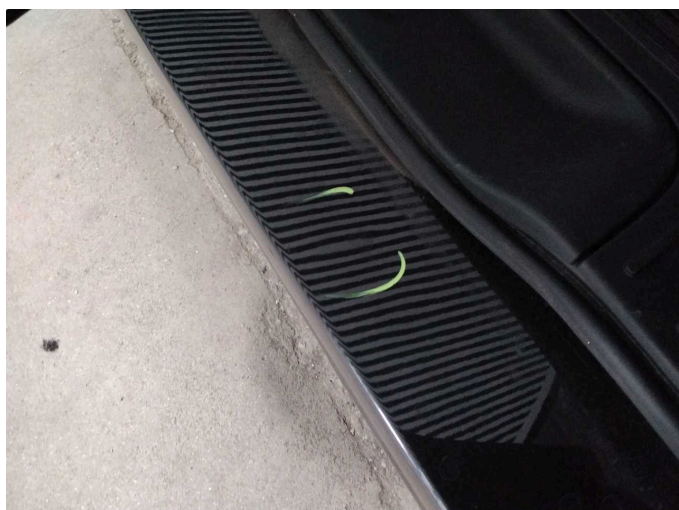
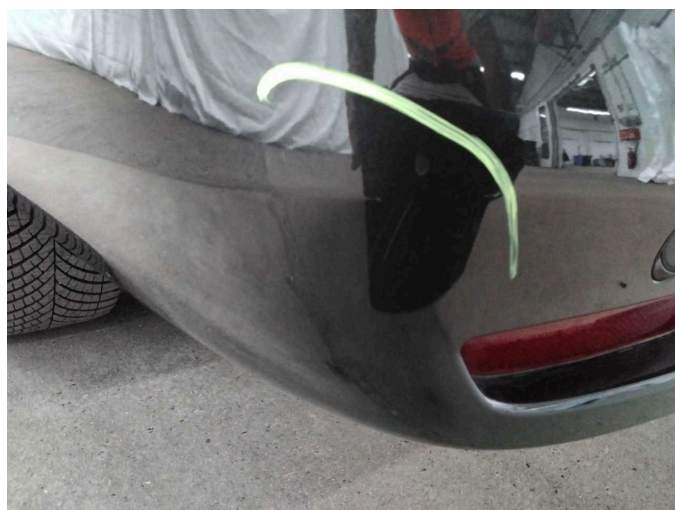
| No. | Component group | Description |
|---|---|---|
| 6 | Rear bumper | Rear bumper - Dent / paintcoat damage - Repair and paint |

**Damage 6:** Rear bumper: Rear bumper - Dent / paintcoat damage - Repair and paint

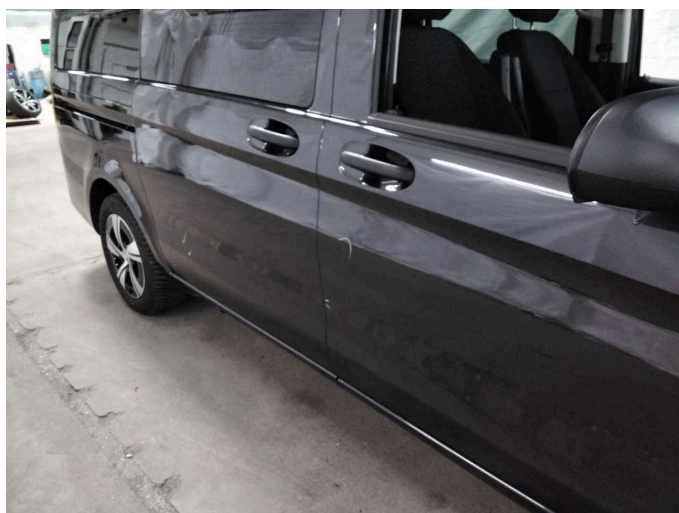
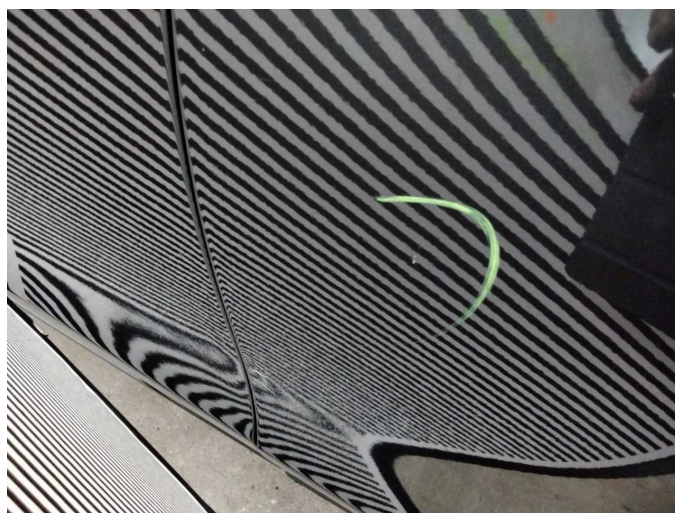
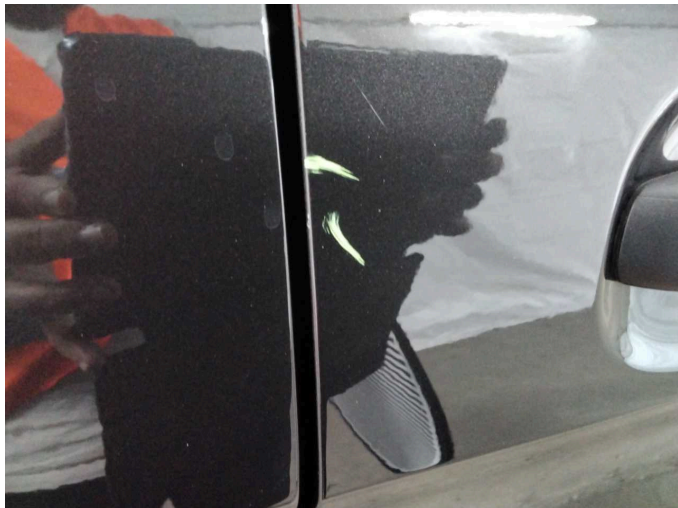
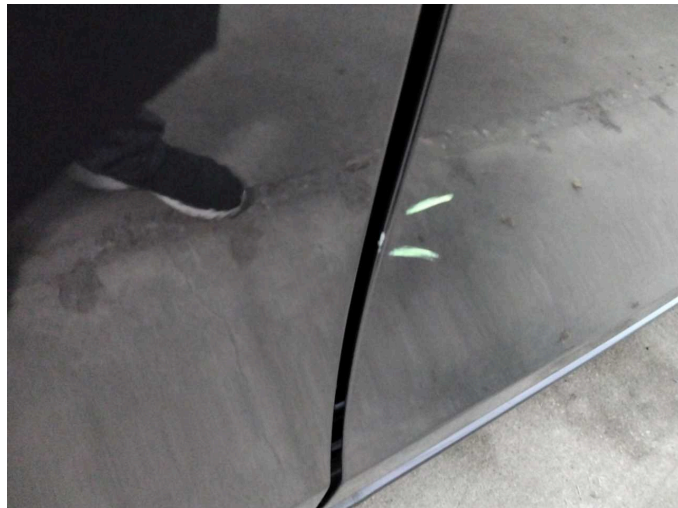
| No. | Component group | Description |
|---|---|---|
| 7 | Door - front right side | Door - Dent / paintcoat damage - Paint |

**Damage 7:** Door - front right side: Door - Dent / paintcoat damage - Paint

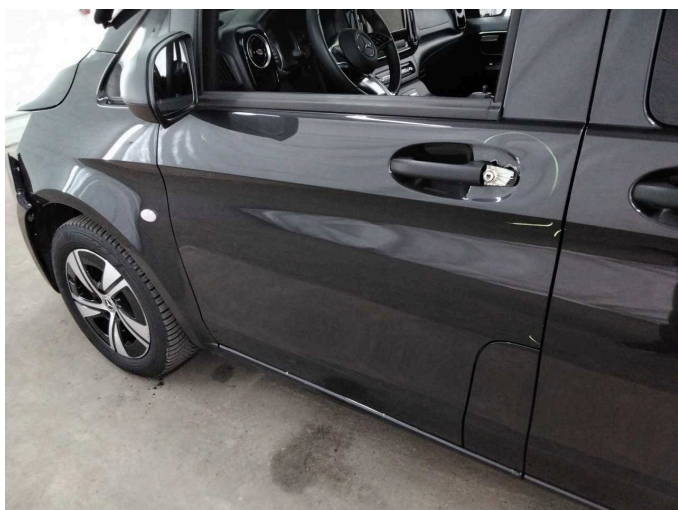
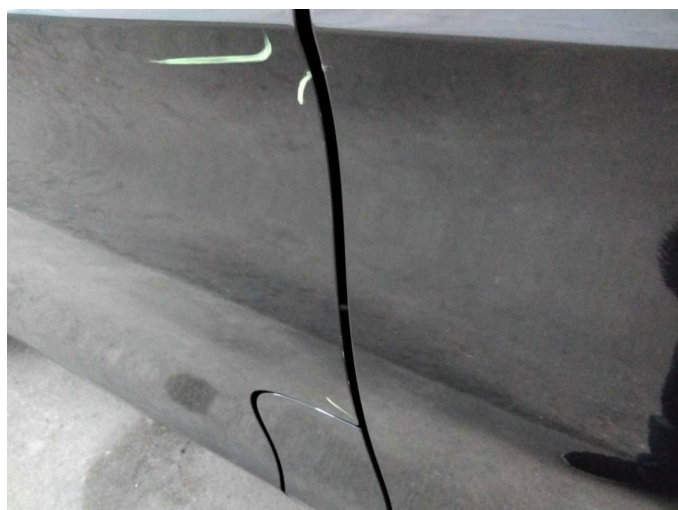
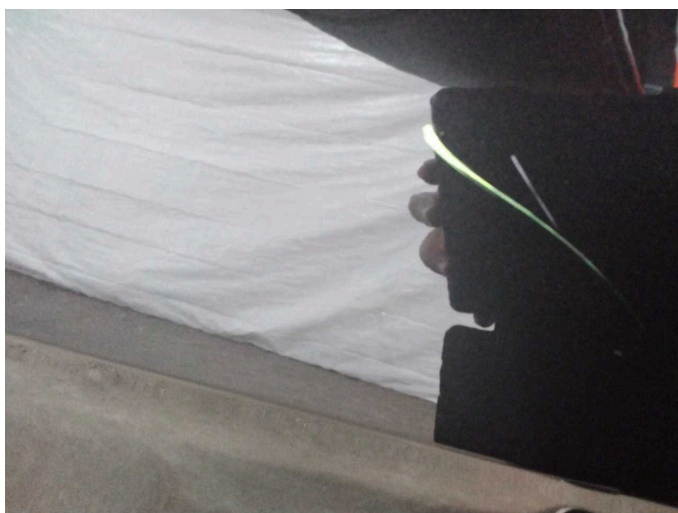
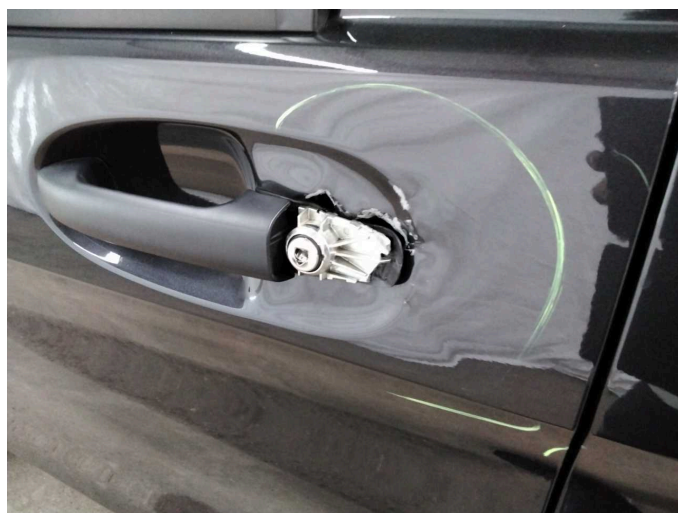
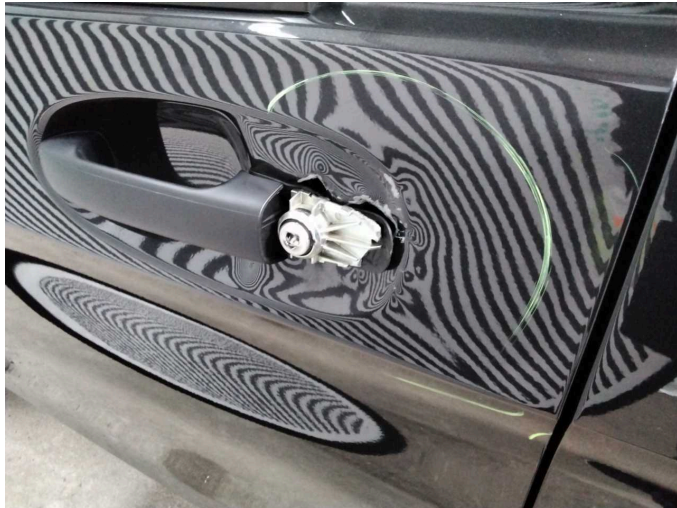
| No. | Component group | Description |
|---|---|---|
| 8 | Door - front left side | Door - Dent / paintcoat damage - repair according to calculation |

Die Türe vorne links und die Scheinwerfer gehören vermutlich zu einem Diebstahl: Hierzu können mehrkosten entstehen, wenn sich herausstellt, das in der Tür noch mehr beschädigt ist und das im Motorraum noch mehr Teile entwendet wurden.

**Damage 8:** Door - front left side: Door - Dent / paintcoat damage - repair according to calculation

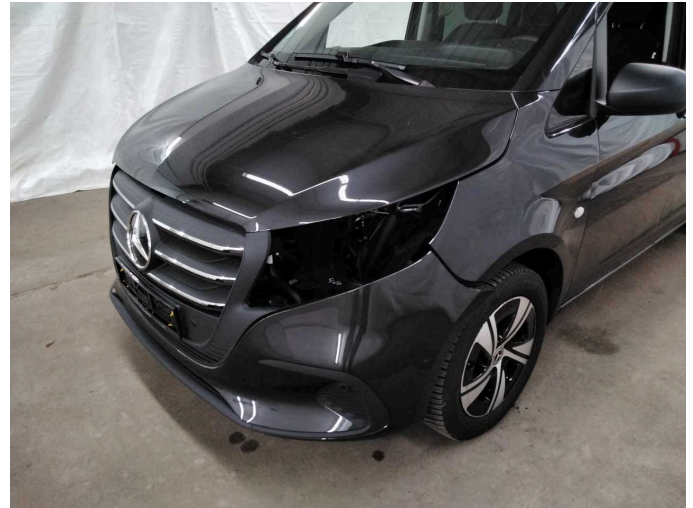
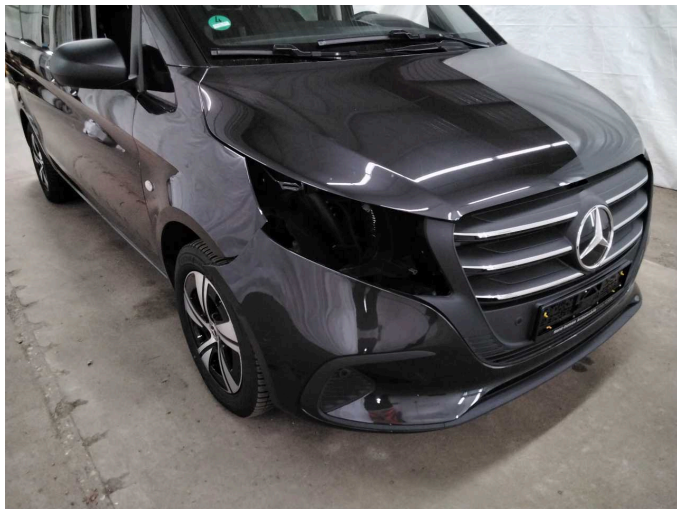
| No. | Component group | Description |
|---|---|---|
| 9 | Headlight | Headlight - left side (+ rechts- Mehrkosten möglich) - Missing - repair according to calculation |

**Damage 9:** Headlight: Headlight - left side (+ rechts- Mehrkosten möglich) - Missing - repair according to calculation
