Expertise

Protocol number: 46621031  
Order No. / Reference: 26617324  
Inspection date: 21 Jul 2026

Manufacturer: Mercedes-Benz

Model: Vito 110 CDI Mixto Kompakt HA

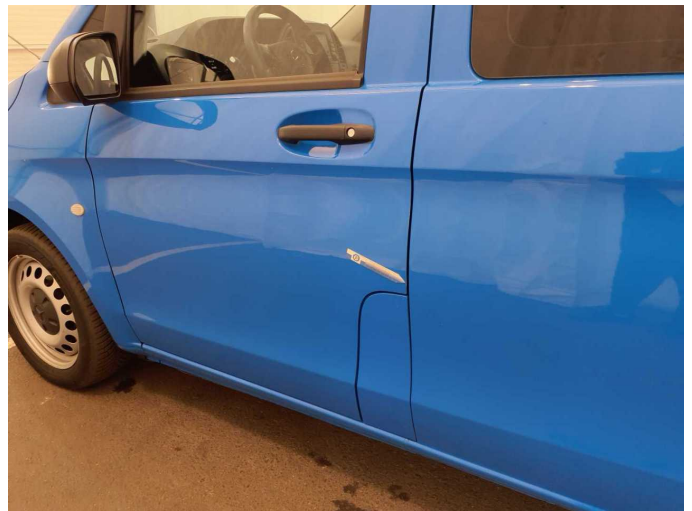
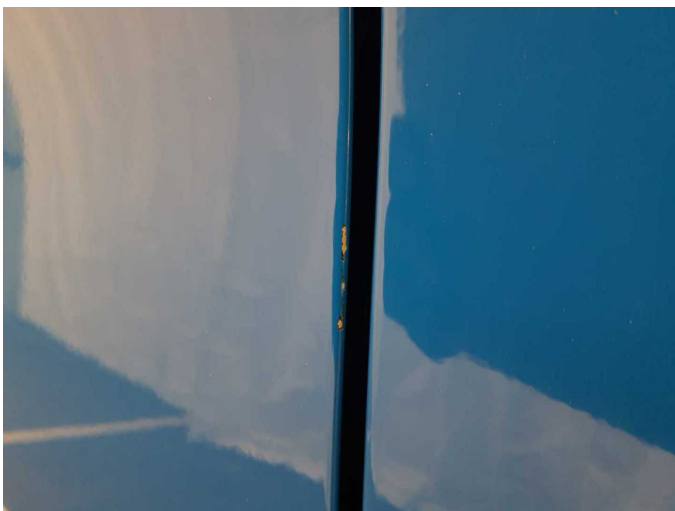
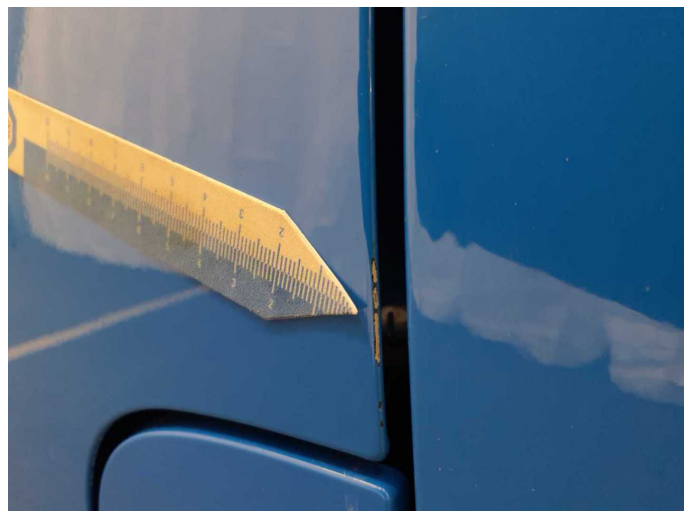
| No. | Component group | Description |
|---|---|---|
| 1 | Door - front left side | Door edge - Scratch(es) - Smart repair |

**Damage 1:** Door - front left side: Door edge - Scratch(es) - Smart repair

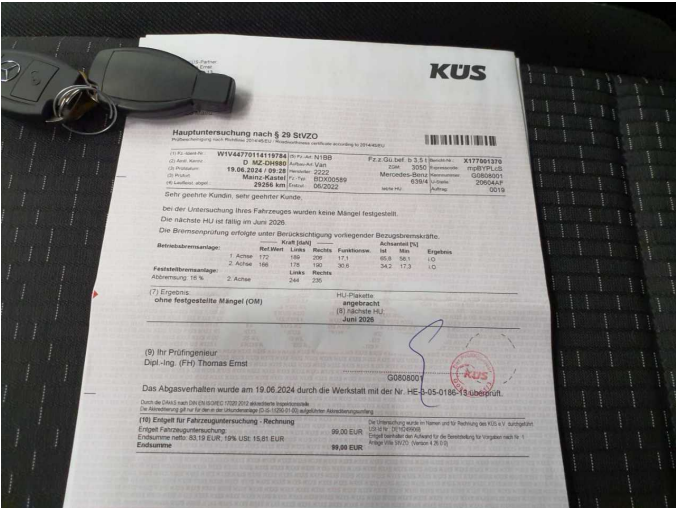
| No. | Component group | Description |
|---|---|---|
| 2 | Misc. | Main inspection - Expired - Replace |

Damage 2: Misc.: Main inspection - Expired - Replace

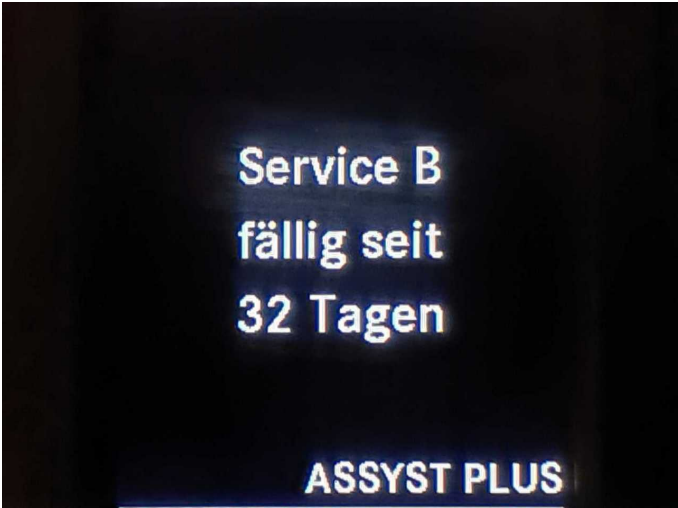
| No. | Component group | Description |
|---|---|---|
| 3 | Misc. | Inspection / maintenance - Due - Replace |

Damage 3: Misc.: Inspection / maintenance - Due - Replace

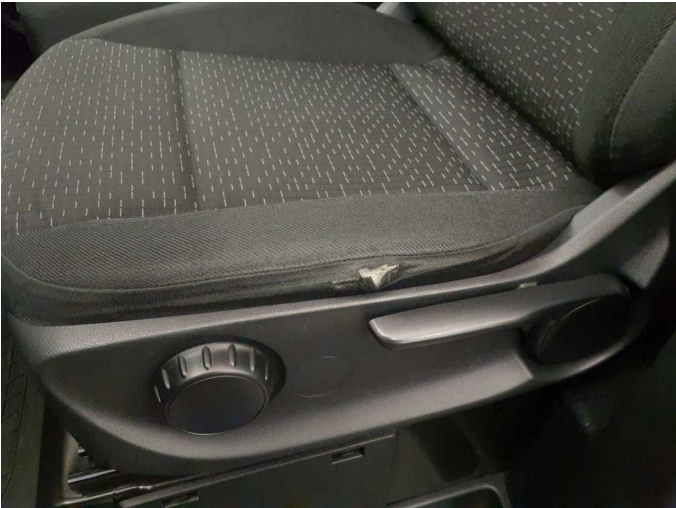
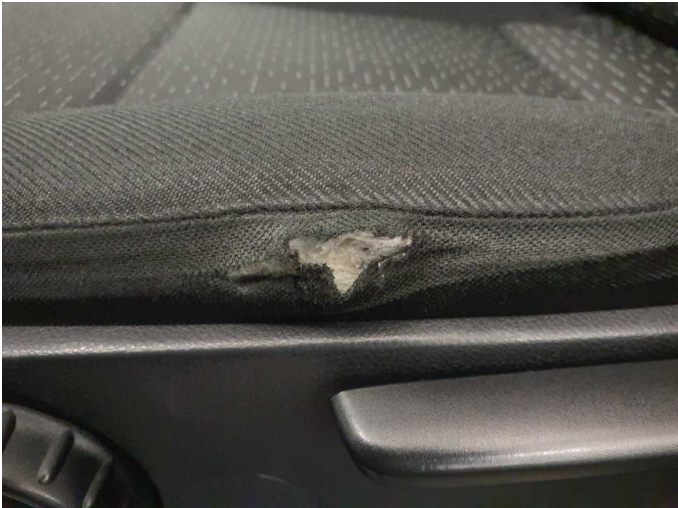
| No. | Component group | Description |
|---|---|---|
| 4 | Seat - front | Seat cover - left side - Broken / torn - Replace |

Damage 4: Seat - front: Seat cover - left side - Broken / torn - Replace

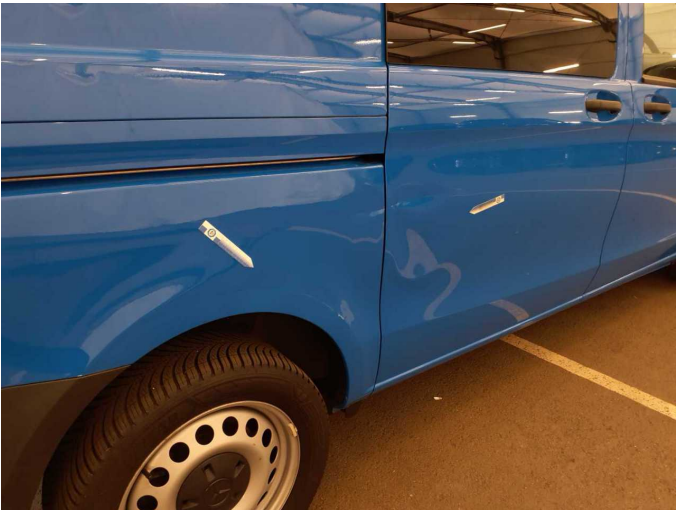
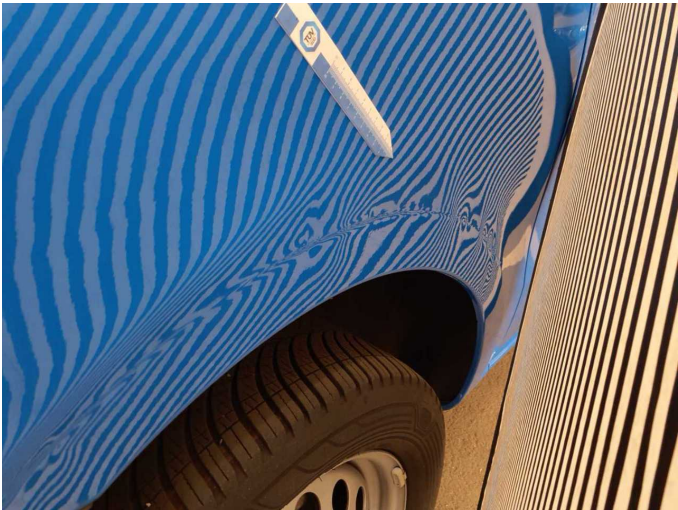
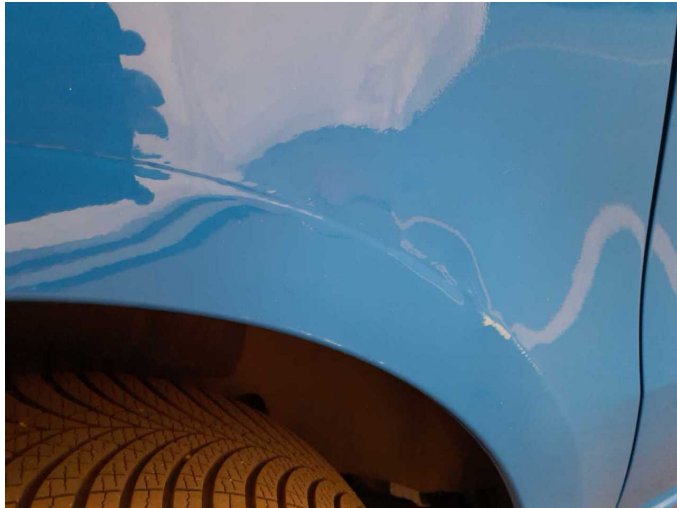
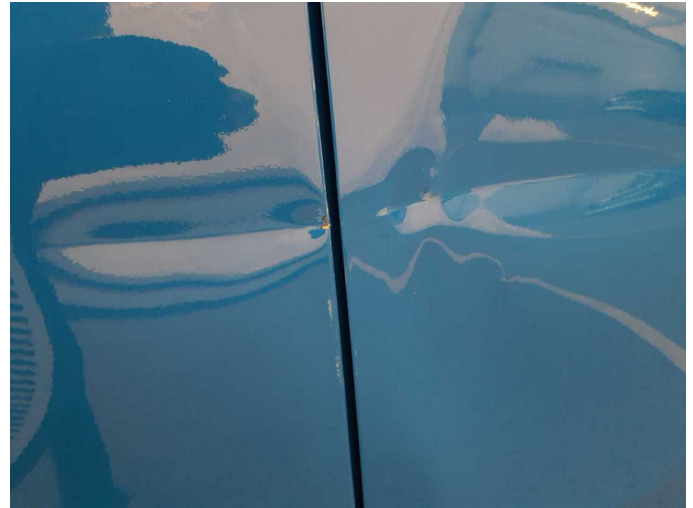
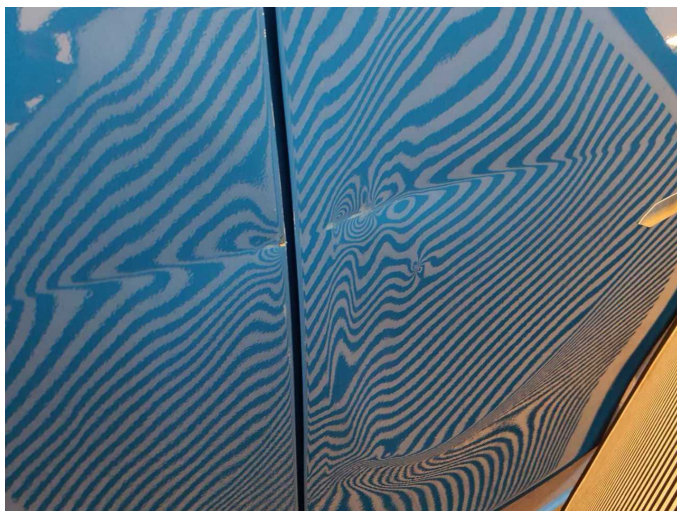
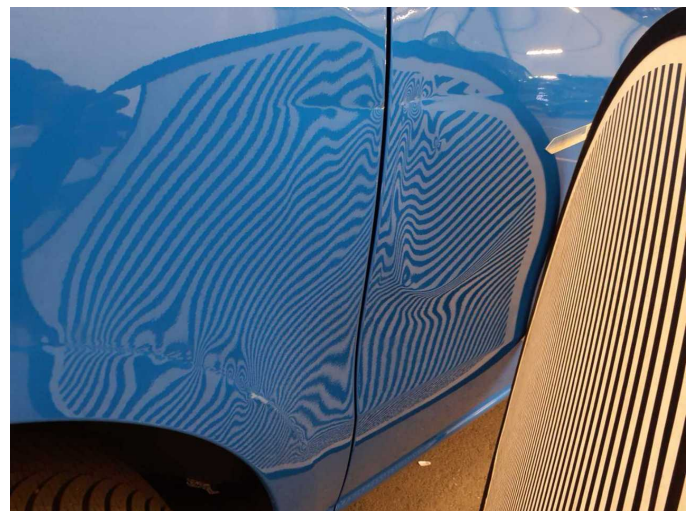
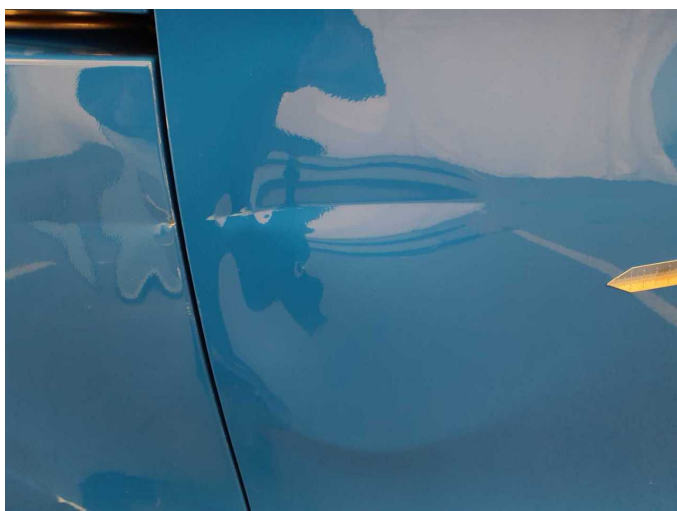
| No. | Accident |
|---|---|
| 1 | Side right |

Accident 1: Side right

**Accident 1: Side right**
