Expertise

Protocol number: 46722934  
Order No. / Reference: 26679519  
Inspection date: 21 Jul 2026

Manufacturer: Ford

Model: Transit Connect 250 L2 Trend

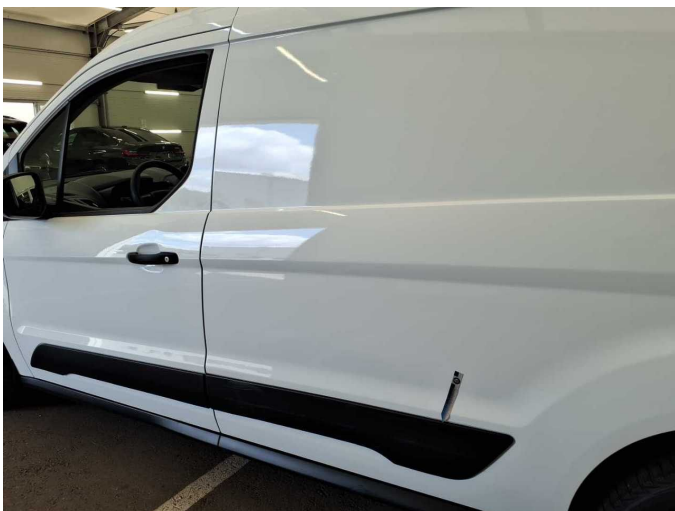
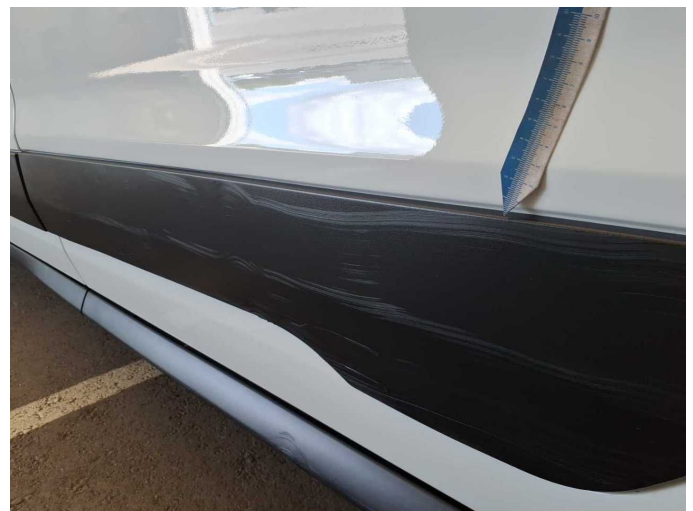
| No. | Component group | Description |
|---|---|---|
| 1 | Side panel - rear left side | Brightware - Scratched - Replace |

Damage 1: Side panel - rear left side: Brightware - Scratched - Replace

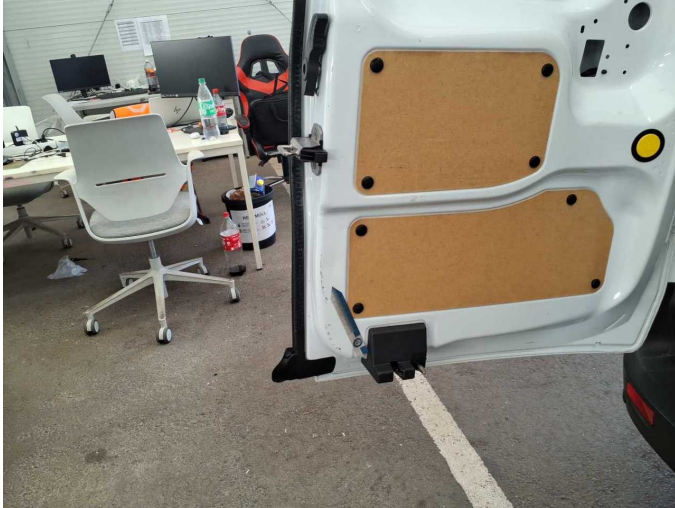
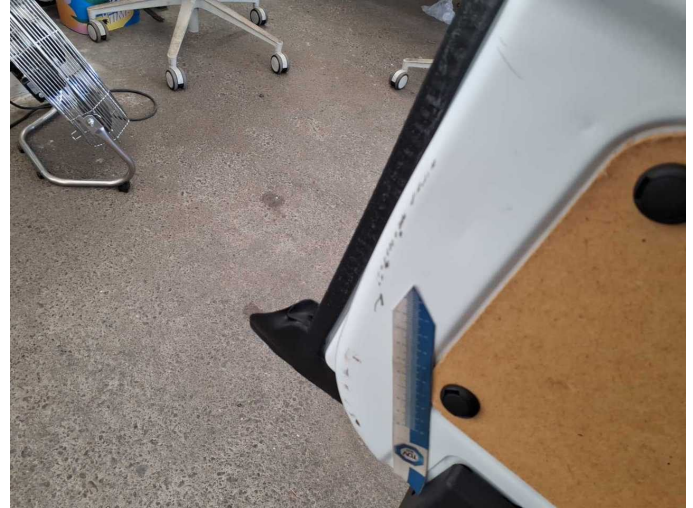
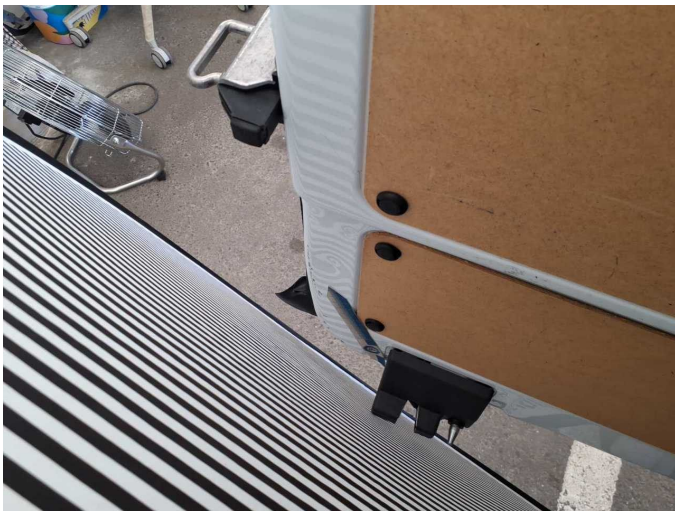
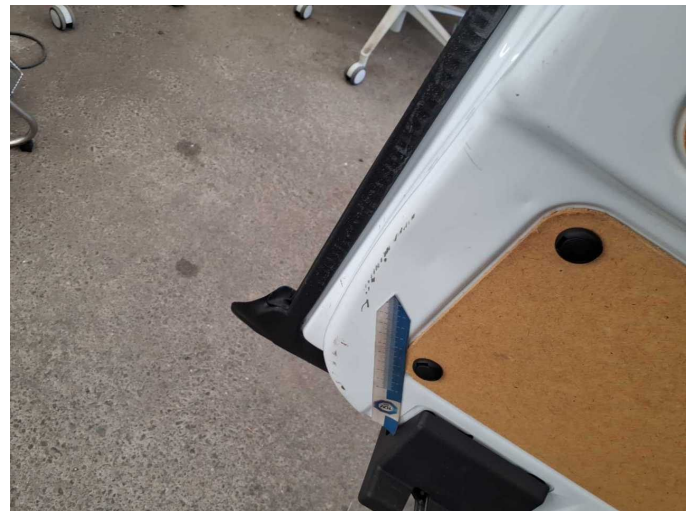
| No. | Component group | Description |
|---|---|---|
| 2 | Boot lid / rear door | Rear door - left side (Innen) - Dent / paintcoat damage - Smart repair |

**Damage 2:** Boot lid / rear door: Rear door - left side (Innen) - Dent / paintcoat damage - Smart repair

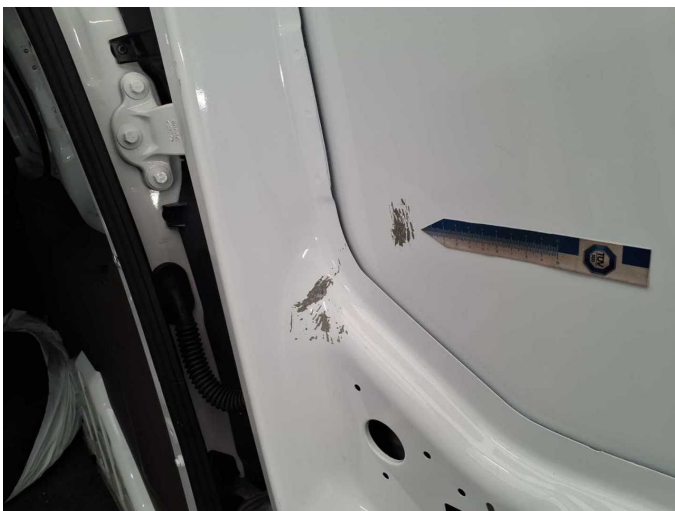
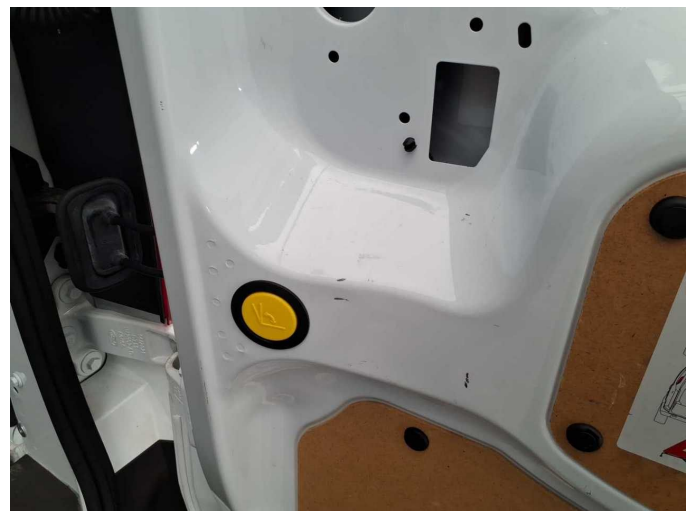
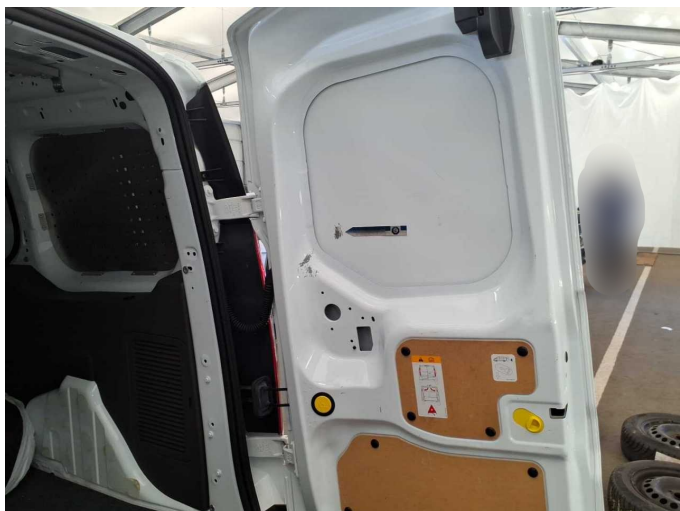
| No. | Component group | Description |
|---|---|---|
| 3 | Boot lid / rear door | Rear door - right side (Innen) - Scratch(es) - Smart repair |

**Damage 3:** Boot lid / rear door: Rear door - right side (Innen) - Scratch(es) - Smart repair

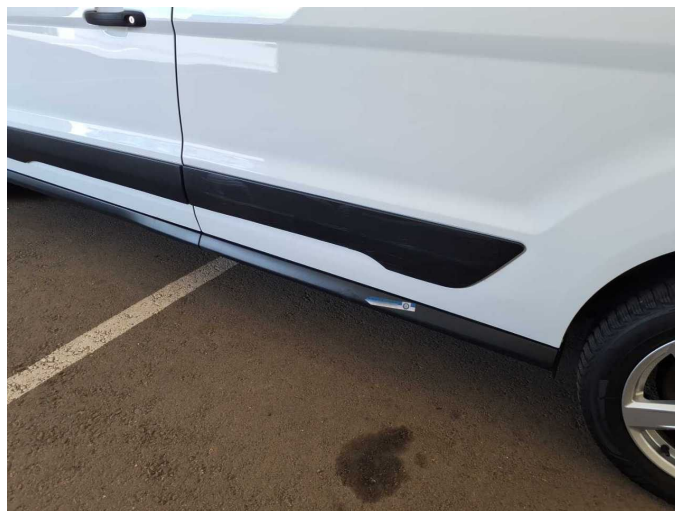
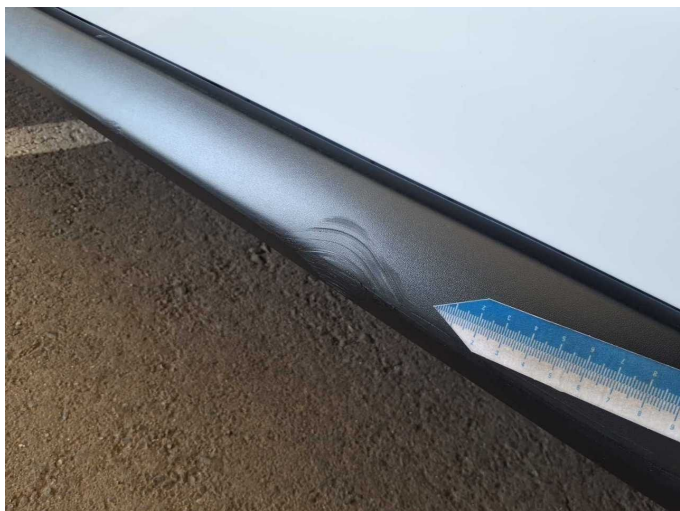
| No. | Component group | Description |
|---|---|---|
| 4 | Sill - left side | Sill (Schwellerleiste hinten links) - Scratched - Replace |

**Damage 4:** Sill - left side: Sill (Schwellerleiste hinten links) - Scratched - Replace

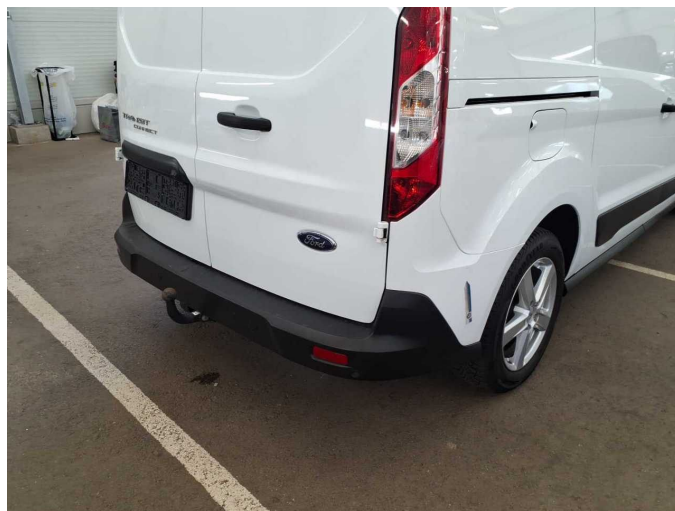
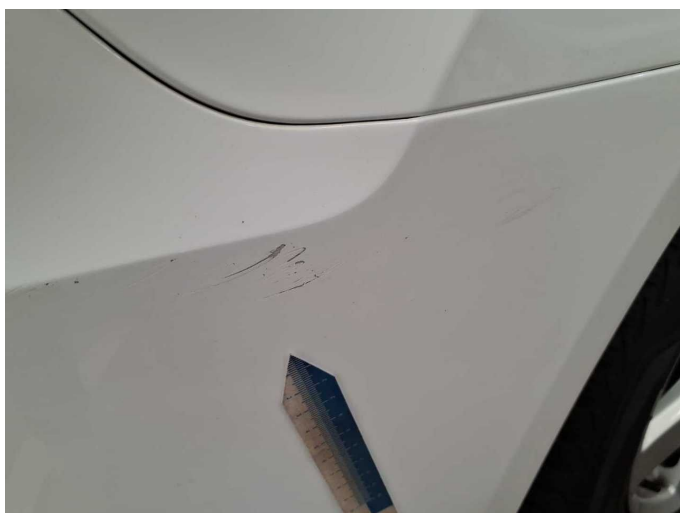
| No. | Component group | Description |
|---|---|---|
| 5 | Rear bumper | Bumper - rear right side - Scratch(es) - Paint |

**Damage 5:** Rear bumper: Bumper - rear right side - Scratch(es) - Paint
