Expertise

Protocol number: 46278560  
Order No. / Reference: 26650722  
Inspection date: 2 Jul 2026

Manufacturer: Ford

Model: Transit 330 L3H2 VA Trend

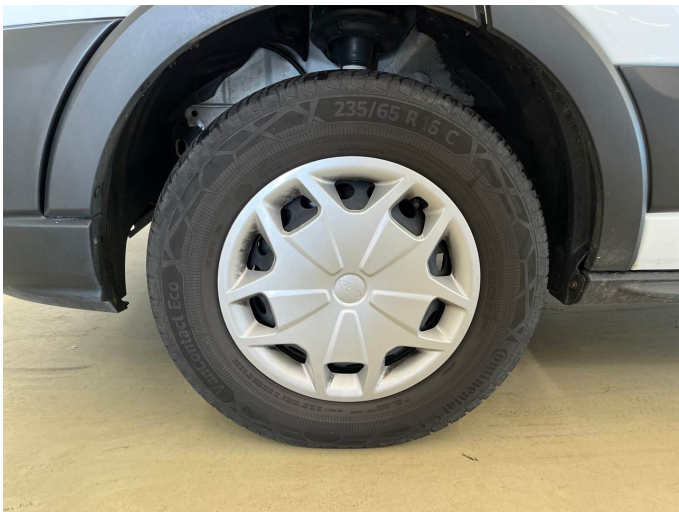
Figure 12: Mounted tyres

| # | Tyre size | Type of tyre | Manufacturer | Tread depth |
|---|---|---|---|---|
| 1) | 235/65 R16 115R | Summer tyres on Steel rim with wheel cover | Continental | 4mm / 4mm |
| 2) | 235/65 R16 115R | Summer tyres on Steel rim with wheel cover | Continental | 5mm / 5mm |

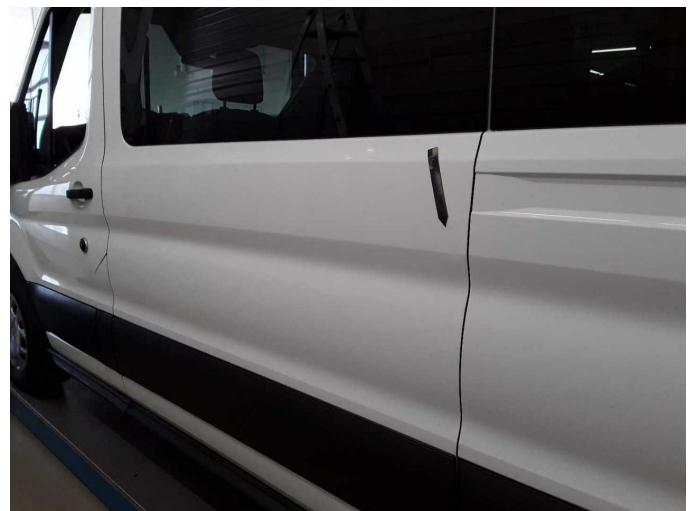
| No. | Component group | Description |
|---|---|---|
| 1 | Side panel - rear left side | Side panel - dent(s) - Smart repair |

Damage 1: Side panel - rear left side: Side panel - dent(s) - Smart repair

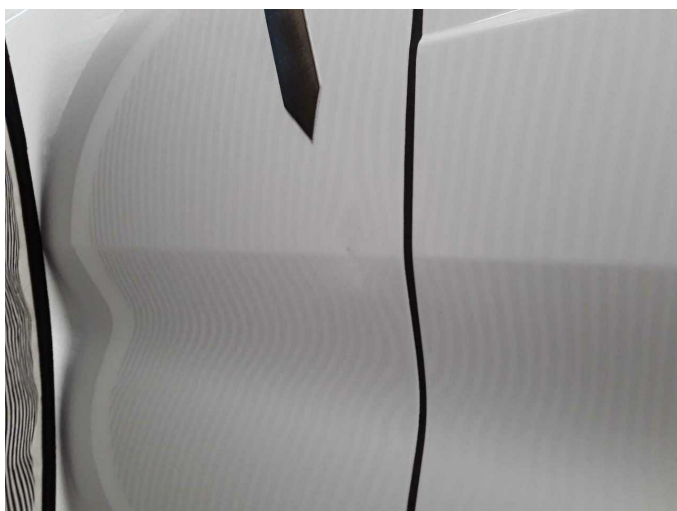
Damage 1: Side panel - rear left side: Side panel - dent(s) - Smart repair

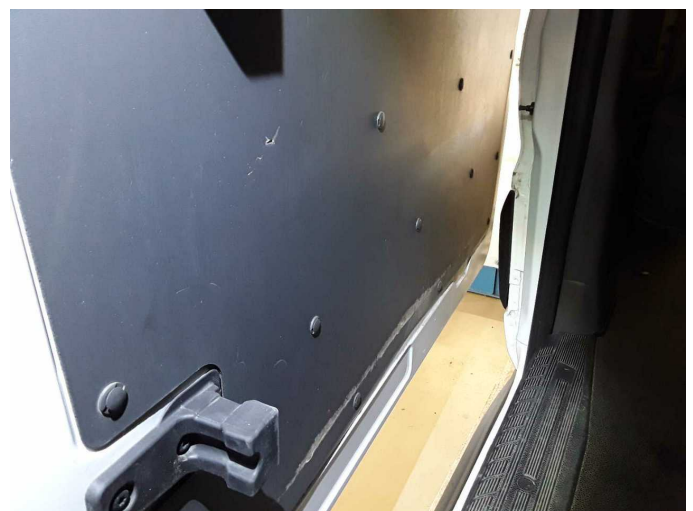
| No. | Component group | Description |
|---|---|---|
| 2 | Sliding door, right | Trim washable - lower - Broken / torn - Replace |

Damage 2: Sliding door, right: Trim washable - lower - Broken / torn - Replace

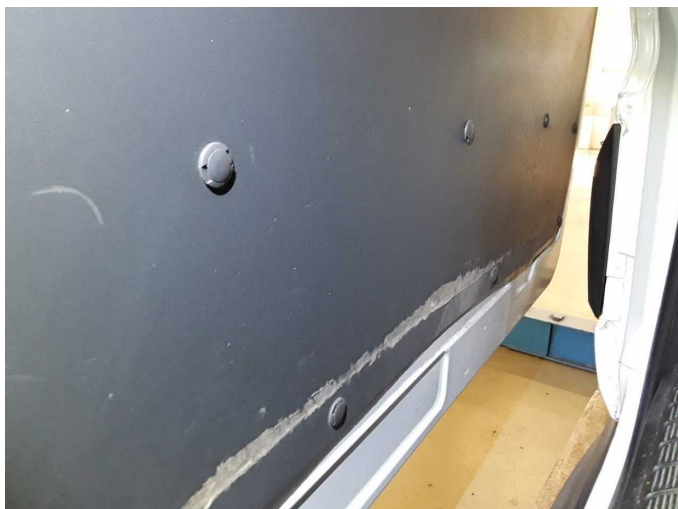
**Damage 2:** Sliding door, right: Trim washable - lower - Broken / torn - Replace

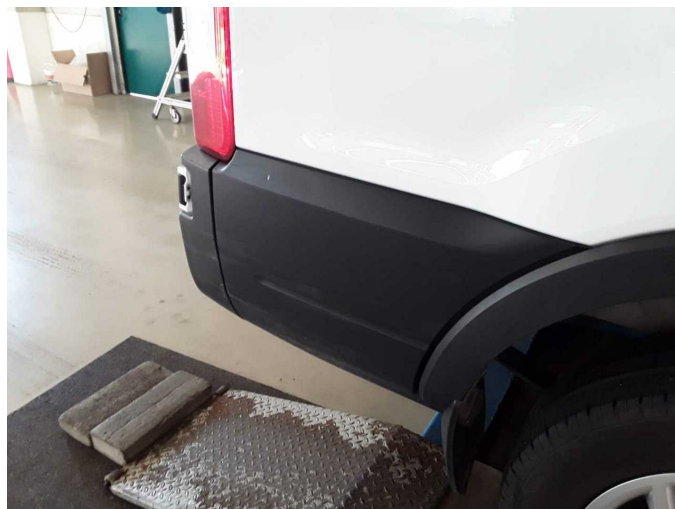
| No. | Component group | Description |
|---|---|---|
| 3 | Side panel - rear right side | Protection strip (hinten) - Scratched - Replace |

**Damage 3:** Side panel - rear right side: Protection strip (hinten) - Scratched - Replace

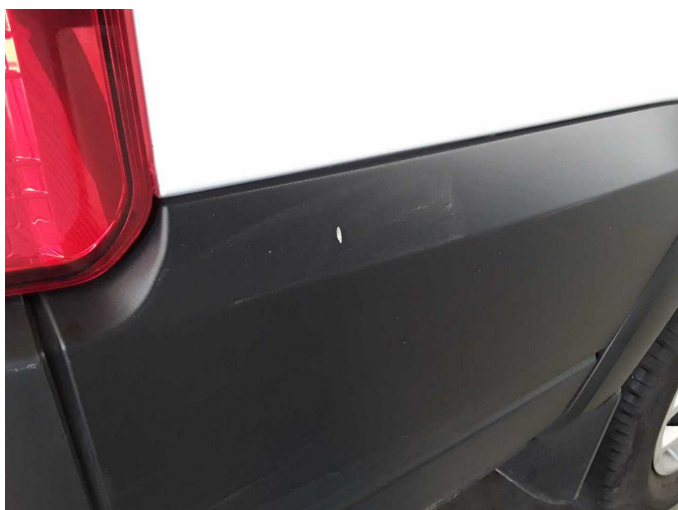
**Damage 3:** Side panel - rear right side: Protection strip (hinten) - Scratched - Replace

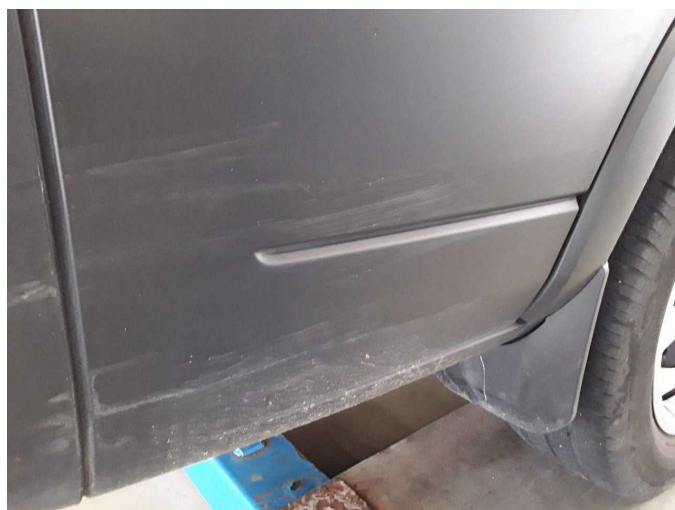
**Damage 3:** Side panel - rear right side: Protection strip (hinten) - Scratched - Replace

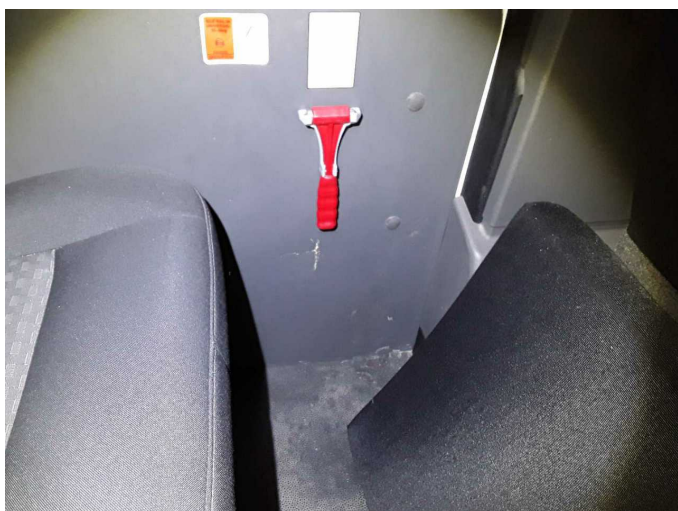
| No. | Component group | Description |
|---|---|---|
| 4 | Side panel - rear left side | Interior trim - Broken / torn - Replace |

**Damage 4:** Side panel - rear left side: Interior trim - Broken / torn - Replace

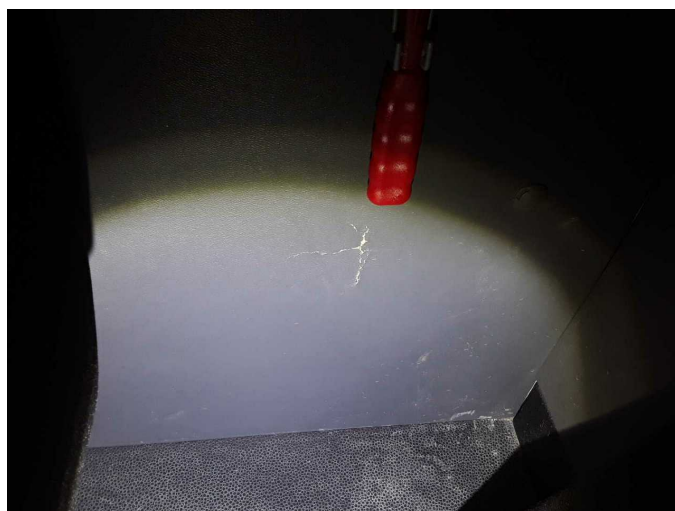
**Damage 4:** Side panel - rear left side: Interior trim - Broken / torn - Replace

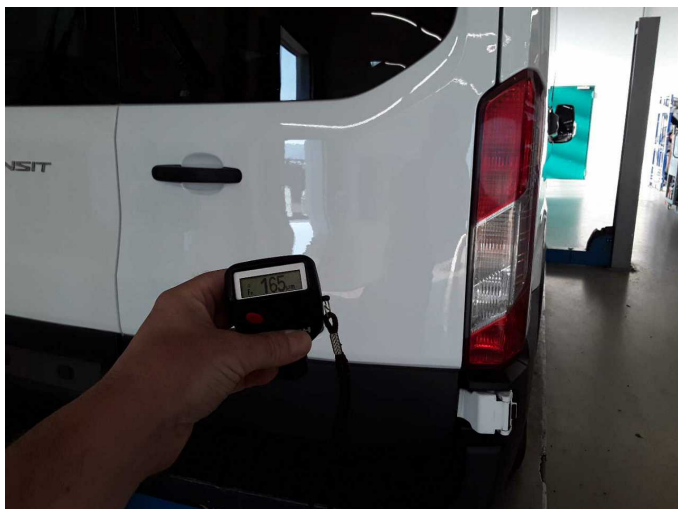
1 Boot lid / rear door, Side panel - rear right side, Professionally carried out

**Boot lid / rear door: 165 µm**

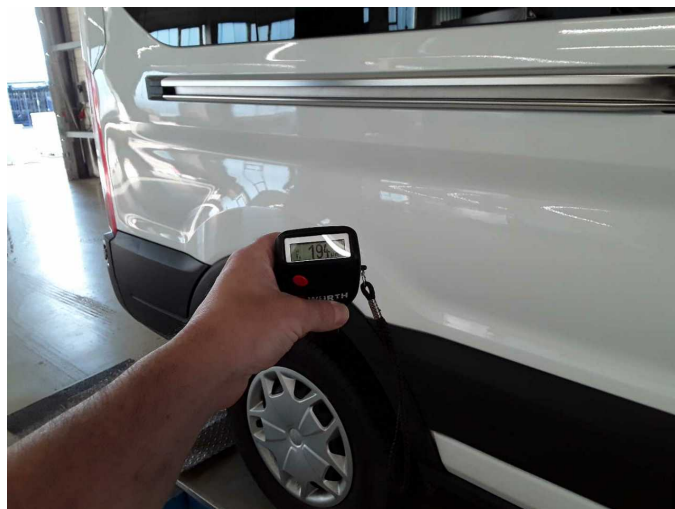
**Side panel - rear right side: 194 µm**
