Expertise

Protocol number: 45933099
Order No. / Reference: 26466347
Inspection date: 10 Jun 2026

Model: Kodiaq 2.0 TDI 4x4 DSG Tour

VIN: TMBLJ7NS4P8043605

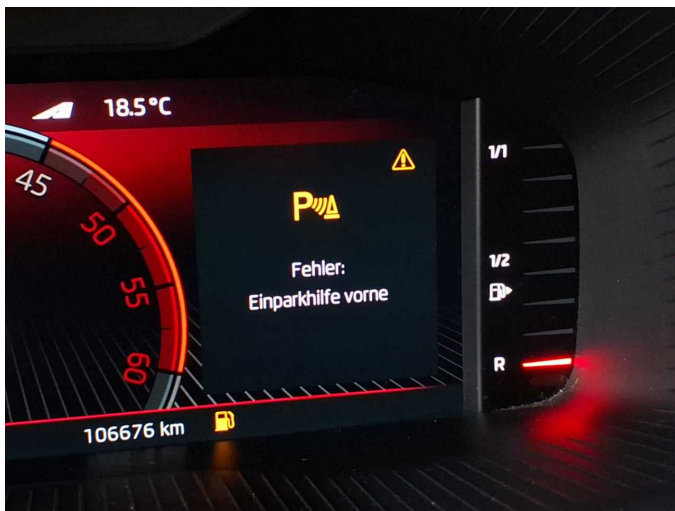
No.	Component group	Description
1	Misc.	Inspection / maintenance - Incomplete - No deduction
2	Misc.	Main inspection - No evidence - No deduction
3	Electronic systems	Parking assistance - on - Perform diagnosis
4	Side panel - rear right side	Side panel - Scratch(es) - Smart repair
5	Rear bumper	Rear bumper - Scratch(es) - Smart repair
6	2nd wheel set	1 alloy rim - Scratch(es) - Smart repair
7	Airbag systems	Airbag system (Folgekosten möglich) - on - Perform diagnosis
8	Electrical system	Battery - Empty - Replace
9	Door - rear left side	Door - Dent / paintcoat damage - Repair and paint

Damage 3: Electronic systems: Parking assistance - on - Perform diagnosis

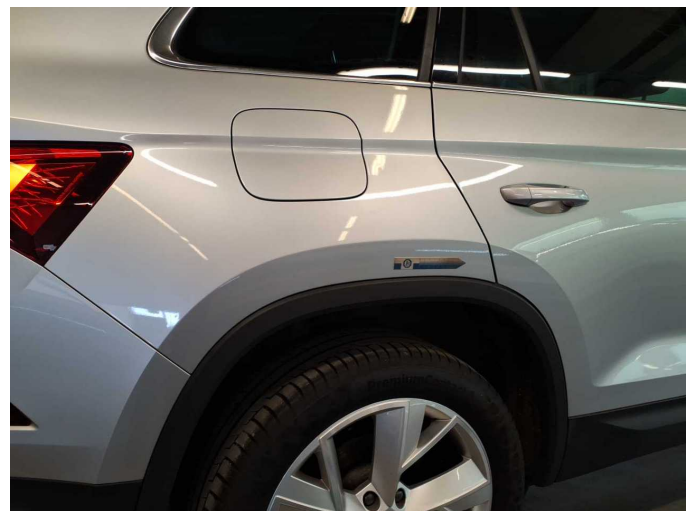
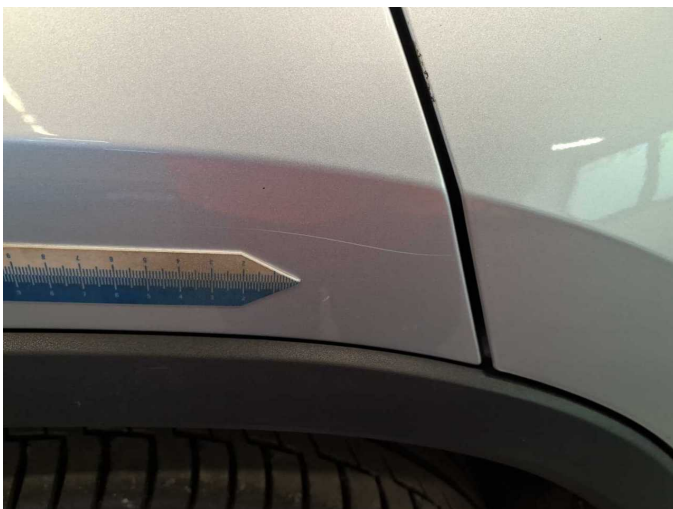
Damage 4: Side panel - rear right side: Side panel - Scratch(es) - Smart repair

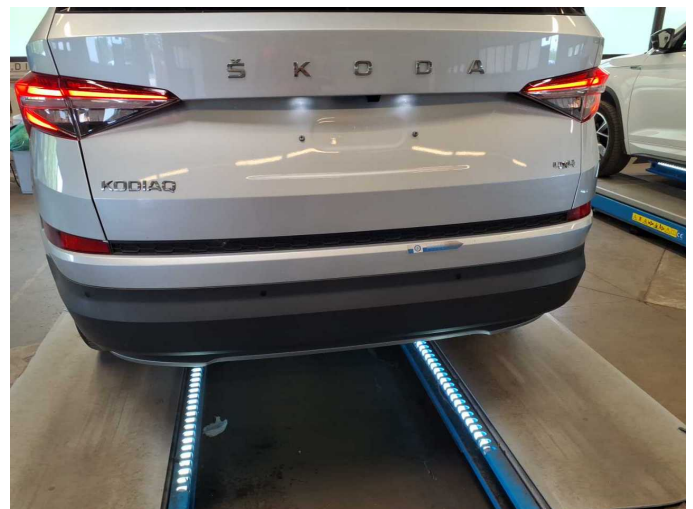
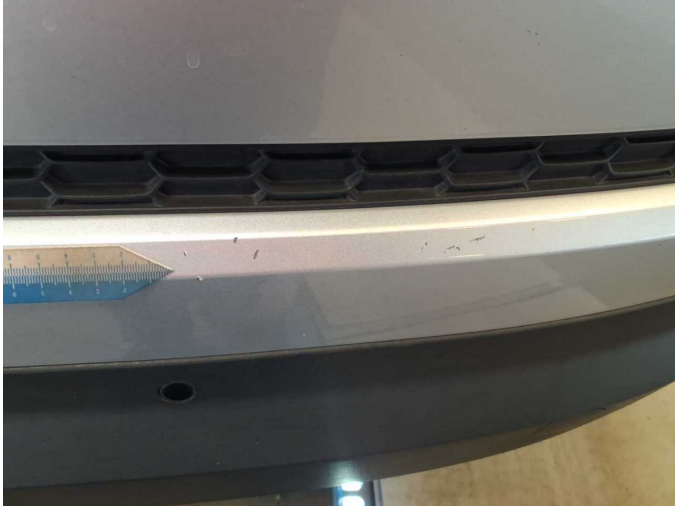
Damage 5: Rear bumper: Rear bumper - Scratch(es) - Smart repair

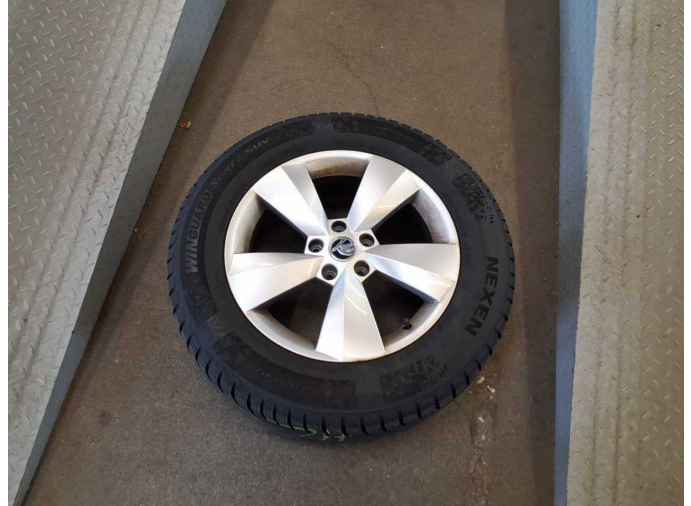
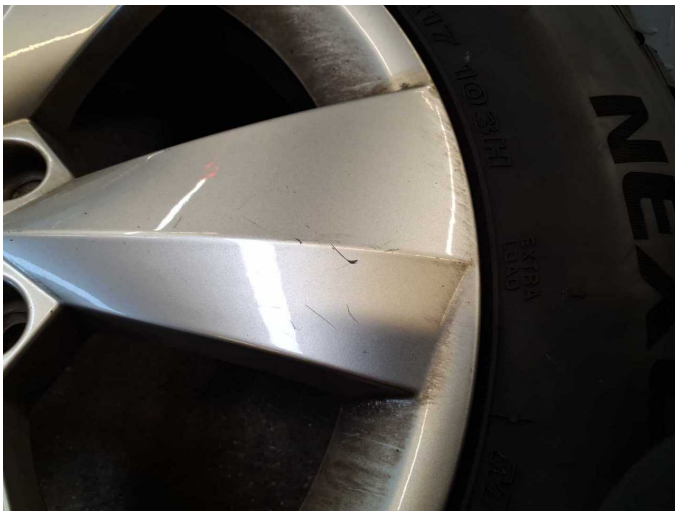
Damage 6: 2nd wheel set: 1 alloy rim - Scratch(es) - Smart repair

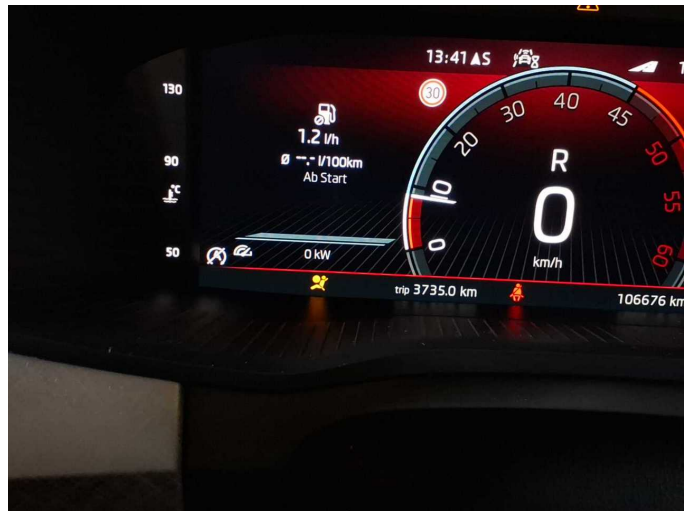
Damage 7: Airbag systems: Airbag system (Folgekosten möglich) - on - Perform diagnosis

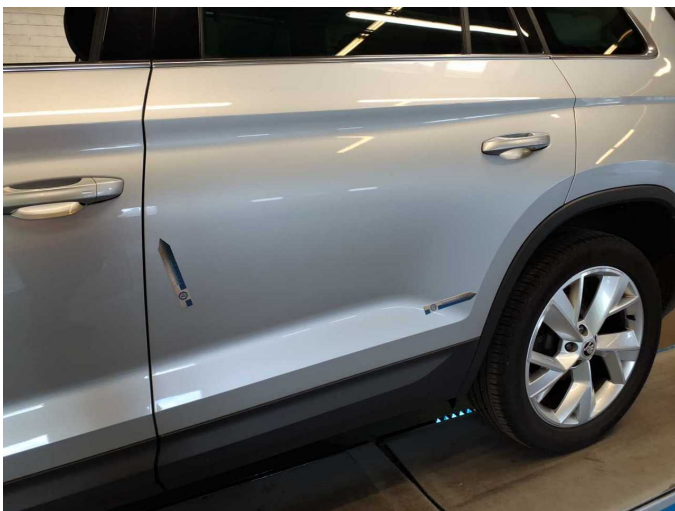
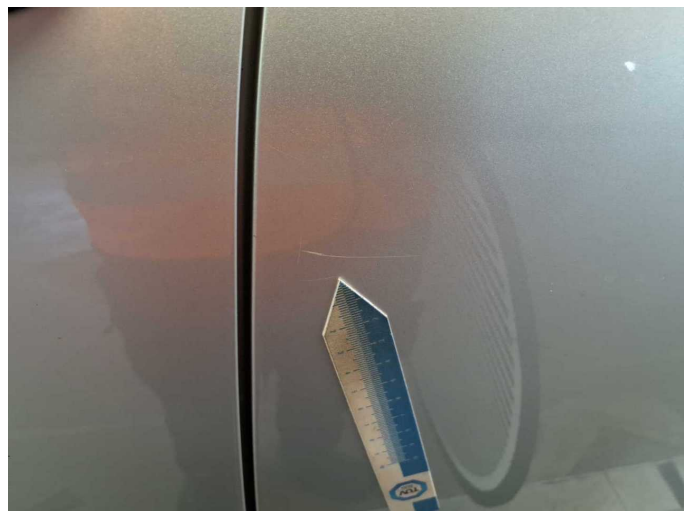
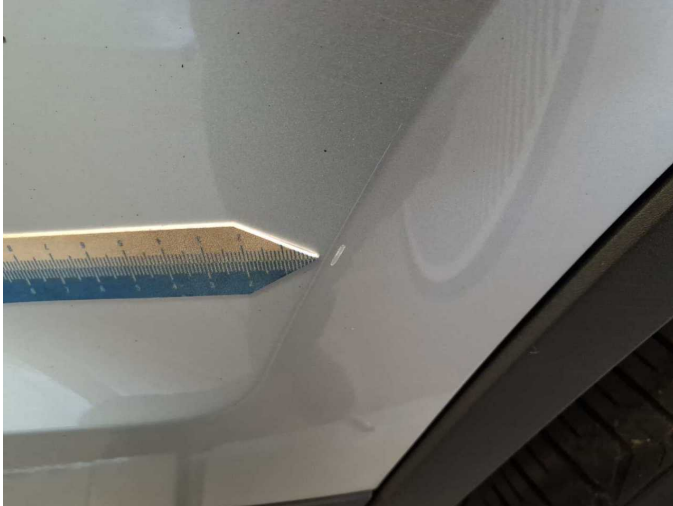
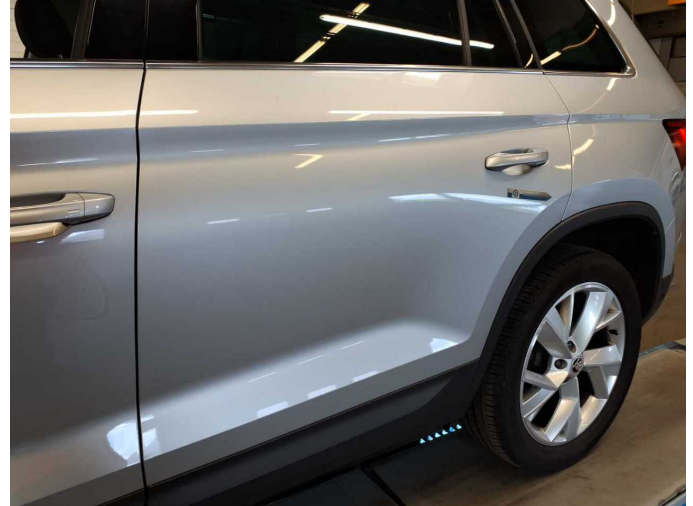
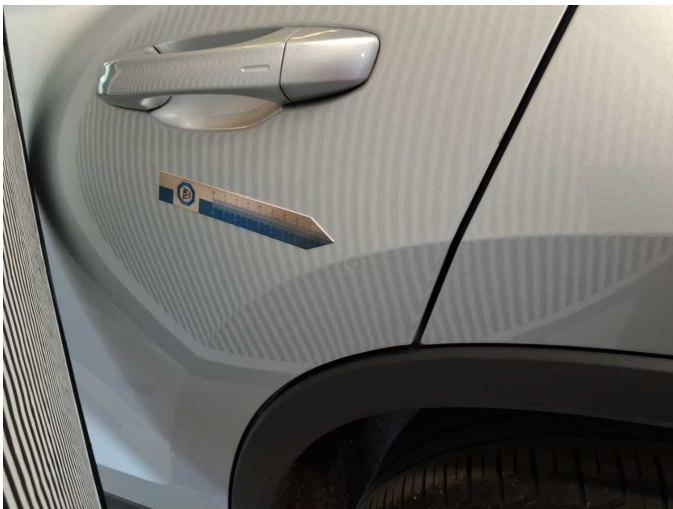
Damage 9: Door - rear left side: Door - Dent / paintcoat damage - Repair and paint

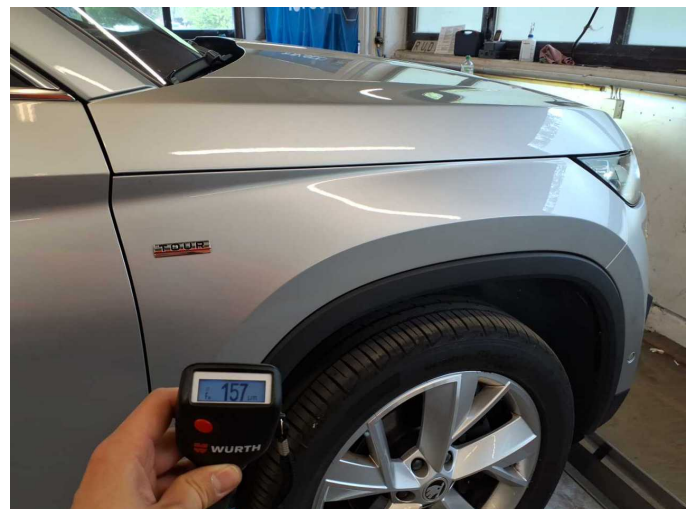
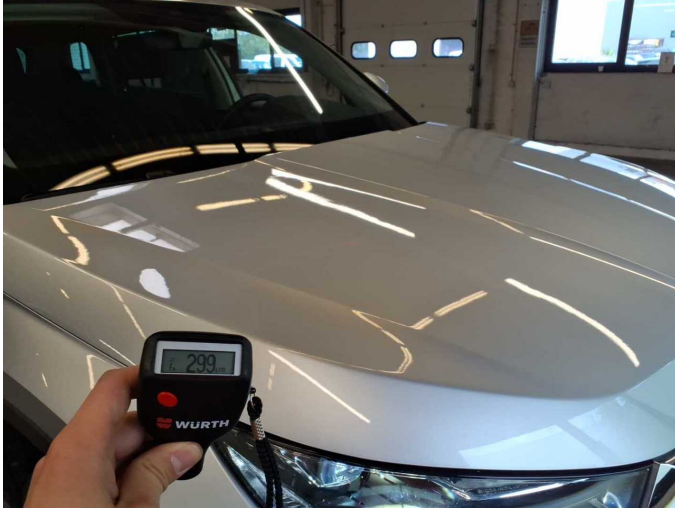
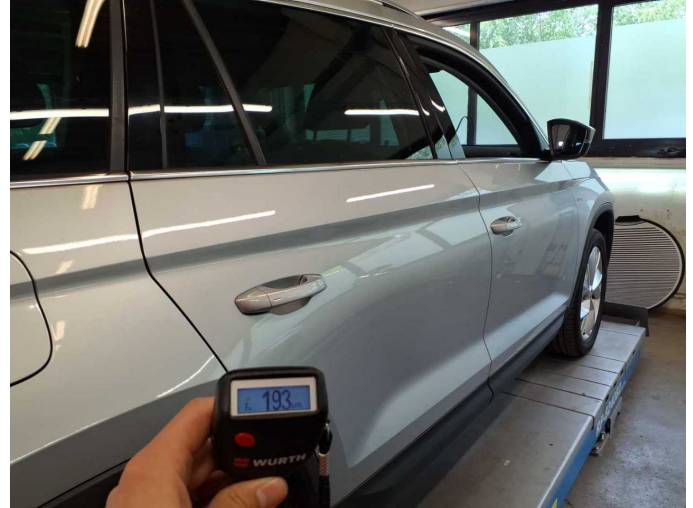
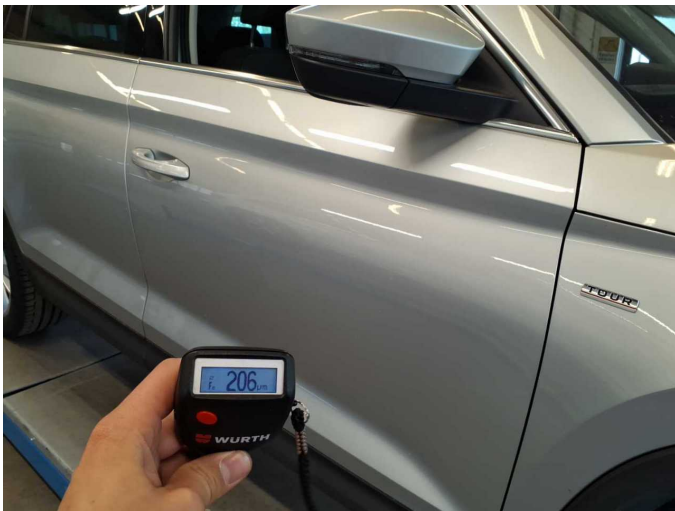
No.	Repainting
1	Mudguard - right side, Bonnet, Door - rear right side, Door - front right side, Professionally carried out, Invoice of repair done Non-existent

Mudguard - right side	157 µm	Bonnet	299 µm
Door - rear right side	193 µm	Door - front right side	206 µm

Repainting 1: Mudguard - right side, Bonnet, Door - rear right side, Door - front right side
