Expertise

Protocol number: 46548697  
Order No. / Reference: 26564894  
Inspection date: 15 Jul 2026

| Manufacturer: Ford | Model: Focus Turnier 1.5 EcoBlue Start-Stopp-System Aut. ACTIVE |
| VIN: WF0PXXGCHPNA25867 | |

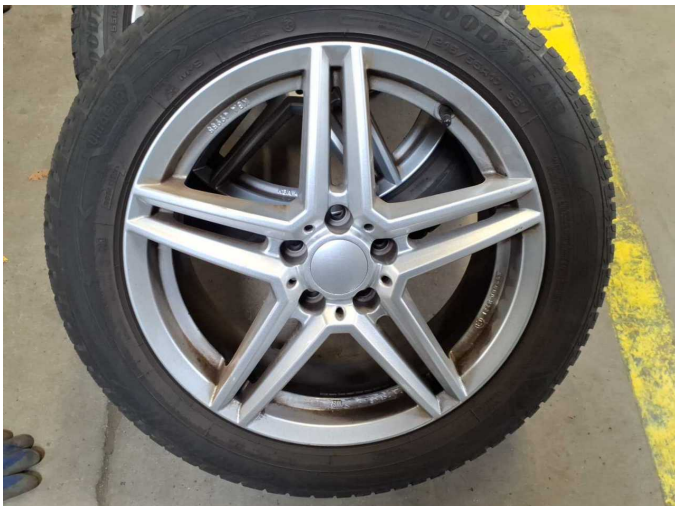
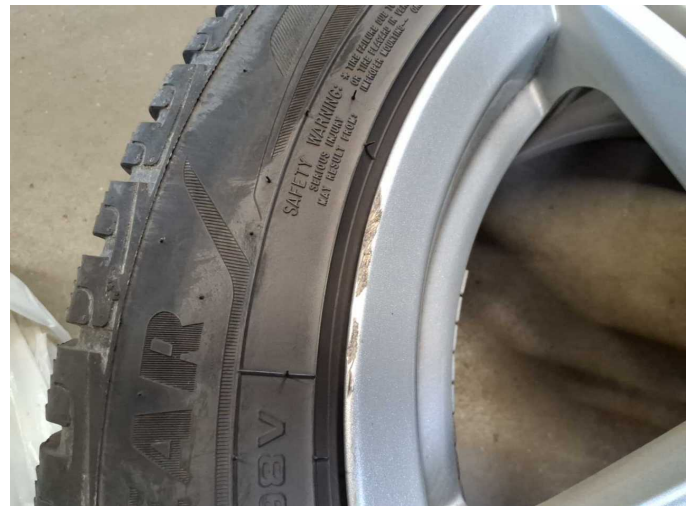
| No. | Component group | Description |
|---|---|---|
| 1 | 2nd wheel set | 1 alloy rim (gehört nicht zur Ausstattung) - Scratched - No deduction |

**Damage 1:** 2nd wheel set: 1 alloy rim (gehört nicht zur Ausstattung) - Scratched - No deduction

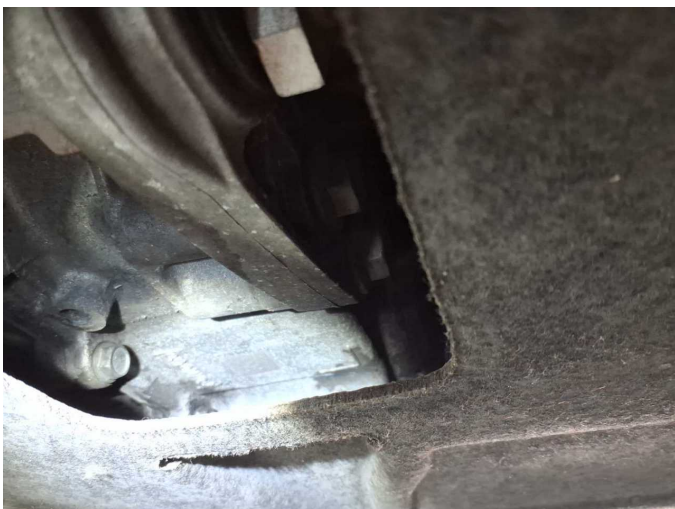
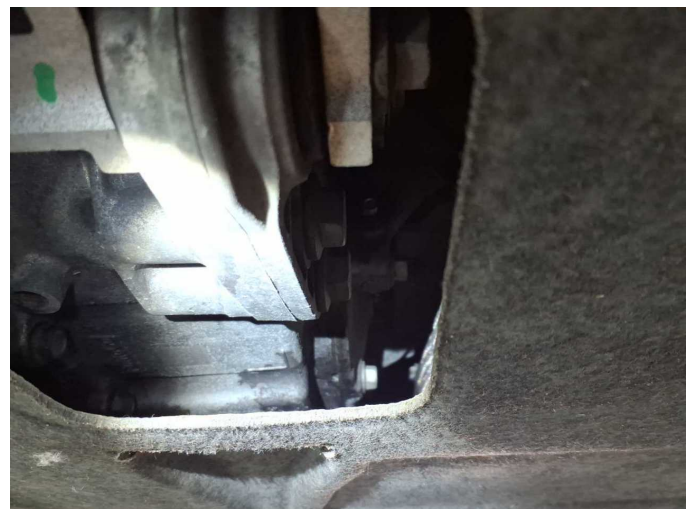
| No. | Component group | Description |
|---|---|---|
| 2 | Gearbox | Gearbox - Leaking - Perform diagnosis |

**Damage 2:** Gearbox: Gearbox - Leaking - Perform diagnosis

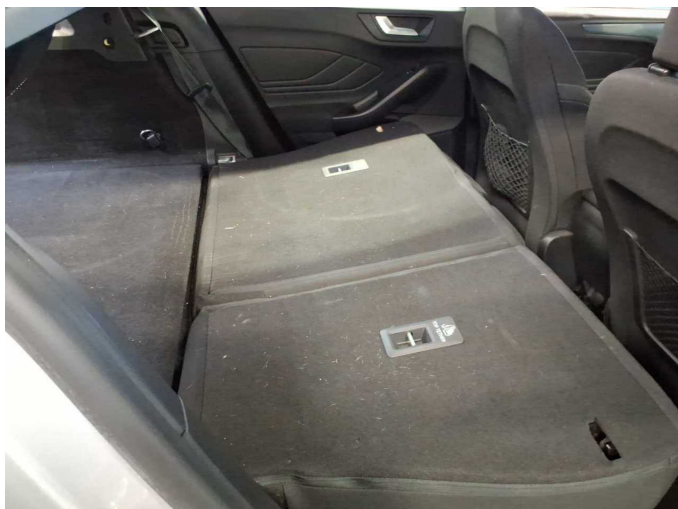
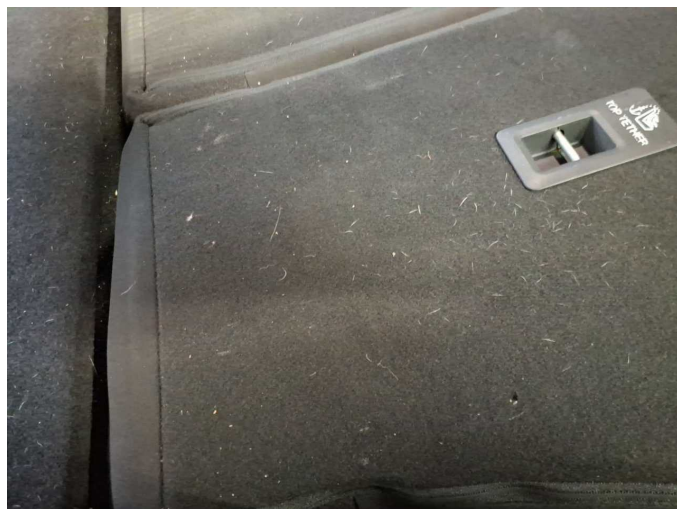
| No. | Component group | Description |
|---|---|---|
| 3 | Interior | Interior (Tier haare) - Soiled - Clean |

**Damage 3:** Interior: Interior (Tier haare) - Soiled - Clean

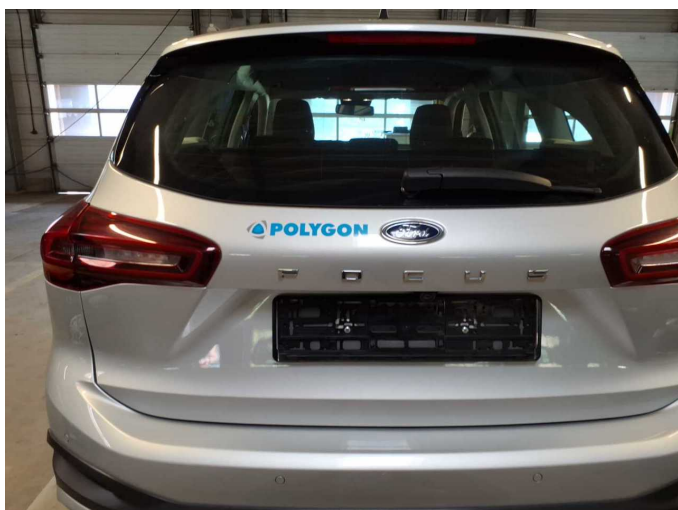
| No. | Component group | Description |
|---|---|---|
| 4 | Boot lid / rear door | Boot lid - Glued / labelled - De-glue / neutralise |

**Damage 4:** Boot lid / rear door: Boot lid - Glued / labelled - De-glue / neutralise

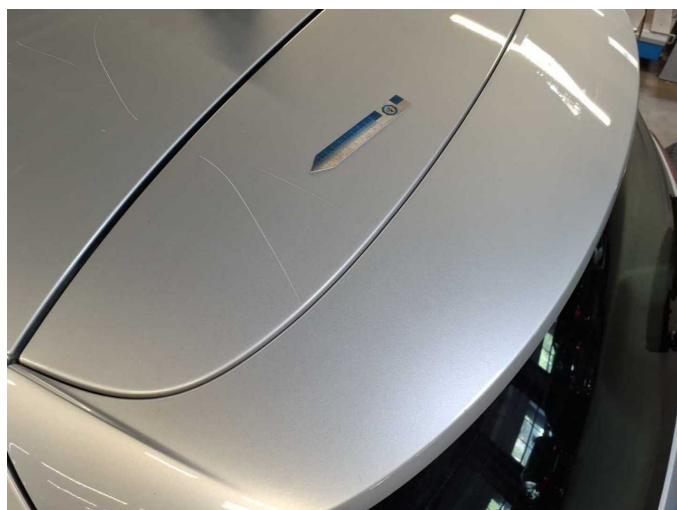
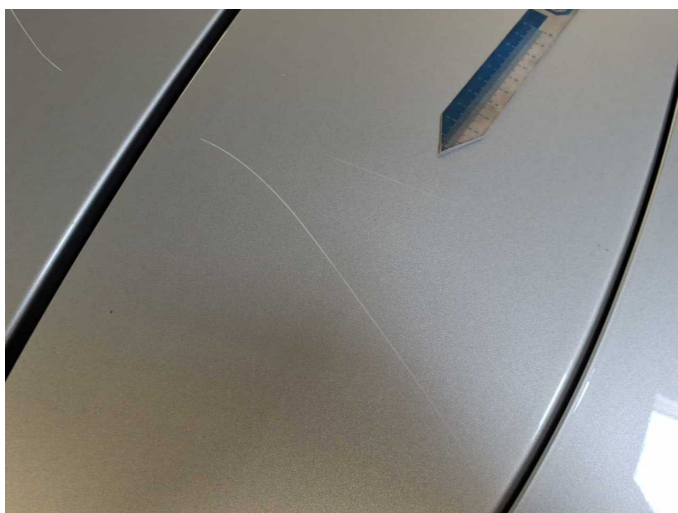
| No. | Component group | Description |
|---|---|---|
| 5 | Boot lid / rear door | Boot lid (Wandalismus) - Scratched - Smart repair |

**Damage 5:** Boot lid / rear door: Boot lid (Wandalismus) - Scratched - Smart repair

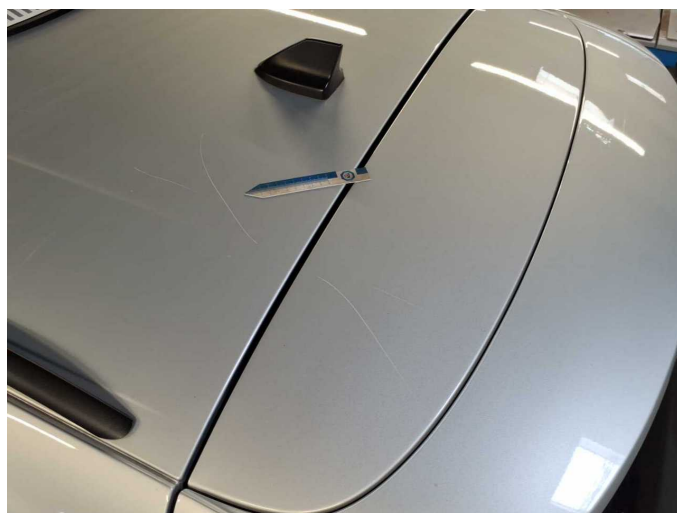
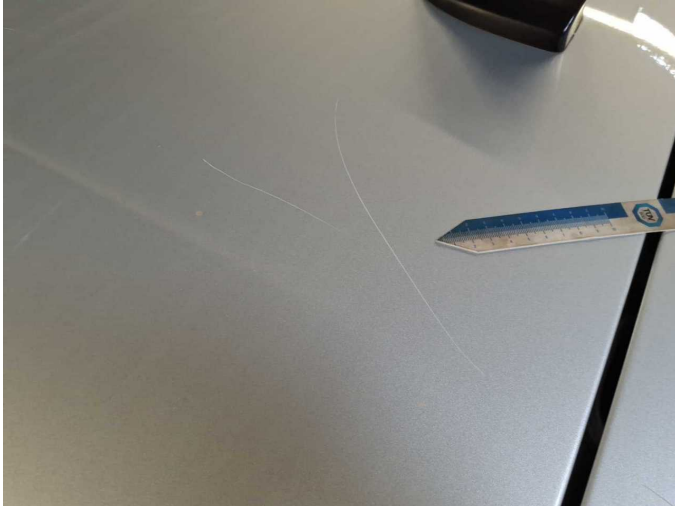
| No. | Component group | Description |
|---|---|---|
| 6 | Roof | Roof (Wandalismus) - Scratch(es) - Smart repair |

**Damage 6:** Roof: Roof (Wandalismus) - Scratch(es) - Smart repair

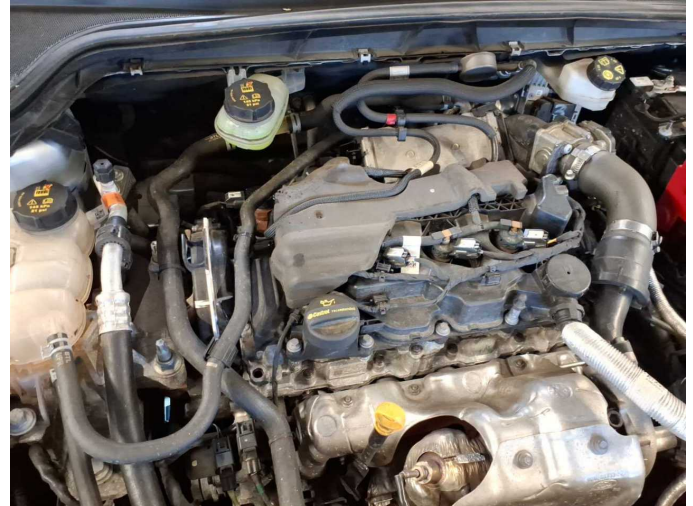
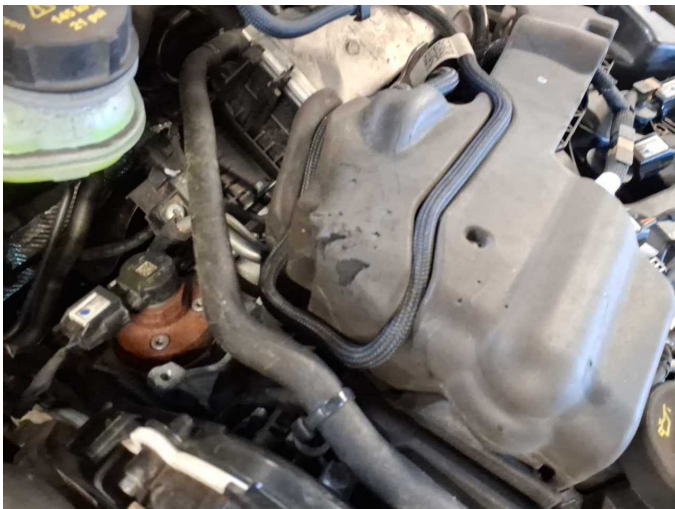
| No. | Component group | Description |
|---|---|---|
| 8 | Engine | Engine cover - Damaged - Replace |

**Damage 8:** Engine: Engine cover - Damaged - Replace

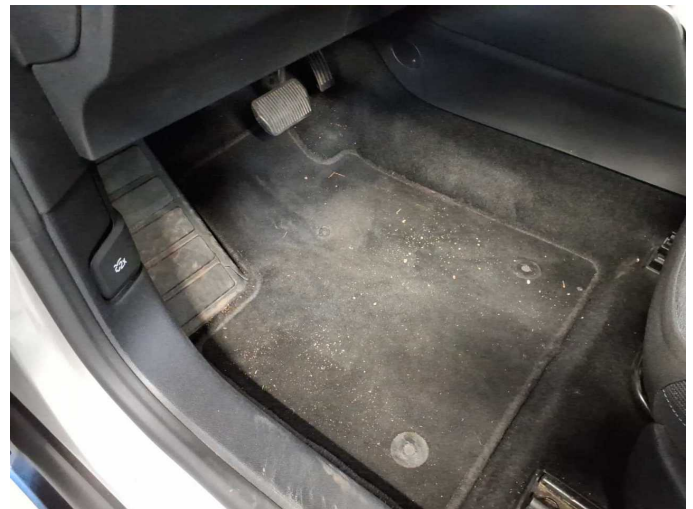
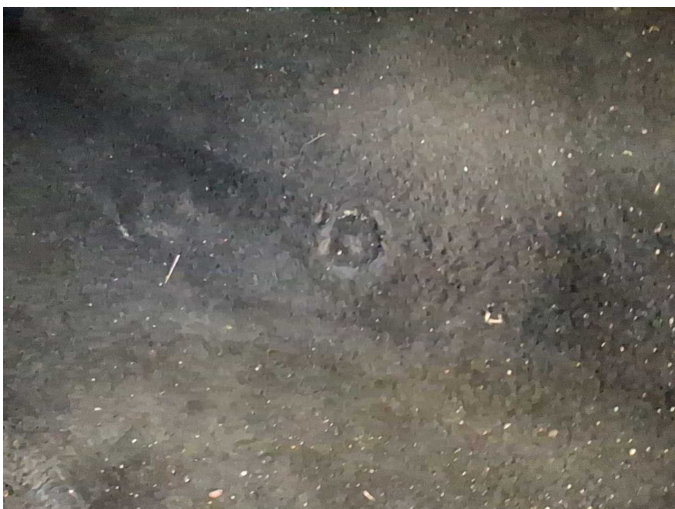
| No. | Component group | Description |
|---|---|---|
| 1 | Trim / covers | Floor mats - Damaged - No deduction |

**Wear and tear 1:** Trim / covers: Floor mats - Damaged - No deduction

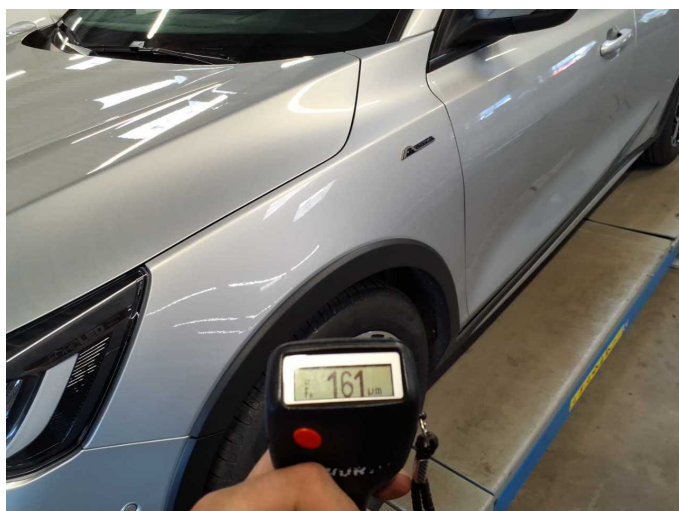
| Mudguard - left side | 161 µm | Mudguard - right side | 177 µm |

**Repainting 1:** Mudguard - left side

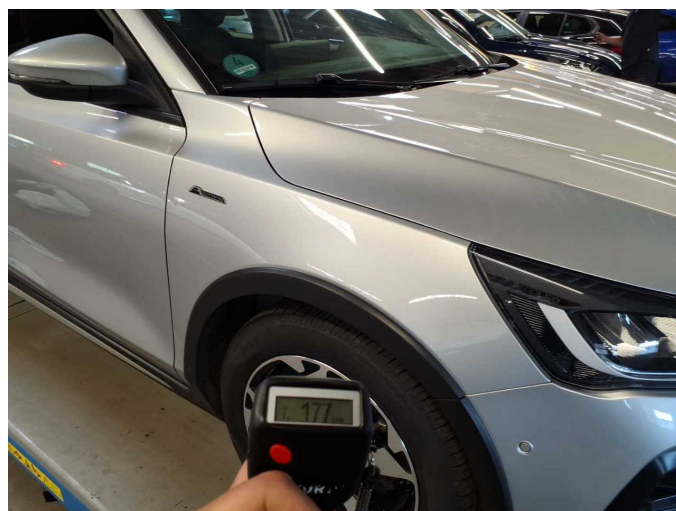
**Repainting 2:** Mudguard - right side
