Expertise

Protocol number: 45577803
Order No. / Reference: 26296167
Inspection date: 19 May 2026

Model: Kuga 2.5 Duratec PHEV TITANIUM X

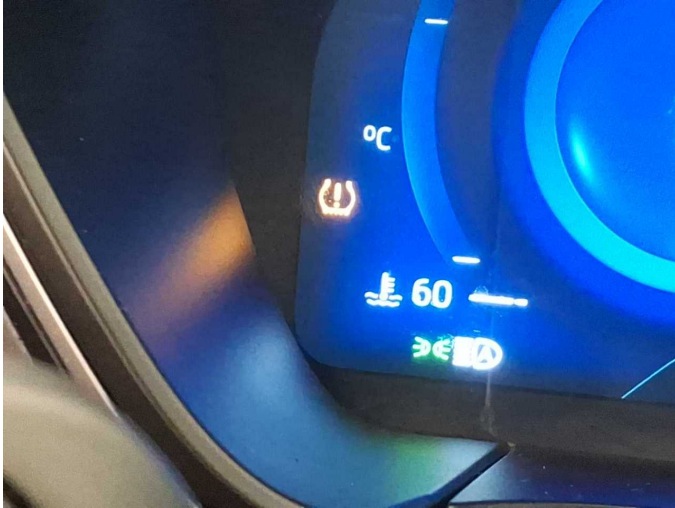
Damage 1: Instrument panel: Indicator light (Reifendruck Kontrollleuchte) - on - Perform diagnosis

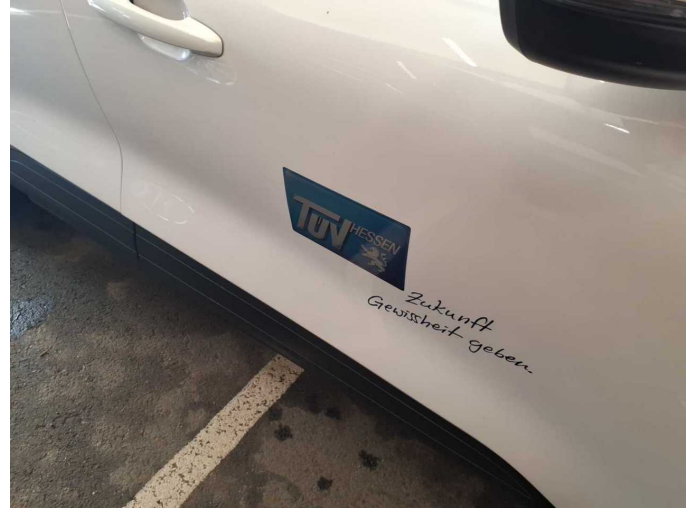
Damage 2: Door - front right side: Door - Glued / labelled - De-gluue / neutralise

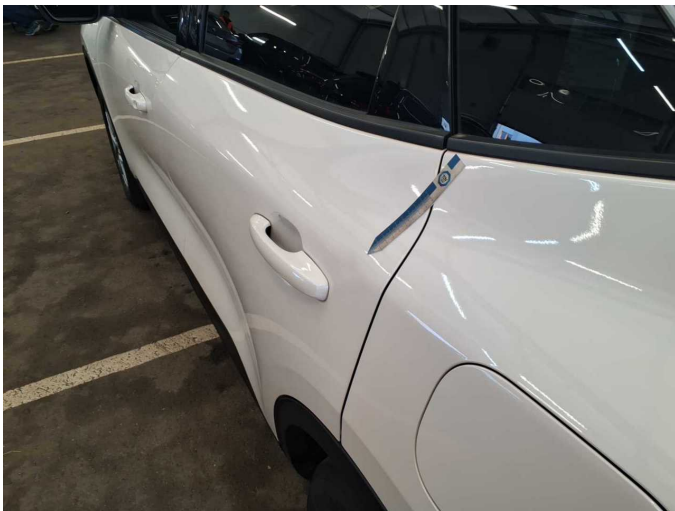
Damage 3: Door - rear left side: Door - dent(s) - Smooth repair work

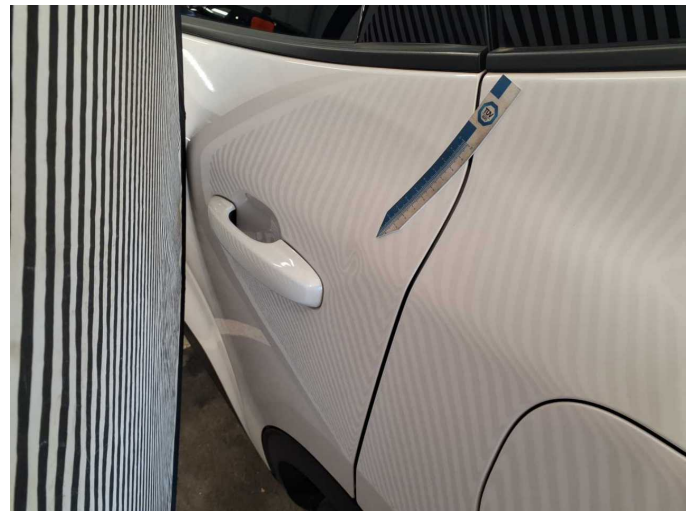
Damage 3: Door - rear left side: Door - dent(s) - Smooth repair work

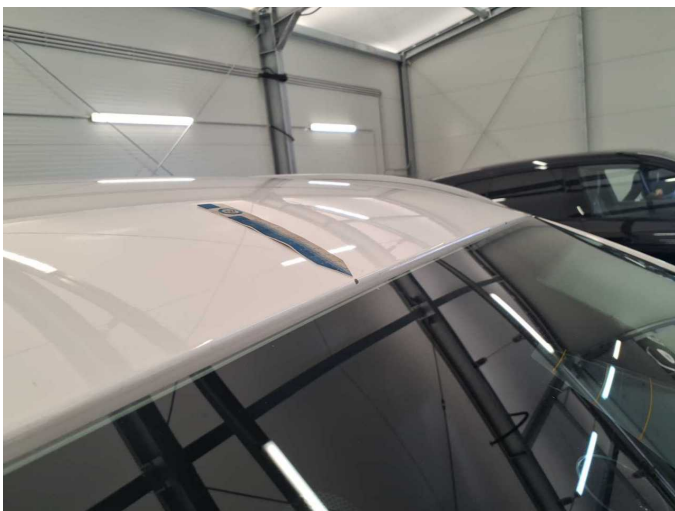
Damage 4: Roof: Roof - Stone chips - Paint

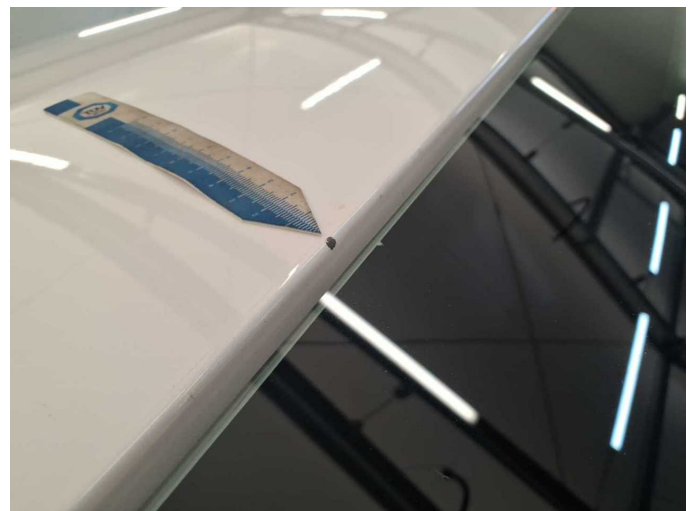
Damage 4: Roof: Roof - Stone chips - Paint

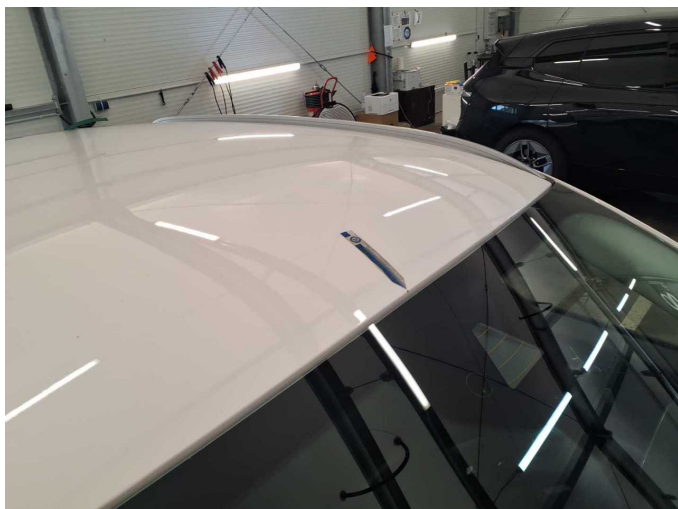
Damage 4: Roof: Roof - Stone chips - Paint

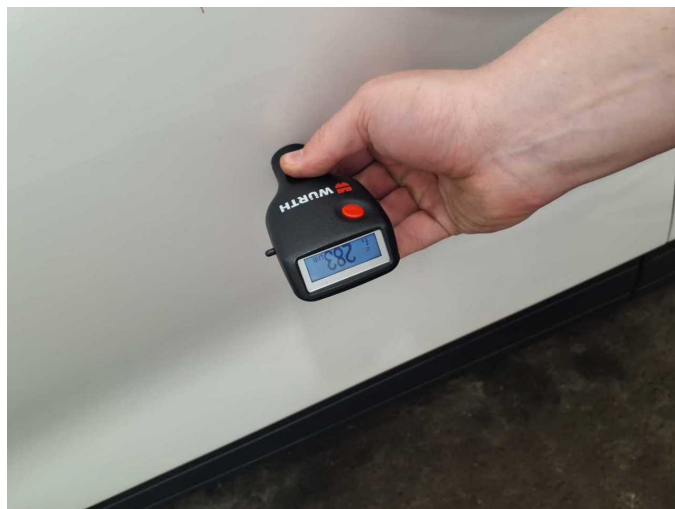
No.	Repainting
1	Door - front left side, Professionally carried out, Invoice of repair done Non-existent

Door - front left side 283 µm |

Repainting 1: Door - front left side

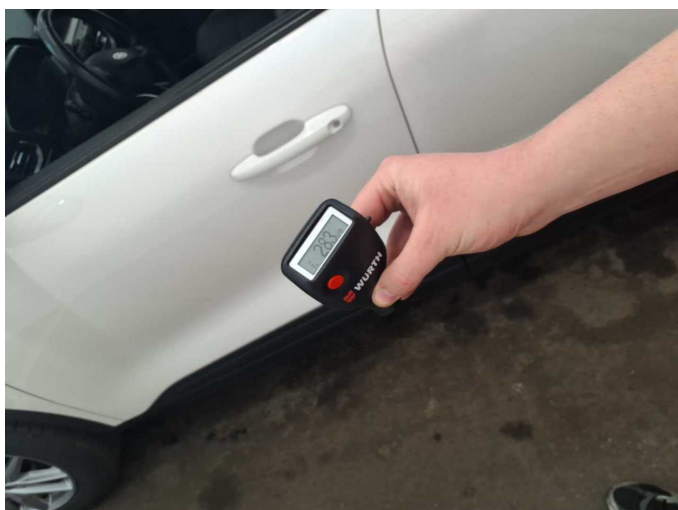
Repainting 1: Door - front left side
