Expertise

Protocol number: 46129802
Order No. / Reference: 26349545
Inspection date: 24 Jun 2026

Model: TGE 3.140 4X2F SB

VIN: WMA03VUY9P9019465

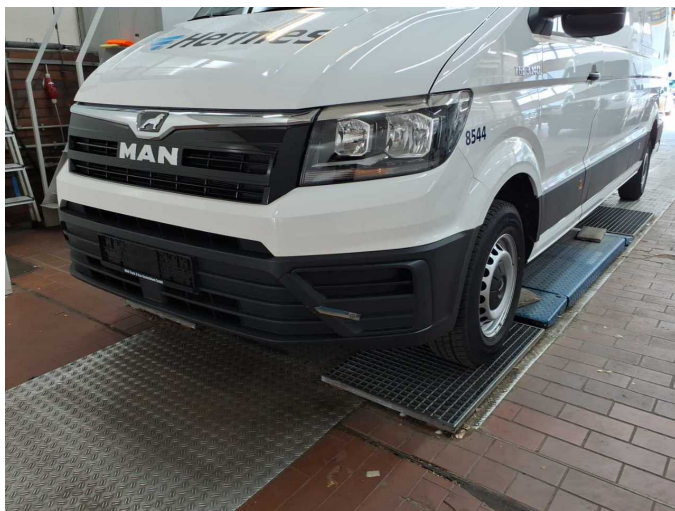
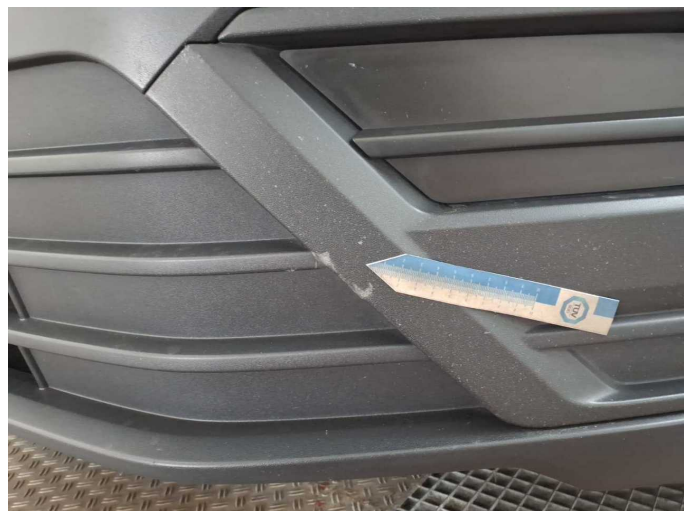
No.	Component group	Description
1	Front bumper	Front bumper (unpainted) (Blend) - Scratch(es) - Loss in value
2	Side panel - rear right side	Side panel - Dent / paintcoat damage - Smart repair
3	Body	Body - Glued / labelled - De-glue / neutralise
4	Boot lid / rear door	Rear door - left side - Dent / paintcoat damage - Repair and paint

Damage 1: Front bumper: Front bumper (unpainted) (Blend) - Scratch(es) - Loss in value

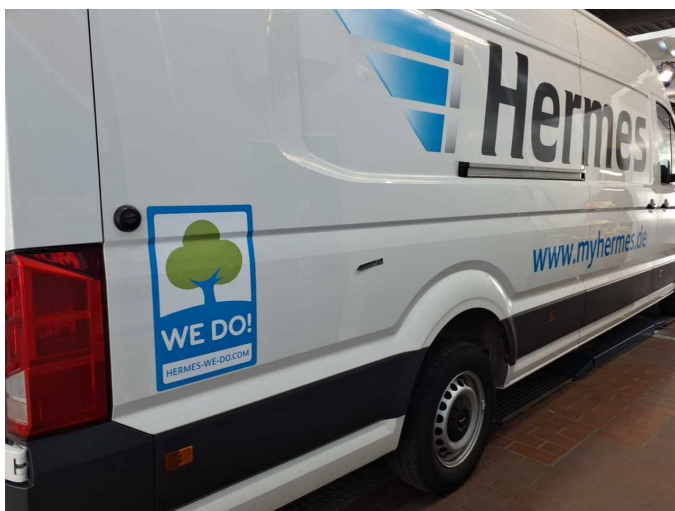
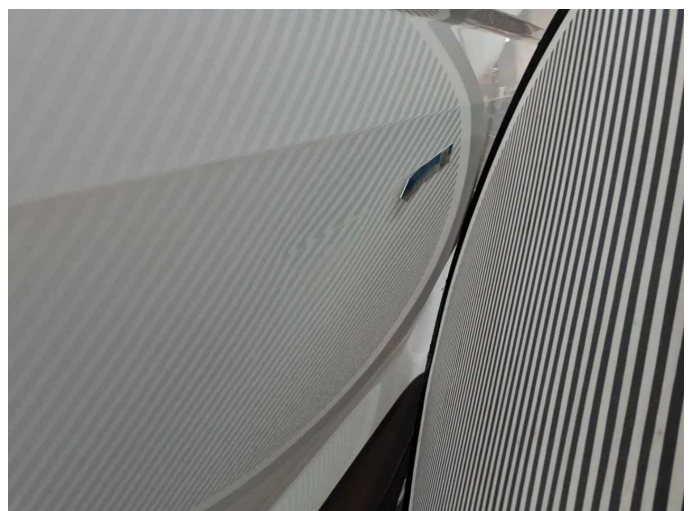
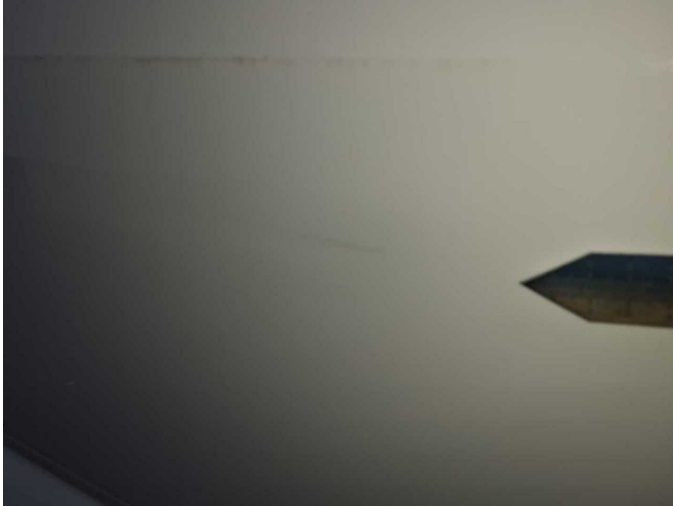
Damage 2: Side panel - rear right side: Side panel - Dent / paintcoat damage - Smart repair

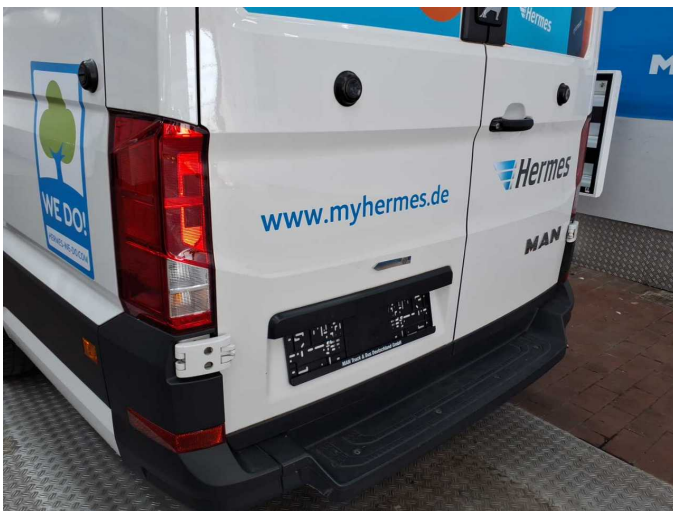
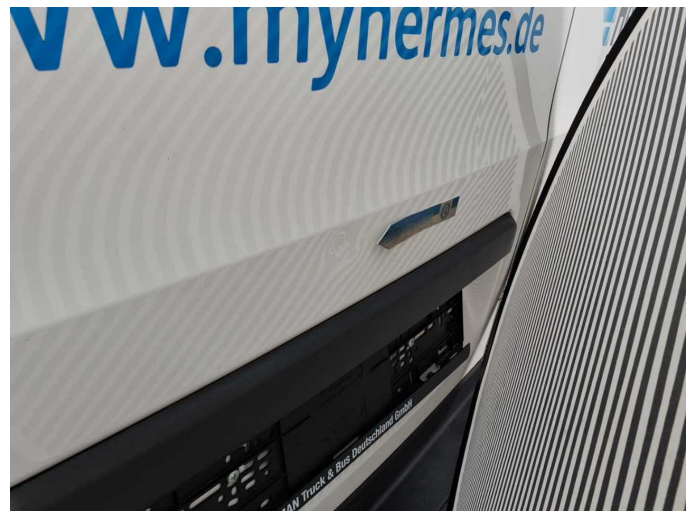
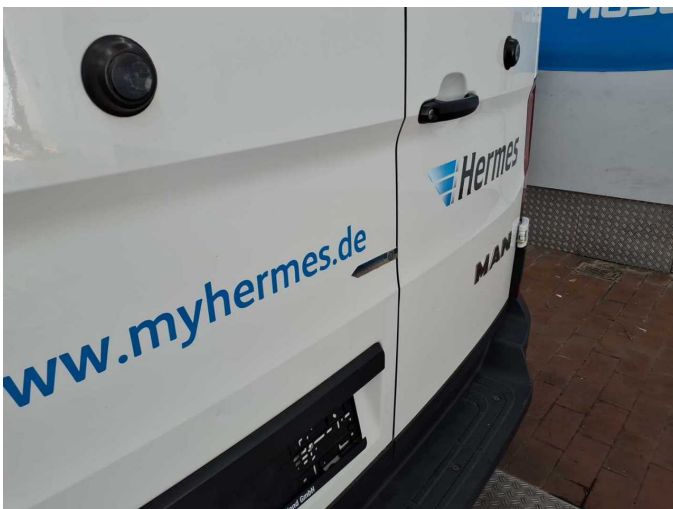
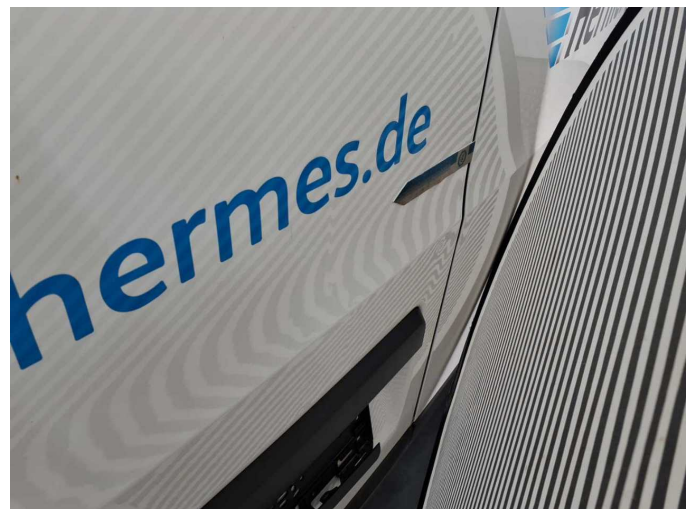
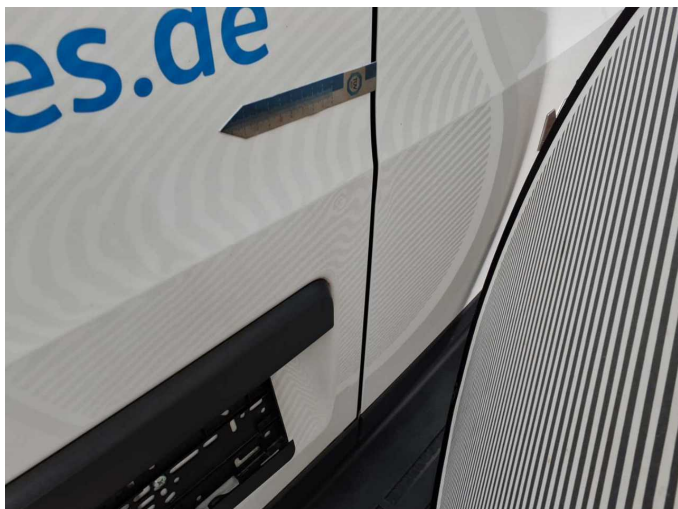
Damage 4: Boot lid / rear door: Rear door - left side - Dent / paintcoat damage - Repair and paint
