Expertise

Protocol number: 46198235
 Order No. / Reference: 26152489
 Inspection date: 22 Jun 2026

Manufacturer: Opel

Model: Movano 2.2 D L3H2 2WD VA Edition

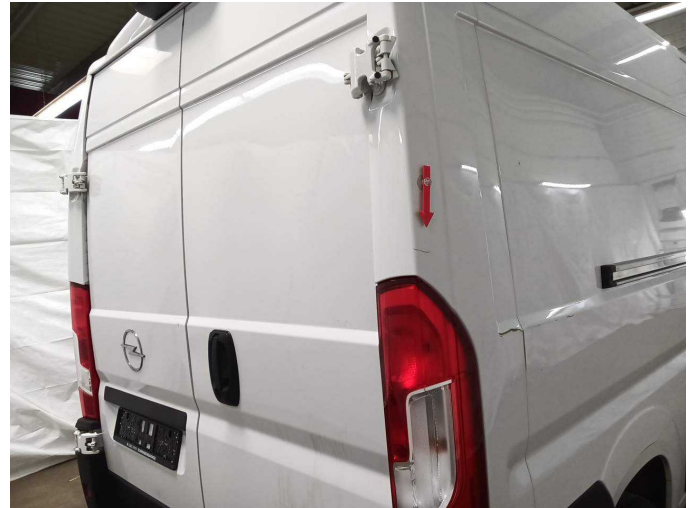
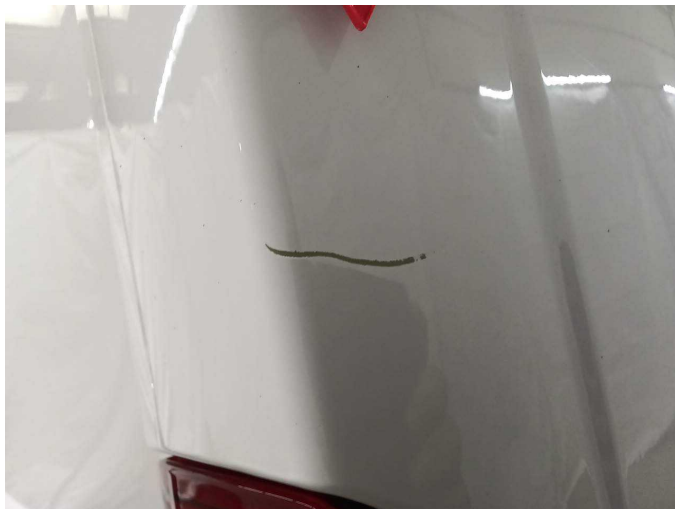
Damage 1: Body: D-pillar - right side (Lackierung bereits im Unfallschaden enthalten) - Scratch(es)

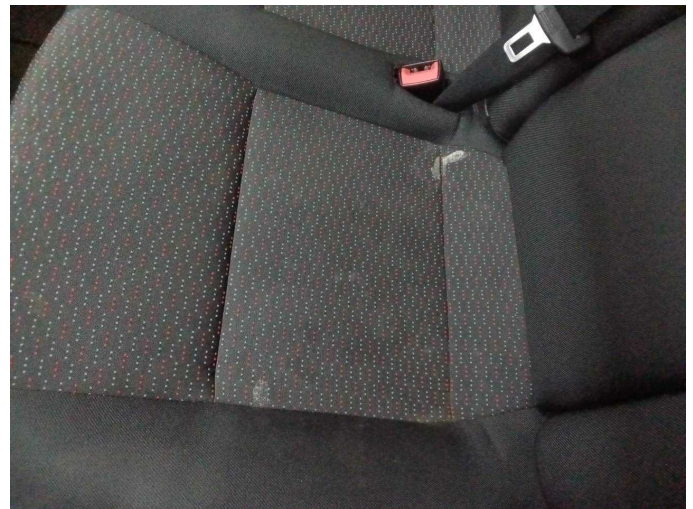
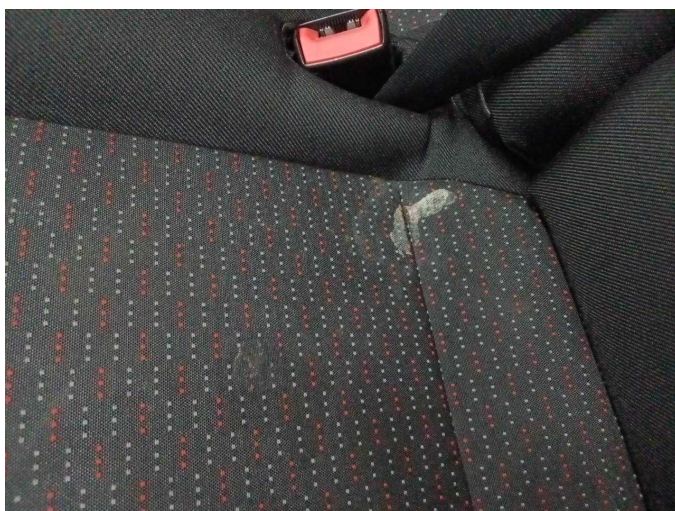
Damage 2: Seat - front: Seat cover - right side - Soiled - Clean

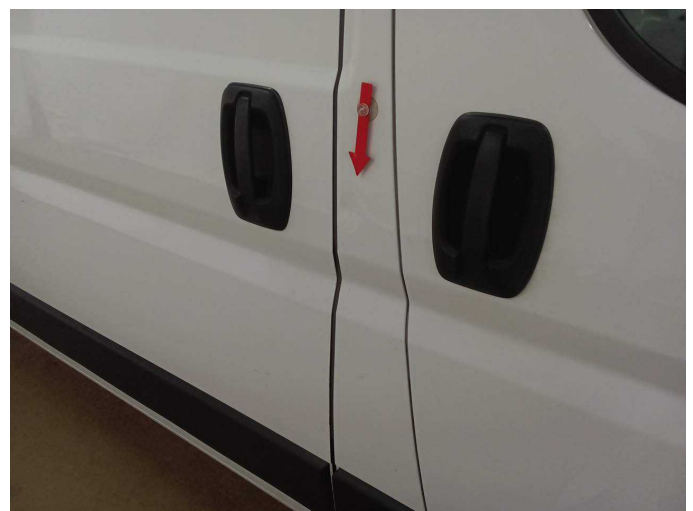
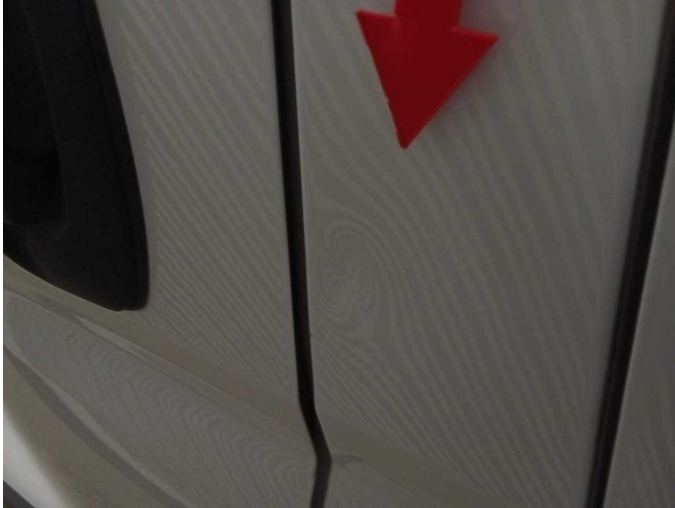
Damage 3: Body: B-pillar - right side - dent(s) - Smooth repair work

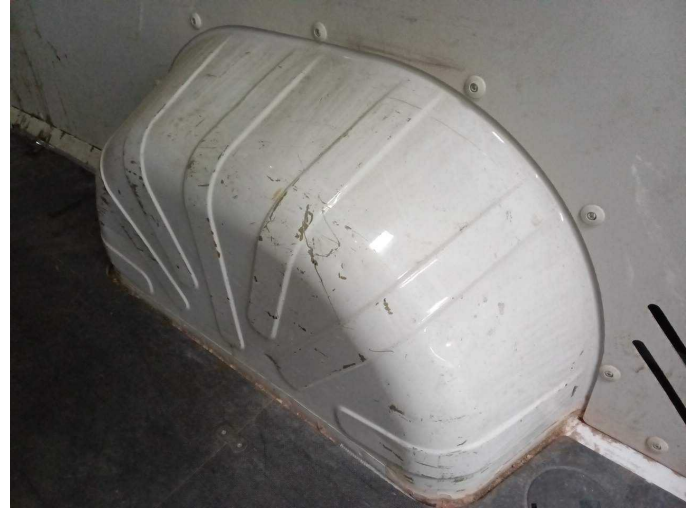
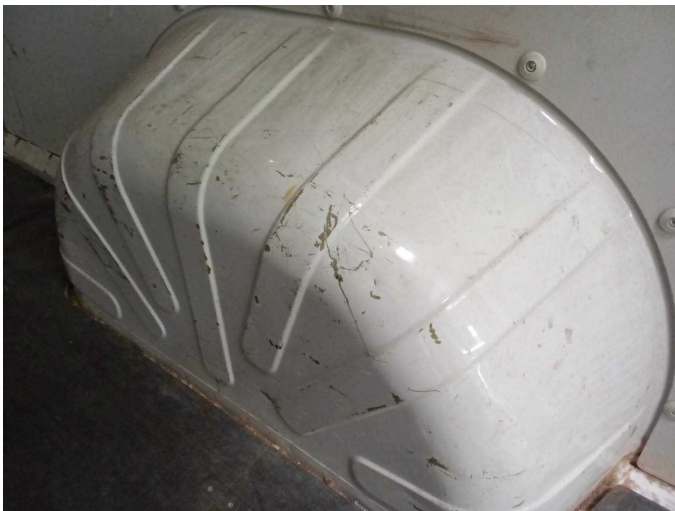
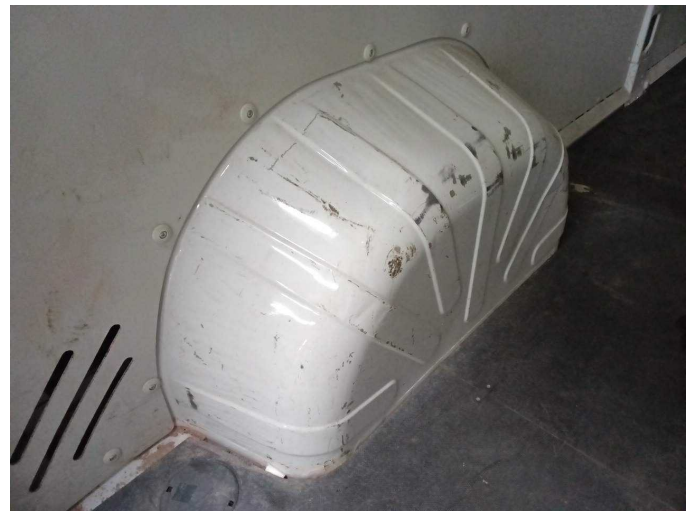
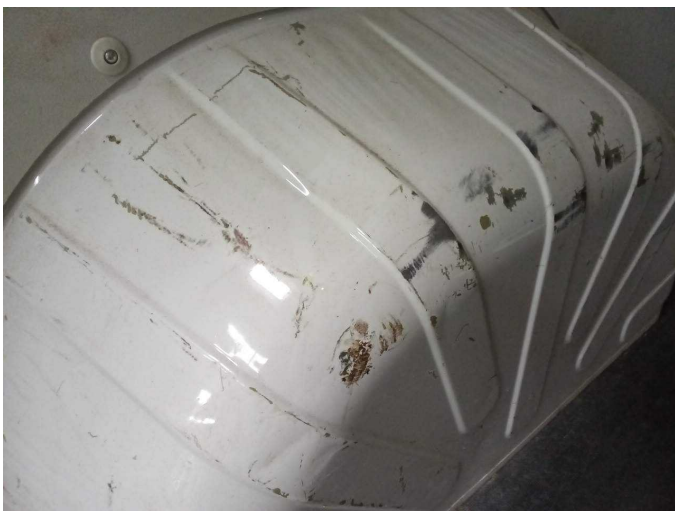
Damage 4: Interior: Interior (Laderaum) - Dent / paintcoat damage - Loss in value

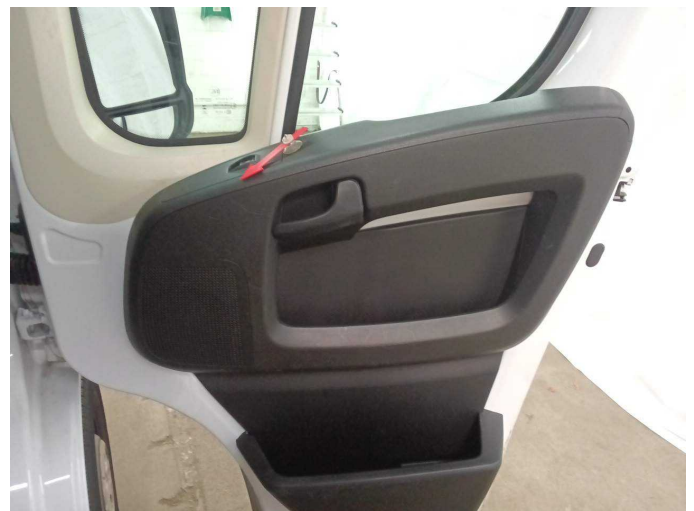
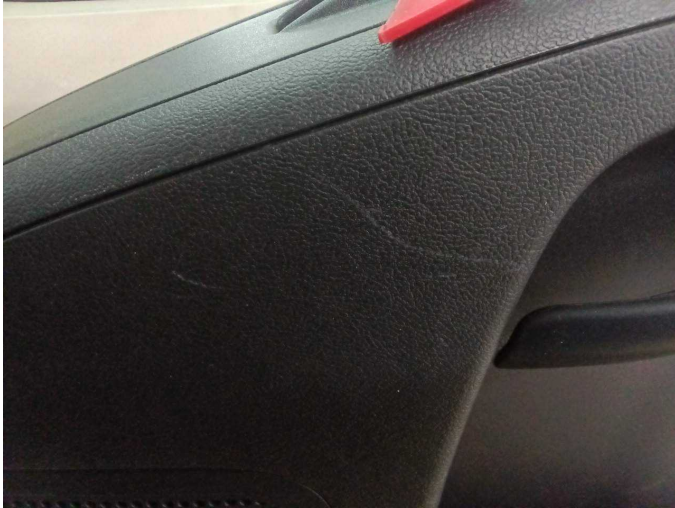
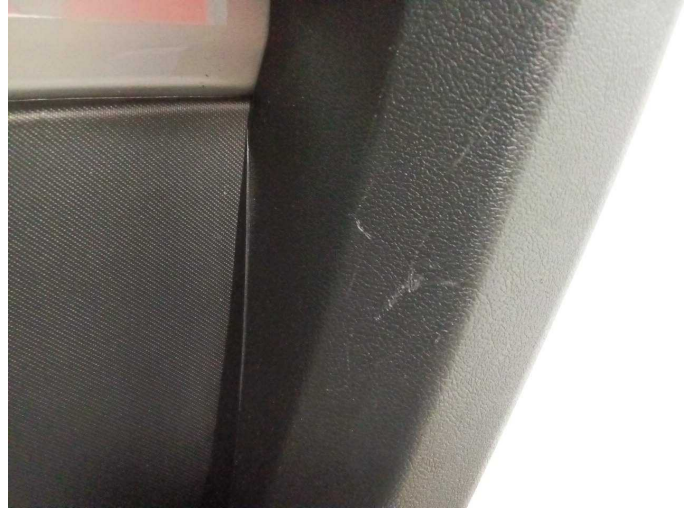
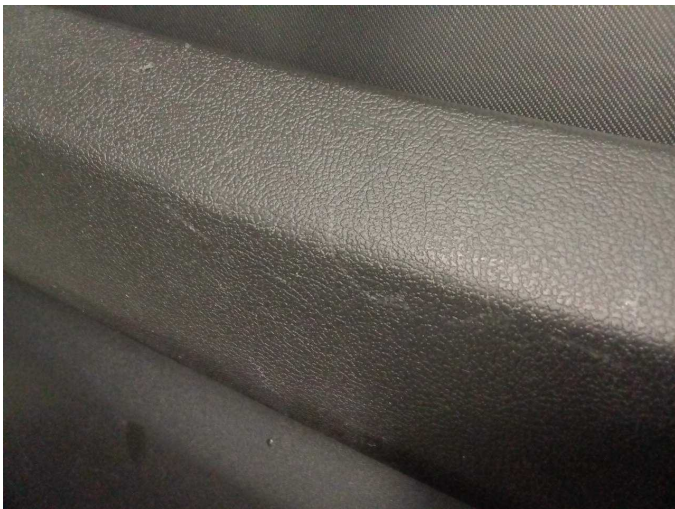
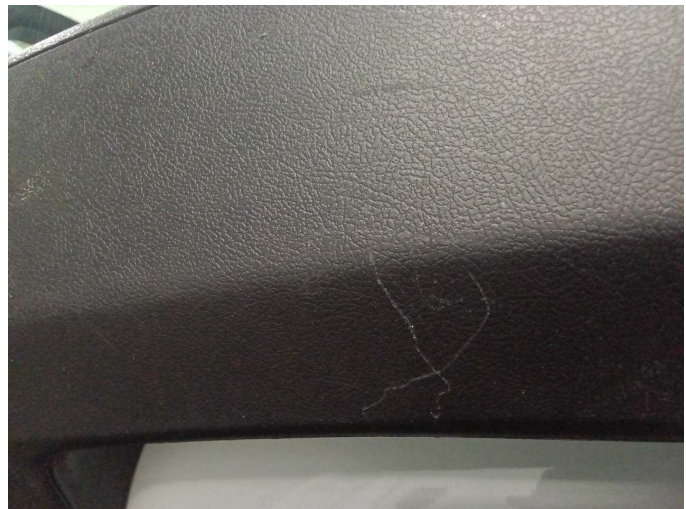
Damage 5: Trim / covers: Door trim - front right side - Scratch(es) - Loss in value

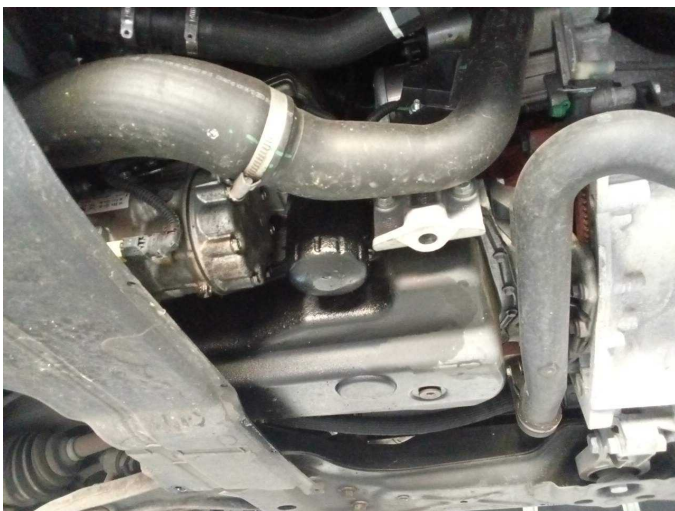
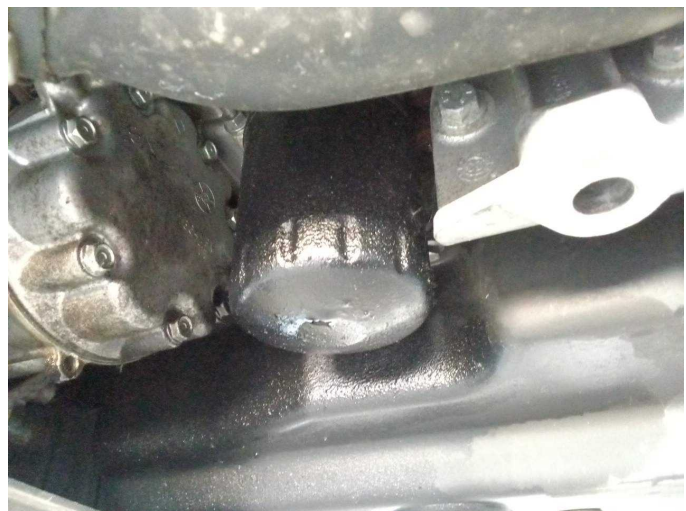
Damage 6: Engine: Engine (Ölverlust - Folgekosten möglich) - Leaking - Perform diagnosis

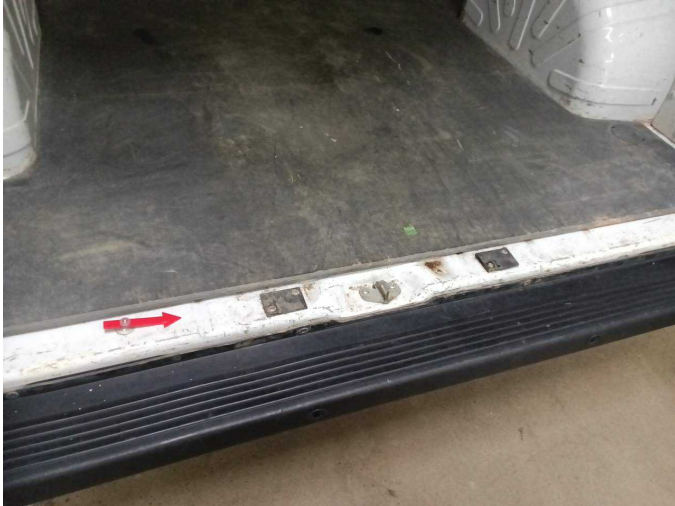
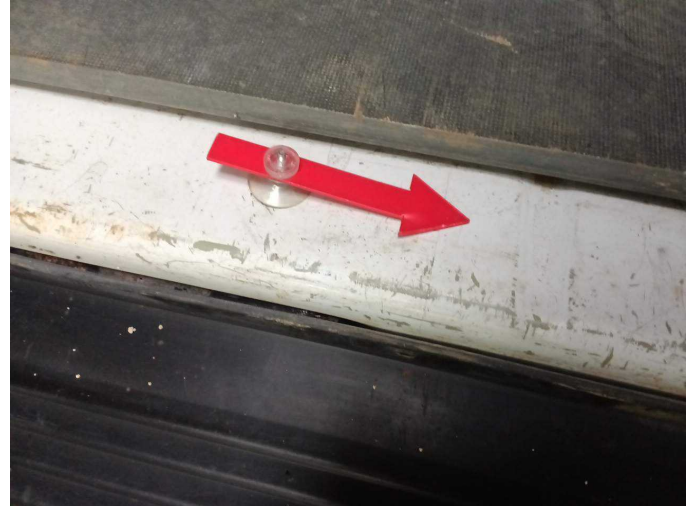
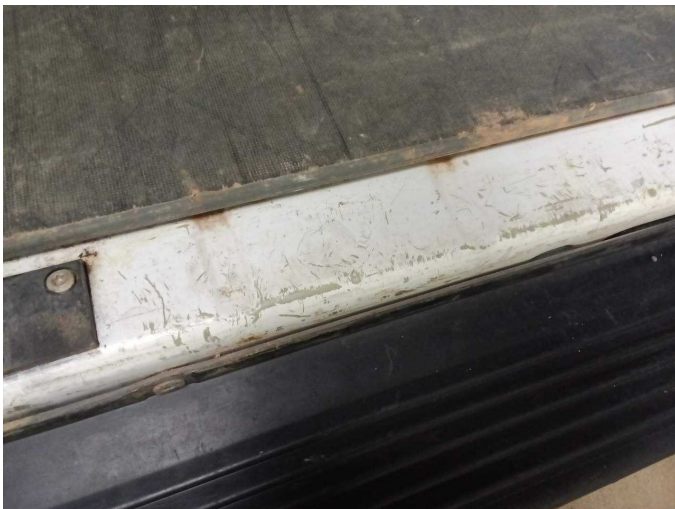
Damage 7: Rear of vehicle: Rear panel - Scratched - Smart repair

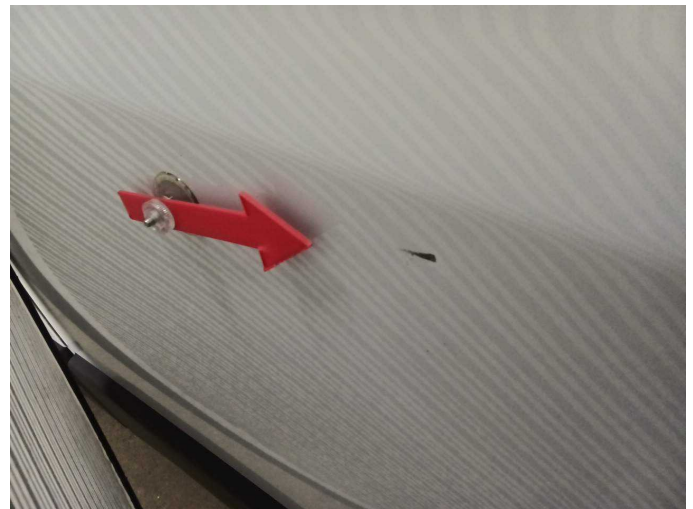
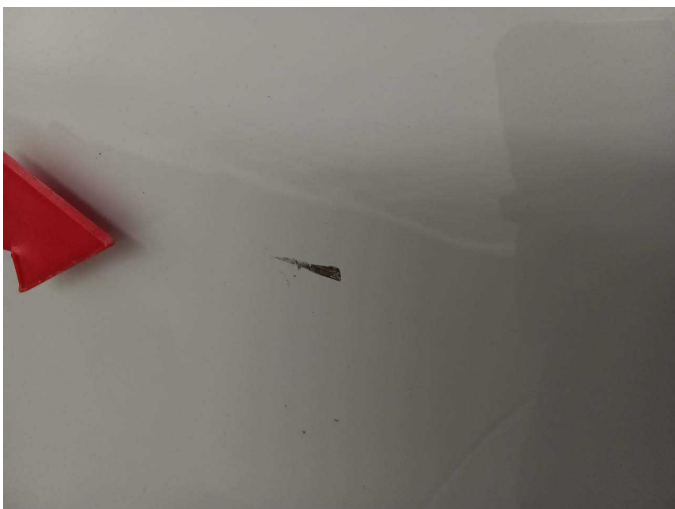
Damage 8: Sliding door, right: Sliding door - Dent / paintcoat damage - Smart repair

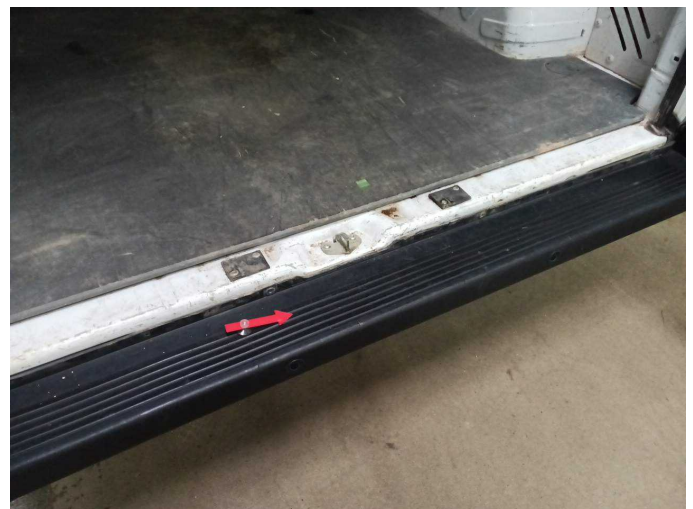
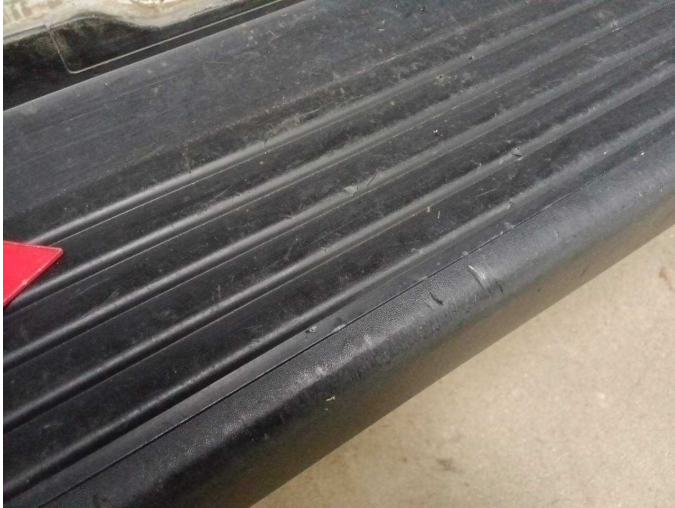
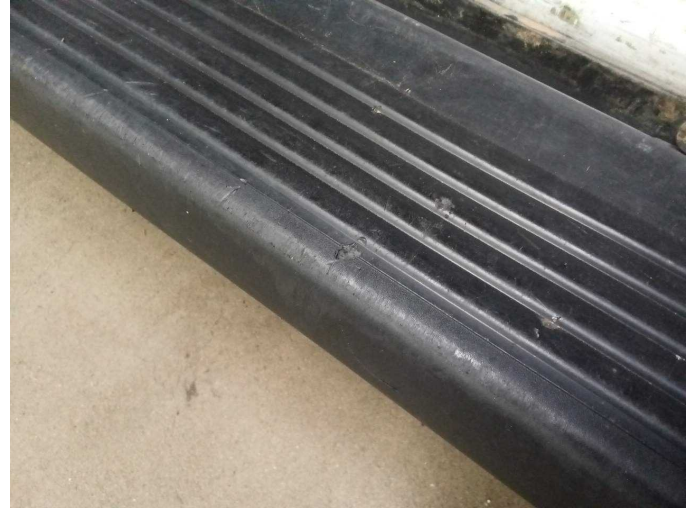
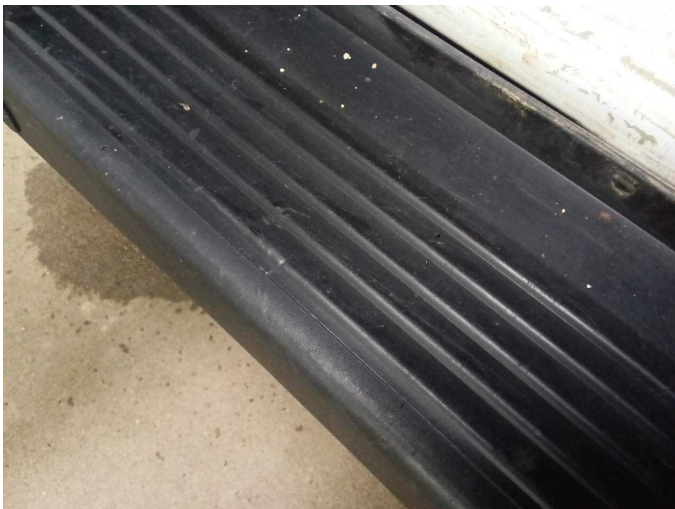
Damage 9: Rear bumper: Rear bumper (unpainted) - Scratched - Loss in value

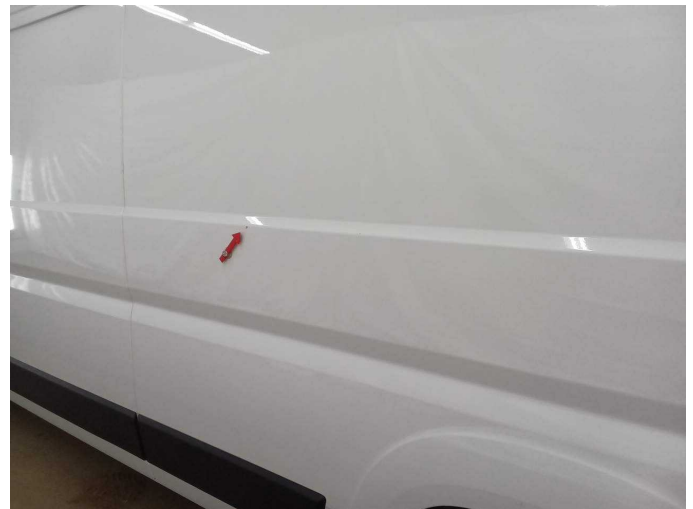
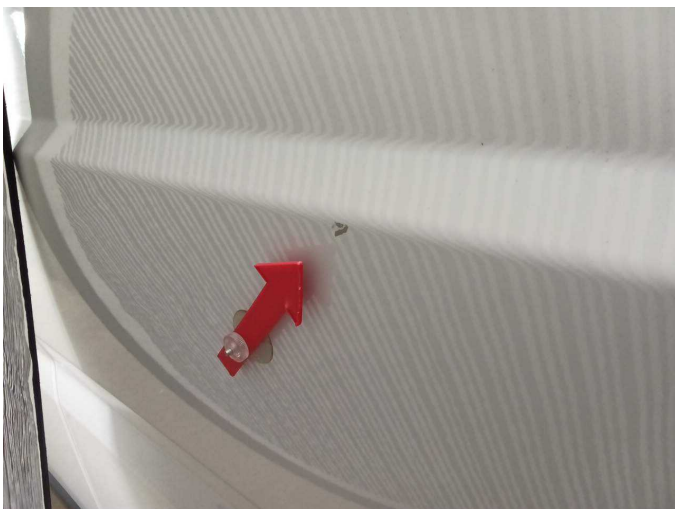
Damage 10: Side panel - rear left side: Side panel - Dent / paintcoat damage - Smart repair

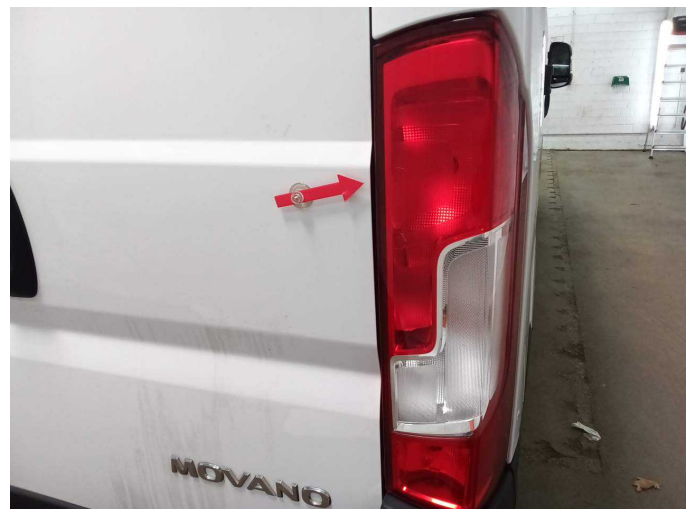
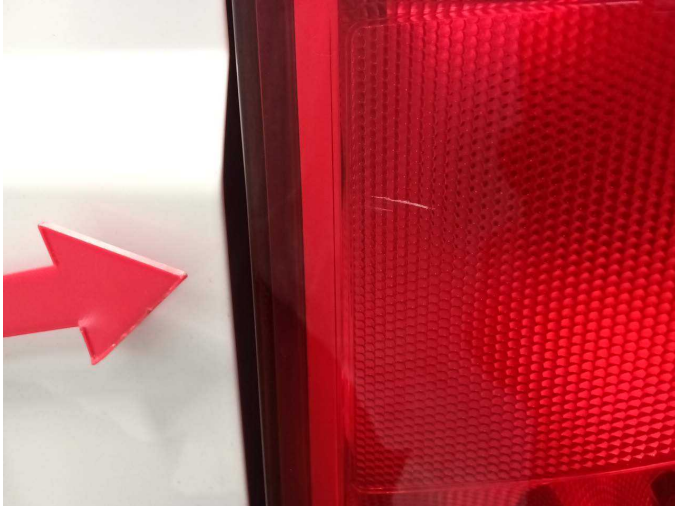
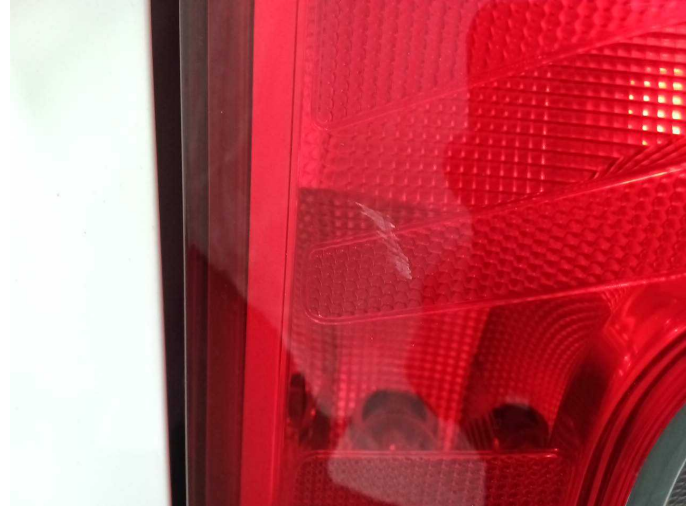
Damage 11: Tail light: Tail lamp - right side - Scratch(es) - Replace

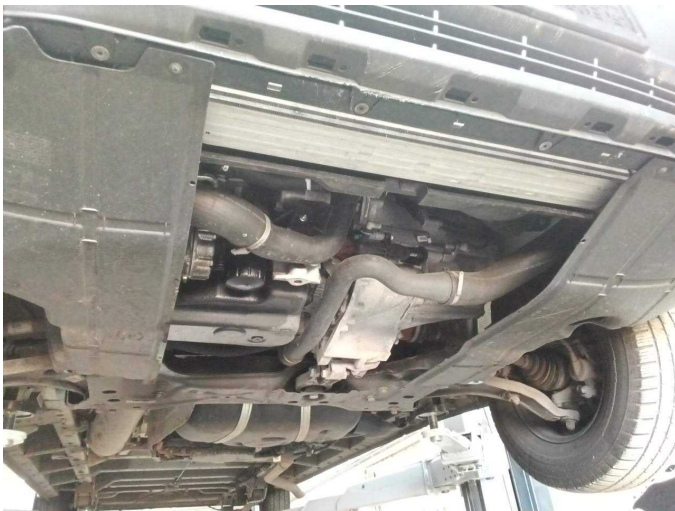
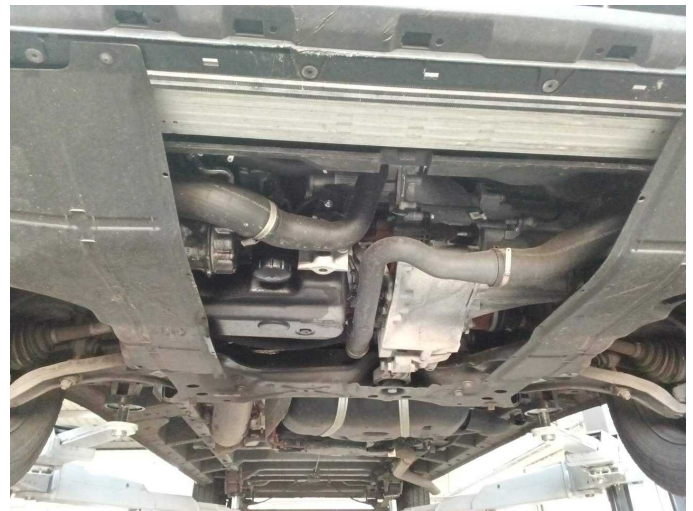
Damage 12: Engine: Engine cowling - lower - Missing - Replace

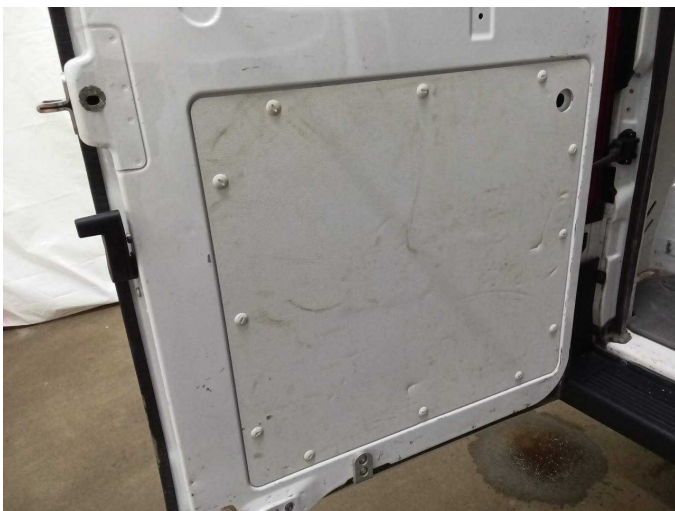
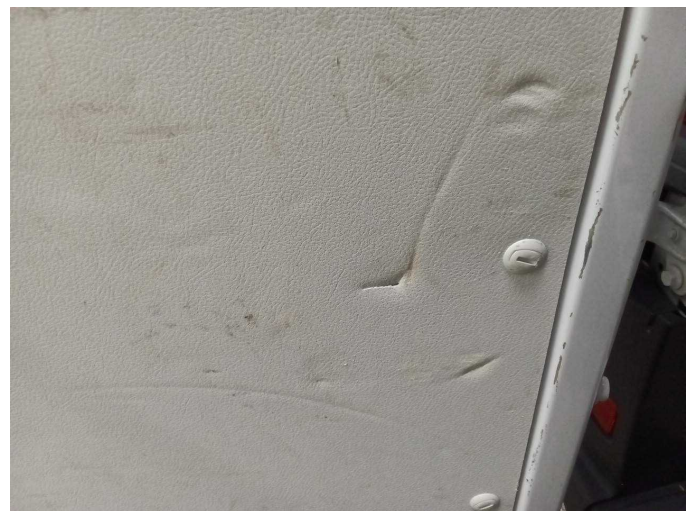
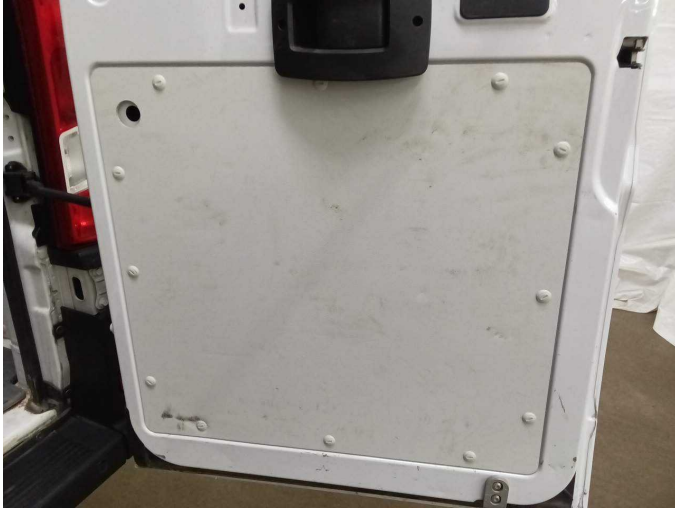
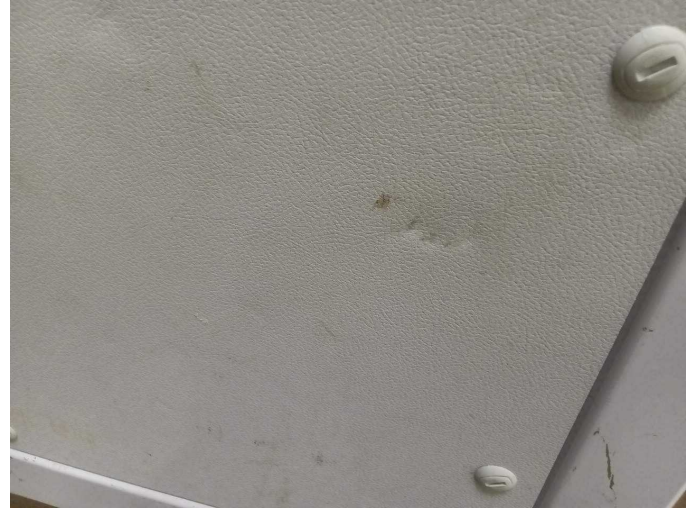
Damage 13: Trim / covers: Boot lid - interior trim (Hecktür links & rechts) - Scratched - Replace

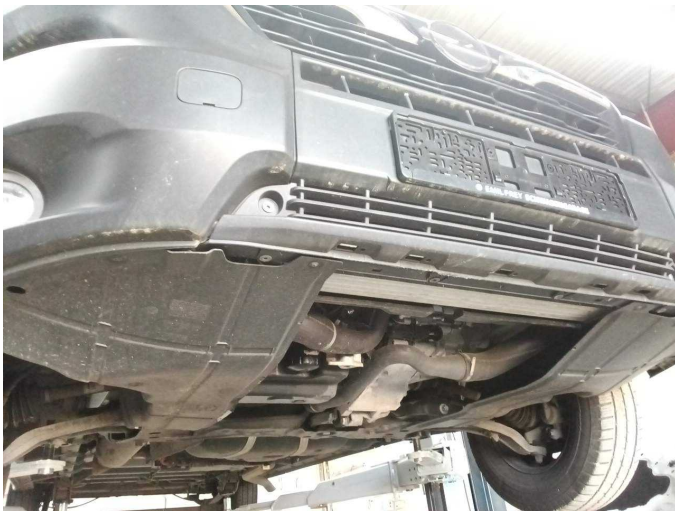
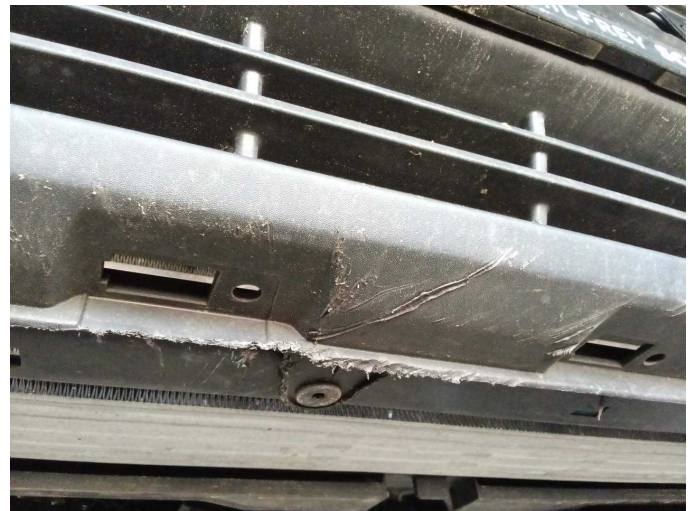
Damage 14: Front bumper: Front bumper - Scratched - Replace

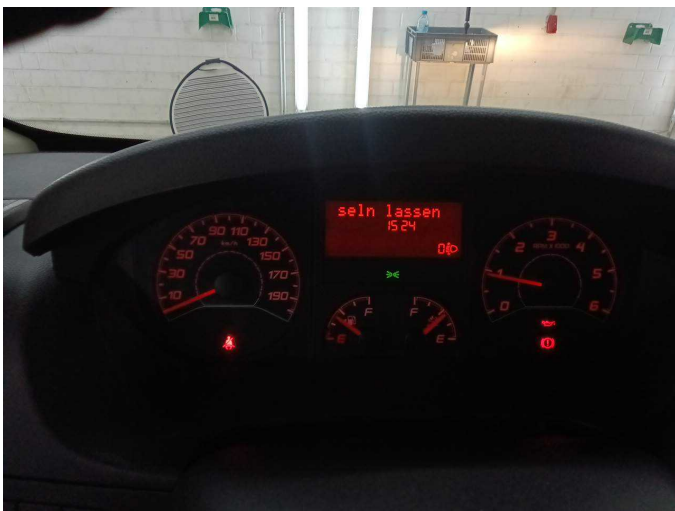
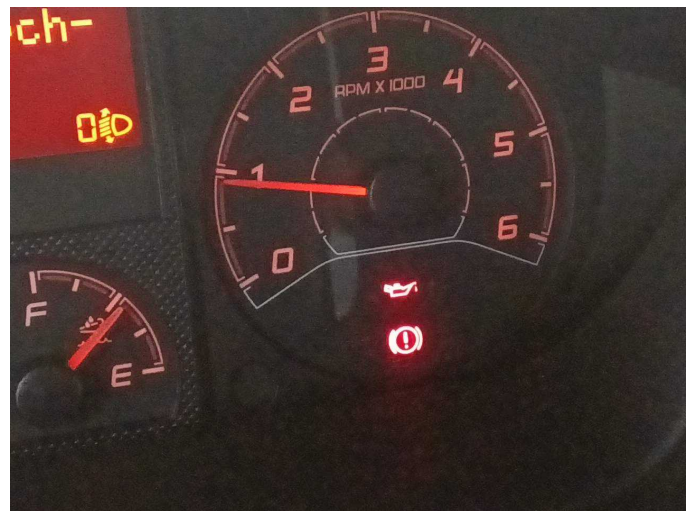
Damage 15: Misc.: Inspection / maintenance - Due - Perform

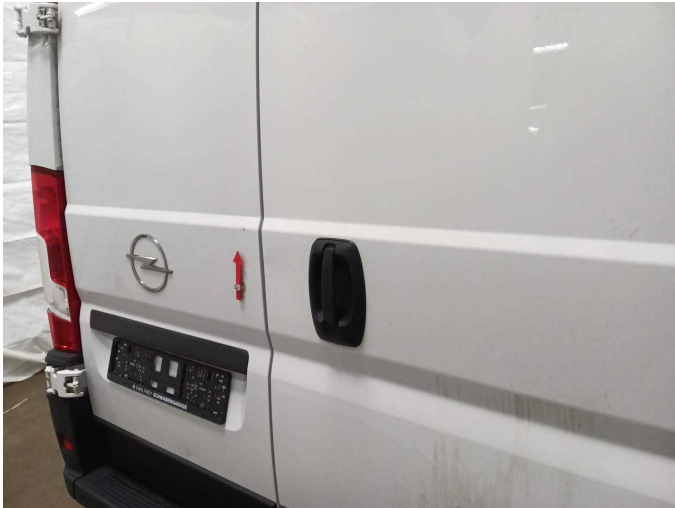
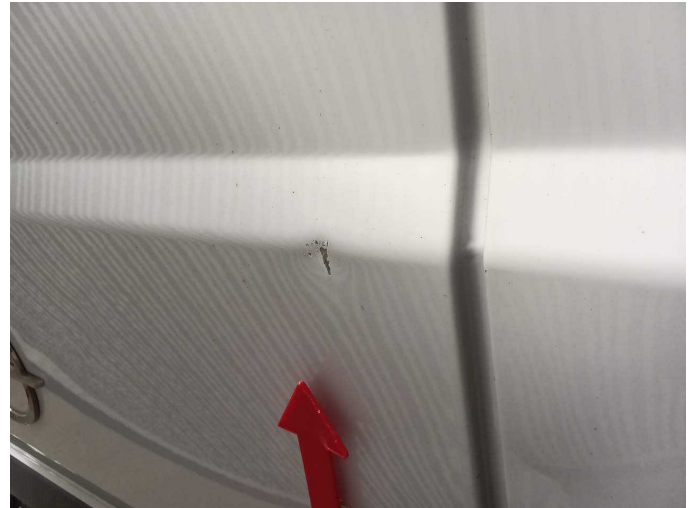
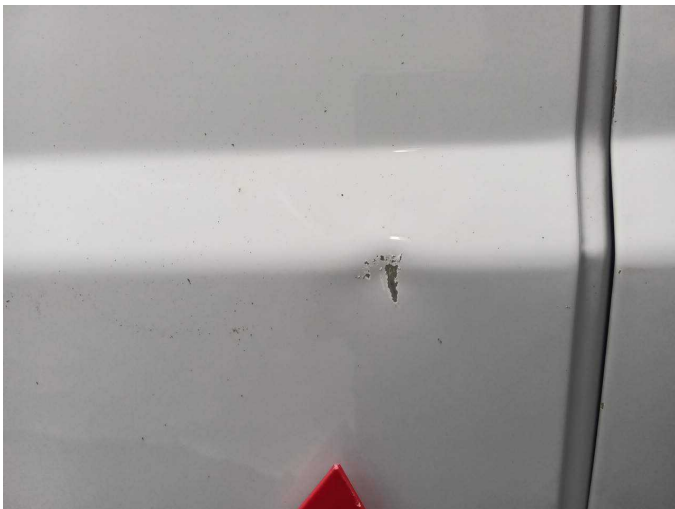
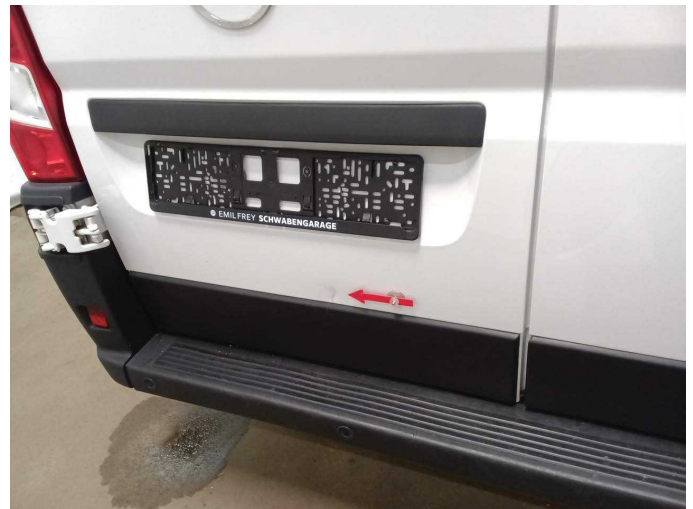
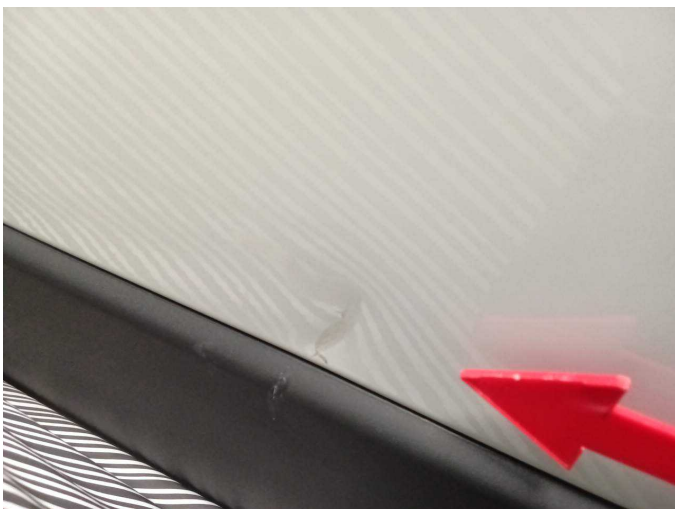
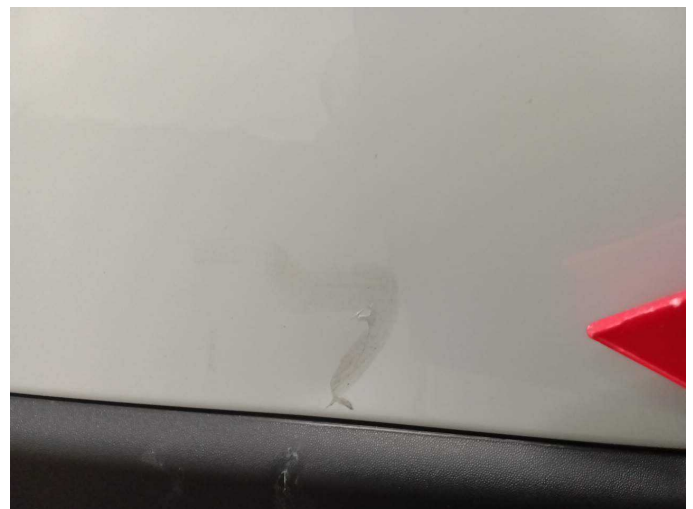
Damage 16: Boot lid / rear door: Rear door - left side - Dent / paintcoat damage - Repair and paint

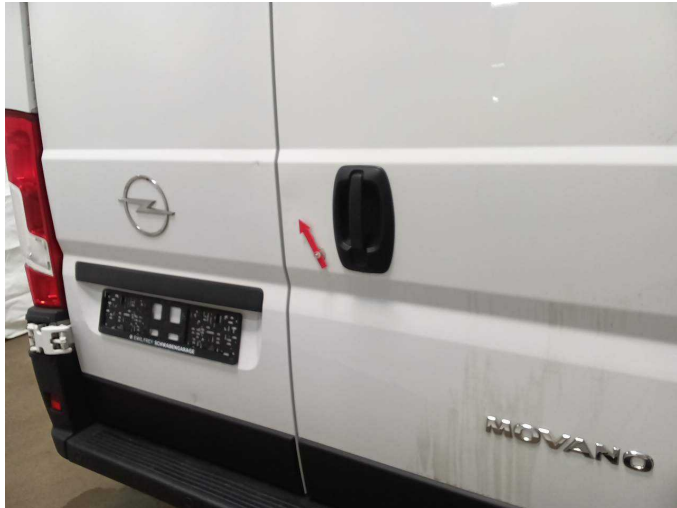
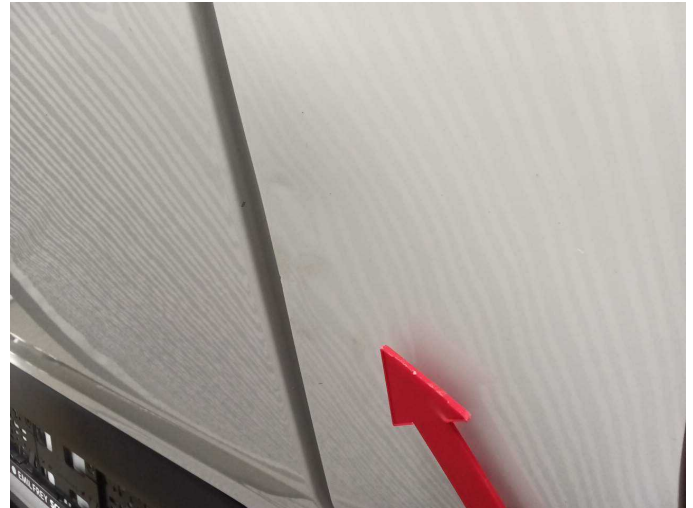
Damage 17: Boot lid / rear door: Rear door - right side - Dent / paintcoat damage - Repair and paint

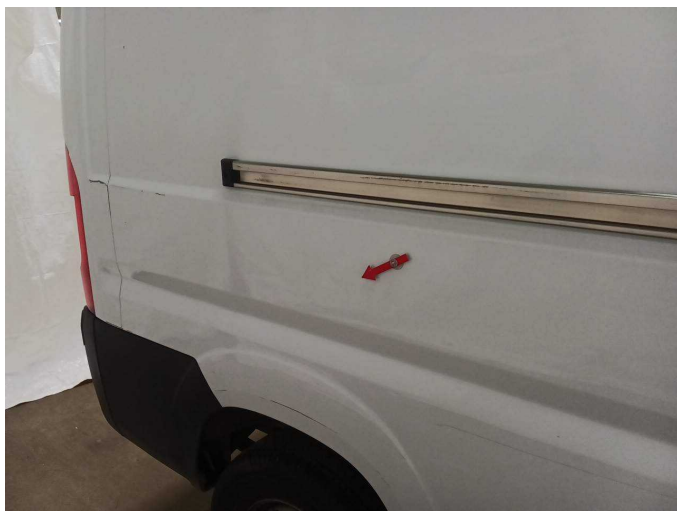
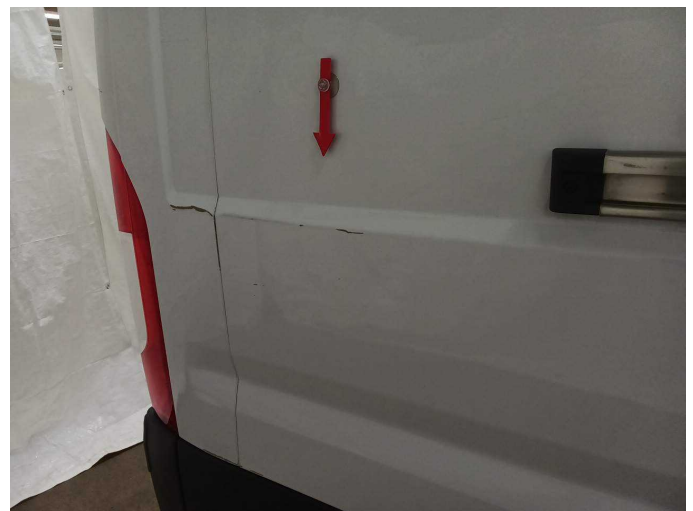
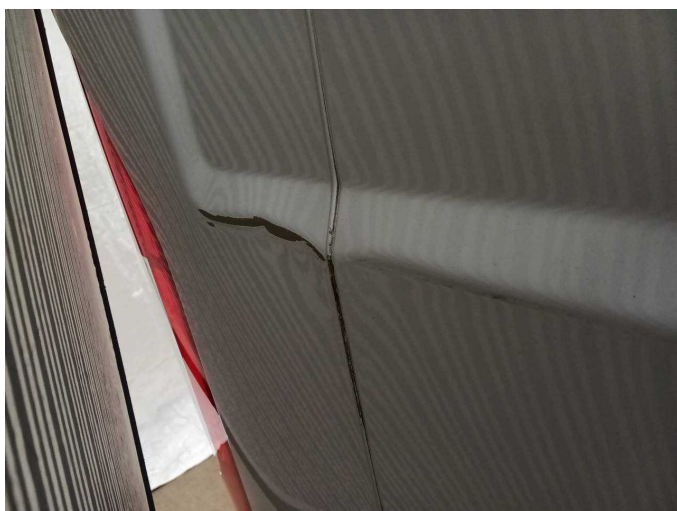
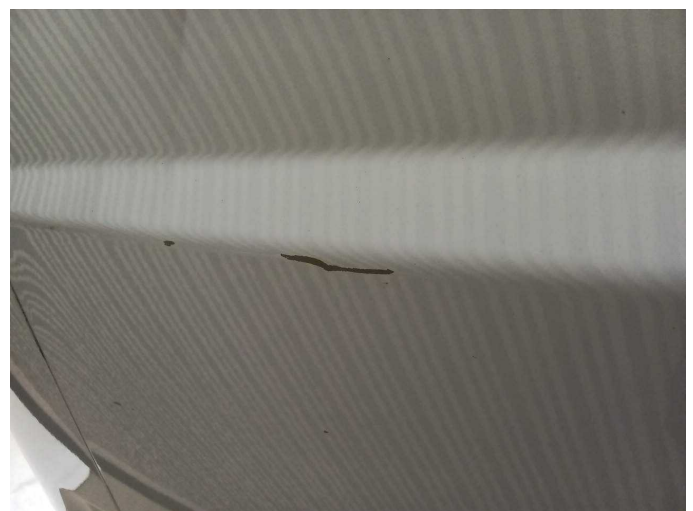
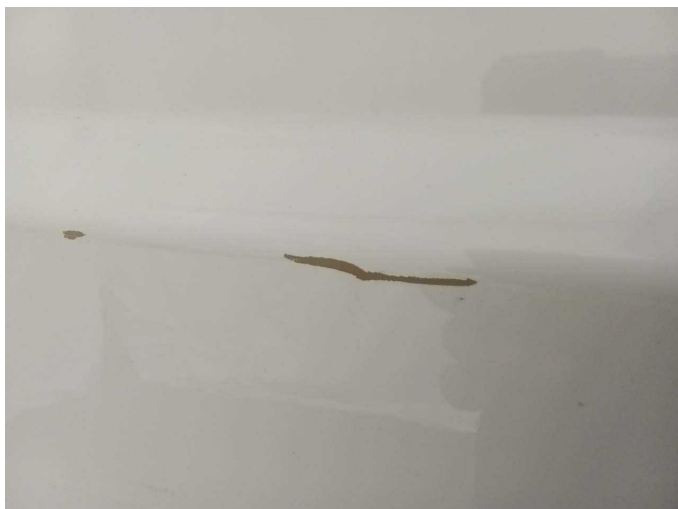
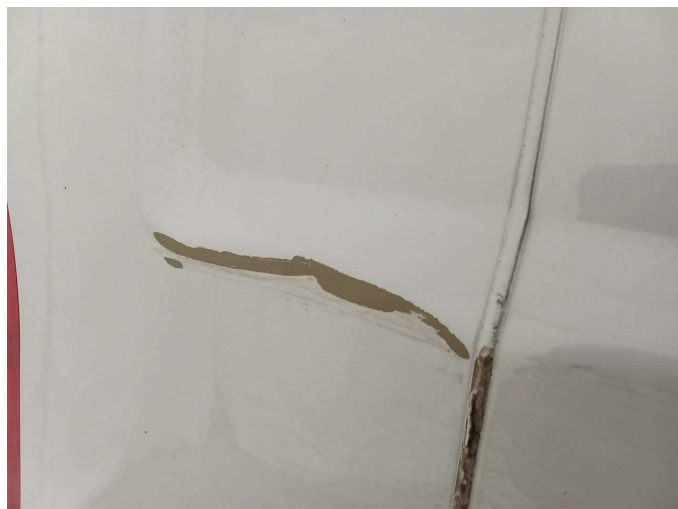
Accident 1: Side right
