Expertise

Protocol number: 46576527  
Order No. / Reference: 26751535  
Inspection date: 15 Jul 2026

Model: Transit Custom 320 L1H1 LKW VA Trend

VIN: WF0YXXTTGYMC77629

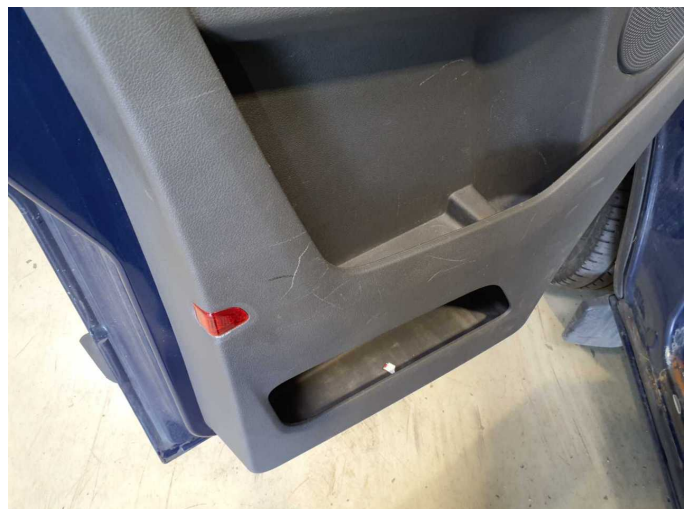
| No. | Component group | Description |
|---|---|---|
| 4 | Trim / covers | Door trim - front left side - Scratch(es) - Loss in value |

Damage 4: Trim / covers: Door trim - front left side - Scratch(es) - Loss in value

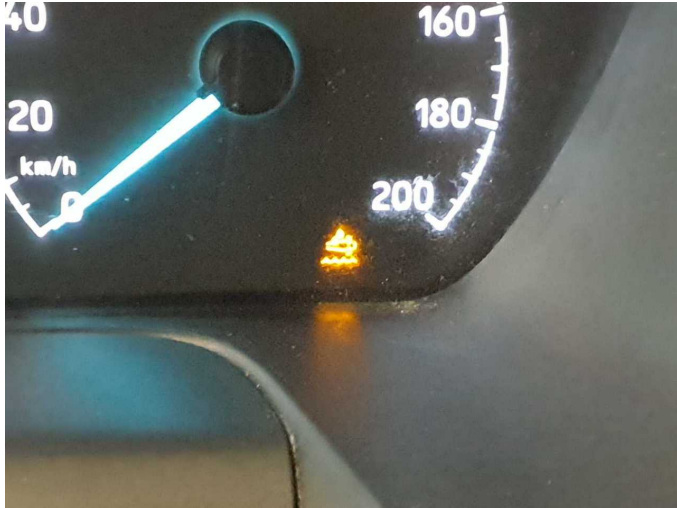
| No. | Component group | Description |
|---|---|---|
| 5 | Instrument panel | Indicator light (Abgassystem) - on - Perform diagnosis |

**Damage 5:** Instrument panel: Indicator light (Abgassystem) - on - Perform diagnosis

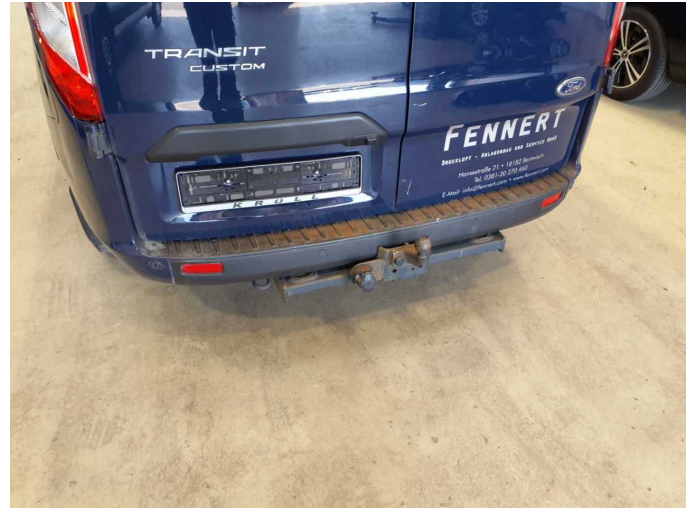
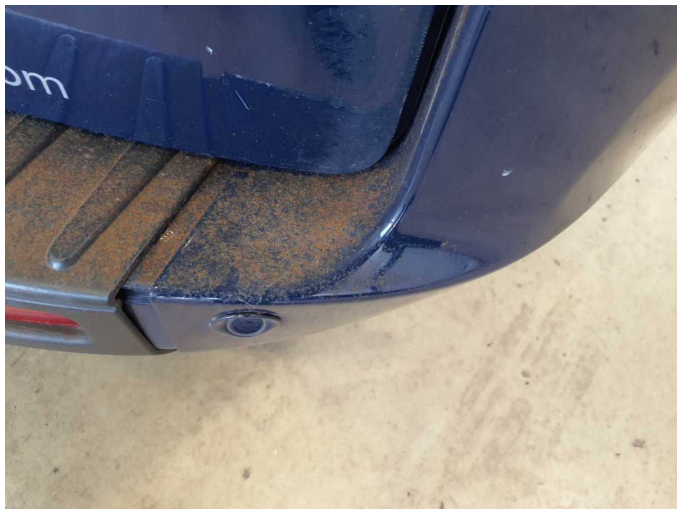
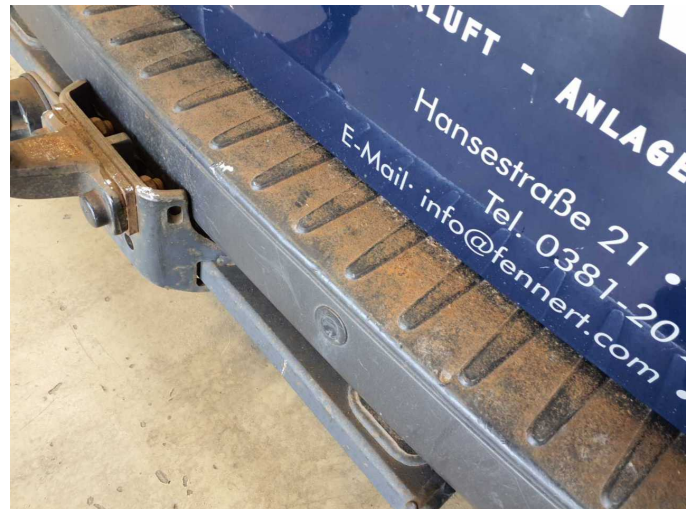
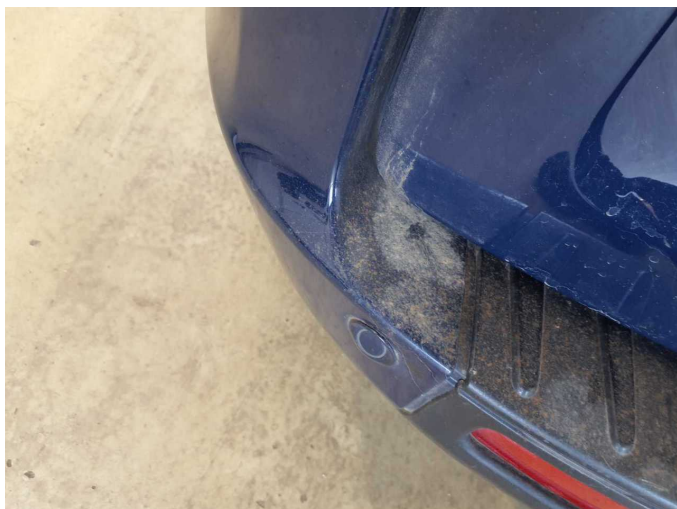
| No. | Component group | Description |
|---|---|---|
| 6 | Rear bumper | Rear bumper (Verschmutzt durch Metalabrieb) - Soiled - Clean |

**Damage 6:** Rear bumper: Rear bumper (Verschmutz durch Metalabrieb) - Soiled - Clean

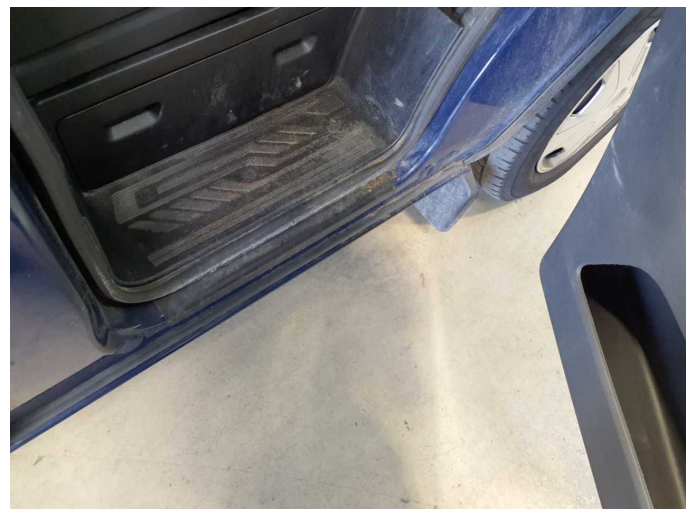
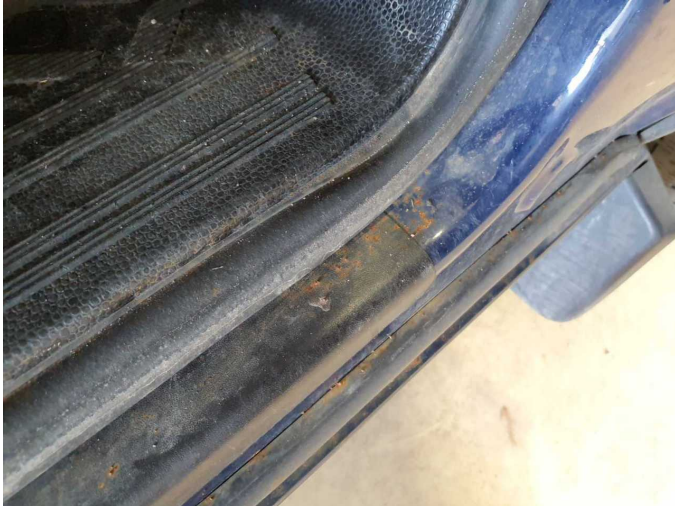
| No. | Component group | Description |
|---|---|---|
| 7 | Sill - right side | Sill - Corrosion - Repair and paint |

**Damage 7:** Sill - right side: Sill - Corrosion - Repair and paint

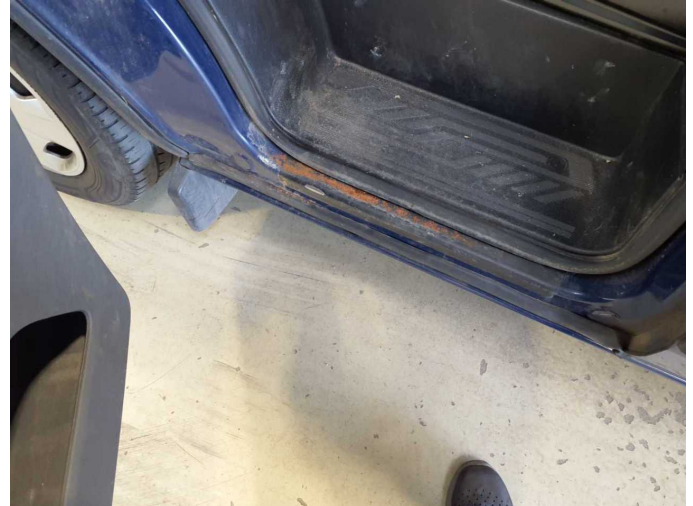
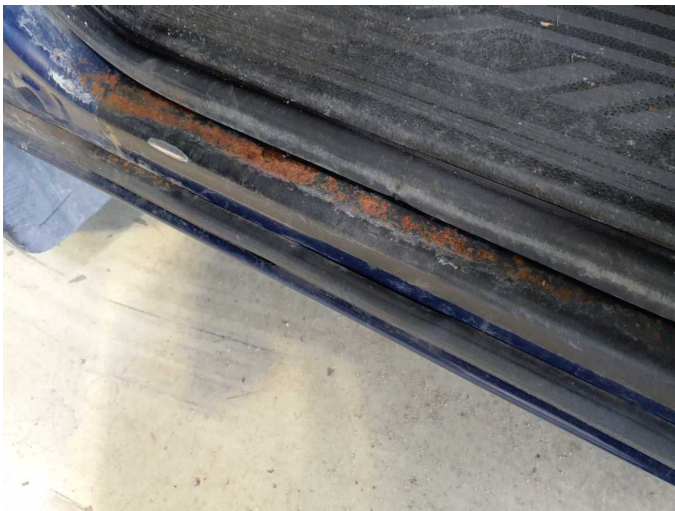
| No. | Component group | Description |
|---|---|---|
| 8 | Sill - left side | Sill - Corrosion - Repair and paint |

**Damage 8:** Sill - left side: Sill - Corrosion - Repair and paint

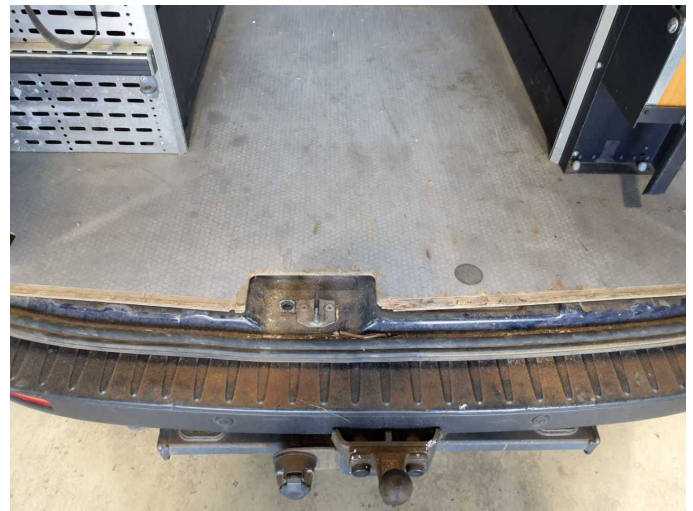
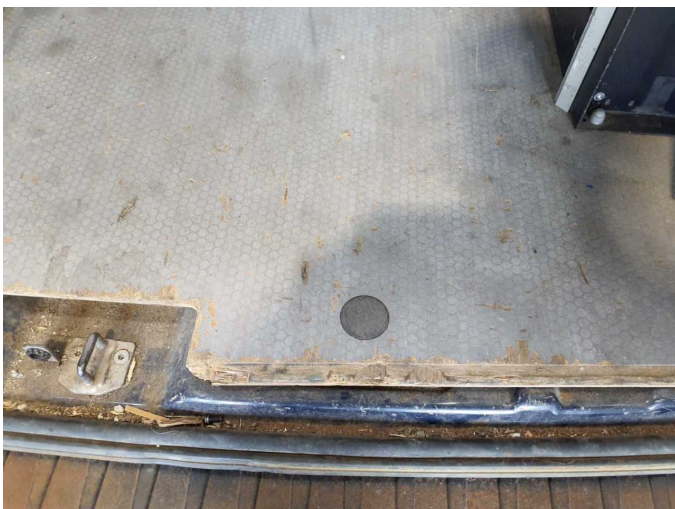
| No. | Component group | Description |
|---|---|---|
| 9 | Interior | Cargo area floor - Scratch(es) - Loss in value |

**Damage 9:** Interior: Cargo area floor - Scratch(es) - Loss in value

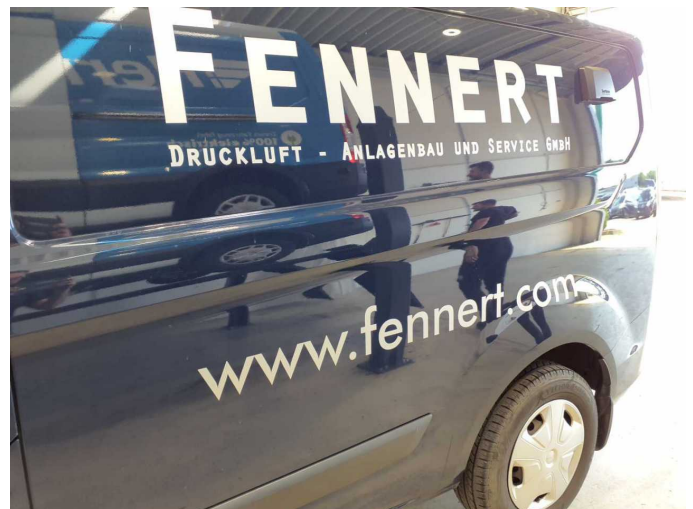
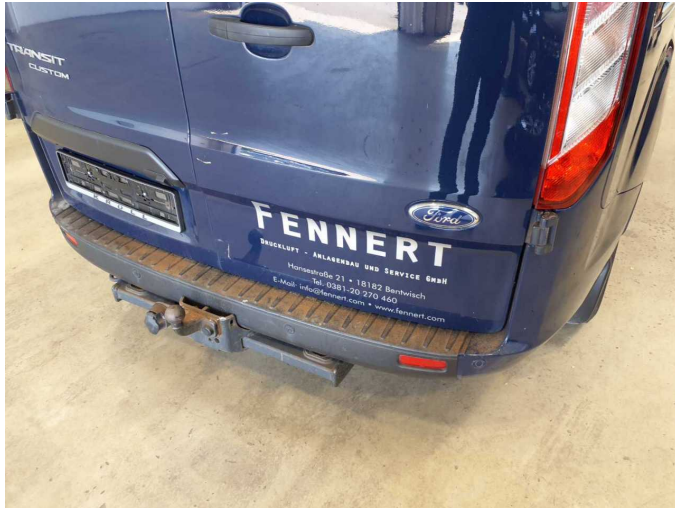
| No. | Component group | Description |
|---|---|---|
| 10 | Body | Body - Glued / labelled - De-glue / neutralise |

**Damage 10:** Body: Body - Glued / labelled - De-glue / neutralise

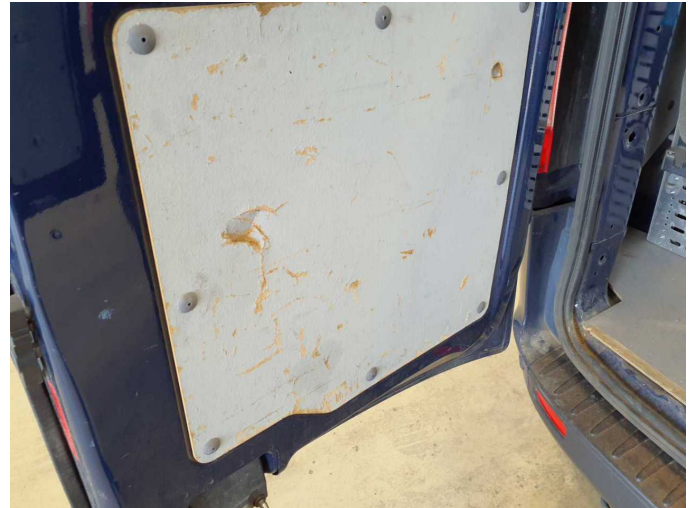
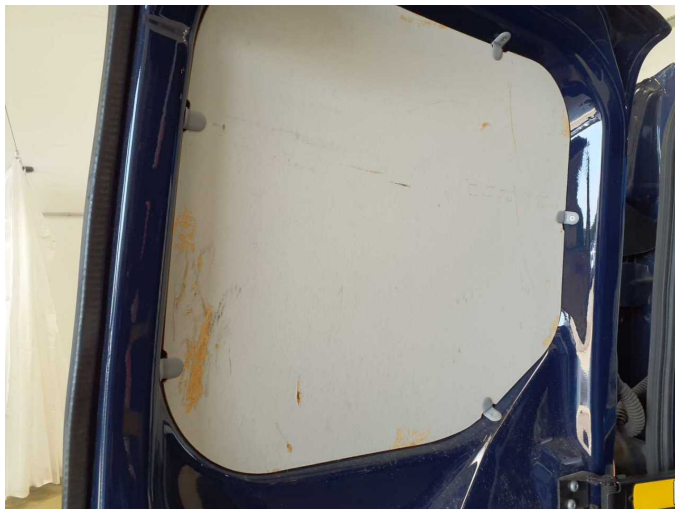
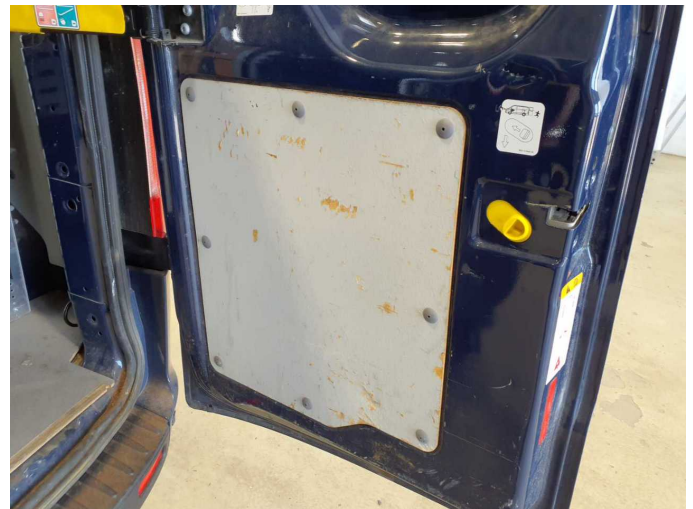
| No. | Component group | Description |
|---|---|---|
| 11 | Trim / covers | Trim / covers (Heck tür links und rechts) - Broken / torn - Replace |

**Damage 11:** Trim / covers: Trim / covers (Heck tür links und rechts) - Broken / torn - Replace

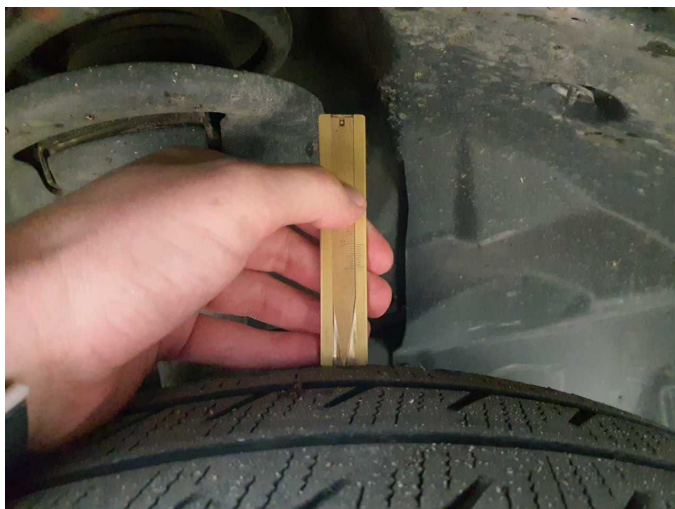
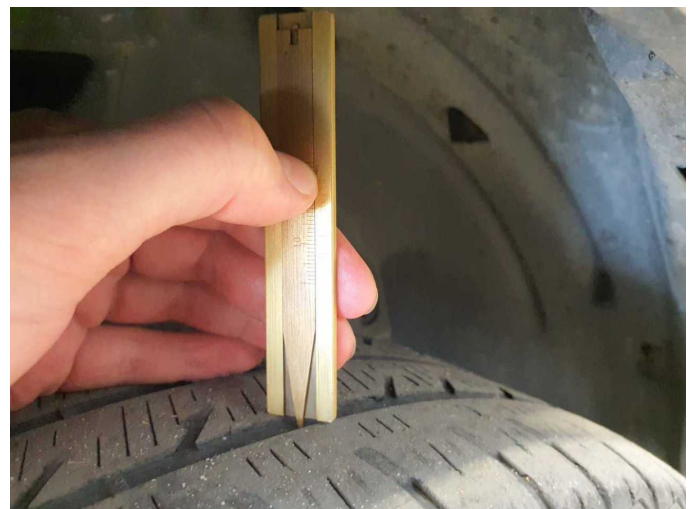
| # | Tyre size | Type of tyre | Manufacturer | Tread depth |
|---|---|---|---|---|
| 1) | 215/65 R16 109T | All-season tyres on Steel rim with wheel cover | Goodyear | 1mm / 3mm |

| No. | Component group | Description |
|---|---|---|
| 12 | Wheel / tyres | Tyre - front - Worn - Replace |

**Damage 12:** Wheel / tyres: Tyre - front - Worn - Replace

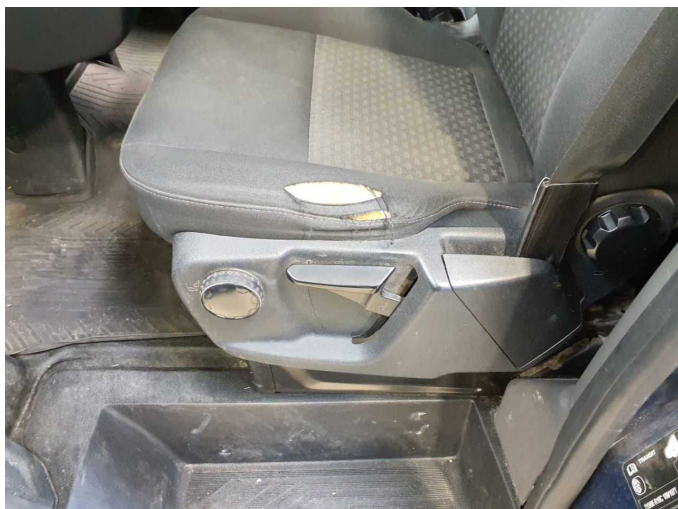
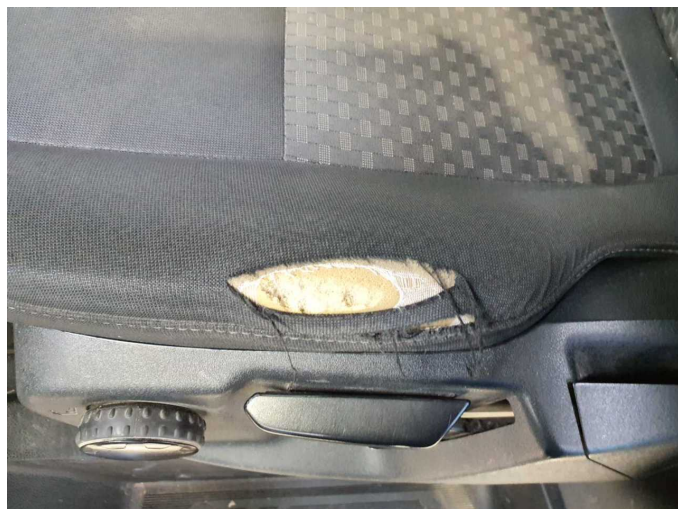
| No. | Component group | Description |
|---|---|---|
| 13 | Seat - front | Seat cover - left side - Broken / torn - Replace |

**Damage 13:** Seat - front: Seat cover - left side - Broken / torn - Replace

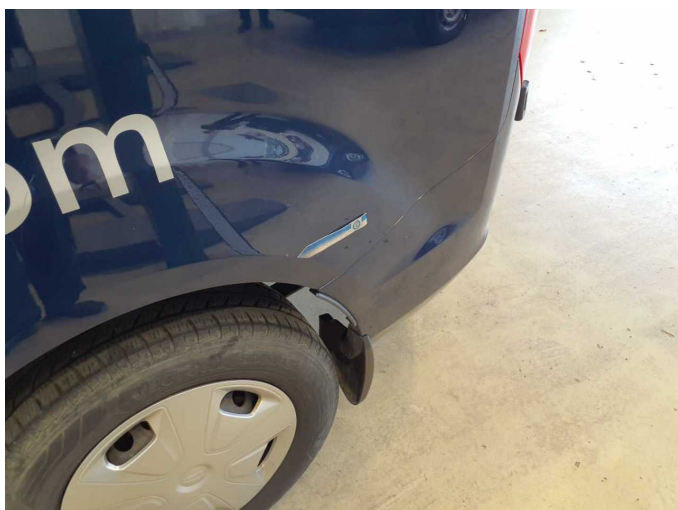
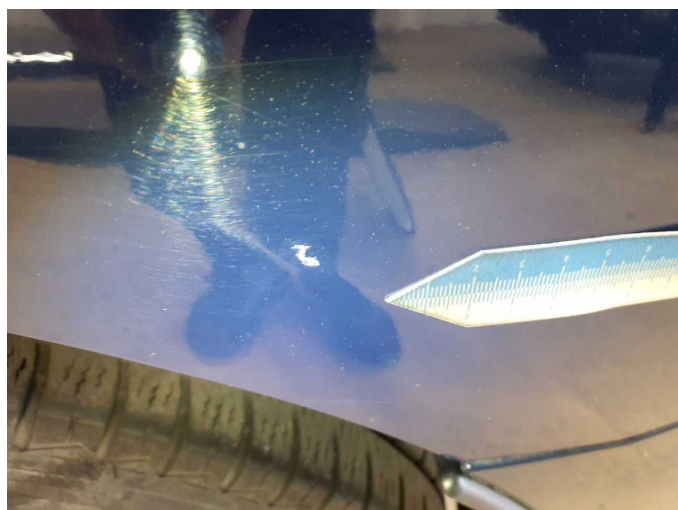
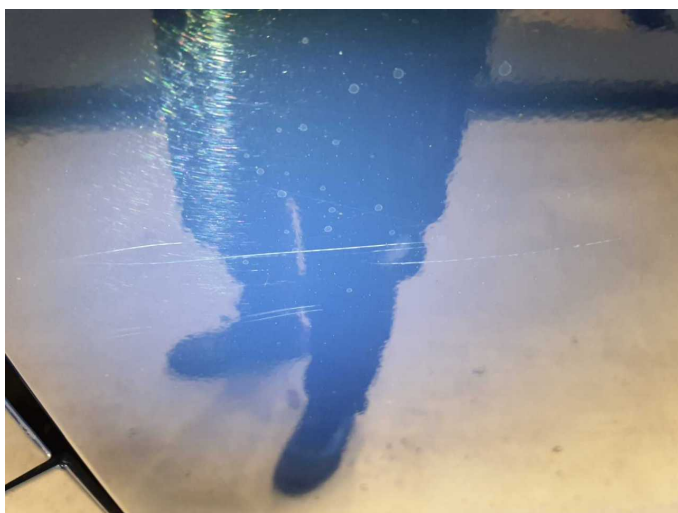
| No. | Component group | Description |
|---|---|---|
| 14 | Side panel - rear left side | Side panel - Scratch(es) - Paint |

**Damage 14:** Side panel - rear left side: Side panel - Scratch(es) - Paint

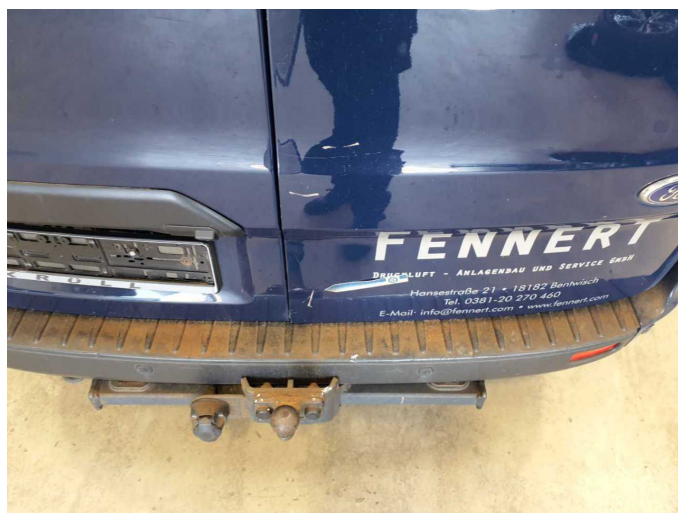
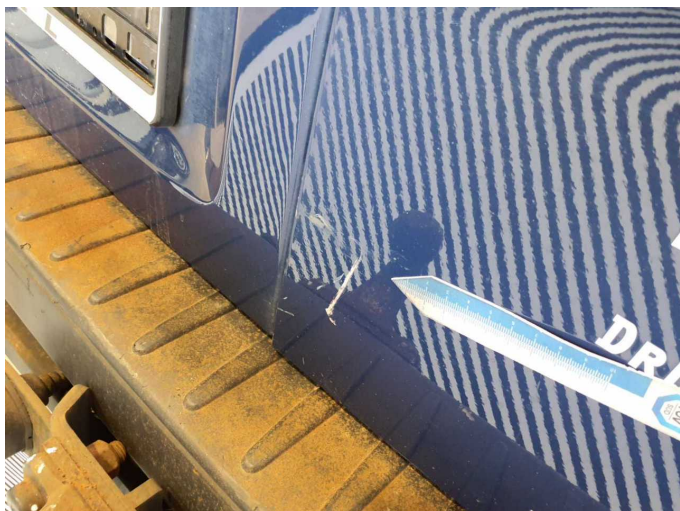
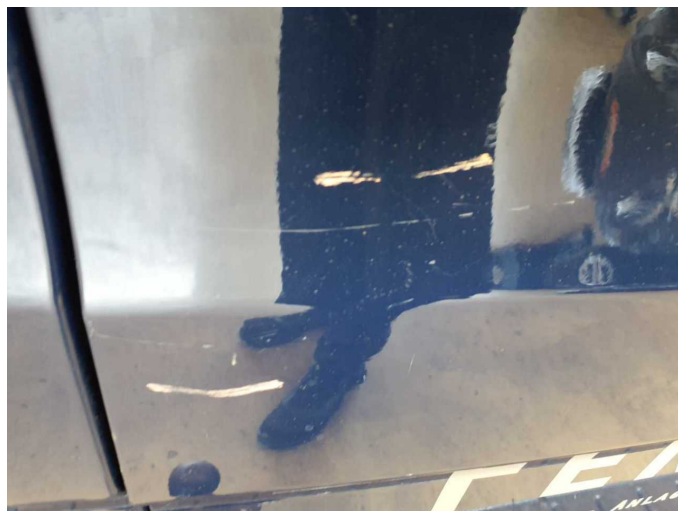
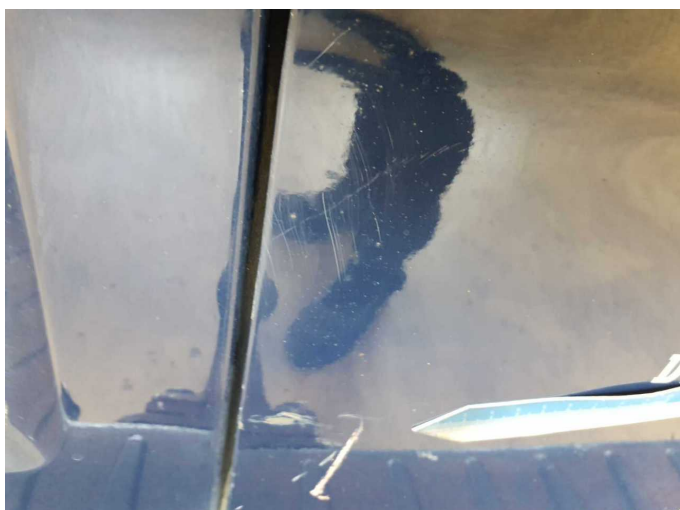
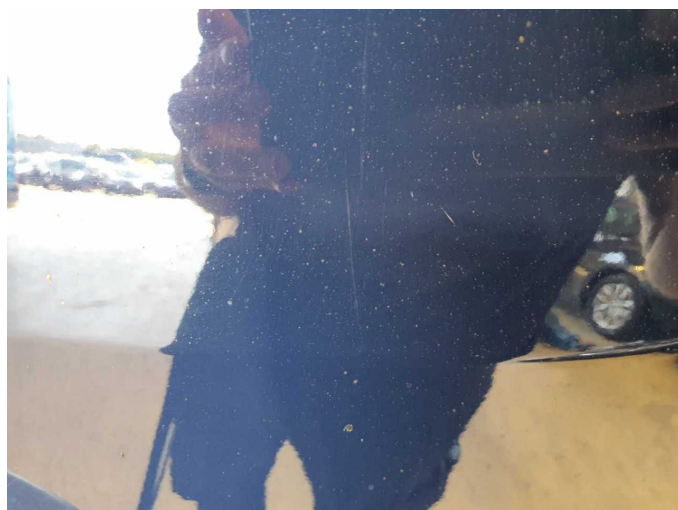
| No. | Component group | Description |
|---|---|---|
| 15 | Boot lid / rear door | Rear door - right side - Dent / paintcoat damage - Repair and paint |

**Damage 15:** Boot lid / rear door: Rear door - right side - Dent / paintcoat damage - Repair and paint

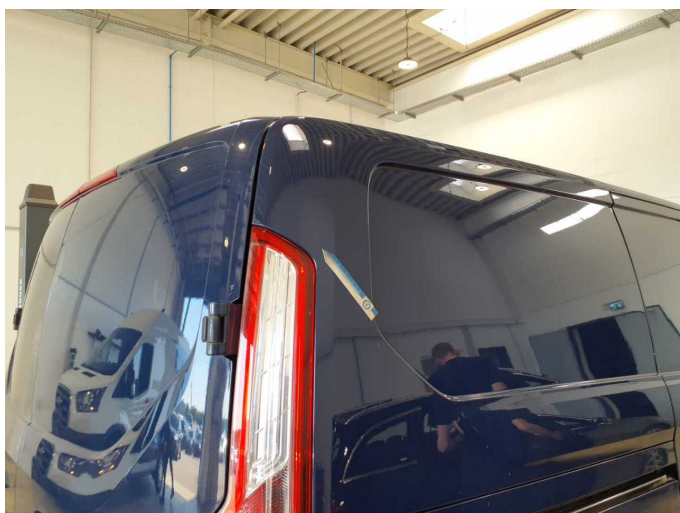
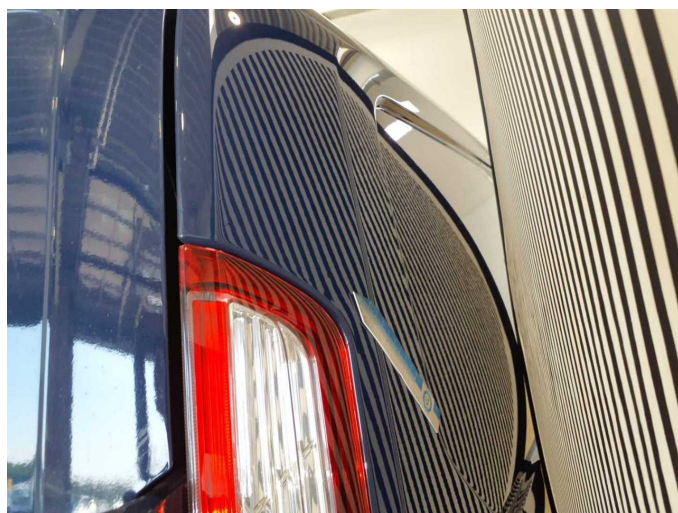
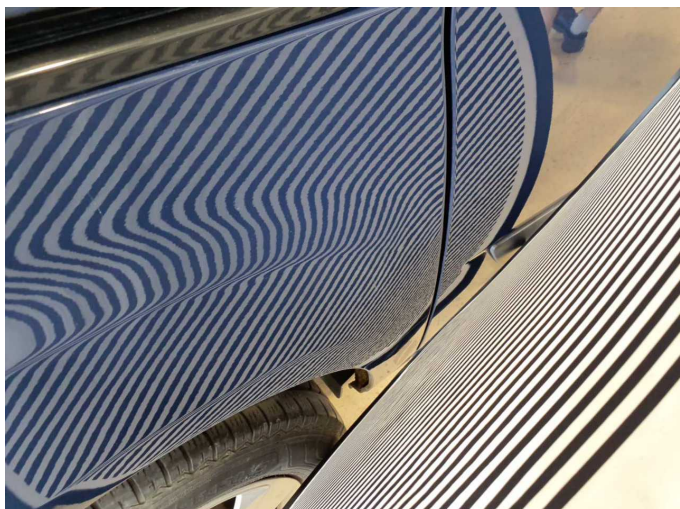
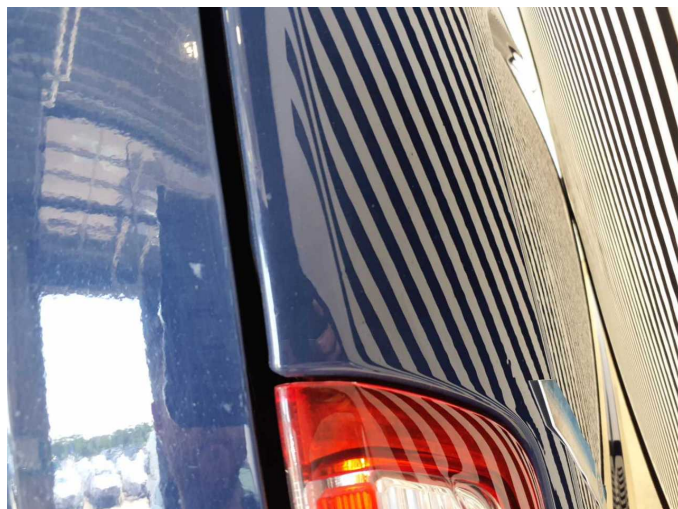
| No. | Component group | Description |
|---|---|---|
| 16 | Side panel - rear right side | Side panel (Spachtel eingefallen Einschlüsse) - Unprofessionally repaired - Repair and paint |

**Damage 16:** Side panel - rear right side: Side panel (Spachtel eingefallen Einschlüsse) - Unprofessionally repaired - Repair and paint

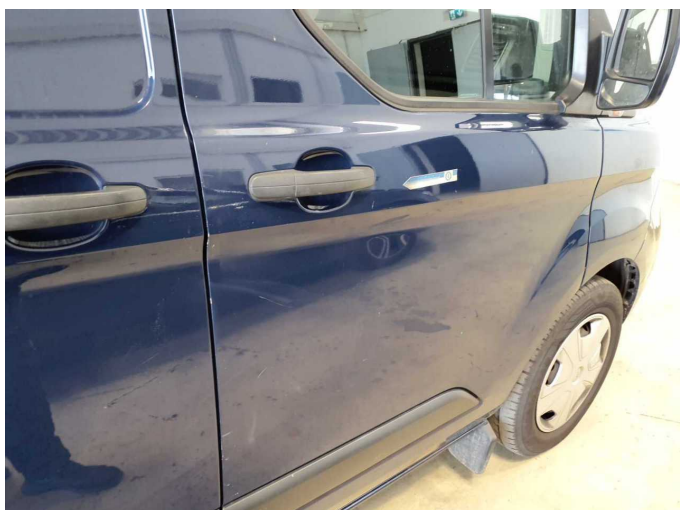
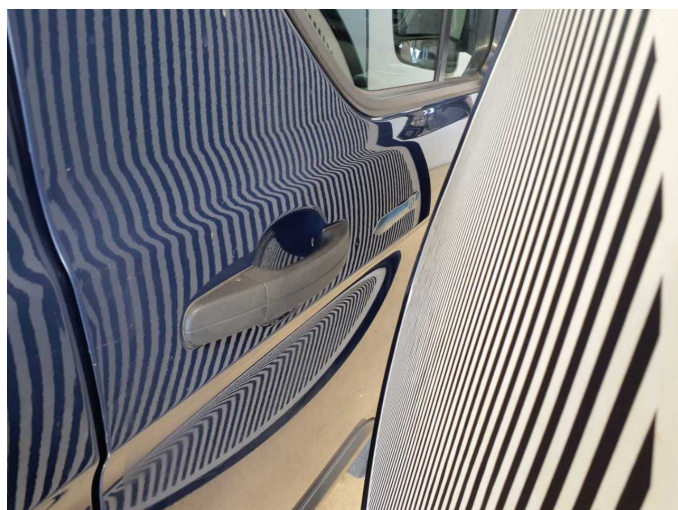
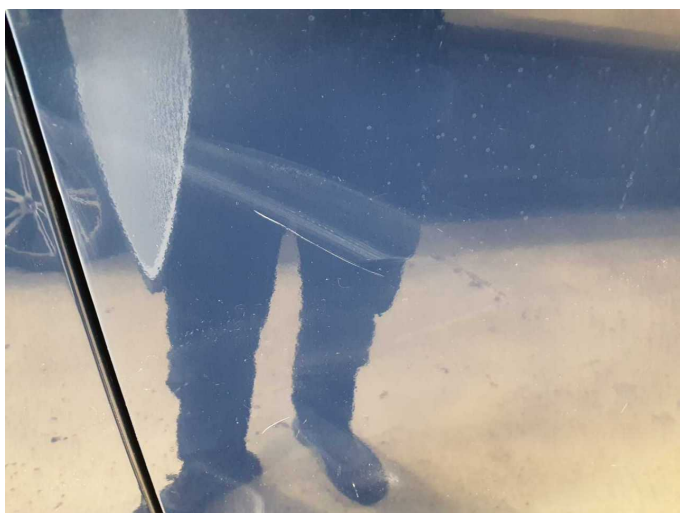
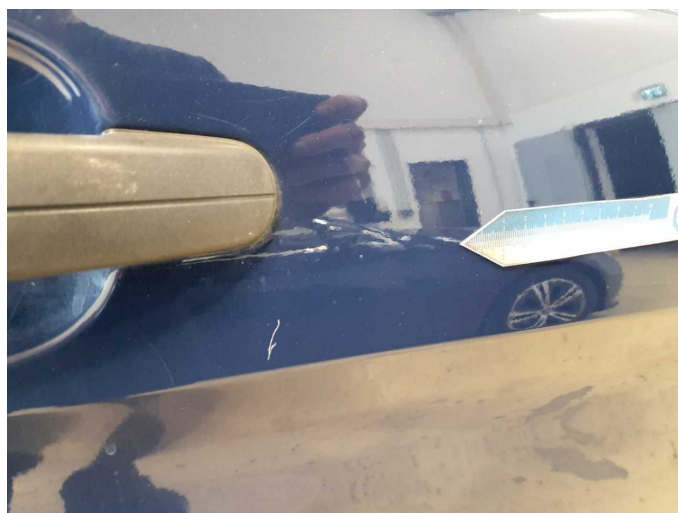
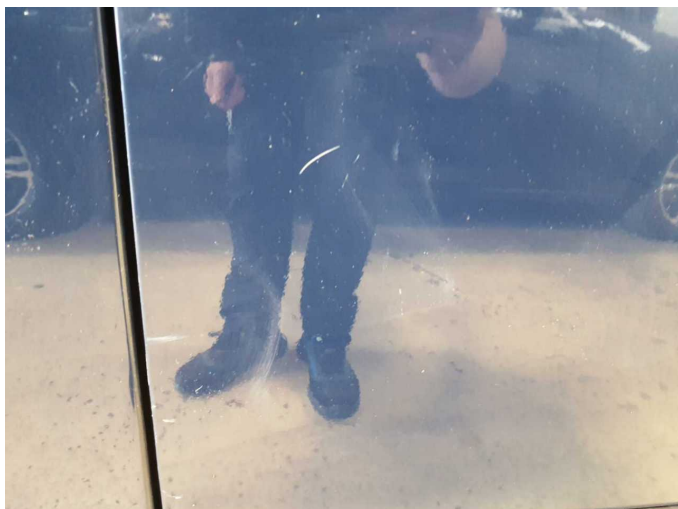
| No. | Component group | Description |
|---|---|---|
| 17 | Door - front right side | Door - Dent / paintcoat damage - Repair and paint |

**Damage 17:** Door - front right side: Door - Dent / paintcoat damage - Repair and paint

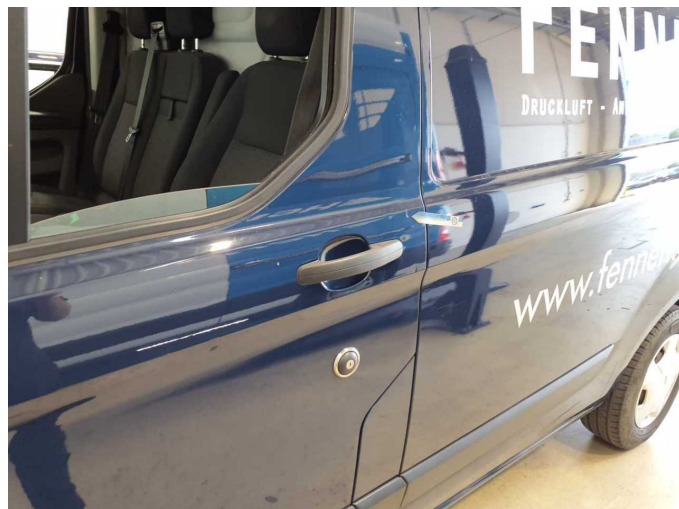
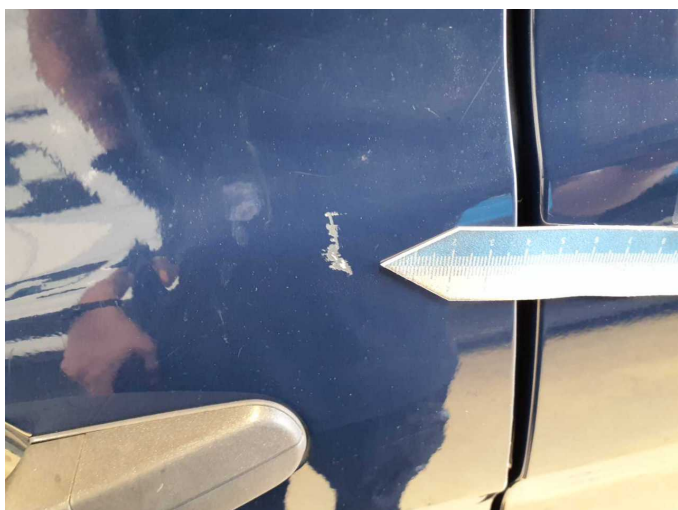
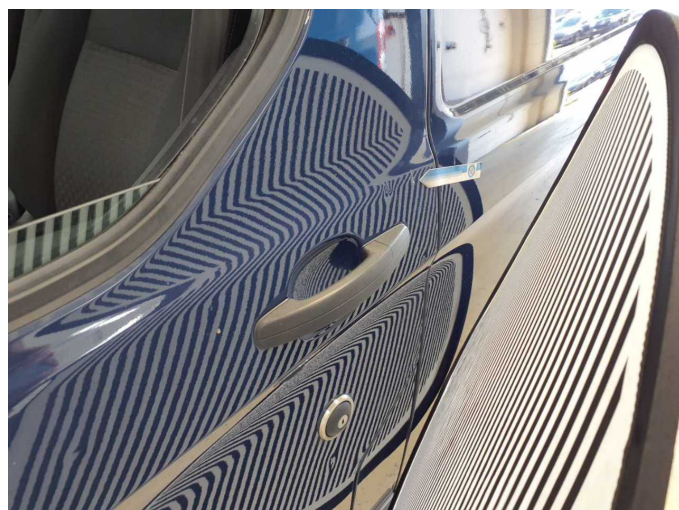
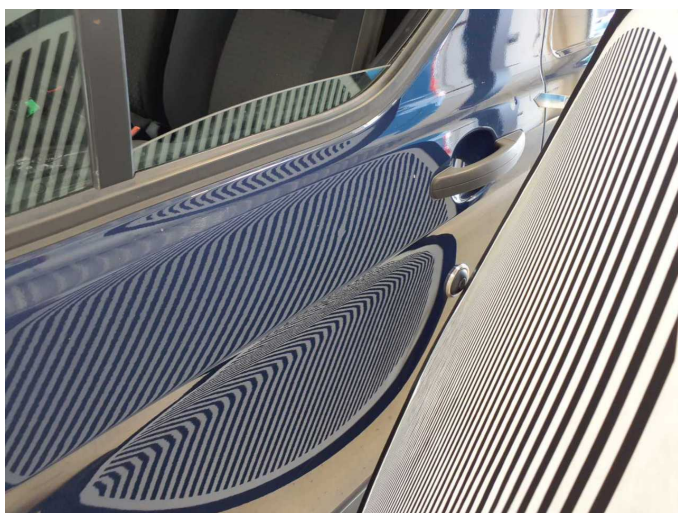
| No. | Component group | Description |
|---|---|---|
| 18 | Door - front left side | Door - Dent / paintcoat damage - Repair and paint |

**Damage 18:** Door - front left side: Door - Dent / paintcoat damage - Repair and paint

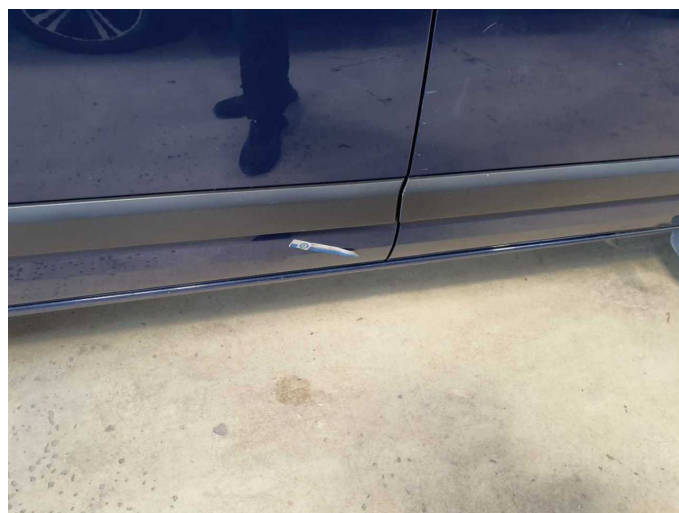
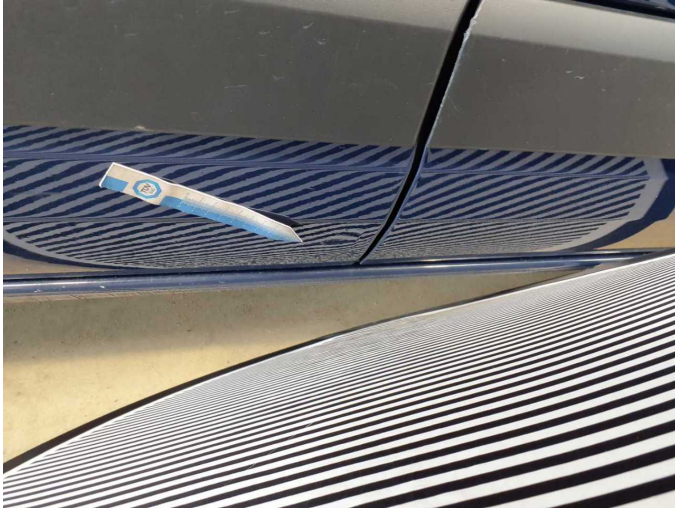
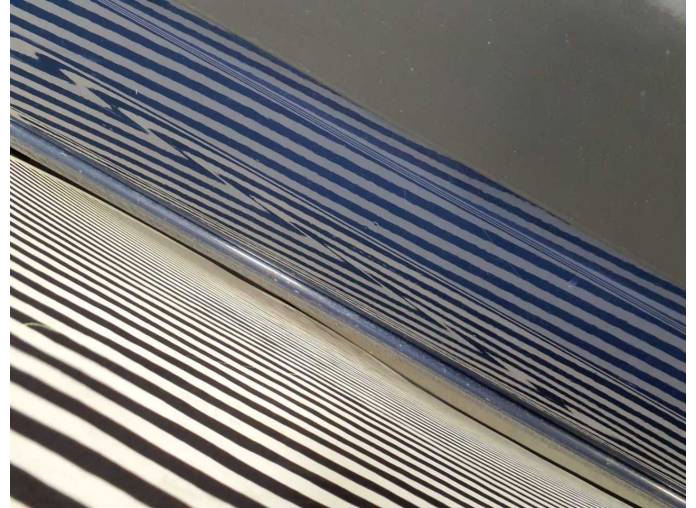
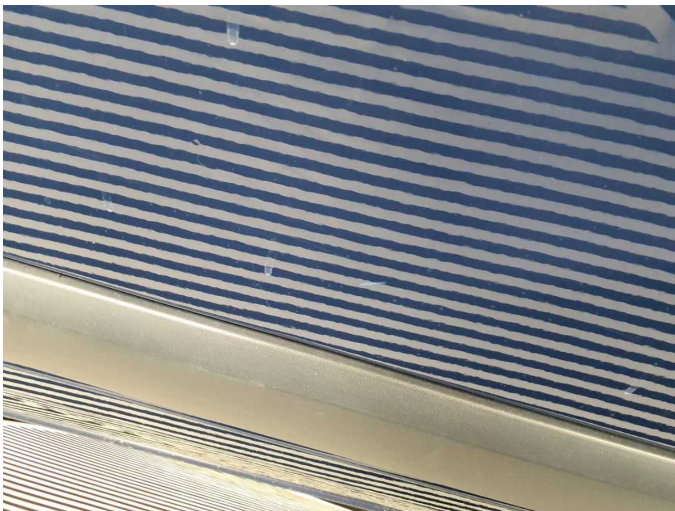
| No. | Component group | Description |
|---|---|---|
| 19 | Sliding door, right | Sliding door (Einschlüsse und unförmig) - Unprofessionally repaired - Repair and paint |

**Damage 19:** Sliding door, right: Sliding door (Einschlüsse und unförmig) - Unprofessionally repaired - Repair and paint

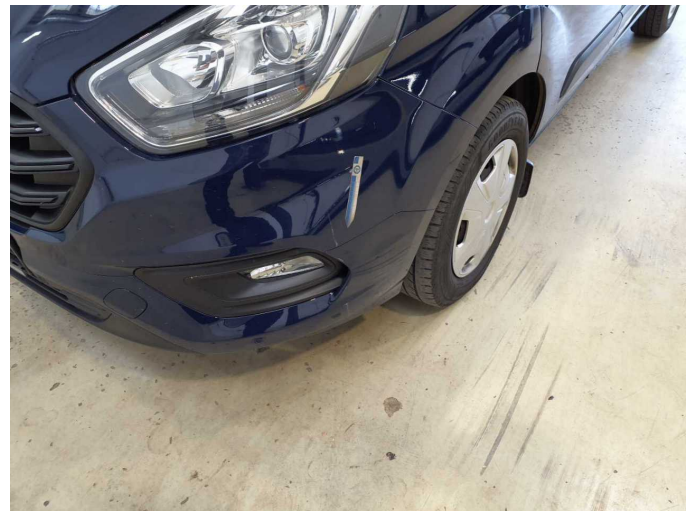
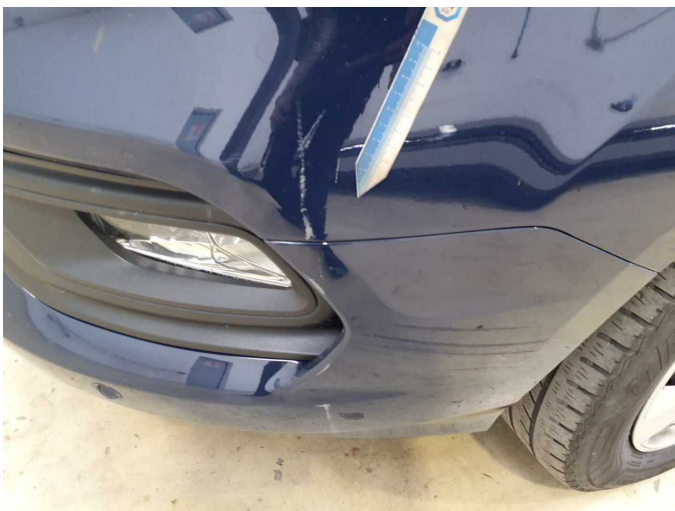
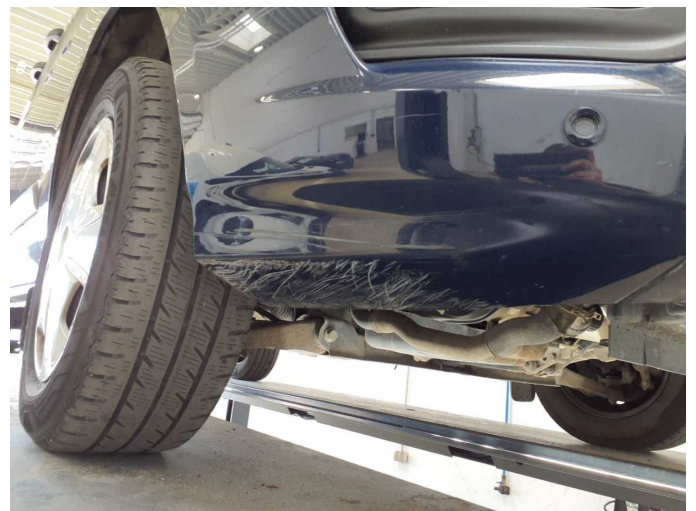
| No. | Component group | Description |
|---|---|---|
| 20 | Front bumper | Front bumper - Scratch(es) - Paint |

**Damage 20:** Front bumper: Front bumper - Scratch(es) - Paint

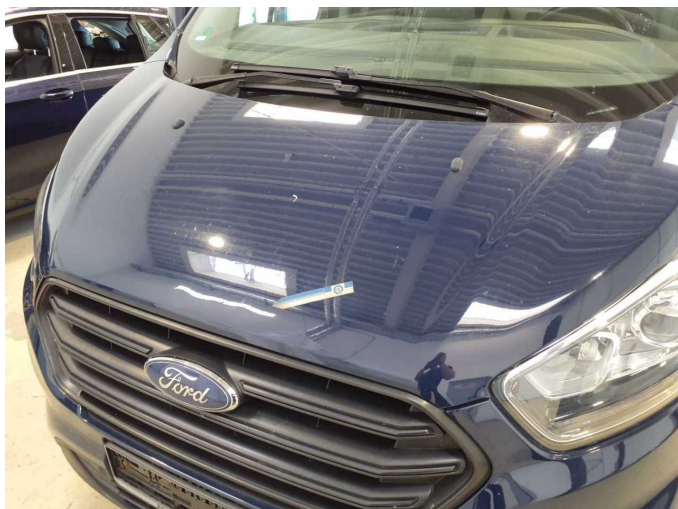
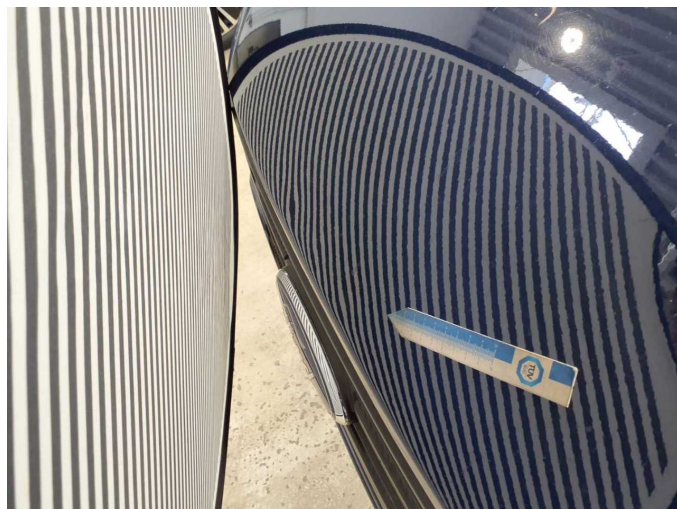
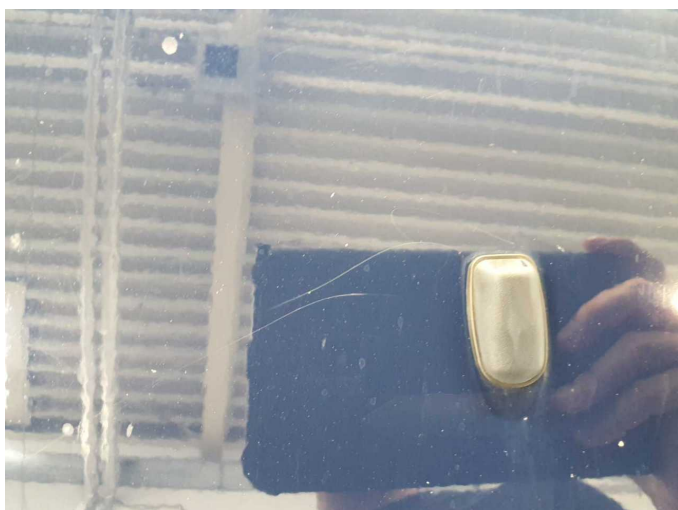
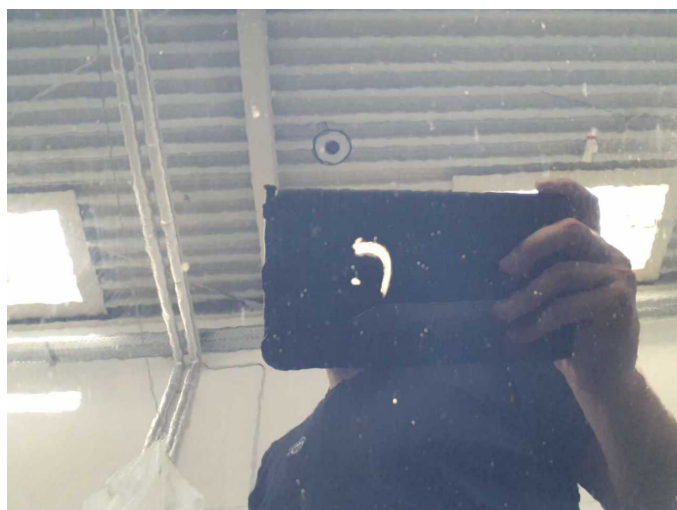
| No. | Component group | Description |
|---|---|---|
| 21 | Bonnet | Bonnet - Dent / paintcoat damage - Repair and paint |

**Damage 21:** Bonnet: Bonnet - Dent / paintcoat damage - Repair and paint

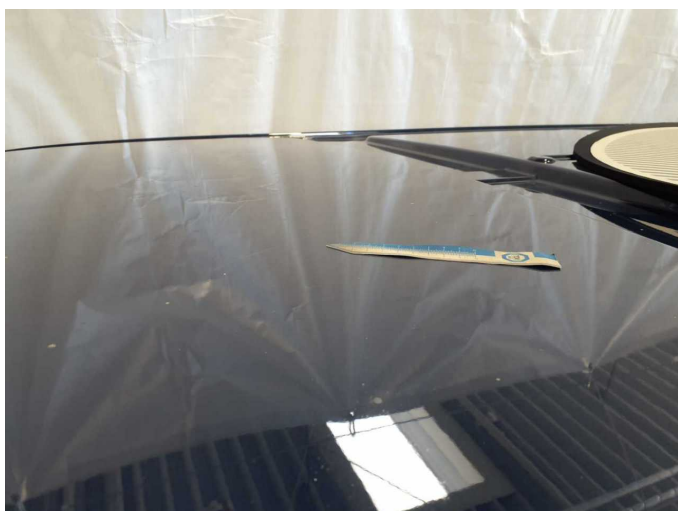
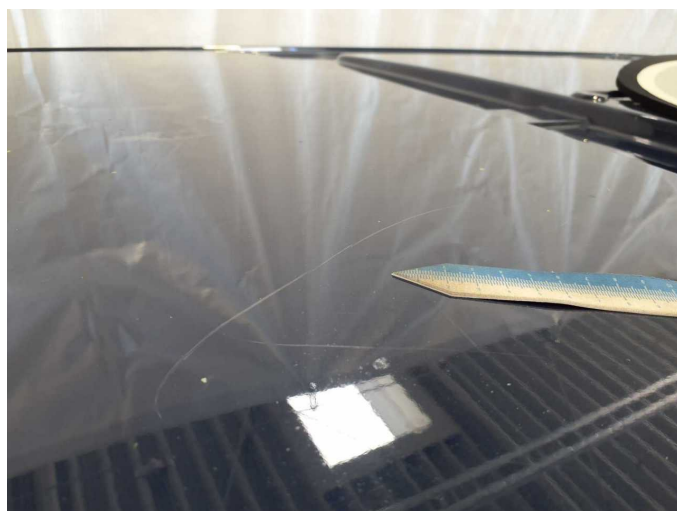
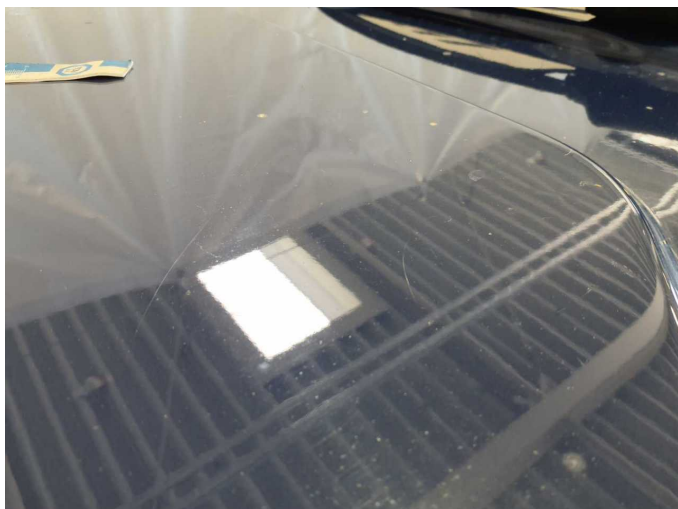
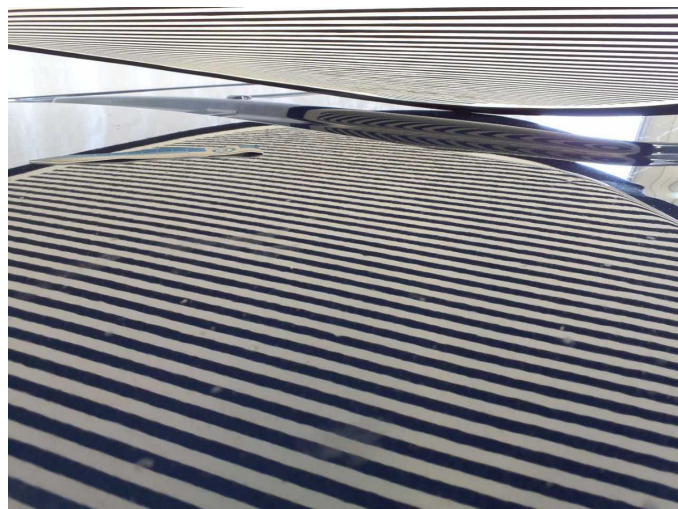
| No. | Component group | Description |
|---|---|---|
| 22 | Roof | Roof - Dent / paintcoat damage - Repair and paint |

**Damage 22:** Roof: Roof - Dent / paintcoat damage - Repair and paint

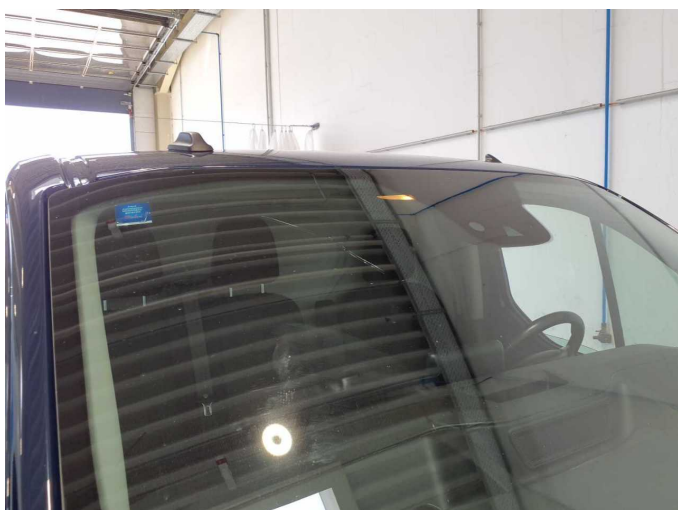
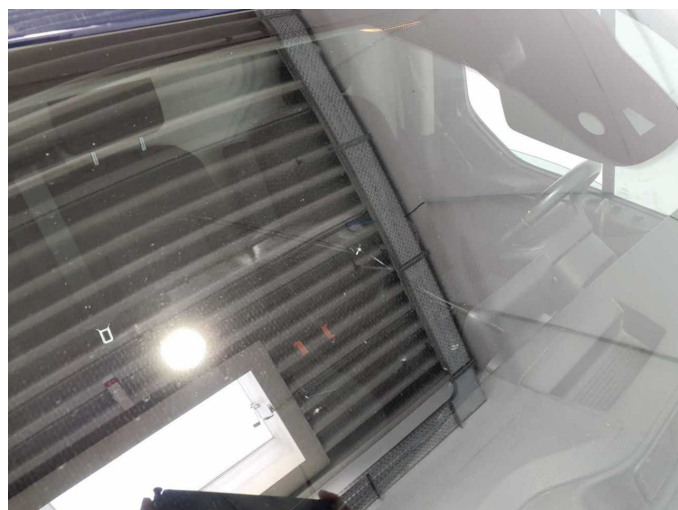
| No. | Component group | Description |
|---|---|---|
| 23 | Vehicle glazing | Windscreen - Stone chips - Replace |

**Damage 23:** Vehicle glazing: Windscreen - Stone chips - Replace

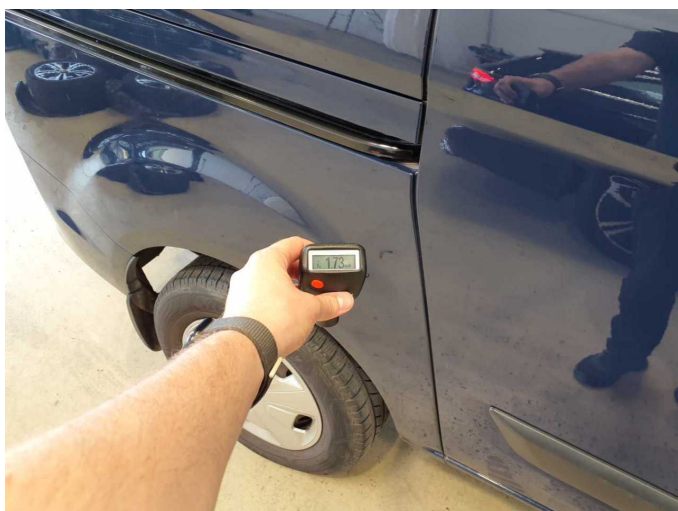
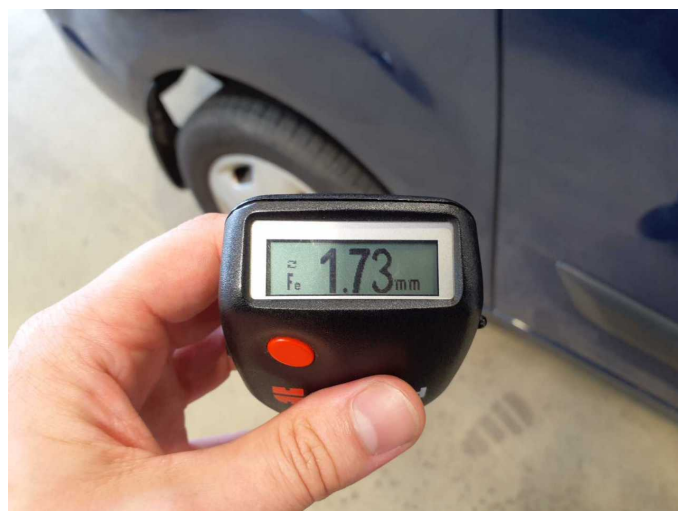
| 1 | Side panel - rear right side, Unprofessionally carried out, Invoice of repair done Non-existent |

| Side panel - rear right side | 1,730<br>µm | Door - rear right side | 189 µm |

**Repainting 1:** Side panel - rear right side

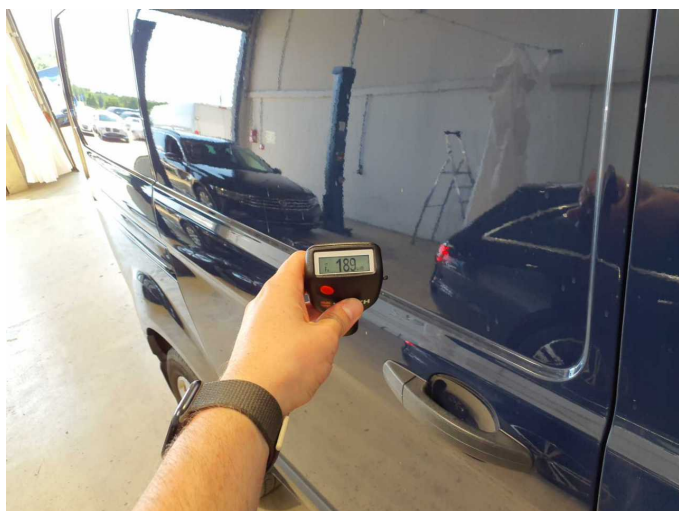
| 2 | Door - rear right side, Unprofessionally carried out, Invoice of repair done Non-existent |

**Repainting 2:** Door - rear right side
