Type: Depreciation value appraisal

- Vehicle Inspection Report -

Number: 10267481
From: 20.03.2026

Vehicle category:	Passenger Car
Vehicle type:	EstateCar
Make:	Volkswagen
Model:	Passat
Manufacturers and type code:	0603 / BQS
Date of first registration:	11.03.2024
Mileage:	85,179 km
Proof of mileage:	ReadOff
Exterior colour:	Deep Black Perleffekt
Roof colour:	Deep Black Perleffekt
Propulsion:	Front
Fuel:	Diesel
Engine size (cc):	2,000 ccm
Performance:	110 kW (150 PS)
Length:	
Height:	
Width:	
Permitted total weight:	
Wheelbase:	
Number of powered axles:	2
Cylinders:	4
Euronorm:	Euro 6
Number of doors:	4
Number of seats:	5
Gearbox:	Automatic 7-speed
Upholstery type:	Lining fabrics
Interior colour:	Titanschwarz/Titanschwarz/Titanschwarz
Number of keys:	1

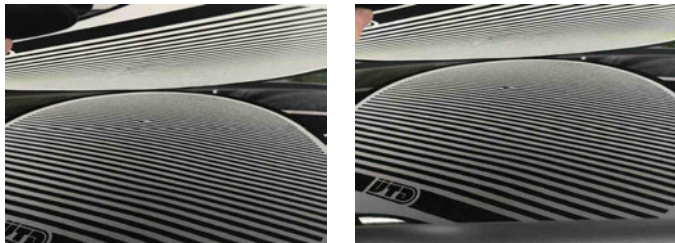
1 - Roof - Dent(s) - Acceptable	Repaircosts:	€ 0.00
	Net cost:	€ 0.00

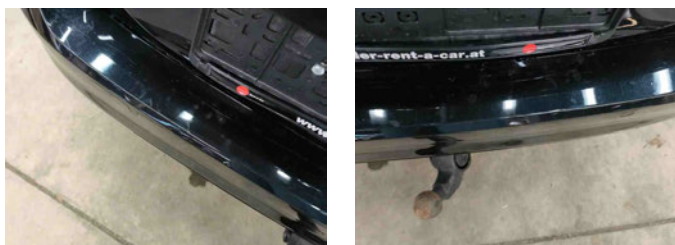
2 - Bumper R - Scratch(es) - Acceptable	Repaircosts:	€ 0.00
	Net cost:	€ 0.00

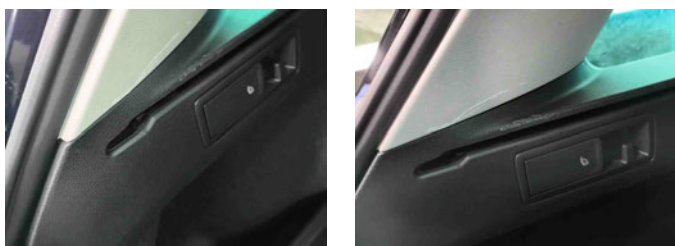
3 - Boot door lining L - Scratch(es) - Acceptable	Repaircosts:	€ 0.00
	Net cost:	€ 0.00
