## Expertise

Protocol number: 46220451  
Order No. / Reference: 26223211-1  
Inspection date: 12 May 2026

Model: Transporter T6.1 TDI SCR DSG 4motion Kurz Sortimo-  
Regalsystem

VIN: WV1ZZZ7H6PX037218

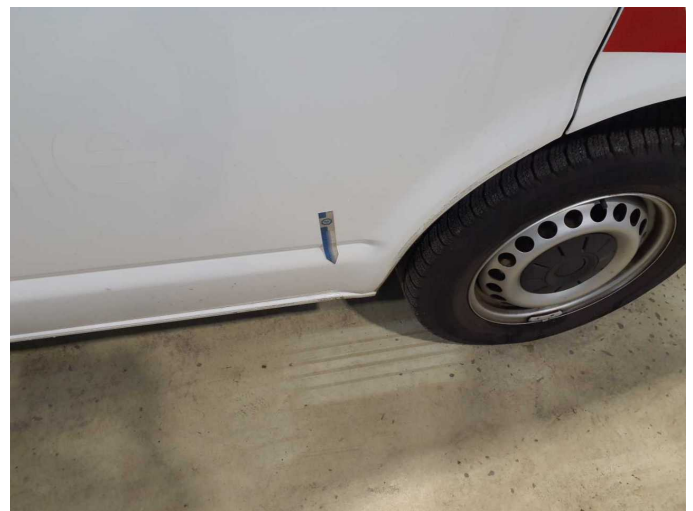
Damage 1: Door - front right side: Door - Scratch(es) - Smart repair

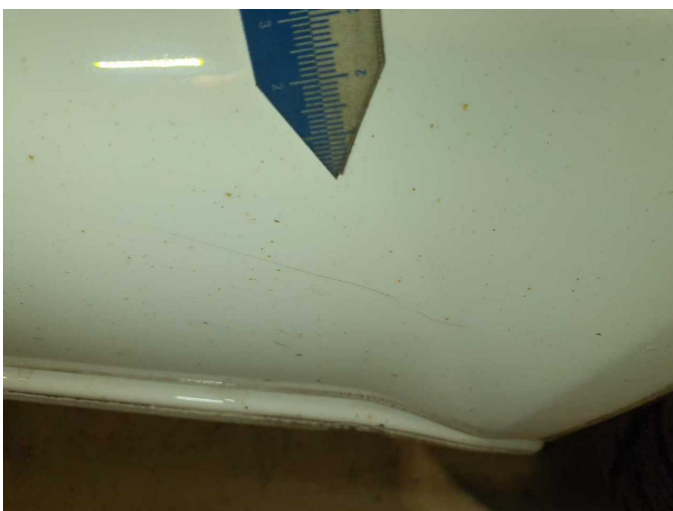
Damage 1: Door - front right side: Door - Scratch(es) - Smart repair

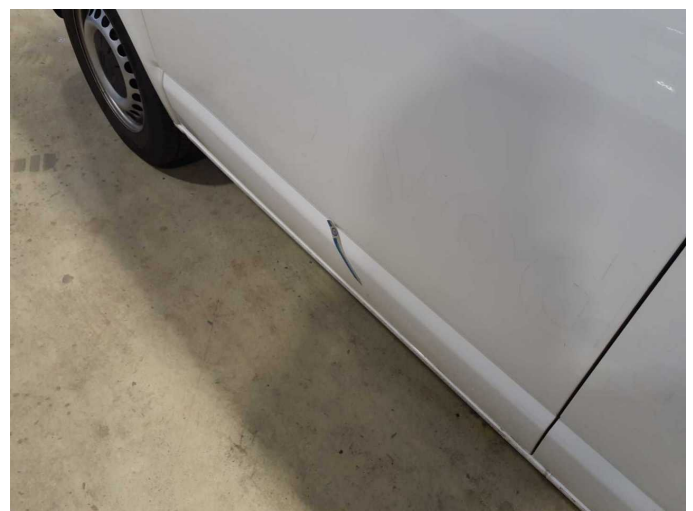
Damage 2: Door - rear right side: Door - Scratch(es) - Smart repair

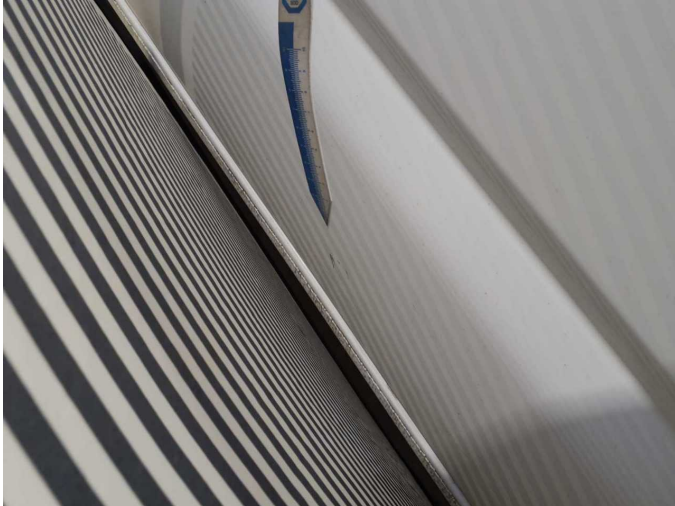
**Damage 2:** Door - rear right side: Door - Scratch(es) - Smart repair

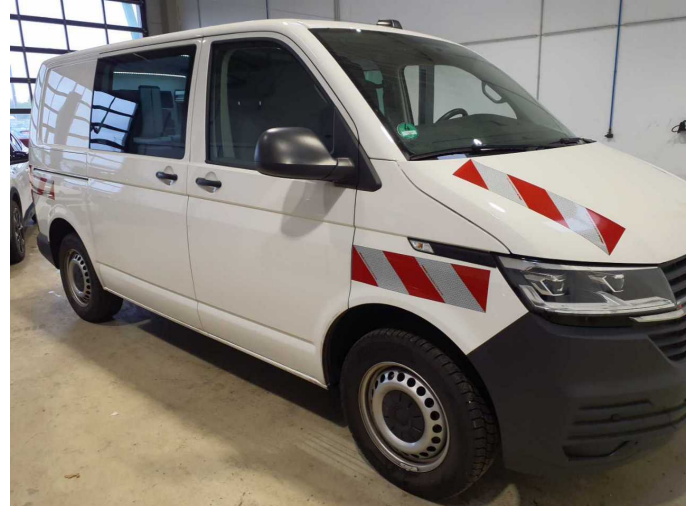
**Damage 3:** Body: Body - Glued / labelled - De-glue / neutralise

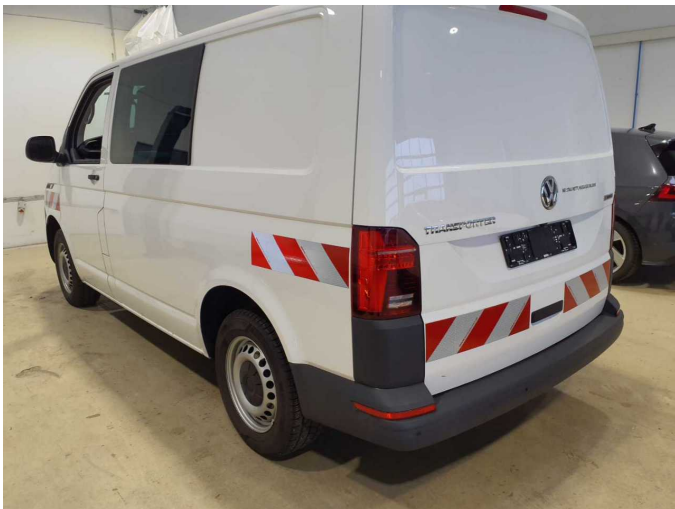
**Damage 3:** Body: Body - Glued / labelled - De-glue / neutralise

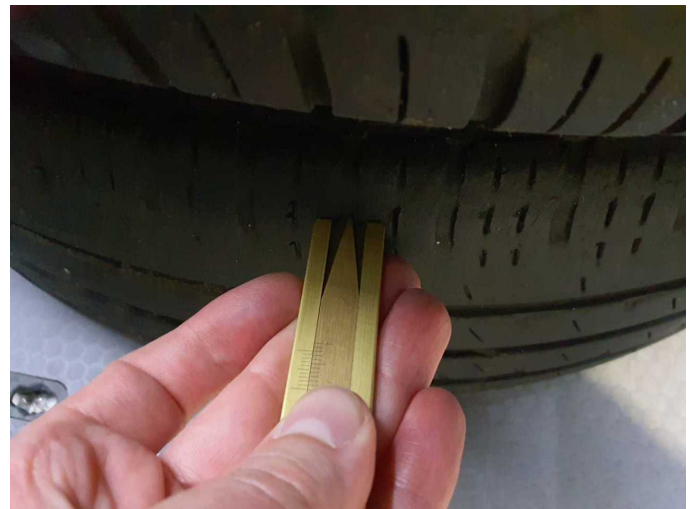
**Damage 4:** 2nd wheel set: 2 tyres (Sommerreifen Profiltiefe <2mm) - Worn - Replace

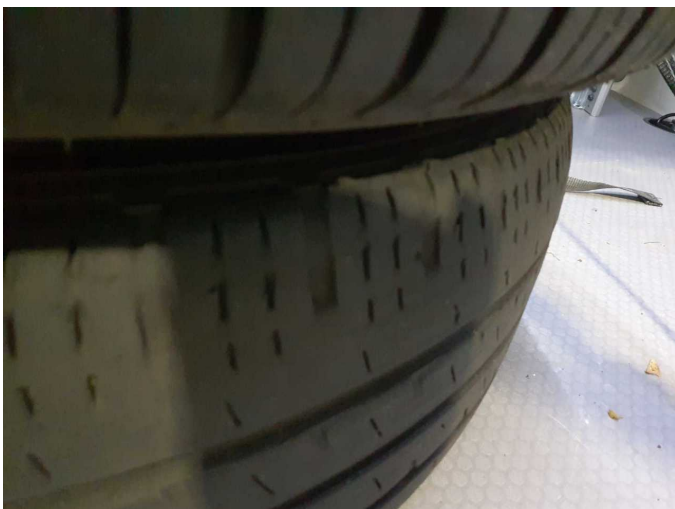
**Damage 4:** 2nd wheel set: 2 tyres (Sommerreifen Profiltiefe <2mm) - Worn - Replace

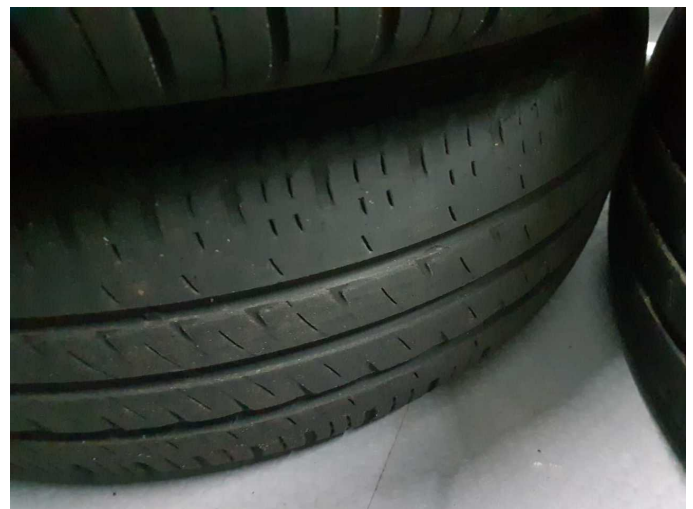
**Damage 4:** 2nd wheel set: 2 tyres (Sommerreifen Profiltiefe <2mm) - Worn - Replace

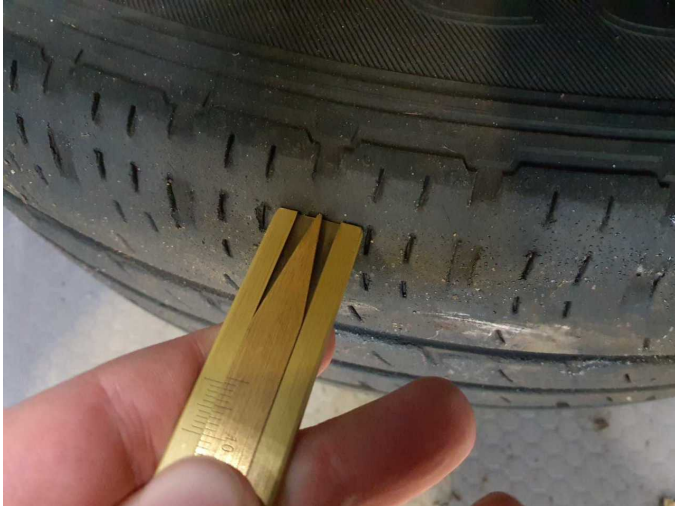
**Damage 4:** 2nd wheel set: 2 tyres (Sommerreifen Profiltiefe <math>< 2\text{mm}</math>) - Worn - Replace

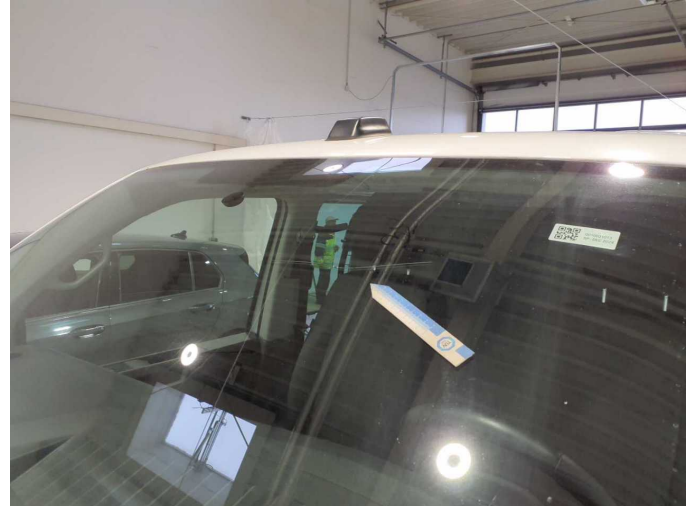
**Damage 5:** Vehicle glazing: Windscreen - Broken / torn - Replace

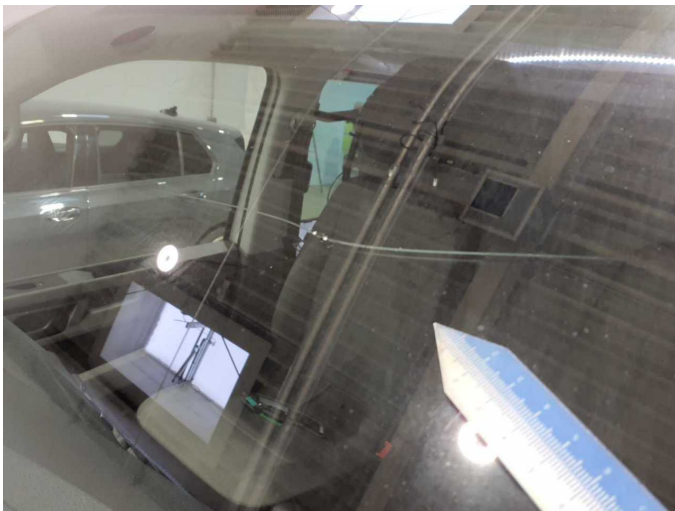
**Damage 5:** Vehicle glazing: Windscreen - Broken / torn - Replace
