Expertise

Protocol number: 46643335  
Order No. / Reference: 26539219  
Inspection date: 17 Jul 2026

Manufacturer: Ford

Model: Transit Custom 320 L2H1 LKW VA MH Basis

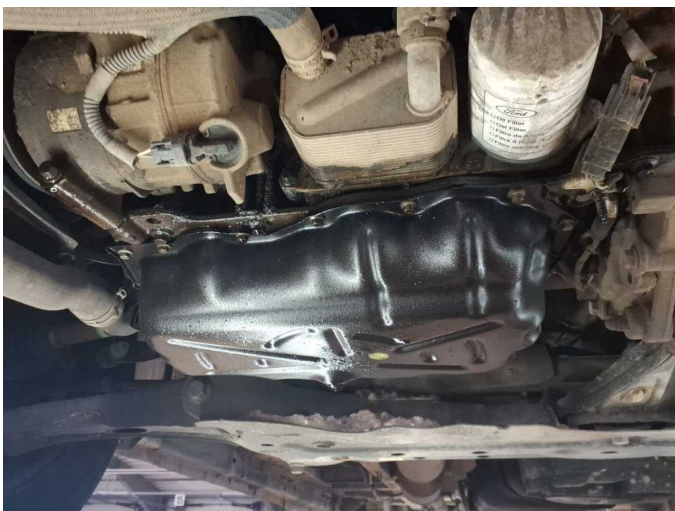
| No. | Component group | Description |
|---|---|---|
| 1 | Engine | Engine - Leaking - Perform diagnosis |

Damage 1: Engine: Engine - Leaking - Perform diagnosis

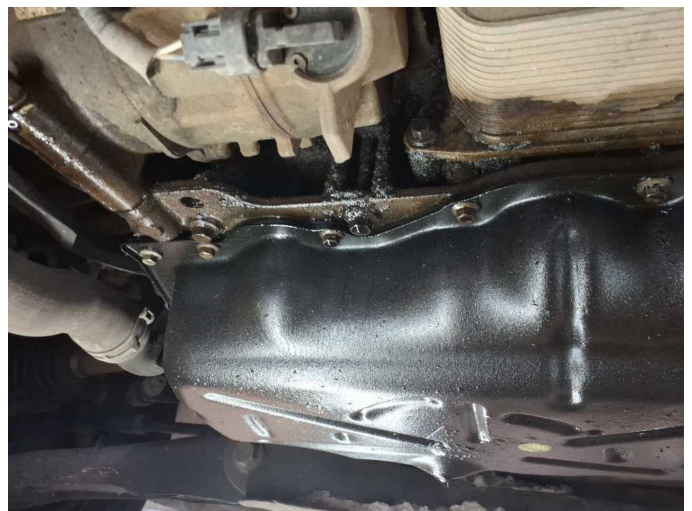
Damage 1: Engine: Engine - Leaking - Perform diagnosis

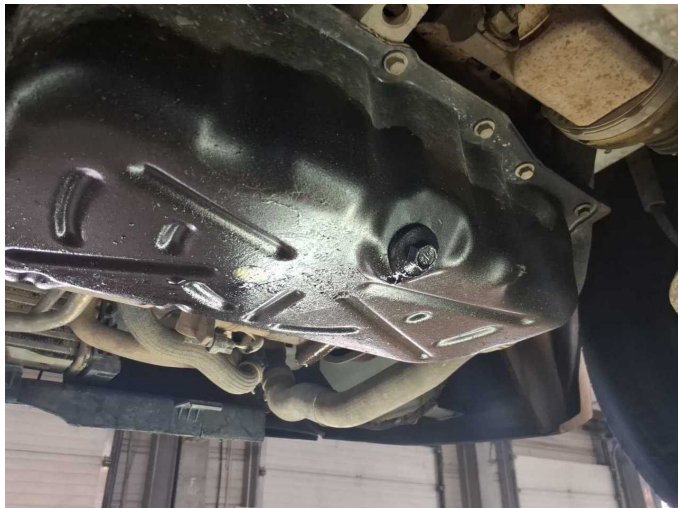
**Damage 1:** Engine: Engine - Leaking - Perform diagnosis

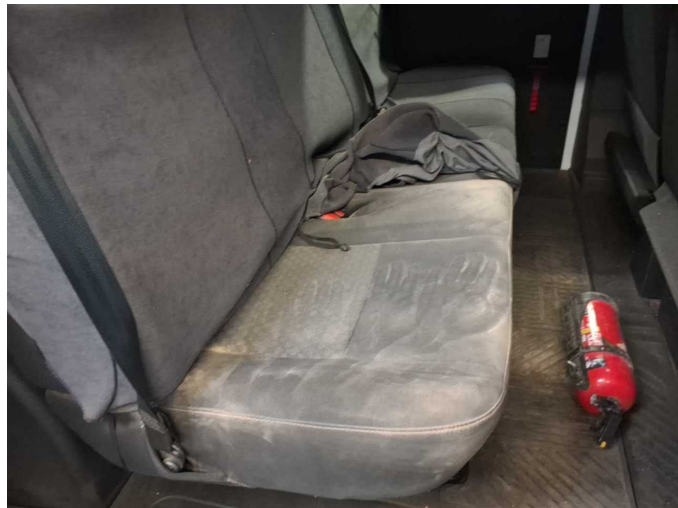
| No. | Component group | Description |
|---|---|---|
| 2 | Interior | Interior - Soiled - Clean |

**Damage 2:** Interior: Interior - Soiled - Clean

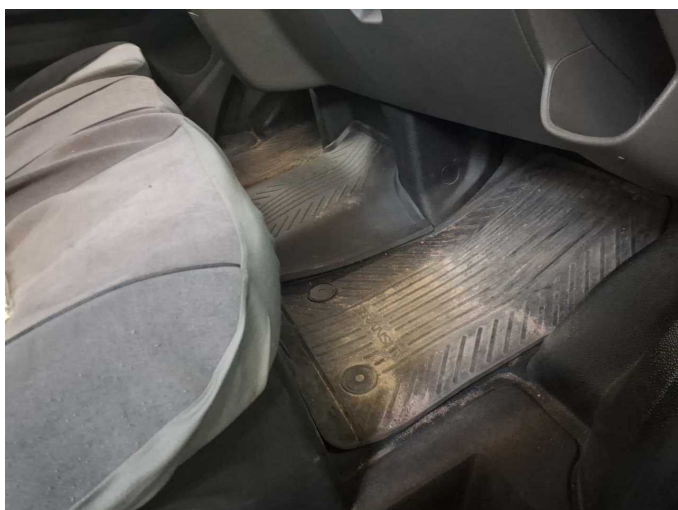
**Damage 2:** Interior: Interior - Soiled - Clean

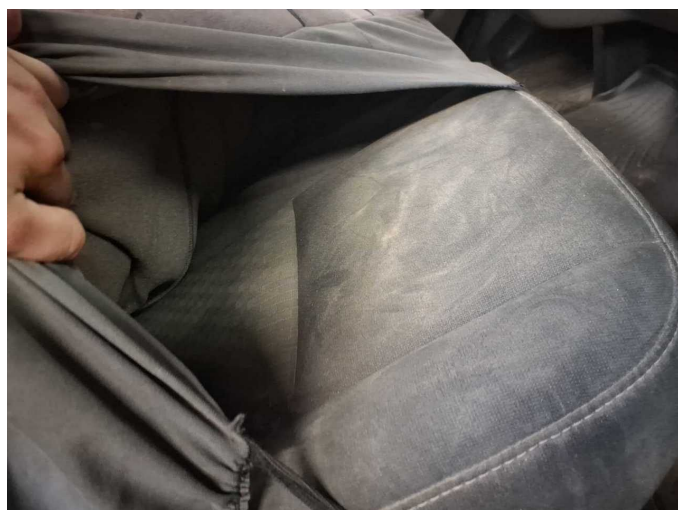
**Damage 2:** Interior: Interior - Soiled - Clean

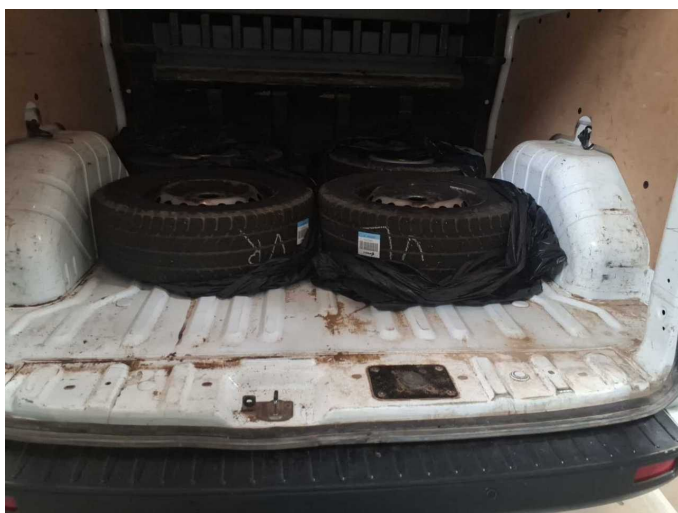
**Damage 2:** Interior: Interior - Soiled - Clean

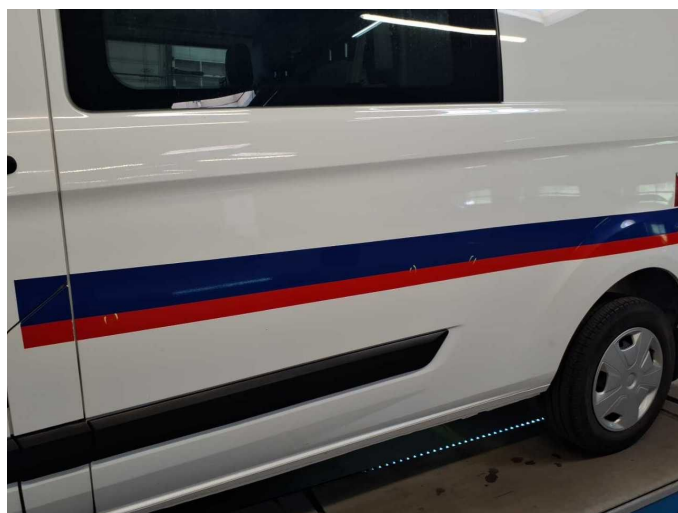
| No. | Component group | Description |
|---|---|---|
| 3 | Misc. | Vehicle (Folie) - Glued / labelled - De-glue / neutralise |

**Damage 3:** Misc.: Vehicle (Folie) - Glued / labelled - De-glue / neutralise

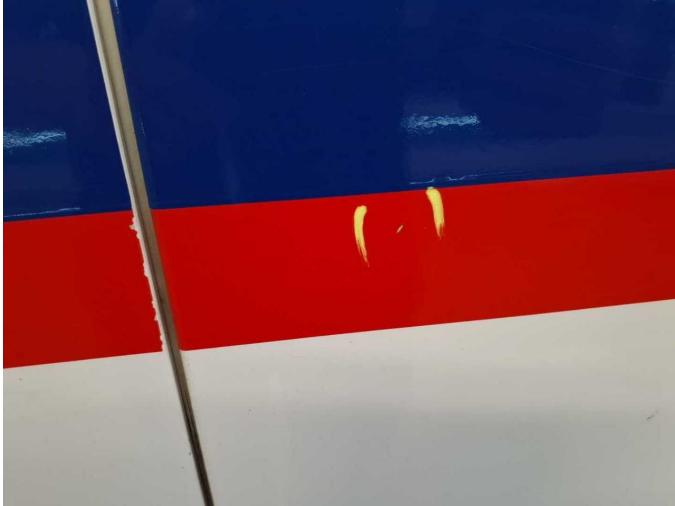
**Damage 3:** Misc.: Vehicle (Folie) - Glued / labelled - De-glue / neutralise

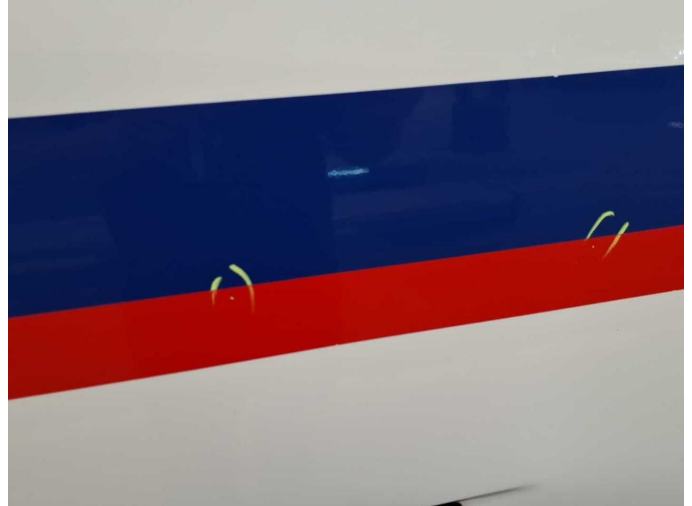
**Damage 3:** Misc.: Vehicle (Folie) - Glued / labelled - De-glue / neutralise

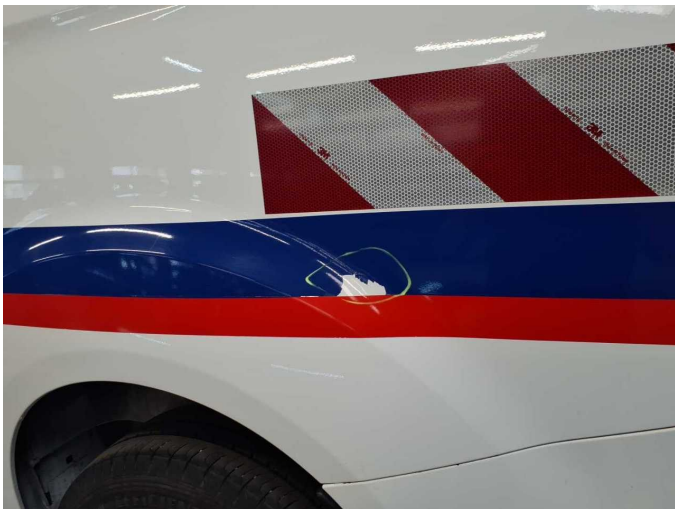
**Damage 3:** Misc.: Vehicle (Folie) - Glued / labelled - De-glue / neutralise

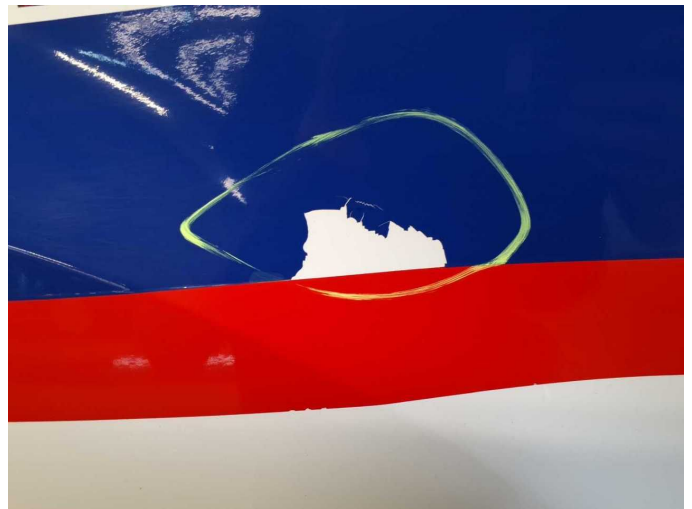
**Damage 3:** Misc.: Vehicle (Folie) - Glued / labelled - De-glue / neutralise

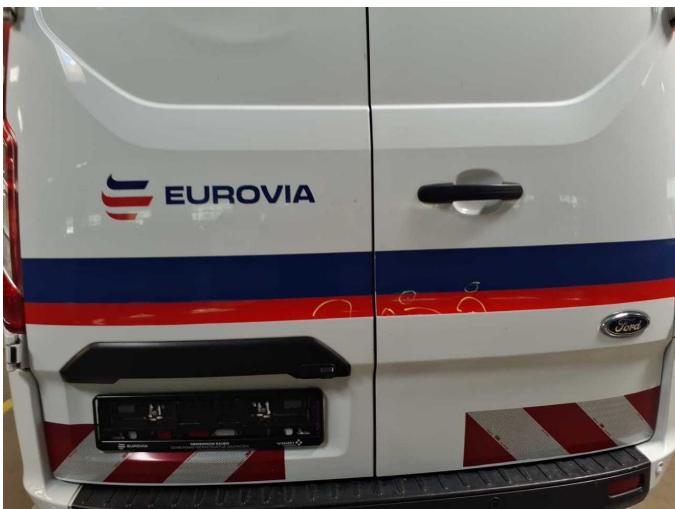
**Damage 3:** Misc.: Vehicle (Folie) - Glued / labelled - De-glue / neutralise

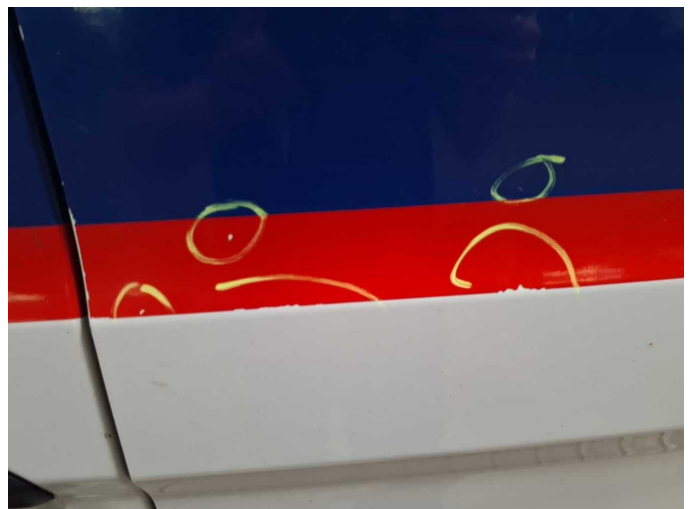
**Damage 3:** Misc.: Vehicle (Folie) - Glued / labelled - De-glue / neutralise

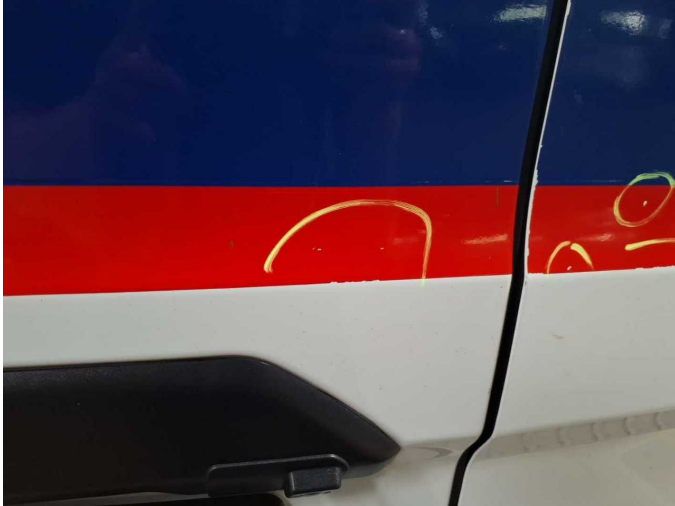
**Damage 3:** Misc.: Vehicle (Folie) - Glued / labelled - De-glue / neutralise

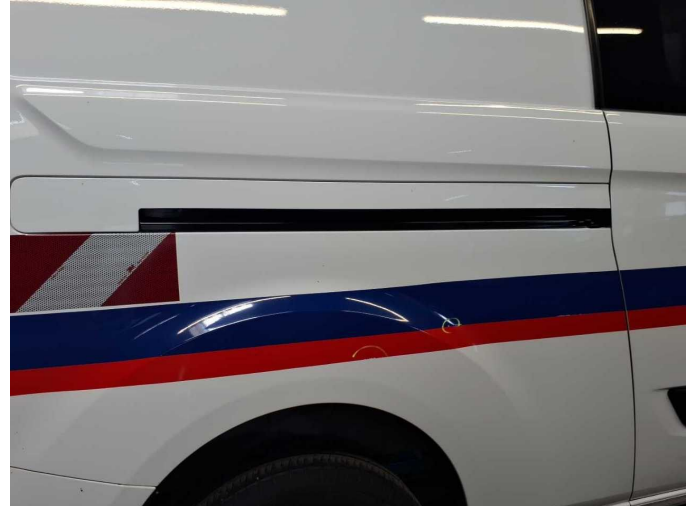
**Damage 3:** Misc.: Vehicle (Folie) - Glued / labelled - De-glue / neutralise

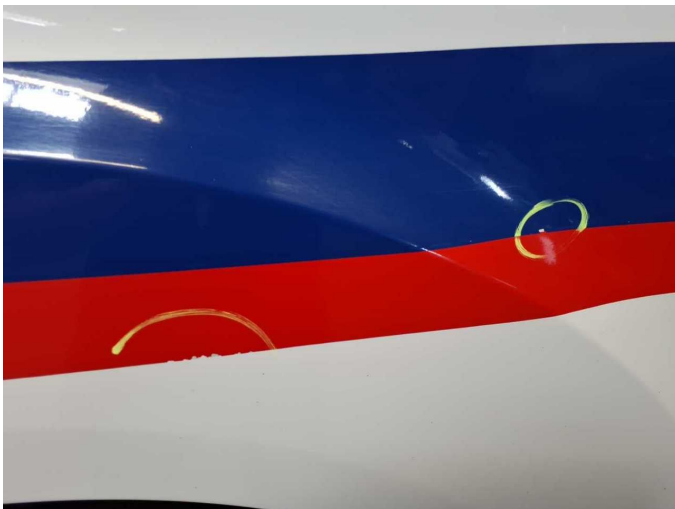
**Damage 3:** Misc.: Vehicle (Folie) - Glued / labelled - De-glue / neutralise

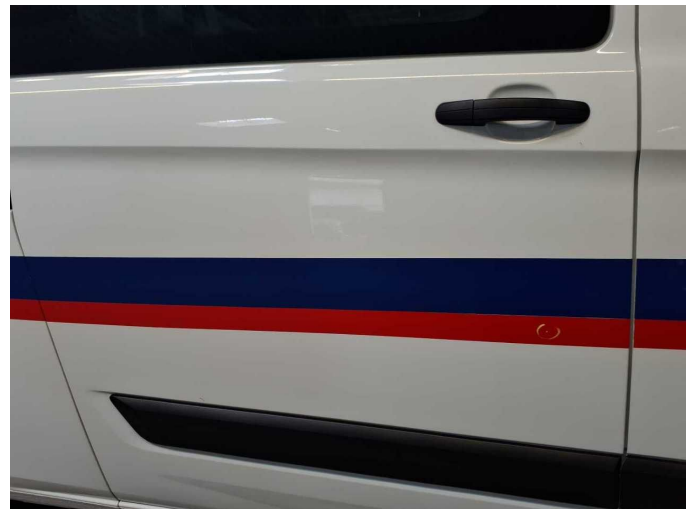
**Damage 3:** Misc.: Vehicle (Folie) - Glued / labelled - De-glue / neutralise

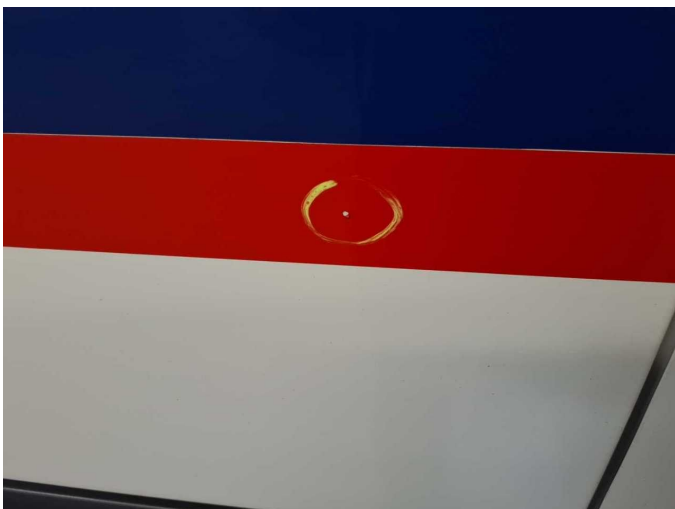
**Damage 3:** Misc.: Vehicle (Folie) - Glued / labelled - De-glue / neutralise

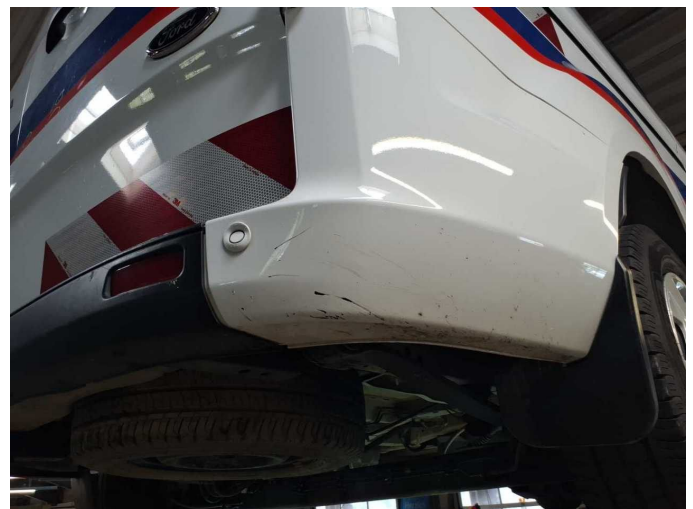
| No. | Component group | Description |
|---|---|---|
| 4 | Rear bumper | Rear bumper - Scratched - Paint |

**Damage 4:** Rear bumper: Rear bumper - Scratched - Paint

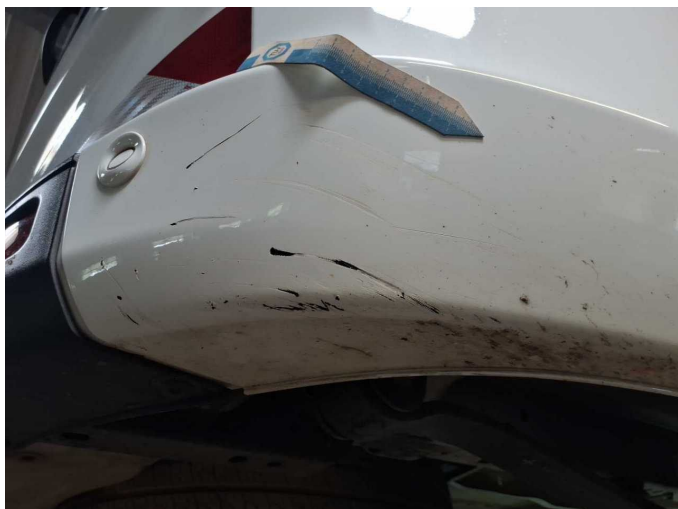
**Damage 4:** Rear bumper: Rear bumper - Scratched - Paint

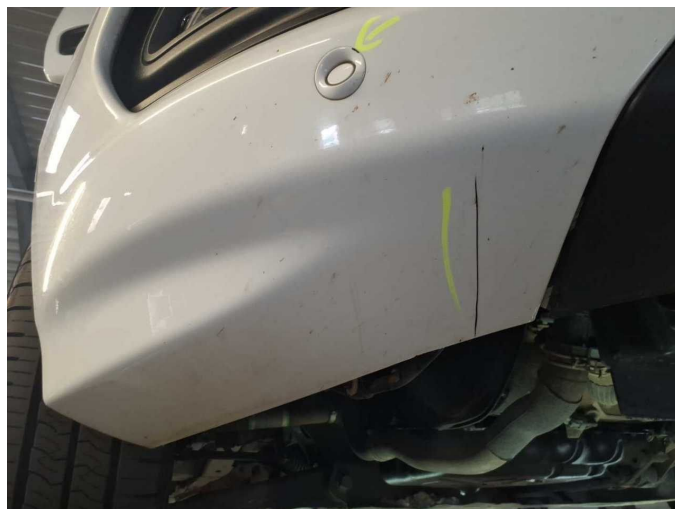
| No. | Component group | Description |
|---|---|---|
| 5 | Front bumper | Front bumper - Scratch(es) - Paint |

**Damage 5:** Front bumper: Front bumper - Scratch(es) - Paint

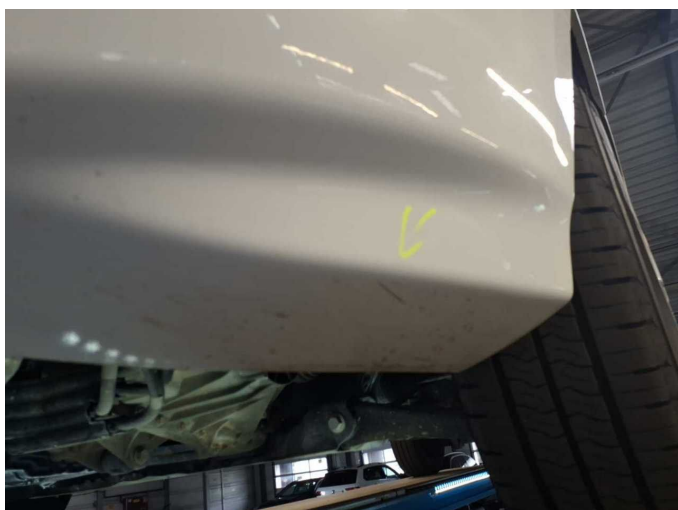
**Damage 5:** Front bumper: Front bumper - Scratch(es) - Paint

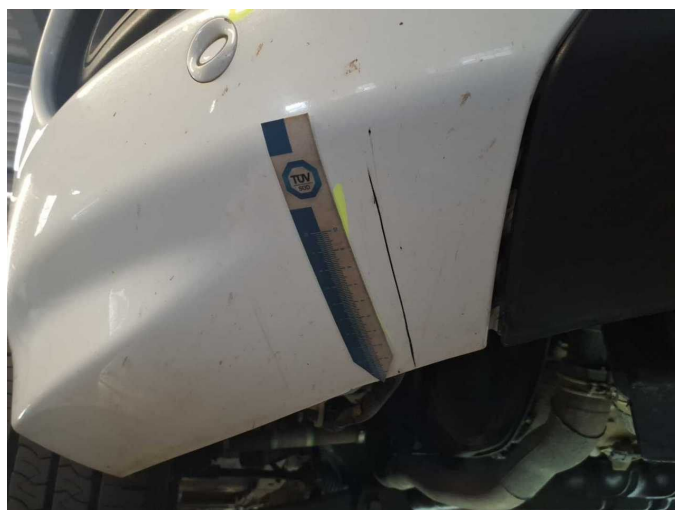
**Damage 5:** Front bumper: Front bumper - Scratch(es) - Paint

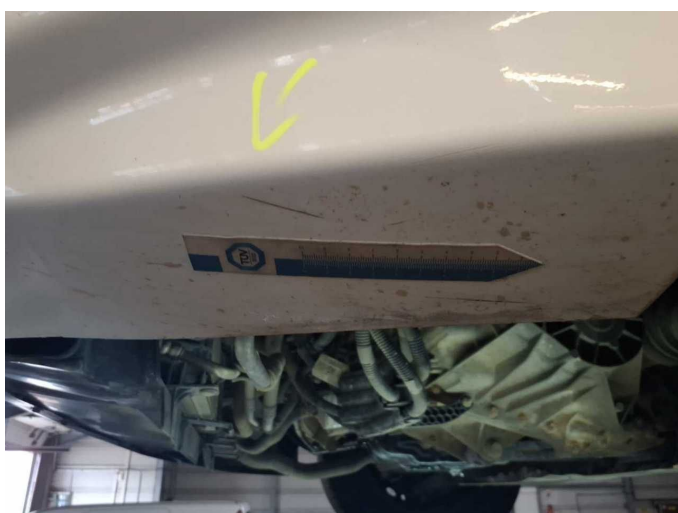
**Damage 5:** Front bumper: Front bumper - Scratch(es) - Paint

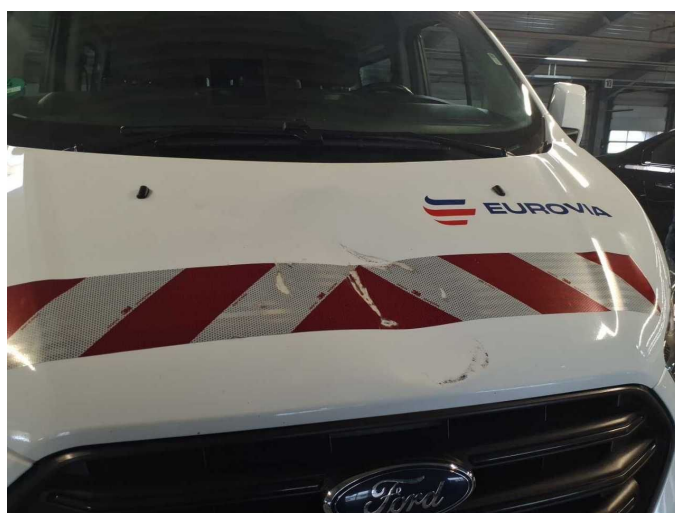
| No. | Component group | Description |
|---|---|---|
| 6 | Bonnet | Bonnet - Dent / paintcoat damage - Replace |

**Damage 6:** Bonnet: Bonnet - Dent / paintcoat damage - Replace

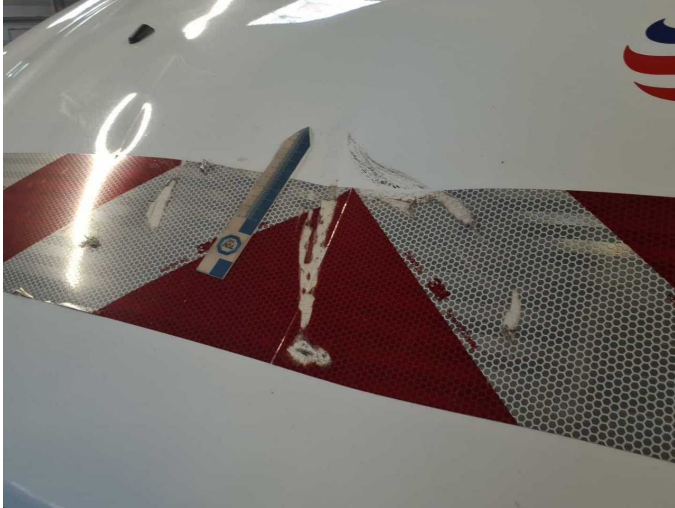
**Damage 6:** Bonnet: Bonnet - Dent / paintcoat damage - Replace

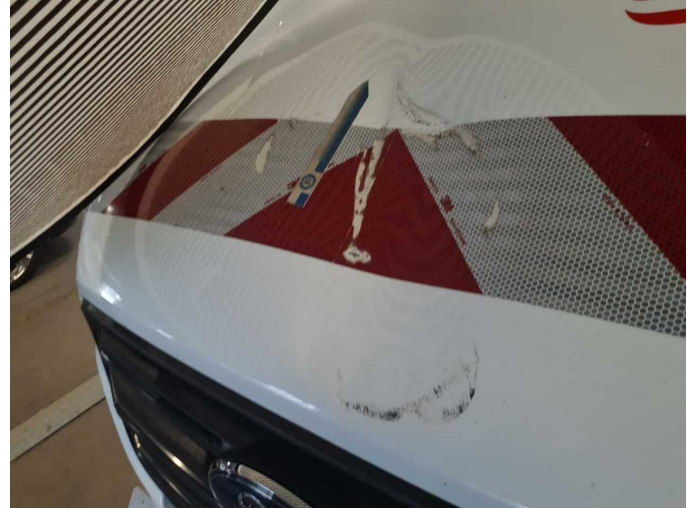
**Damage 6:** Bonnet: Bonnet - Dent / paintcoat damage - Replace

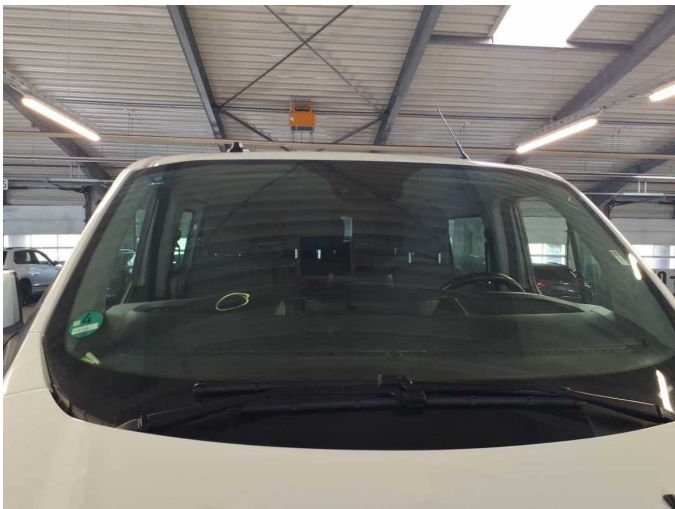
| No. | Component group | Description |
|---|---|---|
| 7 | Vehicle glazing | Windscreen - Unprofessionally repaired - Replace |

**Damage 7:** Vehicle glazing: Windscreen - Unprofessionally repaired - Replace

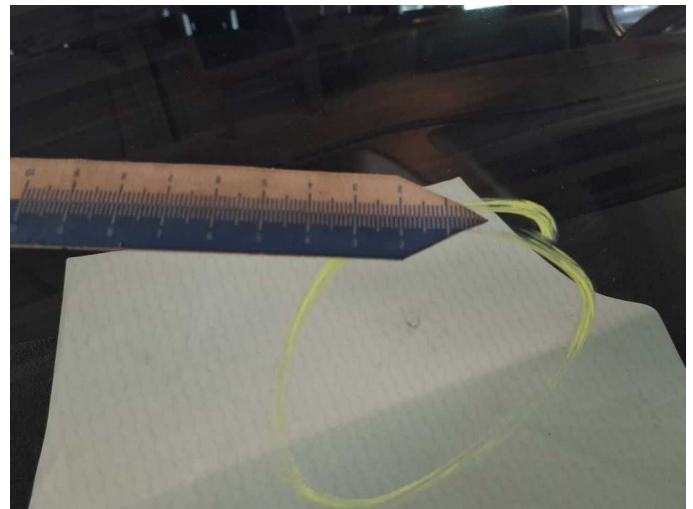
**Damage 7:** Vehicle glazing: Windscreen - Unprofessionally repaired - Replace

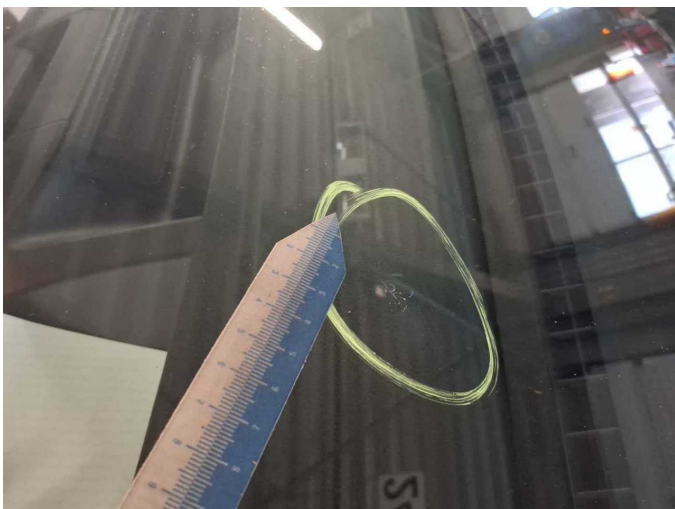
**Damage 7:** Vehicle glazing: Windscreen - Unprofessionally repaired - Replace

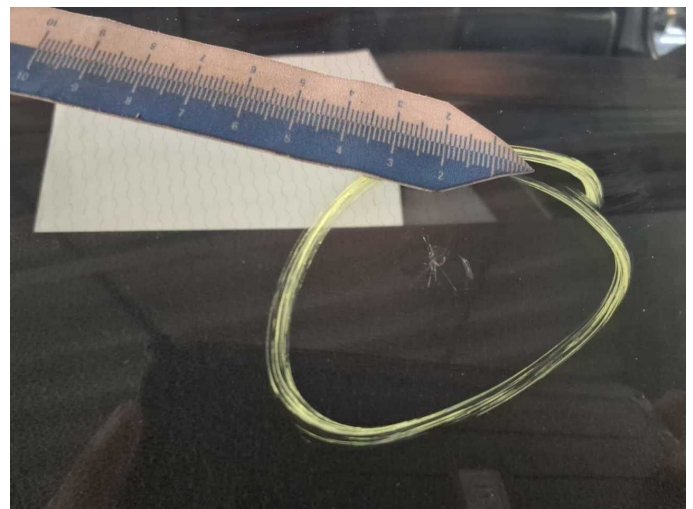
**Damage 7:** Vehicle glazing: Windscreen - Unprofessionally repaired - Replace

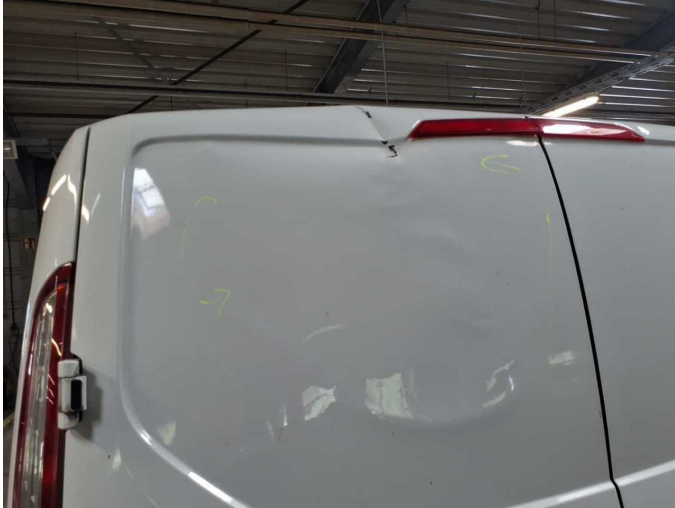
| No. | Component group | Description |
|---|---|---|
| 8 | Boot lid / rear door | Rear door - left side (Inkl. Folie) - Dent / paintcoat damage - Replace |

**Damage 8:** Boot lid / rear door: Rear door - left side (Inkl. Folie) - Dent / paintcoat damage - Replace

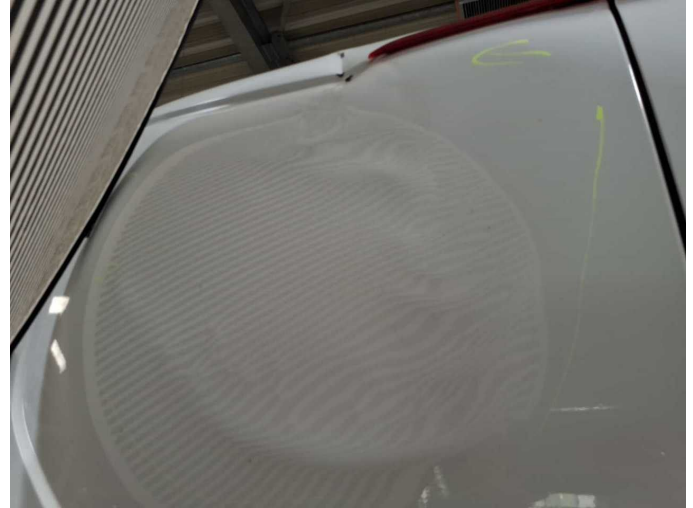
**Damage 8:** Boot lid / rear door: Rear door - left side (Inkl. Folie) - Dent / paintcoat damage - Replace

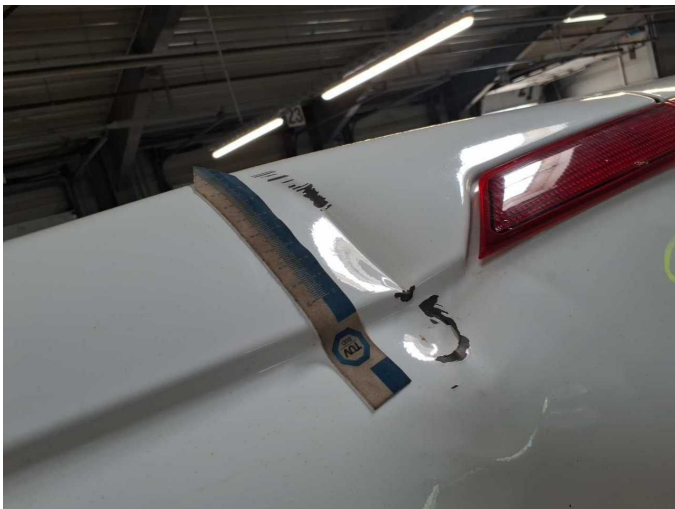
**Damage 8:** Boot lid / rear door: Rear door - left side (Inkl. Folie) - Dent / paintcoat damage - Replace

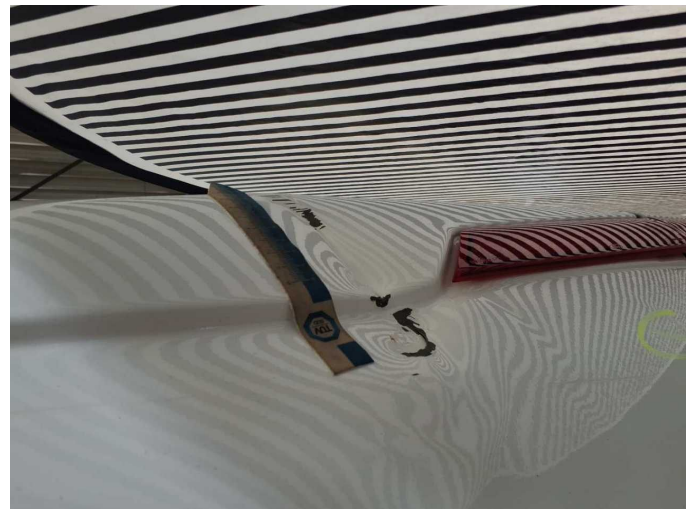
**Damage 8:** Boot lid / rear door: Rear door - left side (Inkl. Folie) - Dent / paintcoat damage - Replace

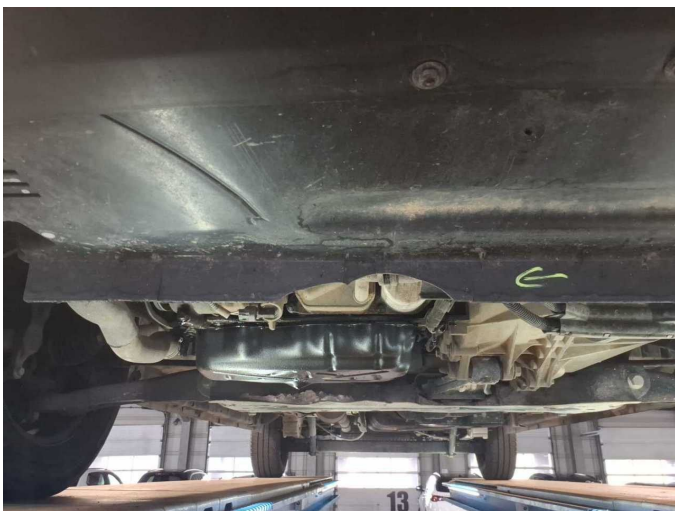
**Accident 1:** Underbody

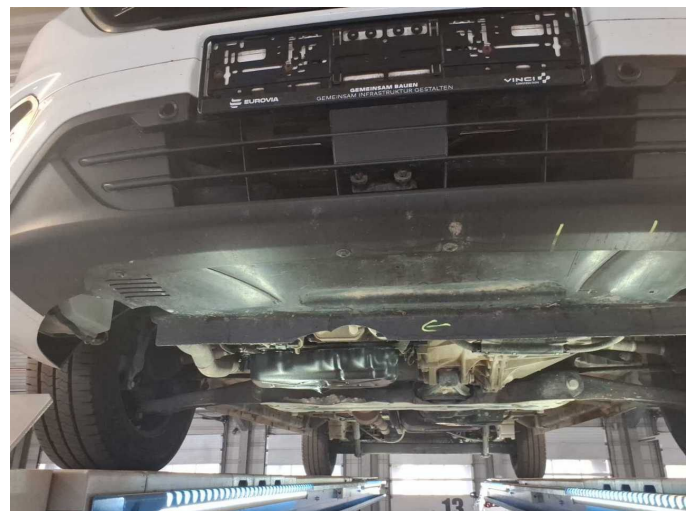
**Accident 1:** Underbody

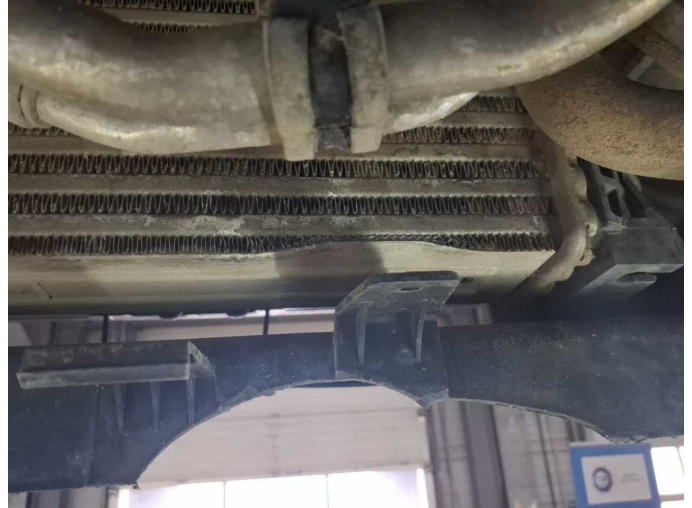
**Accident 1: Underbody**

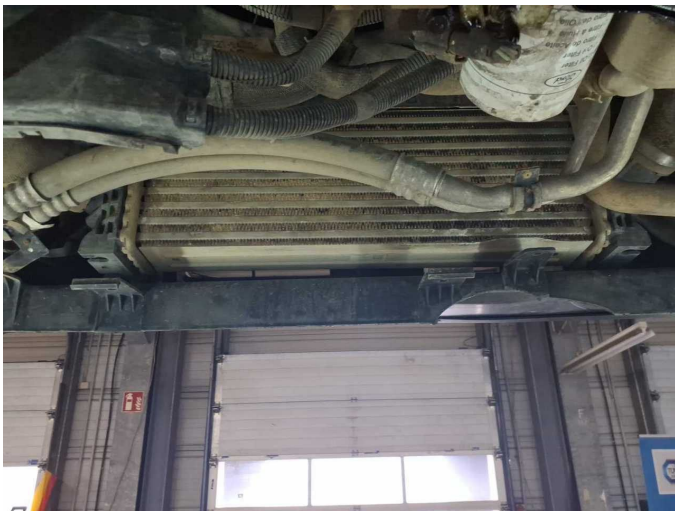
**Accident 1: Underbody**

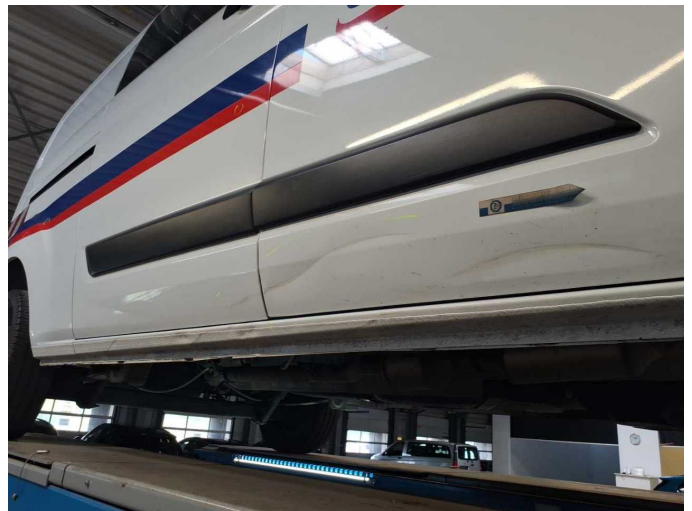
**Accident 2: Side right**

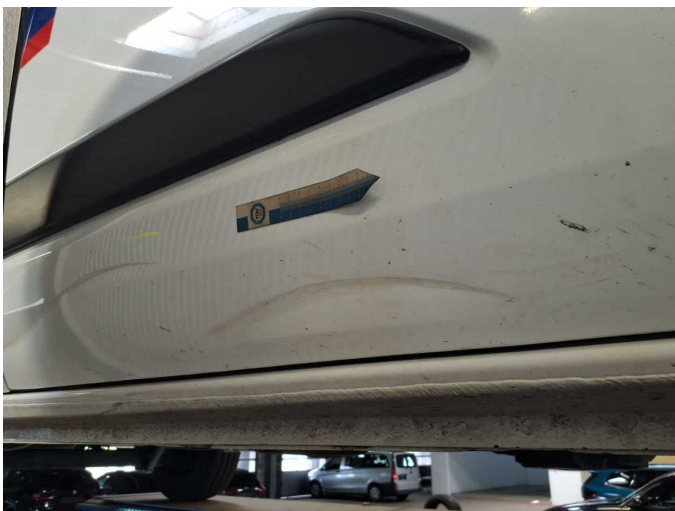
**Accident 2: Side right**

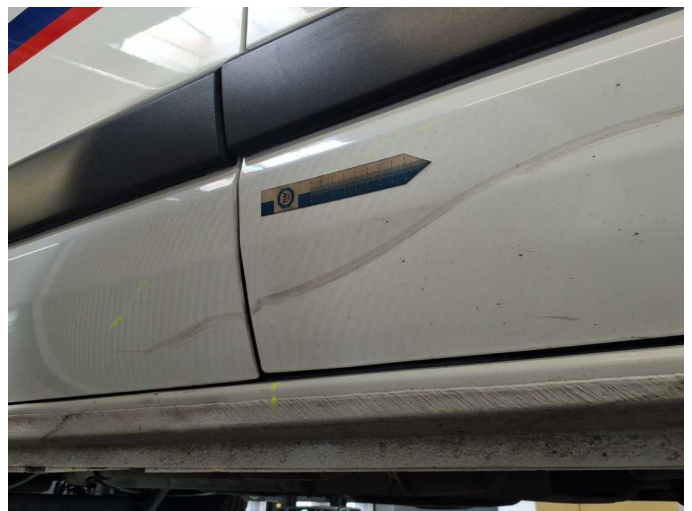
**Accident 2: Side right**

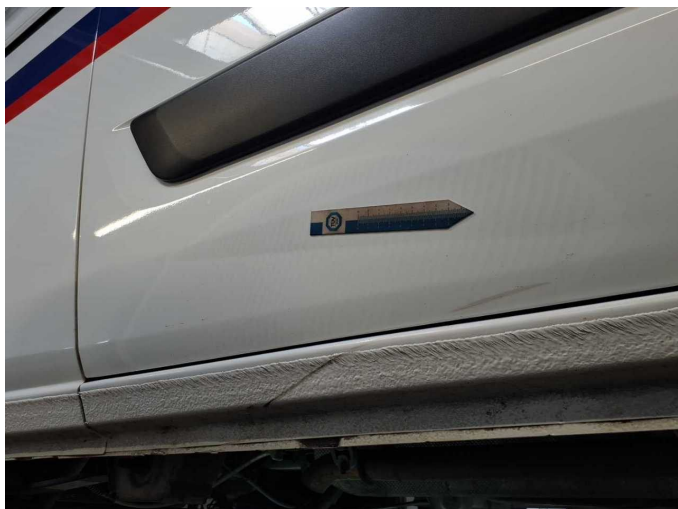
**Accident 2:** Side right

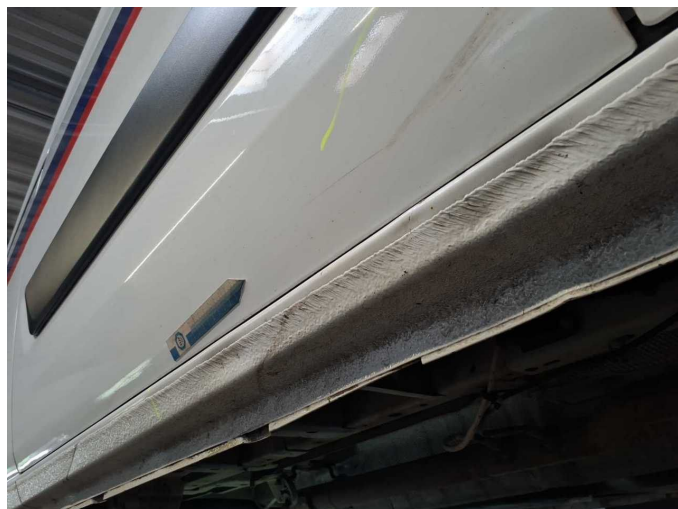
**Accident 2:** Side right

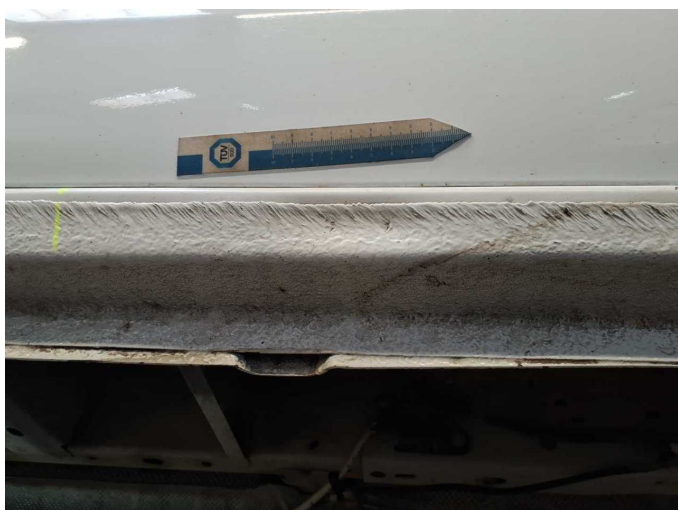
**Accident 2:** Side right
