Expertise

Protocol number: 47255778  
Order No. / Reference: 26867118  
Inspection date: 24 Aug 2026

Model: Transit Custom 320 L1H1 LKW VA Trend Kasten

VIN: WF0YXXTTGYNL14820

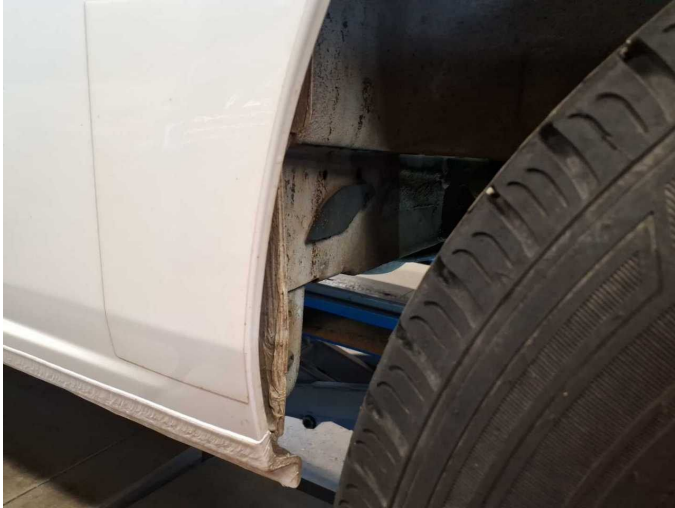
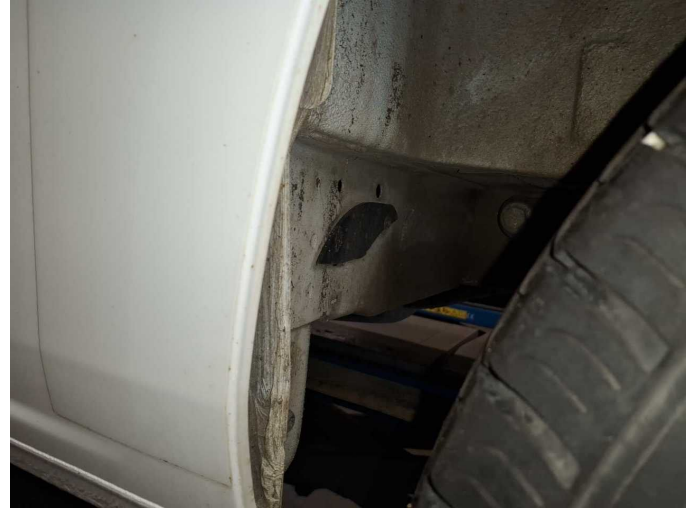
| No. | Component group | Description |
|---|---|---|
| 2 | Side panel - rear left side | Mud flap - Missing - Replace |

**Damage 2:** Side panel - rear left side: Mud flap - Missing - Replace

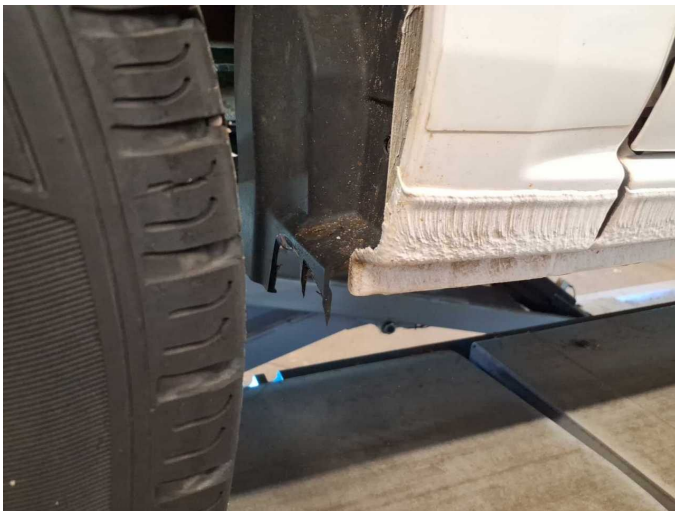
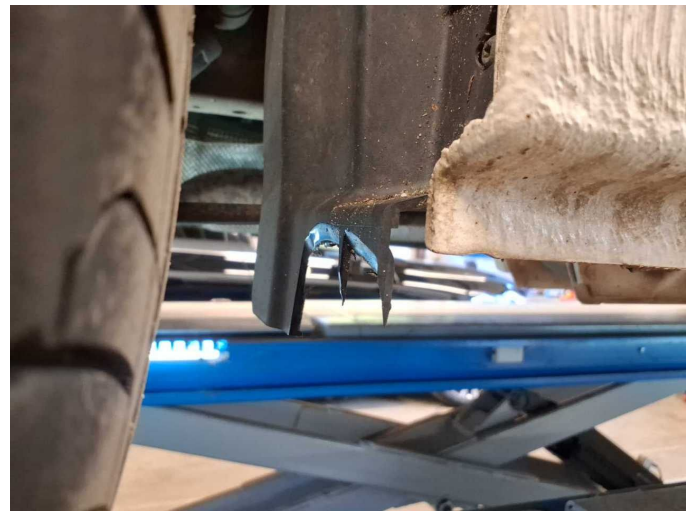
| No. | Component group | Description |
|---|---|---|
| 3 | Side panel - rear right side | Mud flap - Broken / torn - Replace |

**Damage 3:** Side panel - rear right side: Mud flap - Broken / torn - Replace

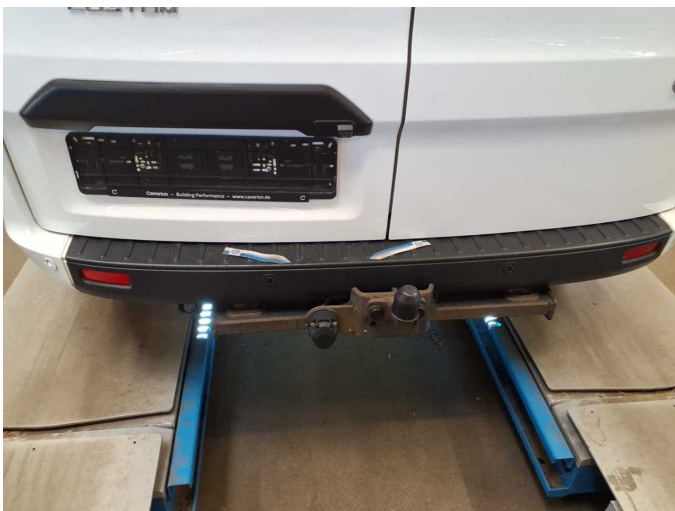
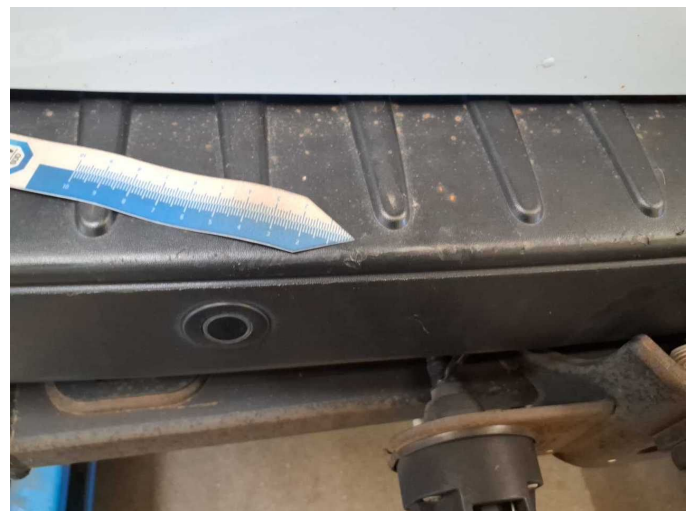
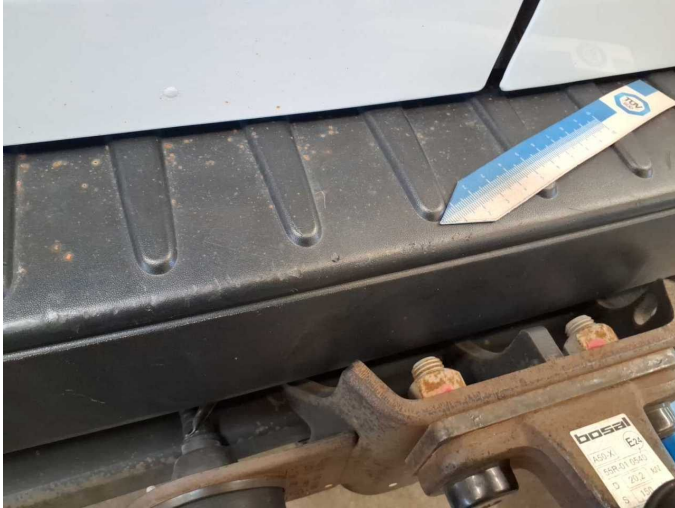
| No. | Component group | Description |
|---|---|---|
| 4 | Rear bumper | Rear bumper (unpainted) - Scratch(es) - Loss in value |

**Damage 4:** Rear bumper: Rear bumper (unpainted) - Scratch(es) - Loss in value

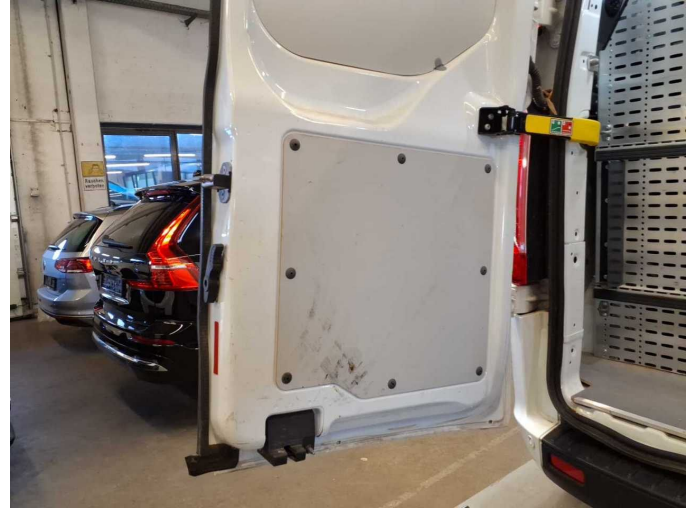
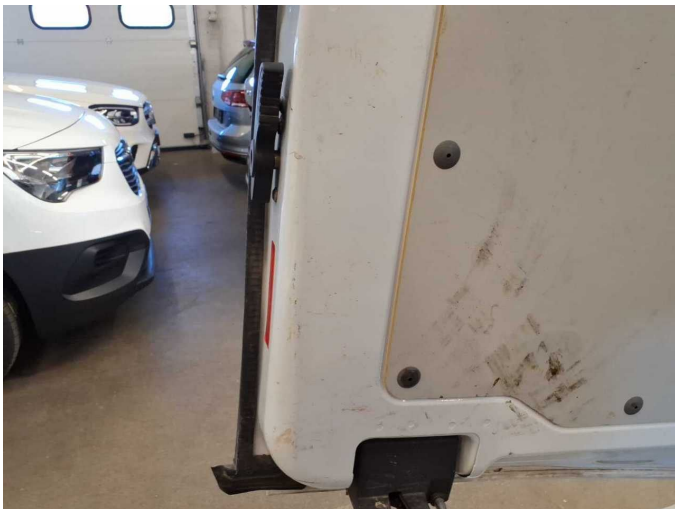
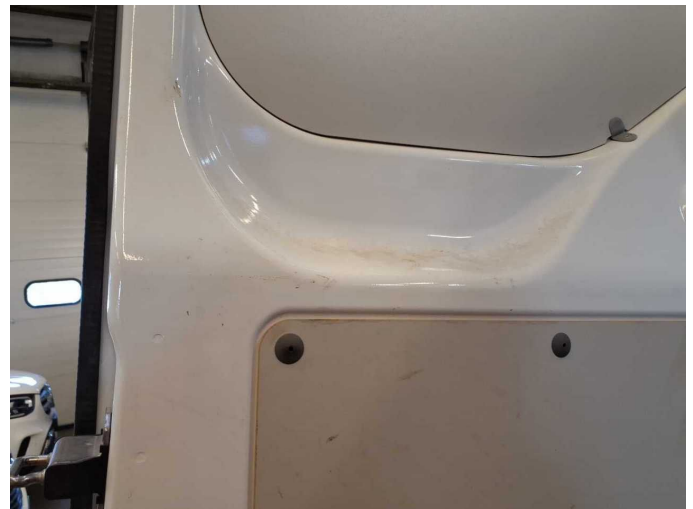
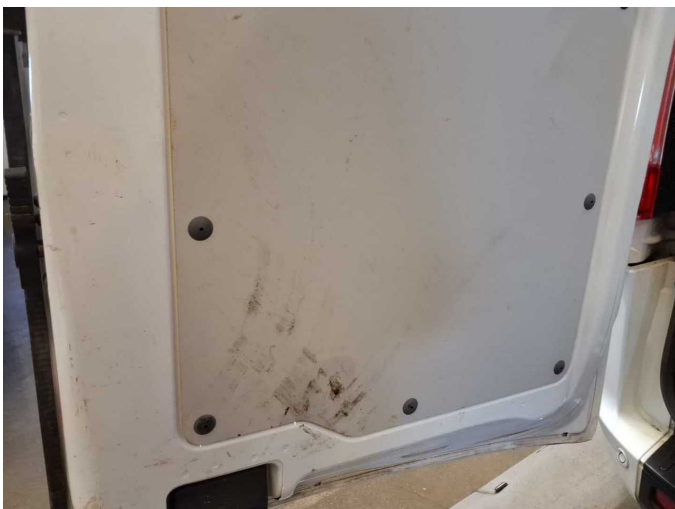
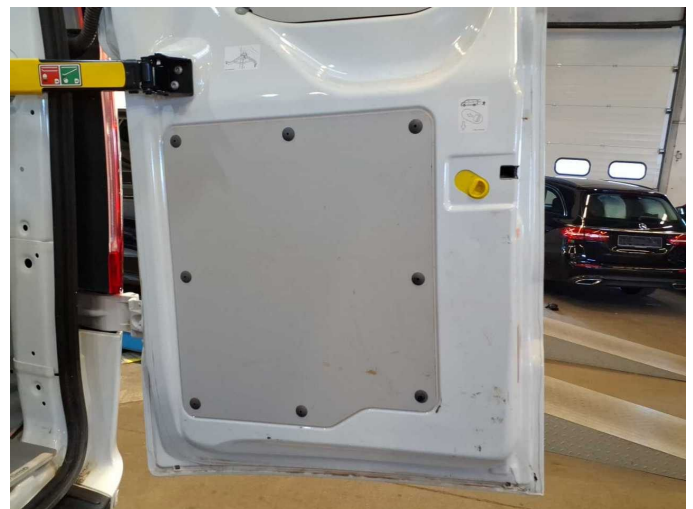
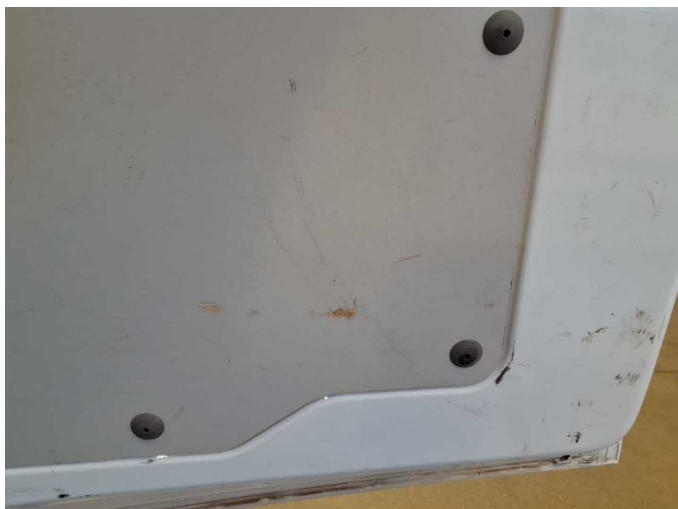
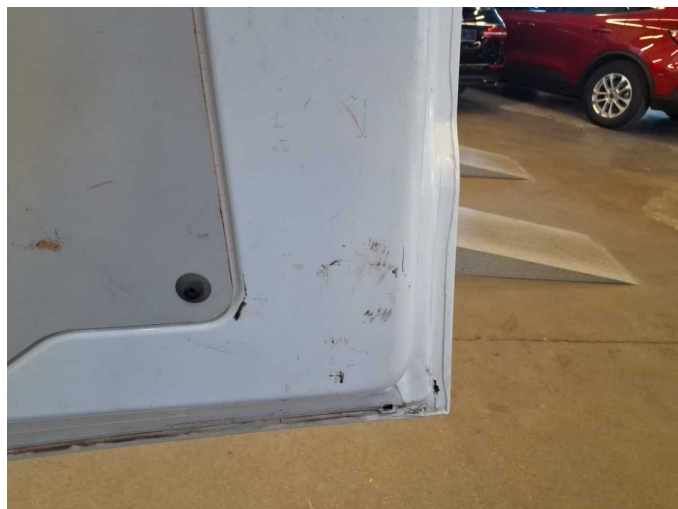
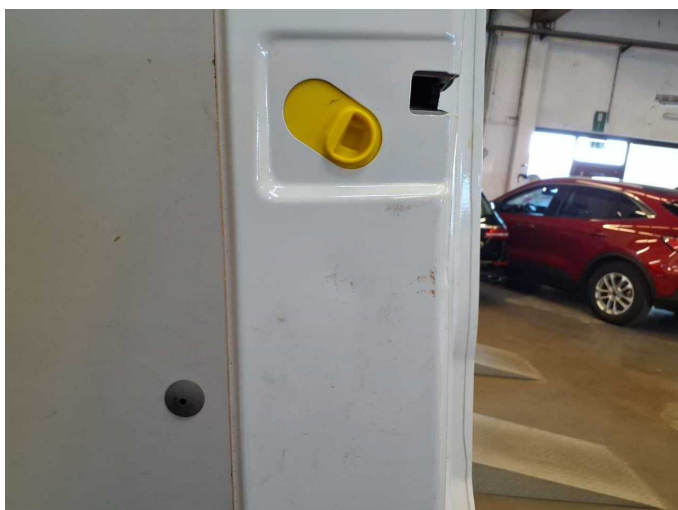
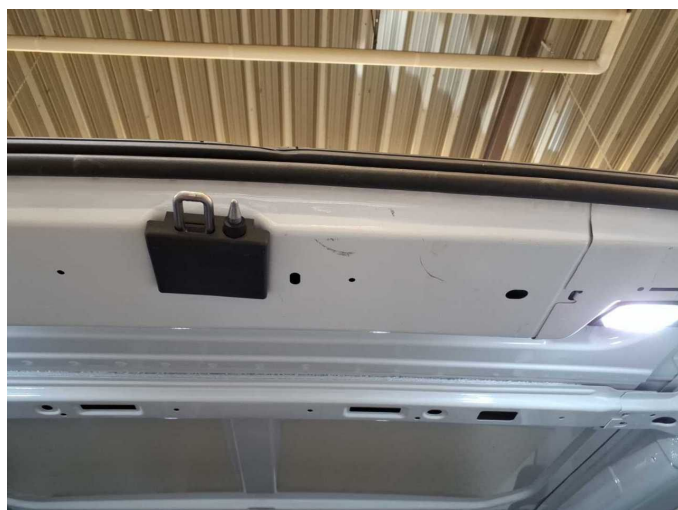
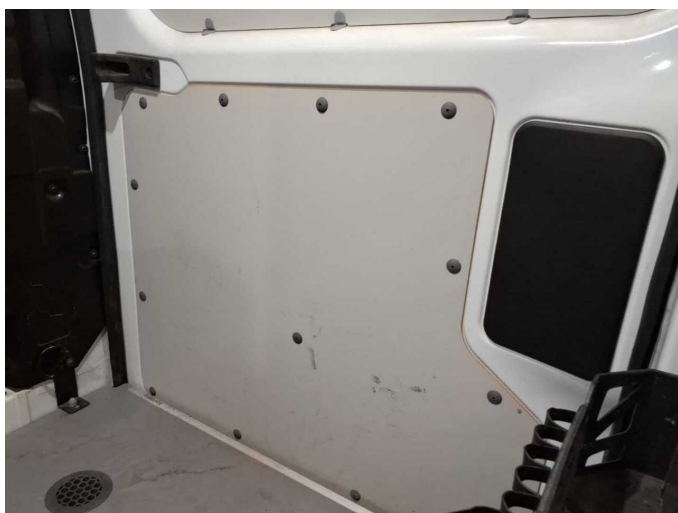
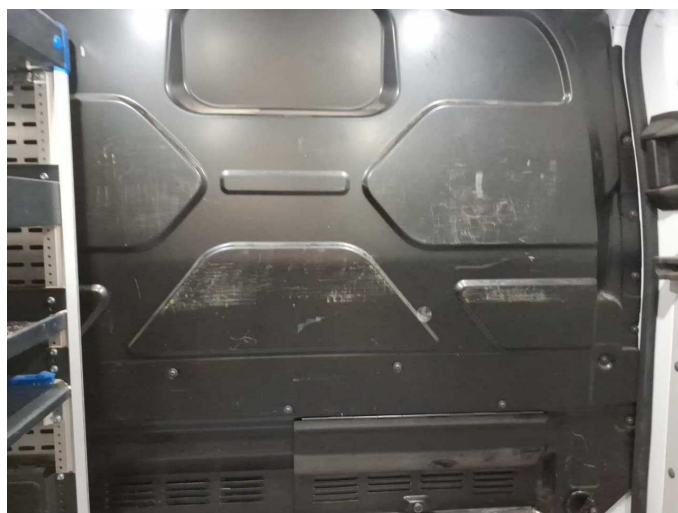
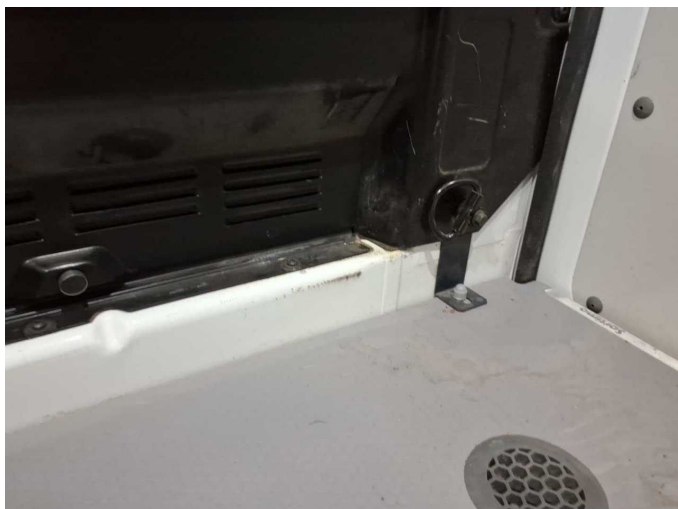
| No. | Component group | Description |
|---|---|---|
| 5 | Interior | Cargo space partition - Scratched - Loss in value |

**Damage 5:** Interior: Cargo space partition - Scratched - Loss in value

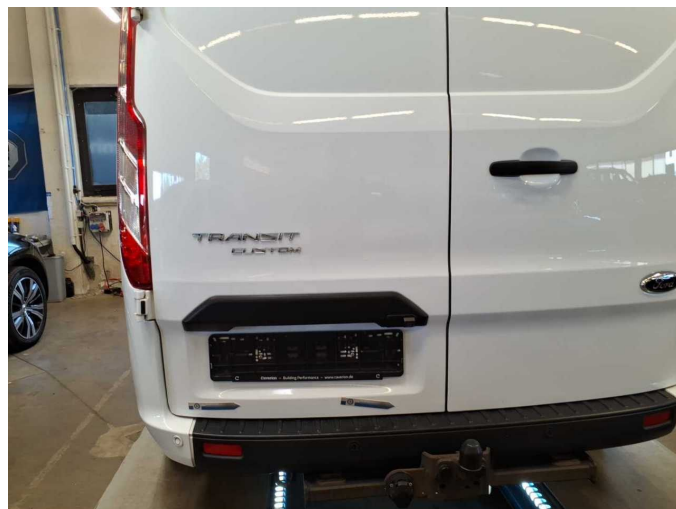
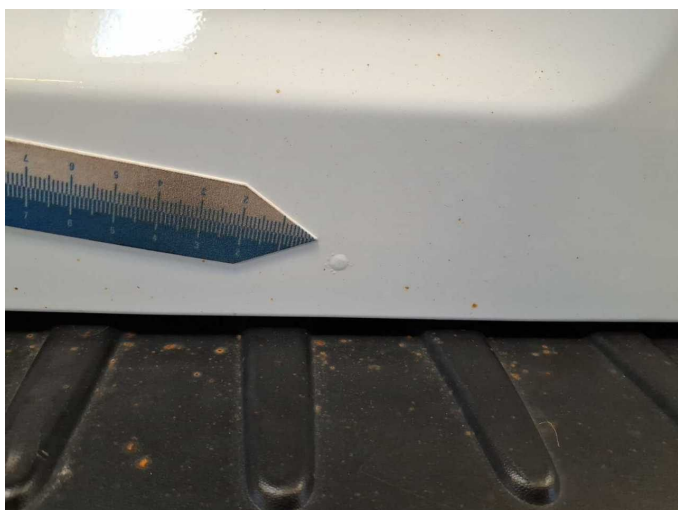
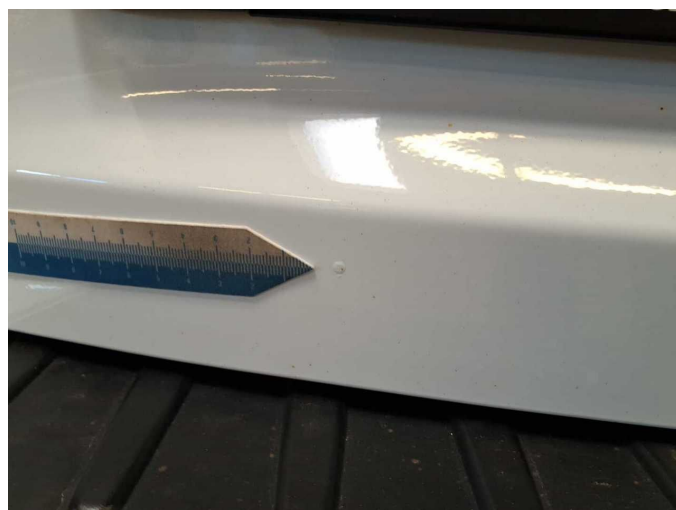
| No. | Component group | Description |
|---|---|---|
| 6 | Boot lid / rear door | Rear door - left side (Korrosion) - Paint defect - Paint |

**Damage 6:** Boot lid / rear door: Rear door - left side (Korrosion) - Paint defect - Paint

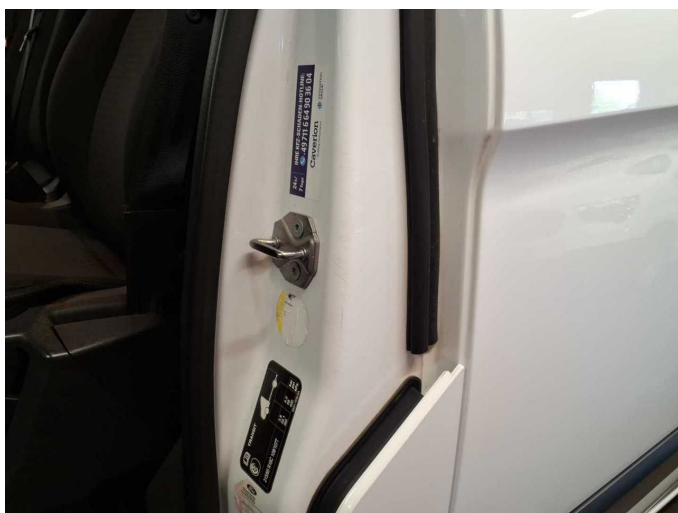
| No. | Component group | Description |
|---|---|---|
| 1 | Body | B-pillar - left side - Scratched - No deduction |

**Wear and tear 1:** Body: B-pillar - left side - Scratched - No deduction

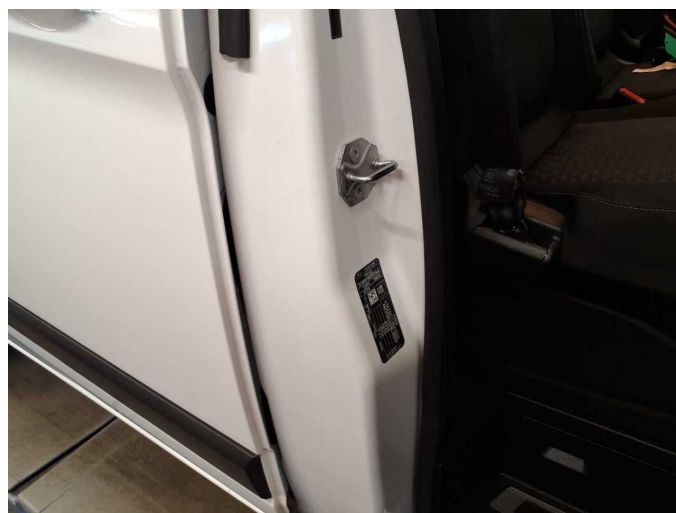
| No. | Component group | Description |
|---|---|---|
| 3 | Body | B-pillar - right side - Scratched - No deduction |

**Wear and tear 3:** Body: B-pillar - right side - Scratched - No deduction

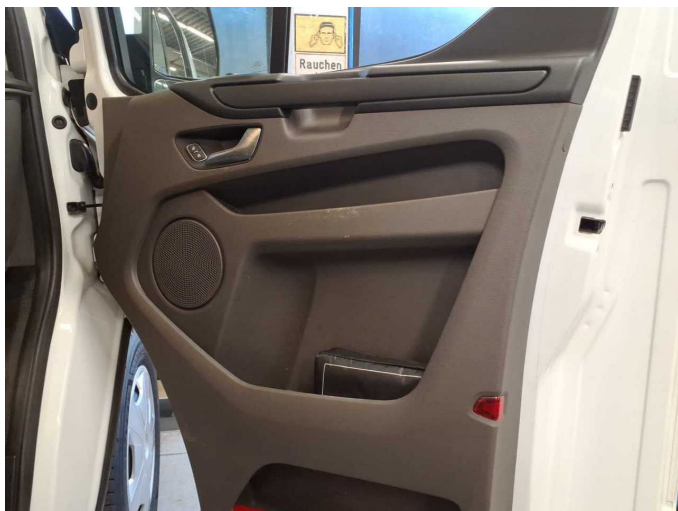
| No. | Component group | Description |
|---|---|---|
| 4 | Trim / covers | Door trim - front right side - Scratched - No deduction |

**Wear and tear 4:** Trim / covers: Door trim - front right side - Scratched -  
No deduction

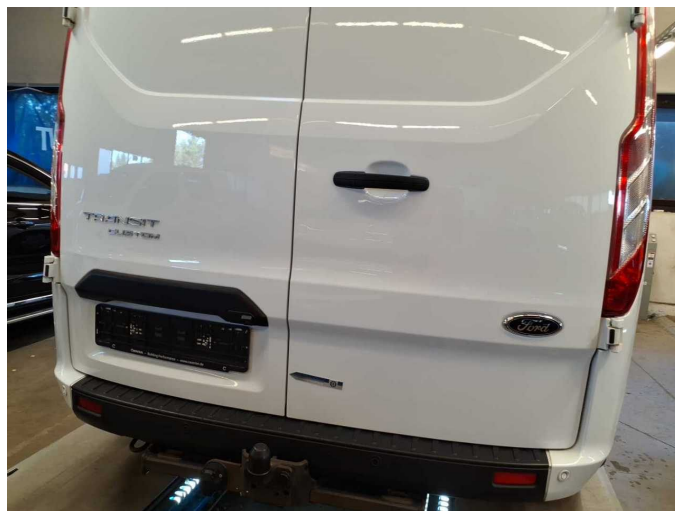
| No. | Component group | Description |
|---|---|---|
| 5 | Boot lid / rear door | Rear door - right side - Scratch(es) - No deduction |

**Wear and tear 5:** Boot lid / rear door: Rear door - right side - Scratch(es)  
- No deduction

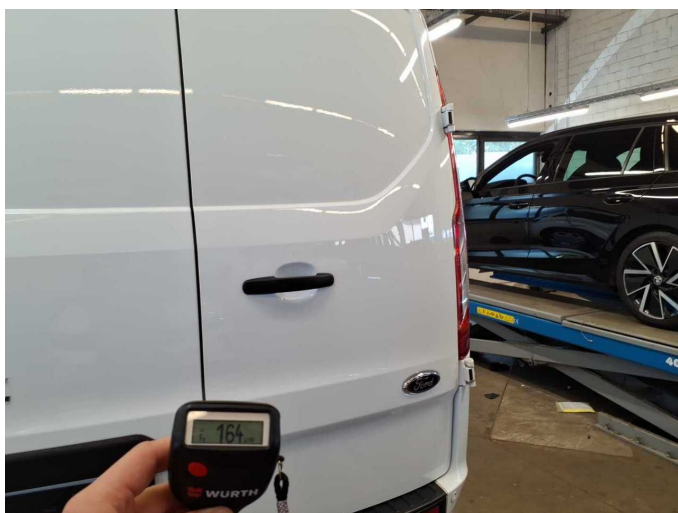
**Repainting 1:** Boot lid / rear door

| No. | Repainting |
|---|---|
| 1 | Boot lid / rear door, Professionally carried out, Invoice of repair done Non-existent |
