Expertise

Protocol number: 46365327
Order No. / Reference: 26571247-1
Inspection date: 25 Jun 2026

Manufacturer: Opel

Model: Insignia Sports Tourer 2.0 Diesel Aut. Elegance

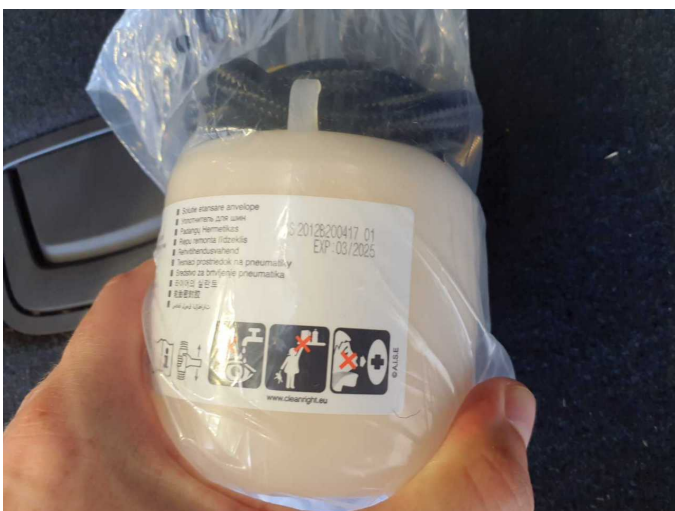
Damage 1: Equipment: Tirefit filler - Expired - Replace

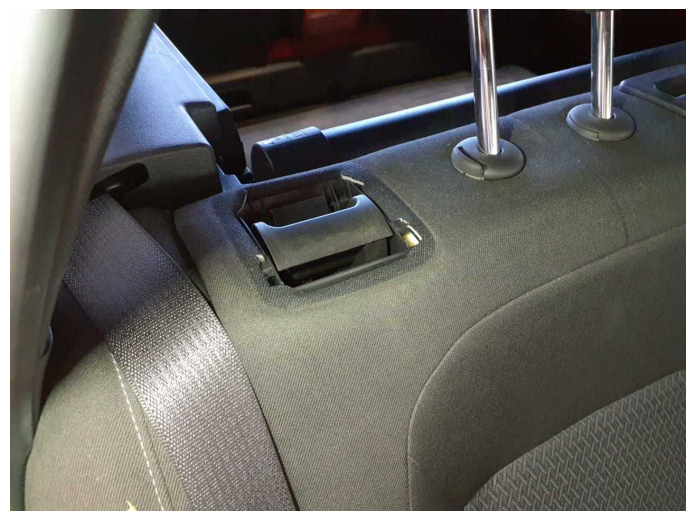
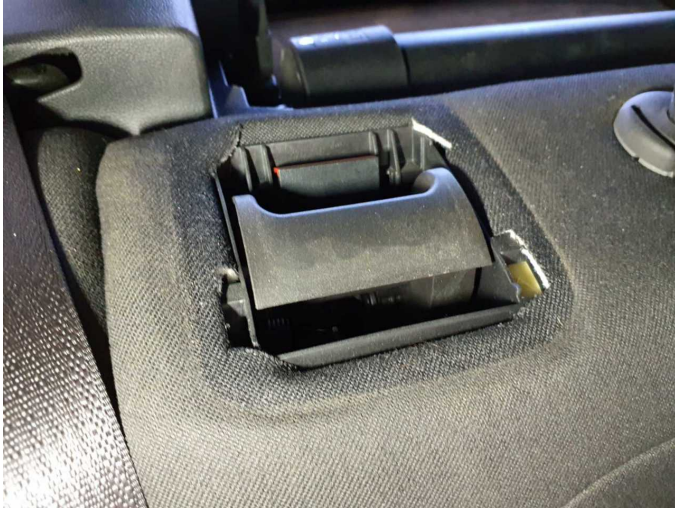
Damage 2: Seat - rear: Lever seat adjustment - Broken / torn - Replace

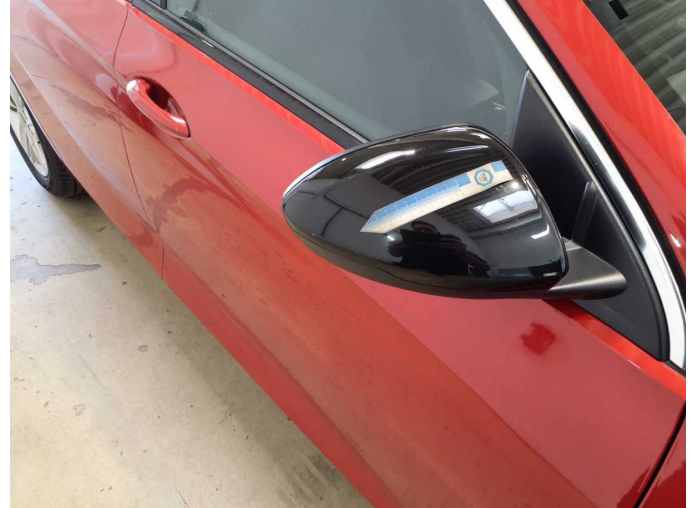
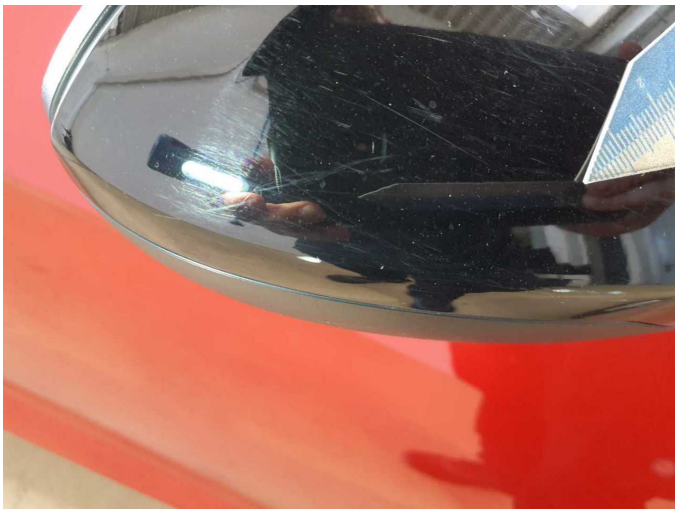
Damage 3: Wing mirror - right side: Cap - Scratch(es) - Smart repair

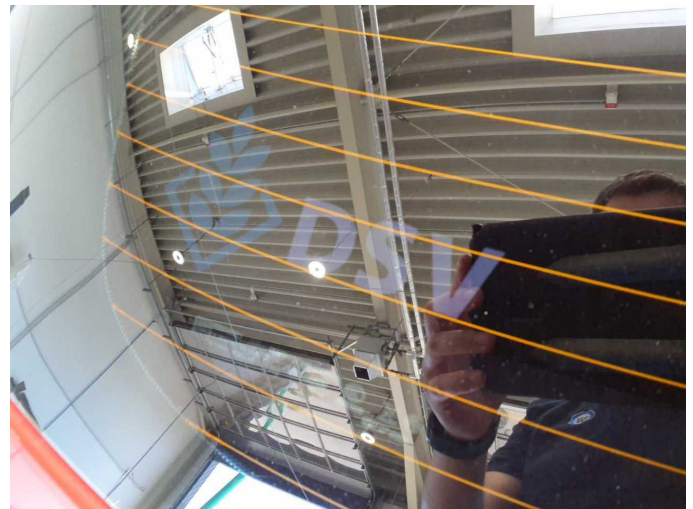
Damage 4: Vehicle glazing: Rear window - Glued / labelled - De-glove / neutralise

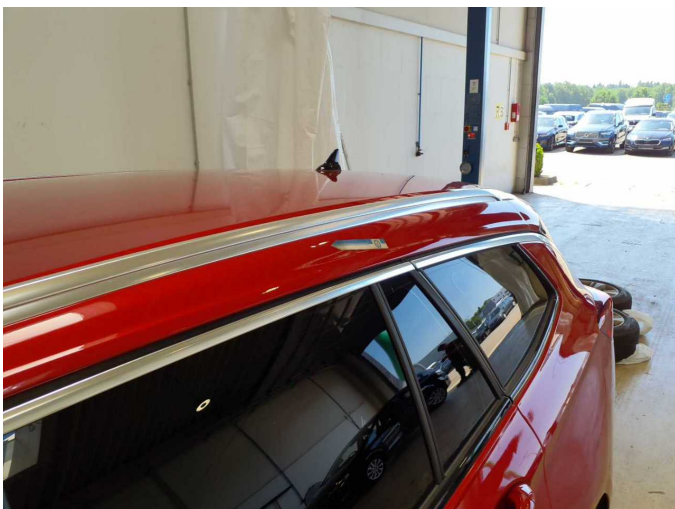
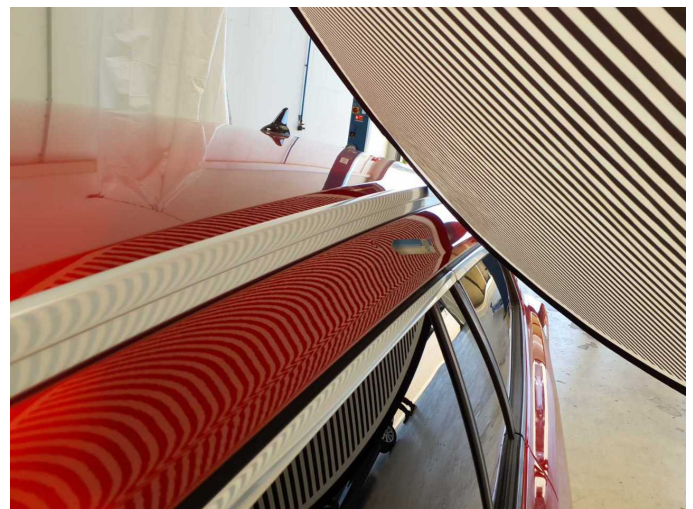
Damage 5: Roof: Roof rail - left side - dent(s) - Smooth repair work

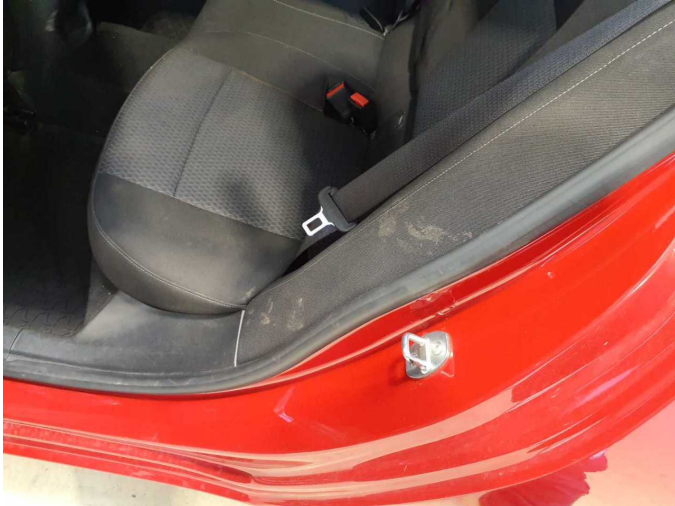
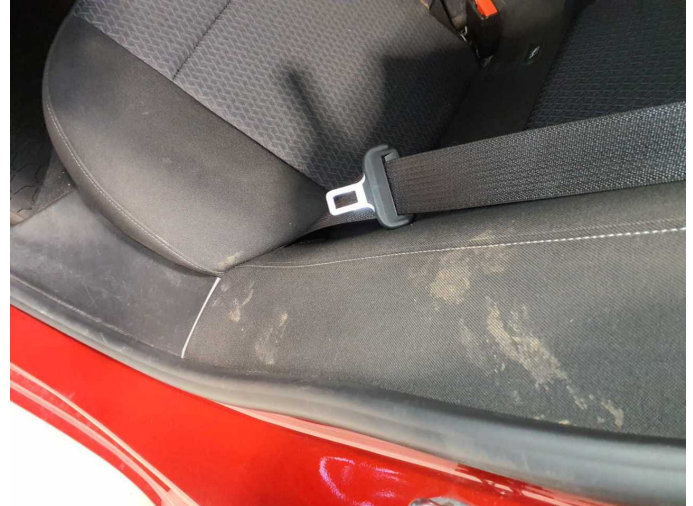
Damage 6: Seat - rear: Upholstery - Soiled - Clean

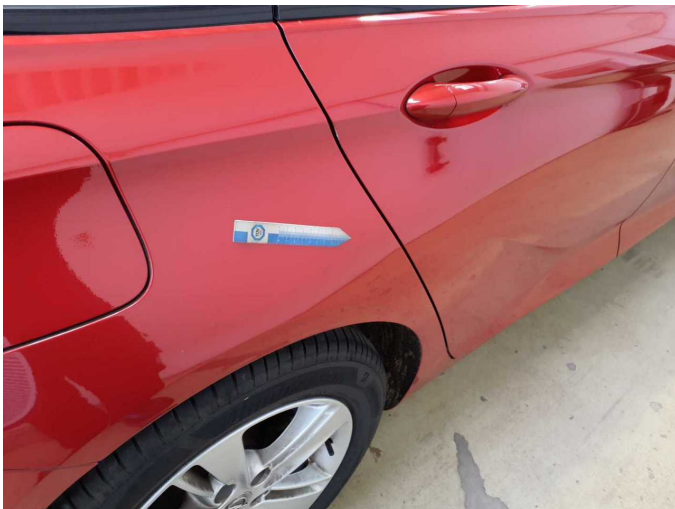
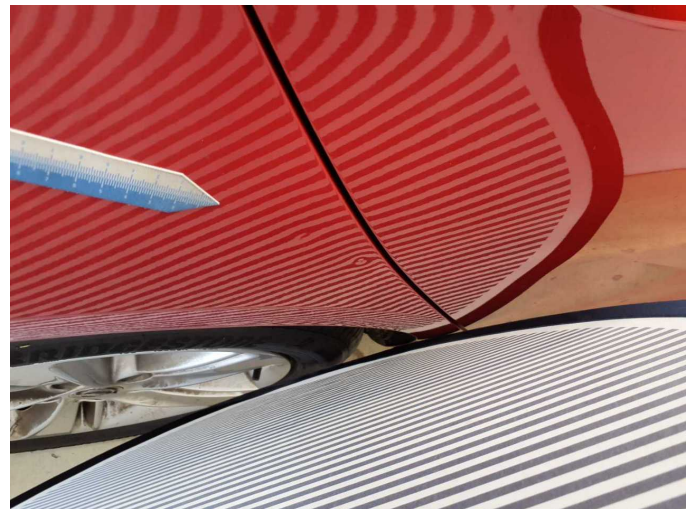
Damage 7: Side panel - rear right side: Side panel - dent(s) - Smooth repair work

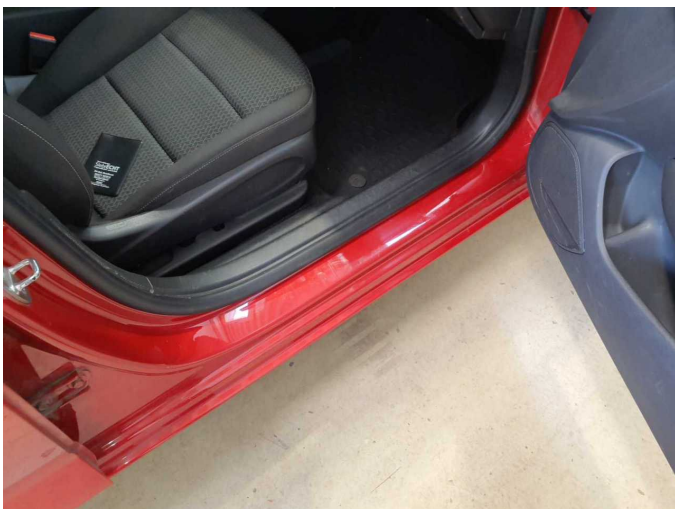
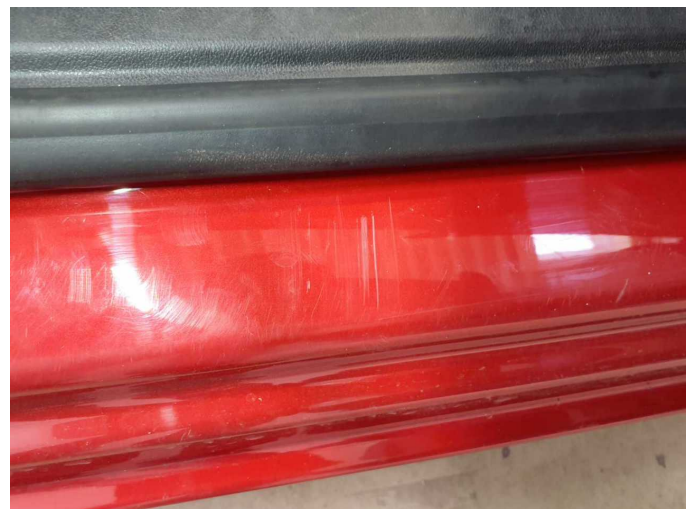
Damage 8: Sill - right side: Sill - Scratch(es) - Smart repair

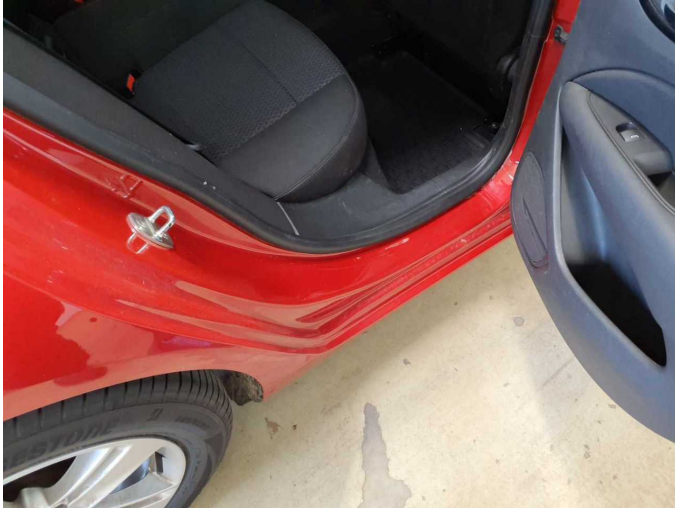
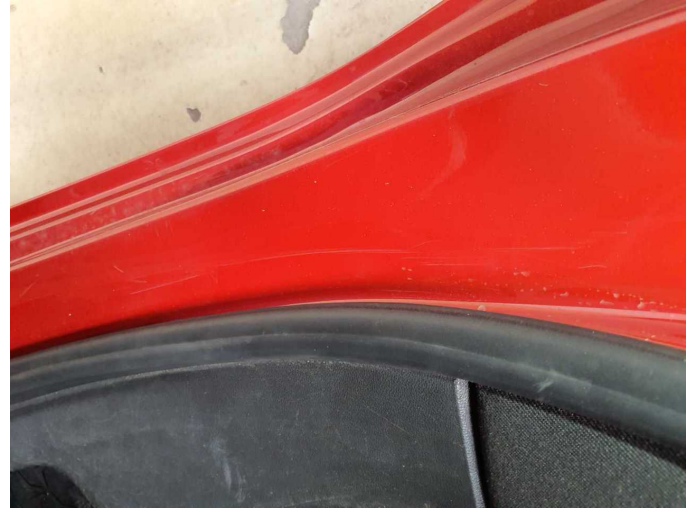
Damage 9: Side panel - rear right side: Sill - Scratch(es) - Smart repair

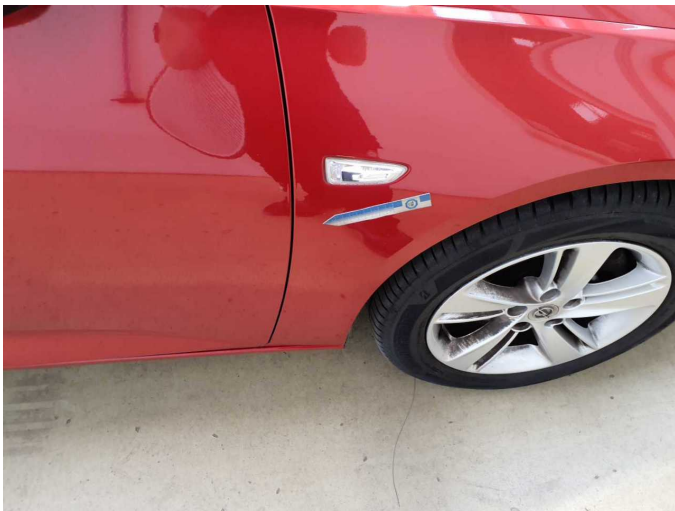
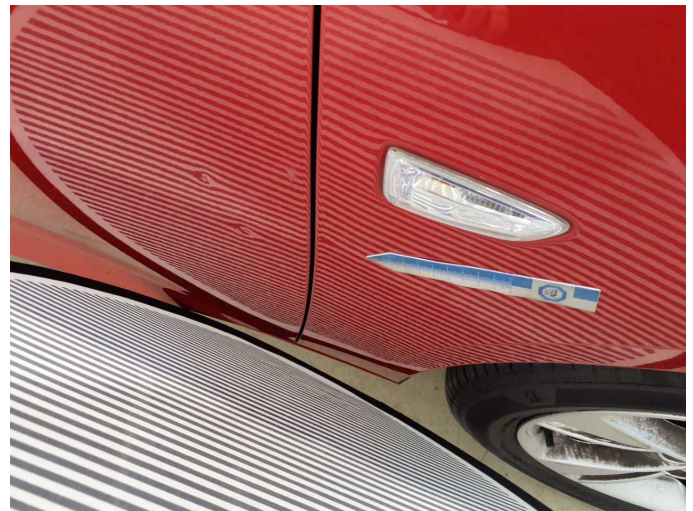
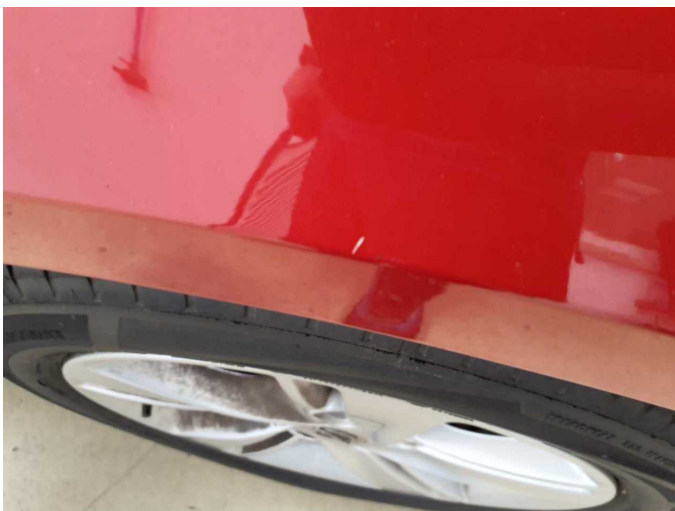
Damage 10: Mudguard - right side: Mudguard - right side - Dent / paintcoat damage - Smart repair

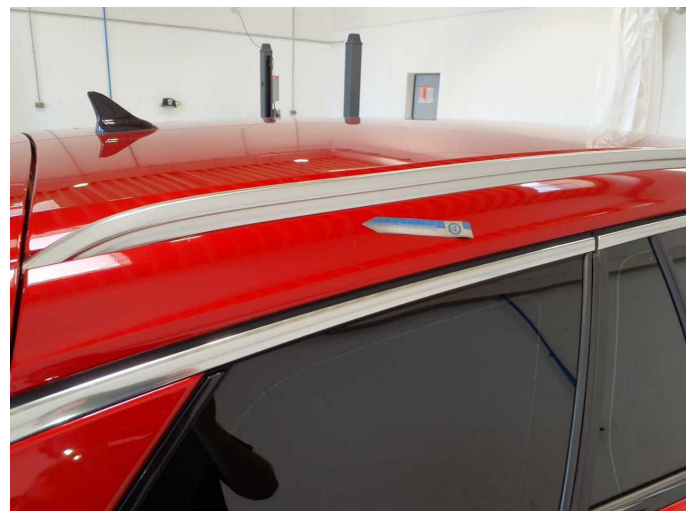
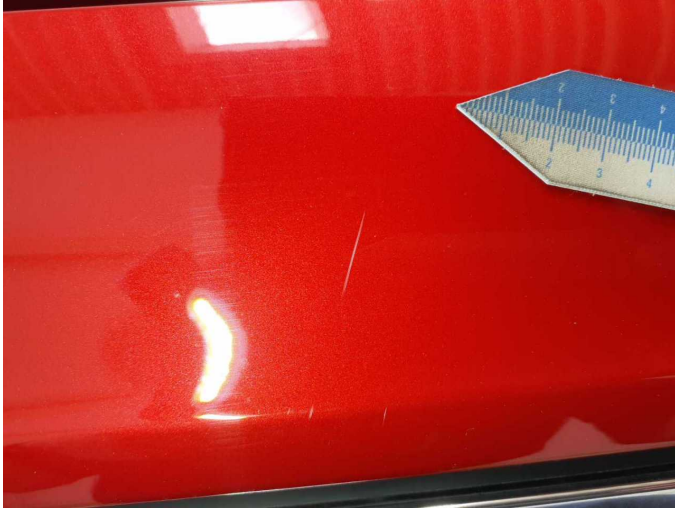
Damage 11: Roof: Roof rail - right side - Scratch(es) - Smart repair

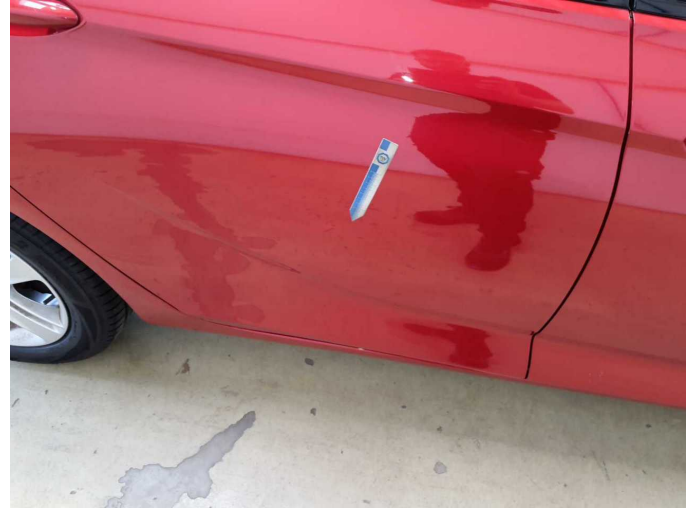
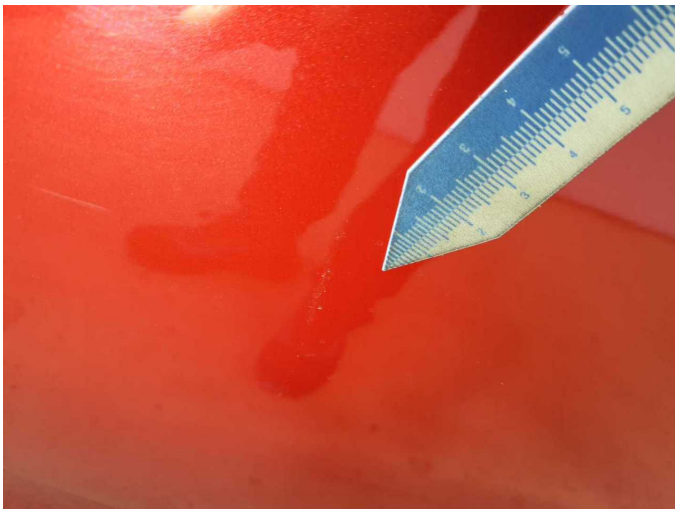
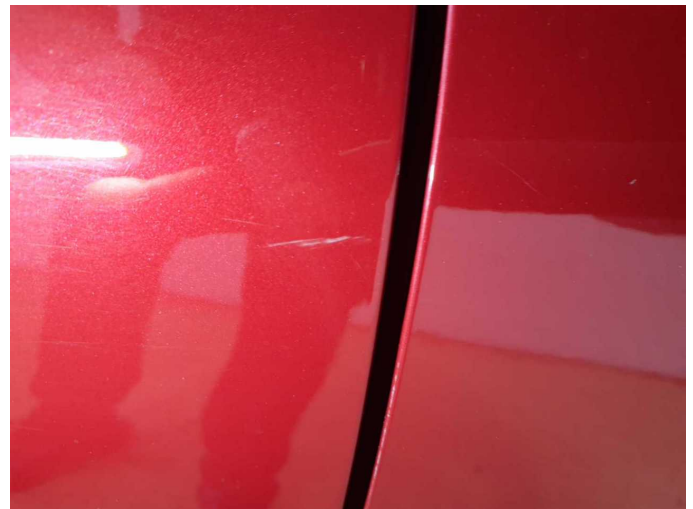
Damage 12: Door - rear right side: Door - Scratch(es) - Loss in value

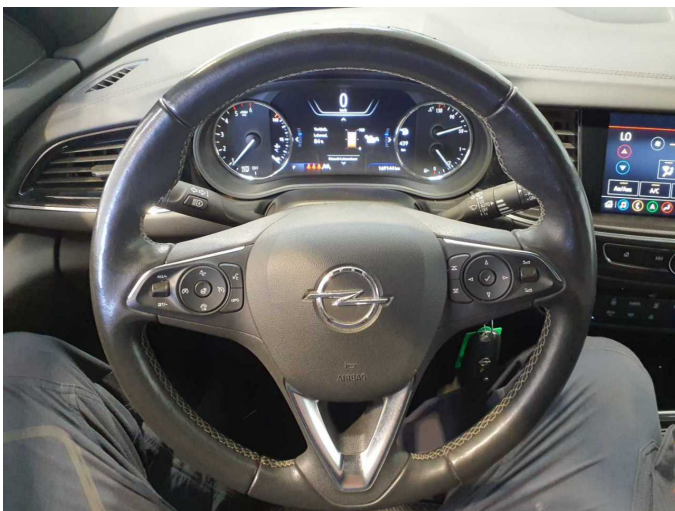
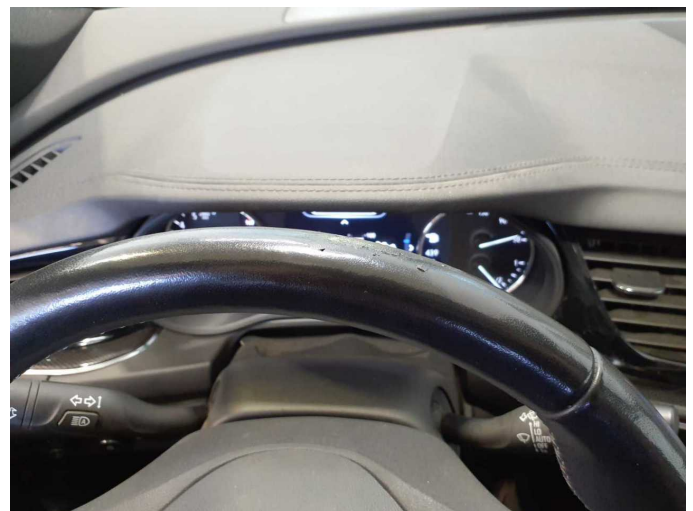
Damage 13: Steering system: Steering wheel - Scratch(es) - Loss in value

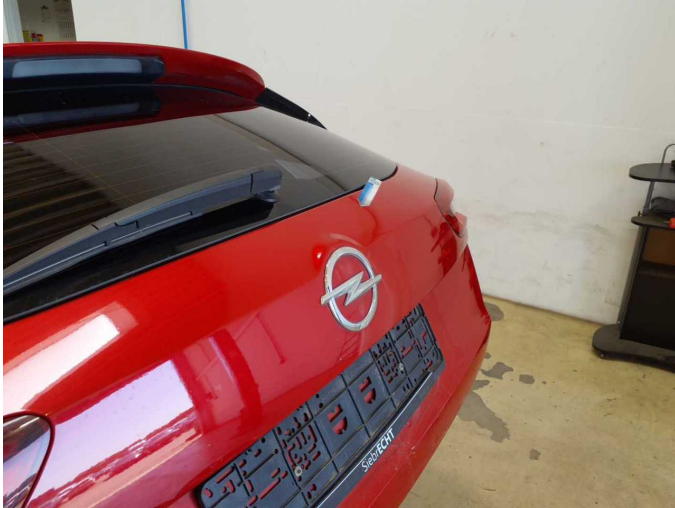
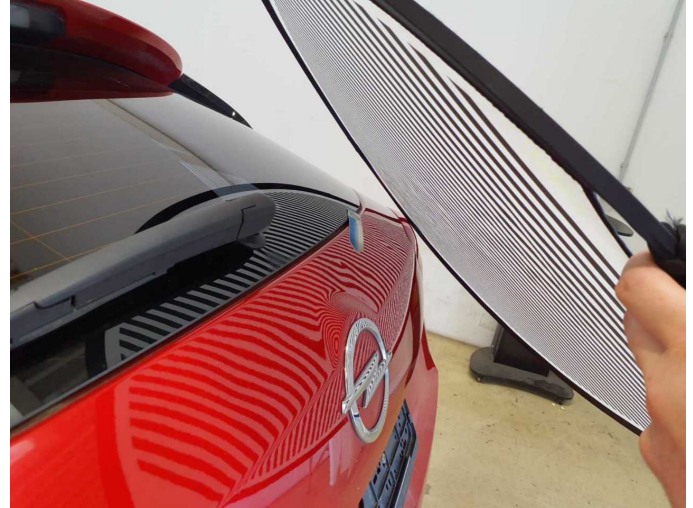
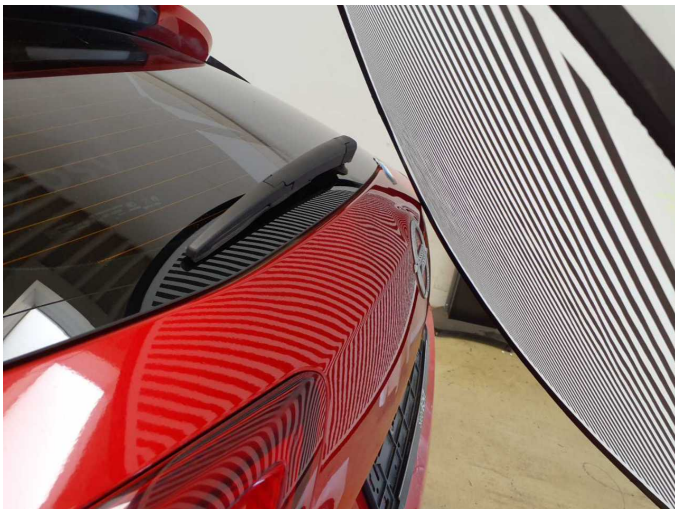
Damage 14: Boot lid / rear door: Boot lid - dent(s) - Smooth repair work

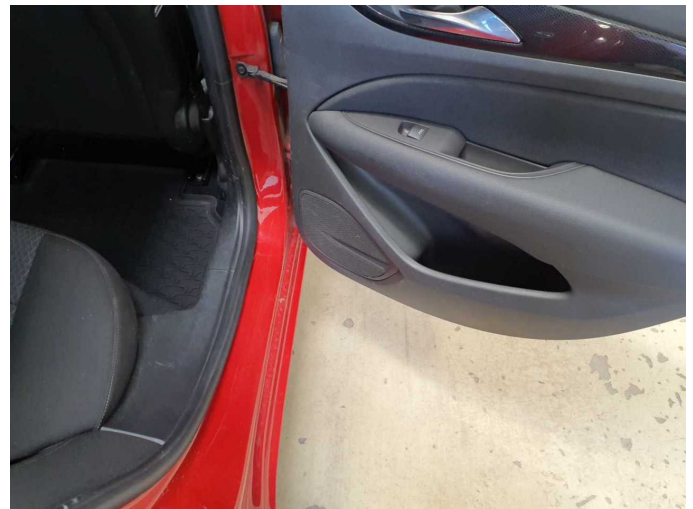
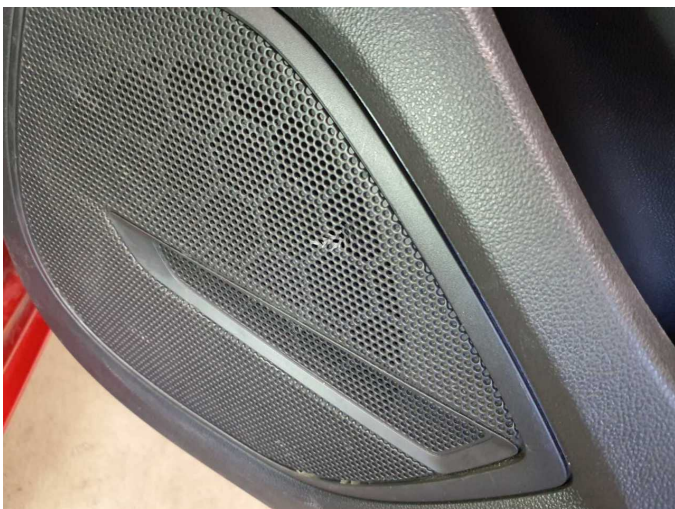
Damage 15: Trim / covers: Door trim - rear right side - Broken / torn - Replace

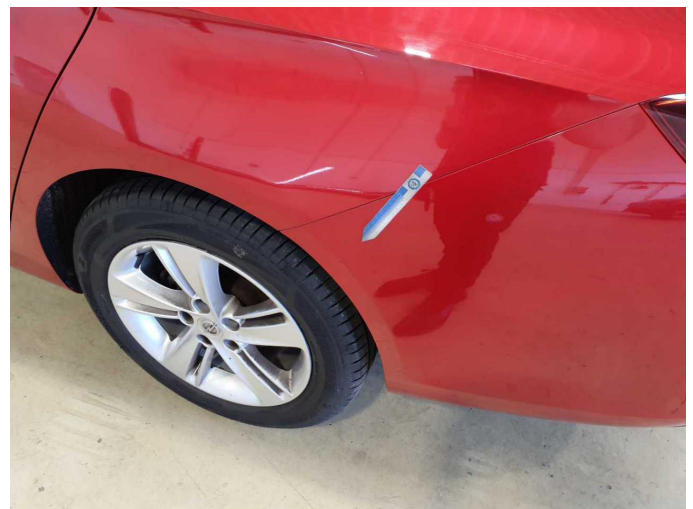
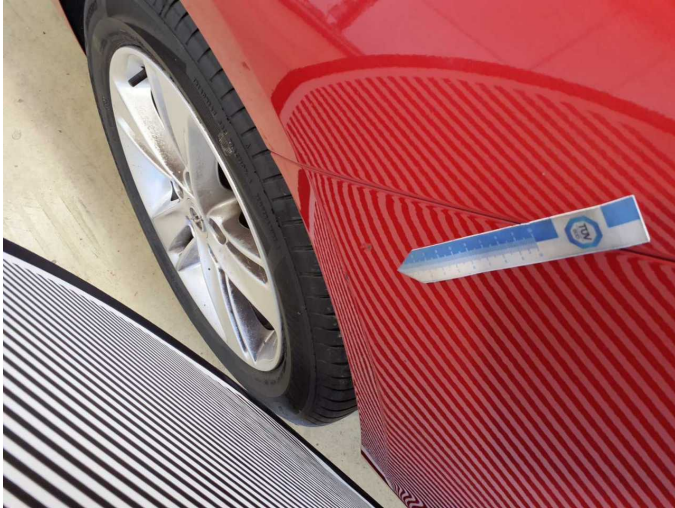
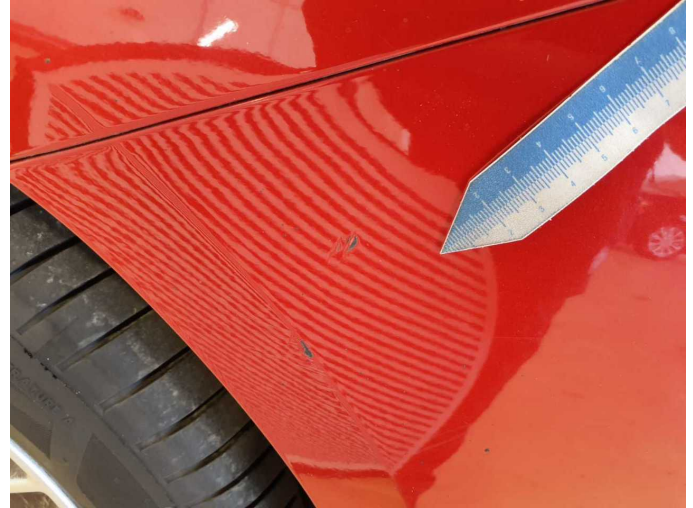
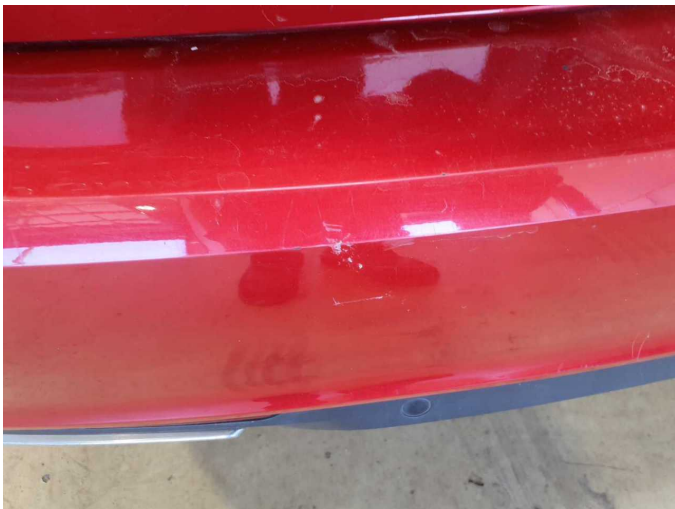
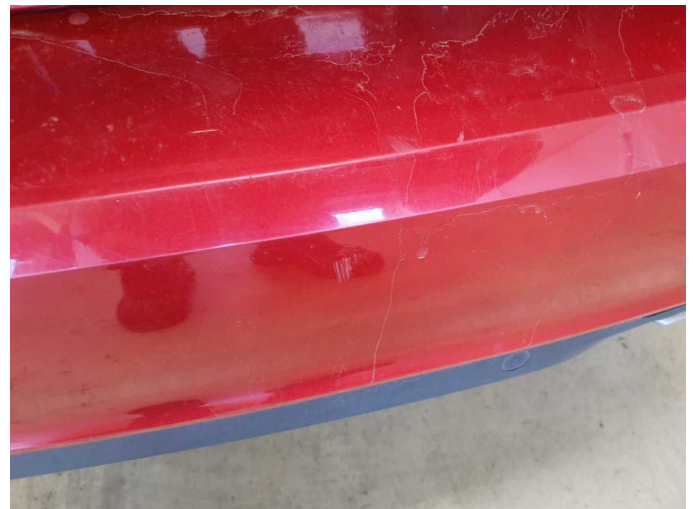
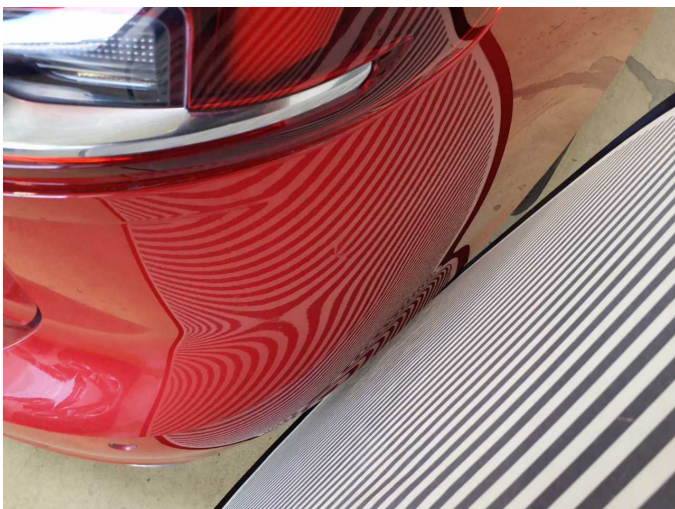
Damage 16: Rear bumper: Rear bumper - Dent / paintcoat damage - Repair and paint

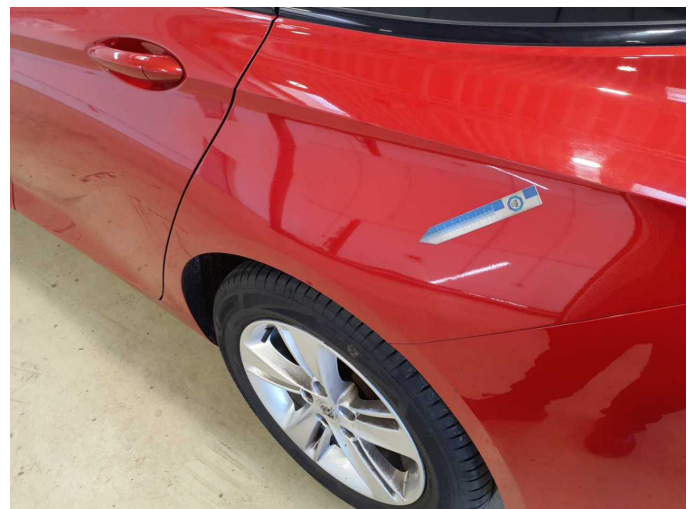
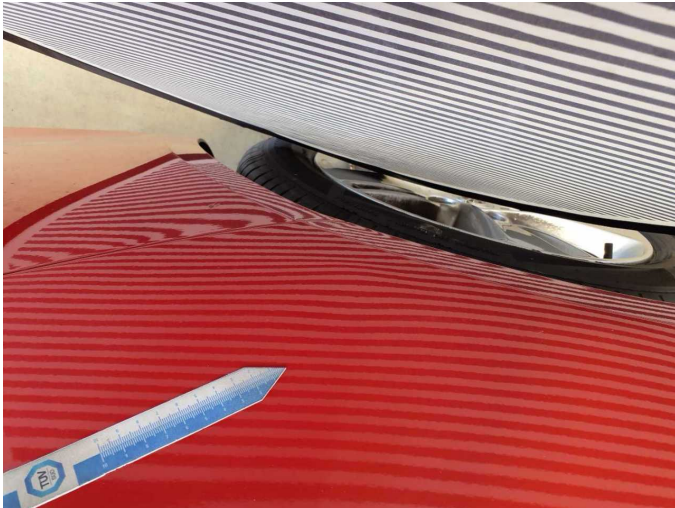
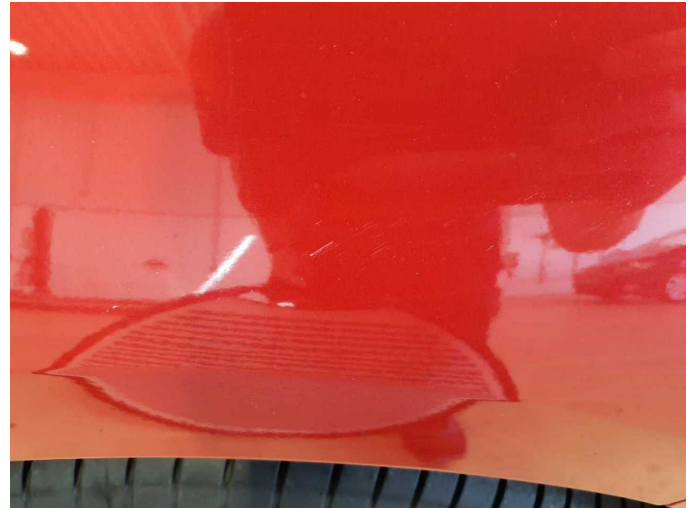
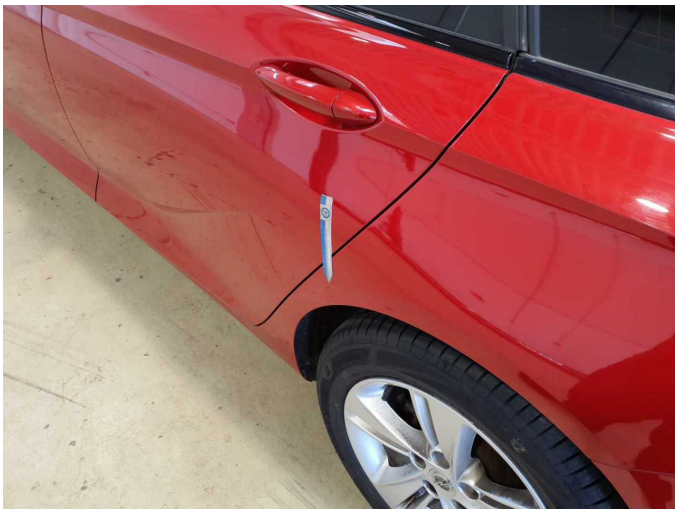
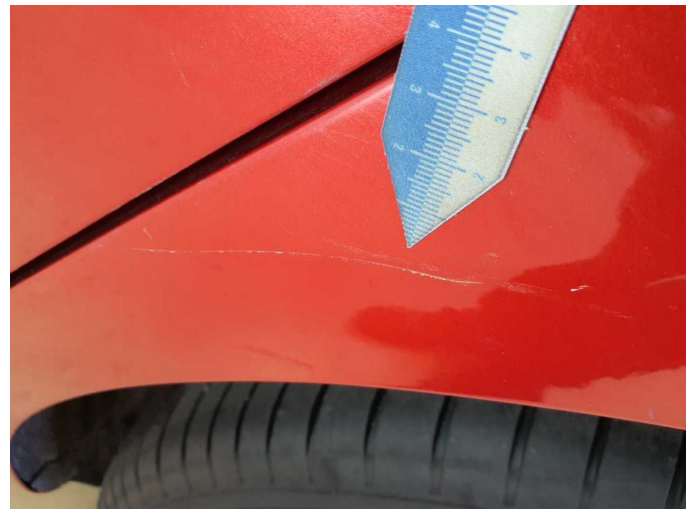
Damage 17: Side panel - rear left side: Side panel - Dent / paintcoat damage - Repair and paint

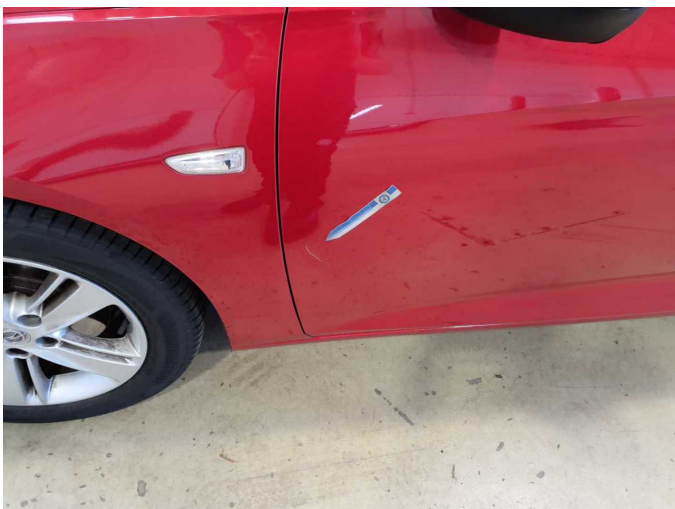
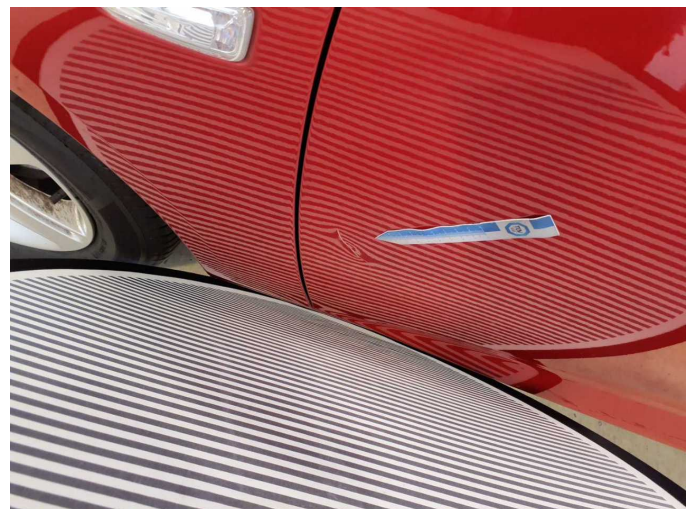
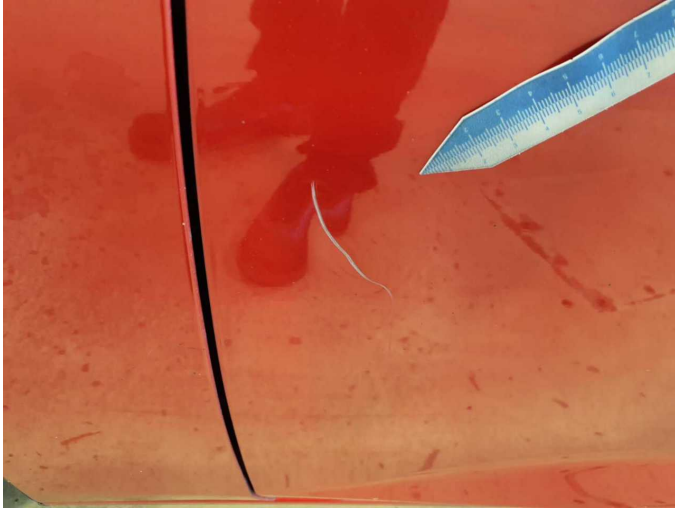
Damage 18: Door - front left side: Door - Dent / paintcoat damage - Repair and paint

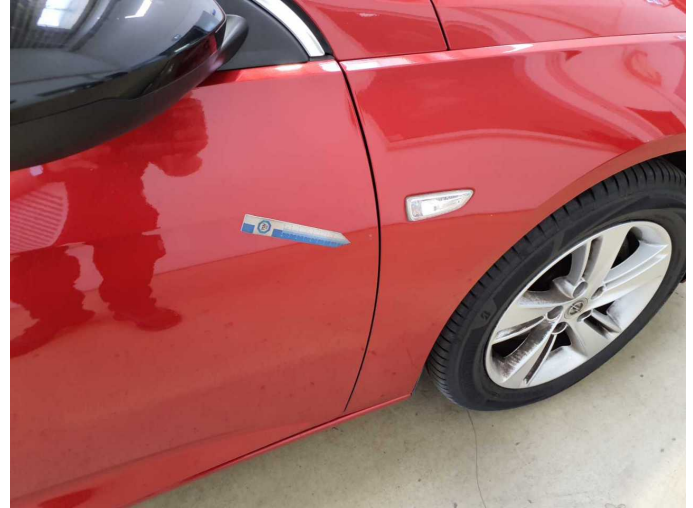
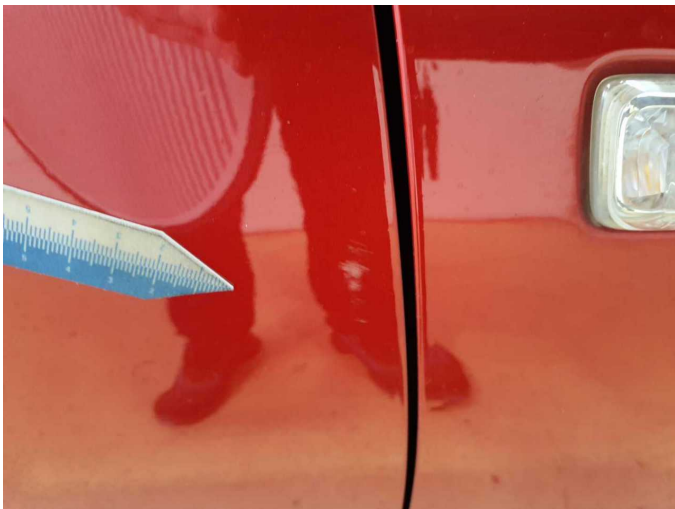
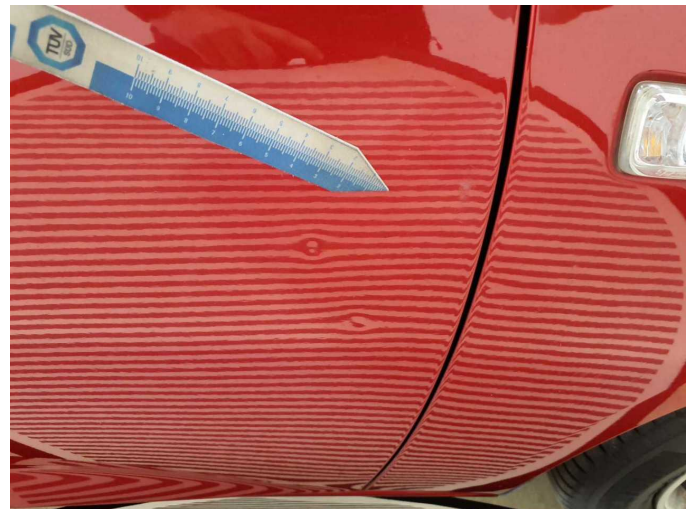
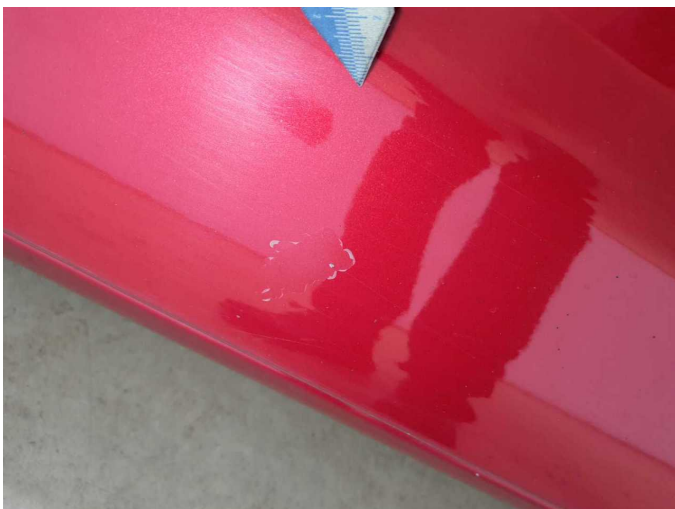
Damage 19: Door - front right side: Door - Dent / paintcoat damage - Repair and paint

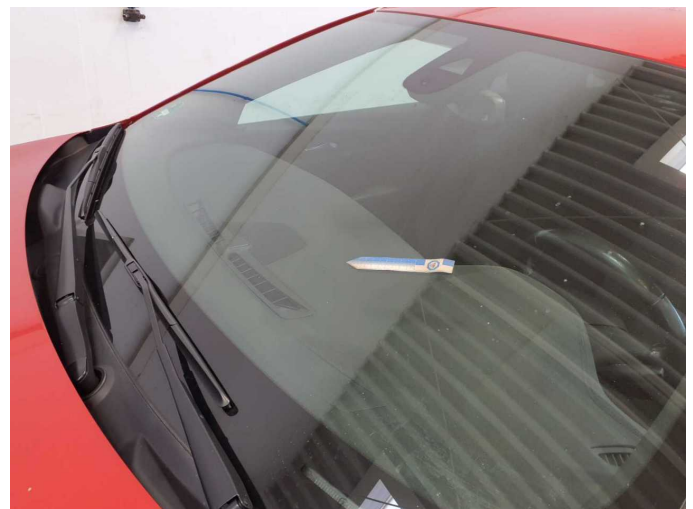
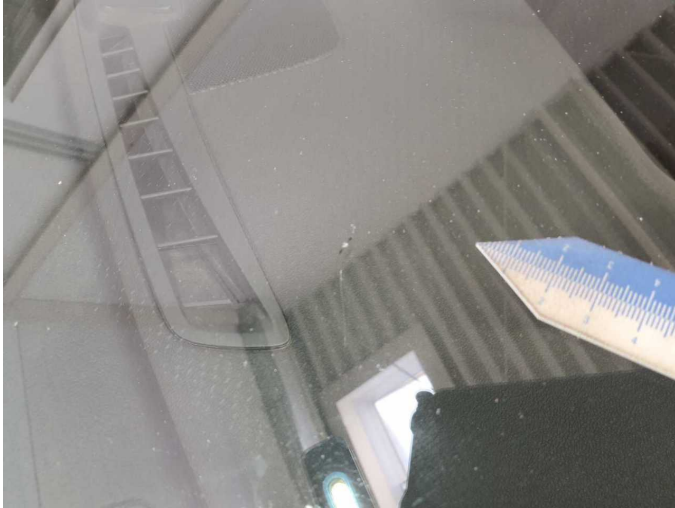
Damage 20: Vehicle glazing: Windscreen - Broken / torn - Replace

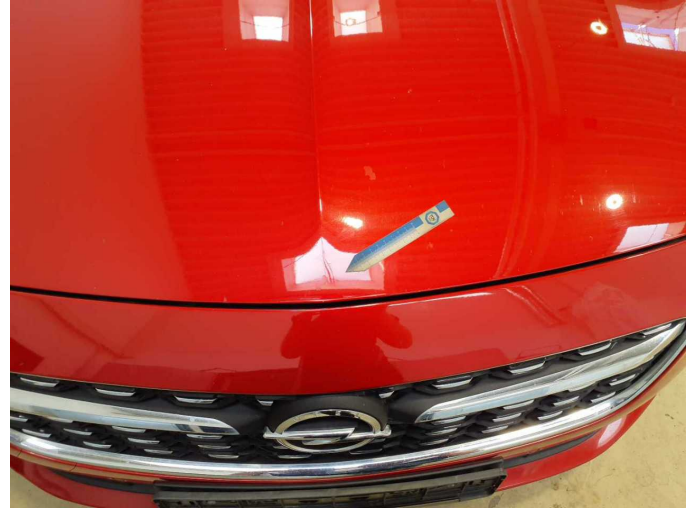
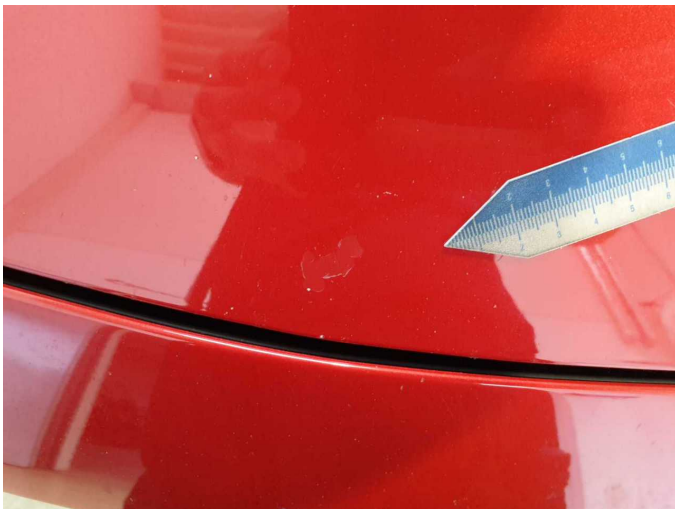
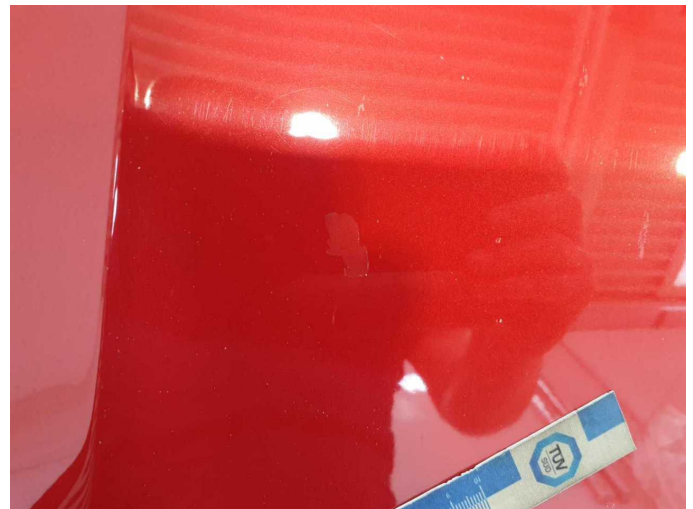
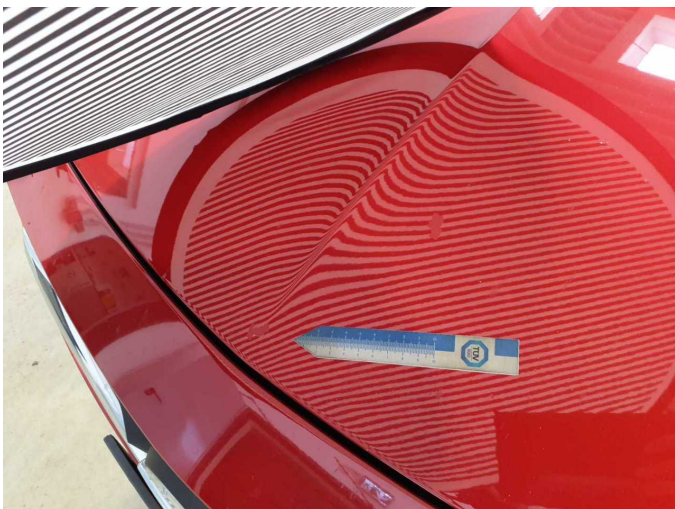
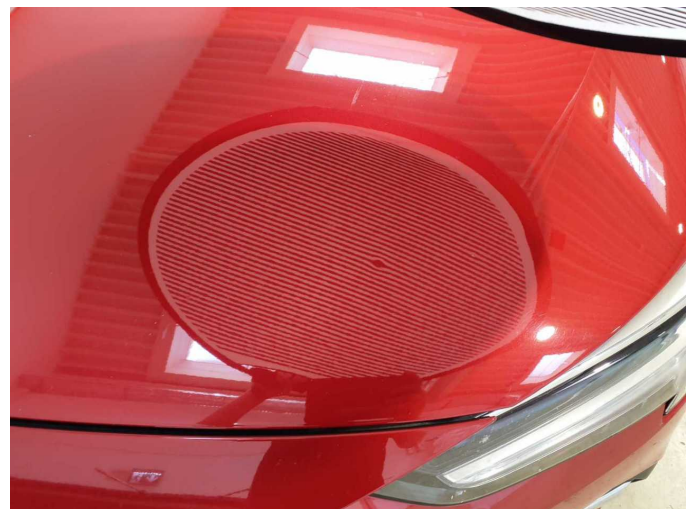
Damage 21: Bonnet: Bonnet (Lack löst sich) - Paint defect - Repair and paint

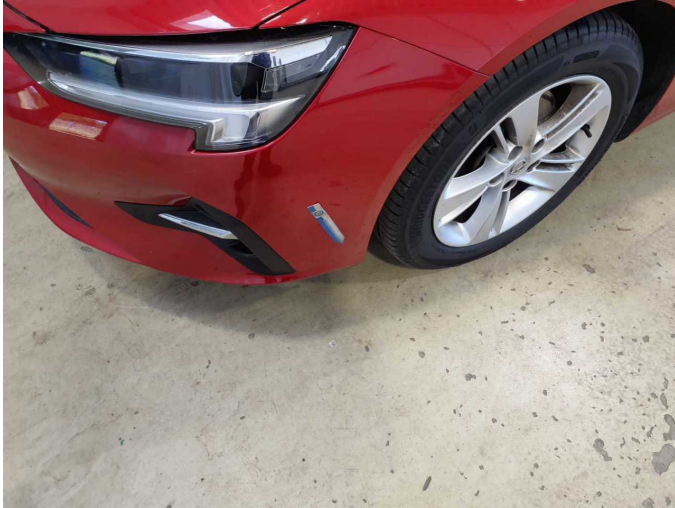
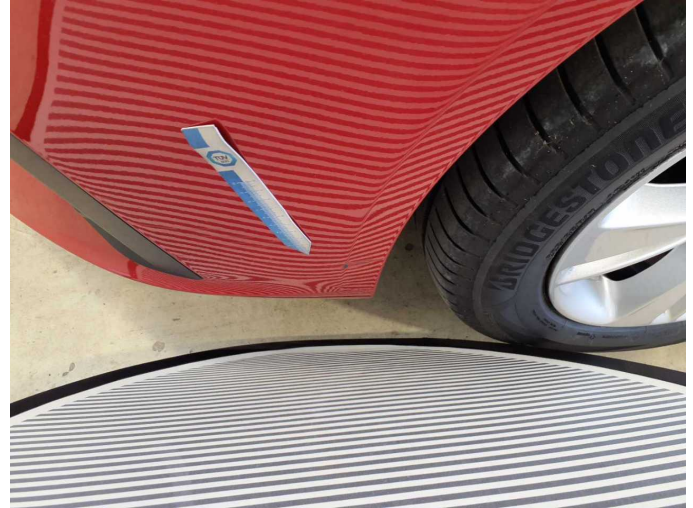
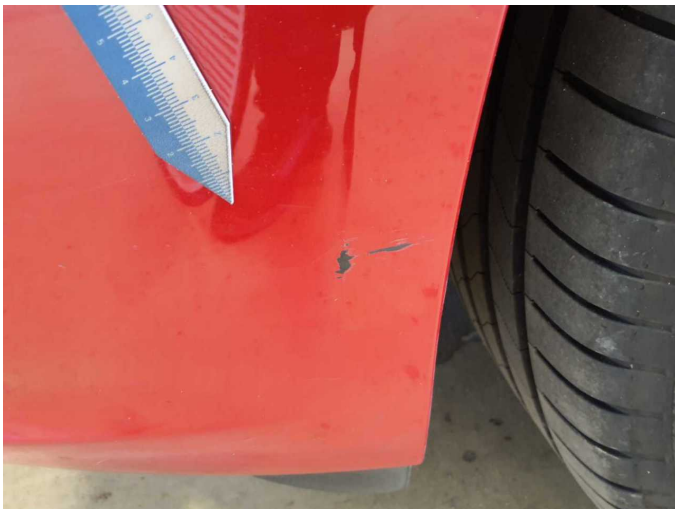
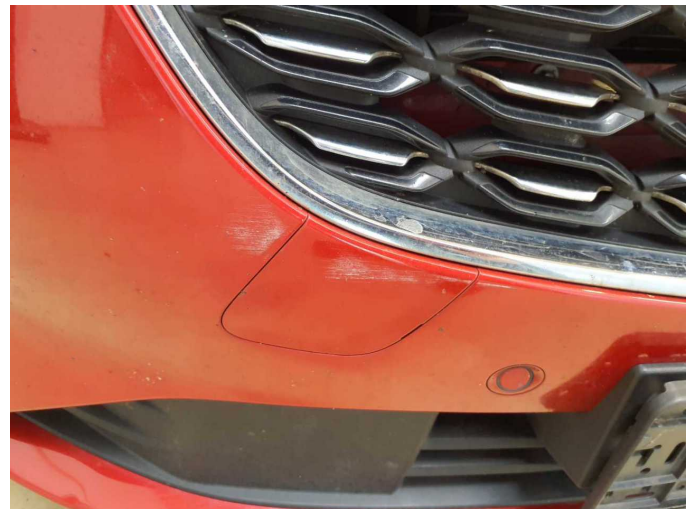
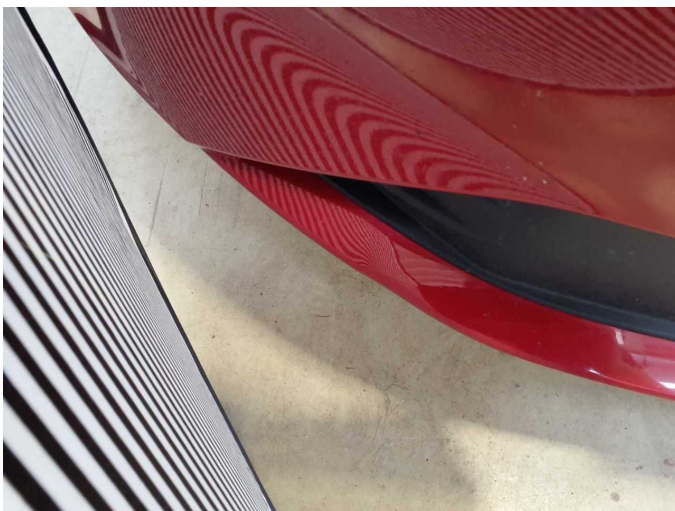
Damage 22: Front bumper: Front bumper (Gestaucht) - Dent / paintcoat damage - Replace
