Expertise

Protocol number: 46365327
Order No. / Reference: 26571247-1
Inspection date: 25 Jun 2026

Manufacturer: Opel

Model: Insignia Sports Tourer 2.0 Diesel Aut. Elegance

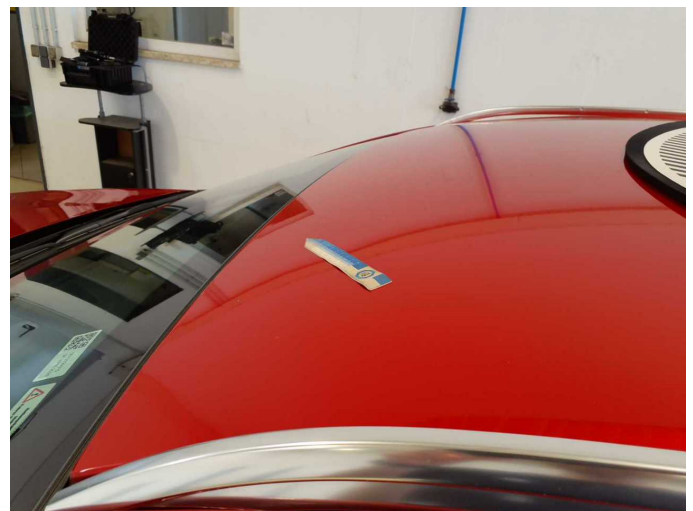
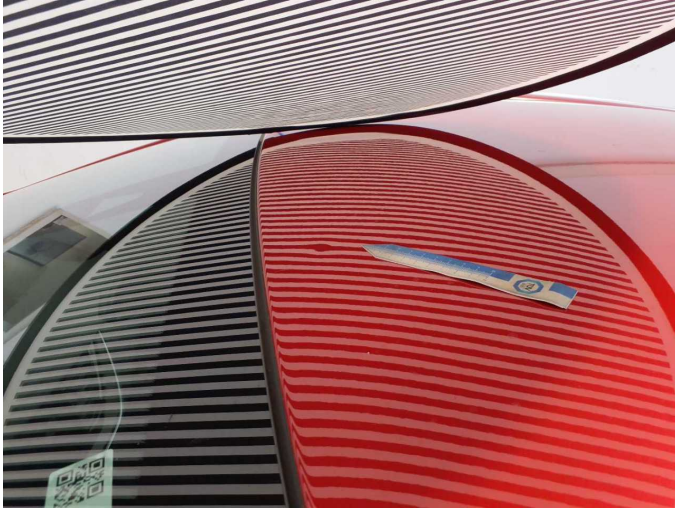
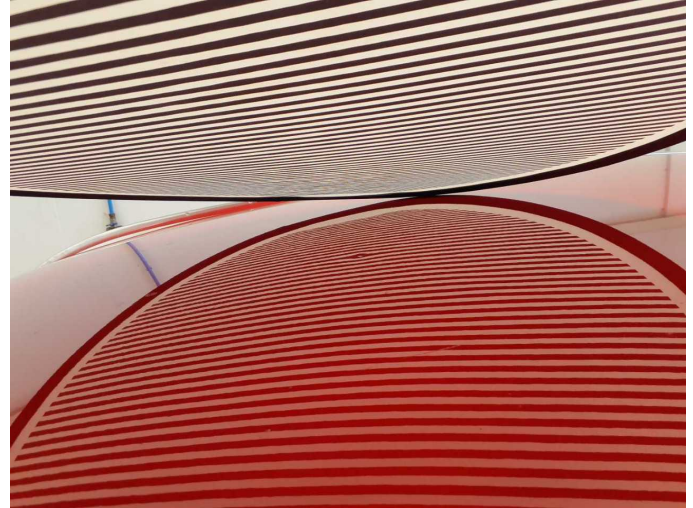
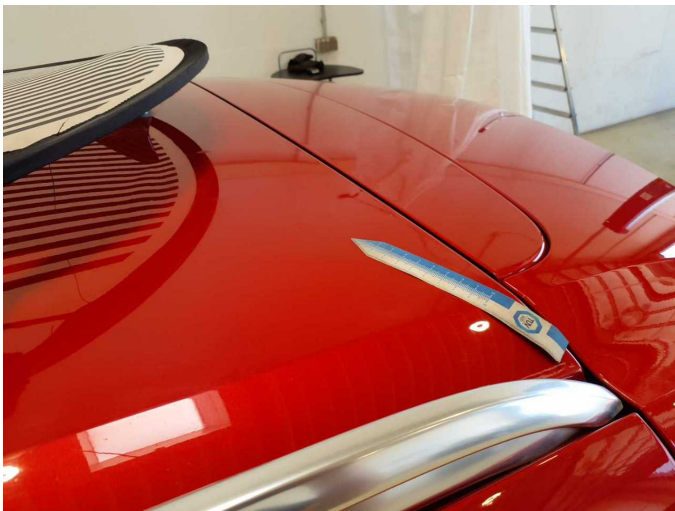
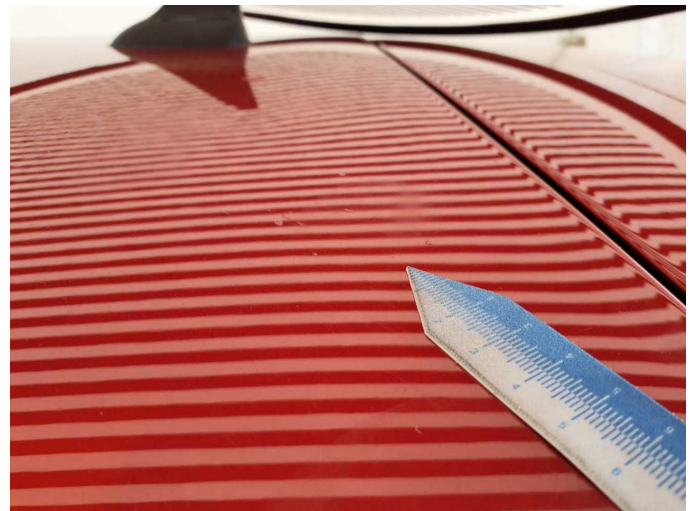
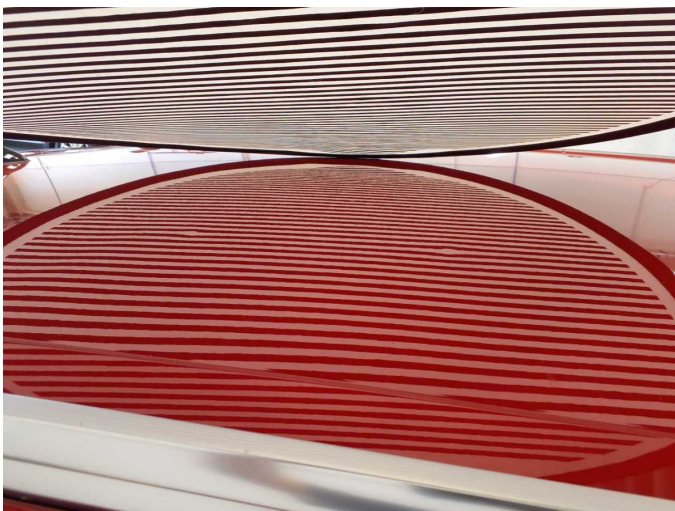
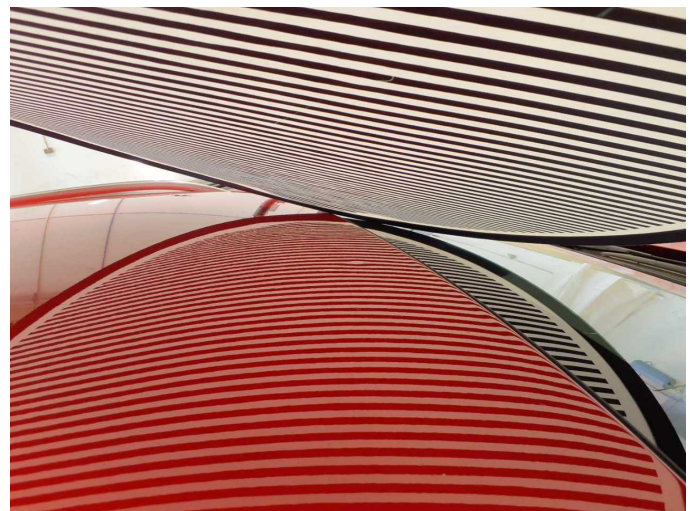
Damage 23: Roof: Roof (Anätzung) - Paint defect - Paint
