Expertise

Protocol number: 46531029  
Order No. / Reference: 26637909  
Inspection date: 15 Jul 2026

Manufacturer: Skoda  
VIN: TMBLJ8NX6PY079054

Model: Octavia Combi 2.0 TDI DSG 4x4 Scout

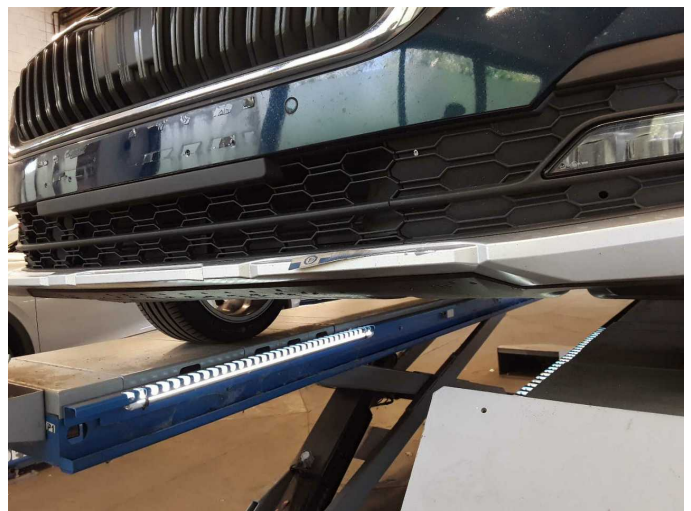
| No. | Component group | Description |
|---|---|---|
| 1 | Front bumper | Spoiler - Scratch(es) - Smart repair |

Damage 1: Front bumper: Spoiler - Scratch(es) - Smart repair

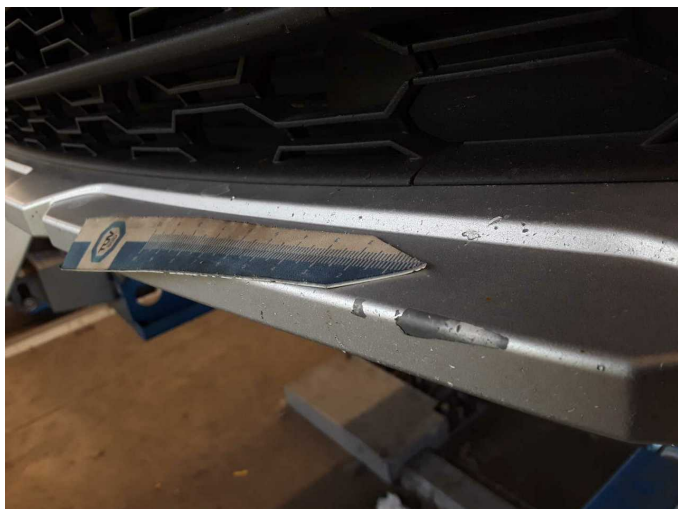
**Damage 1:** Front bumper: Spoiler - Scratch(es) - Smart repair

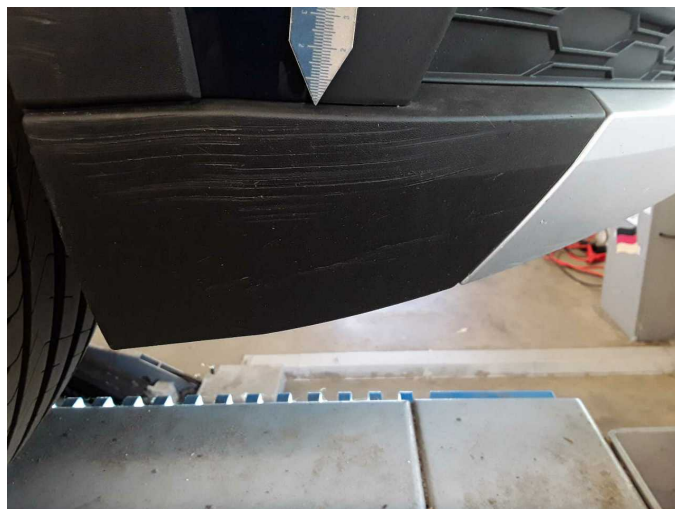
**Damage 1:** Front bumper: Spoiler - Scratch(es) - Smart repair

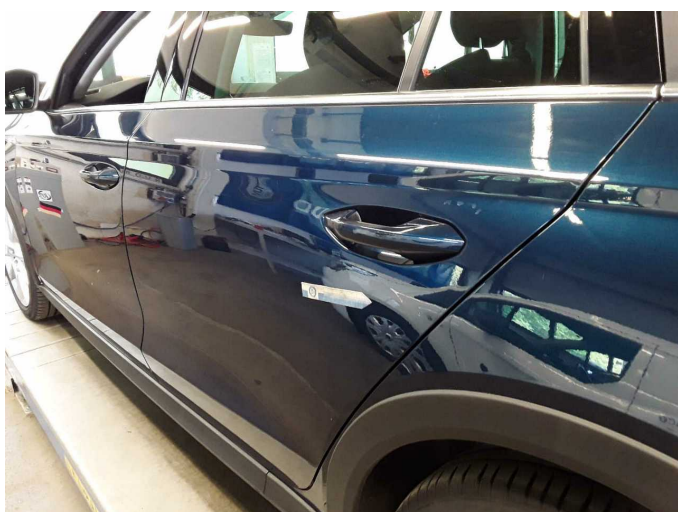
| No. | Component group | Description |
|---|---|---|
| 2 | Door - rear left side | Door - Scratch(es) - Smart repair |

**Damage 2:** Door - rear left side: Door - Scratch(es) - Smart repair

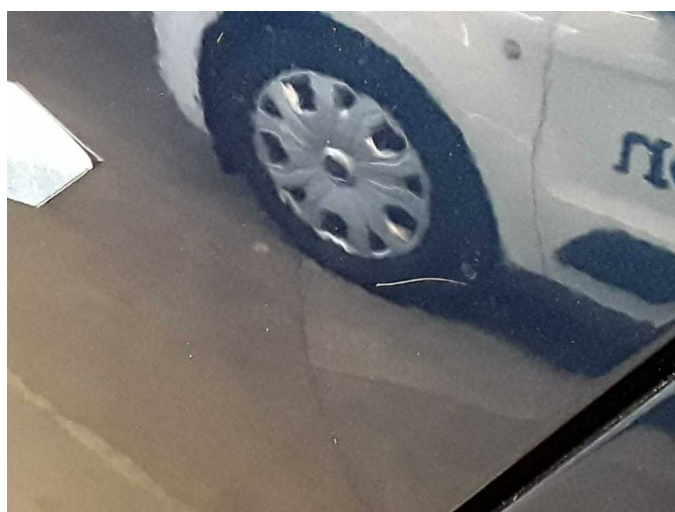
**Damage 2:** Door - rear left side: Door - Scratch(es) - Smart repair

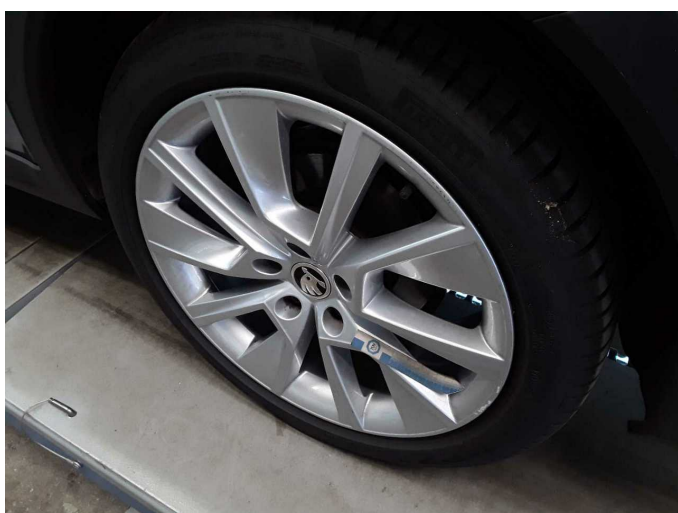
| No. | Component group | Description |
|---|---|---|
| 4 | Wheel / tyres | Alloy rim - rear left side - Scratch(es) - Loss in value |

**Damage 4:** Wheel / tyres: Alloy rim - rear left side - Scratch(es) - Loss in value

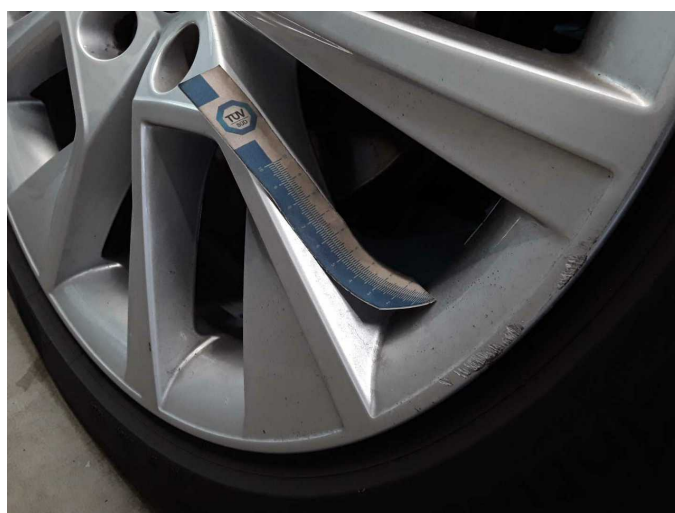
**Damage 4:** Wheel / tyres: Alloy rim - rear left side - Scratch(es) - Loss in value

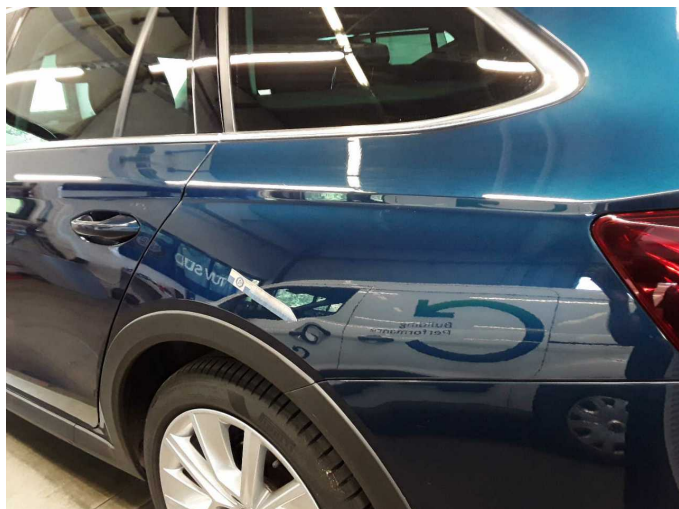
| No. | Component group | Description |
|---|---|---|
| 5 | Side panel - rear right side | Side panel - Dent / paintcoat damage - Repair and paint |

**Damage 5:** Side panel - rear right side: Side panel - Dent / paintcoat damage - Repair and paint

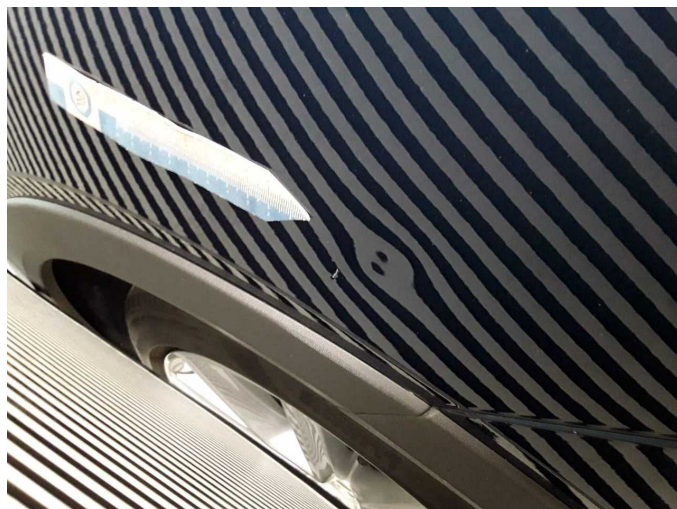
**Damage 5:** Side panel - rear right side: Side panel - Dent / paintcoat damage - Repair and paint

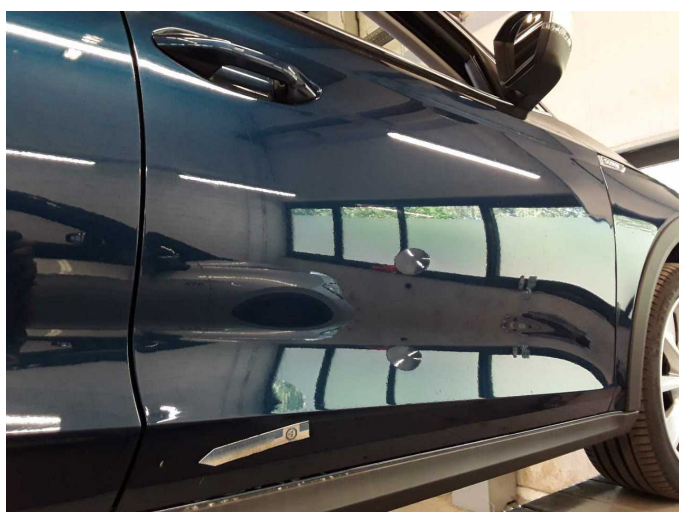
| No. | Component group | Description |
|---|---|---|
| 6 | Door - front right side | Door - Dent / paintcoat damage - Repair and paint |

**Damage 6:** Door - front right side: Door - Dent / paintcoat damage - Repair and paint

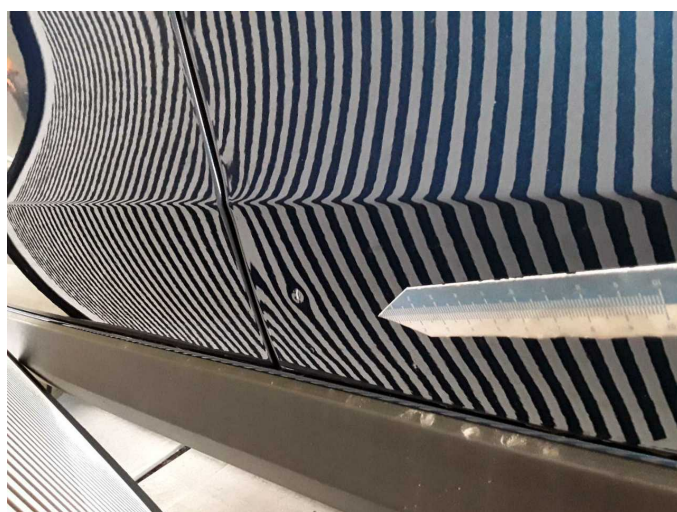
**Damage 6:** Door - front right side: Door - Dent / paintcoat damage - Repair and paint

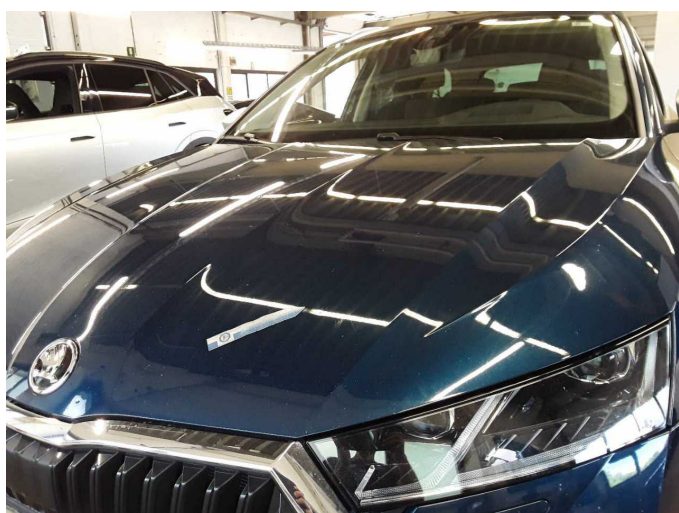
| No. | Component group | Description |
|---|---|---|
| 7 | Bonnet | Bonnet - Scratch(es) - Paint |

**Damage 7:** Bonnet: Bonnet - Scratch(es) - Paint

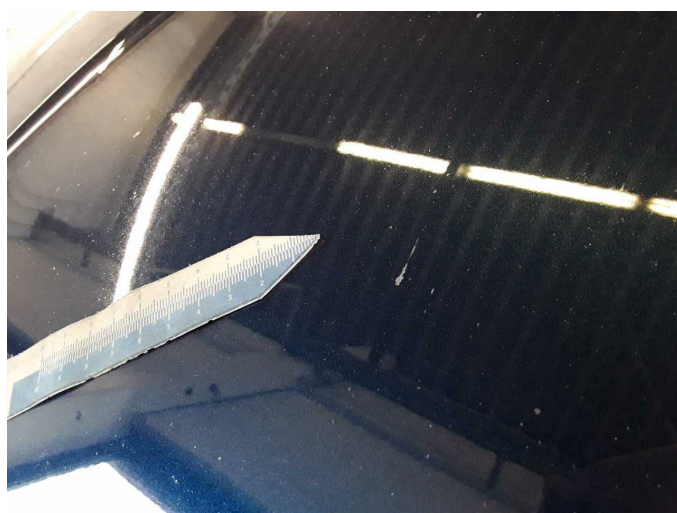
**Damage 7:** Bonnet: Bonnet - Scratch(es) - Paint

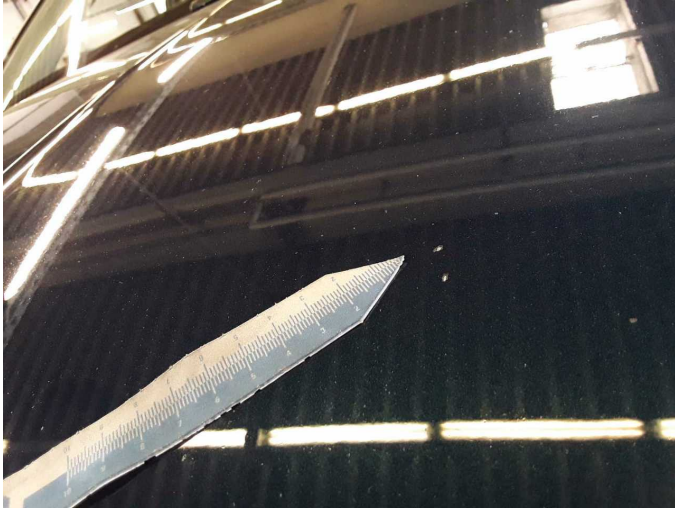
**Damage 7:** Bonnet: Bonnet - Scratch(es) - Paint

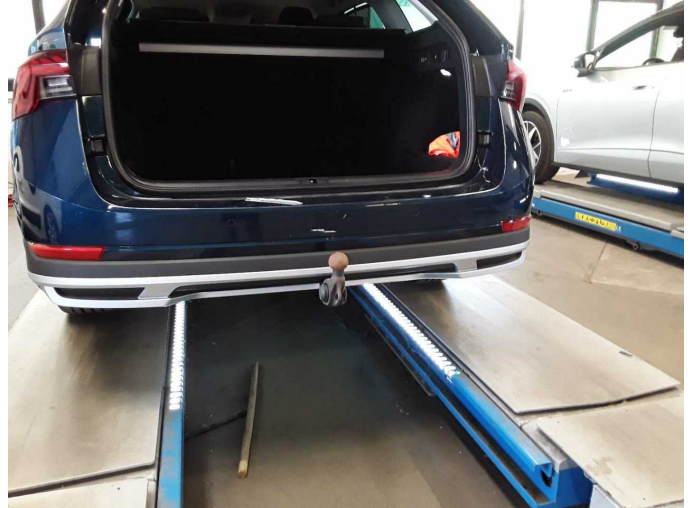
| No. | Component group | Description |
|---|---|---|
| 8 | Rear bumper | Rear bumper - Broken / torn - repair according to calculation |

**Damage 8:** Rear bumper: Rear bumper - Broken / torn - repair according to calculation

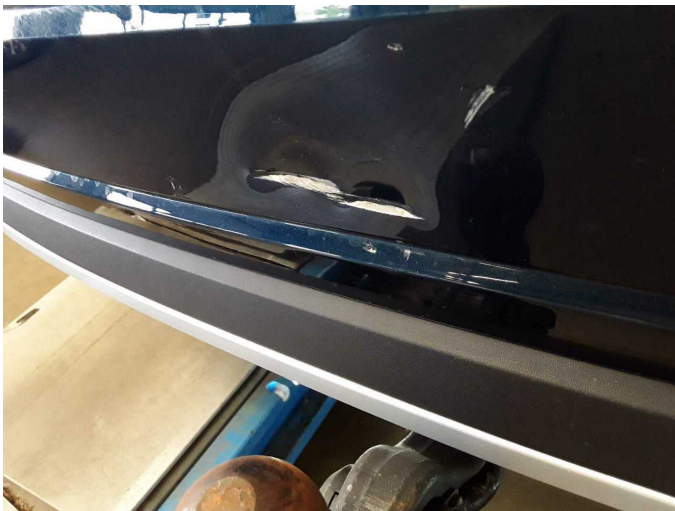
**Damage 8:** Rear bumper: Rear bumper - Broken / torn - repair according to calculation

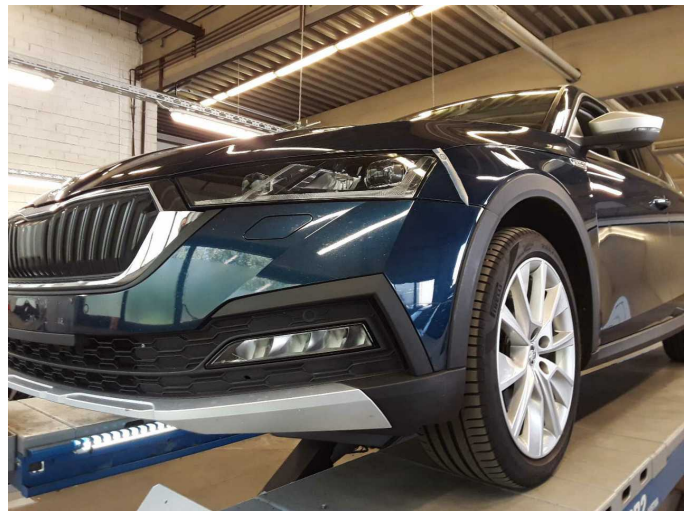
- 1 Front, Side - left

**Accident 1:** Front, Side - left

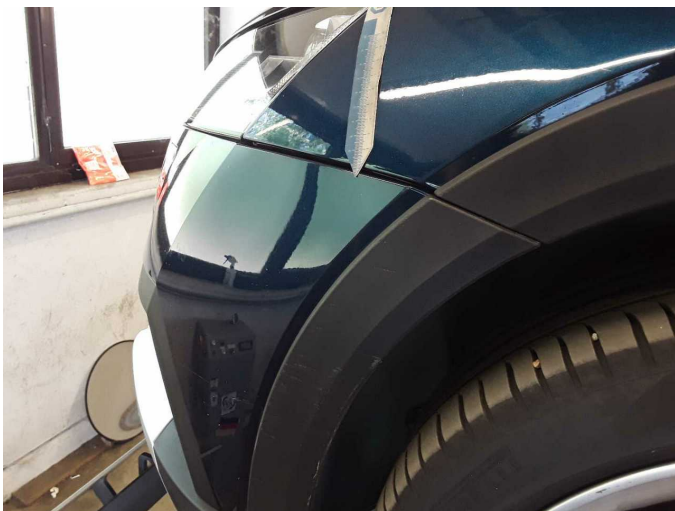
**Accident 1:** Front, Side - left

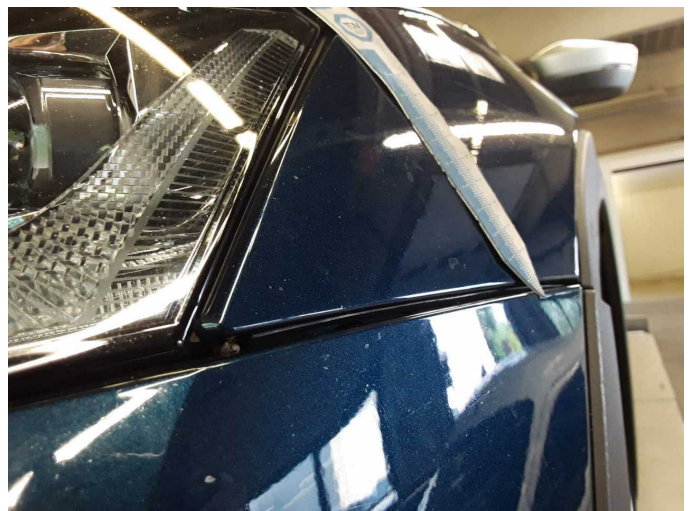
**Accident 1:** Front, Side - left

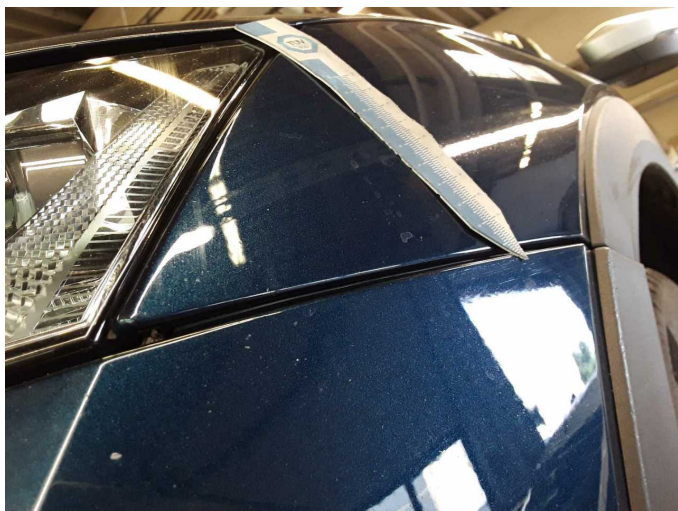
**Accident 1: Front, Side - left**

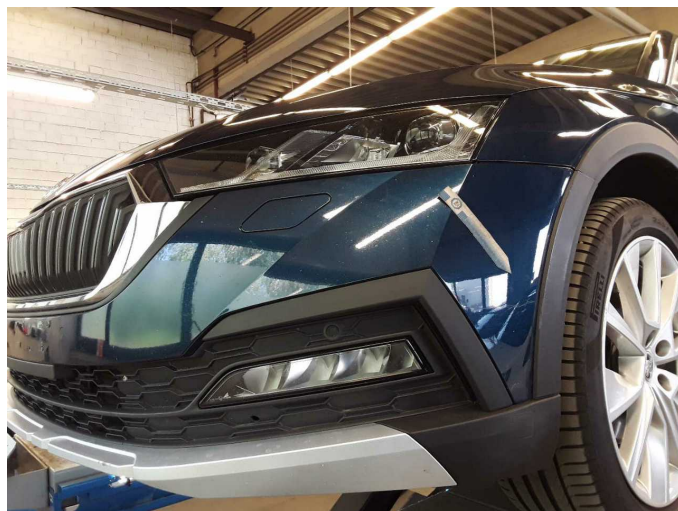
**Accident 1: Front, Side - left**

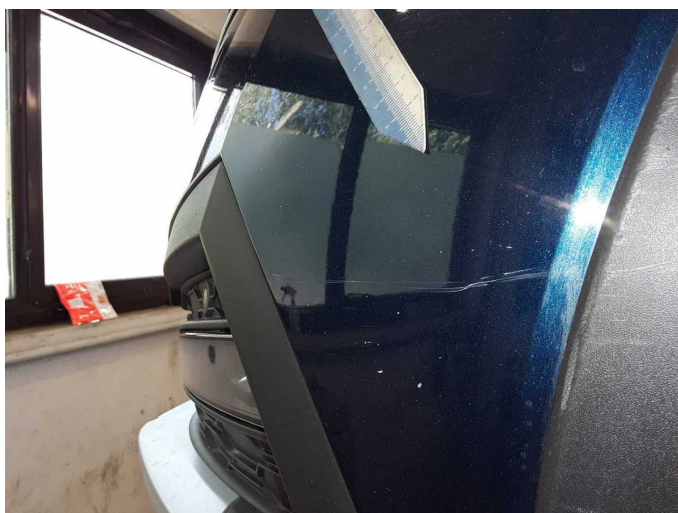
**Accident 1: Front, Side - left**

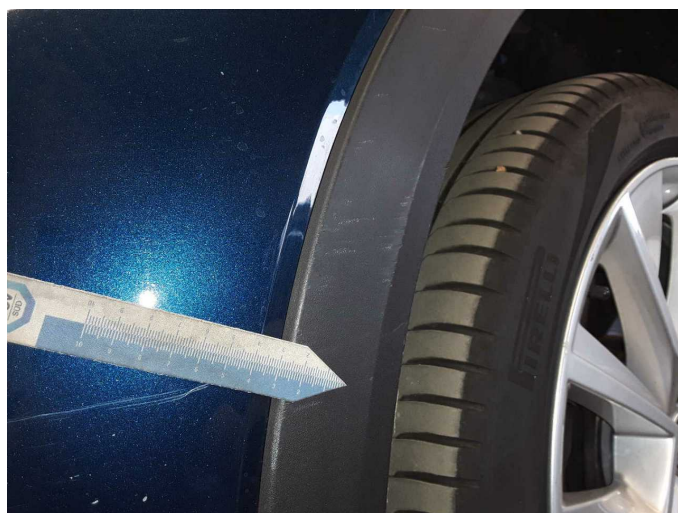
**Accident 1: Front, Side - left**

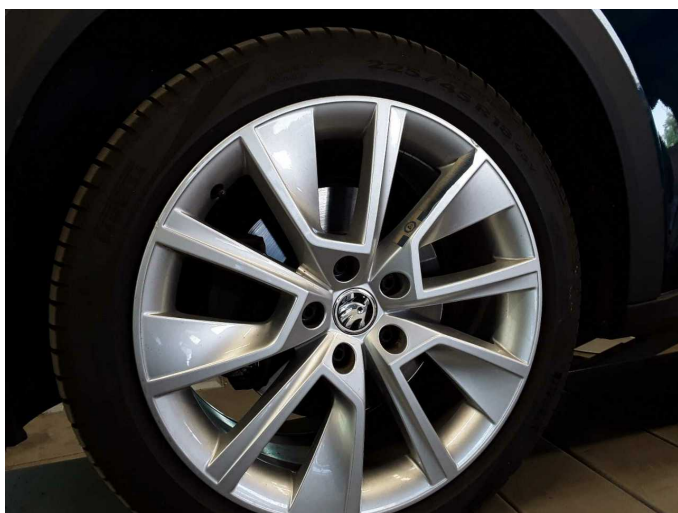
**Accident 1: Front, Side - left**

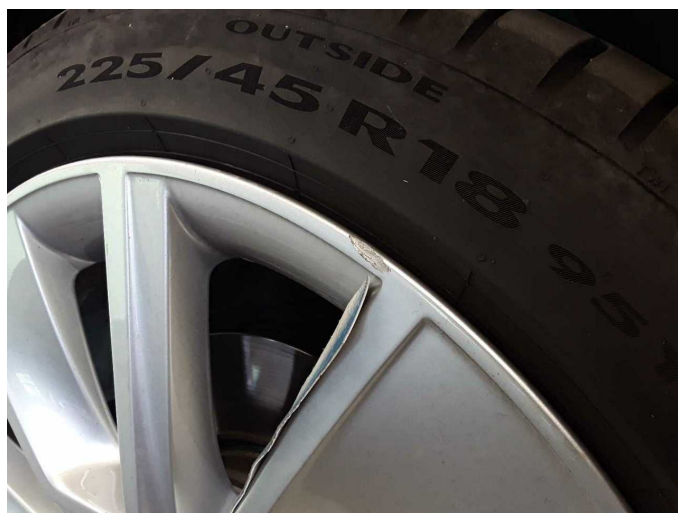
**Accident 1: Front, Side - left**
