## Expertise

Protocol number: 46343047  
Order No. / Reference: 26194901  
Inspection date: 2 Jul 2026

Manufacturer: Mercedes-Benz

Model: Vito 116 CDI Lang HA Aut. PRO

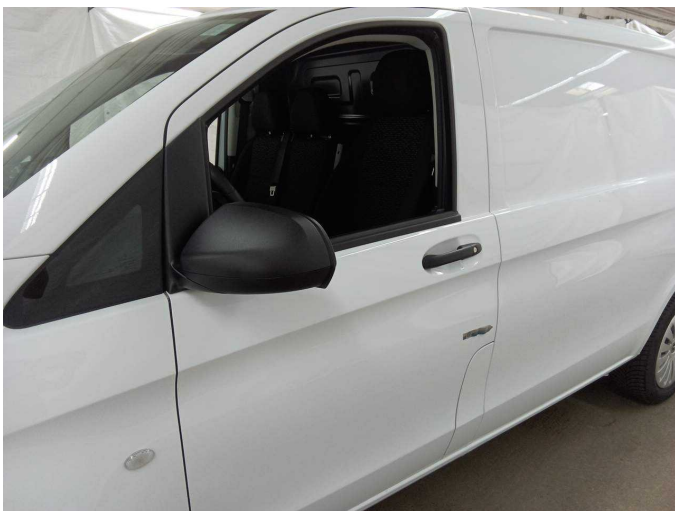
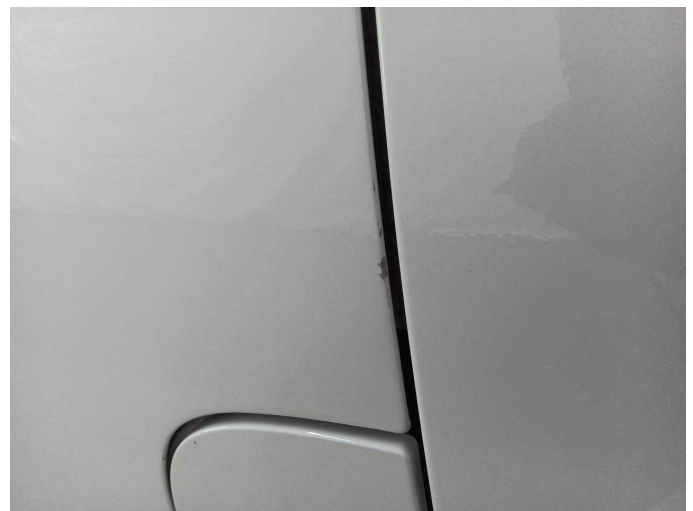
No.	Component group	Description
1	Door - front left side	Door edge - Scratch(es) - Smart repair
2	Bonnet	Bonnet - Stone chips - Paint

Damage 1: Door - front left side: Door edge - Scratch(es) - Smart repair

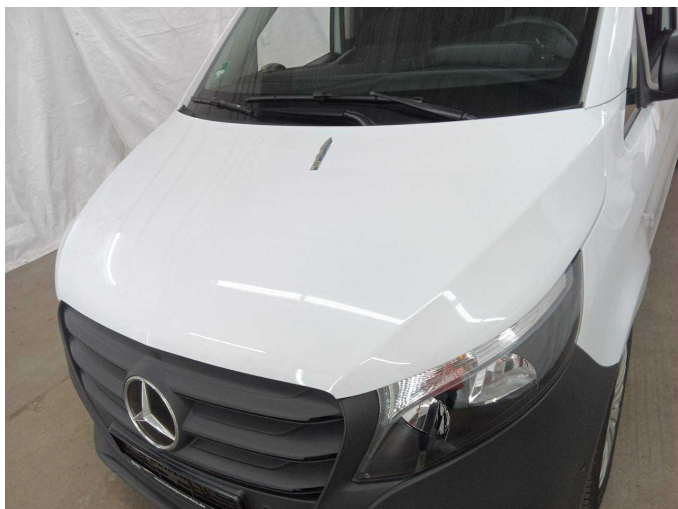
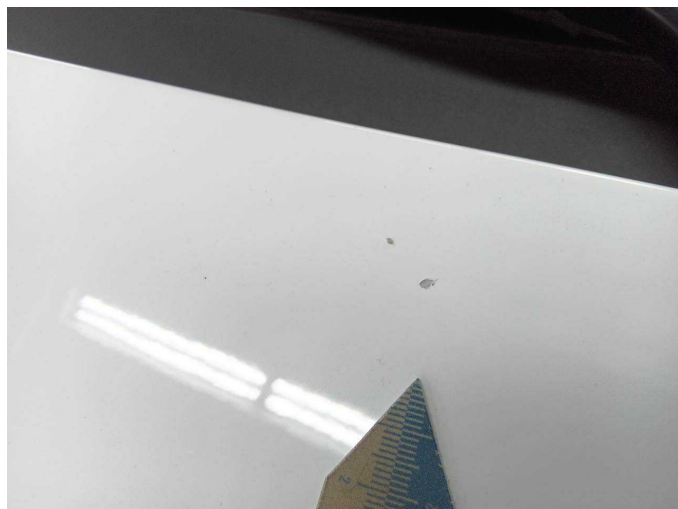
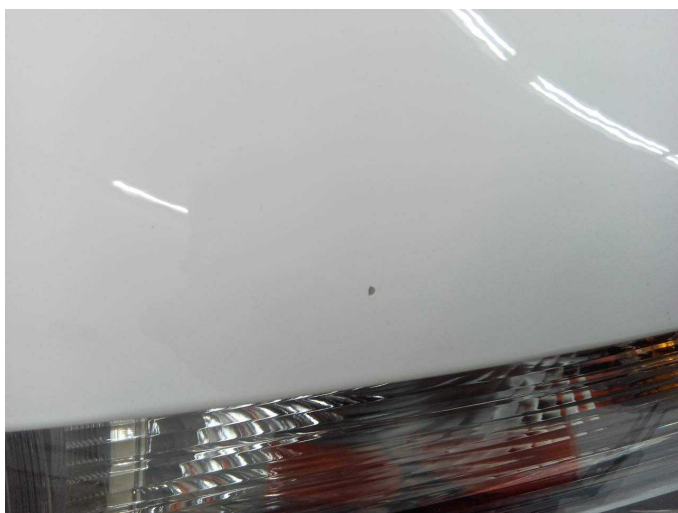
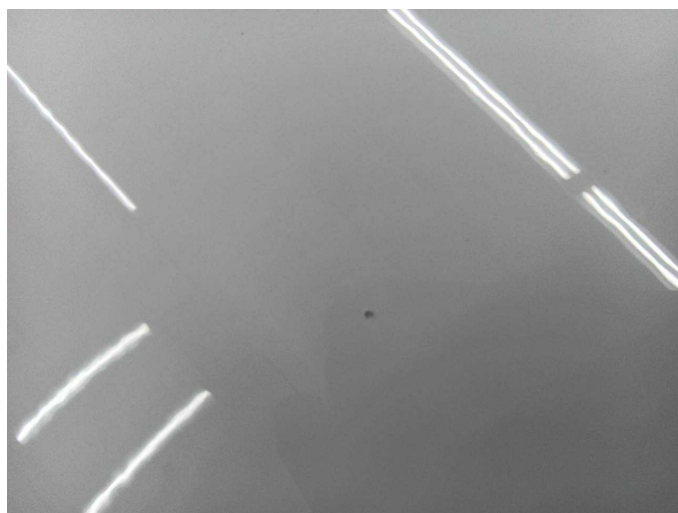
**Damage 2:** Bonnet: Bonnet - Stone chips - Paint
