## Expertise

Protocol number: 46327297  
Order No. / Reference: MW3058797  
Inspection date: 13 Nov 2025

Manufacturer: Kia

Model: Niro 1.6 GDI PHEV 2WD OPF Aut. Spirit

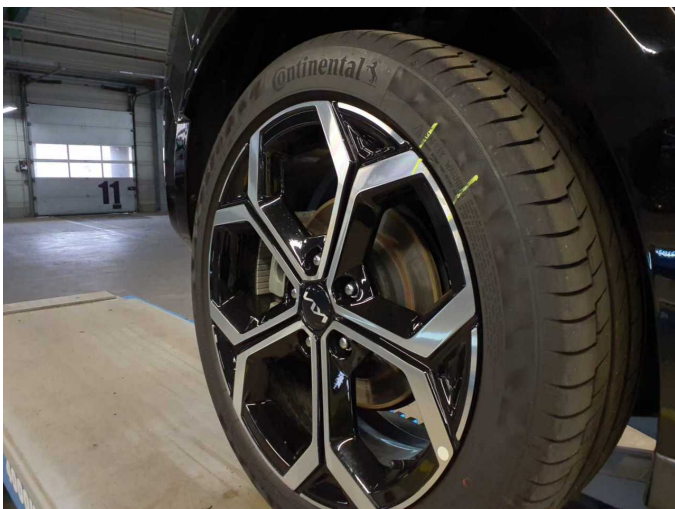
No.	Component group	Description
1	Wheel / tyres	Tyre - rear right side (nicht fahrbereit) - Porous / cracked - Replace
2	Wheel / tyres	Alloy rim - rear right side - Scratched - Loss in value

**Damage 1:** Wheel / tyres: Tyre - rear right side (nicht fahbereit) - Porous / cracked - Replace

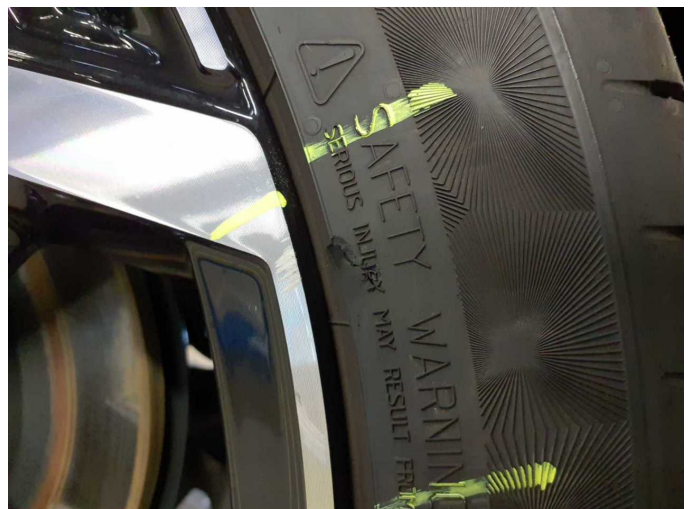
**Damage 1:** Wheel / tyres: Tyre - rear right side (nicht fahbereit) - Porous / cracked - Replace

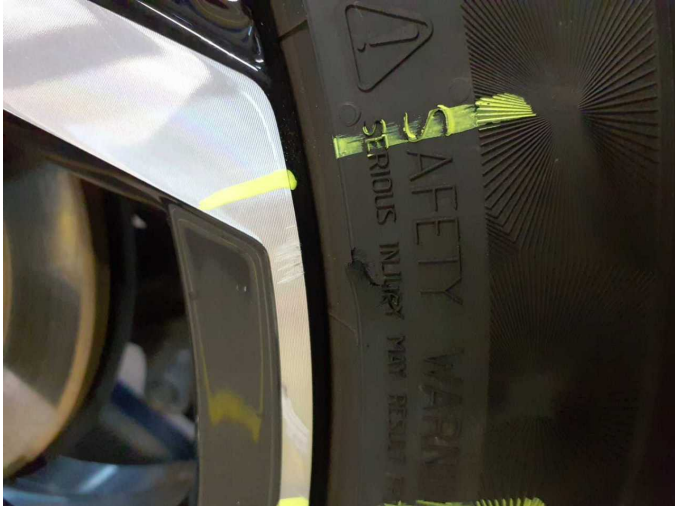
**Damage 1:** Wheel / tyres: Tyre - rear right side (nicht fahbereit) - Porous / cracked - Replace

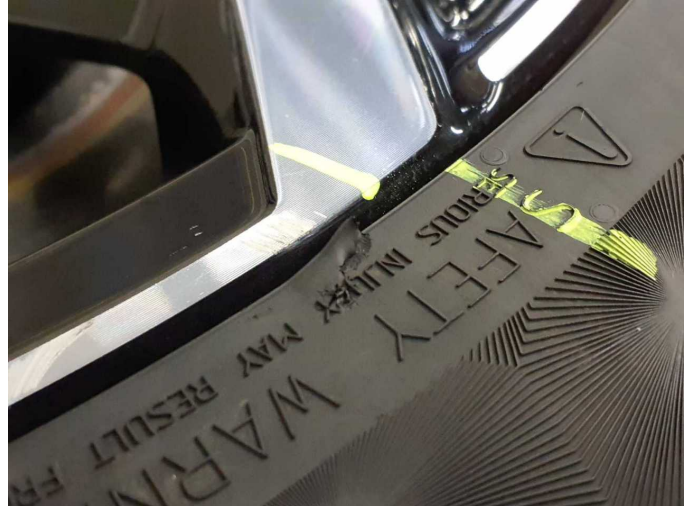
**Damage 1:** Wheel / tyres: Tyre - rear right side (nicht fahbereit) - Porous / cracked - Replace

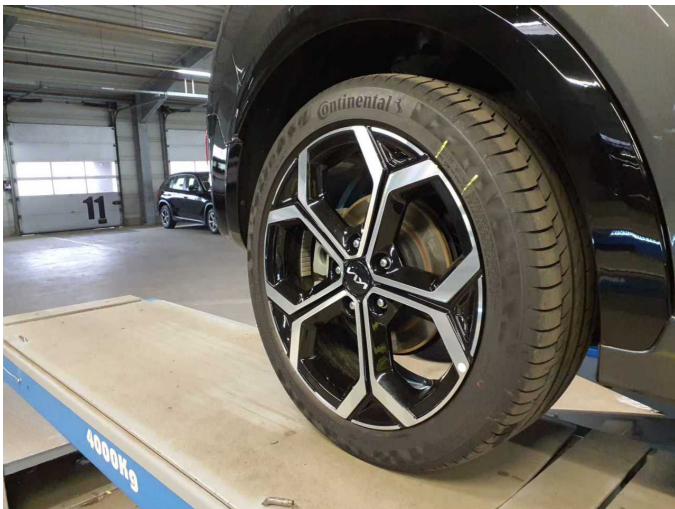
**Damage 2:** Wheel / tyres: Alloy rim - rear right side - Scratched - Loss in value

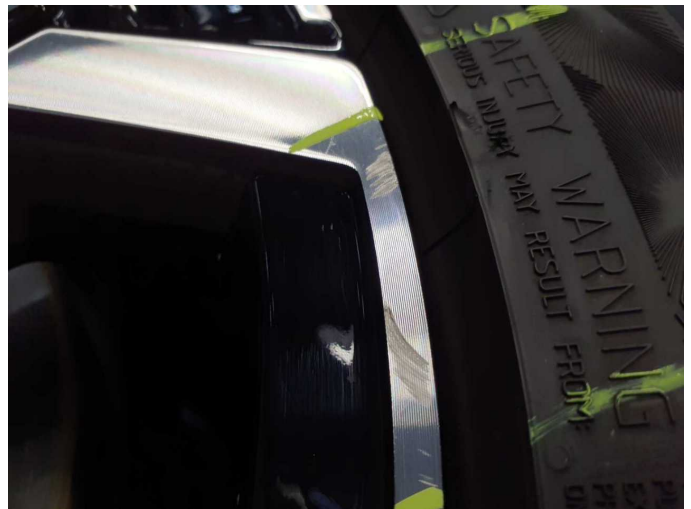
**Damage 2:** Wheel / tyres: Alloy rim - rear right side - Scratched - Loss in value

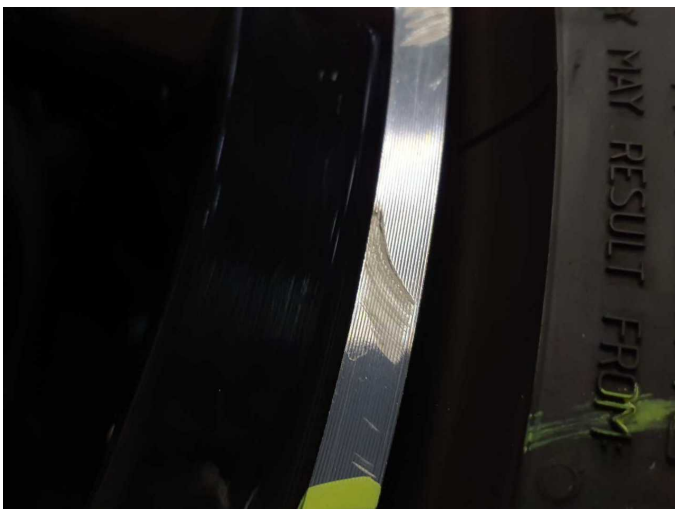
**Damage 2:** Wheel / tyres: Alloy rim - rear right side - Scratched - Loss in value

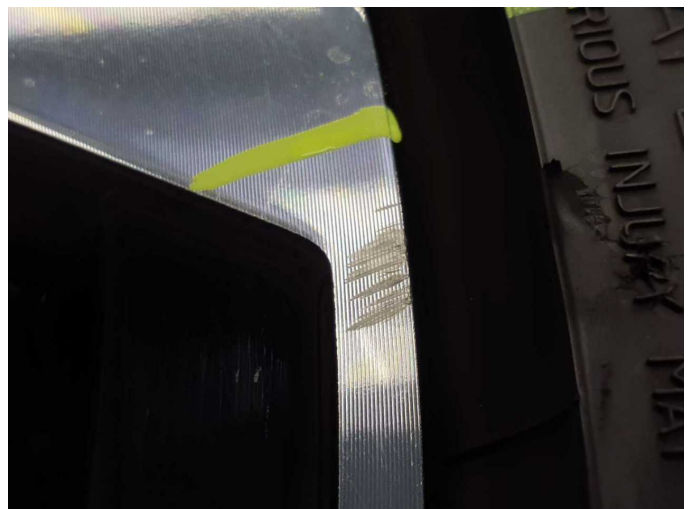
**Damage 2:** Wheel / tyres: Alloy rim - rear right side - Scratched - Loss in value
