Expertise

Protocol number: 46873740  
Order No. / Reference: 26697722  
Inspection date: 4 Aug 2026

Manufacturer: Ford

Model: S-Max 2.0 EcoBlue Aut. TITANIUM

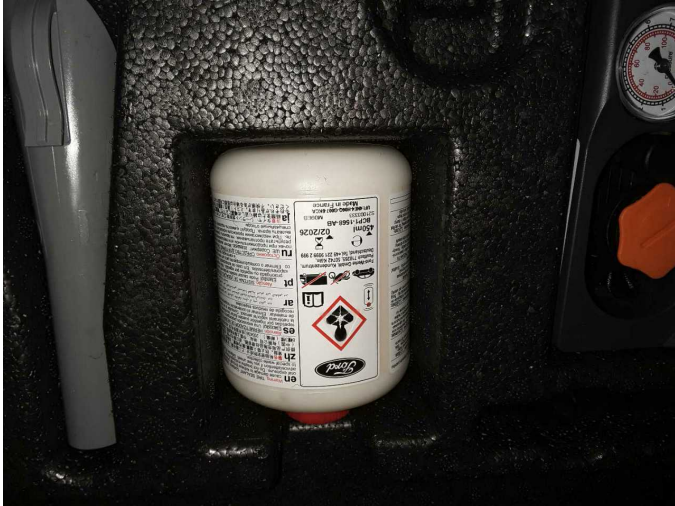
| No. | Component group | Description |
|---|---|---|
| 1 | Equipment | Tirefit filler - Expired - Replace |

**Damage 1:** Equipment: Tirefit filler - Expired - Replace

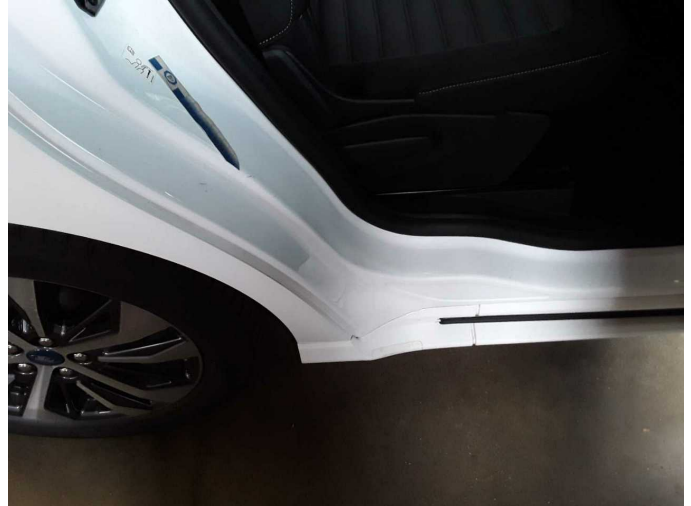
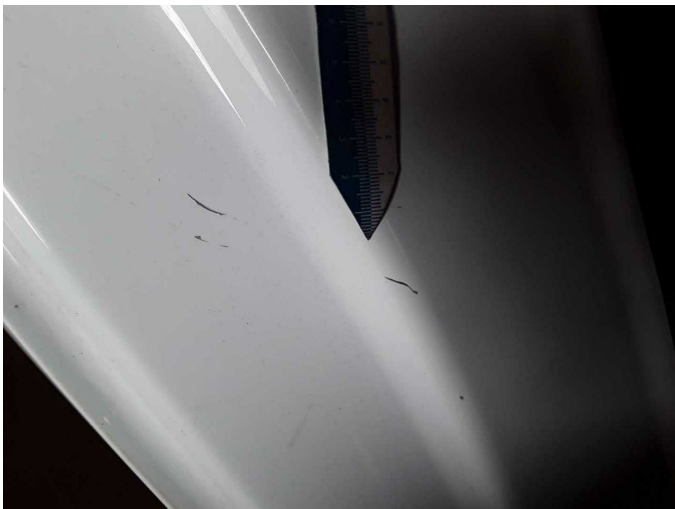
| No. | Component group | Description |
|---|---|---|
| 2 | Side panel - rear right side | Sill - Scratch(es) - Smart repair |

**Damage 2:** Side panel - rear right side: Sill - Scratch(es) - Smart repair

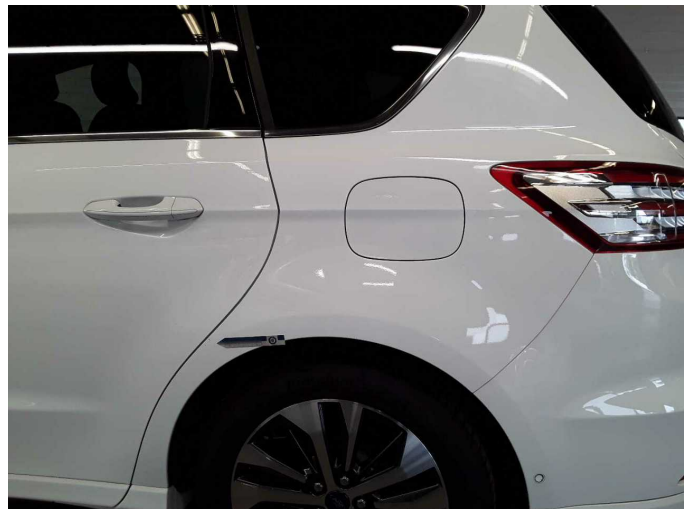
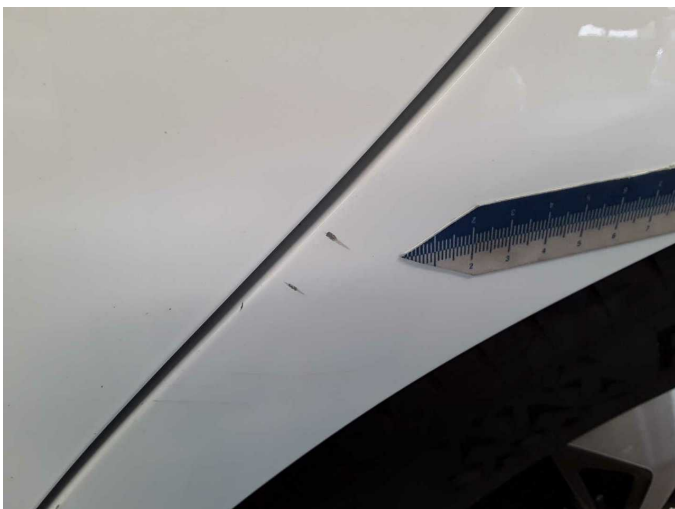
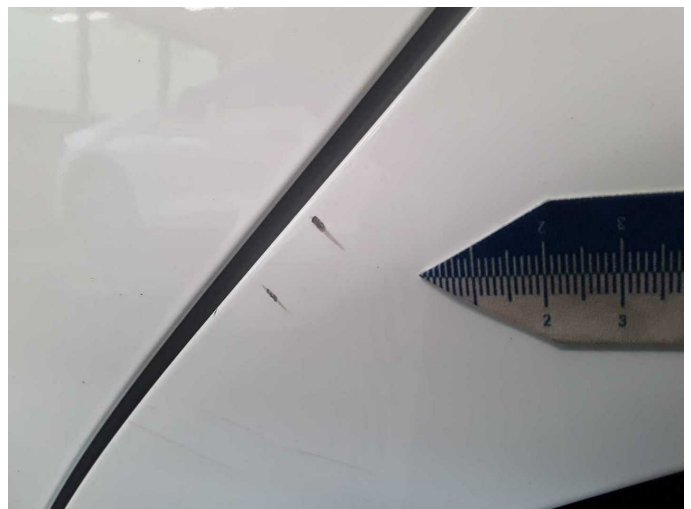
| No. | Component group | Description |
|---|---|---|
| 3 | Side panel - rear left side | Side panel - Scratch(es) - Smart repair |

**Damage 3:** Side panel - rear left side: Side panel - Scratch(es) - Smart repair

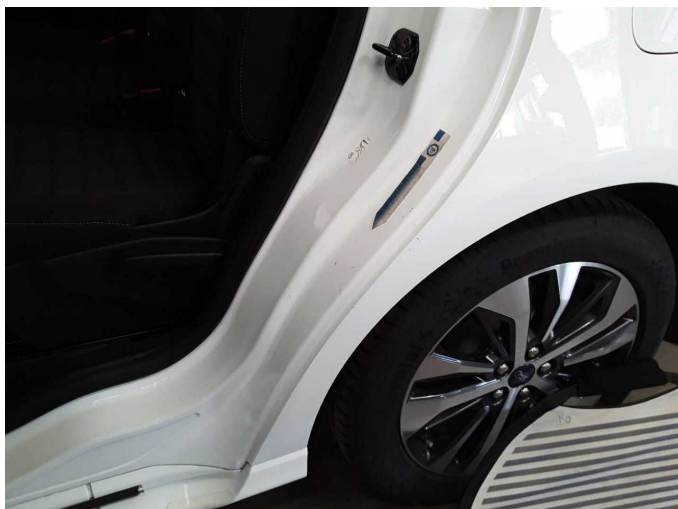
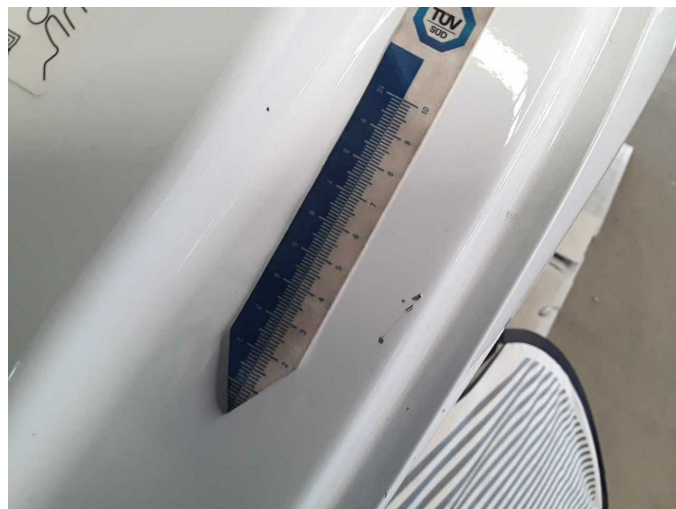
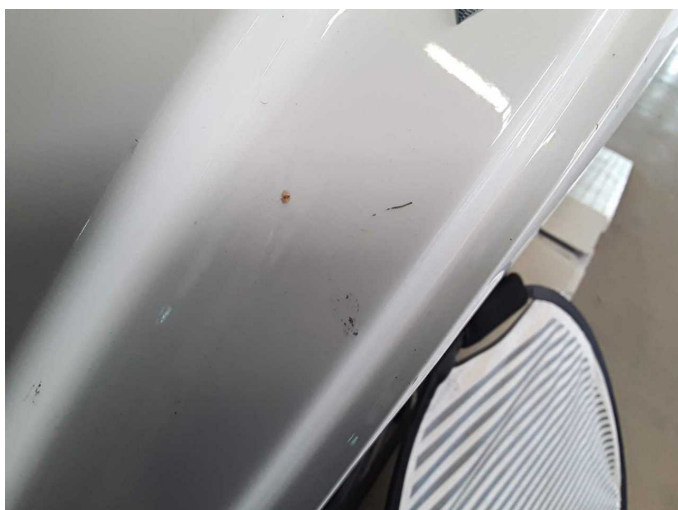
| No. | Component group | Description |
|---|---|---|
| 4 | Side panel - rear left side | Sill - Scratched - Smart repair |

**Damage 4:** Side panel - rear left side: Sill - Scratched - Smart repair

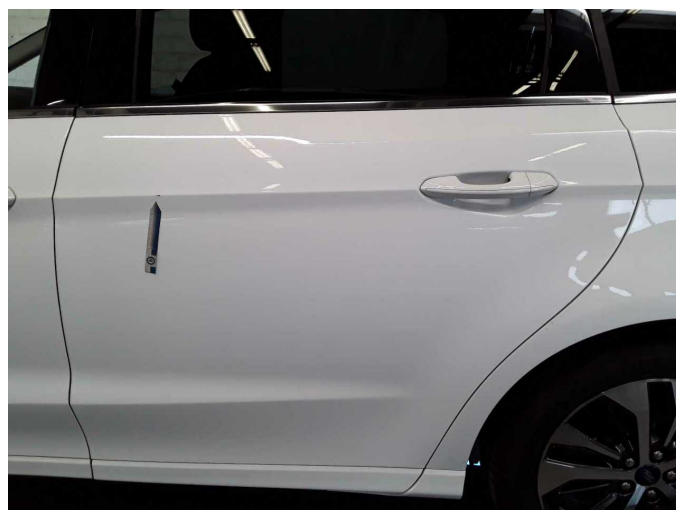
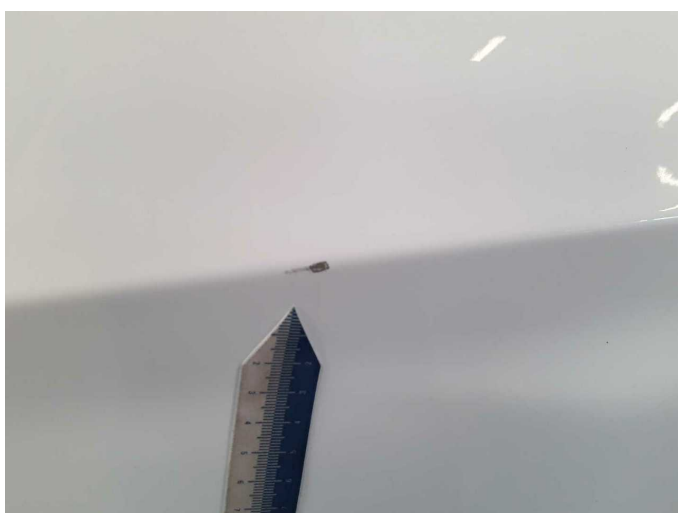
| No. | Component group | Description |
|---|---|---|
| 5 | Door - rear left side | Door - Scratched - Smart repair |

**Damage 5:** Door - rear left side: Door - Scratched - Smart repair

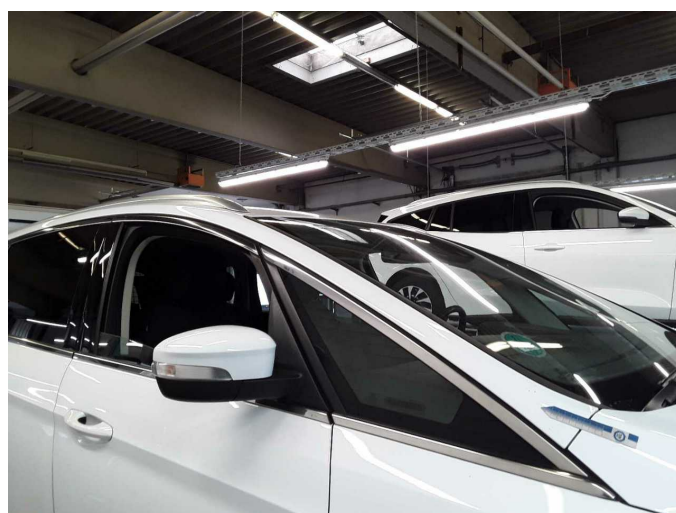
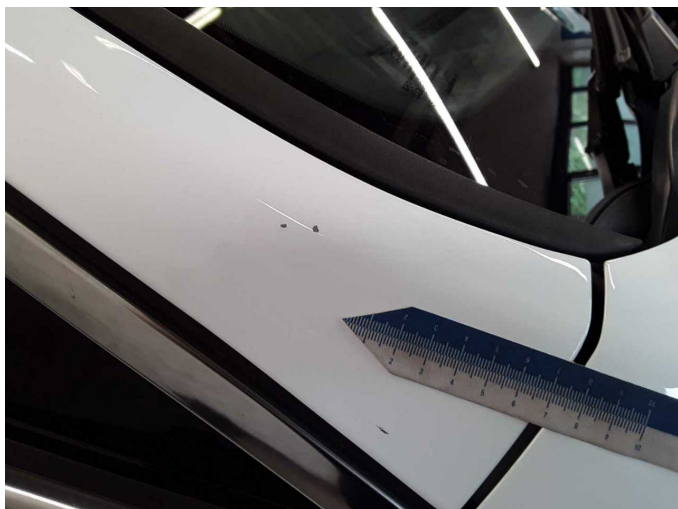
| No. | Component group | Description |
|---|---|---|
| 6 | Roof | Roof rail - right side - Stone chips - Smart repair |

**Damage 6:** Roof: Roof rail - right side - Stone chips - Smart repair

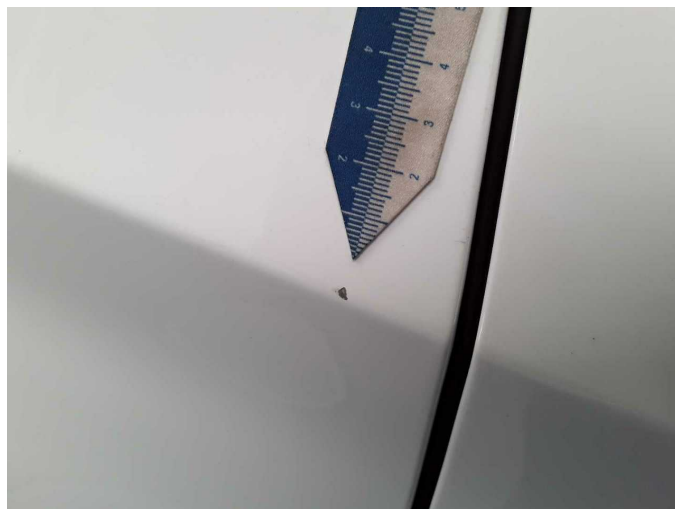
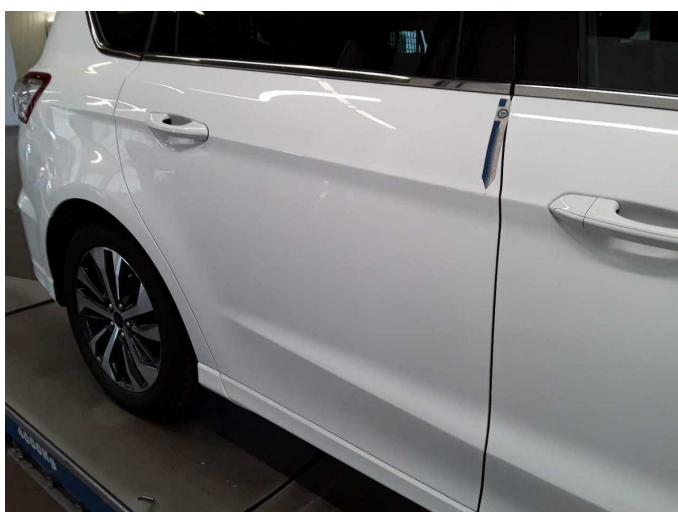
| No. | Component group | Description |
|---|---|---|
| 7 | Door - rear right side | Door - Stone chips - Smart repair |

**Damage 7:** Door - rear right side: Door - Stone chips - Smart repair

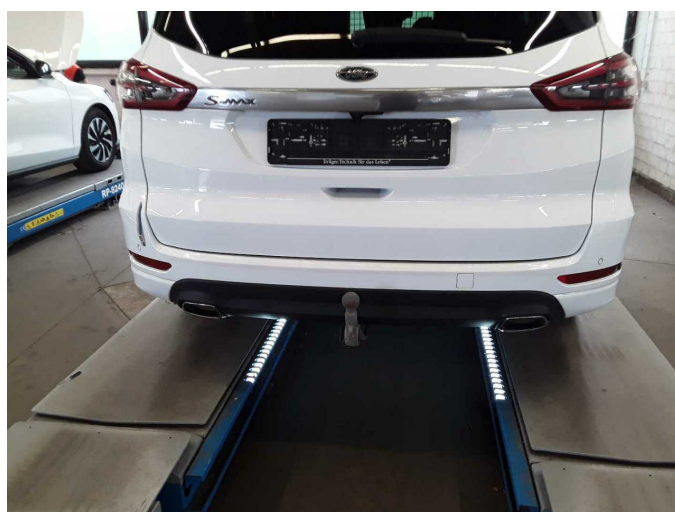
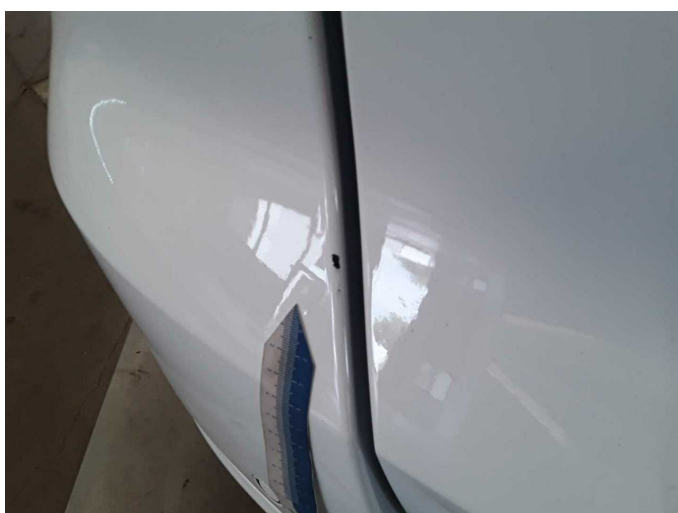
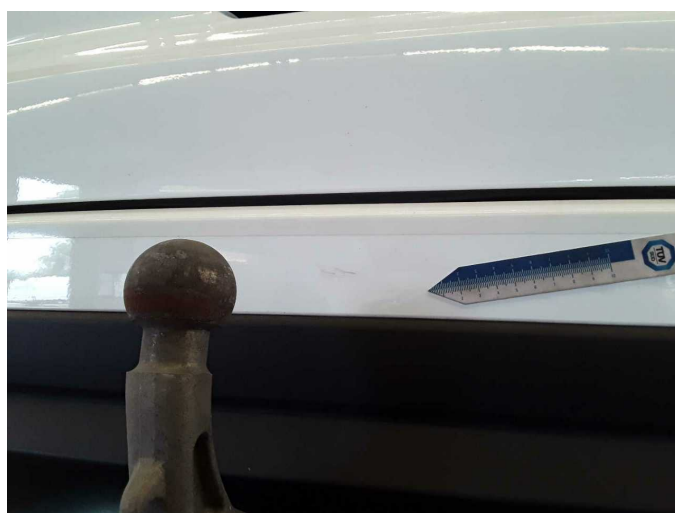
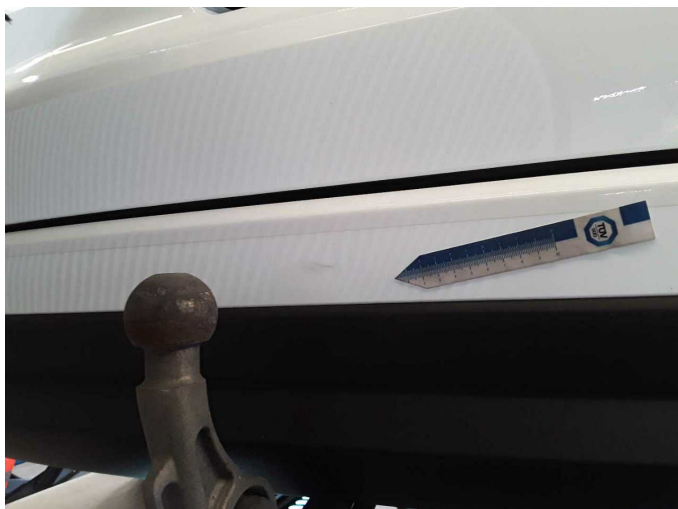
| No. | Component group | Description |
|---|---|---|
| 8 | Rear bumper | Rear bumper - Dent / paintcoat damage - Repair and paint |

**Damage 8:** Rear bumper: Rear bumper - Dent / paintcoat damage - Repair and paint

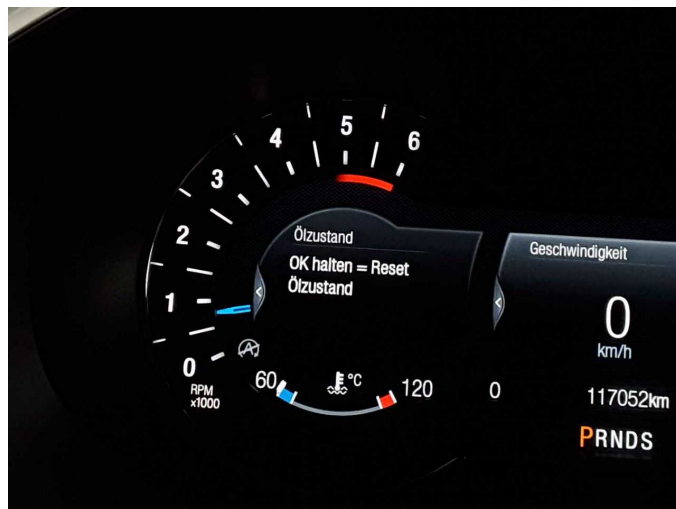
| No. | Component group | Description |
|---|---|---|
| 9 | Misc. | Inspection / maintenance - Due - Replace |

**Damage 9:** Misc.: Inspection / maintenance - Due - Replace

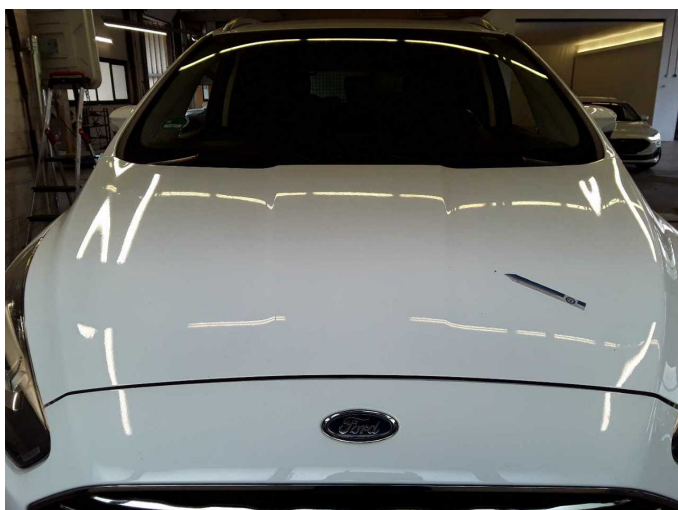
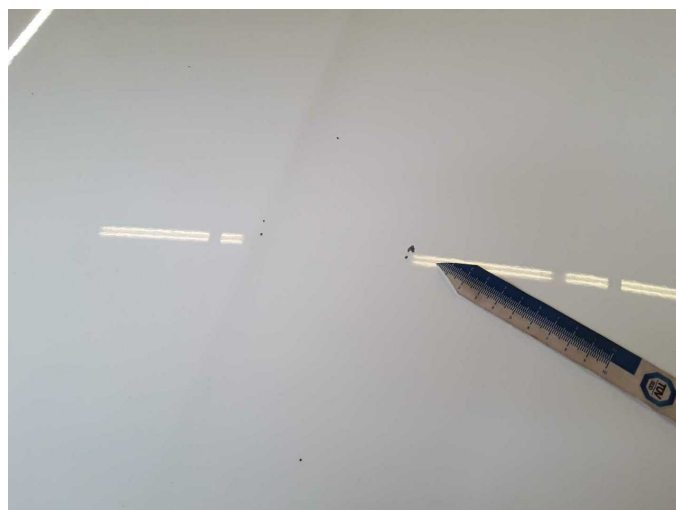
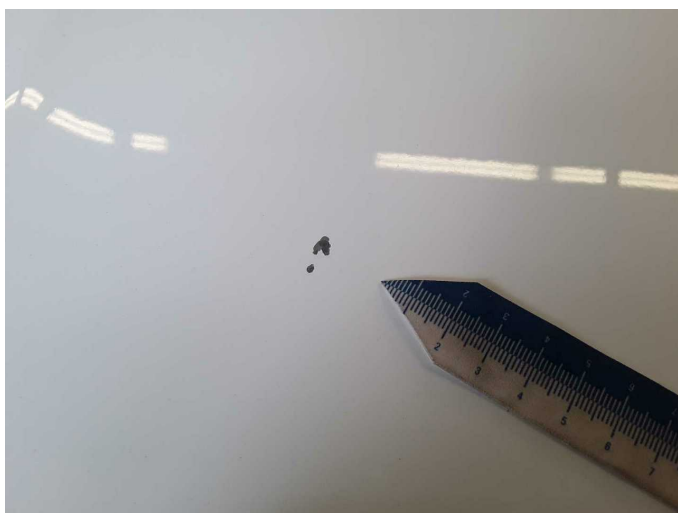
| No. | Component group | Description |
|---|---|---|
| 10 | Bonnet | Bonnet - Stone chips - Paint |

**Damage 10:** Bonnet: Bonnet - Stone chips - Paint

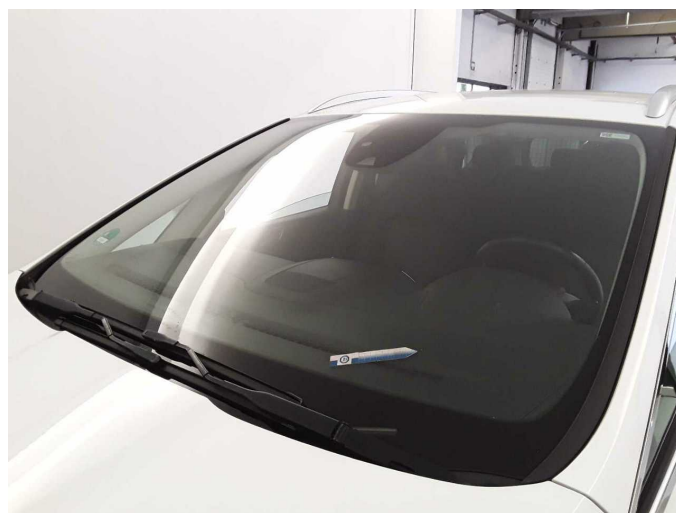
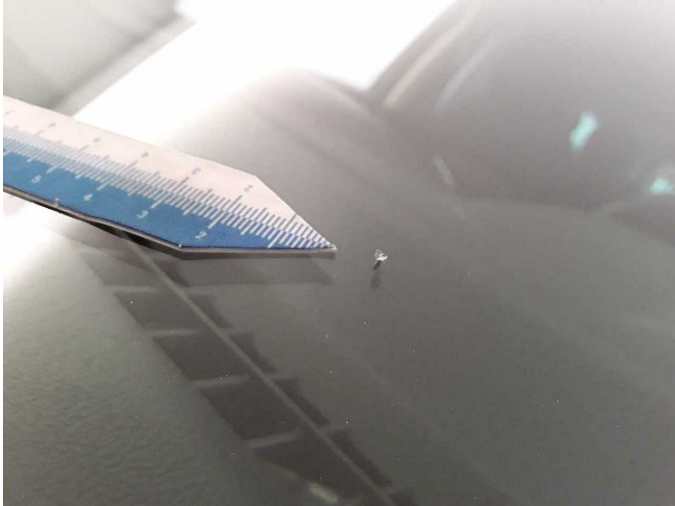
| No. | Component group | Description |
|---|---|---|
| 11 | Vehicle glazing | Windscreen (Rissbildung) - Broken / torn - Replace |

**Damage 11:** Vehicle glazing: Windscreen (Rissbildung) - Broken / torn - Replace

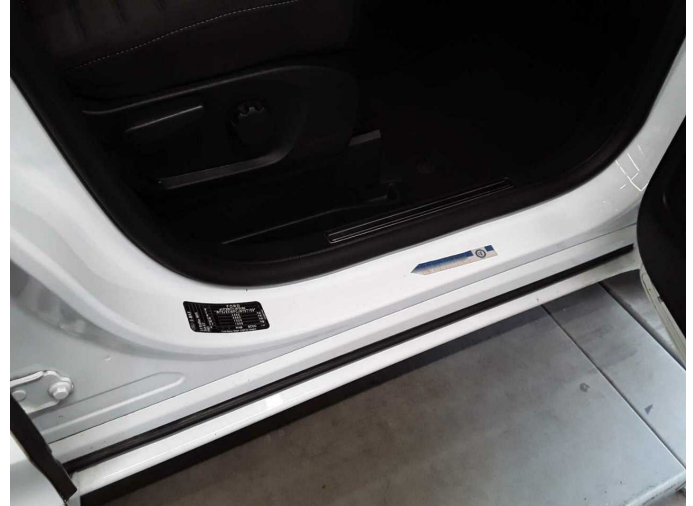
| No. | Component group | Description |
|---|---|---|
| 1 | Sill - right side | Sill - dent(s) - No deduction |

**Wear and tear 1:** Sill - right side: Sill - dent(s) - No deduction

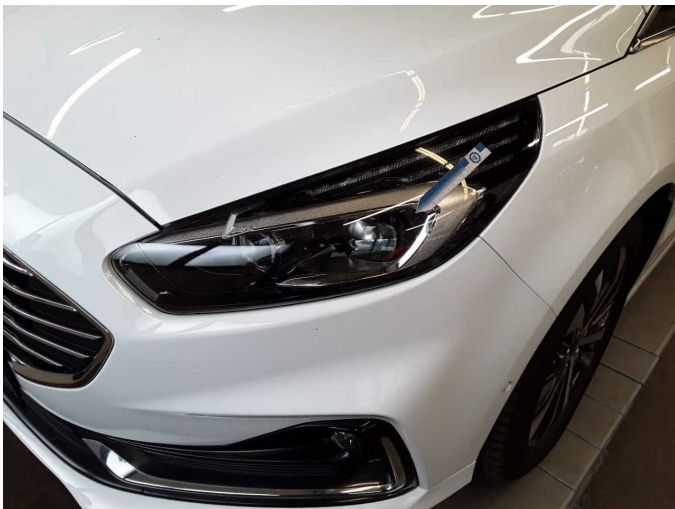
| No. | Component group | Description |
|---|---|---|
| 2 | Headlight | Headlight - left side - Soiled - No deduction |

**Wear and tear 2:** Headlight: Headlight - left side - Soiled - No deduction

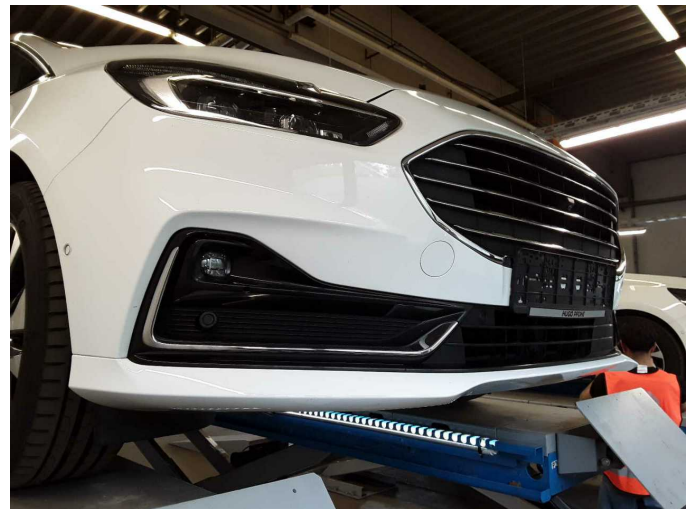
| No. | Component group | Description |
|---|---|---|
| 3 | Front bumper | Front bumper - Stone chips - No deduction |

**Wear and tear 3:** Front bumper: Front bumper - Stone chips - No deduction
