## Expertise

Protocol number: 46183347  
Order No. / Reference: 26417296  
Inspection date: 26 Jun 2026

Model: Kodiaq 2.0 TDI 4x4 DSG L&K

VIN: TMBLN9NS8P8049309

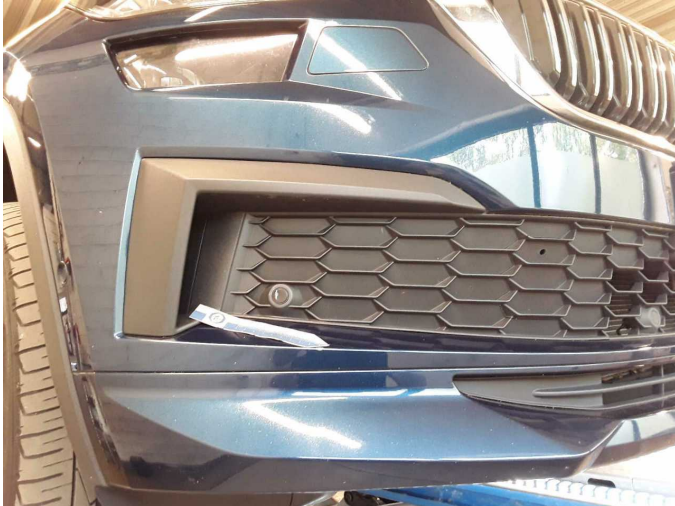
No.	Component group	Description
1	Front bumper	Front bumper - Scratch(es) - Smart repair
2	Engine	Engine - Leaking - Diagnosed and repair if necessary
3	Body	Body (Mehrkosten sind möglich) - Soiled - Clean
4	Door - rear left side	Door - Deformed - Repair and paint
5	Bonnet	Bonnet (Vogelkot) - Paint defect - Paint
6	Vehicle glazing	Windscreen (Rissbildung) - Stone chips - Replace
7	Roof	Roof (Vogelkot eingebrannt) - Paint defect - Paint

**Damage 1:** Front bumper: Front bumper - Scratch(es) - Smart repair

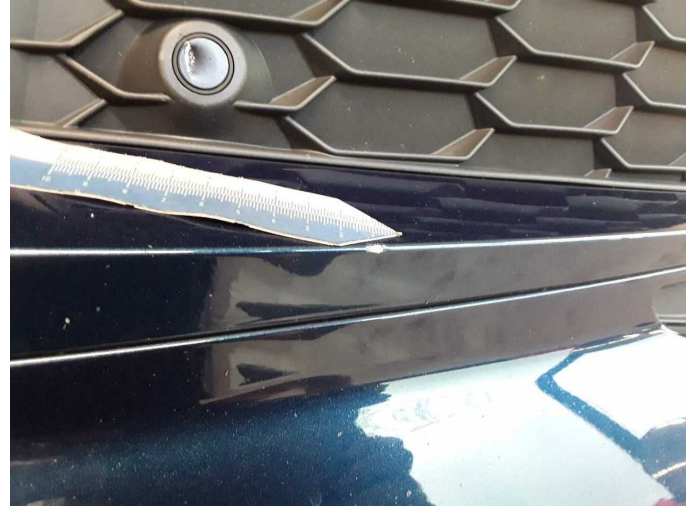
**Damage 1:** Front bumper: Front bumper - Scratch(es) - Smart repair

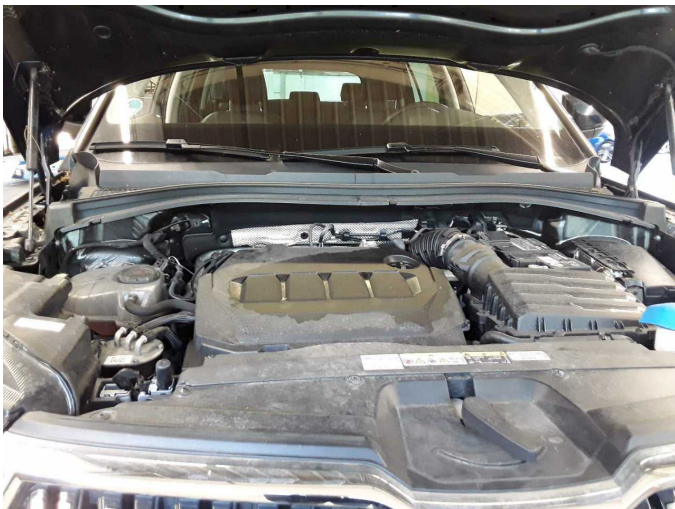
**Damage 2:** Engine: Engine - Leaking - Diagnosed and repair if necessary

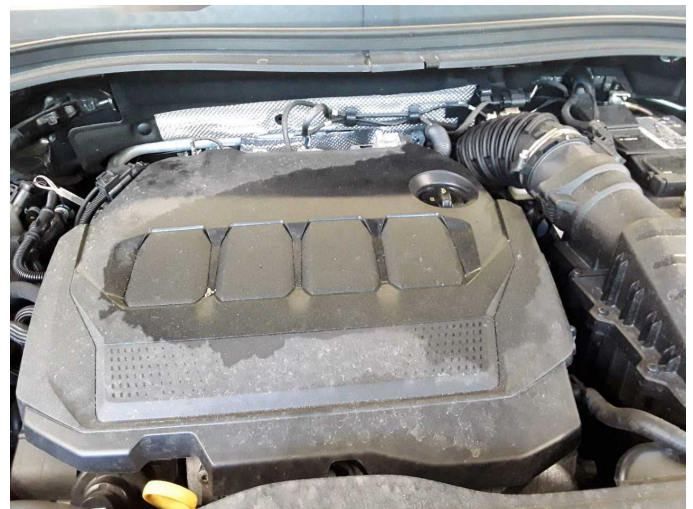
**Damage 2:** Engine: Engine - Leaking - Diagnosed and repair if necessary

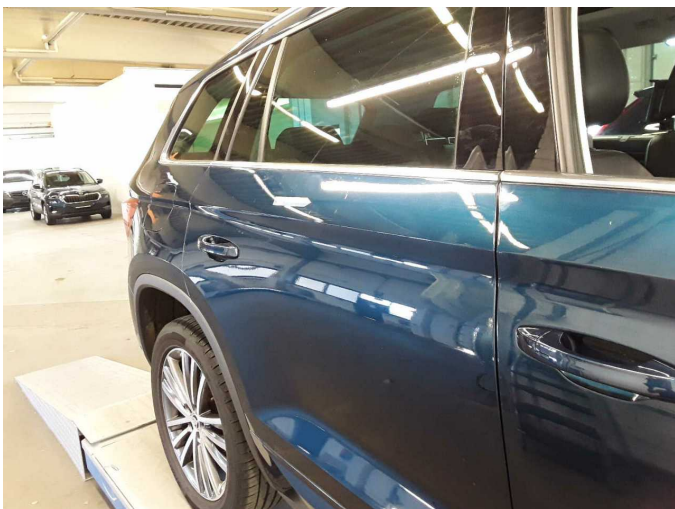
**Damage 3:** Body: Body (Mehrkosten sind möglich) - Soiled - Clean

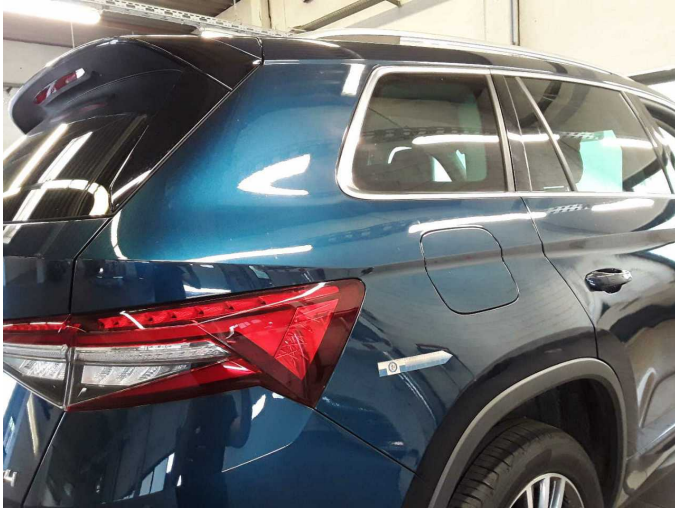
**Damage 3:** Body: Body (Mehrkosten sind möglich) - Soiled - Clean

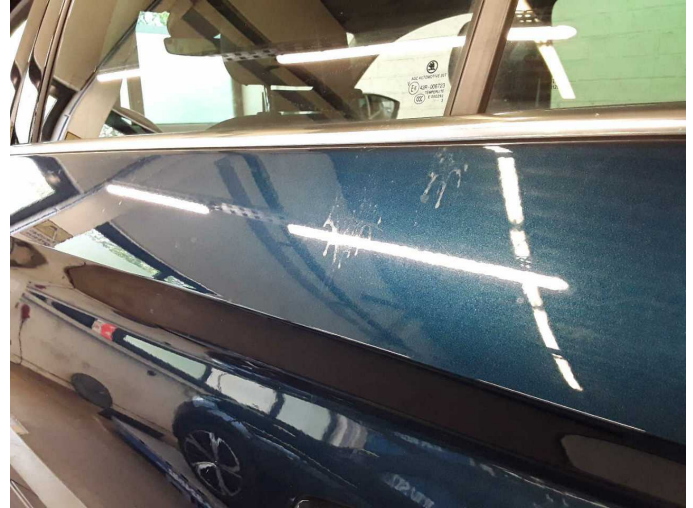
**Damage 3:** Body: Body (Mehrkosten sind möglich) - Soiled - Clean

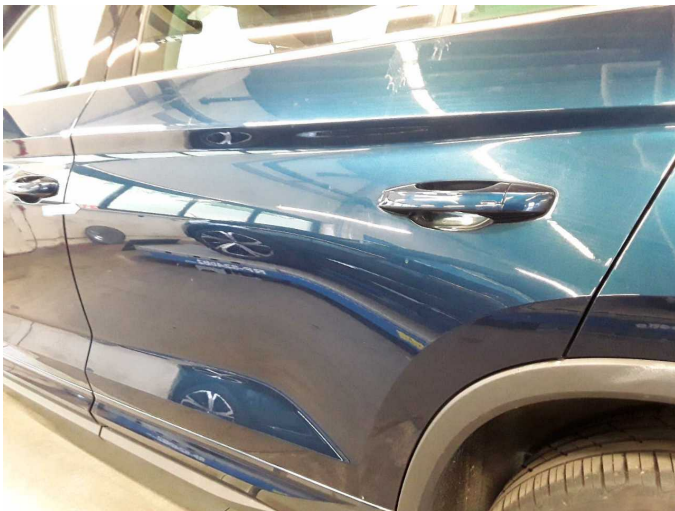
**Damage 4:** Door - rear left side: Door - Deformed - Repair and paint

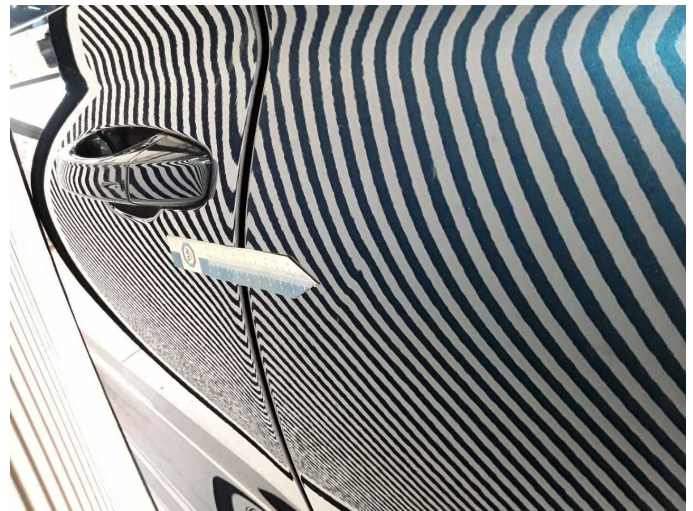
**Damage 4:** Door - rear left side: Door - Deformed - Repair and paint

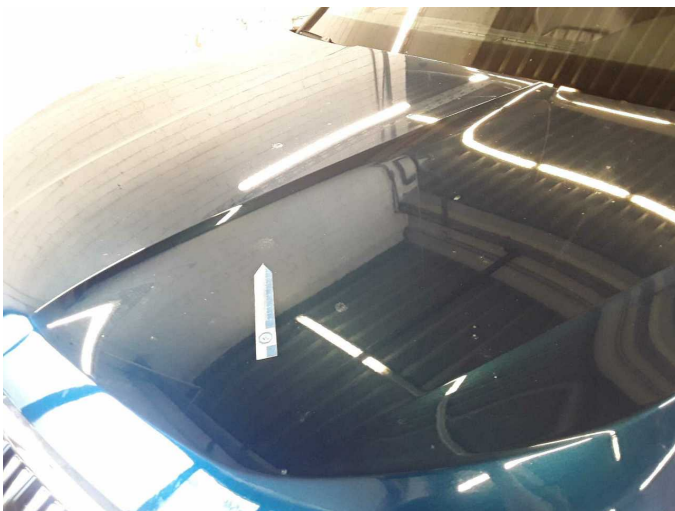
**Damage 5:** Bonnet: Bonnet (Vogelkot) - Paint defect - Paint

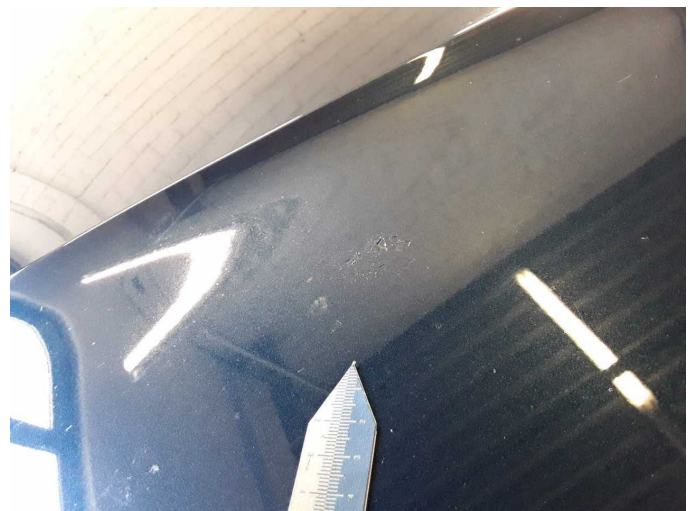
**Damage 5:** Bonnet: Bonnet (Vogelkot) - Paint defect - Paint

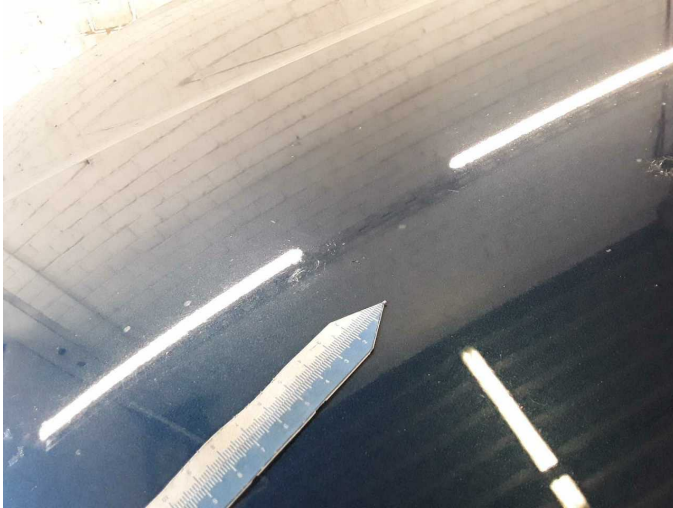
**Damage 5:** Bonnet: Bonnet (Vogelkot) - Paint defect - Paint

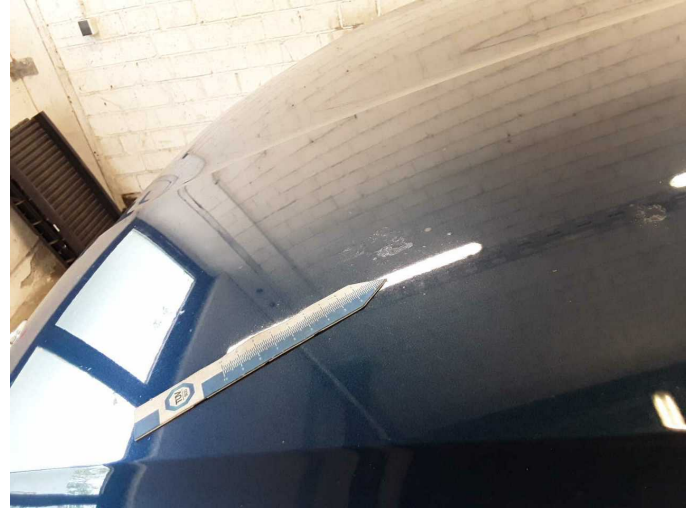
**Damage 5:** Bonnet: Bonnet (Vogelkot) - Paint defect - Paint

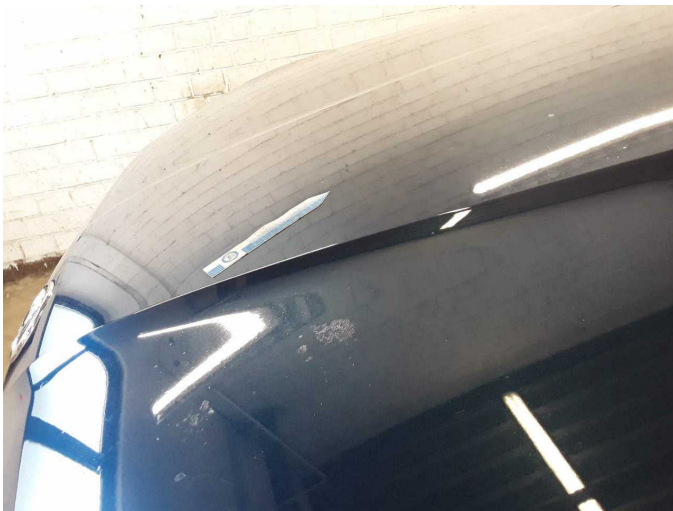
**Damage 5:** Bonnet: Bonnet (Vogelkot) - Paint defect - Paint

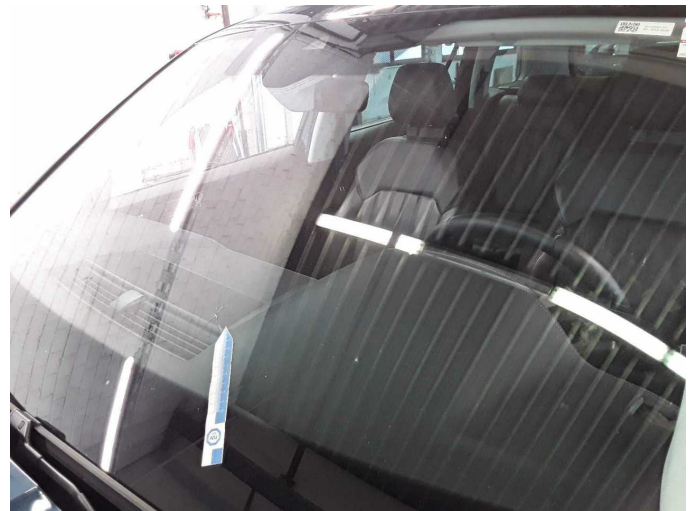
**Damage 6:** Vehicle glazing: Windscreen (Rissbildung) - Stone chips - Replace

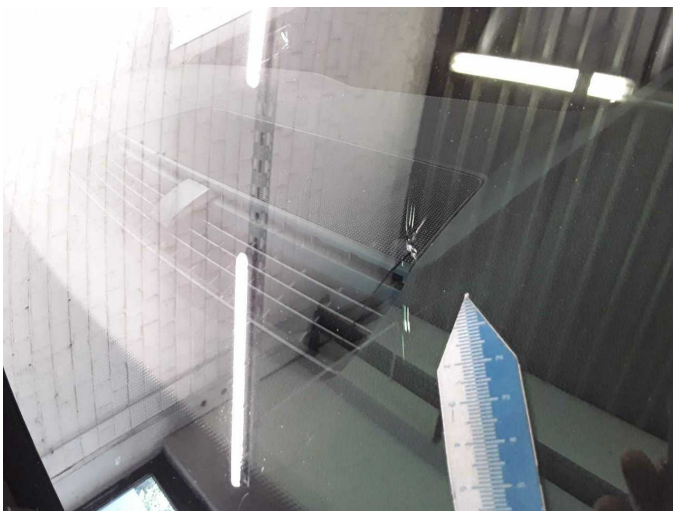
**Damage 6:** Vehicle glazing: Windscreen (Rissbildung) - Stone chips - Replace

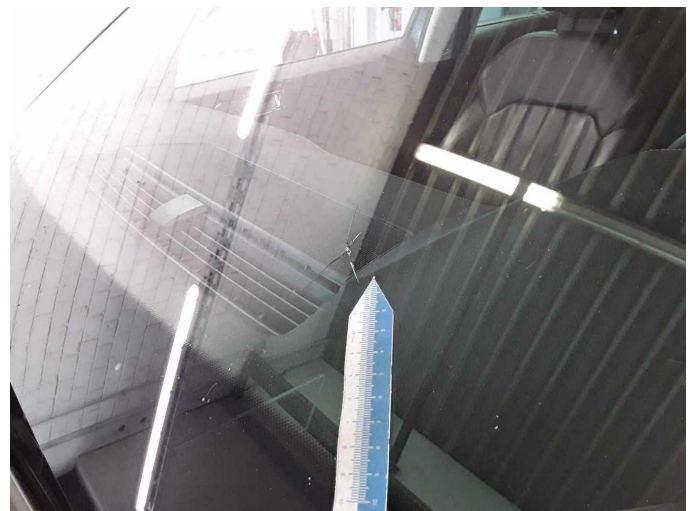
**Damage 6:** Vehicle glazing: Windscreen (Rissbildung) - Stone chips - Replace

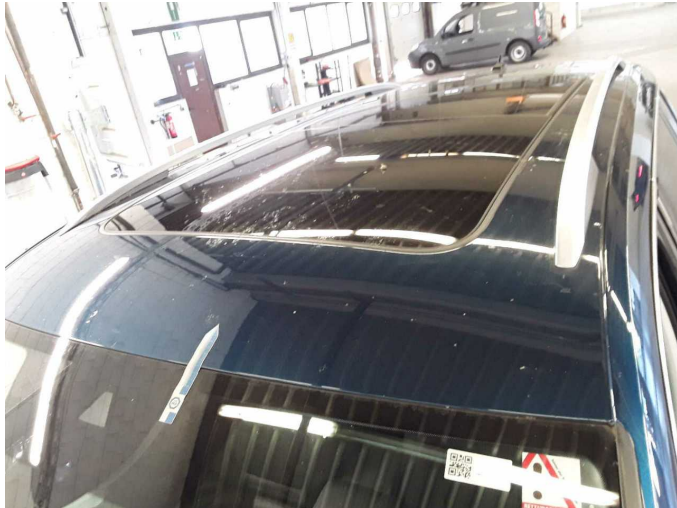
**Damage 7:** Roof: Roof (Vogelkot eingebrannt) - Paint defect - Paint

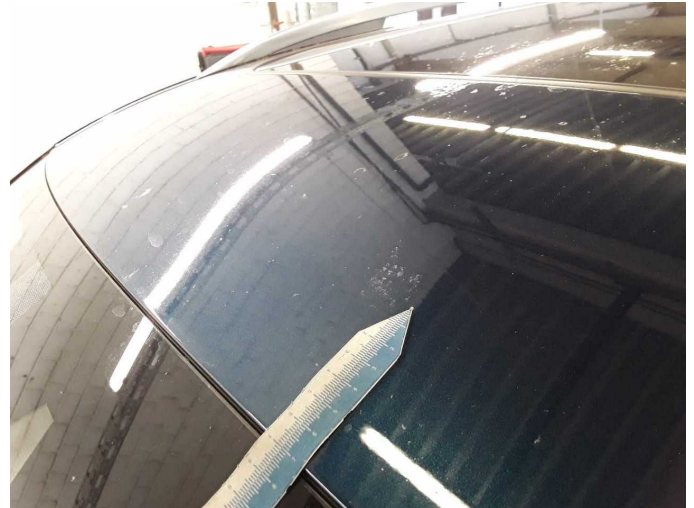
**Damage 7:** Roof: Roof (Vogelkot eingebrannt) - Paint defect - Paint

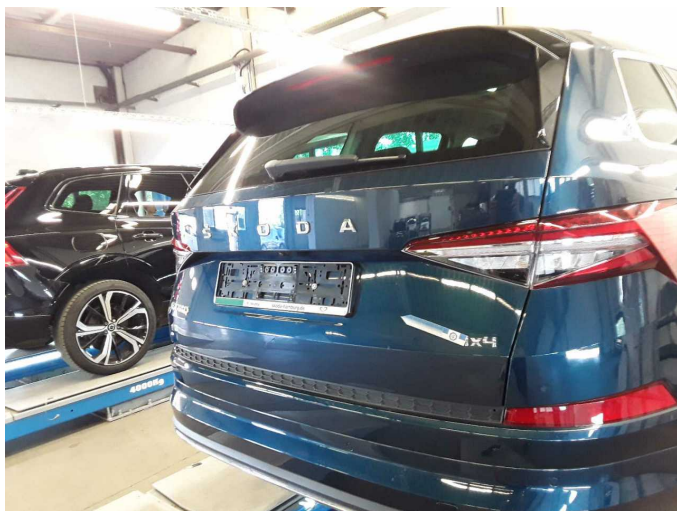
No.	Component group	Description
1	Boot lid / rear door	Boot lid - dent(s) - No deduction

**Wear and tear 1:** Boot lid / rear door: Boot lid - dent(s) - No deduction

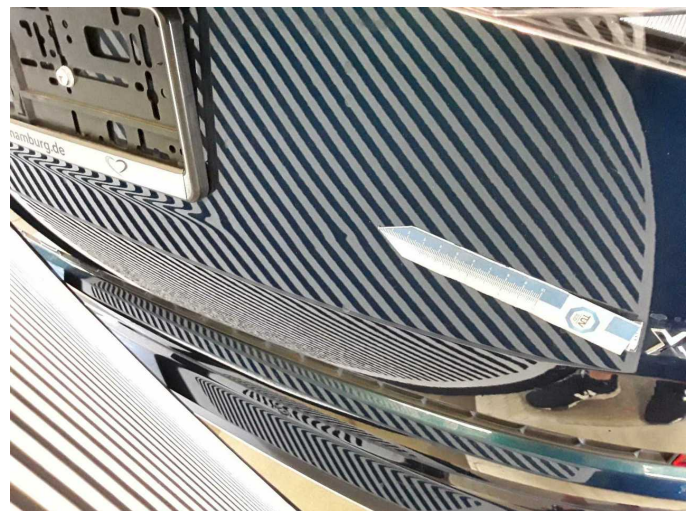
**Wear and tear 1:** Boot lid / rear door: Boot lid - dent(s) - No deduction
