Expertise

Protocol number: 46344291
Order No. / Reference: 26042884
Inspection date: 30 Jun 2026

Model: Vito 116 CDI Extralang HA Aut. PRO

VIN: W1VVLCEZ9T4563642

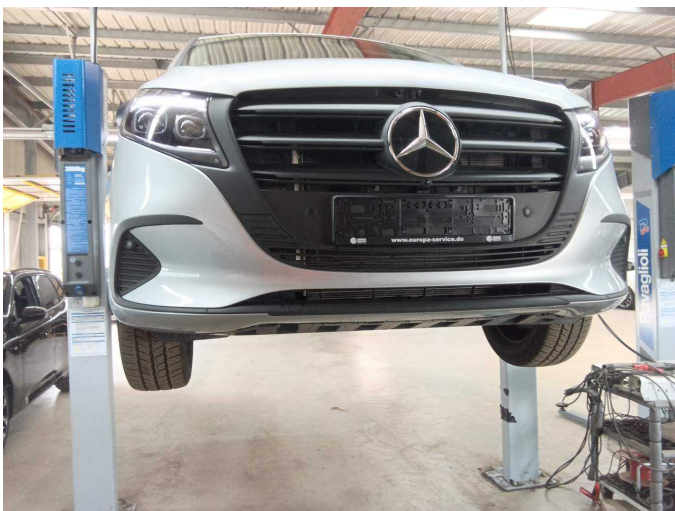
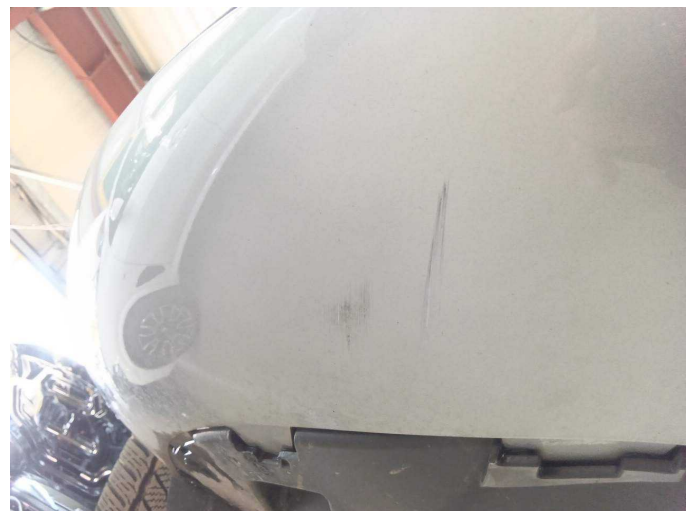
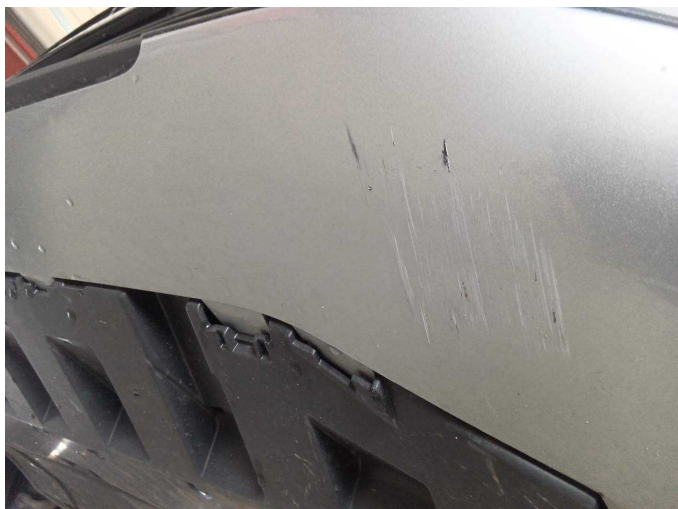
No.	Component group	Description
1	Front bumper	Front bumper - Scratch(es) - Paint

Damage 1: Front bumper: Front bumper - Scratch(es) - Paint

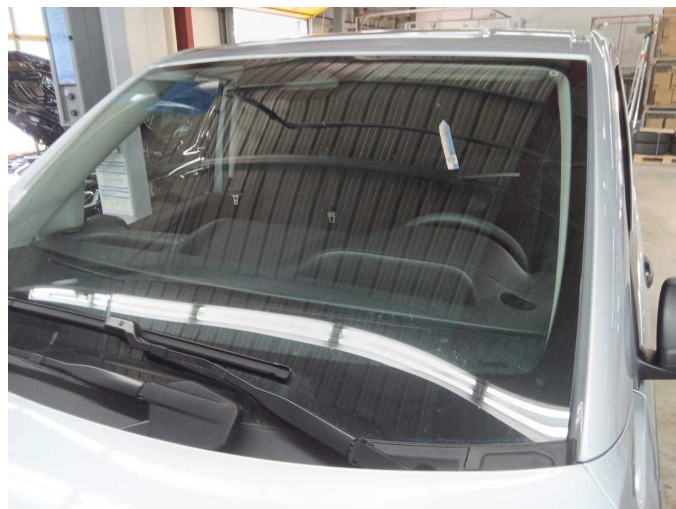
No.	Component group	Description
1	Vehicle glazing	Windscreen - Stone chips - No deduction
2	Boot lid / rear door	Boot lid - dent(s) - No deduction

Wear and tear 1: Vehicle glazing: Windscreen - Stone chips - No deduction

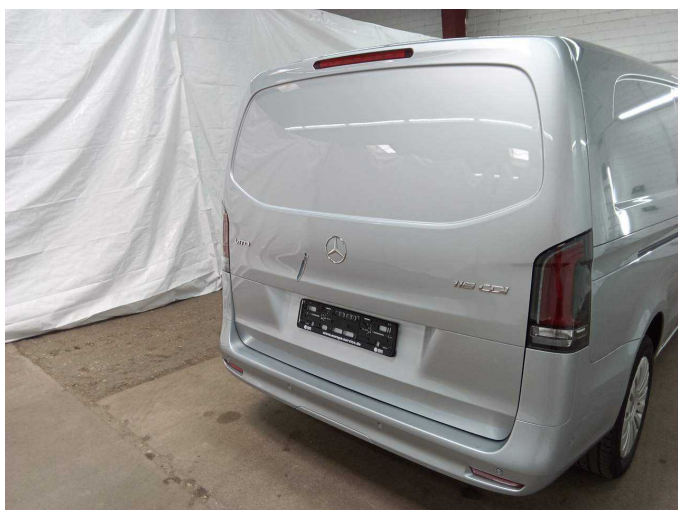
Wear and tear 2: Boot lid / rear door: Boot lid - dent(s) - No deduction
