Expertise

Protocol number: 46193332
Order No. / Reference: 25932942
Inspection date: 22 May 2026

Model: Vito 116 CDI Lang HA Aut. PRO

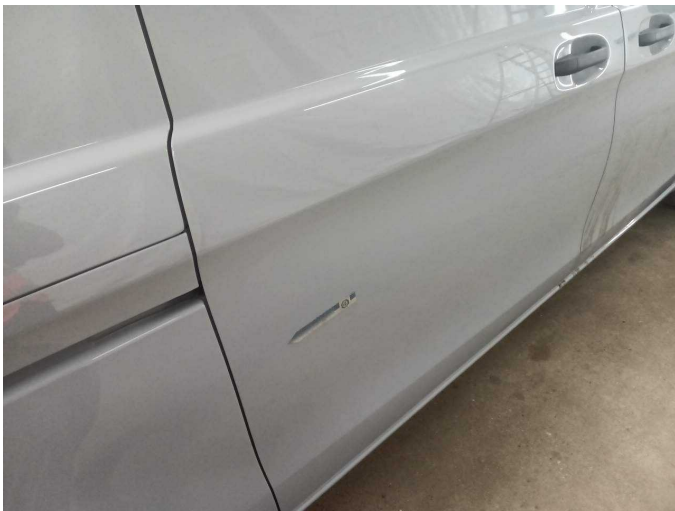
No.	Component group	Description
1	Misc.	Main inspection - No evidence - No deduction
2	Sliding door, right	Sliding door - dent(s) - Smooth repair work
3	Sill - left side	Sill - Scratch(es) - Smart repair
4	Roof	Roof - dent(s) - Smooth repair work
5	Instrument panel	Indicator light (Motorkontrollleuchte - Folgekosten möglich) - on - Perform diagnosis
6	Wheel / tyres	Tyre - front - Worn - Replace
7	Rear bumper	Rear bumper - Scratched - Loss in value
8	Front bumper	Front bumper - Scratched - Loss in value
9	Bonnet	Bonnet - Dent / paintcoat damage - Repair and paint
10	Vehicle glazing	Windscreen (Rissbildung) - Stone chips - Replace

Damage 2: Sliding door, right: Sliding door - dent(s) - Smooth repair work

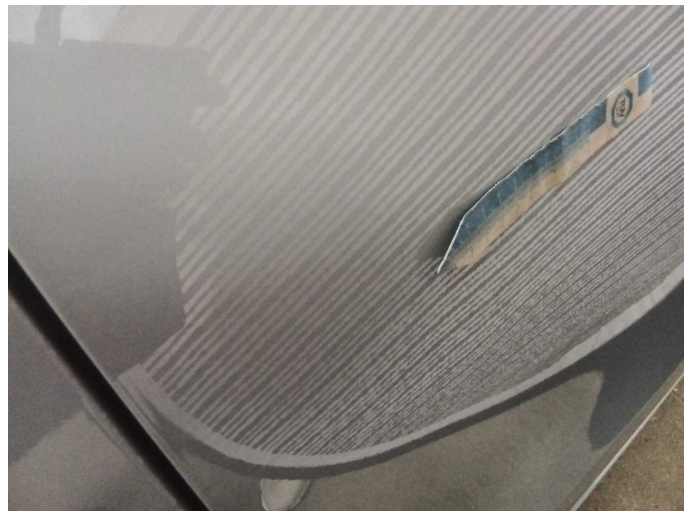
Damage 2: Sliding door, right: Sliding door - dent(s) - Smooth repair work

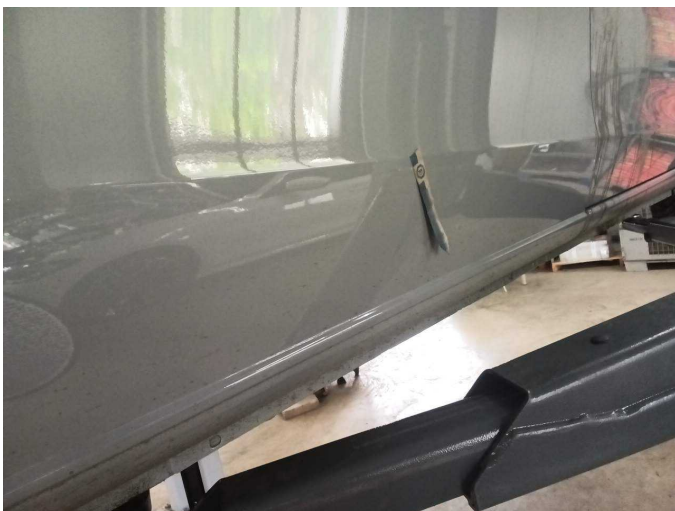
Damage 2: Sliding door, right: Sliding door - dent(s) - Smooth repair work

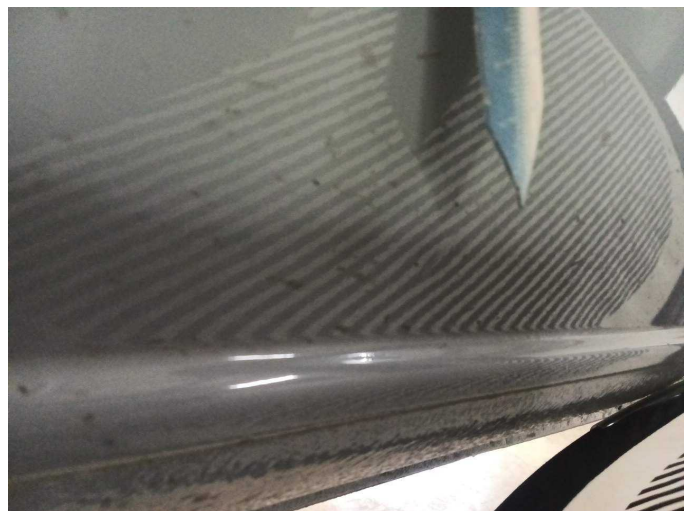
Damage 2: Sliding door, right: Sliding door - dent(s) - Smooth repair work

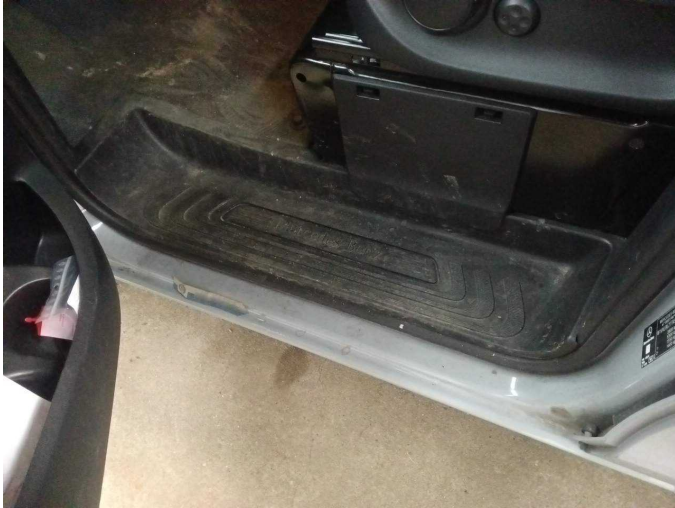
Damage 3: Sill - left side: Sill - Scratch(es) - Smart repair

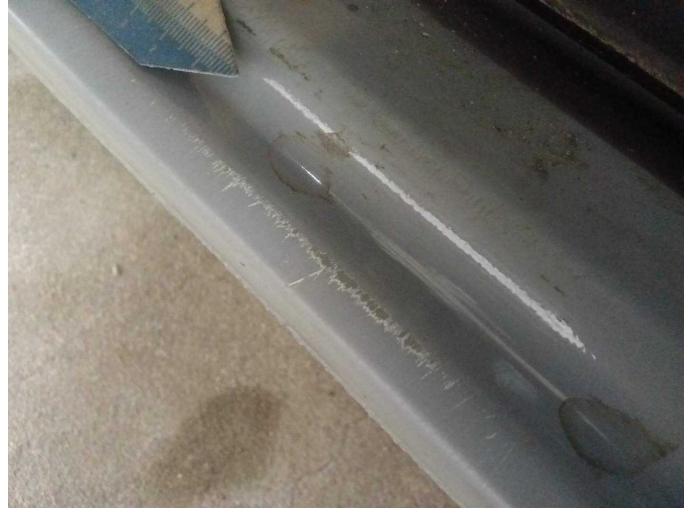
Damage 3: Sill - left side: Sill - Scratch(es) - Smart repair

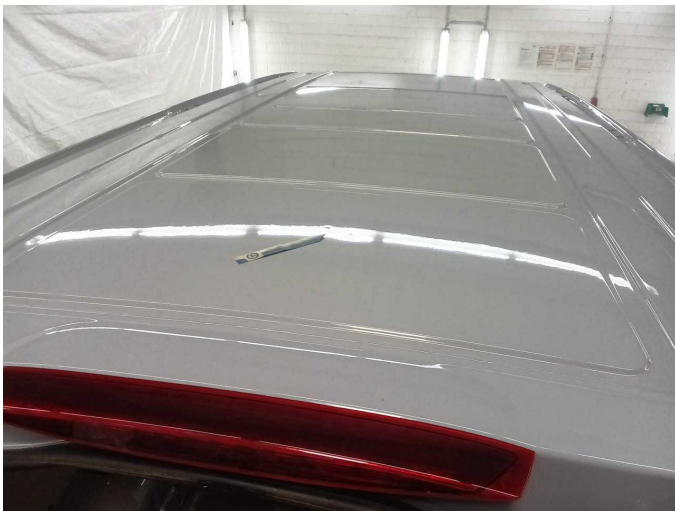
Damage 4: Roof: Roof - dent(s) - Smooth repair work

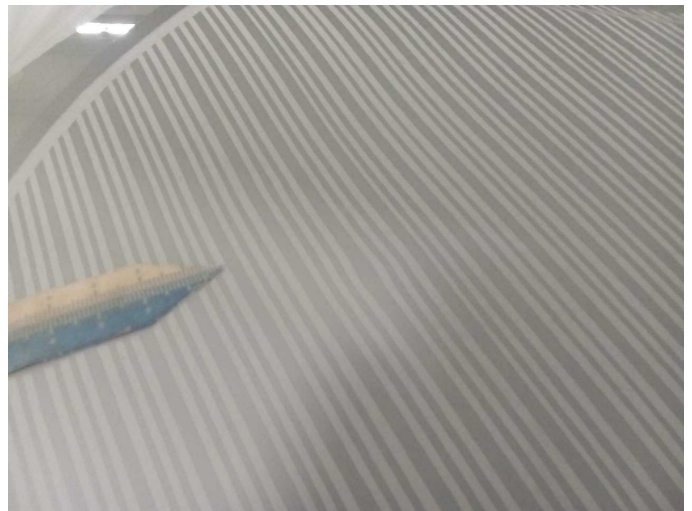
Damage 4: Roof: Roof - dent(s) - Smooth repair work

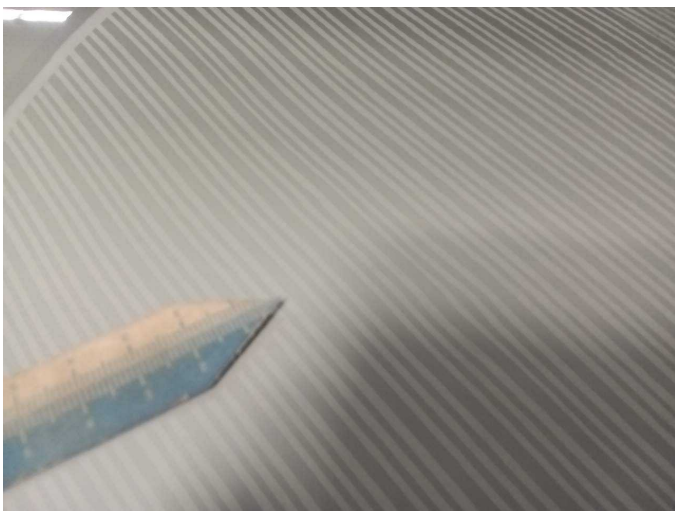
Damage 4: Roof: Roof - dent(s) - Smooth repair work

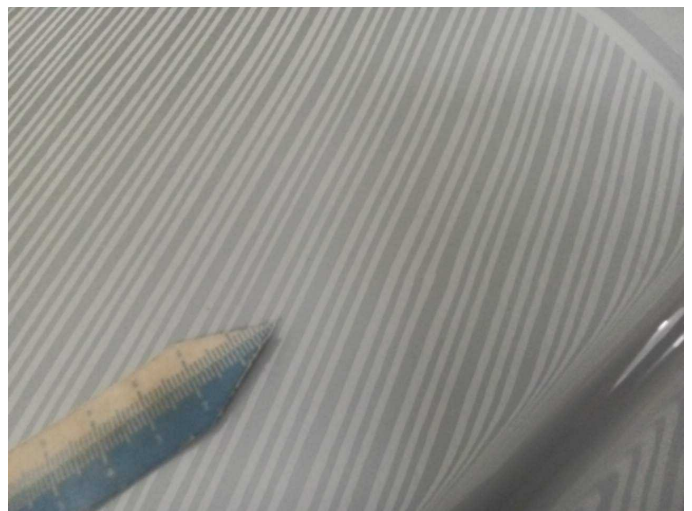
Damage 4: Roof: Roof - dent(s) - Smooth repair work

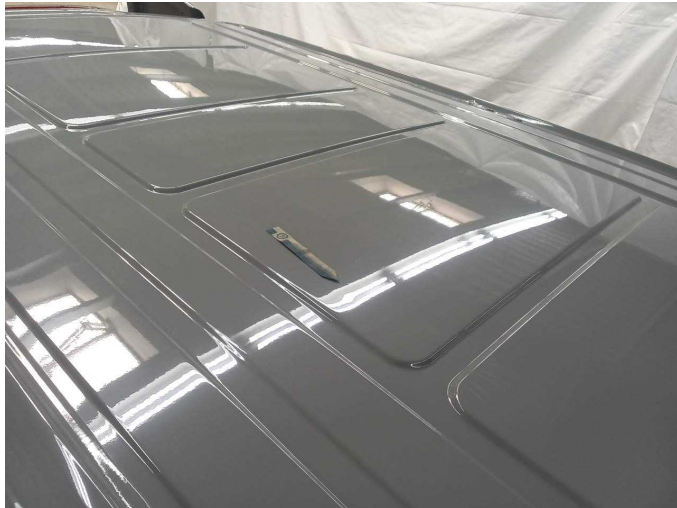
Damage 4: Roof: Roof - dent(s) - Smooth repair work

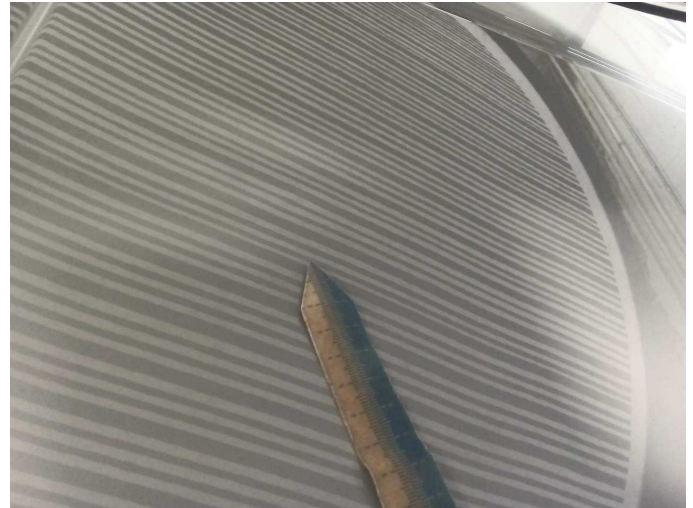
Damage 4: Roof: Roof - dent(s) - Smooth repair work

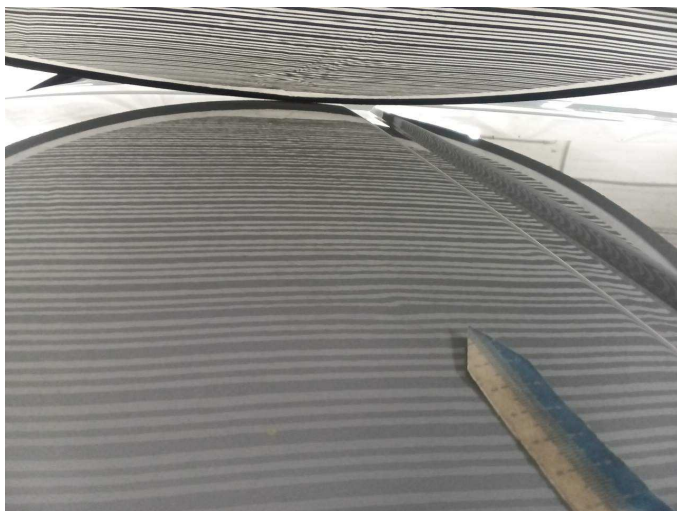
Damage 4: Roof: Roof - dent(s) - Smooth repair work

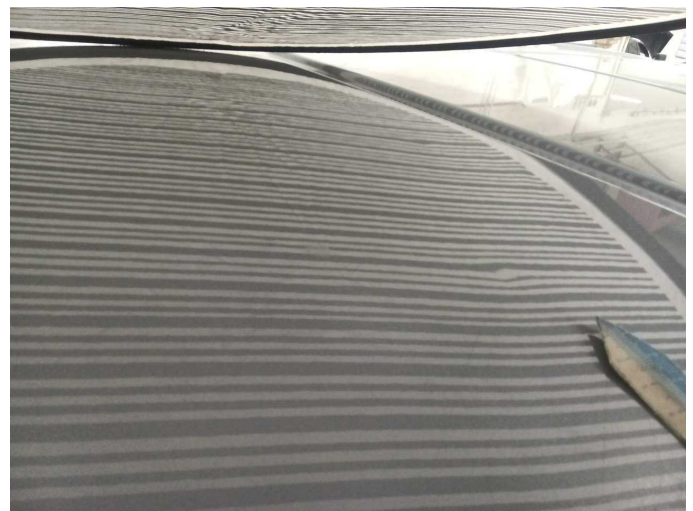
Damage 4: Roof: Roof - dent(s) - Smooth repair work

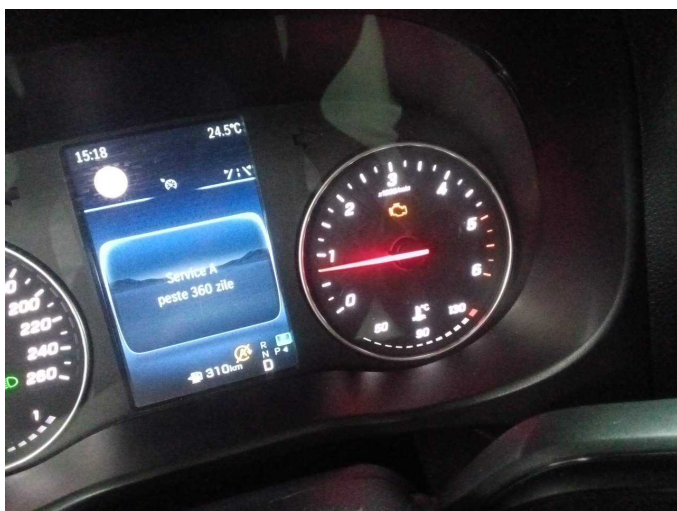
Damage 5: Instrument panel: Indicator light (Motorkontrollleuchte - Folgekosten möglich) - on - Perform diagnosis

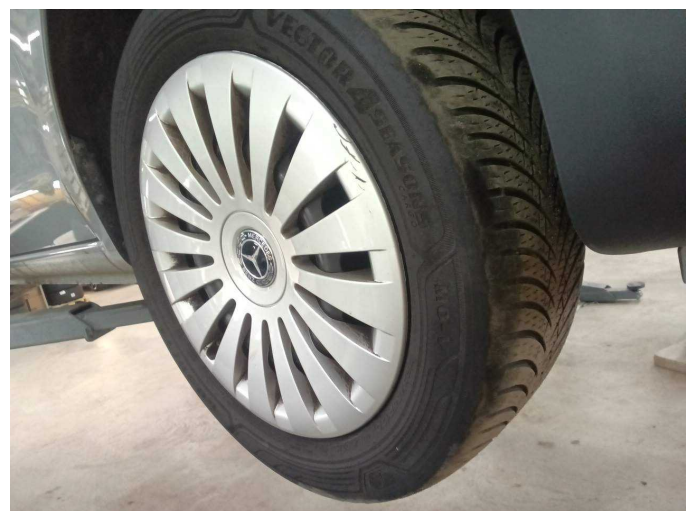
#	Tyre size	Type of tyre	Manufacturer	Tread depth
1)	225/55 R17 109H	All-season tyres on Steel rim with wheel cover	Goodyear	4mm / 4mm
2)	225/55 R17 109H	All-season tyres on Steel rim with wheel cover	Goodyear	6mm / 6mm

Damage 6: Wheel / tyres: Tyre - front - Worn - Replace

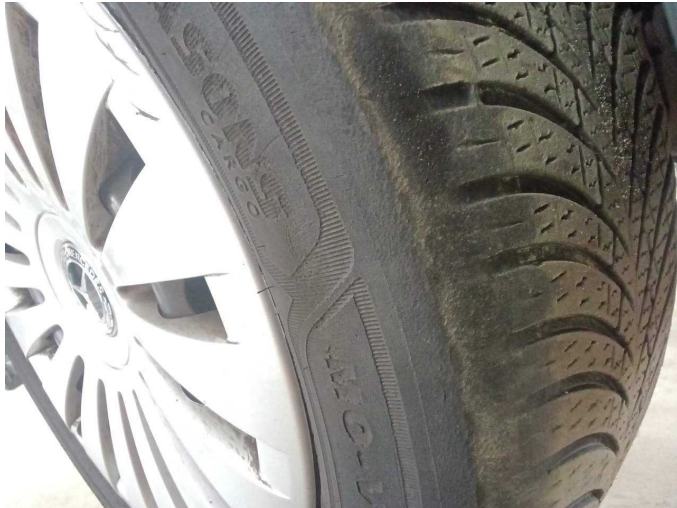
Damage 6: Wheel / tyres: Tyre - front - Worn - Replace

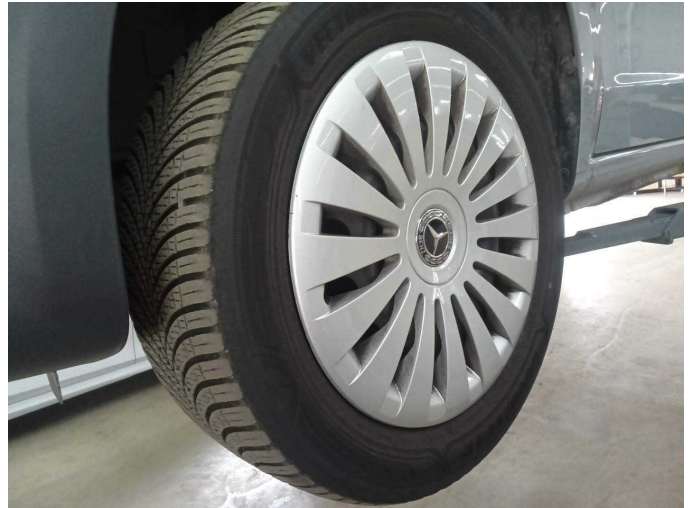
Damage 6: Wheel / tyres: Tyre - front - Worn - Replace

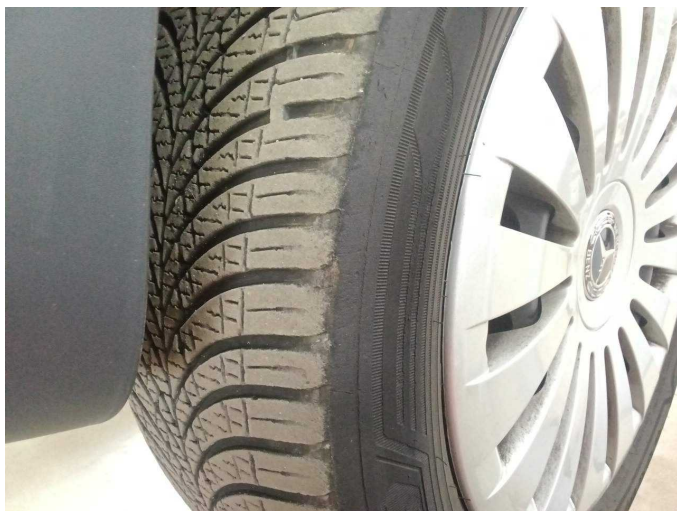
Damage 6: Wheel / tyres: Tyre - front - Worn - Replace

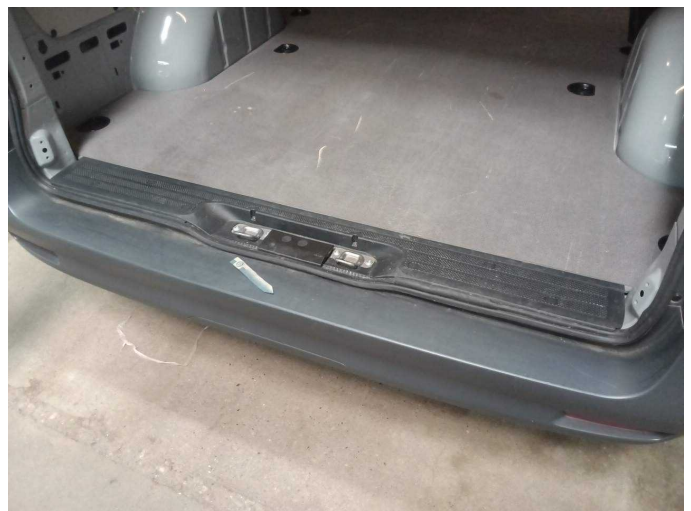
Damage 7: Rear bumper: Rear bumper - Scratched - Loss in value

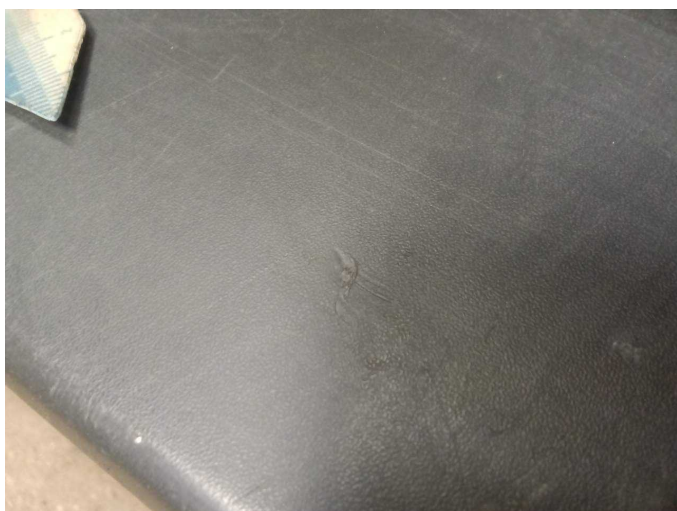
Damage 7: Rear bumper: Rear bumper - Scratched - Loss in value

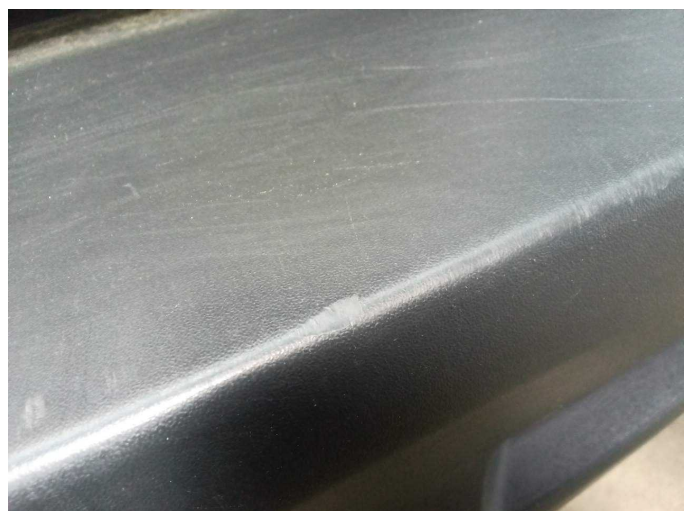
Damage 7: Rear bumper: Rear bumper - Scratched - Loss in value

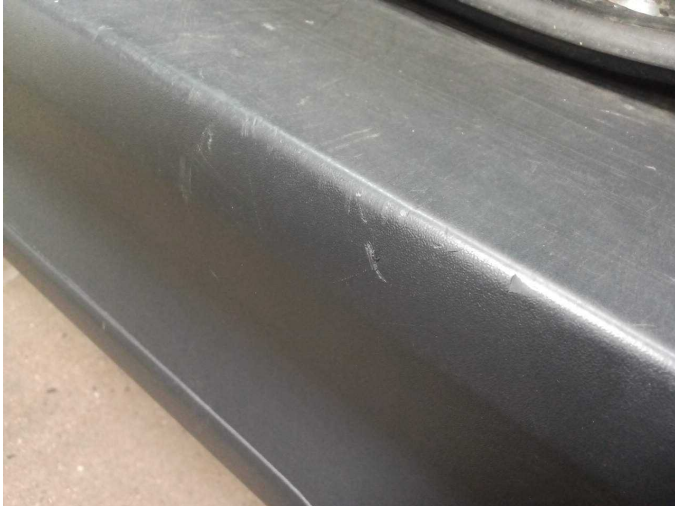
Damage 7: Rear bumper: Rear bumper - Scratched - Loss in value

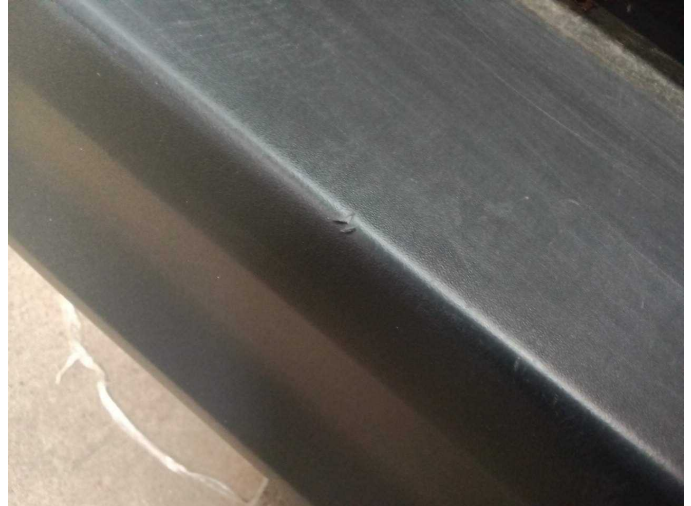
Damage 7: Rear bumper: Rear bumper - Scratched - Loss in value

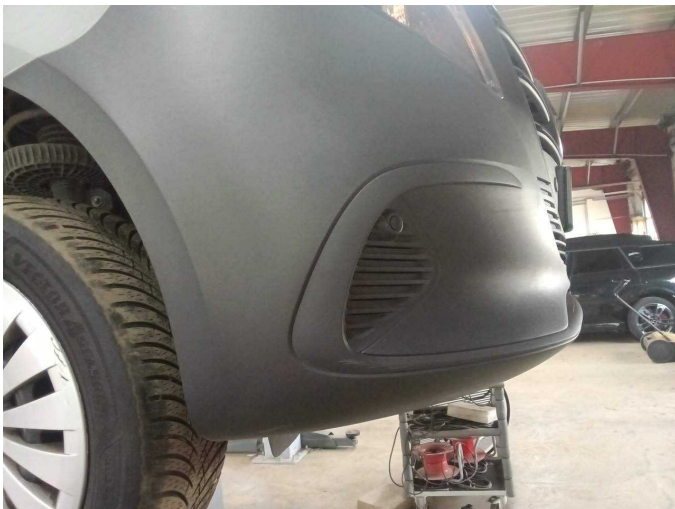
Damage 8: Front bumper: Front bumper - Scratched - Loss in value

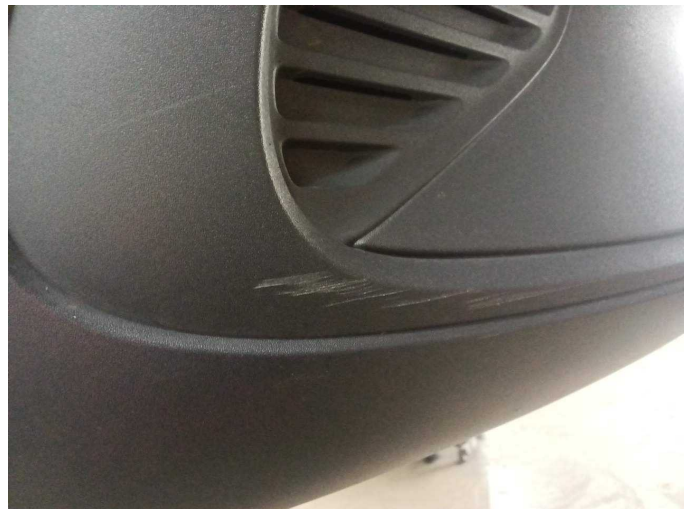
Damage 8: Front bumper: Front bumper - Scratched - Loss in value

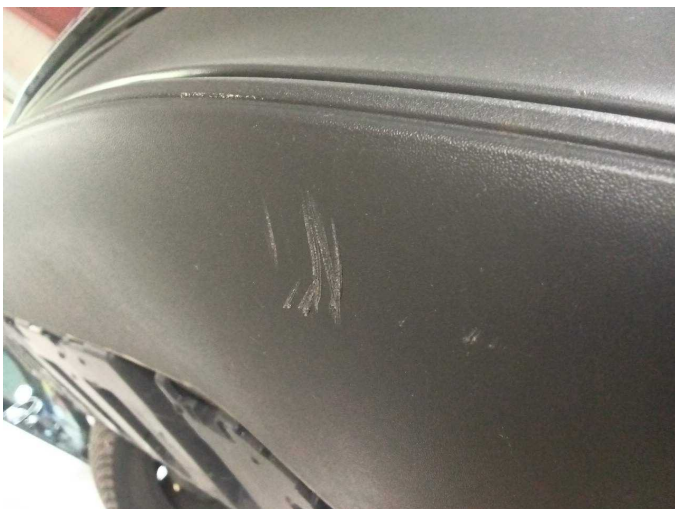
Damage 8: Front bumper: Front bumper - Scratched - Loss in value

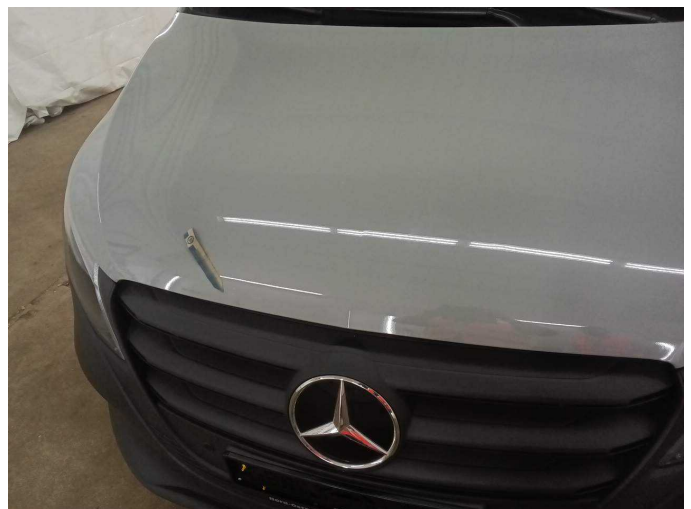
Damage 9: Bonnet: Bonnet - Dent / paintcoat damage - Repair and paint

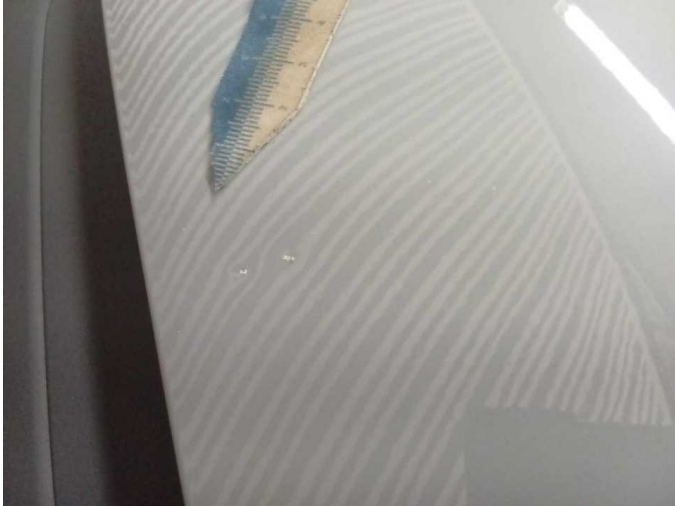
Damage 9: Bonnet: Bonnet - Dent / paintcoat damage - Repair and paint

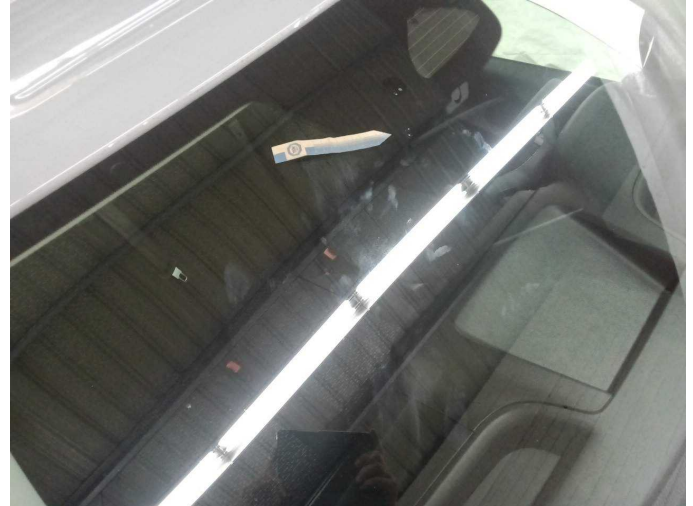
Damage 10: Vehicle glazing: Windscreen (Rissbildung) - Stone chips - Replace

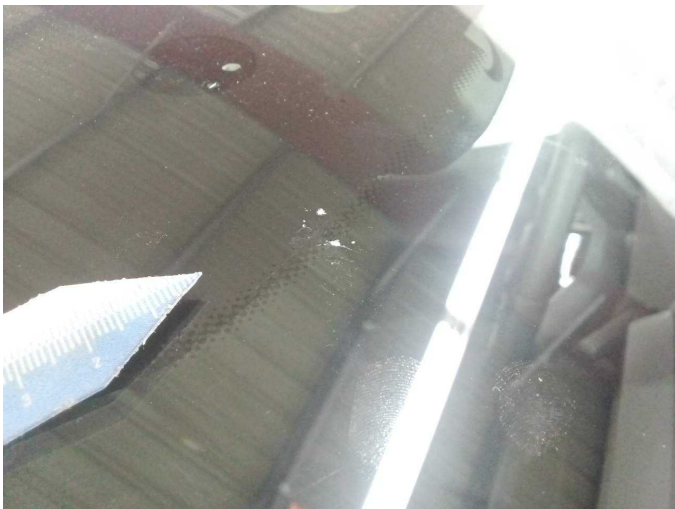
Damage 10: Vehicle glazing: Windscreen (Rissbildung) - Stone chips - Replace

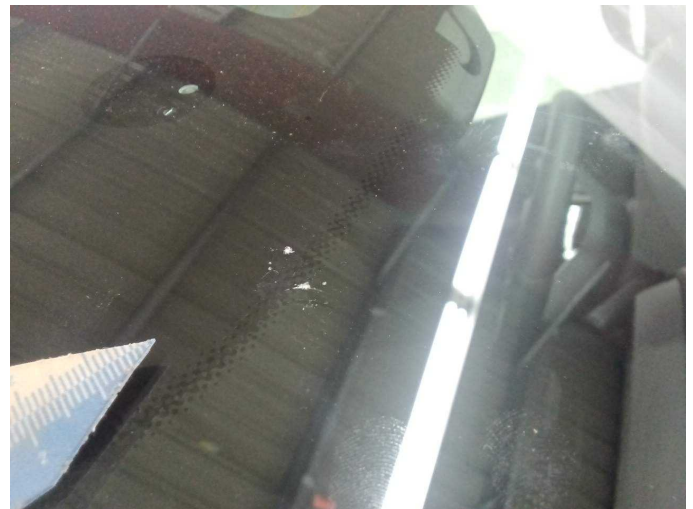
Damage 10: Vehicle glazing: Windscreen (Rissbildung) - Stone chips - Replace
