## Expertise

Protocol number: 46042759  
Order No. / Reference: 26154445  
Inspection date: 16 Jun 2026

Manufacturer: Mercedes-Benz

Model: Vito 116 CDI Lang HA Aut. PRO

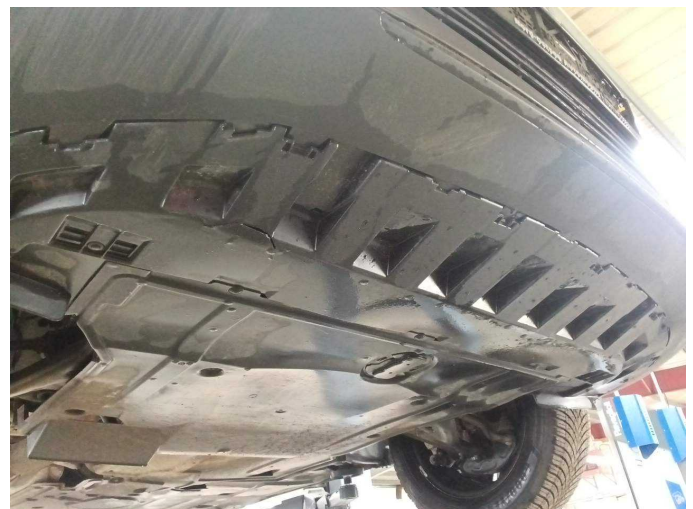
Damage 3: Body: Underbody panelling - Broken / torn - Replace

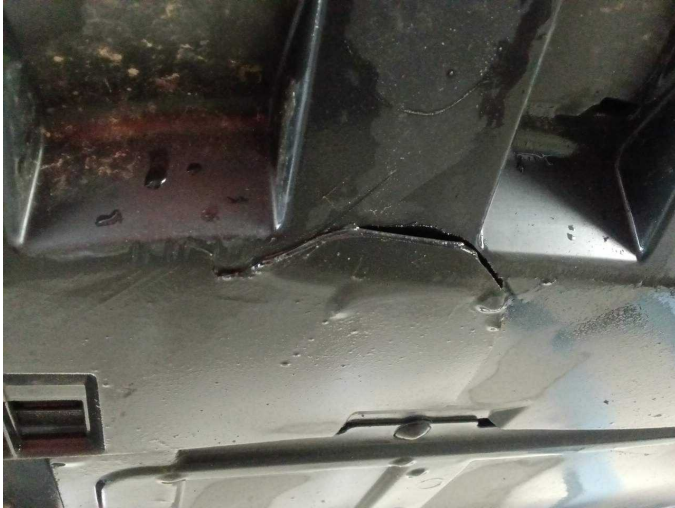
**Damage 3:** Body: Underbody panelling - Broken / torn - Replace

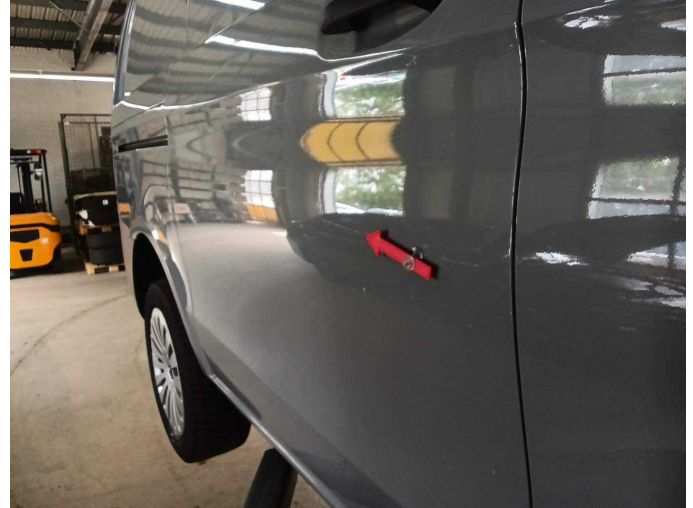
**Damage 4:** Sliding door, right: Sliding door - dent(s) - Smooth repair work

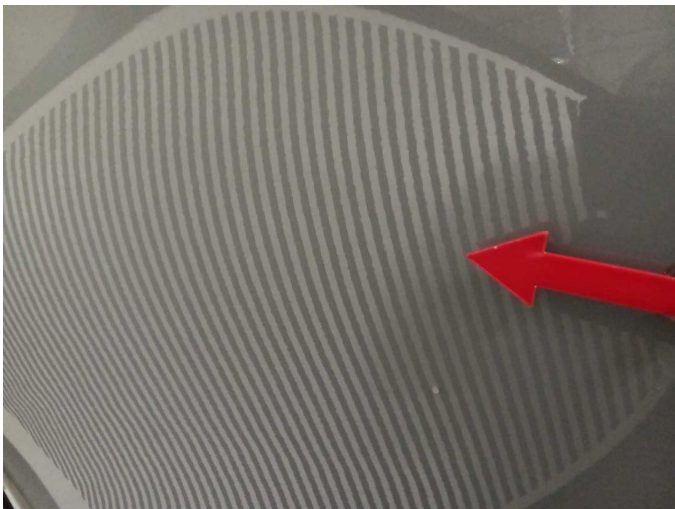
**Damage 4:** Sliding door, right: Sliding door - dent(s) - Smooth repair work

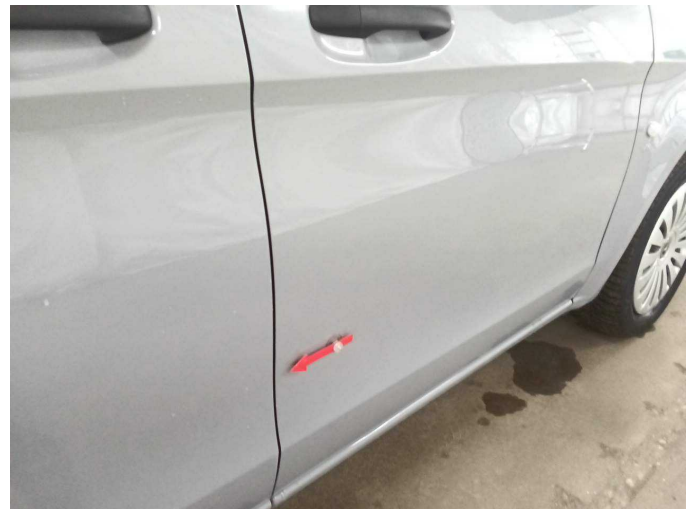
**Damage 5:** Door - front right side: Door edge - Scratch(es) - Smart repair

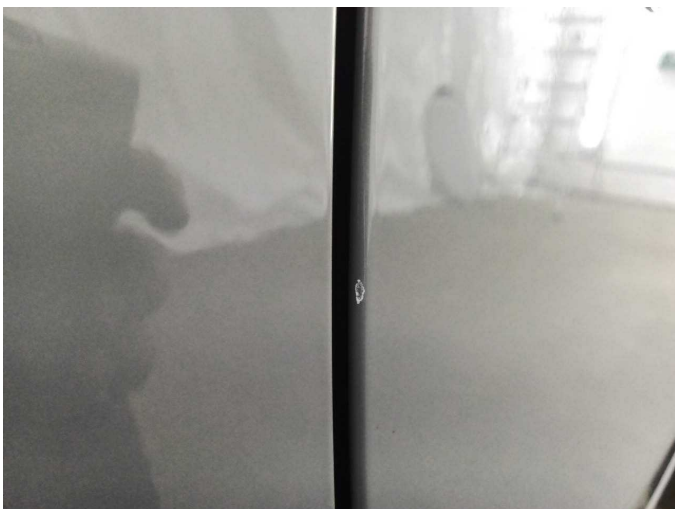
**Damage 5:** Door - front right side: Door edge - Scratch(es) - Smart repair

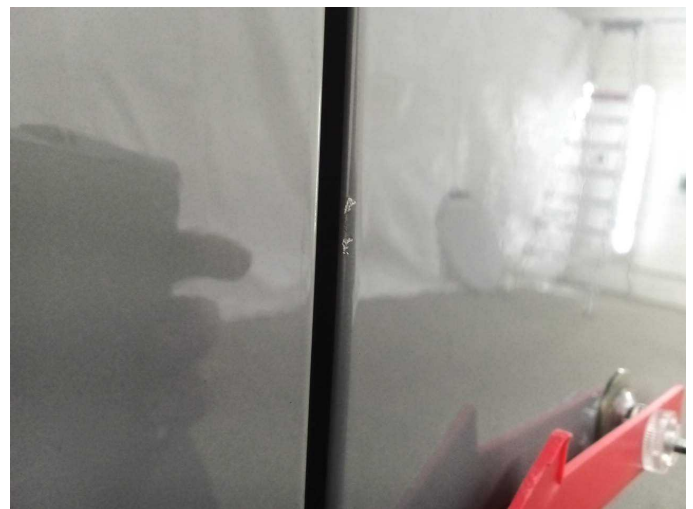
**Damage 5:** Door - front right side: Door edge - Scratch(es) - Smart repair

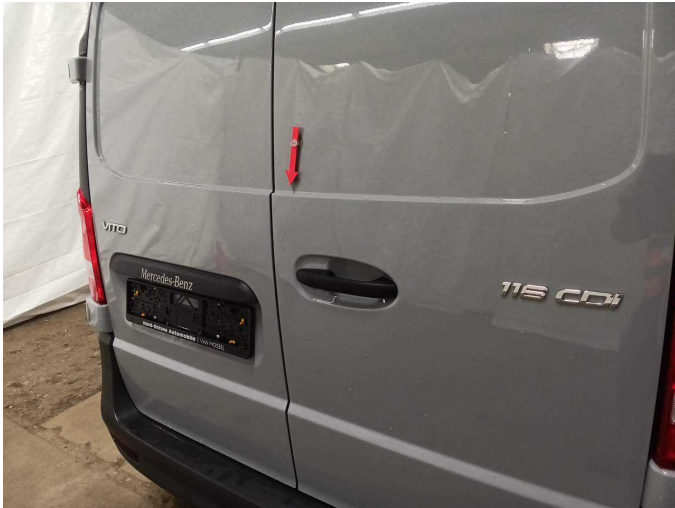
**Damage 6:** Boot lid / rear door: Boot lid - dent(s) - Smooth repair work

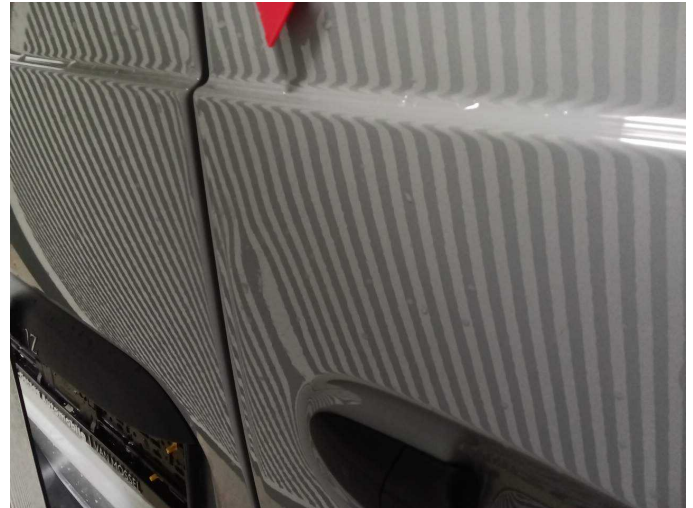
**Damage 6:** Boot lid / rear door: Boot lid - dent(s) - Smooth repair work

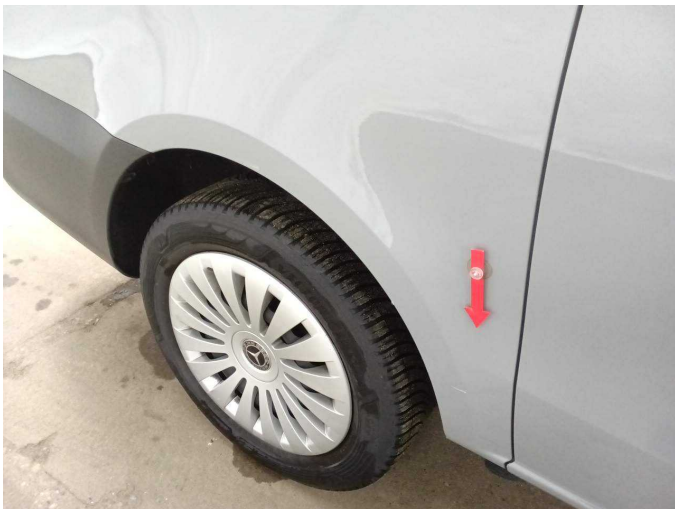
**Damage 7:** Side panel - rear right side: Elbow - Dent / paintcoat damage - Smart repair

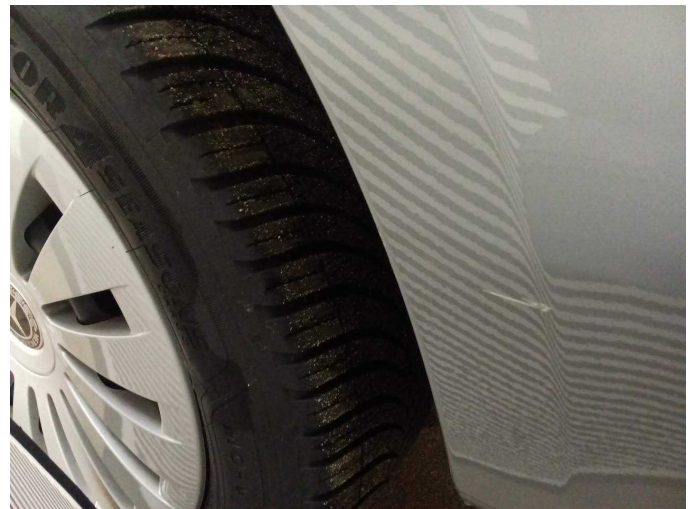
**Damage 7:** Side panel - rear right side: Elbow - Dent / paintcoat damage - Smart repair

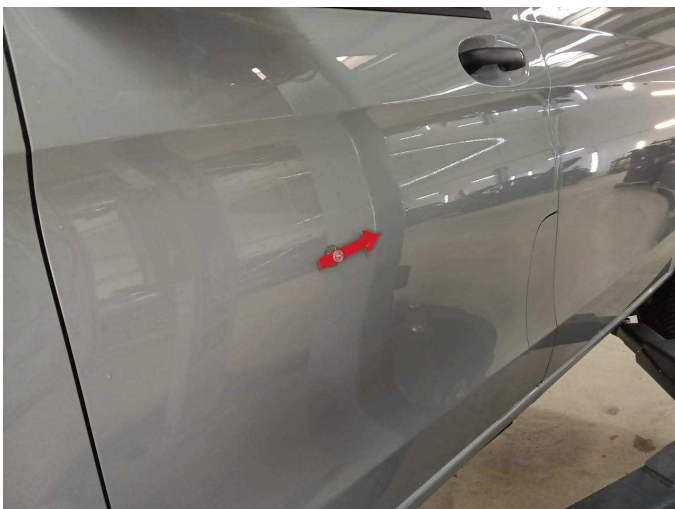
**Damage 8:** Door - front left side: Door - Dent / paintcoat damage - Smart repair

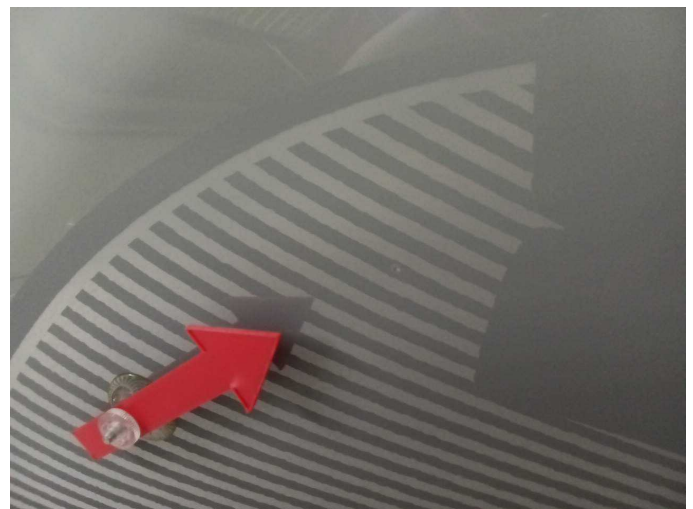
**Damage 8:** Door - front left side: Door - Dent / paintcoat damage - Smart repair

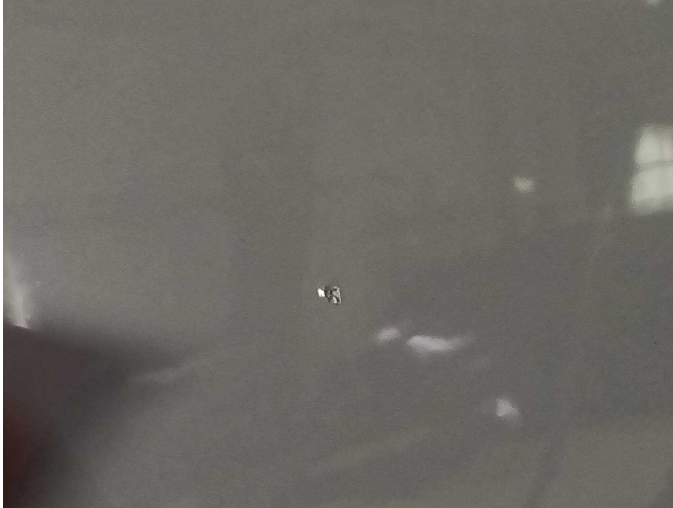
**Damage 8:** Door - front left side: Door - Dent / paintcoat damage - Smart repair

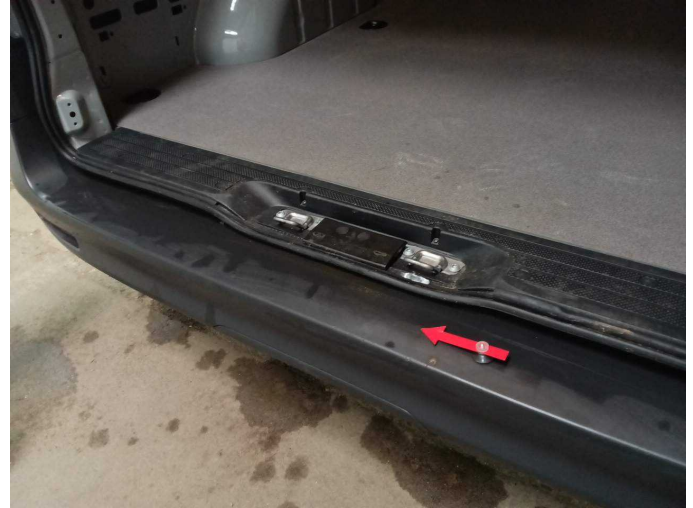
**Damage 9:** Rear bumper: Rear bumper (Befestigung gebrochen) - Deformed - Replace

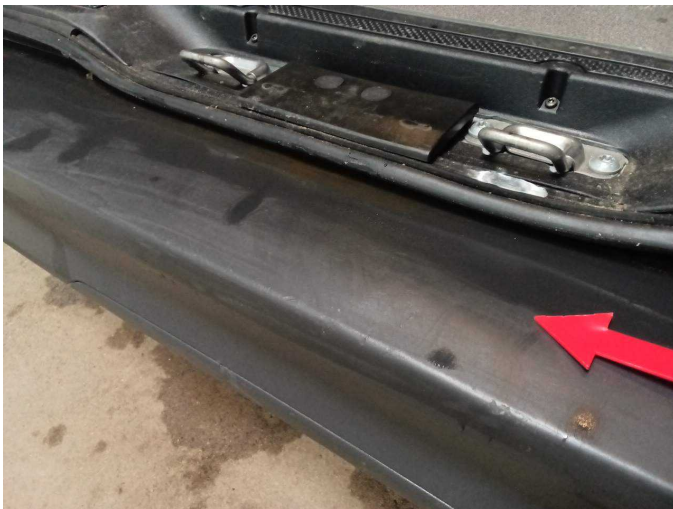
**Damage 9:** Rear bumper: Rear bumper (Befestigung gebrochen) - Deformed - Replace

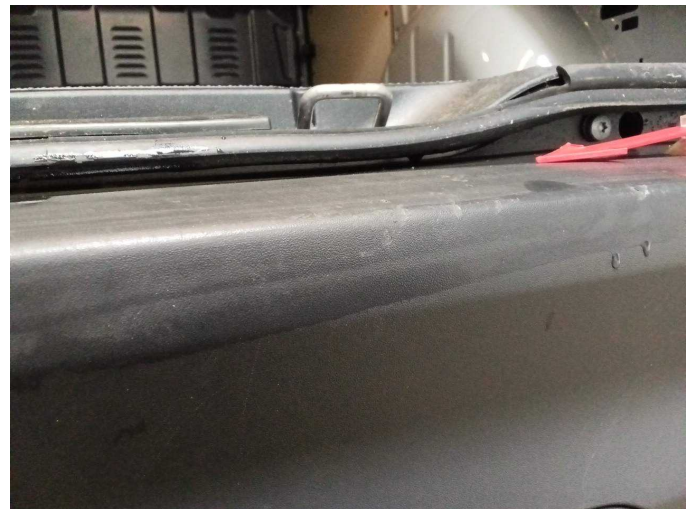
**Damage 9:** Rear bumper: Rear bumper (Befestigung gebrochen) - Deformed - Replace

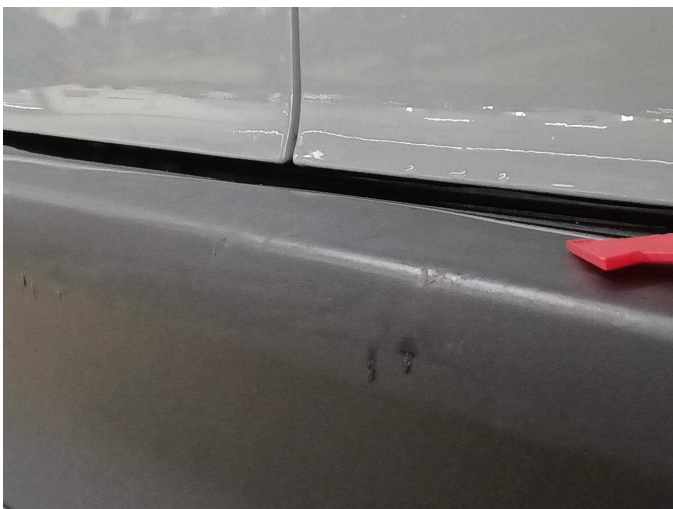
**Damage 9:** Rear bumper: Rear bumper (Befestigung gebrochen) - Deformed - Replace

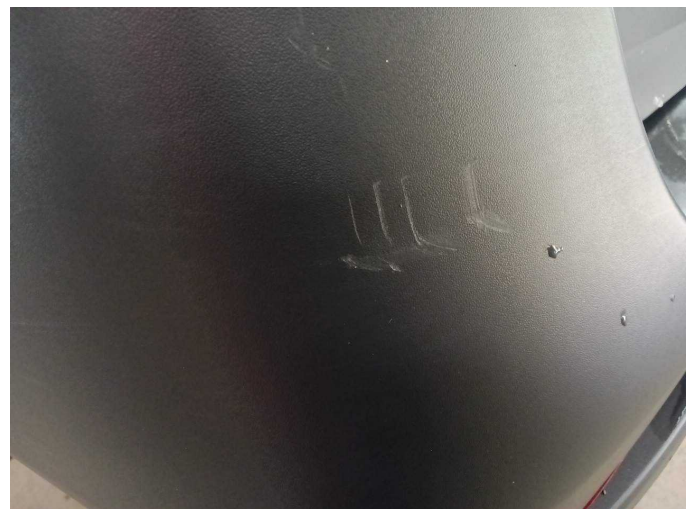
**Damage 9:** Rear bumper: Rear bumper (Befestigung gebrochen) - Deformed - Replace

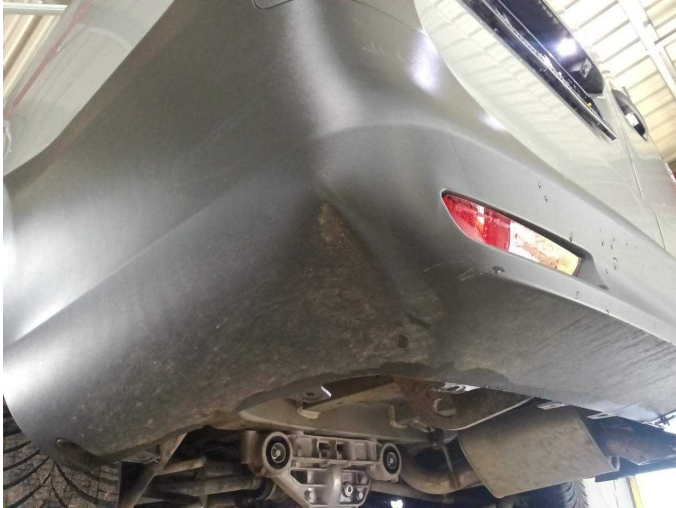
**Damage 9:** Rear bumper: Rear bumper (Befestigung gebrochen) - Deformed - Replace

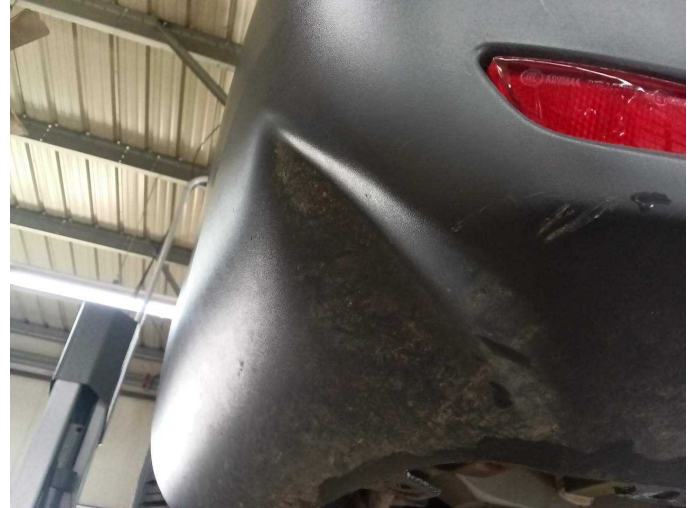
**Damage 9:** Rear bumper: Rear bumper (Befestigung gebrochen) - Deformed - Replace

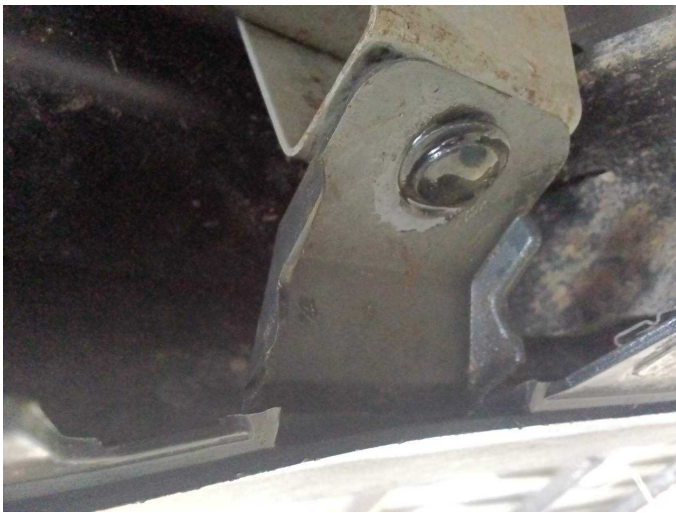
**Damage 9:** Rear bumper: Rear bumper (Befestigung gebrochen) - Deformed - Replace

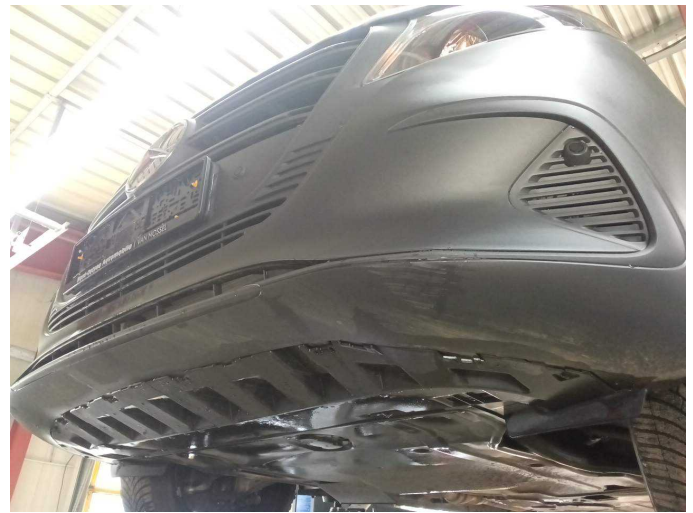
**Damage 10:** Front bumper: Front bumper - Scratched - Replace

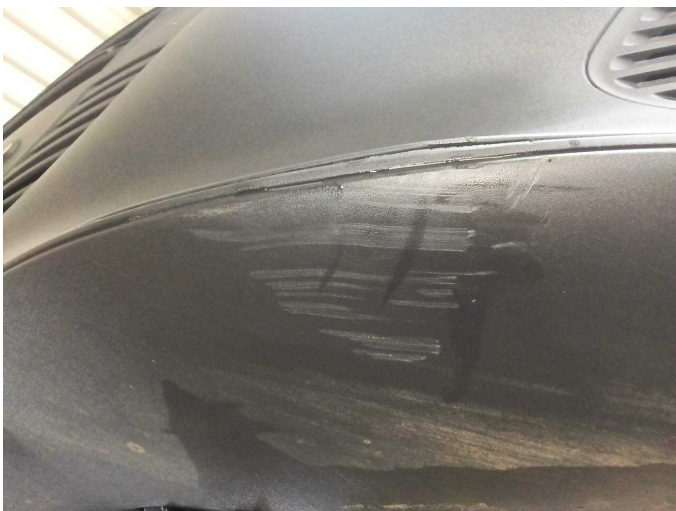
**Damage 10:** Front bumper: Front bumper - Scratched - Replace

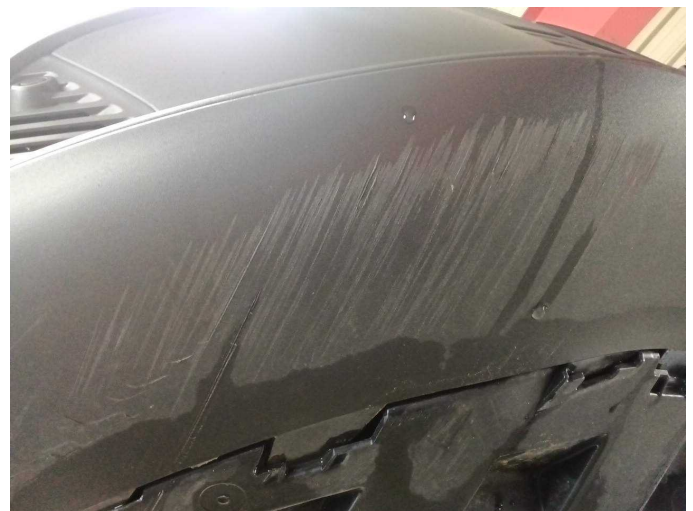
**Damage 10:** Front bumper: Front bumper - Scratched - Replace

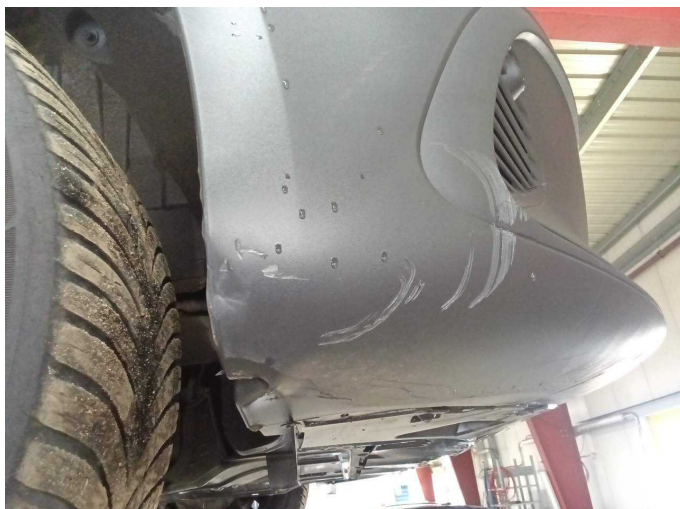
**Damage 10:** Front bumper: Front bumper - Scratched - Replace

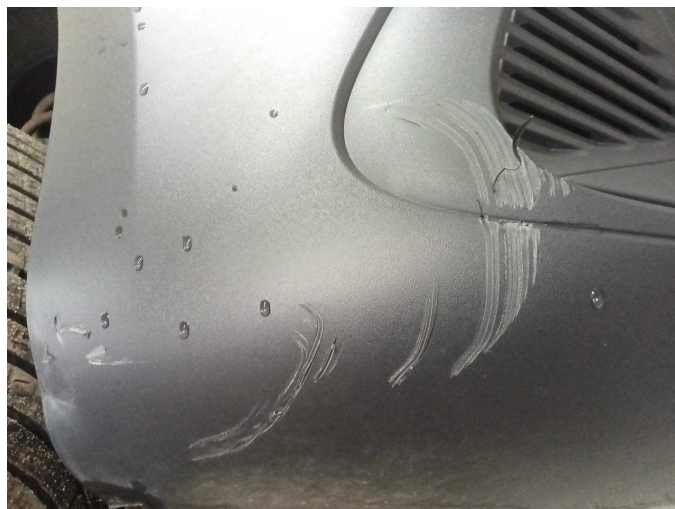
**Damage 10:** Front bumper: Front bumper - Scratched - Replace

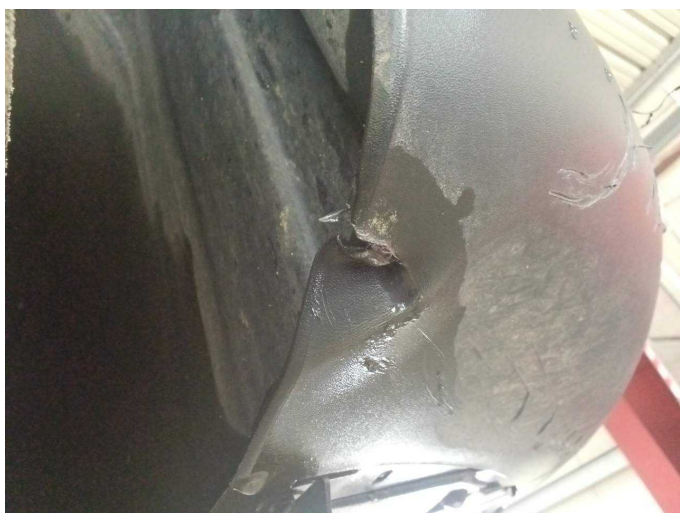
**Damage 10:** Front bumper: Front bumper - Scratched - Replace
