Expertise

Protocol number: 46191696
Order No. / Reference: 26562056
Inspection date: 19 Jun 2026

Manufacturer: Peugeot

Model: 2008 Elektro GT

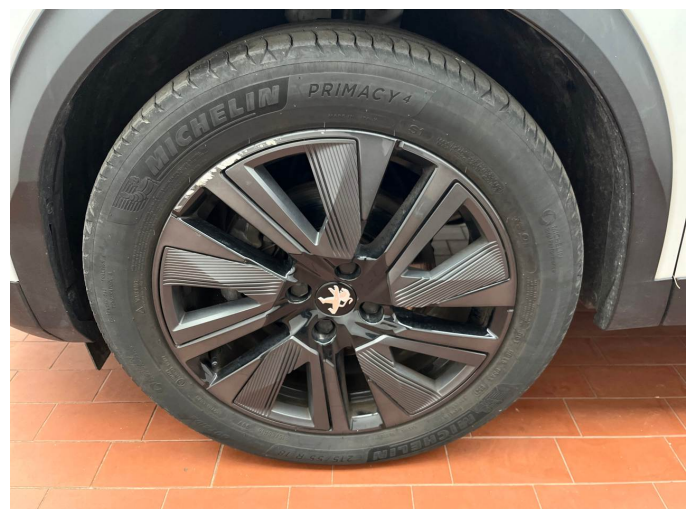
- Der verbaute Sommerradsatz ist höherwertiger als der, in der Ausstattungsliste angegebene. Für den Radsatz wurde kein Nachweis erbracht.

Figure 12: Mounted tyres

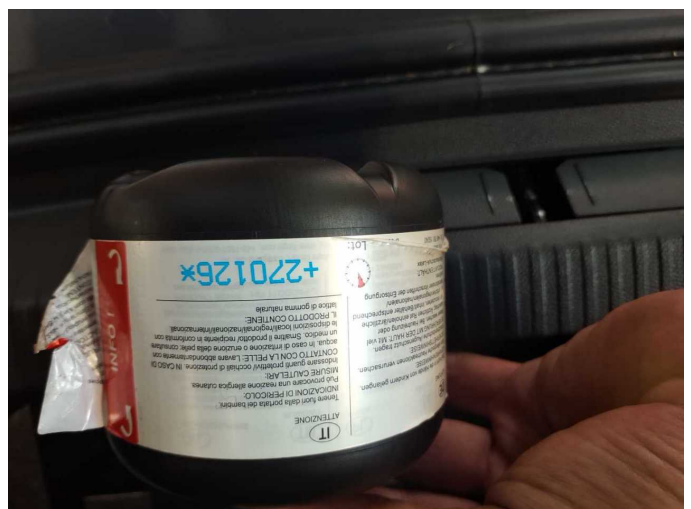
Damage 1: Equipment: Tirefit filler - Expired - Replace

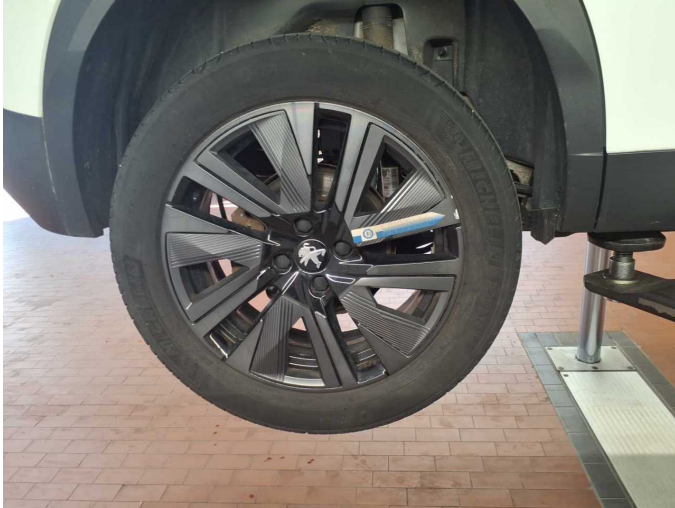
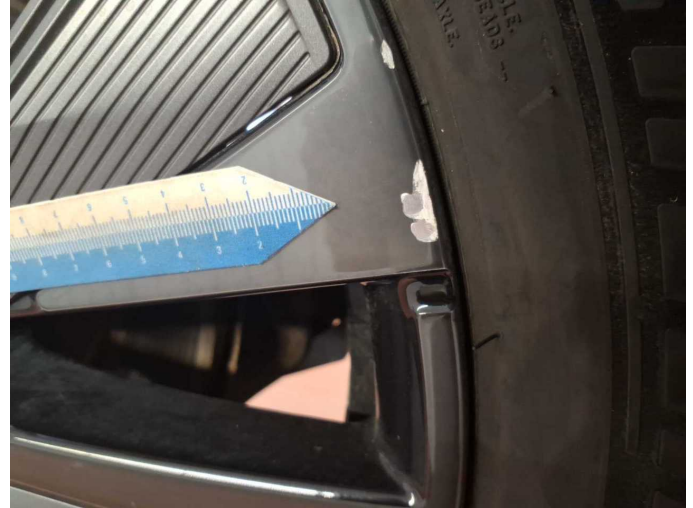
Damage 2: Wheel / tyres: Alloy rim - rear right side - Scratched - Loss in value

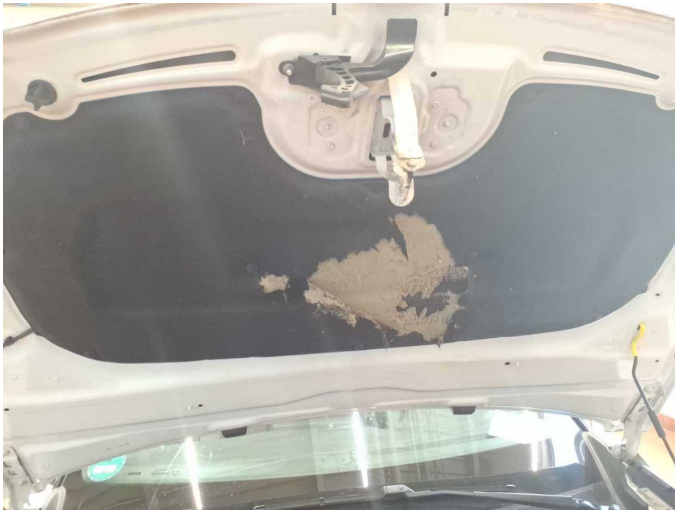
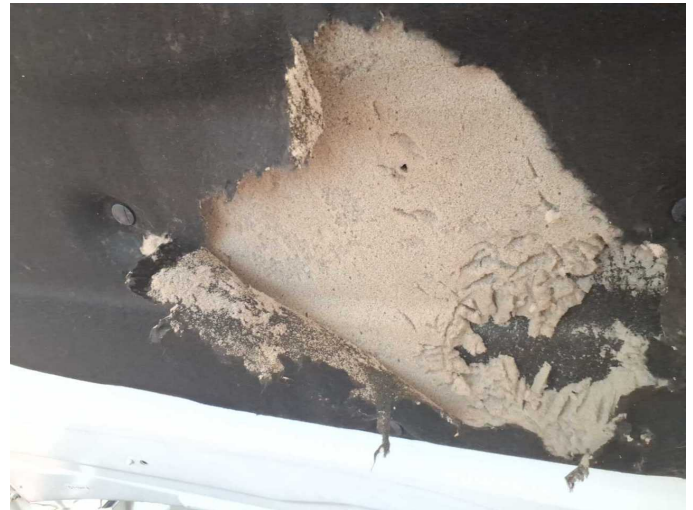
Damage 3: Bonnet: Insulation lining - Damage caused by marten / rodent - Replace

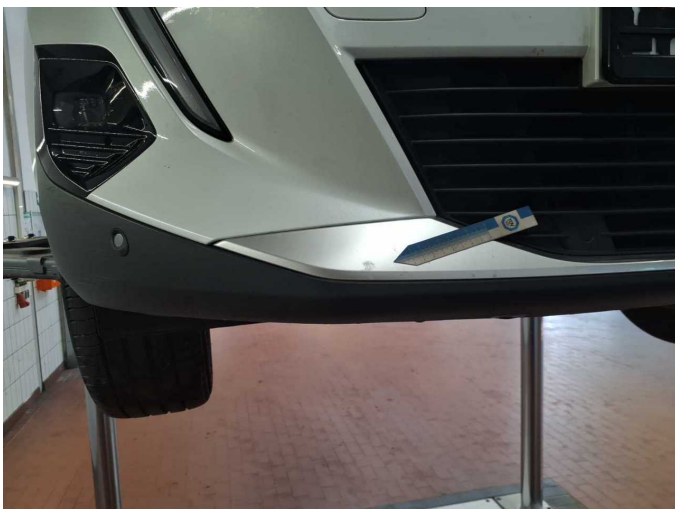
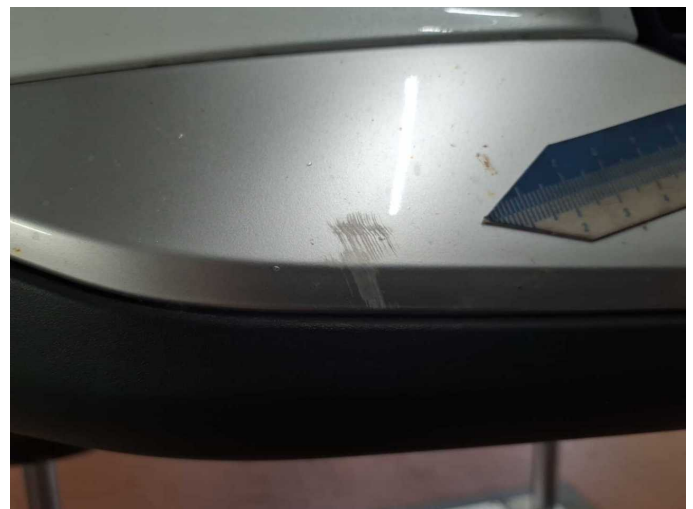
Damage 4: Trim / covers: Brightware / decorative strip (Stoßfänger vorne) - Scratch(es) - Replace

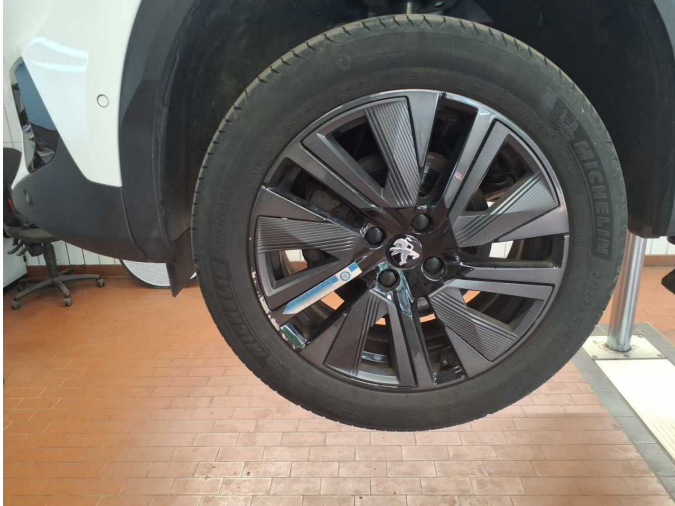
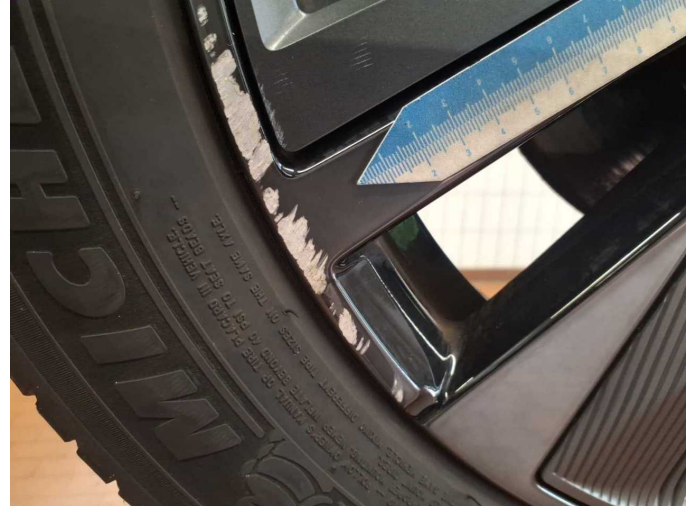
Damage 5: Wheel / tyres: Alloy rim - front left side (Materialabtrag) - Scratched - Replace

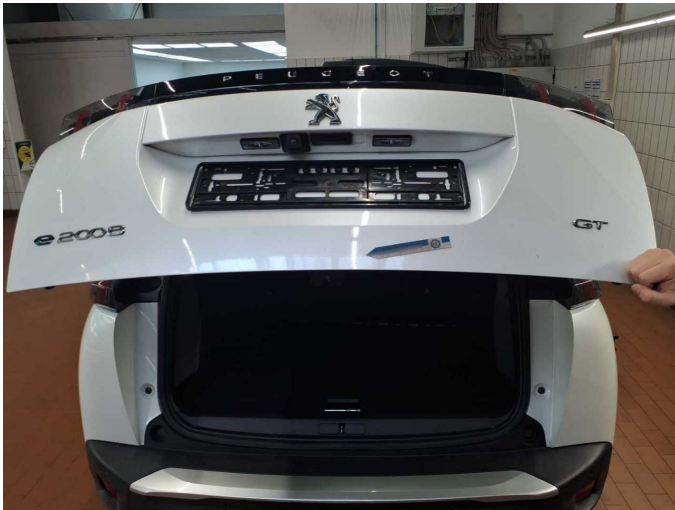
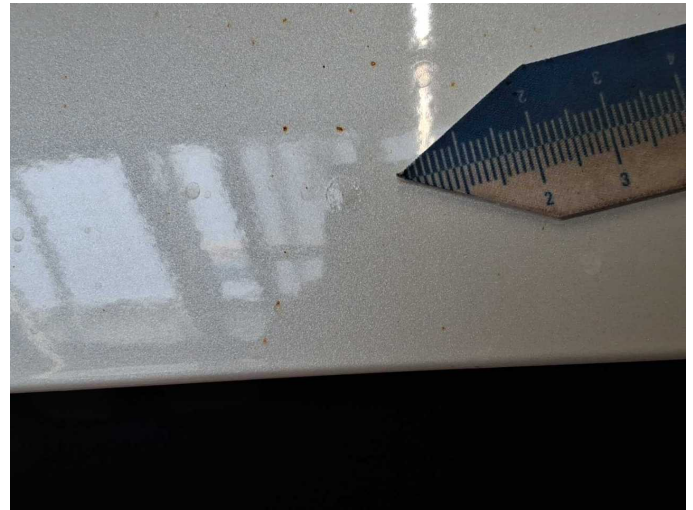
Damage 6: Boot lid / rear door: Boot lid - Corrosion - Repair and paint

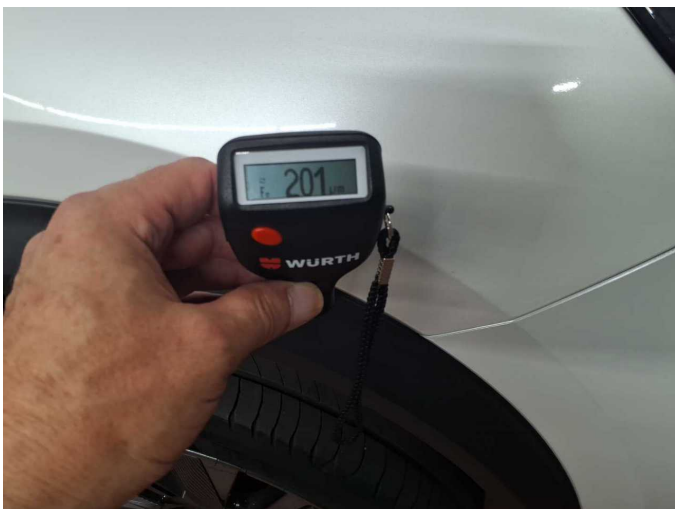
Mudguard - right side	201 µm	Door - front left side	206 µm
-----------------------	--------	------------------------	--------

Repainting 1: Mudguard - right side

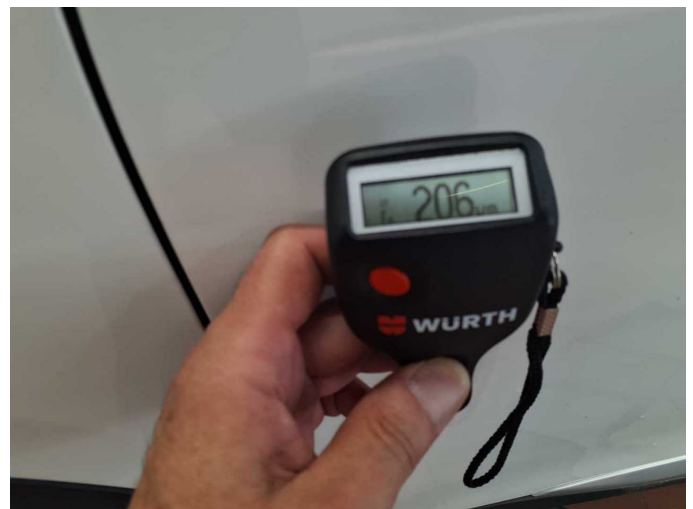
Repainting 2: Mudguard - right side, Door - front left side
