Expertise

Protocol number: 46410620  
Order No. / Reference: 26597894  
Inspection date: 8 Jul 2026

Manufacturer: Skoda  
VIN: TMBJJ8NX4PY071610

Model: Octavia Combi 2.0 TDI DSG Tour

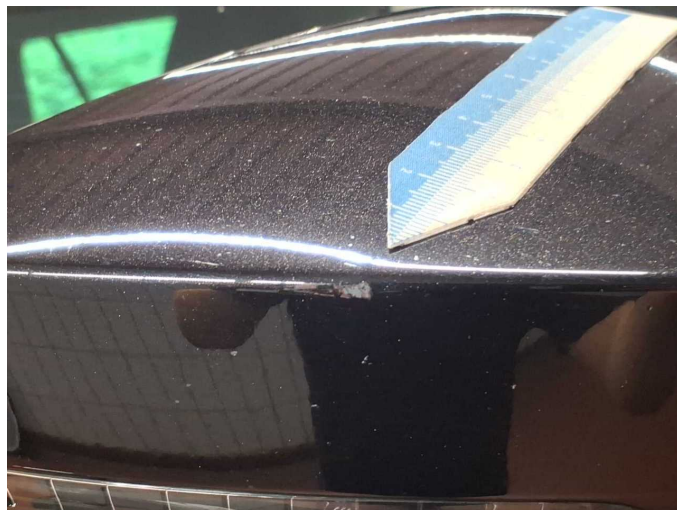
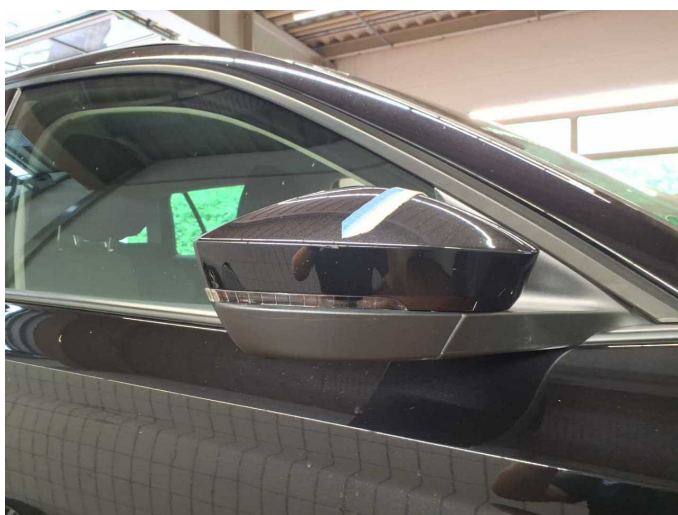
| No. | Component group | Description |
|---|---|---|
| 2 | Wing mirror - right side | Cap - Scratch(es) - Smart repair |

**Damage 2:** Wing mirror - right side: Cap - Scratch(es) - Smart repair

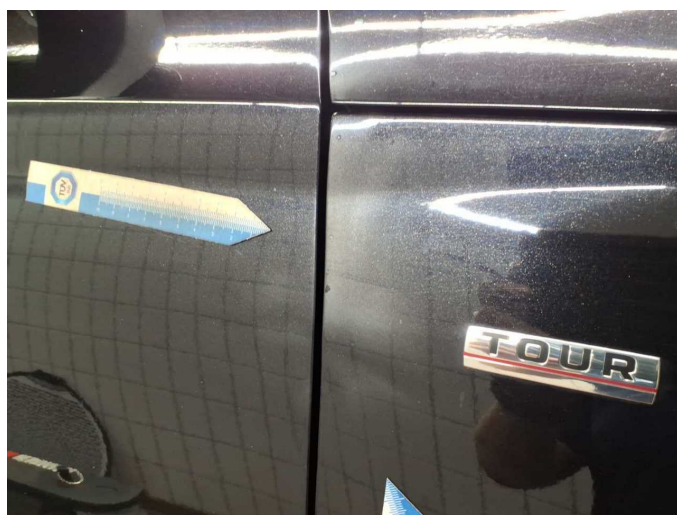
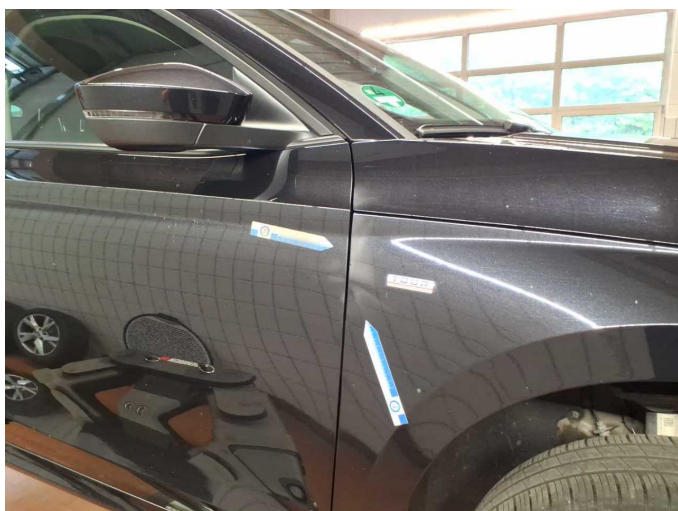
| No. | Component group | Description |
|---|---|---|
| 3 | Body | Body (Lacknebel) - Paint defect - Conditioning |

**Damage 3:** Body: Body (Lacknebel) - Paint defect - Conditioning

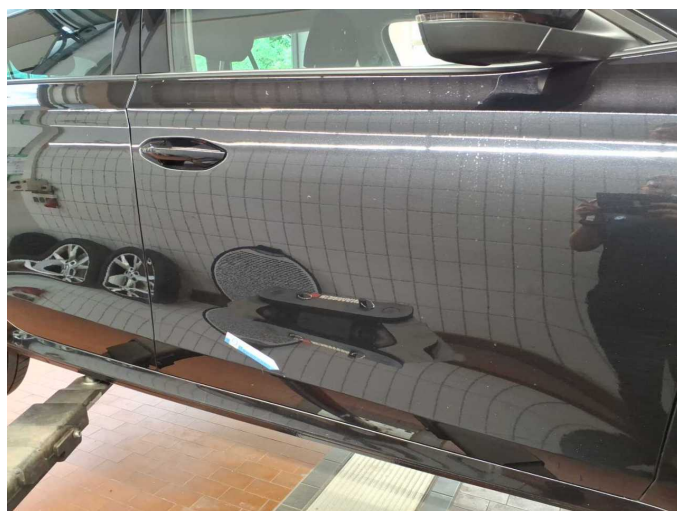
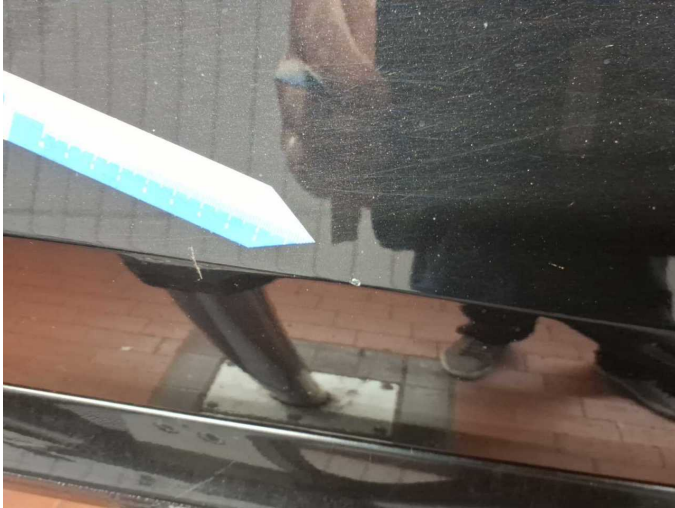
| No. | Component group | Description |
|---|---|---|
| 4 | Door - front right side | Door - Scratch(es) - Smart repair |

**Damage 4:** Door - front right side: Door - Scratch(es) - Smart repair

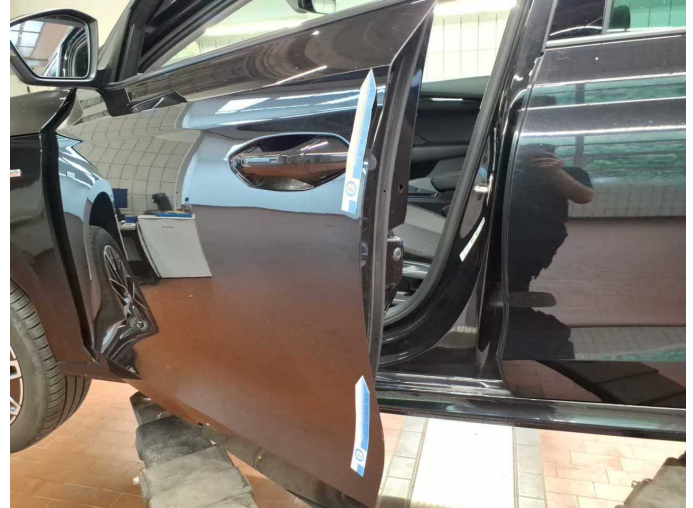
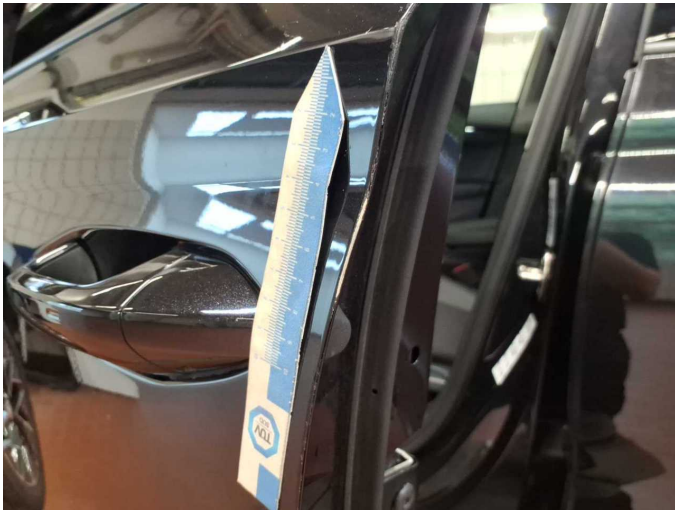
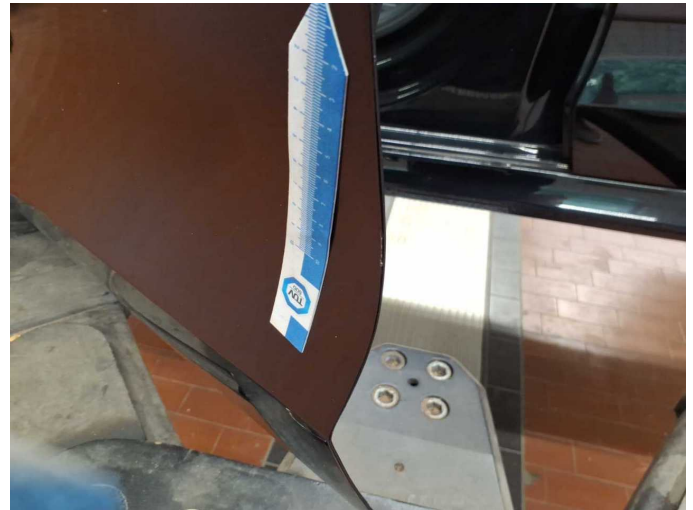
| No. | Component group | Description |
|---|---|---|
| 5 | Door - front left side | Door edge - Scratch(es) - Smart repair |

**Damage 5:** Door - front left side: Door edge - Scratch(es) - Smart repair

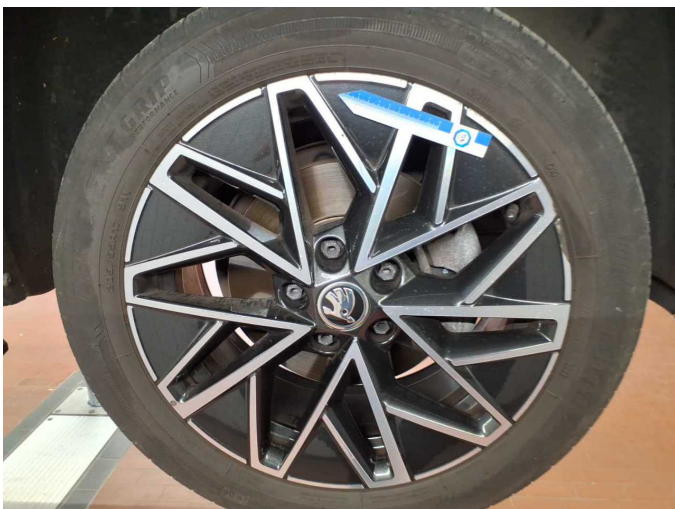
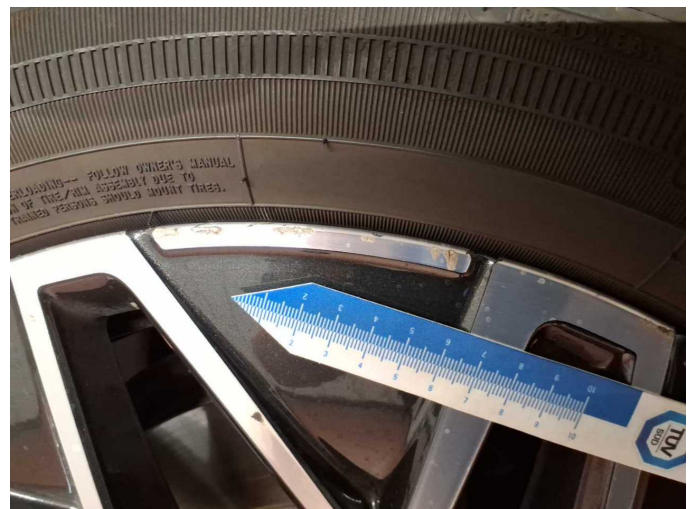
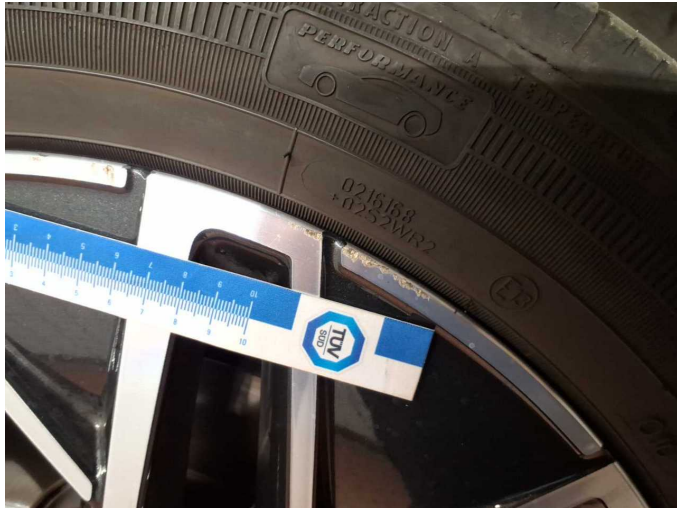
| No. | Component group | Description |
|---|---|---|
| 6 | Wheel / tyres | Alloy rim - front right side - Scratch(es) - Loss in value |

**Damage 6:** Wheel / tyres: Alloy rim - front right side - Scratch(es) - Loss in value

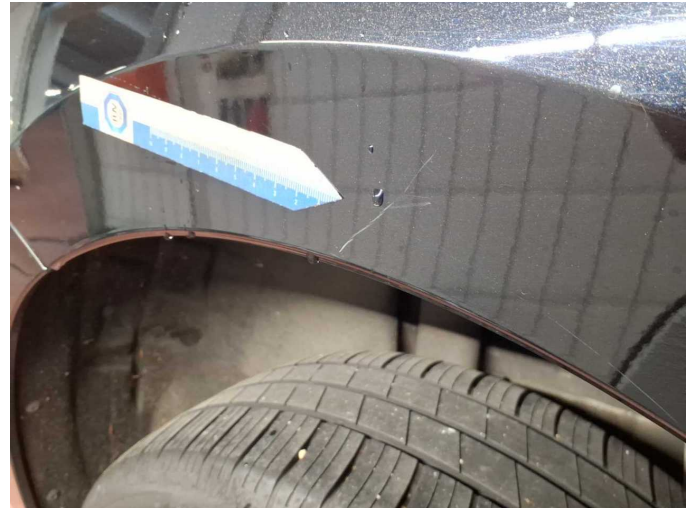
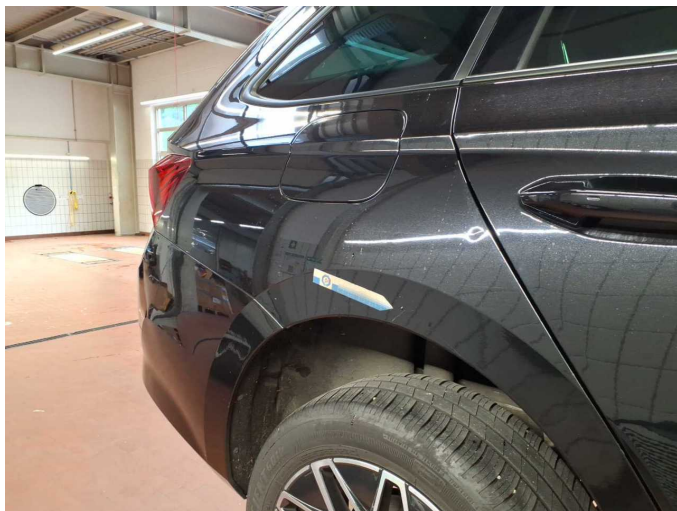
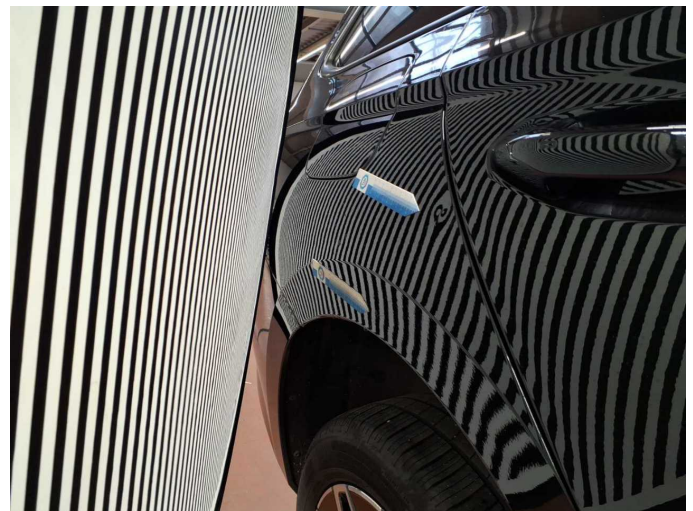
| No. | Component group | Description |
|---|---|---|
| 7 | Side panel - rear right side | Side panel - Dent / paintcoat damage - Repair and paint |

**Damage 7:** Side panel - rear right side: Side panel - Dent / paintcoat damage - Repair and paint

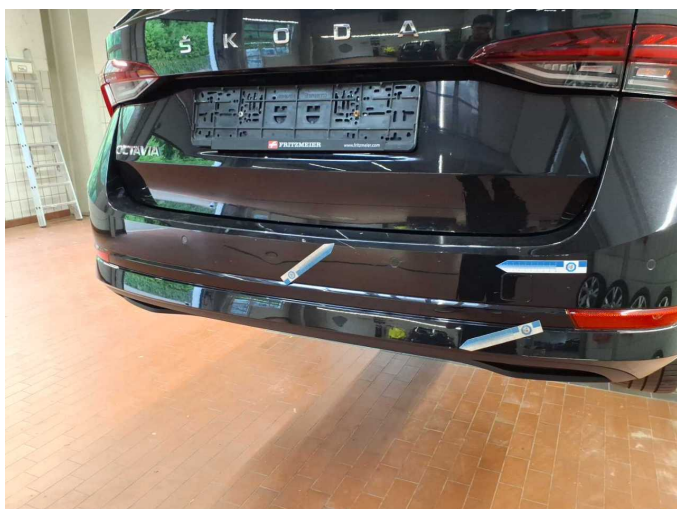
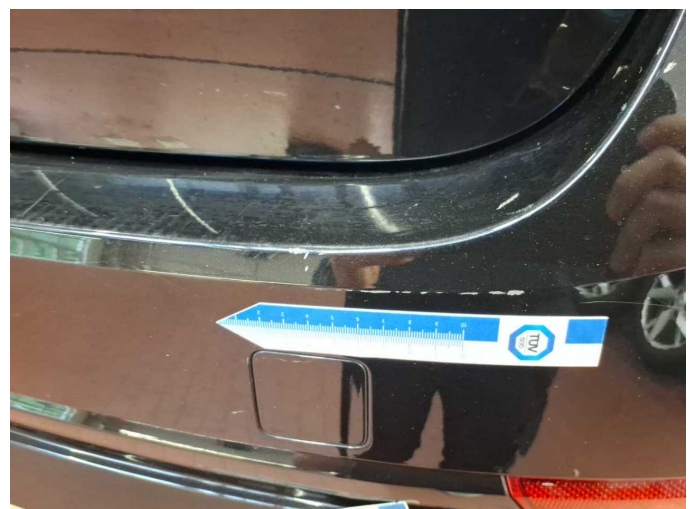
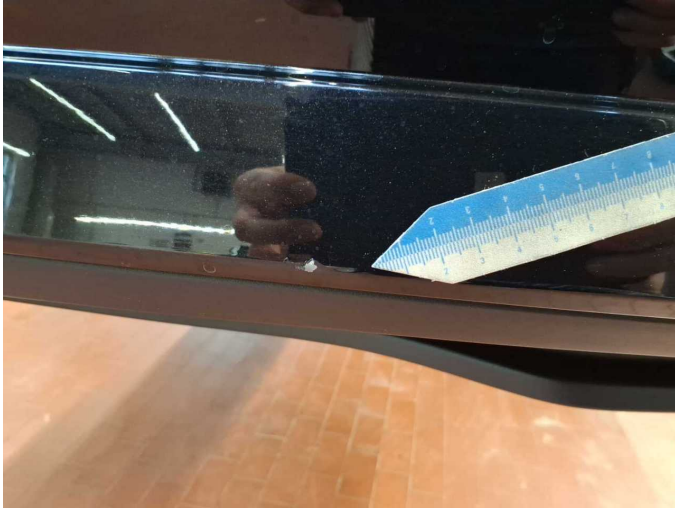
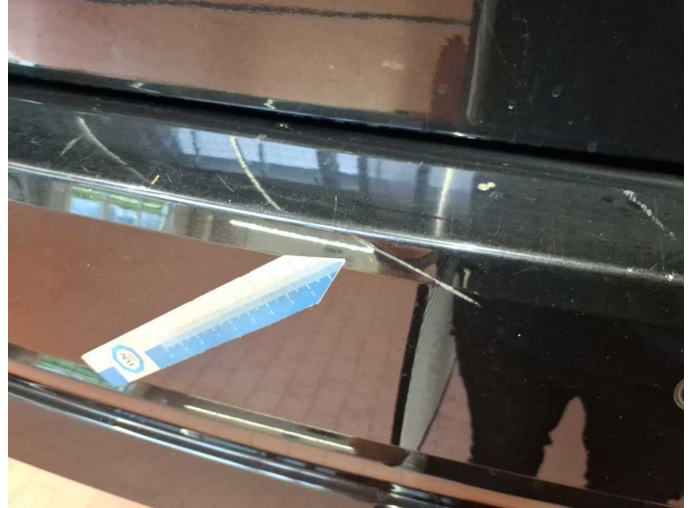
| No. | Component group | Description |
|---|---|---|
| 8 | Rear bumper | Rear bumper - Scratch(es) - Paint |

**Damage 8:** Rear bumper: Rear bumper - Scratch(es) - Paint

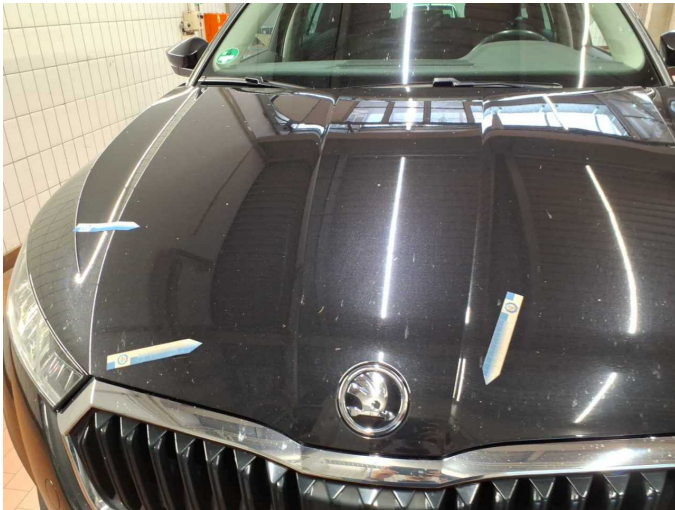
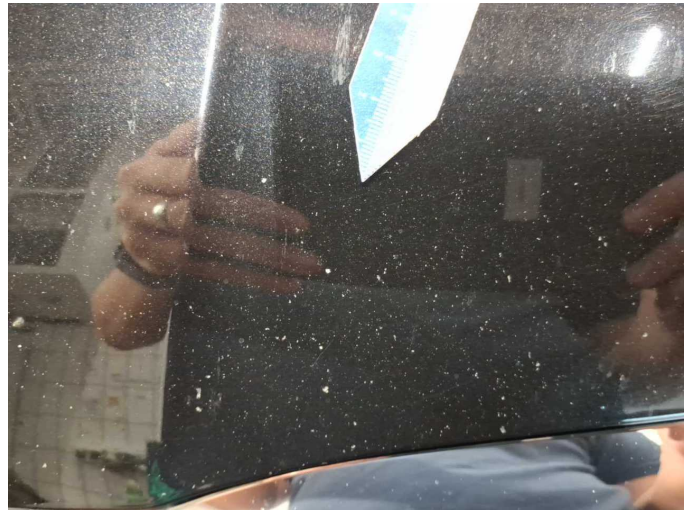
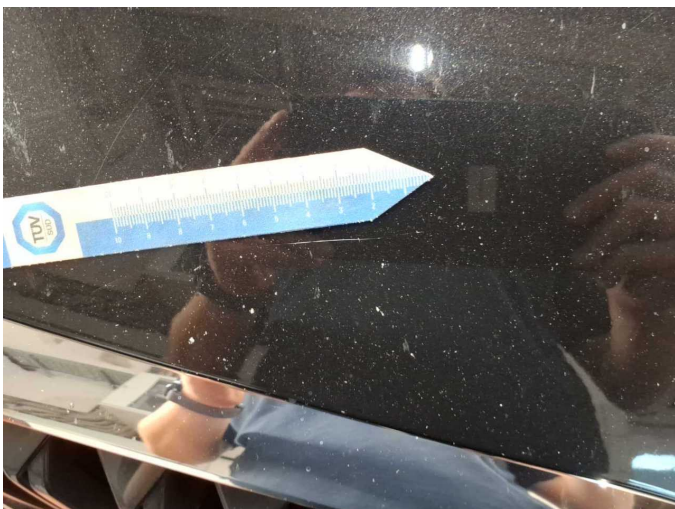
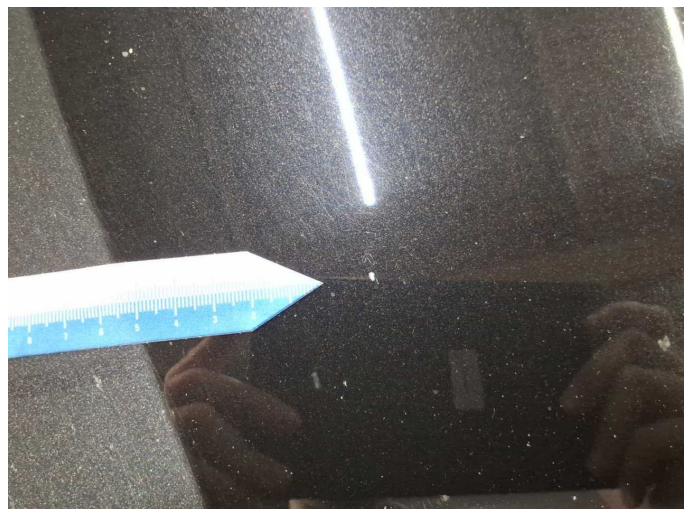
| No. | Component group | Description |
|---|---|---|
| 9 | Bonnet | Bonnet - Stone chips - Paint |

**Damage 9:** Bonnet: Bonnet - Stone chips - Paint

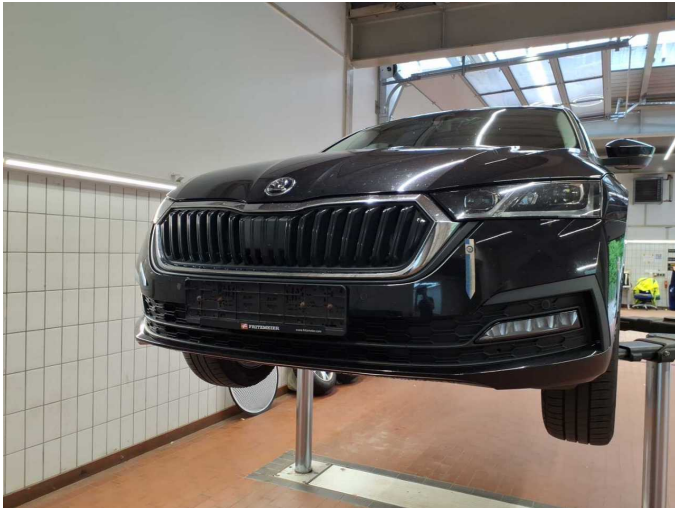
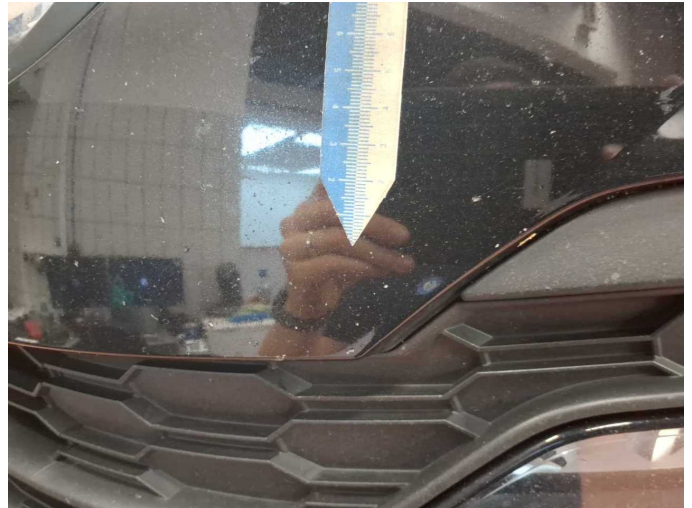
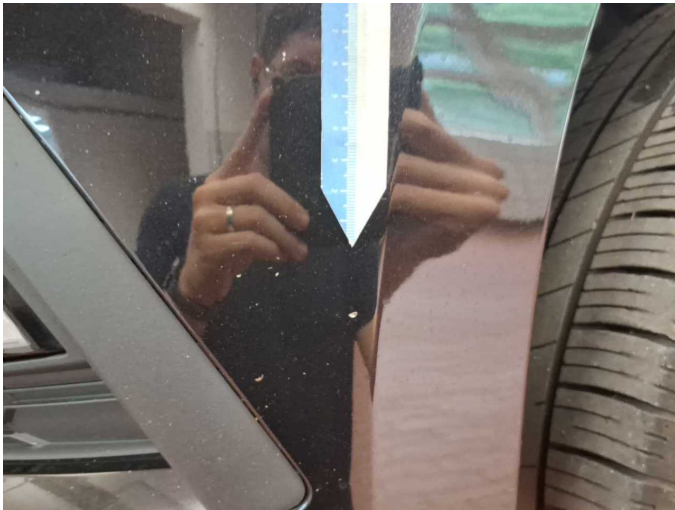
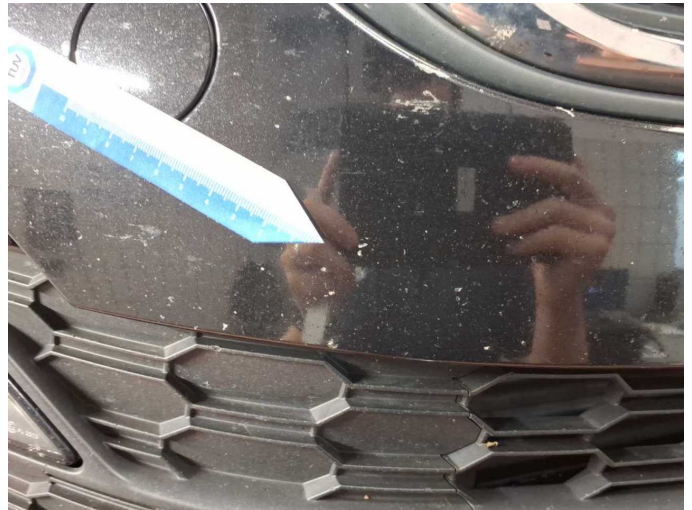
| No. | Component group | Description |
|---|---|---|
| 10 | Front bumper | Front bumper - Stone chips - Paint |

**Damage 10:** Front bumper: Front bumper - Stone chips - Paint

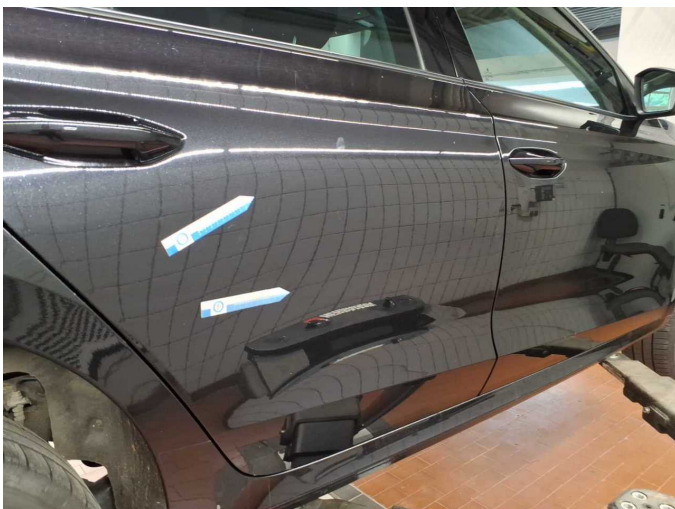
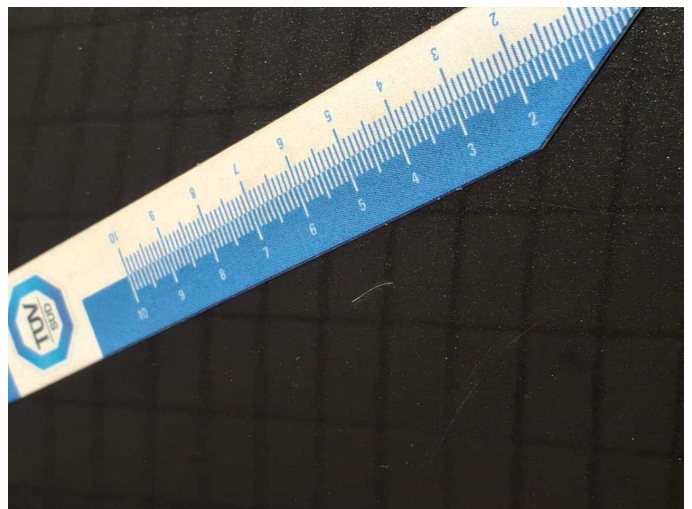
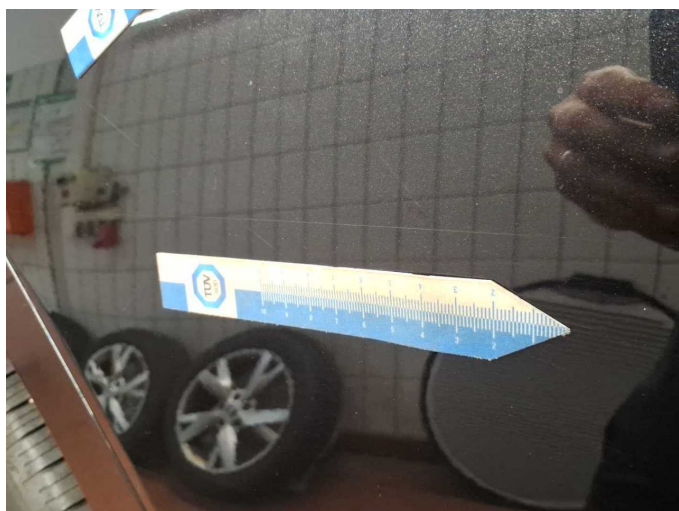
| No. | Component group | Description |
|---|---|---|
| 1 | Door - rear right side | Door - Scratch(es) - No deduction |

**Wear and tear 1:** Door - rear right side: Door - Scratch(es) - No deduction

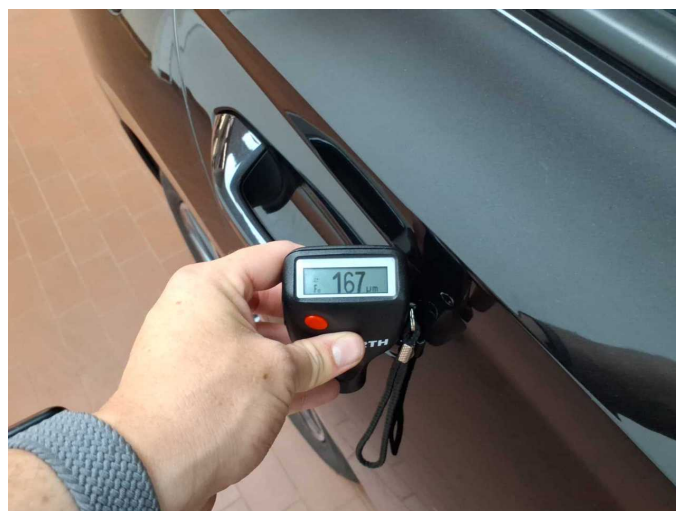
**Repainting 1:** Door - rear right side

1 Door - rear right side, Professionally carried out, Invoice of repair done Non-existent

167 µm
