Expertise

Protocol number: 46400646  
Order No. / Reference: 26527946  
Inspection date: 1 Jul 2026

Manufacturer: Volkswagen

Model: Touran 2.0 TDI SCR DSG Comfortline

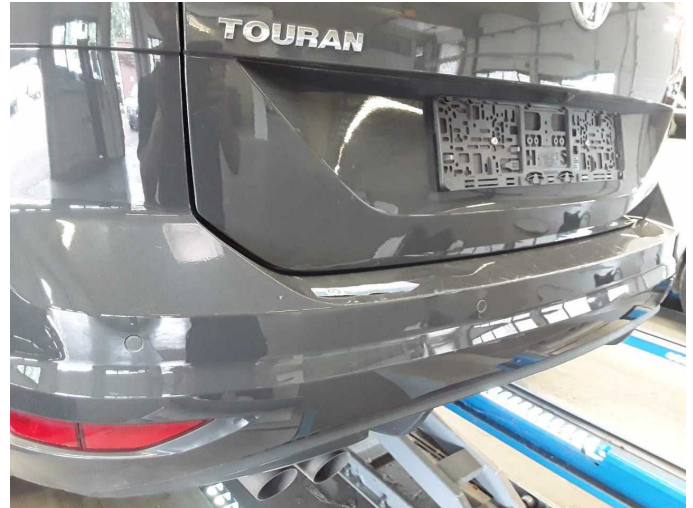
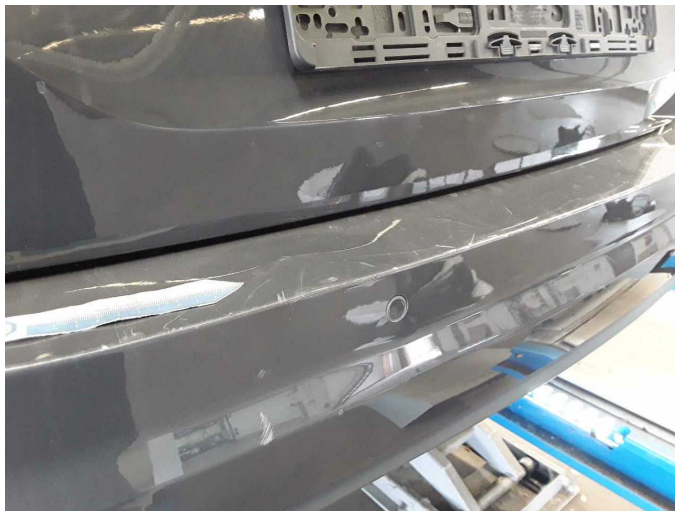
| No. | Component group | Description |
|---|---|---|
| 1 | Rear bumper | Rear bumper (In Unfallschaden Berücksichtigt) - Deformed - No deduction |

**Damage 1:** Rear bumper: Rear bumper (In Unfallschaden Berücksichtigt)  
- Deformed - No deduction

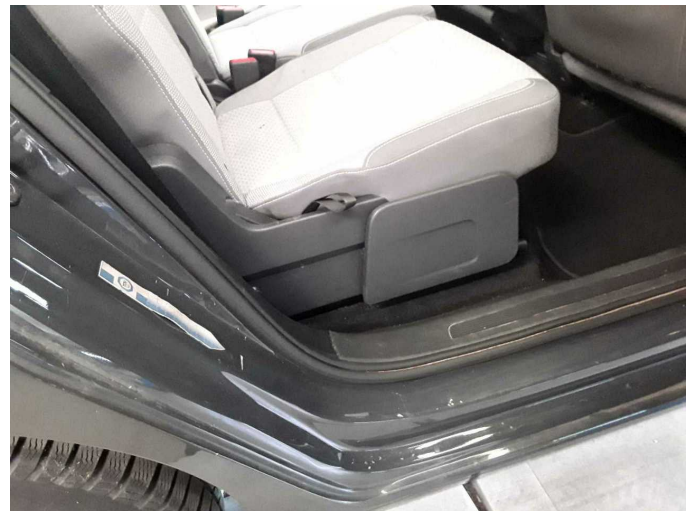
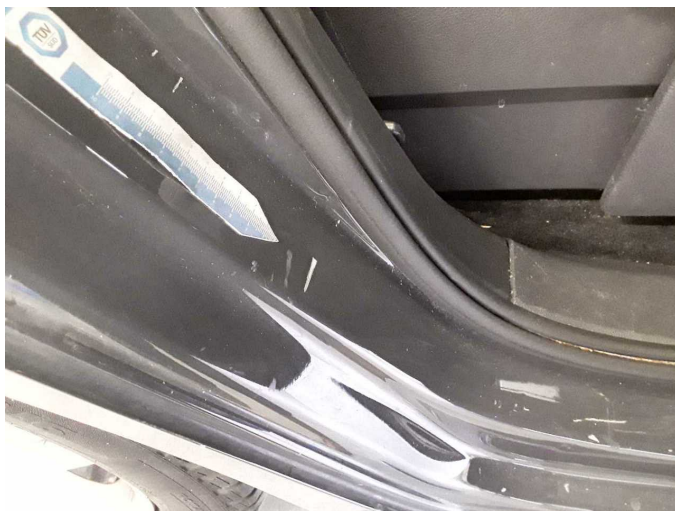
| No. | Component group | Description |
|---|---|---|
| 2 | Side panel - rear right side | Sill - Dent / paintcoat damage - Smart repair |

**Damage 2:** Side panel - rear right side: Sill - Dent / paintcoat damage -  
Smart repair

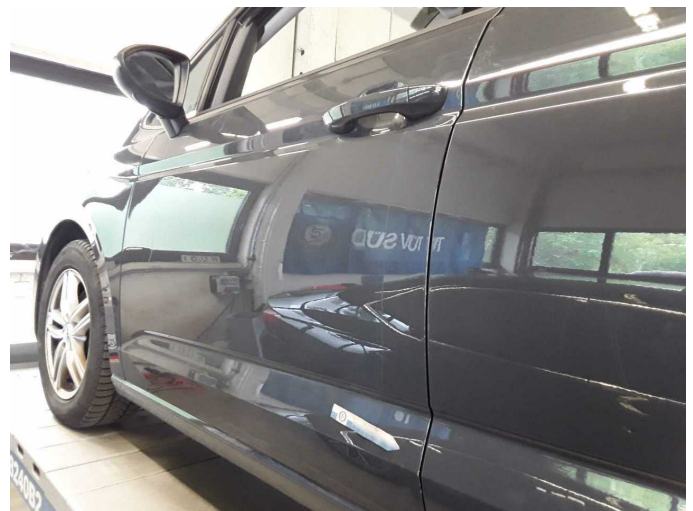
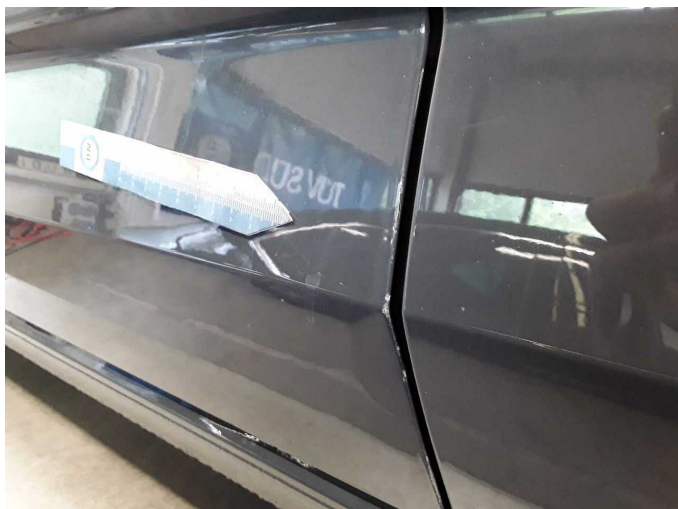
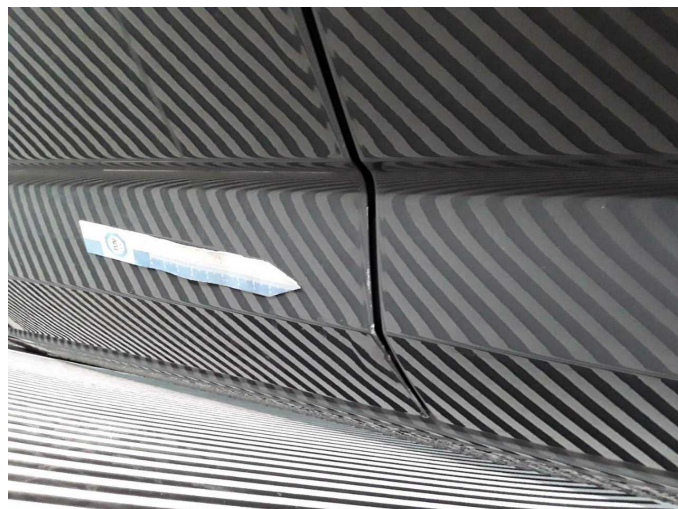
| No. | Component group | Description |
|---|---|---|
| 3 | Door - front left side | Door - Dent / paintcoat damage - Smart repair |

**Damage 3:** Door - front left side: Door - Dent / paintcoat damage - Smart  
repair

**Damage 3:** Door - front left side: Door - Dent / paintcoat damage - Smart repair

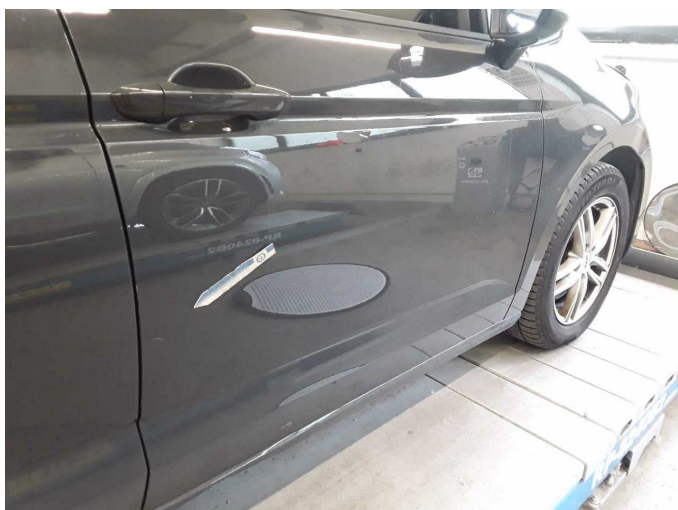
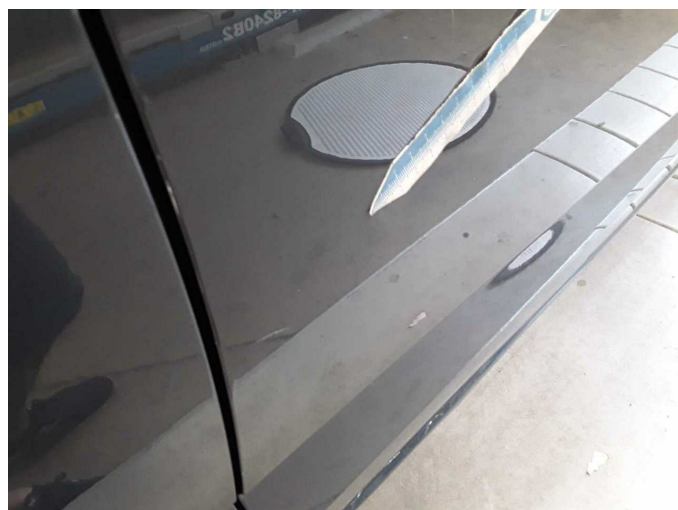
| No. | Component group | Description |
|---|---|---|
| 4 | Door - front right side | Door - Scratch(es) - Smart repair |

**Damage 4:** Door - front right side: Door - Scratch(es) - Smart repair

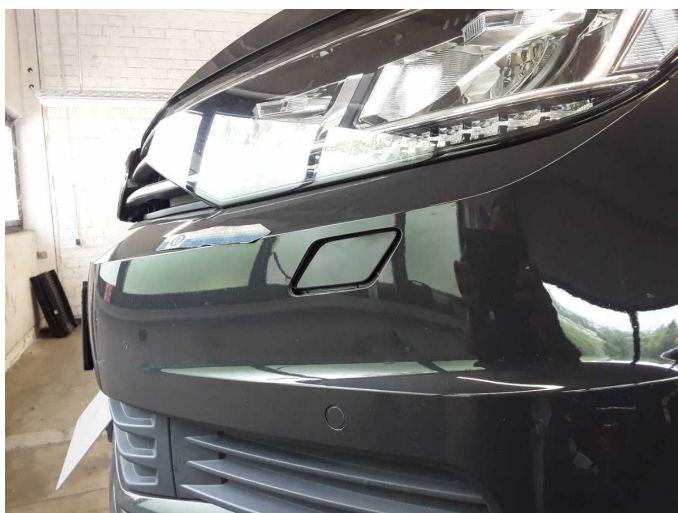
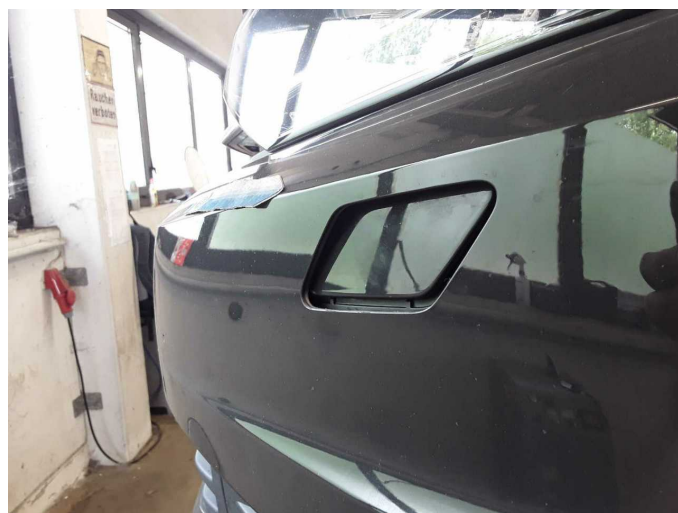
| No. | Component group | Description |
|---|---|---|
| 5 | Front bumper | Front strip (Abdeckung) - Damaged - Replace |

**Damage 5:** Front bumper: Front strip (Abdeckung) - Damaged - Replace

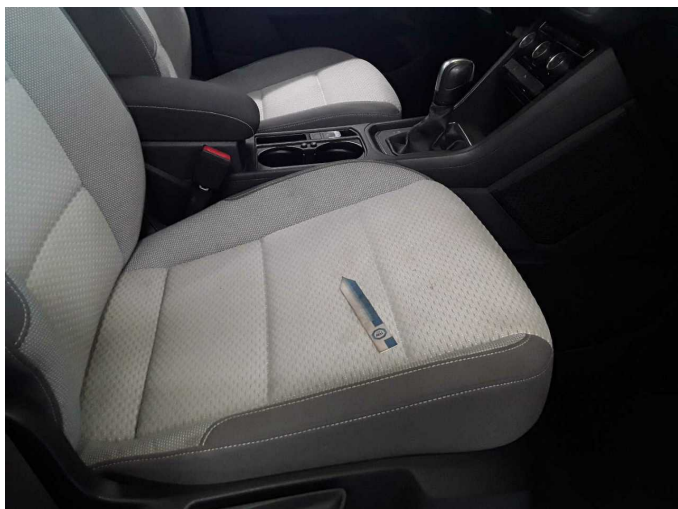
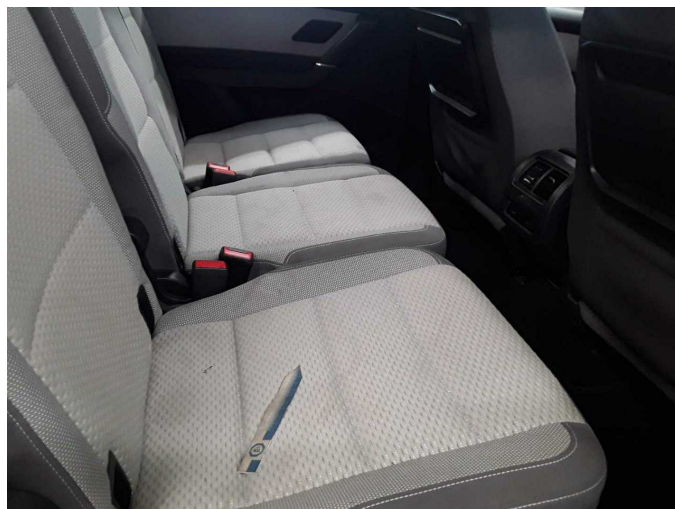
| No. | Component group | Description |
|---|---|---|
| 6 | Interior | Interior - Soiled - Conditioning |

**Damage 6:** Interior: Interior - Soiled - Conditioning

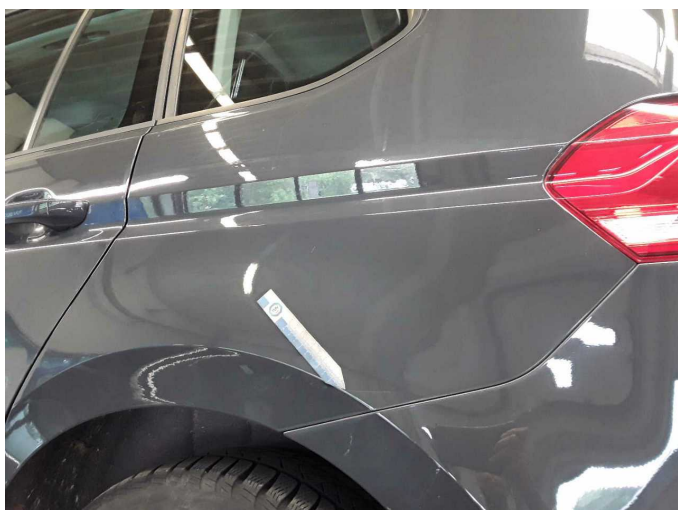
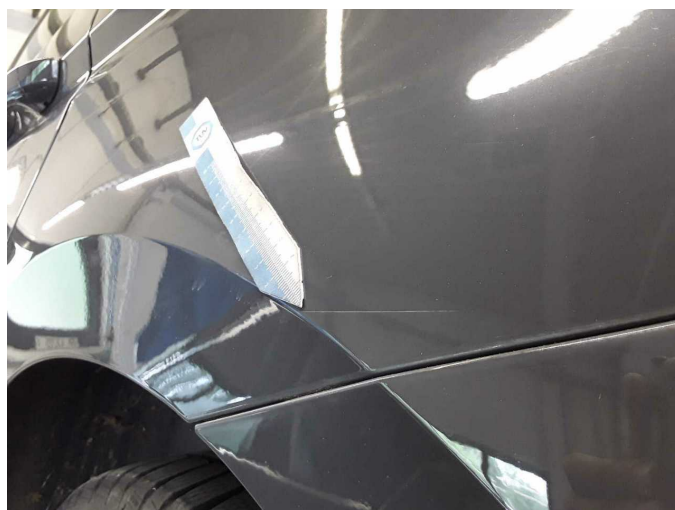
| No. | Component group | Description |
|---|---|---|
| 7 | Side panel - rear left side | Side panel - Scratch(es) - Paint |

**Damage 7:** Side panel - rear left side: Side panel - Scratch(es) - Paint

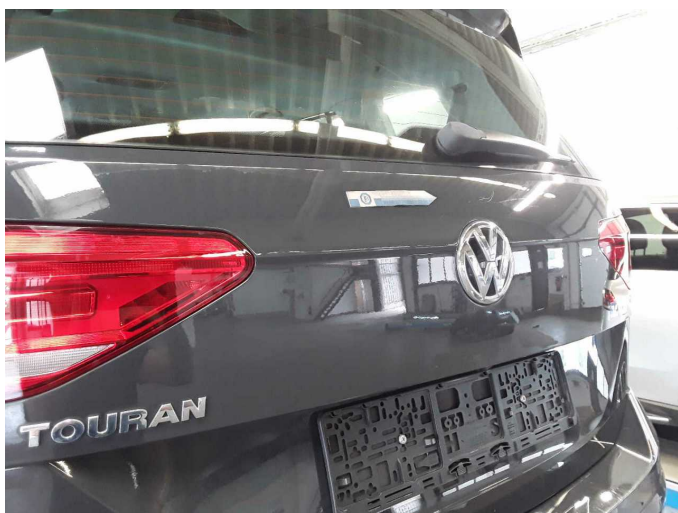
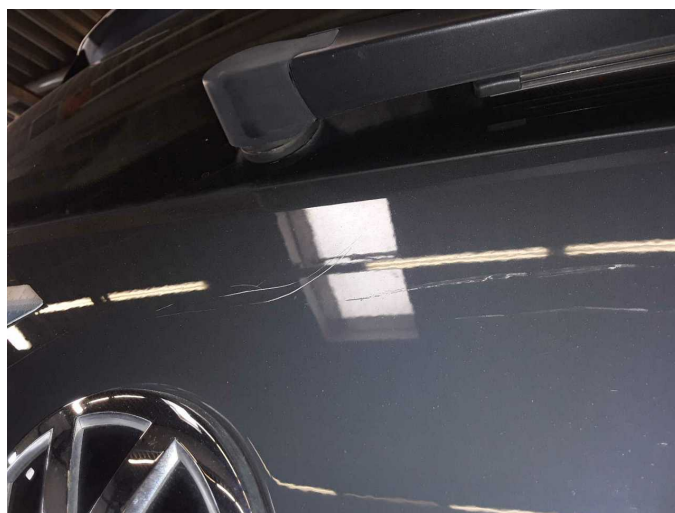
| No. | Component group | Description |
|---|---|---|
| 8 | Boot lid / rear door | Boot lid - Scratch(es) - Paint |

**Damage 8:** Boot lid / rear door: Boot lid - Scratch(es) - Paint

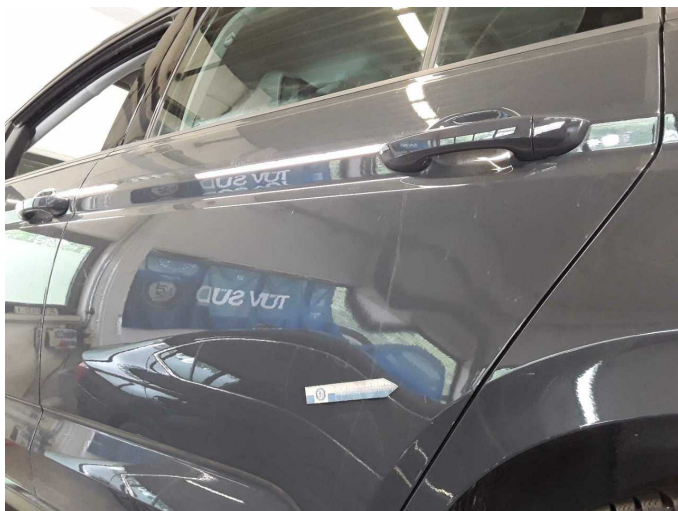
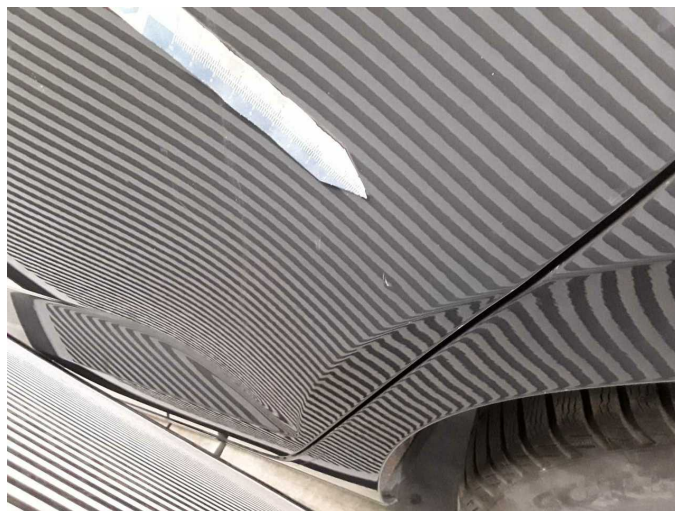
| No. | Component group | Description |
|---|---|---|
| 9 | Door - rear left side | Door - Dent / paintcoat damage - Paint |

**Damage 9:** Door - rear left side: Door - Dent / paintcoat damage - Paint

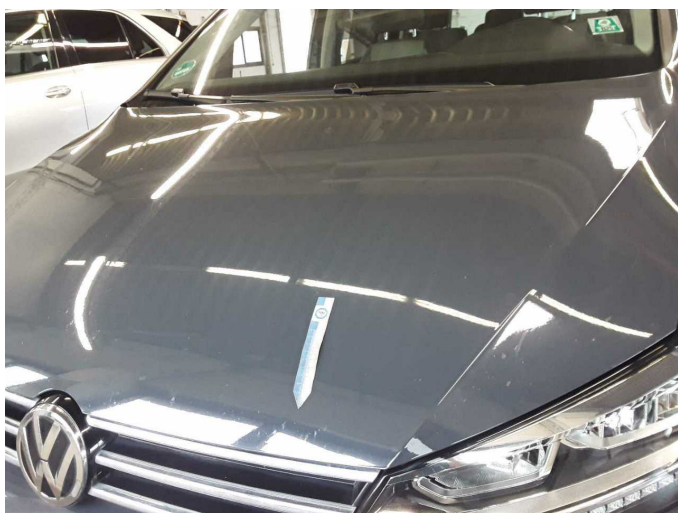
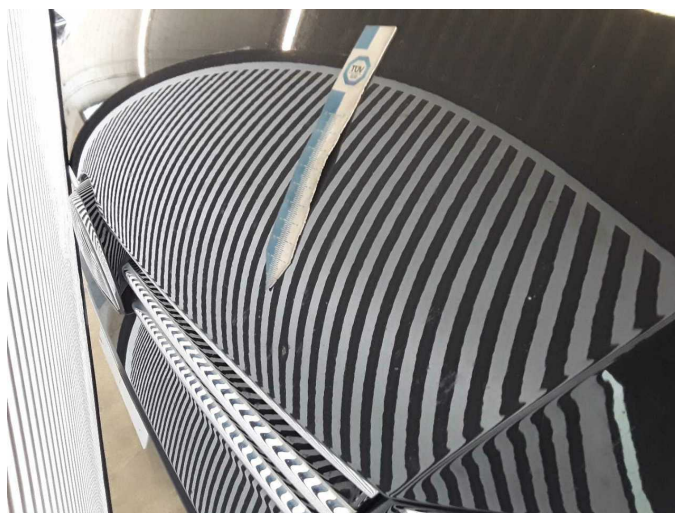
| No. | Component group | Description |
|---|---|---|
| 10 | Bonnet | Bonnet - Dent / paintcoat damage - Paint |

**Damage 10:** Bonnet: Bonnet - Dent / paintcoat damage - Paint

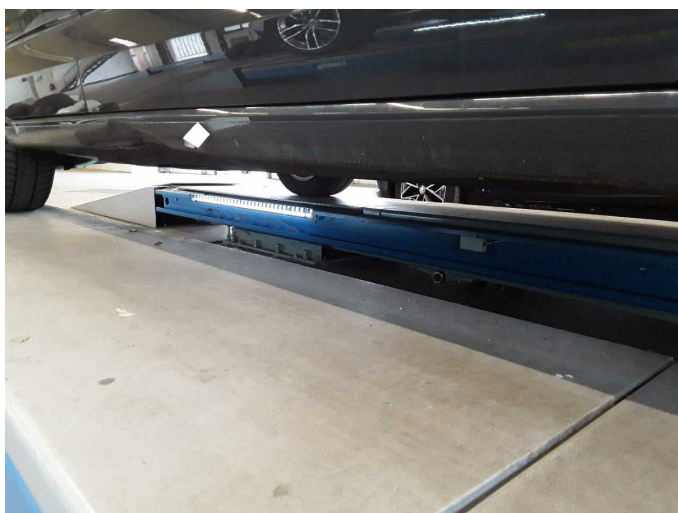
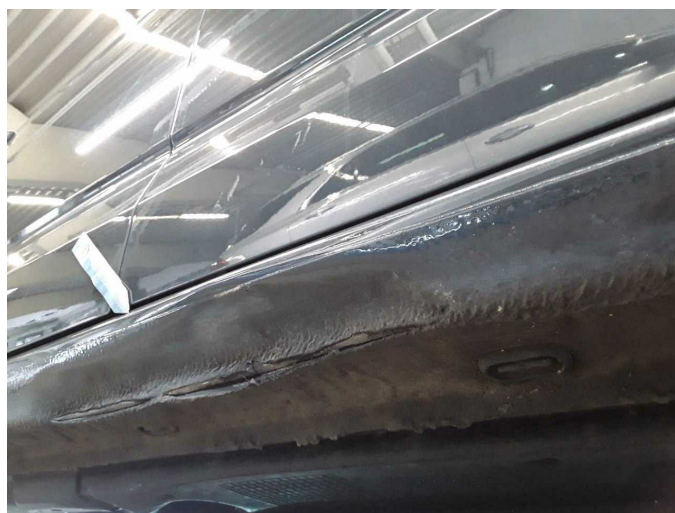
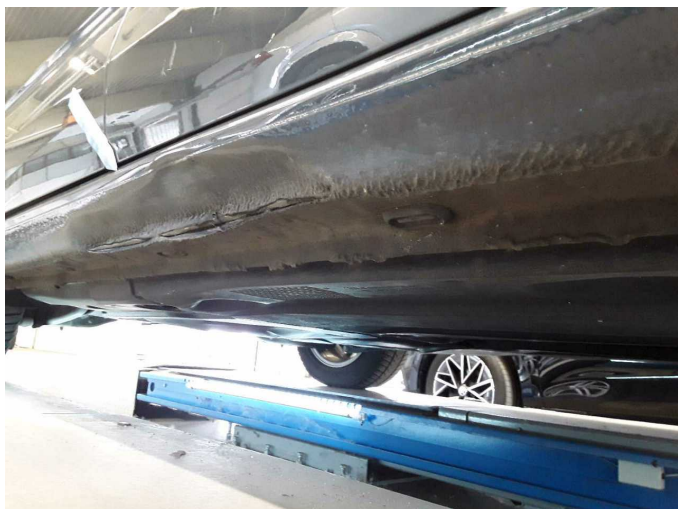
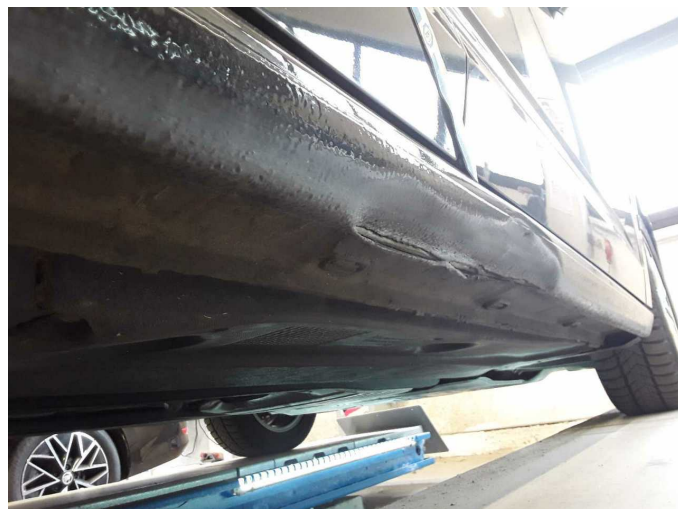
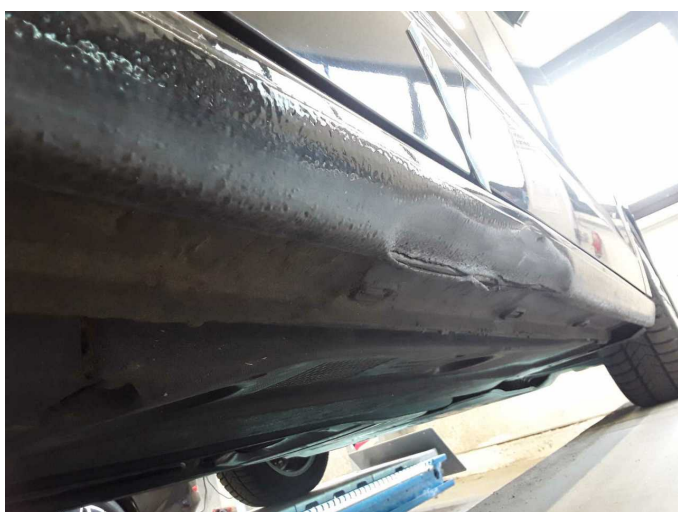
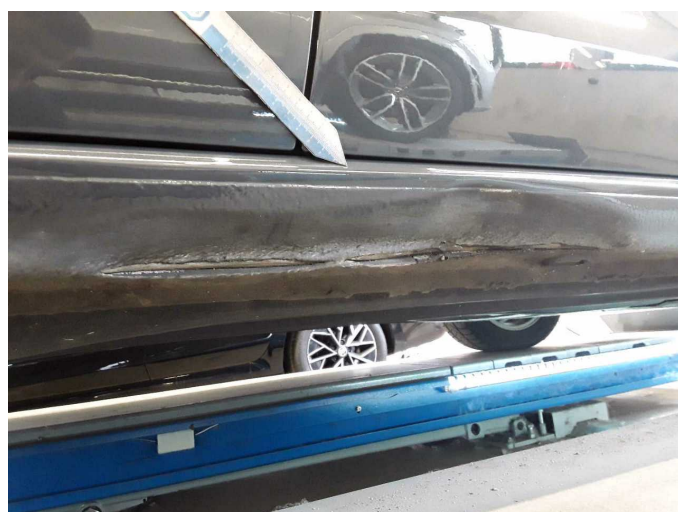
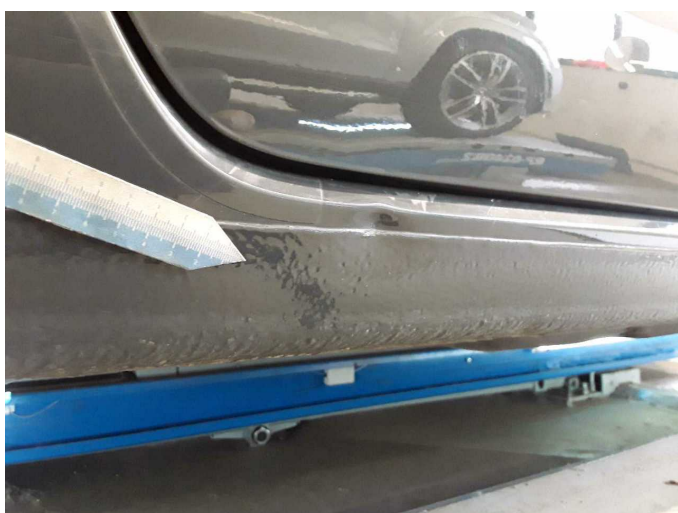
| No. | Component group | Description |
|---|---|---|
| 11 | Sill - right side | Sill (Teilersatz) - Deformed - Replace |

**Damage 11:** Sill - right side: Sill (Teilersatz) - Deformed - Replace

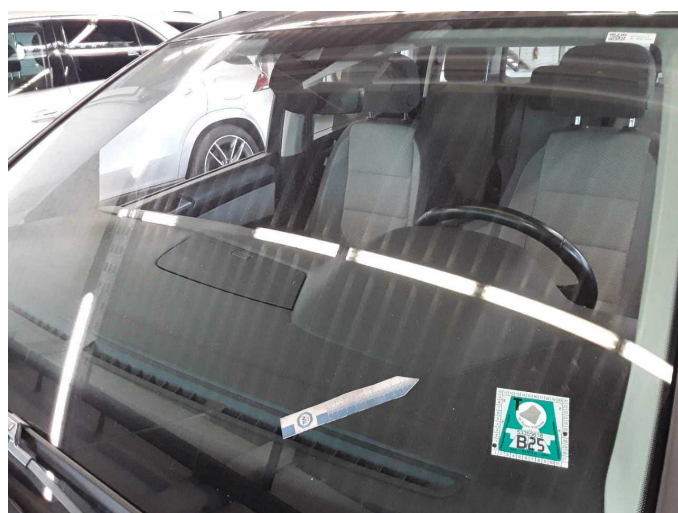
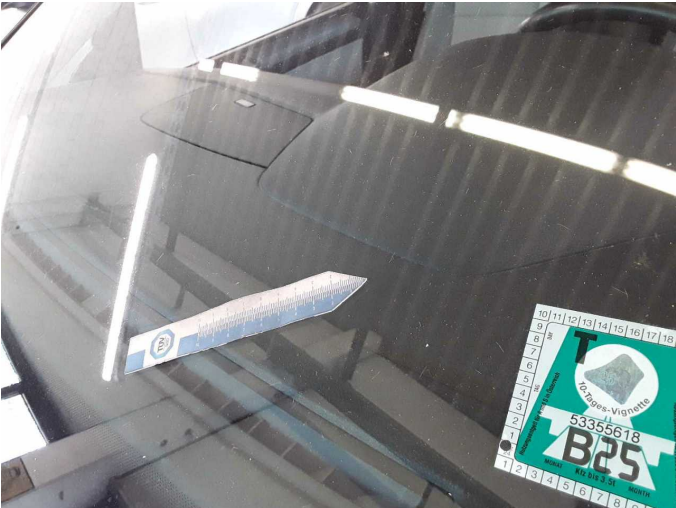
| No. | Component group | Description |
|---|---|---|
| 2 | Vehicle glazing | Windscreen - Stone chips - No deduction |

**Wear and tear 2:** Vehicle glazing: Windscreen - Stone chips - No deduction

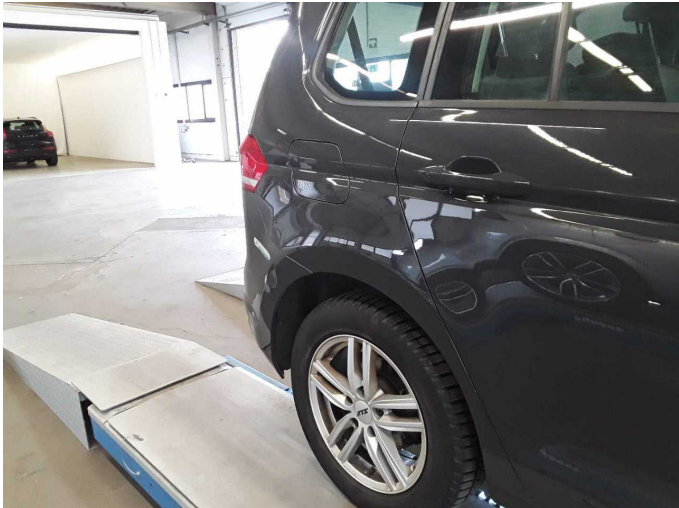
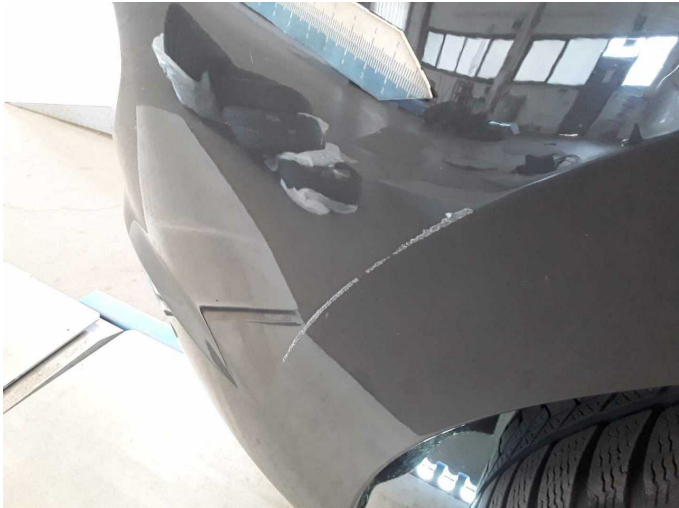
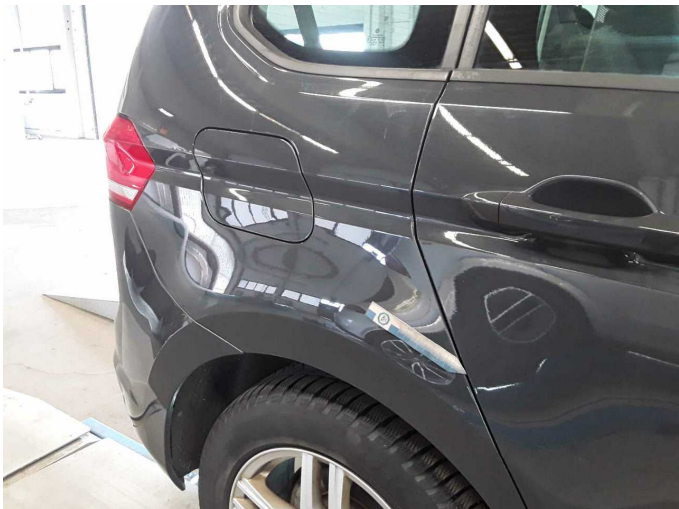
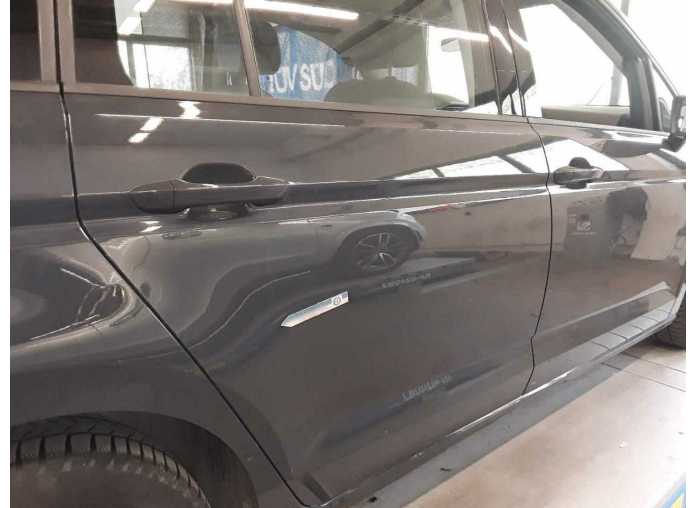
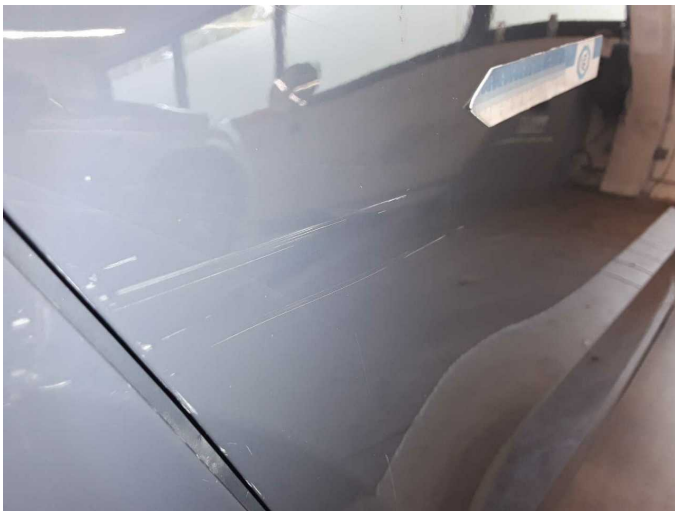
**Accident 1:** Side right

**Accident 1: Side right**

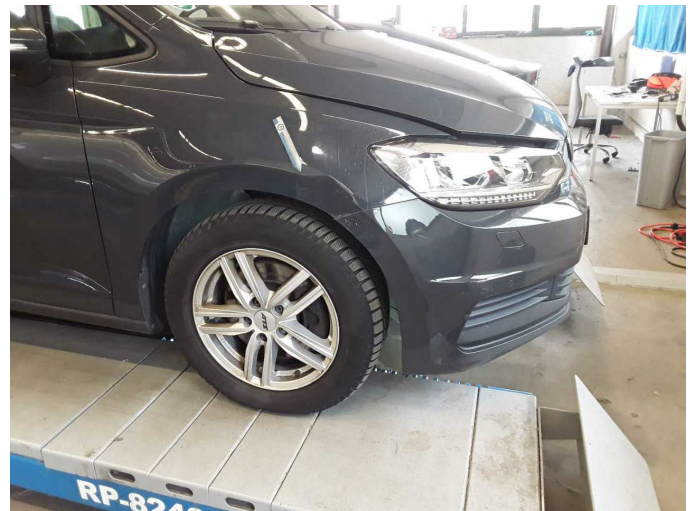
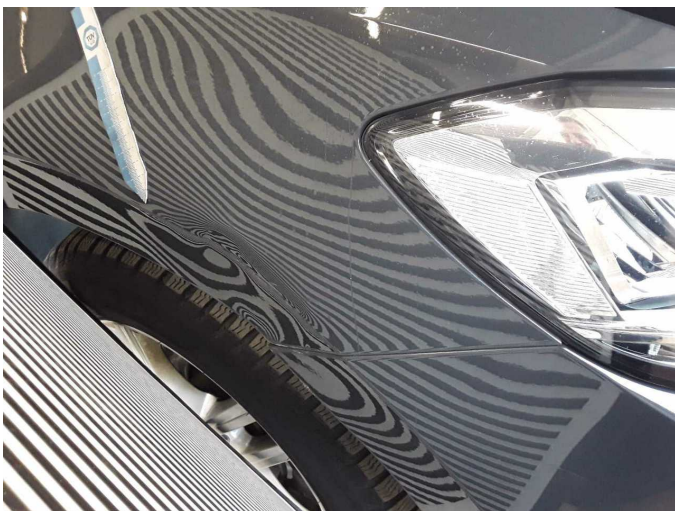
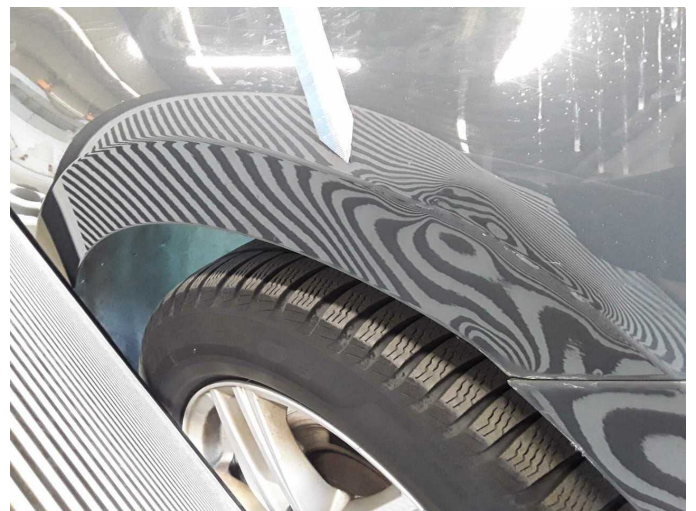
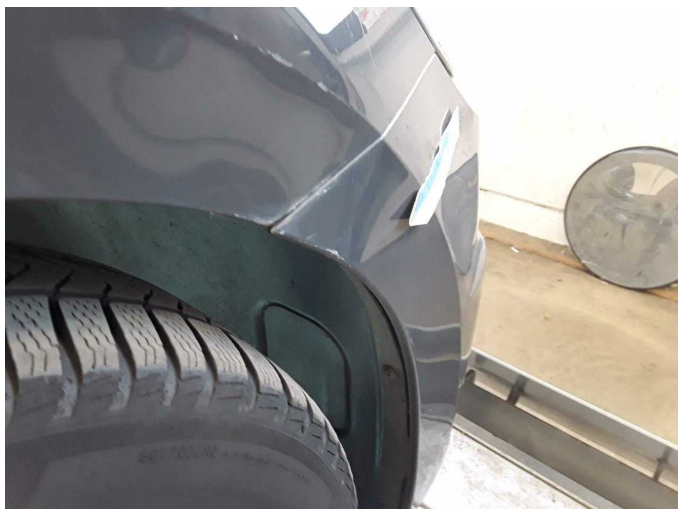
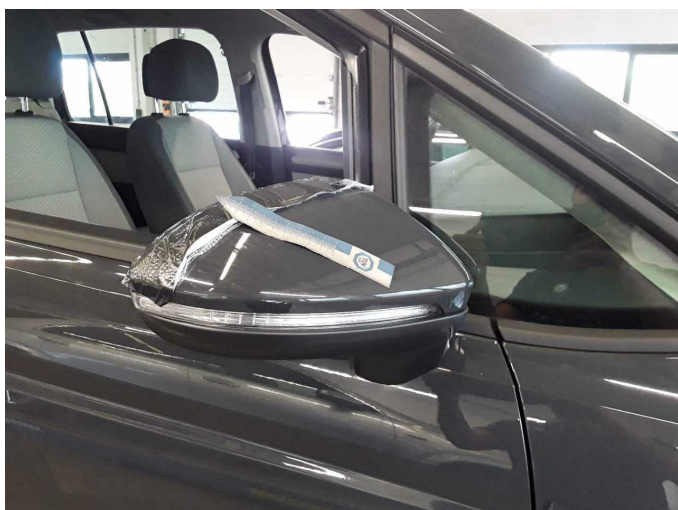
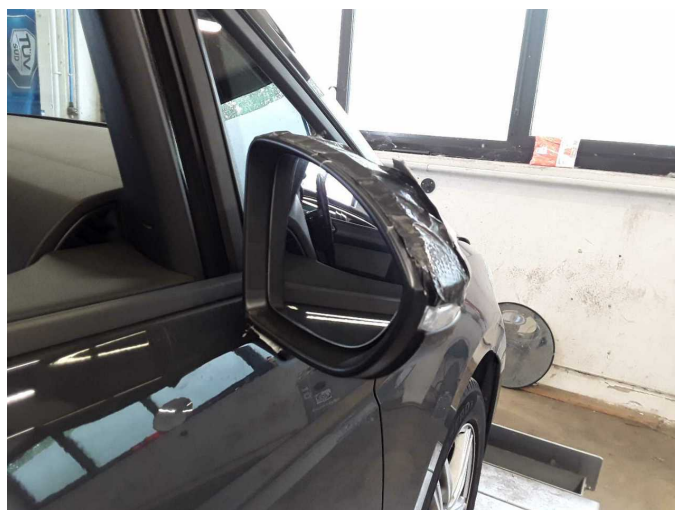
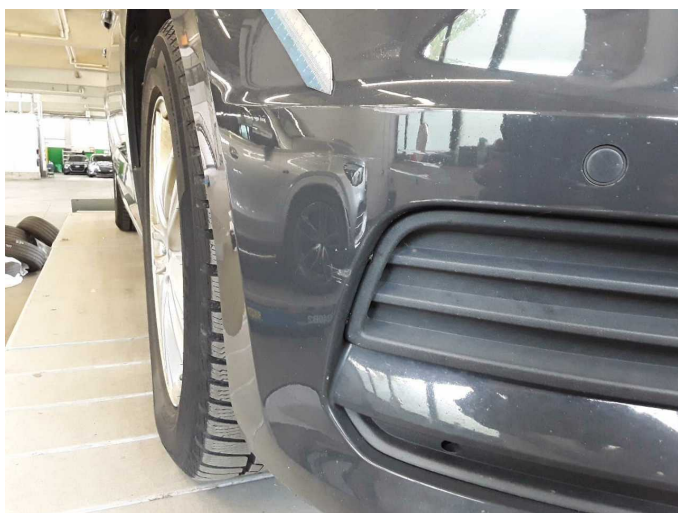
**Accident 2: Side right**
