Expertise

Protocol number: 45796891
Order No. / Reference: 26529501
Inspection date: 5 Jun 2026

Model: Focus Turnier 1.5 EcoBlue Start-Stopp-System Aut. TITANIUM

VIN: WF0PXXGCHPPL84048

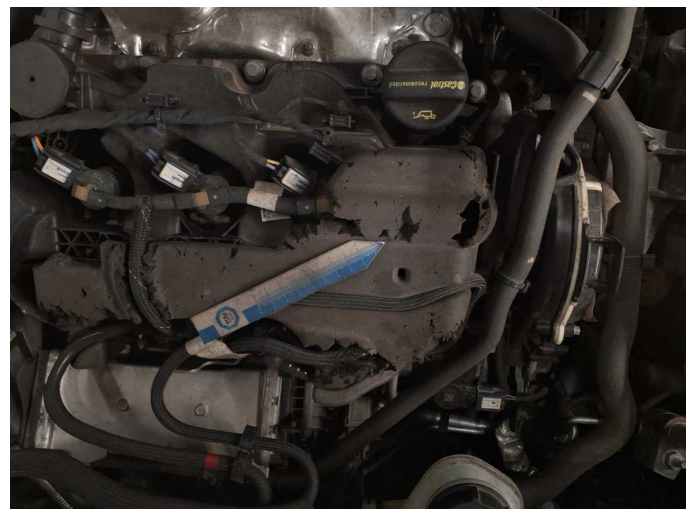
Damage 1: Misc.: Misc. (Isolierung Motor) - Damage caused by marten / rodent - Replace

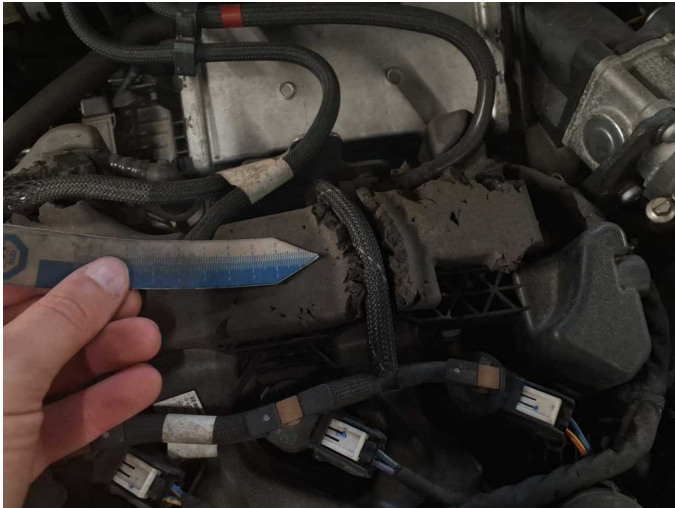
Damage 1: Misc.: Misc. (Isolierung Motor) - Damage caused by marten / rodent - Replace

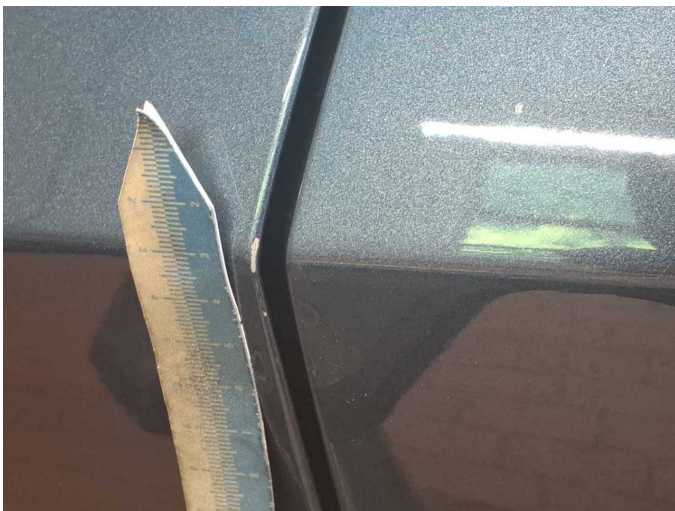
Damage 2: Door - front left side: Door edge - Scratch(es) - Smart repair

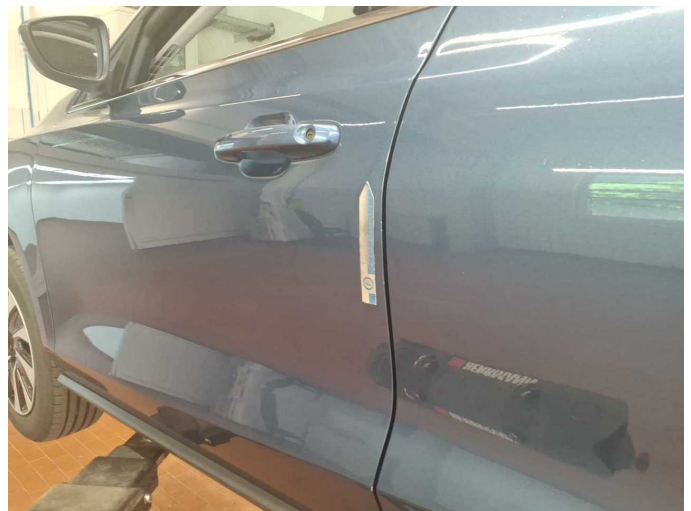
Damage 2: Door - front left side: Door edge - Scratch(es) - Smart repair

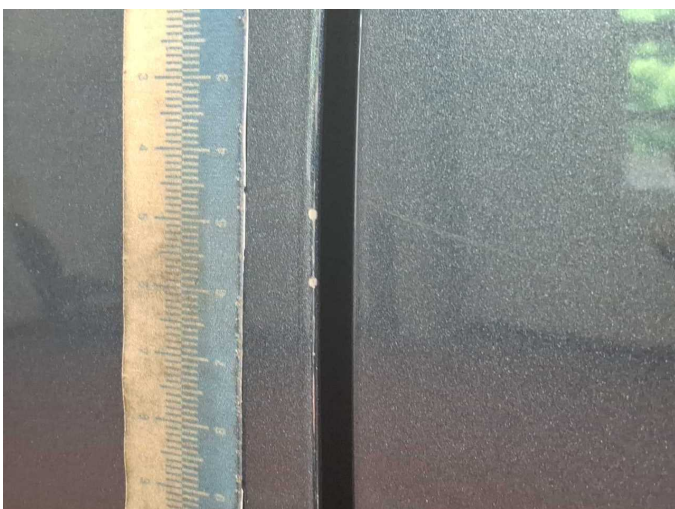
Damage 2: Door - front left side: Door edge - Scratch(es) - Smart repair

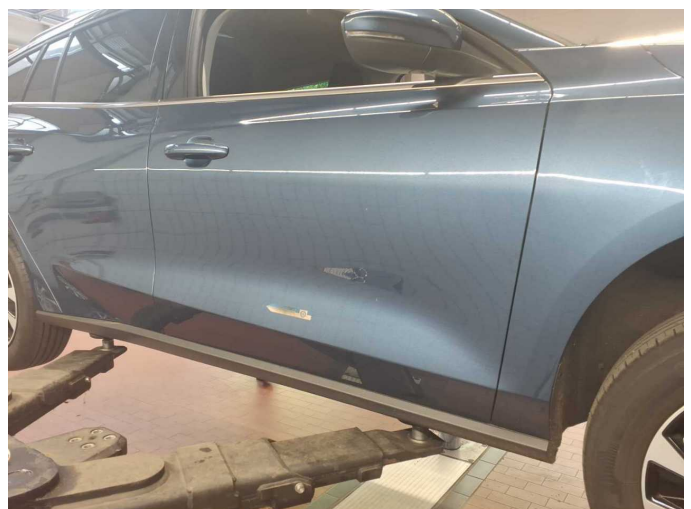
Damage 2: Door - front left side: Door edge - Scratch(es) - Smart repair

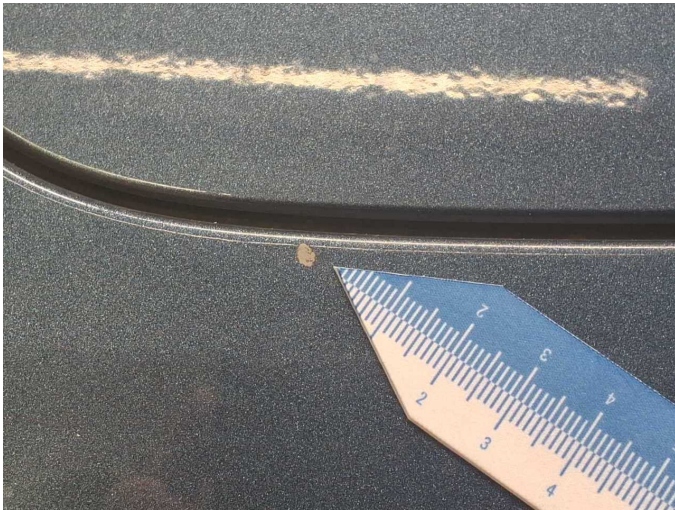
Damage 4: Side panel - rear left side: Side panel - Scratch(es) - Smart repair

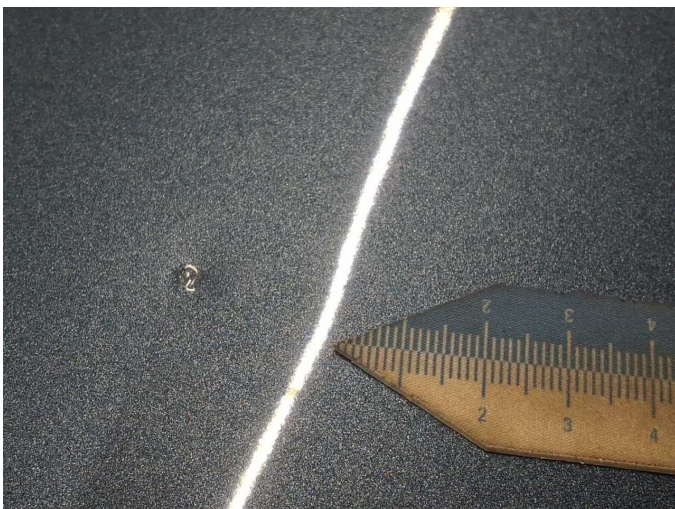
Damage 5: Boot lid / rear door: Boot lid - Dent / paintcoat damage - Smart repair

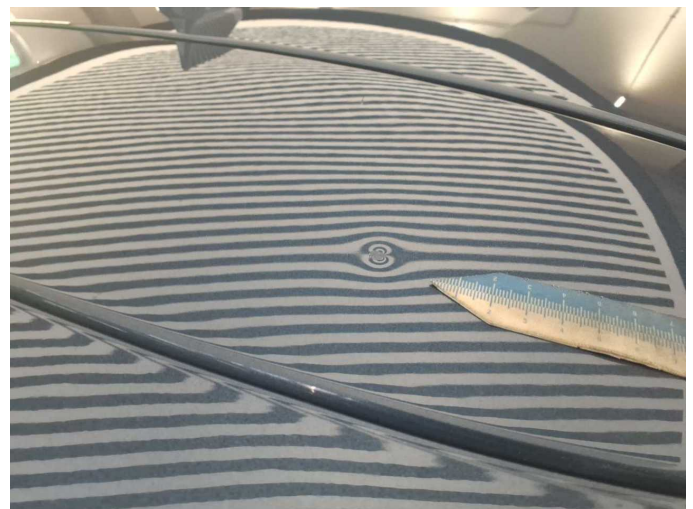
Damage 5: Boot lid / rear door: Boot lid - Dent / paintcoat damage - Smart repair

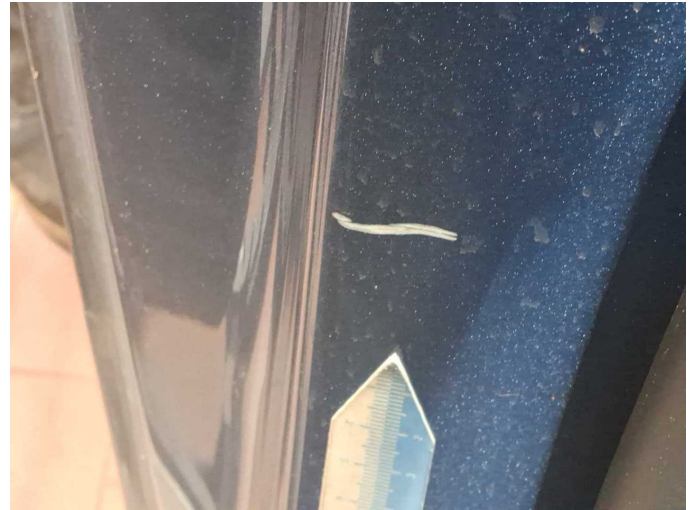
Damage 6: Side panel - rear right side: Sill - Dent / paintcoat damage - Smart repair

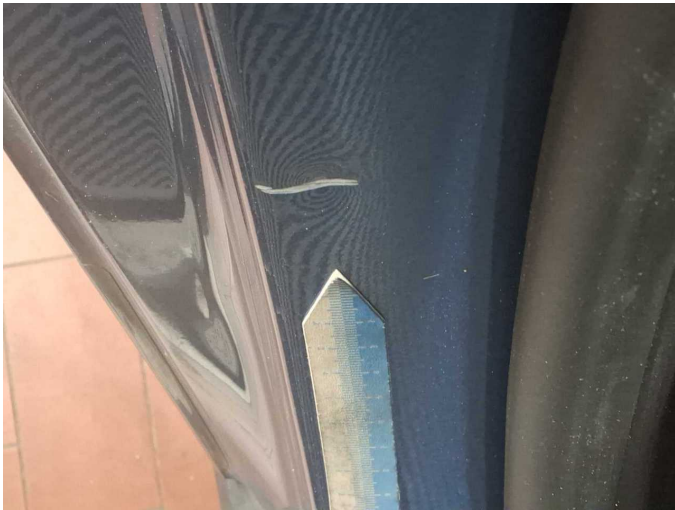
Damage 6: Side panel - rear right side: Sill - Dent / paintcoat damage - Smart repair

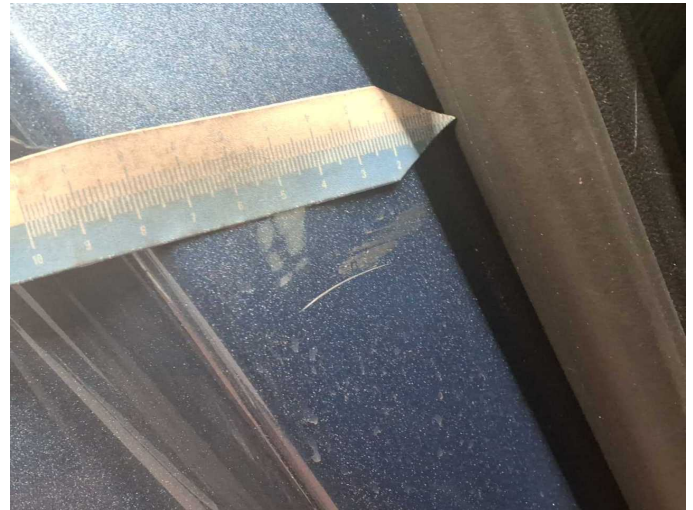
Damage 6: Side panel - rear right side: Sill - Dent / paintcoat damage - Smart repair

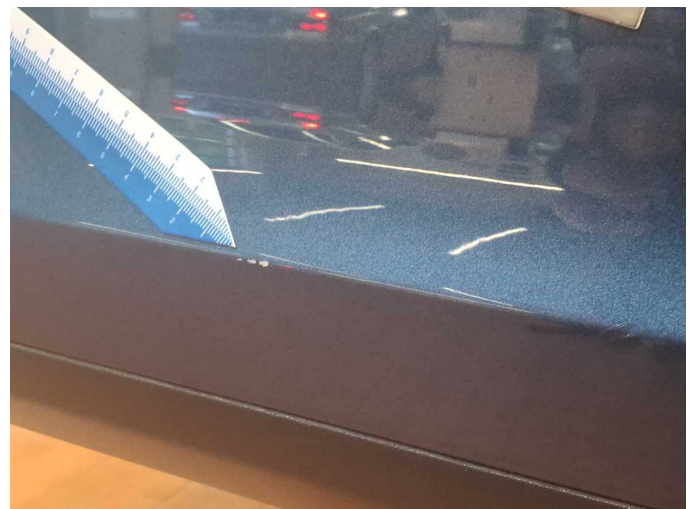
Damage 7: Rear bumper: Rear bumper - Dent / paintcoat damage - Repair and paint

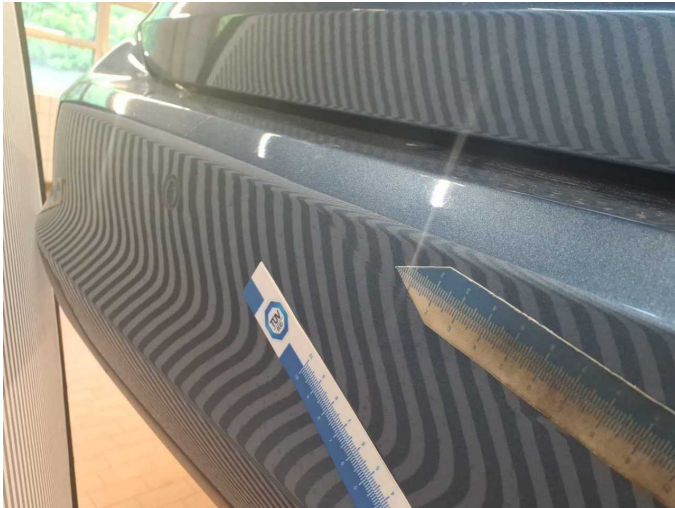
Damage 7: Rear bumper: Rear bumper - Dent / paintcoat damage - Repair and paint

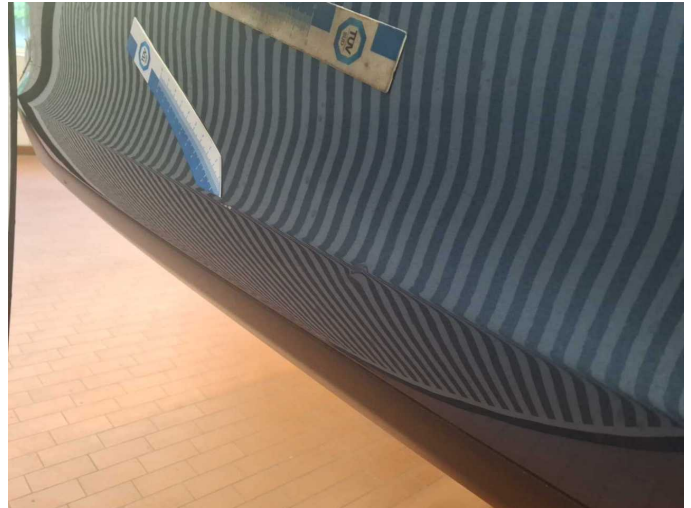
Damage 7: Rear bumper: Rear bumper - Dent / paintcoat damage - Repair and paint

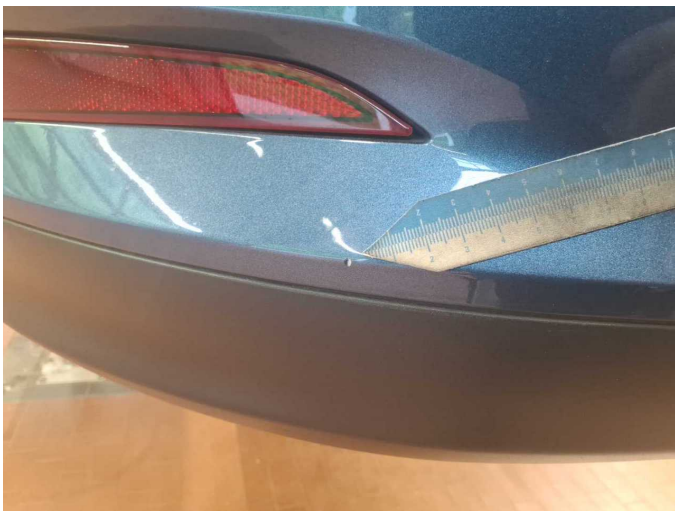
Damage 7: Rear bumper: Rear bumper - Dent / paintcoat damage - Repair and paint

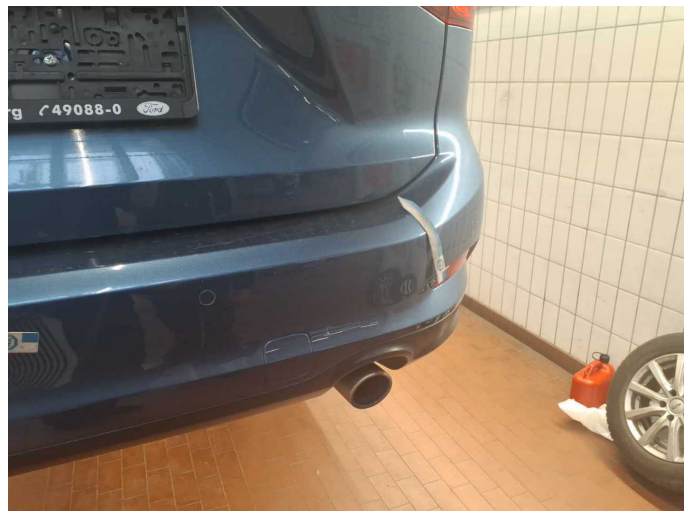
Damage 7: Rear bumper: Rear bumper - Dent / paintcoat damage - Repair and paint

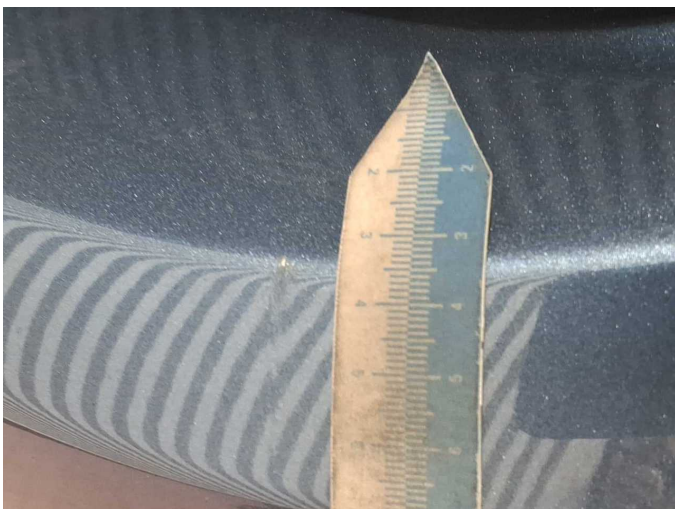
Damage 7: Rear bumper: Rear bumper - Dent / paintcoat damage - Repair and paint

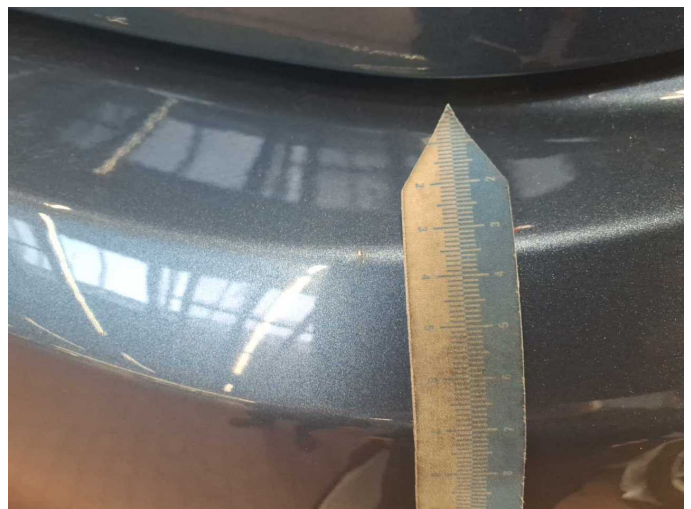
Damage 7: Rear bumper: Rear bumper - Dent / paintcoat damage - Repair and paint

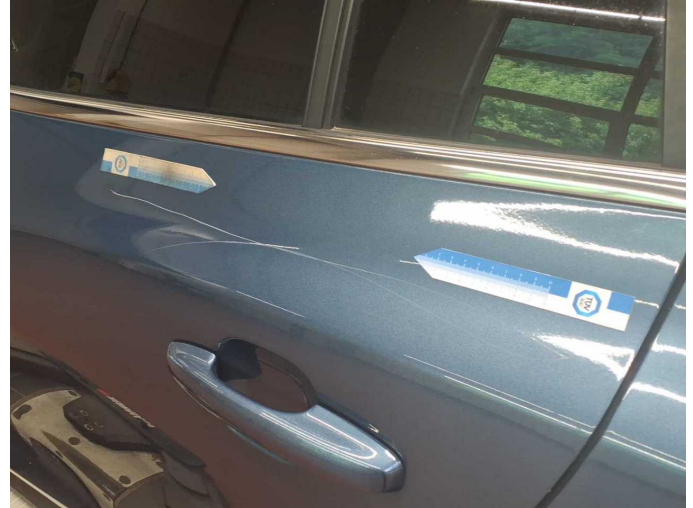
Damage 8: Door - rear left side: Door - Scratch(es) - Paint

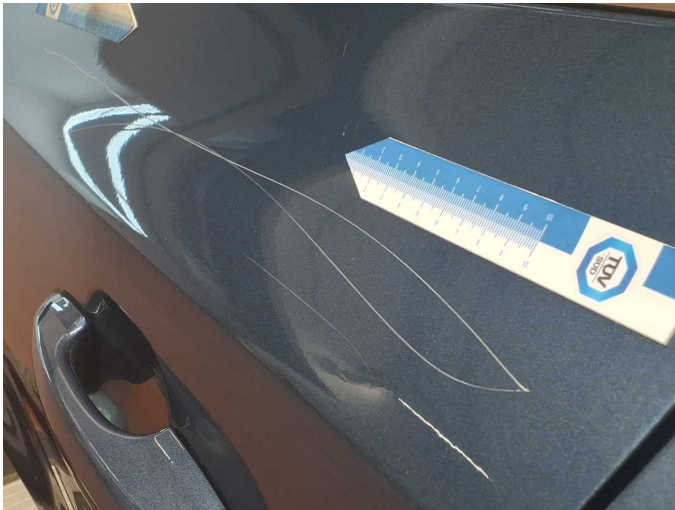
Damage 8: Door - rear left side: Door - Scratch(es) - Paint

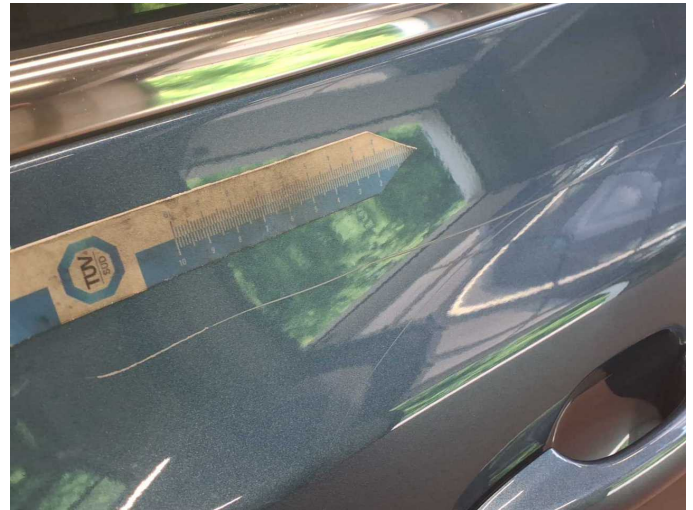
Damage 8: Door - rear left side: Door - Scratch(es) - Paint

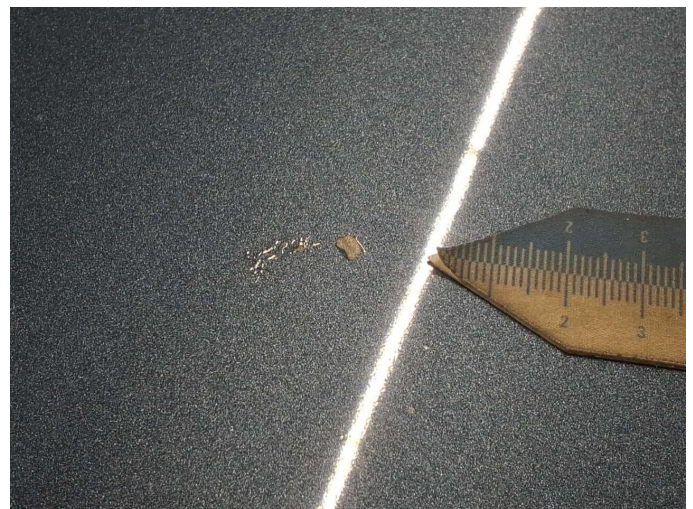
Damage 9: Bonnet: Bonnet - Paint defect - Paint

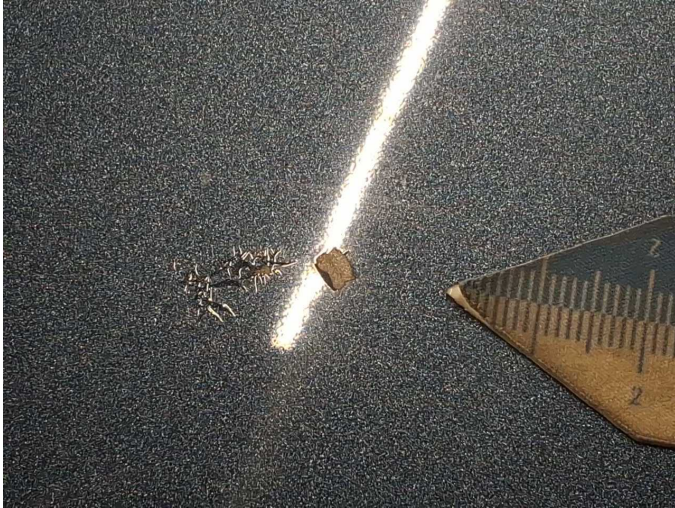
Damage 9: Bonnet: Bonnet - Paint defect - Paint

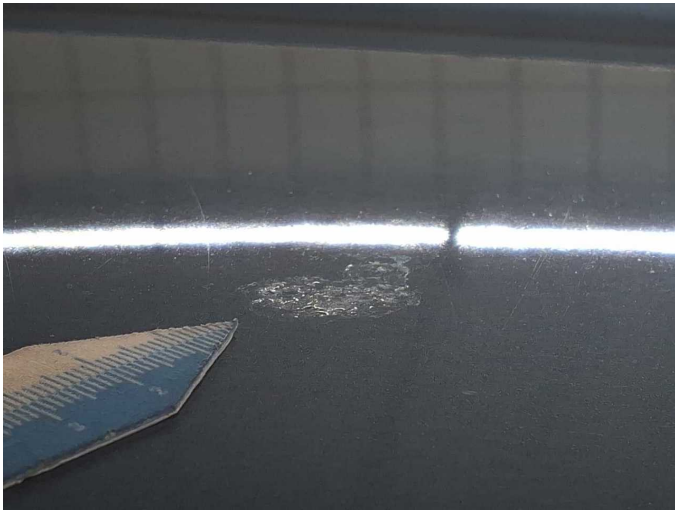
Damage 10: Roof: Roof (Verätzungen) - Paint defect - Paint

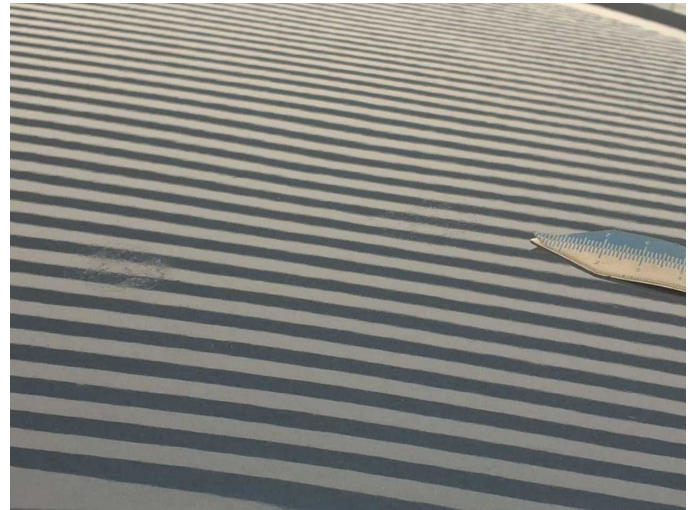
Damage 10: Roof: Roof (Verätzungen) - Paint defect - Paint

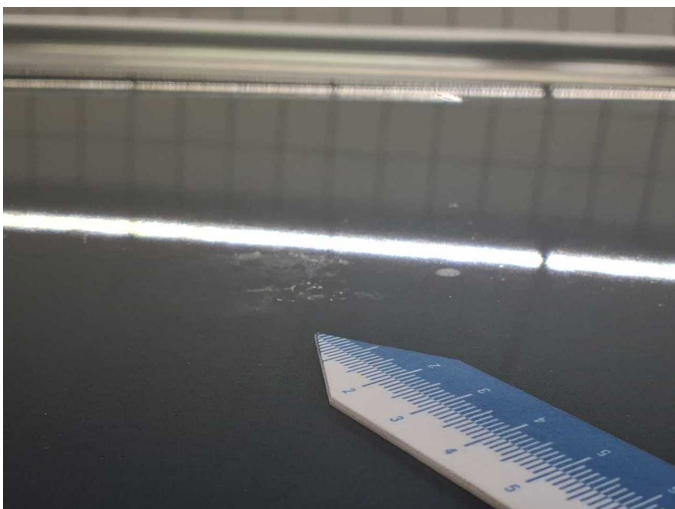
Damage 10: Roof: Roof (Verätzungen) - Paint defect - Paint

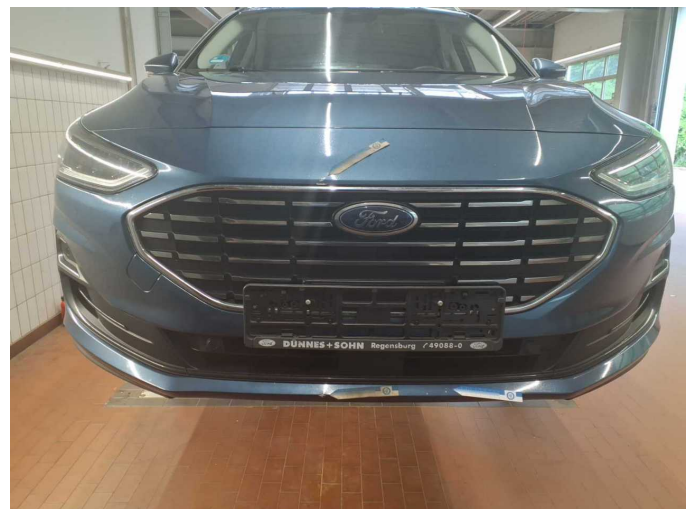
Damage 10: Roof: Roof (Verätzungen) - Paint defect - Paint

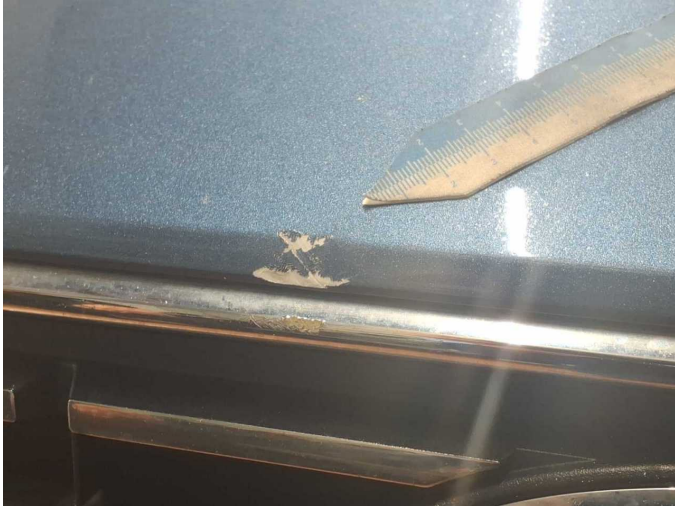
Damage 11: Front bumper: Front bumper (+ Kühlergrill verschärft erneuern) - Dent / paintcoat damage - Repair and paint

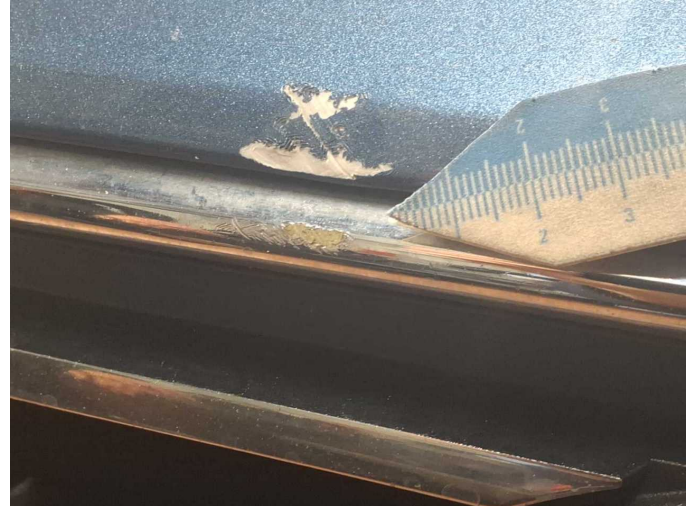
Damage 11: Front bumper: Front bumper (+ Kühlergrill verschärft erneuern) - Dent / paintcoat damage - Repair and paint

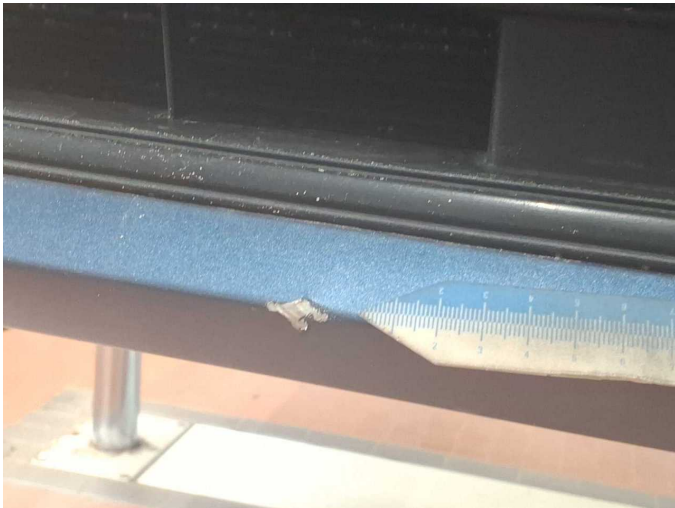
Damage 11: Front bumper: Front bumper (+ Kühlergrill verschärft erneuern) - Dent / paintcoat damage - Repair and paint

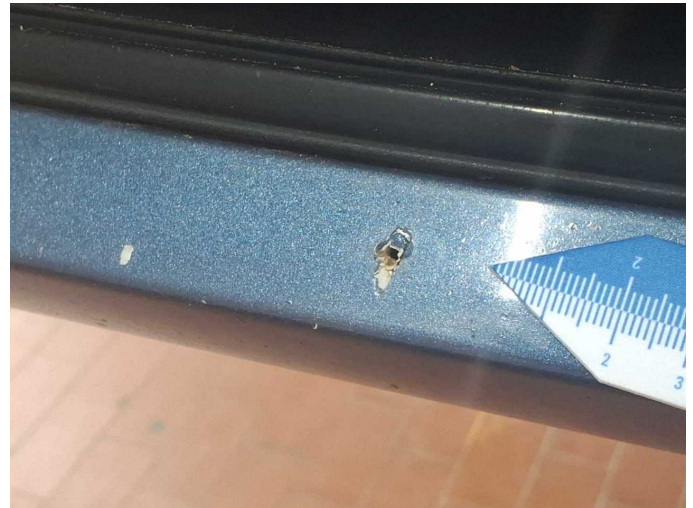
Damage 11: Front bumper: Front bumper (+ Kühlergrill verschärft erneuern) - Dent / paintcoat damage - Repair and paint

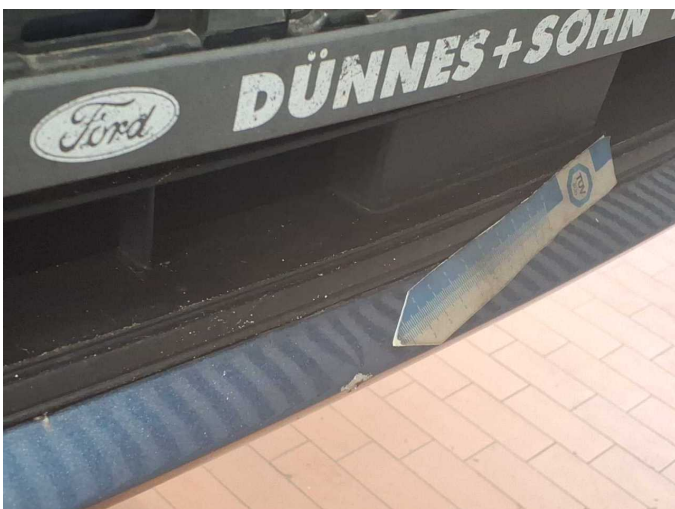
Damage 11: Front bumper: Front bumper (+ Kühlergrill verschärft erneuern) - Dent / paintcoat damage - Repair and paint

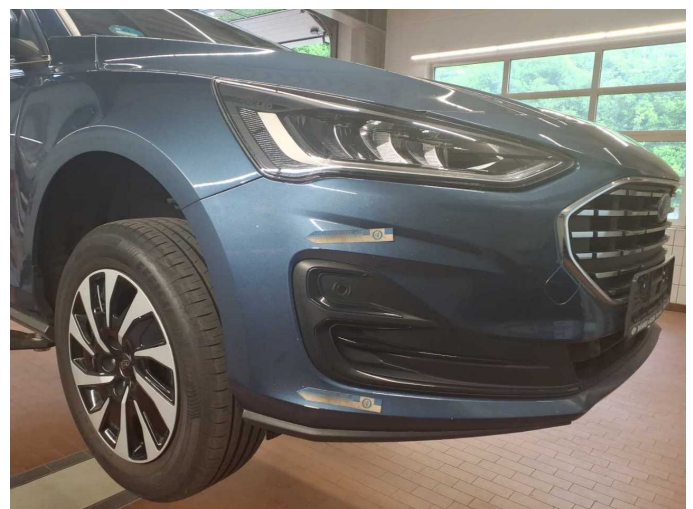
Damage 11: Front bumper: Front bumper (+ Kühlergrill verschärft erneuern) - Dent / paintcoat damage - Repair and paint

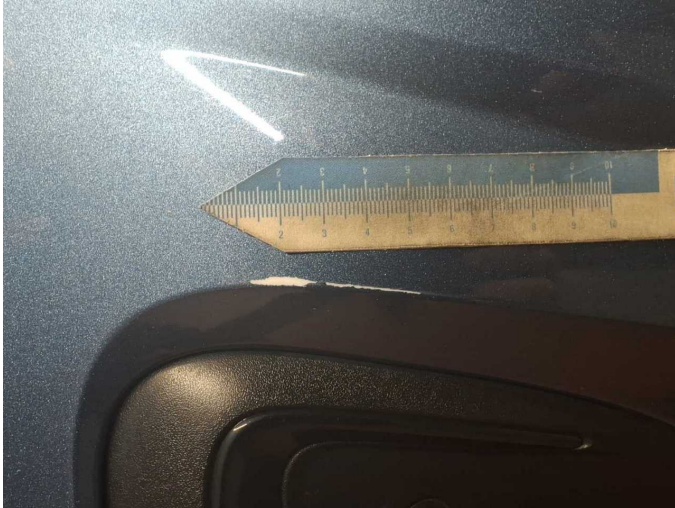
Damage 11: Front bumper: Front bumper (+ Kühlergrill verschärft erneuern) - Dent / paintcoat damage - Repair and paint

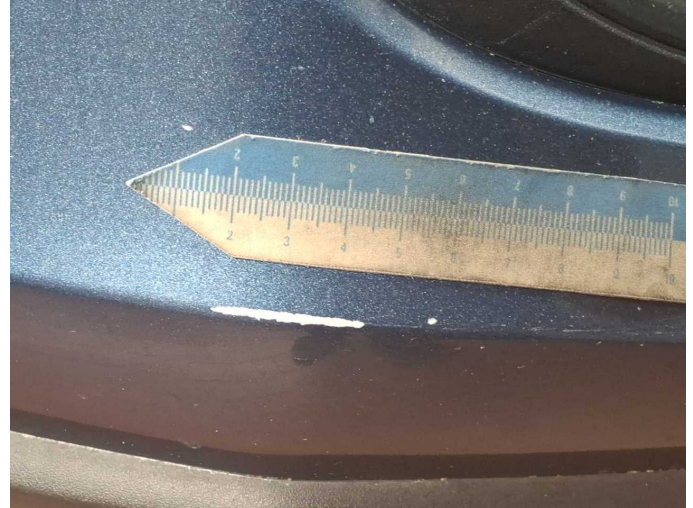
Damage 11: Front bumper: Front bumper (+ Kühlergrill verschürft erneuern) - Dent / paintcoat damage - Repair and paint
