Expertise

Protocol number: 46557958  
Order No. / Reference: 26559442  
Inspection date: 16 Jul 2026

Manufacturer: Peugeot

Model: 3008 BlueHDi 130 Stop & Start Allure

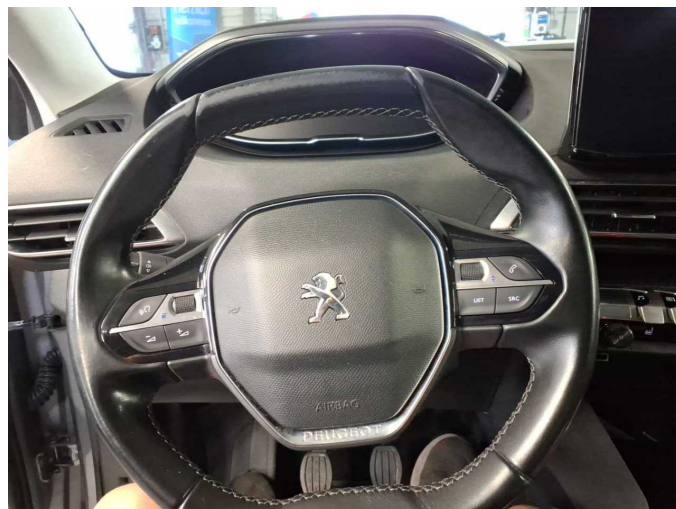
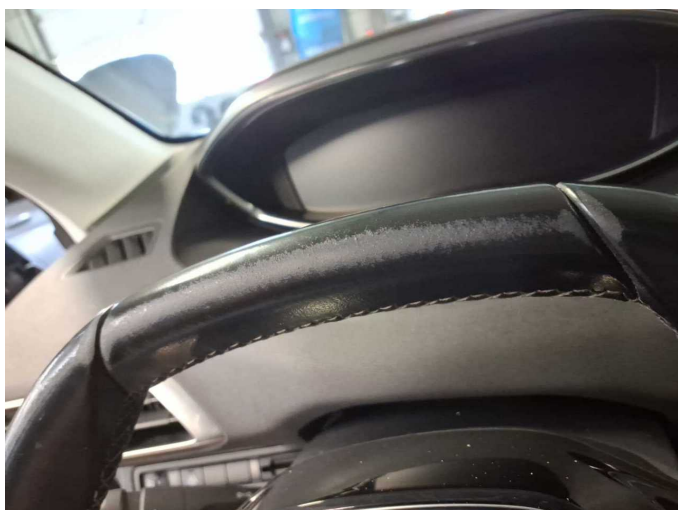
| No. | Component group | Description |
|---|---|---|
| 1 | Steering system | Steering wheel - Abrasion - Smart repair |

**Damage 1:** Steering system: Steering wheel - Abrasion - Smart repair

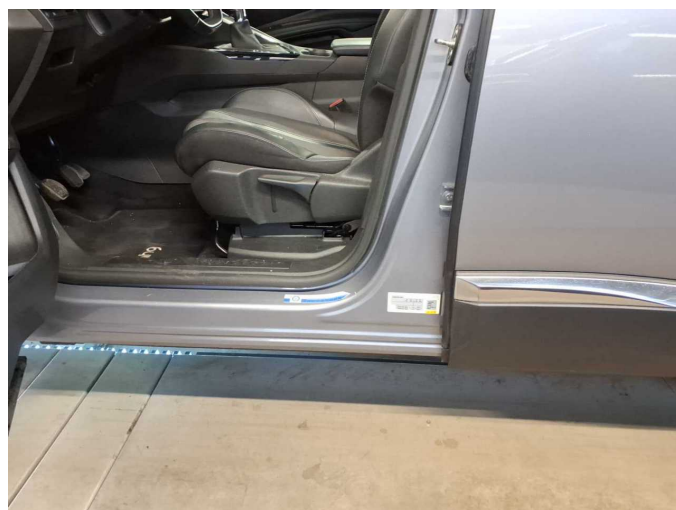
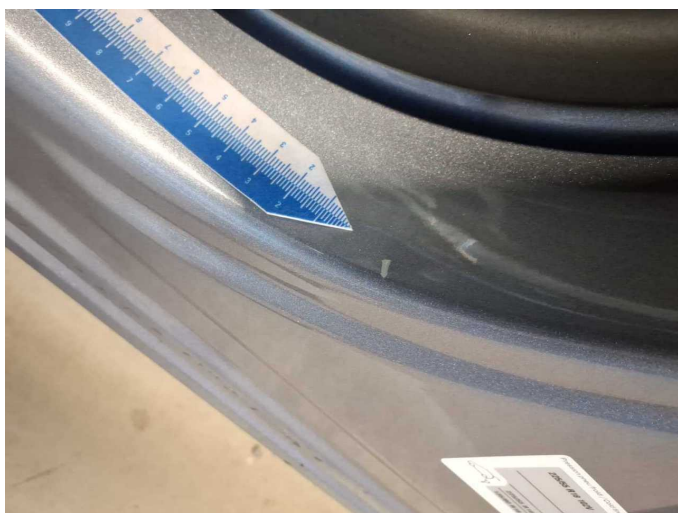
| No. | Component group | Description |
|---|---|---|
| 2 | Sill - left side | Sill - Scratch(es) - Smart repair |

**Damage 2:** Sill - left side: Sill - Scratch(es) - Smart repair

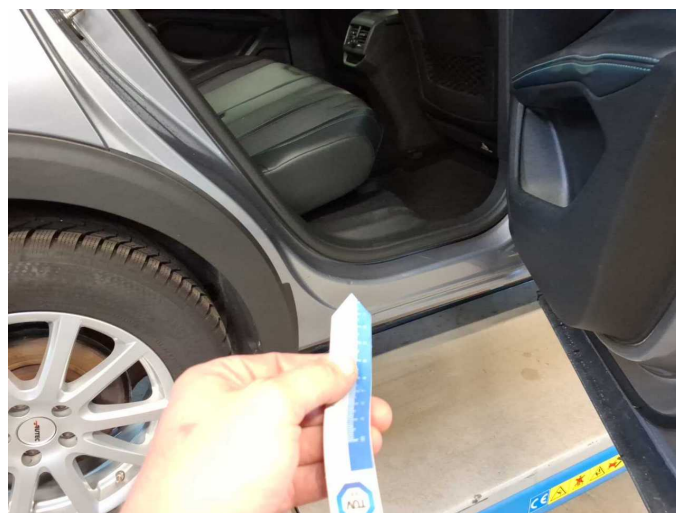
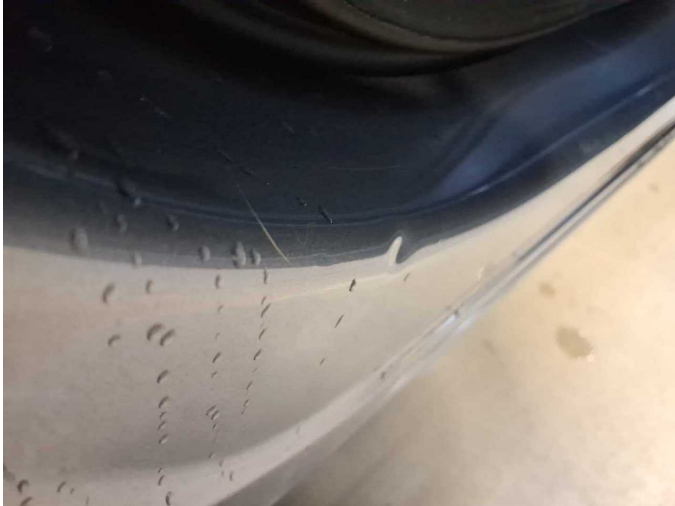
| No. | Component group | Description |
|---|---|---|
| 3 | Side panel - rear right side | Sill - dent(s) - Smooth repair work |

**Damage 3:** Side panel - rear right side: Sill - dent(s) - Smooth repair work

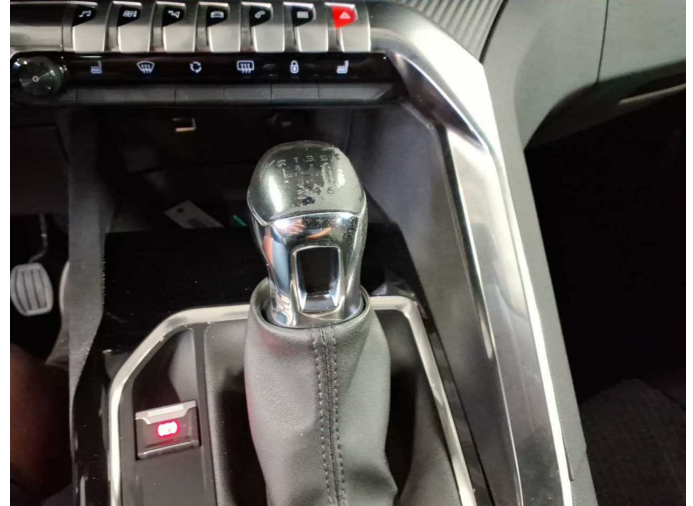
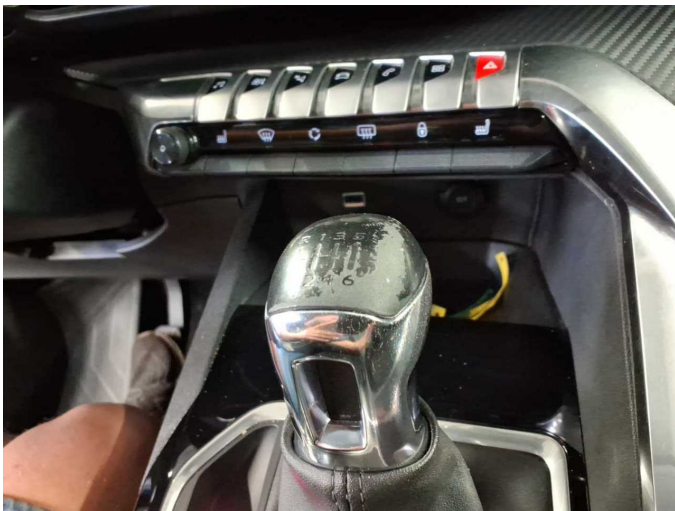
| No. | Component group | Description |
|---|---|---|
| 4 | Gearbox | Gear knob (Leder) - Abrasion - Replace |

**Damage 4:** Gearbox: Gear knob (Leder) - Abrasion - Replace

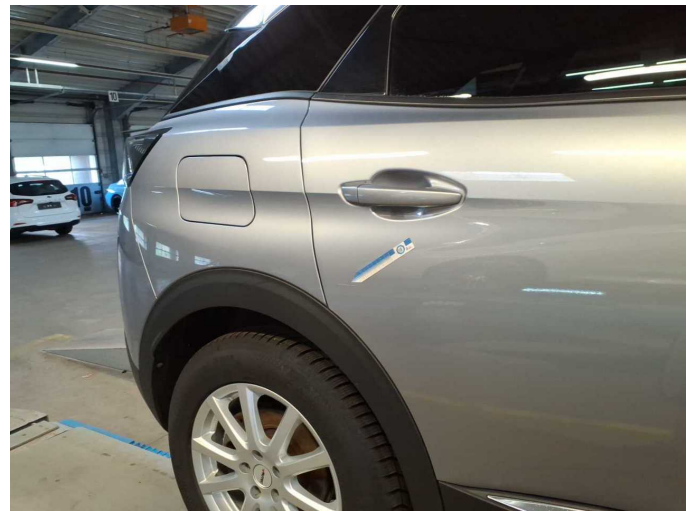
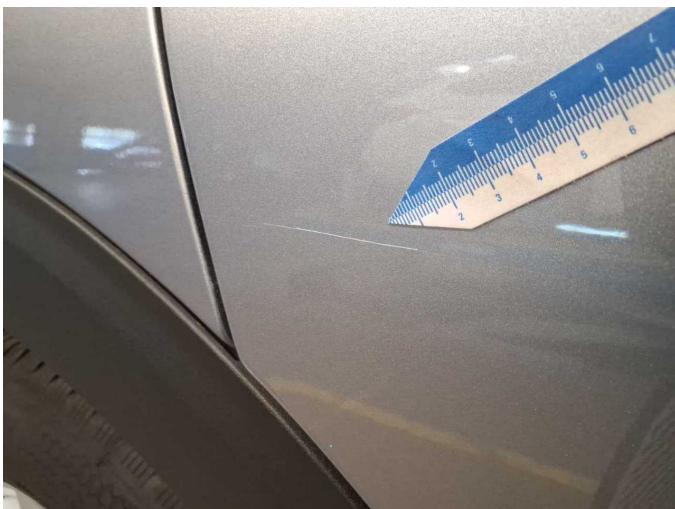
| No. | Component group | Description |
|---|---|---|
| 5 | Door - rear right side | Door - Scratch(es) - Smart repair |

**Damage 5:** Door - rear right side: Door - Scratch(es) - Smart repair

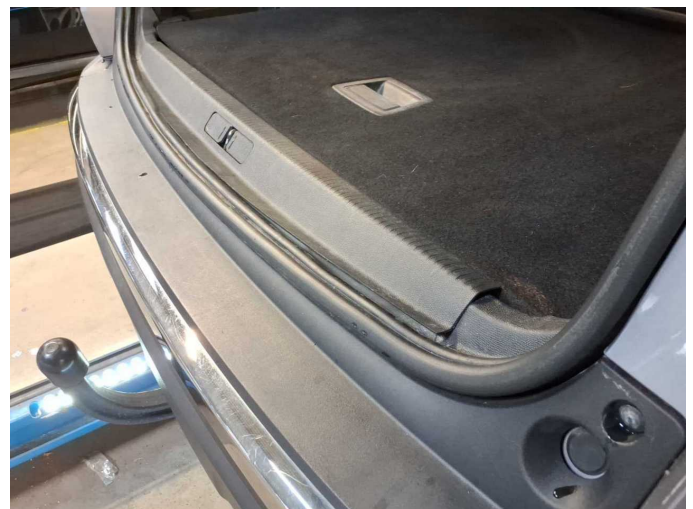
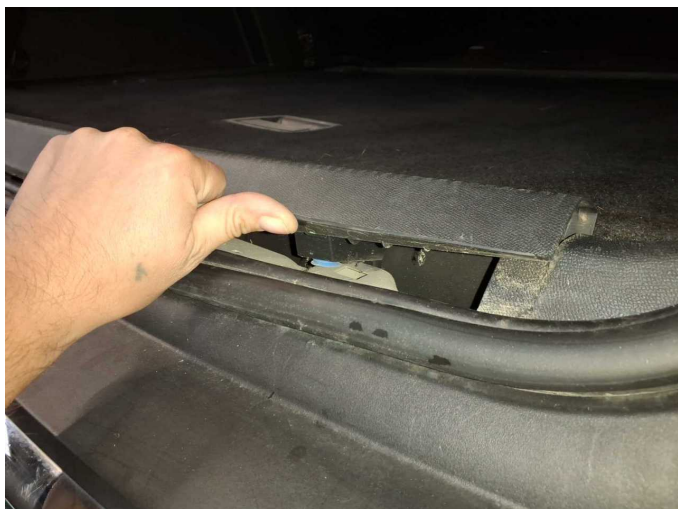
| No. | Component group | Description |
|---|---|---|
| 6 | Trim / covers | Boot sill cover (Nasen gebrochen) - Loose - Replace |

**Damage 6:** Trim / covers: Boot sill cover (Nasen gebrochen) - Loose - Replace

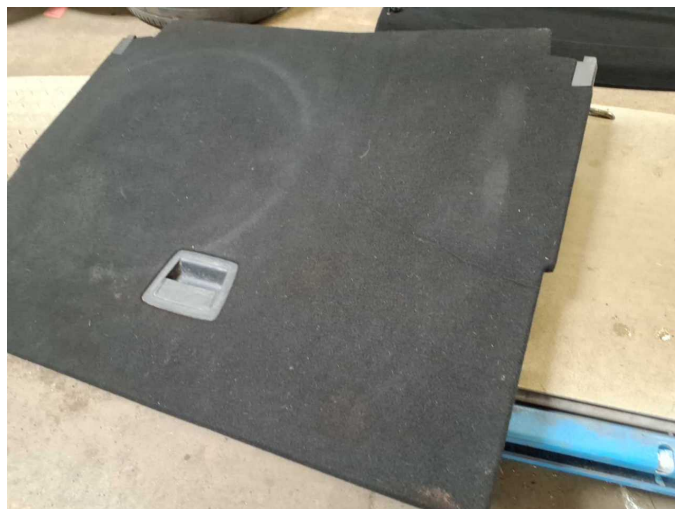
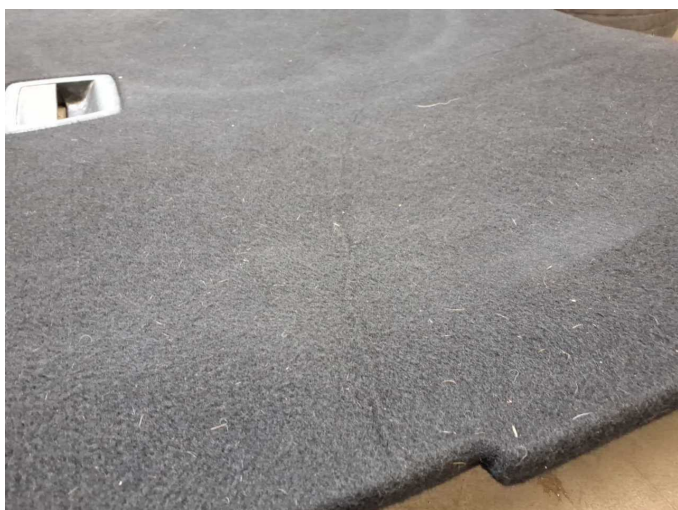
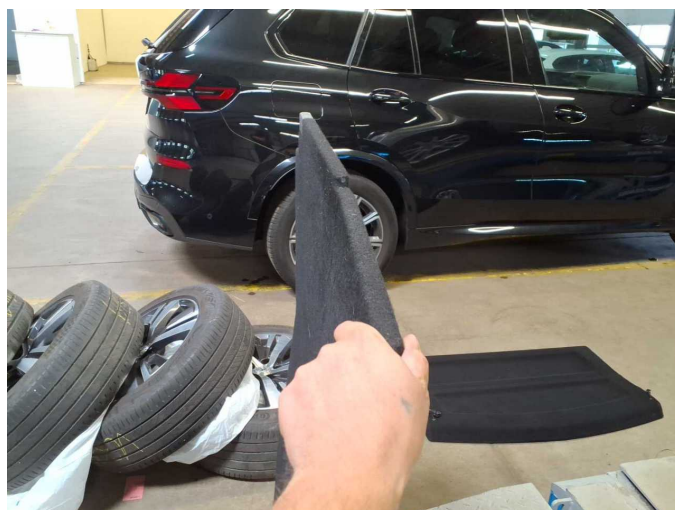
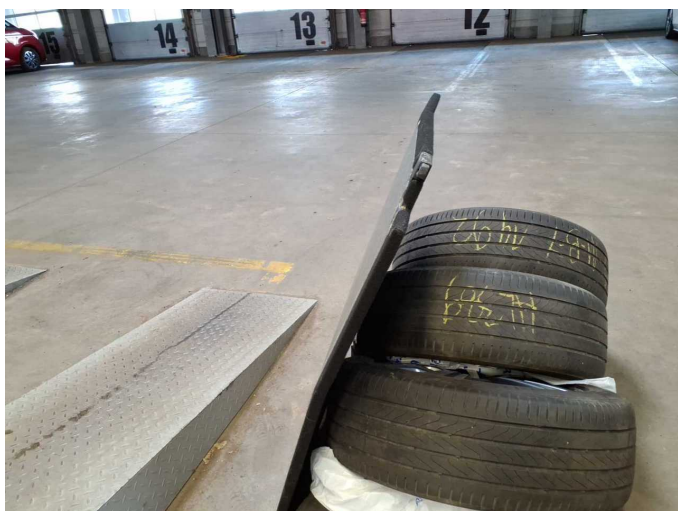
| No. | Component group | Description |
|---|---|---|
| 7 | Interior | Cargo area floor - Broken / torn - Replace |

**Damage 7:** Interior: Cargo area floor - Broken / torn - Replace

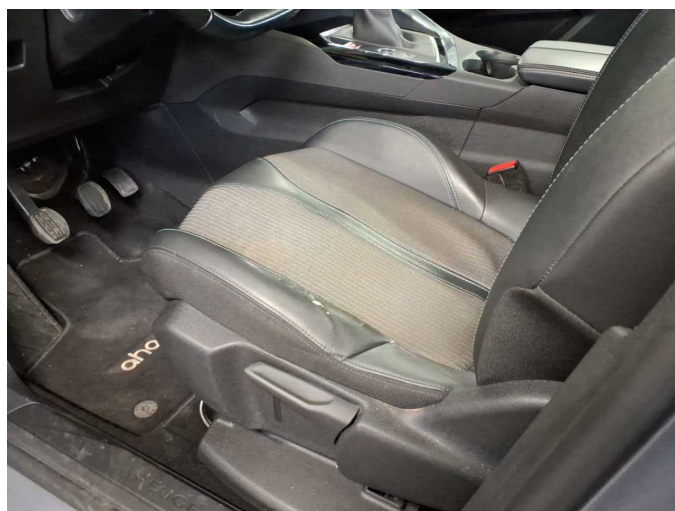
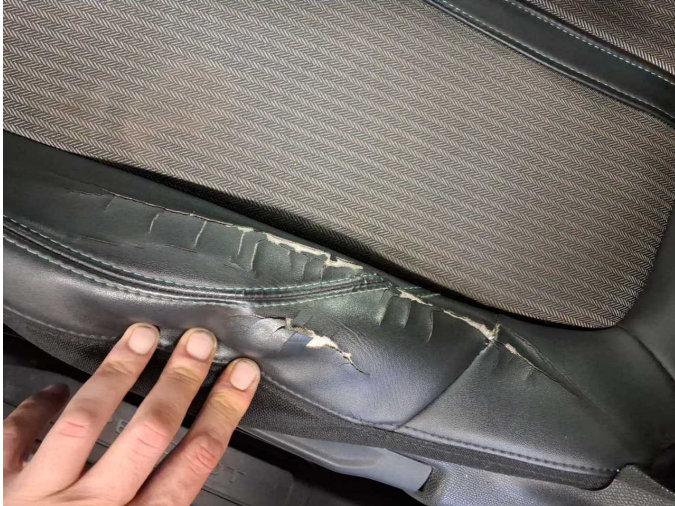
| No. | Component group | Description |
|---|---|---|
| 8 | Seat - front | Seat cover - left side (Wange) - Broken / torn - Replace |

**Damage 8:** Seat - front: Seat cover - left side (Wange) - Broken / torn - Replace

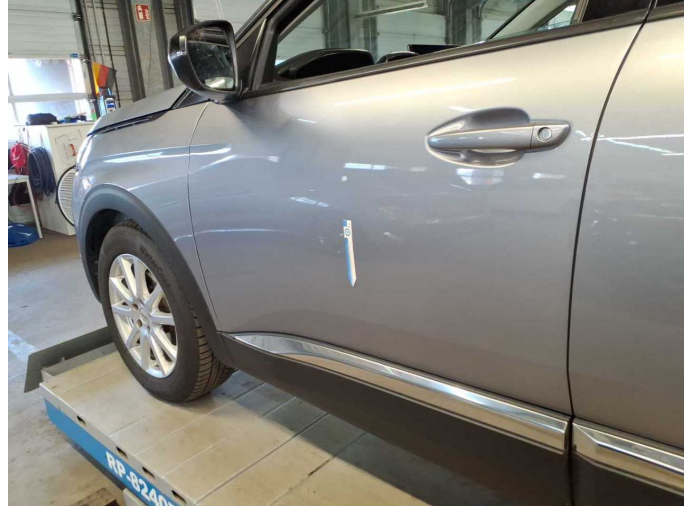
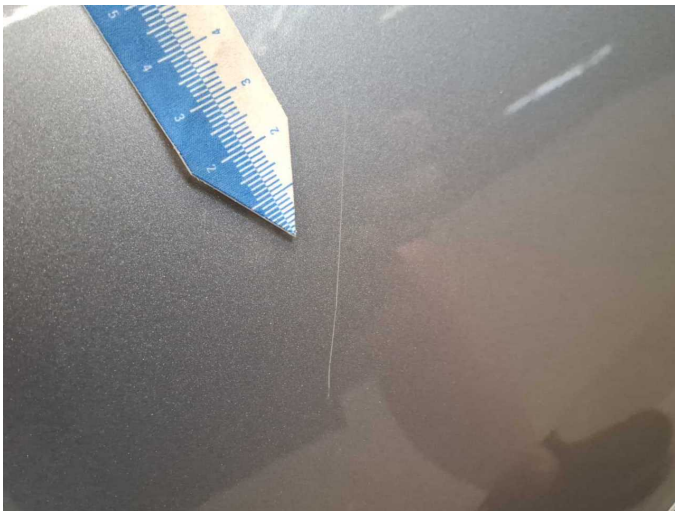
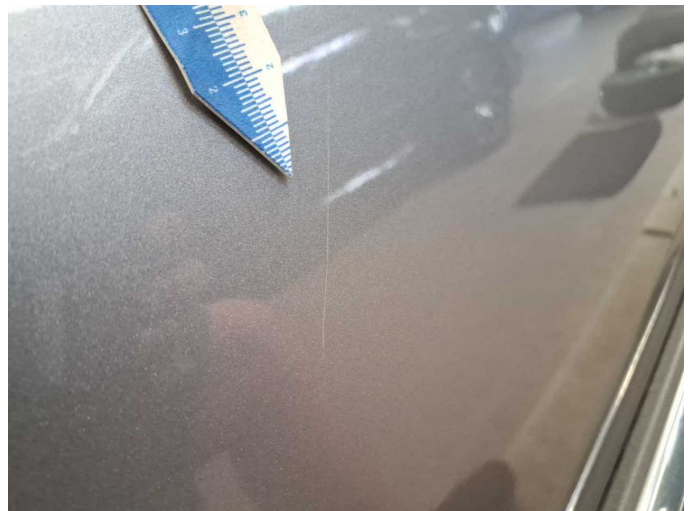
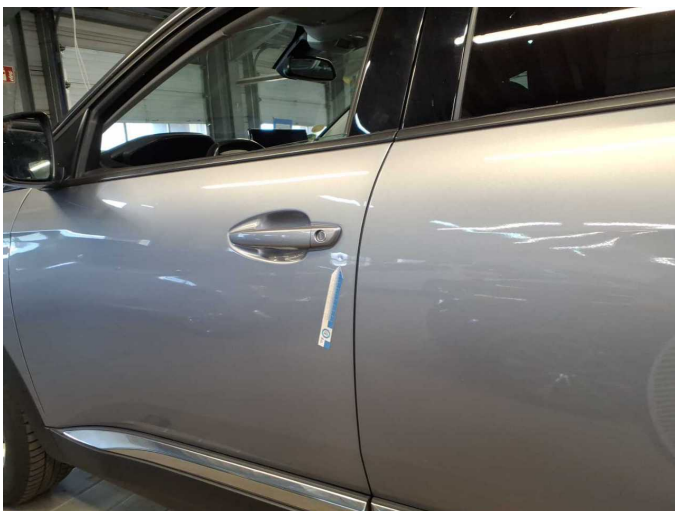
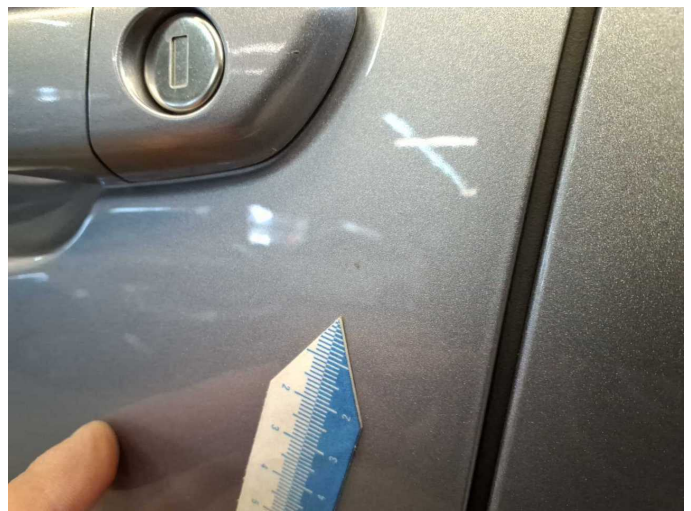
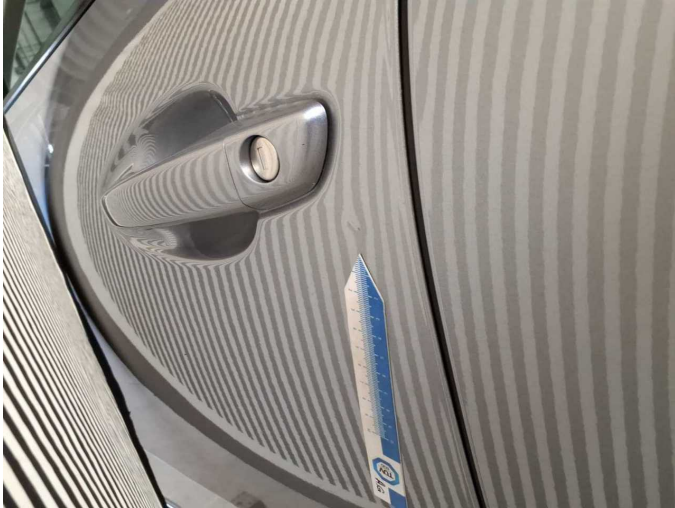
| No. | Component group | Description |
|---|---|---|
| 9 | Door - front left side | Door - Dent / paintcoat damage - Repair and paint |

**Damage 9:** Door - front left side: Door - Dent / paintcoat damage - Repair and paint

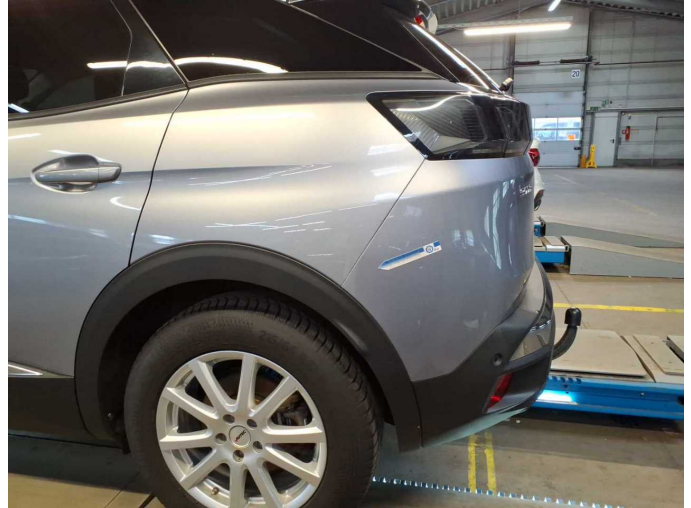
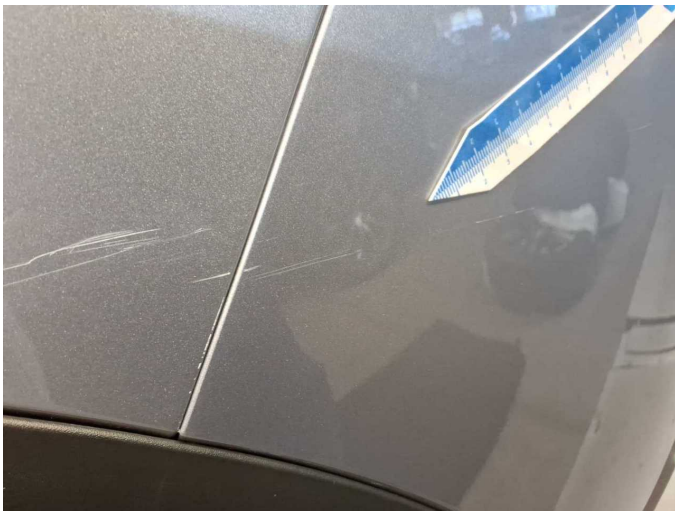
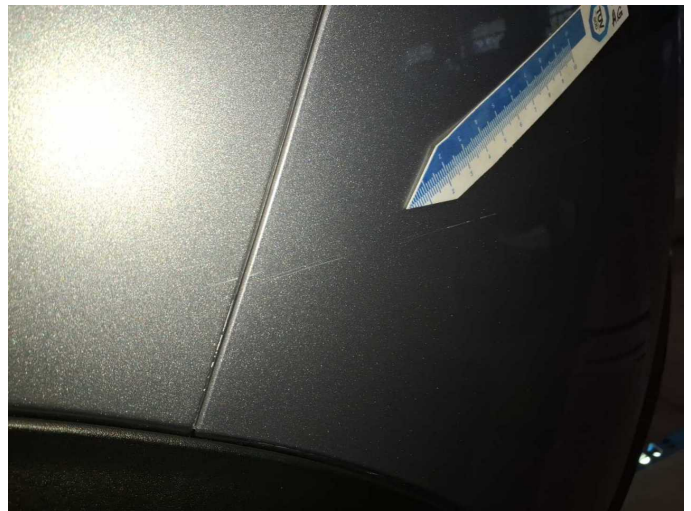
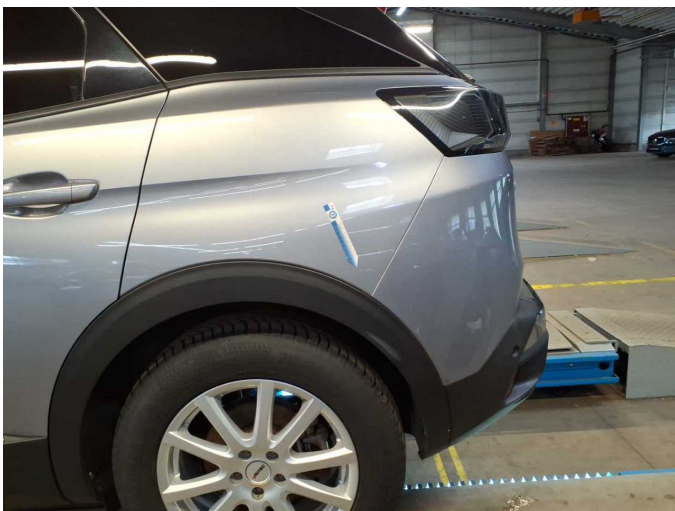
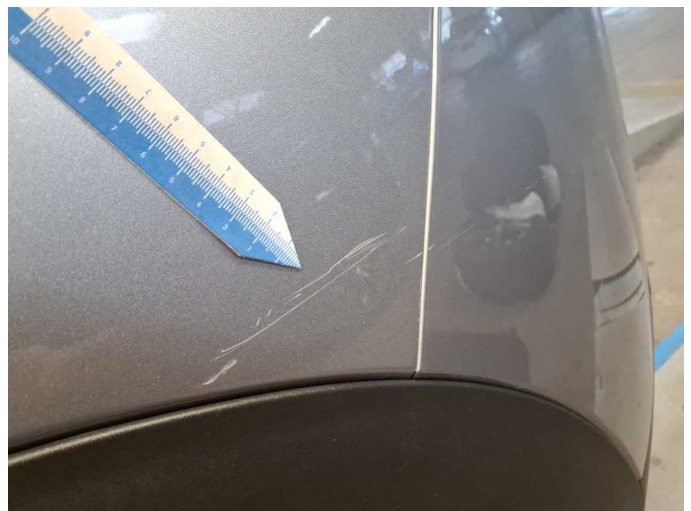
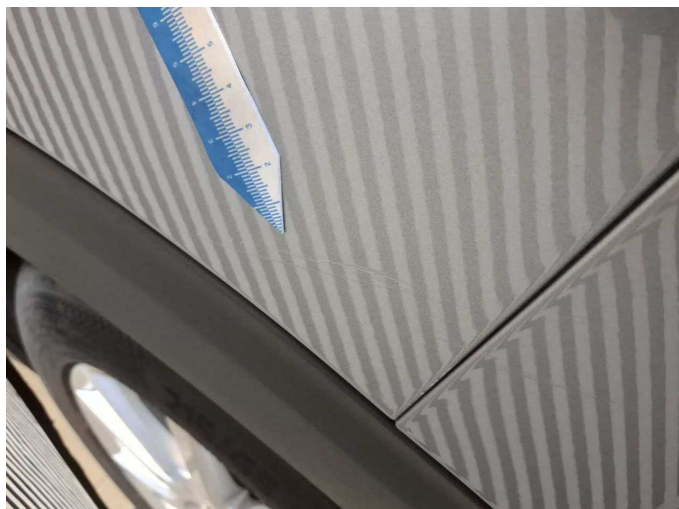
| No. | Accident |
|---|---|
| 1 | Side - left |

**Accident 1:** Side - left

**Accident 1: Side - left**

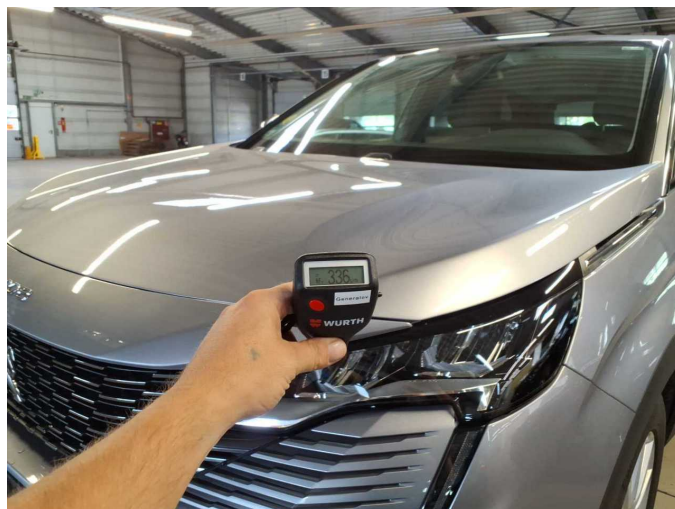
**Repainting 1: Bonnet**

| No. | Repainting |
|---|---|
| 1 | Bonnet, Professionally carried out, Invoice of repair done Non-existent |

336 µm |
