Expertise

Protocol number: 46191477  
Order No. / Reference: 26595014  
Inspection date: 25 Jun 2026

Model: Transit Custom 280 L1H1 LKW VA Trend

VIN: WF0YXXTTGYNA74915

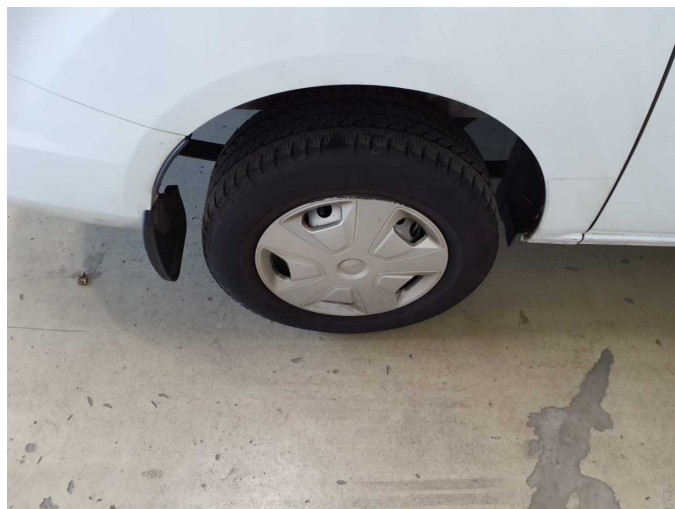
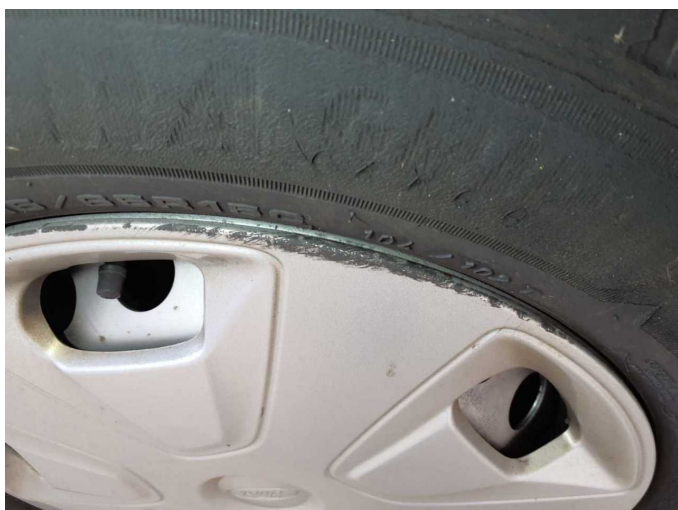
| No. | Component group | Description |
|---|---|---|
| 1 | Wheel / tyres | Wheel cover - rear right side - Scratch(es) - Replace |

**Damage 1:** Wheel / tyres: Wheel cover - rear right side - Scratch(es) - Replace

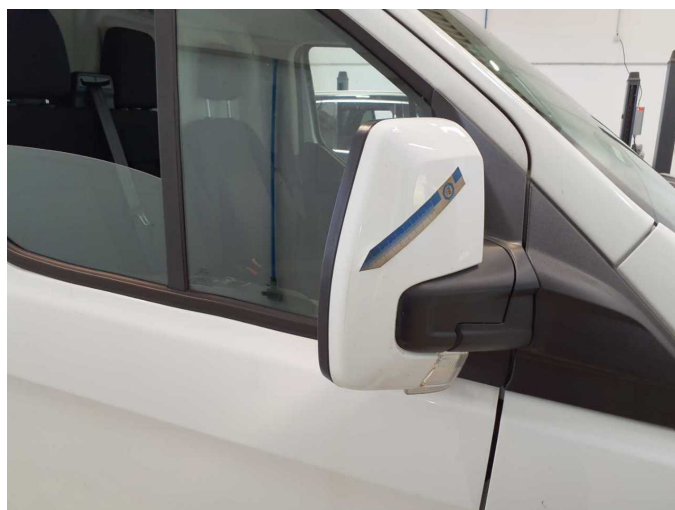
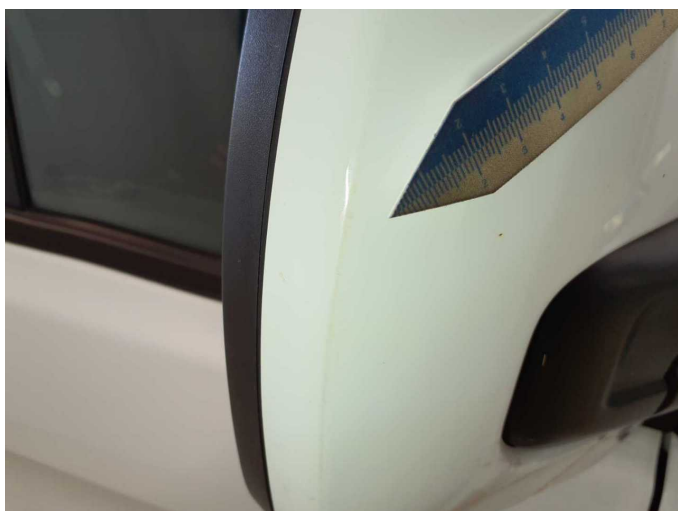
| No. | Component group | Description |
|---|---|---|
| 2 | Wing mirror - right side | Cap - Scratch(es) - Smart repair |

**Damage 2:** Wing mirror - right side: Cap - Scratch(es) - Smart repair

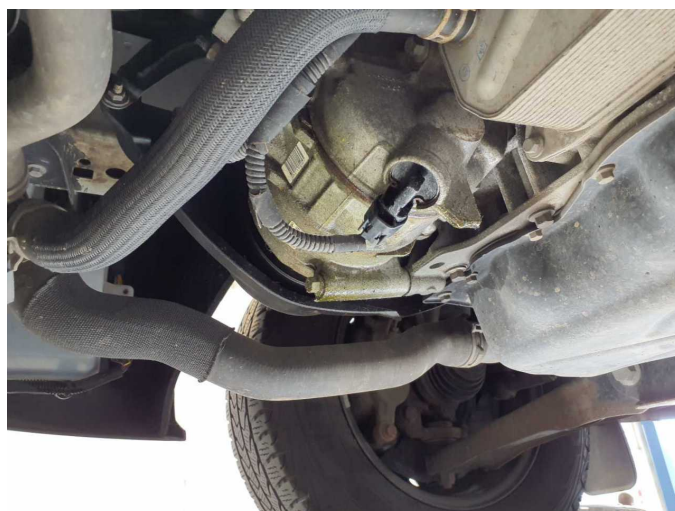
| No. | Component group | Description |
|---|---|---|
| 3 | Air-conditioning system | Air-conditioning system (Kompressor, Mehrkosten möglich) - Leaking - Perform diagnosis |

**Damage 3:** Air-conditioning system: Air-conditioning system (Kompressor, Mehrkosten möglich) - Leaking - Perform diagnosis

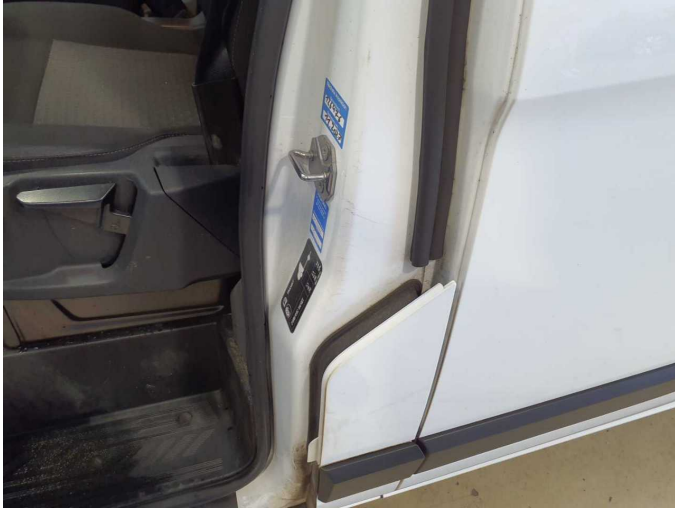
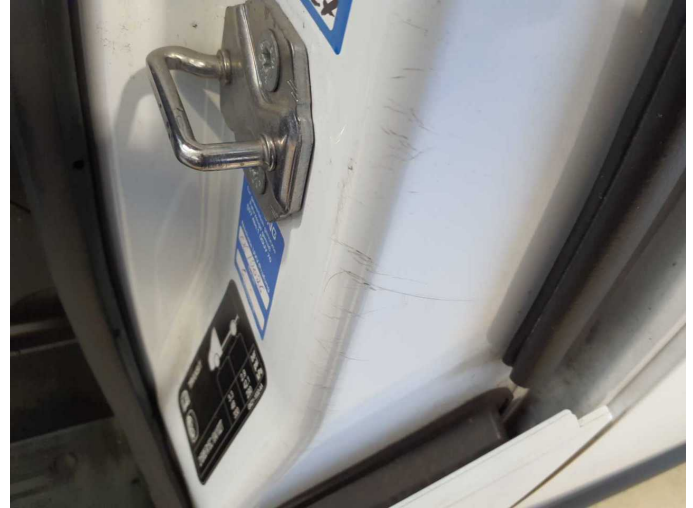
| No. | Component group | Description |
|---|---|---|
| 4 | Side panel - rear left side | Sill - Scratch(es) - Smart repair |

**Damage 4:** Side panel - rear left side: Sill - Scratch(es) - Smart repair

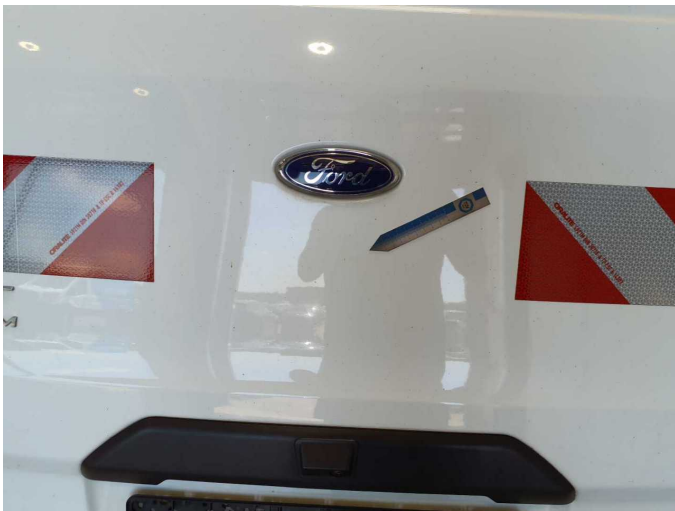
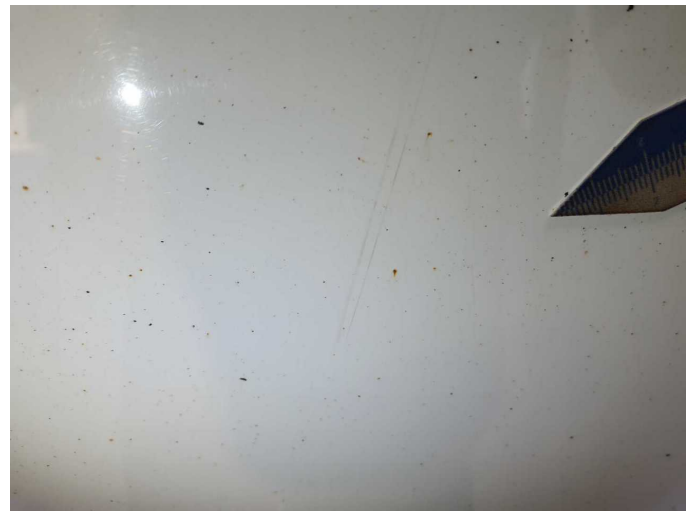
| No. | Component group | Description |
|---|---|---|
| 5 | Boot lid / rear door | Boot lid - Scratch(es) - Smart repair |

**Damage 5:** Boot lid / rear door: Boot lid - Scratch(es) - Smart repair

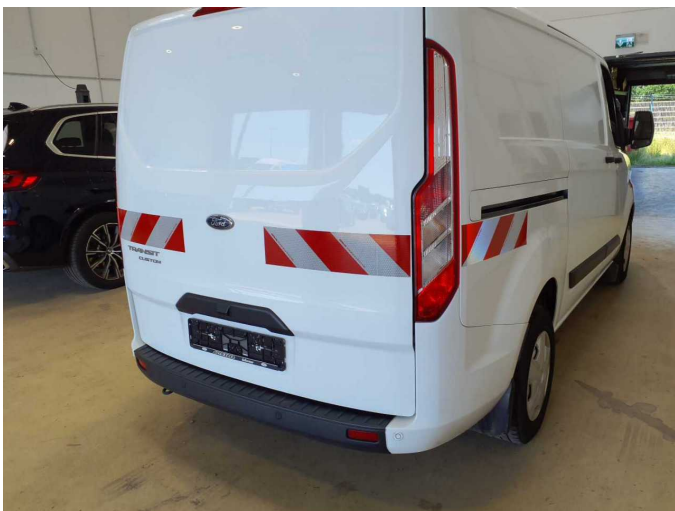
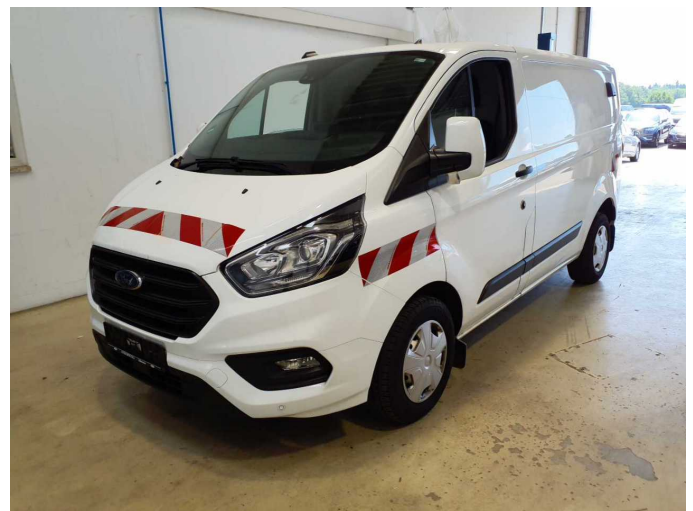
| No. | Component group | Description |
|---|---|---|
| 6 | Body | Body - Glued / labelled - De-glue / neutralise |

**Damage 6:** Body: Body - Glued / labelled - De-glue / neutralise

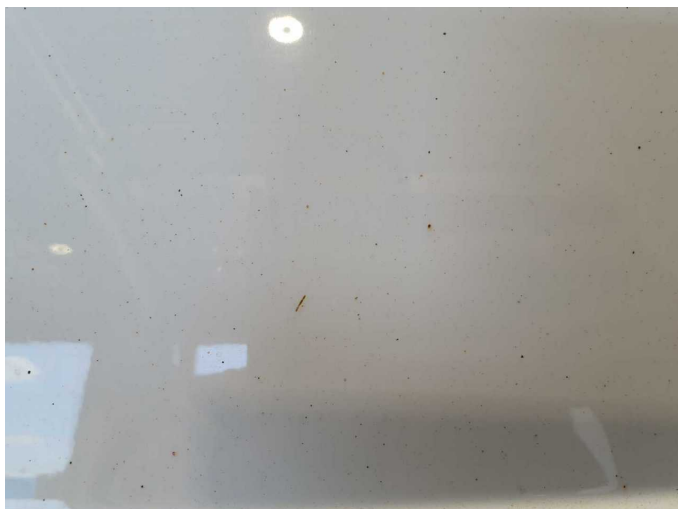
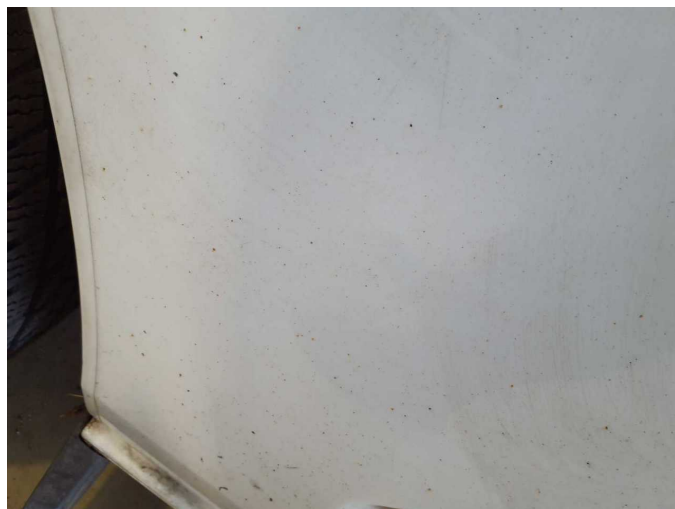
| No. | Component group | Description |
|---|---|---|
| 7 | Body | Body - Stone chips - Conditioning |

**Damage 7:** Body: Body - Stone chips - Conditioning

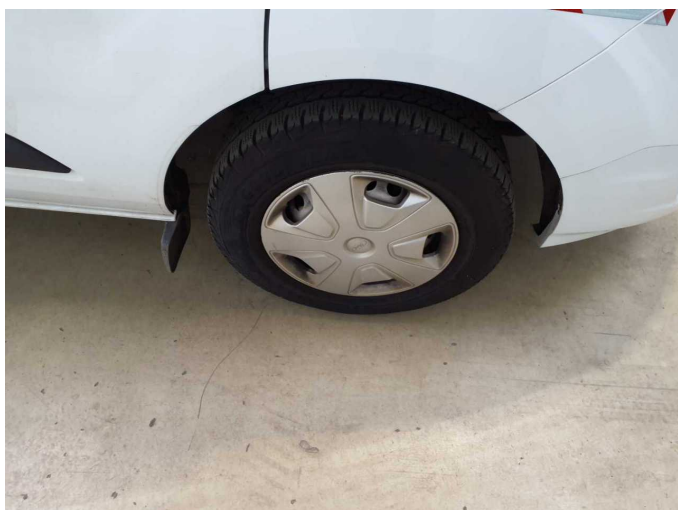
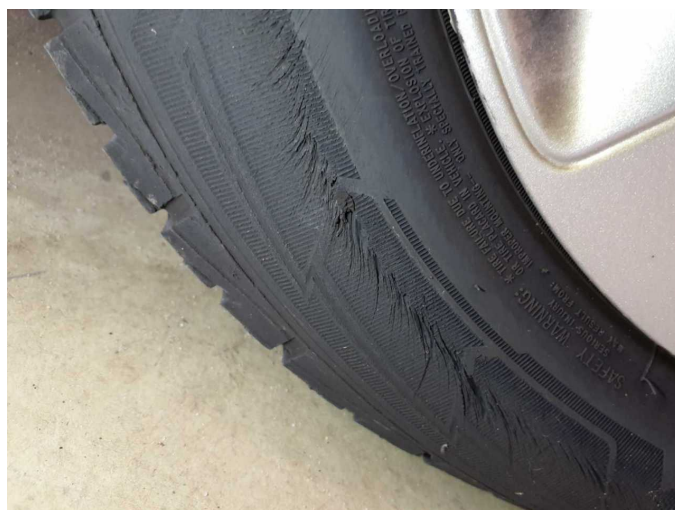
| No. | Component group | Description |
|---|---|---|
| 8 | Wheel / tyres | Tyre - front right side - Broken / torn - Replace |

**Damage 8:** Wheel / tyres: Tyre - front right side - Broken / torn - Replace

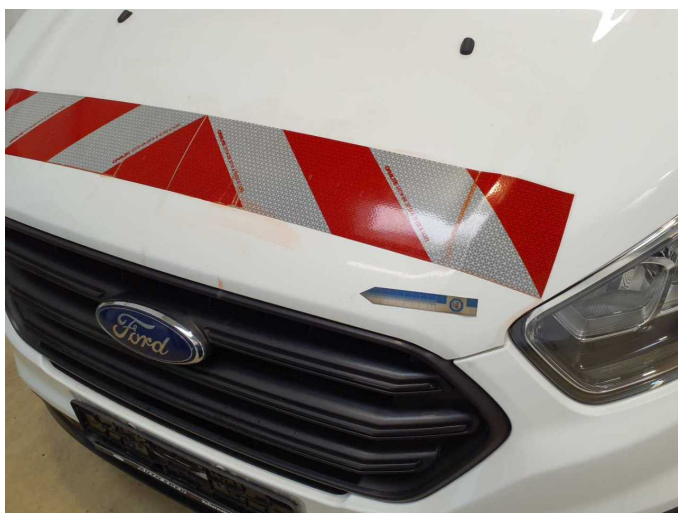
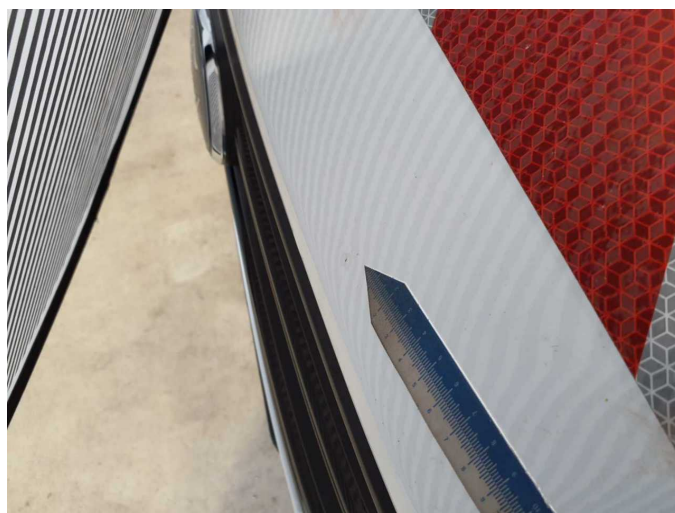
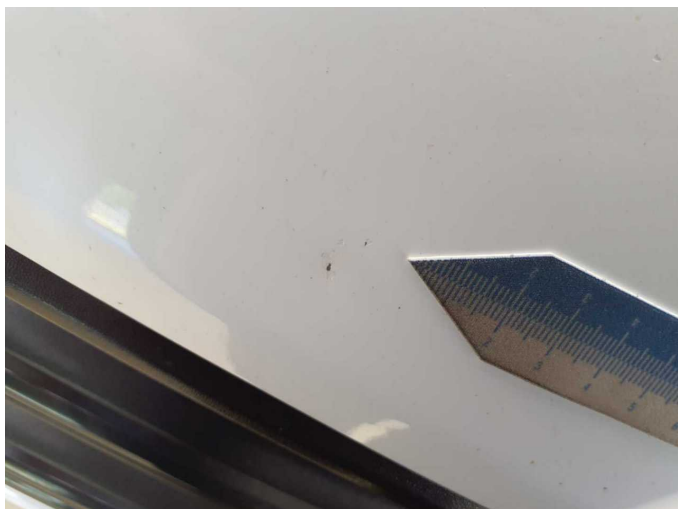
| No. | Component group | Description |
|---|---|---|
| 9 | Bonnet | Bonnet - Dent / paintcoat damage - Paint |

**Damage 9:** Bonnet: Bonnet - Dent / paintcoat damage - Paint

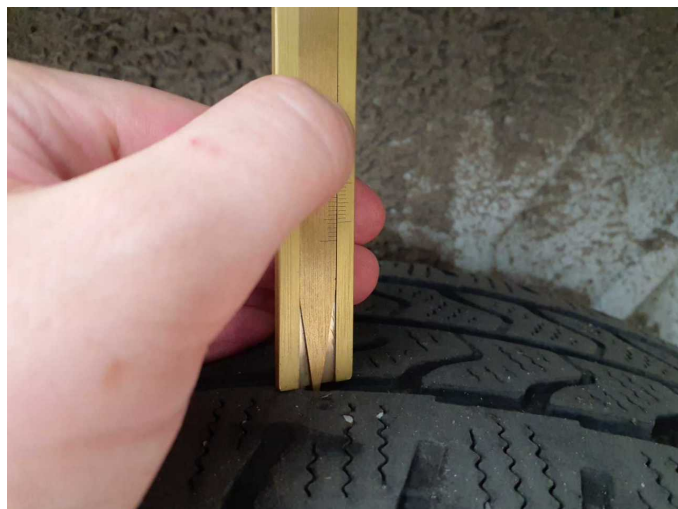
| No. | Component group | Description |
|---|---|---|
| 5 | Wheel / tyres | Tyre - rear right side (4,1mm) - Abrasion - No deduction |

**Wear and tear 5:** Wheel / tyres: Tyre - rear right side (4,1mm) - Abrasion  
- No deduction
