Expertise

Protocol number: 46044980
Order No. / Reference: 26484625-1
Inspection date: 11 Jun 2026

Manufacturer: Volkswagen

Model: Multivan T6.1 Kurz Generation Six

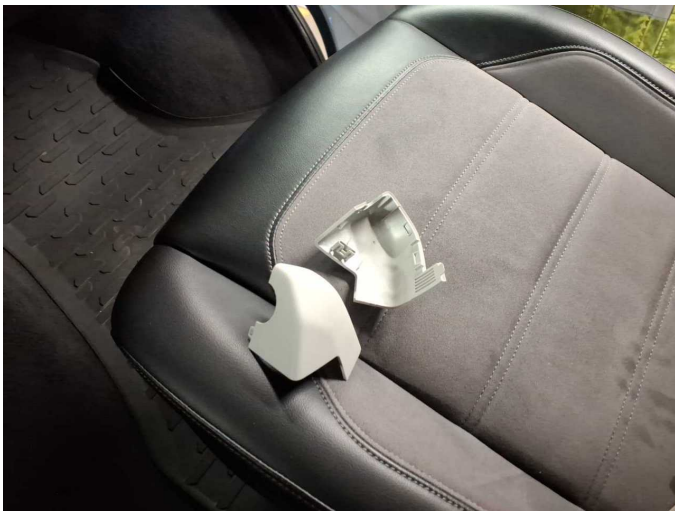
Damage 1: Instrument panel: Interior mirror - Loose - Un- / install

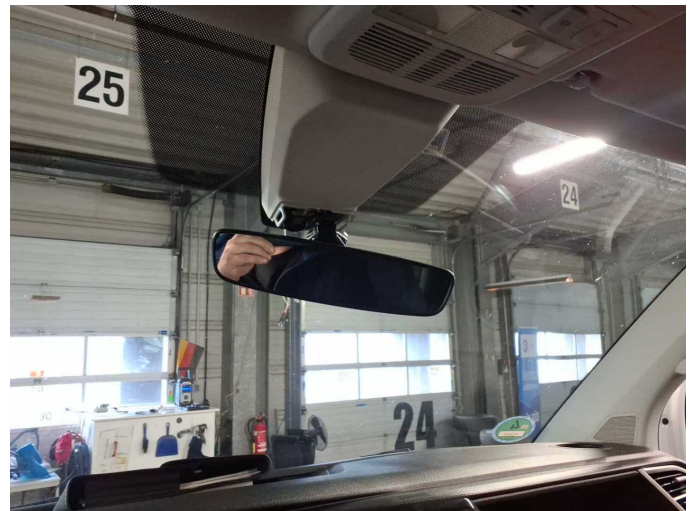
Damage 1: Instrument panel: Interior mirror - Loose - Un- / install

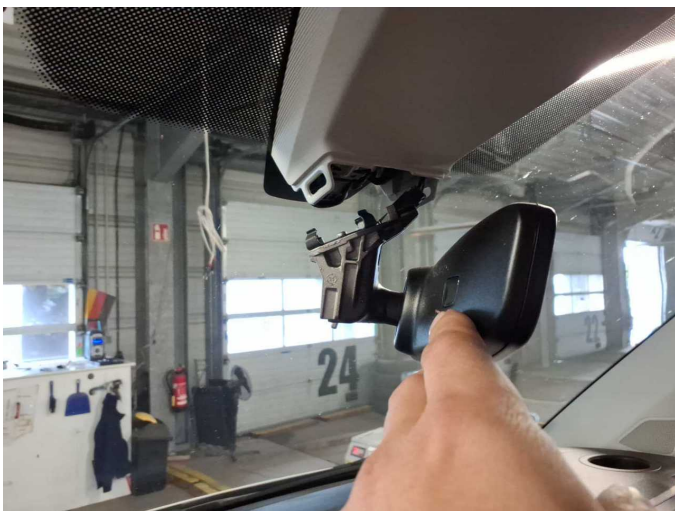
Damage 1: Instrument panel: Interior mirror - Loose - Un- / install

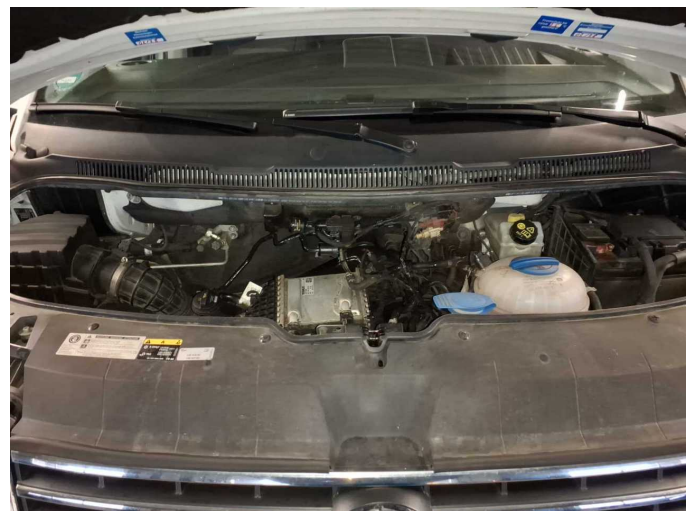
Damage 2: Engine: Engine (Motorraum voller Öl) - Leaking - Perform diagnosis

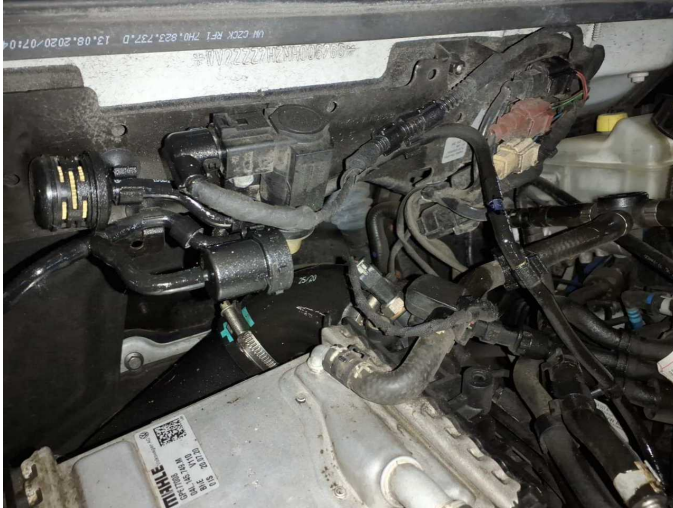
Damage 2: Engine: Engine (Motorraum voller Öl) - Leaking - Perform diagnosis

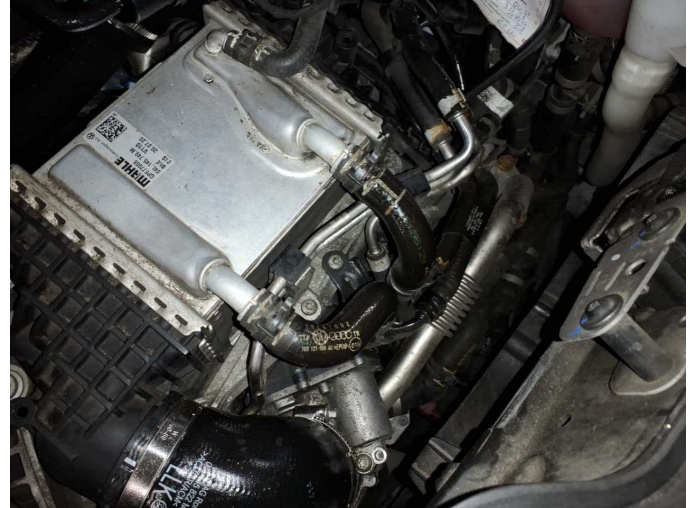
Damage 2: Engine: Engine (Motorraum voller Öl) - Leaking - Perform diagnosis

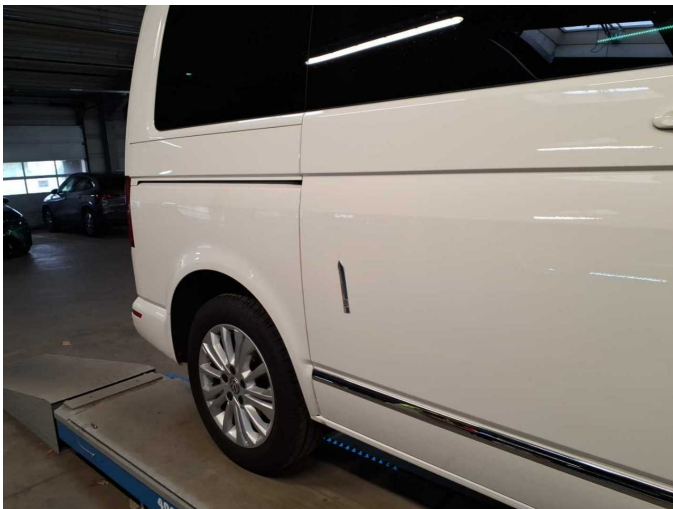
Damage 3: Sliding door, right: Sliding door with glass panel - dent(s) - Smooth repair work

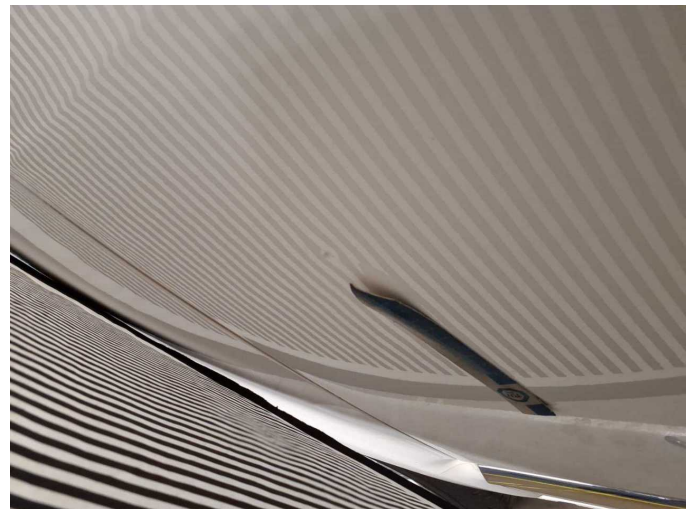
Damage 3: Sliding door, right: Sliding door with glass panel - dent(s) - Smooth repair work

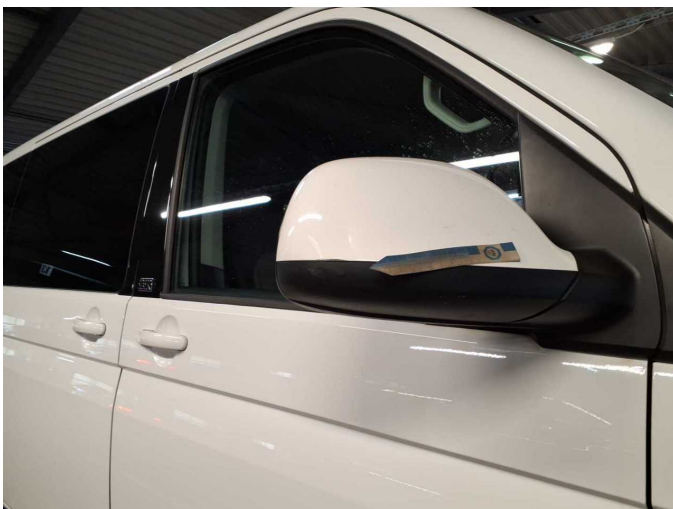
Damage 4: Wing mirror - right side: Mirror housing - Scratched - Replace

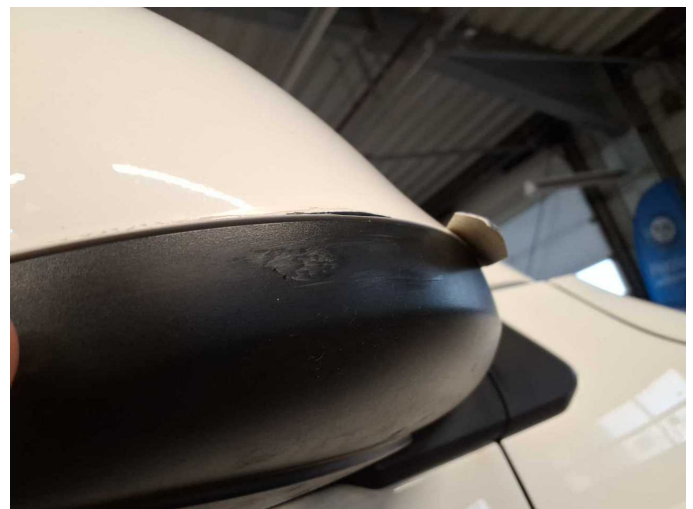
Damage 4: Wing mirror - right side: Mirror housing - Scratched - Replace

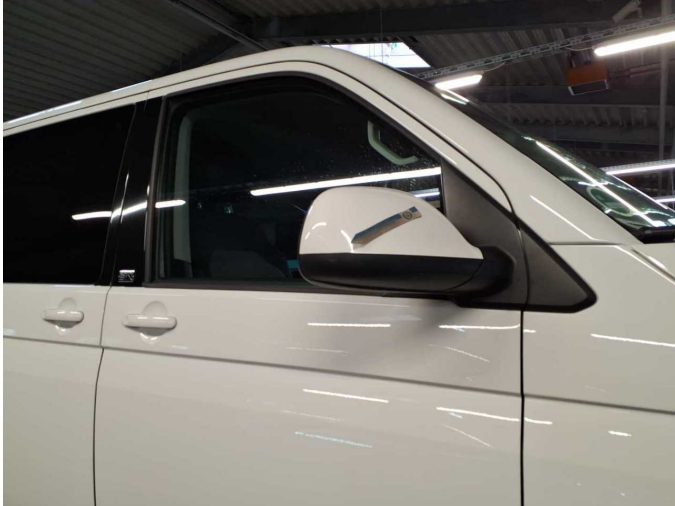
Damage 5: Wing mirror - right side: Cap - Scratch(es) - Paint

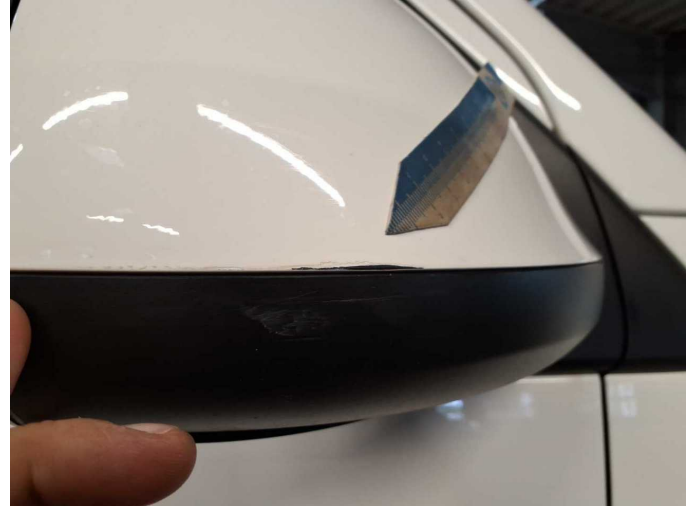
Damage 5: Wing mirror - right side: Cap - Scratch(es) - Paint

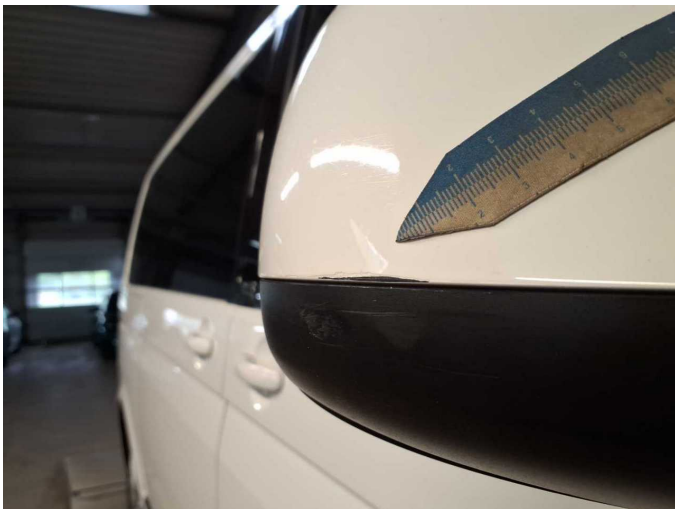
Damage 5: Wing mirror - right side: Cap - Scratch(es) - Paint

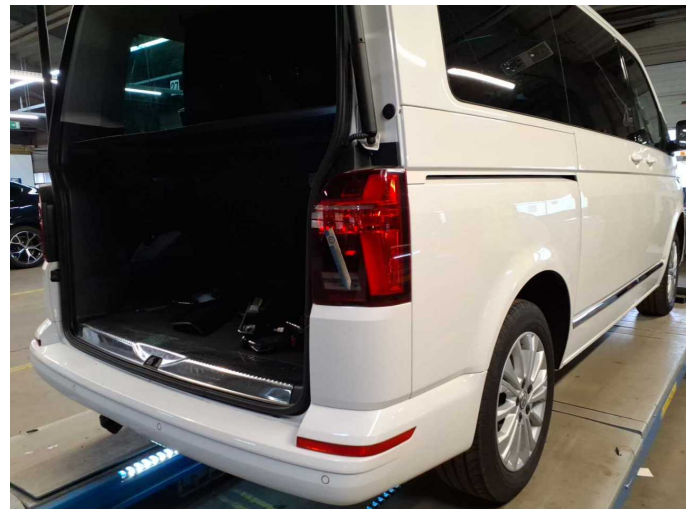
Damage 6: Tail light: Tail lamp - right side - Broken / torn - Replace

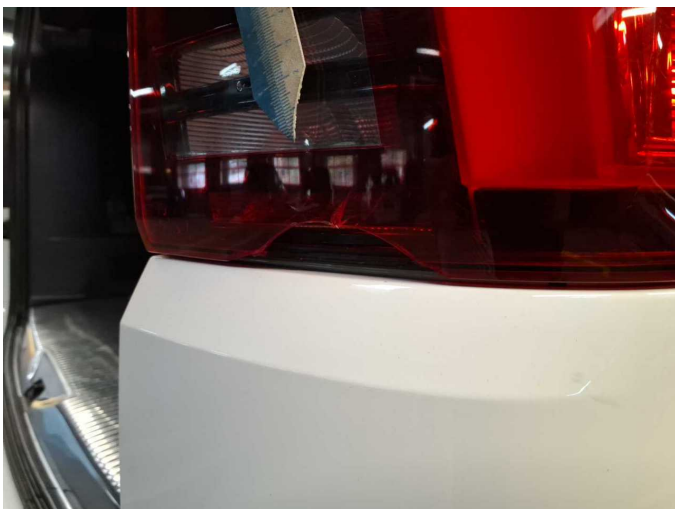
Damage 6: Tail light: Tail lamp - right side - Broken / torn - Replace

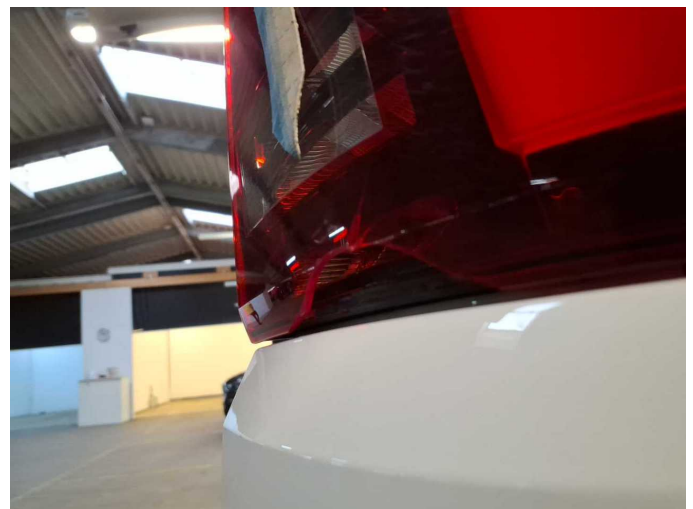
Damage 6: Tail light: Tail lamp - right side - Broken / torn - Replace

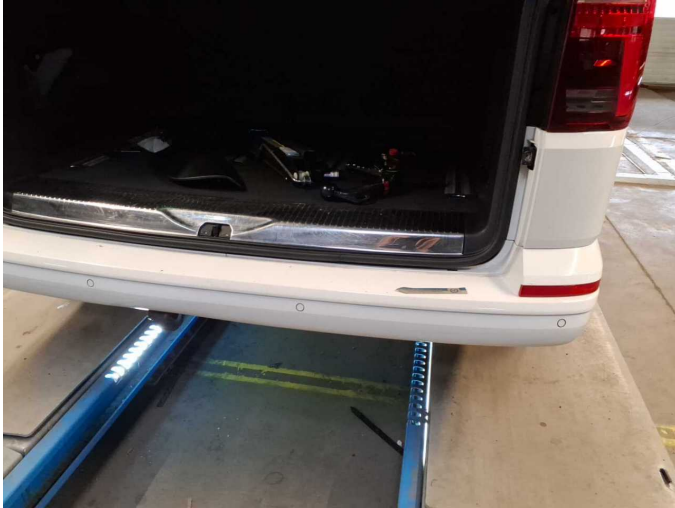
Damage 7: Rear bumper: Rear bumper - Scratch(es) - Paint

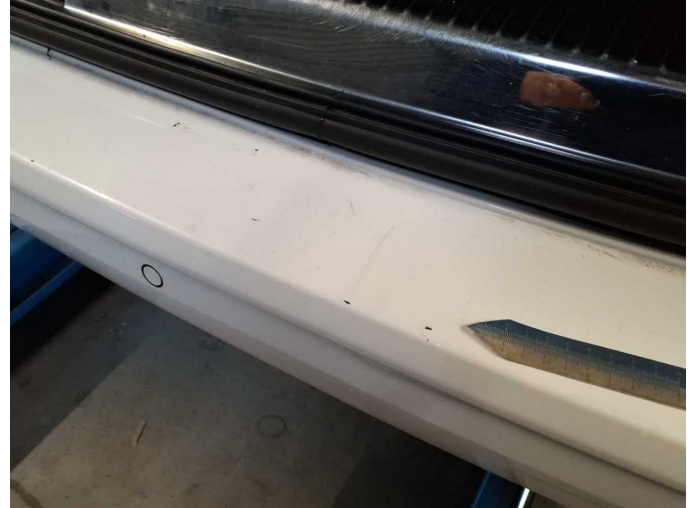
Damage 7: Rear bumper: Rear bumper - Scratch(es) - Paint

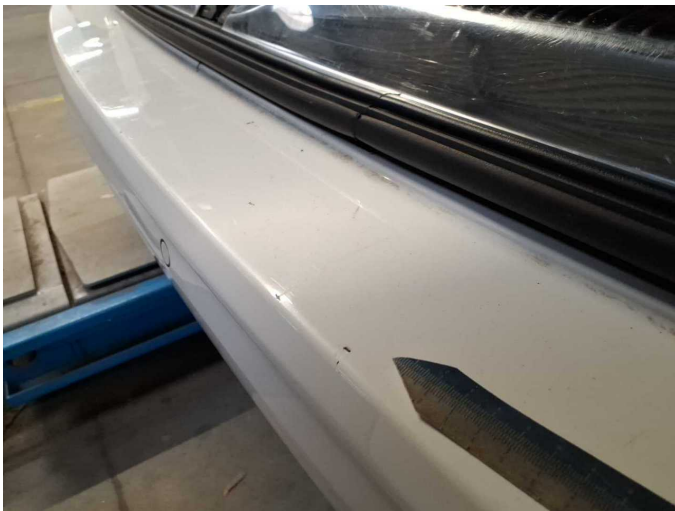
Damage 7: Rear bumper: Rear bumper - Scratch(es) - Paint

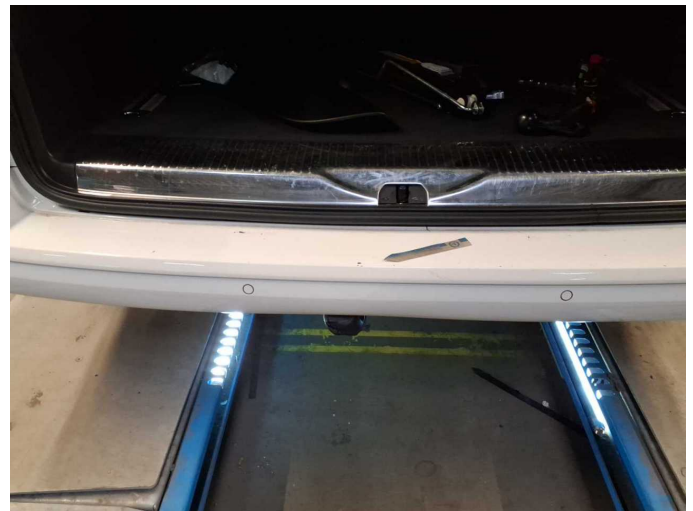
Damage 7: Rear bumper: Rear bumper - Scratch(es) - Paint

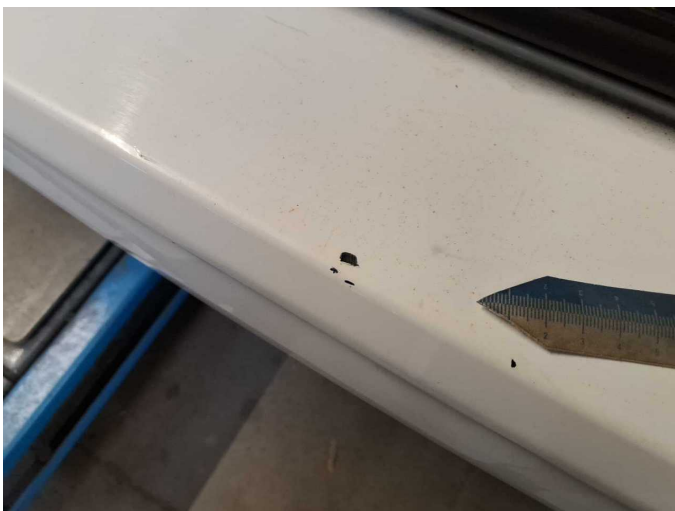
Damage 7: Rear bumper: Rear bumper - Scratch(es) - Paint

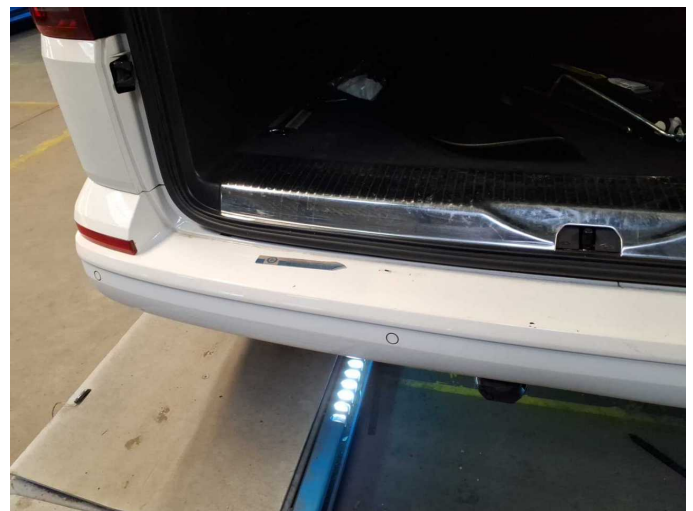
Damage 7: Rear bumper: Rear bumper - Scratch(es) - Paint

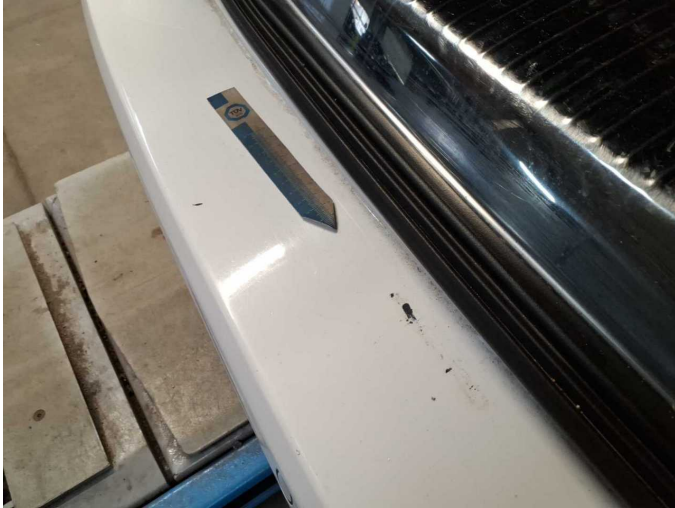
Damage 7: Rear bumper: Rear bumper - Scratch(es) - Paint

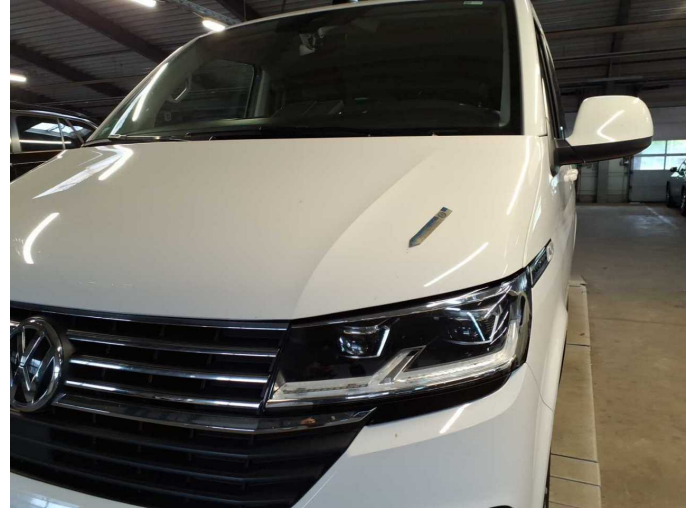
Damage 8: Bonnet: Bonnet - Stone chips - Paint

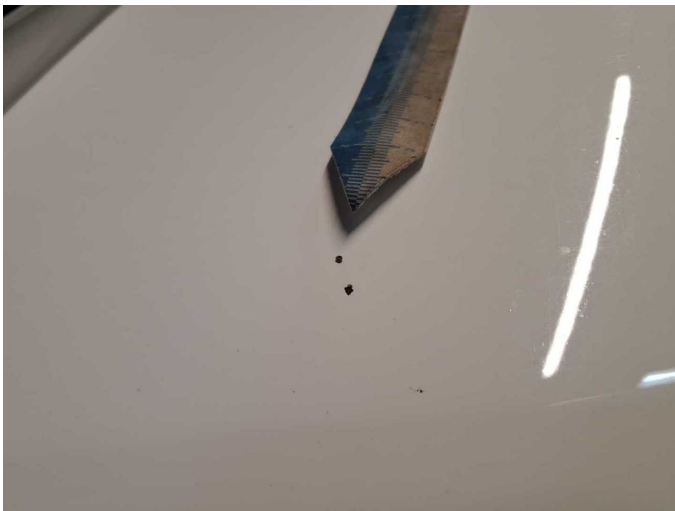
Damage 8: Bonnet: Bonnet - Stone chips - Paint

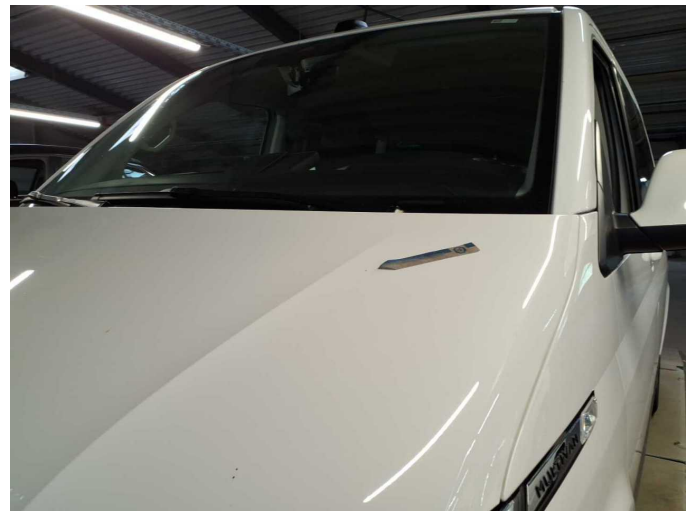
Damage 8: Bonnet: Bonnet - Stone chips - Paint

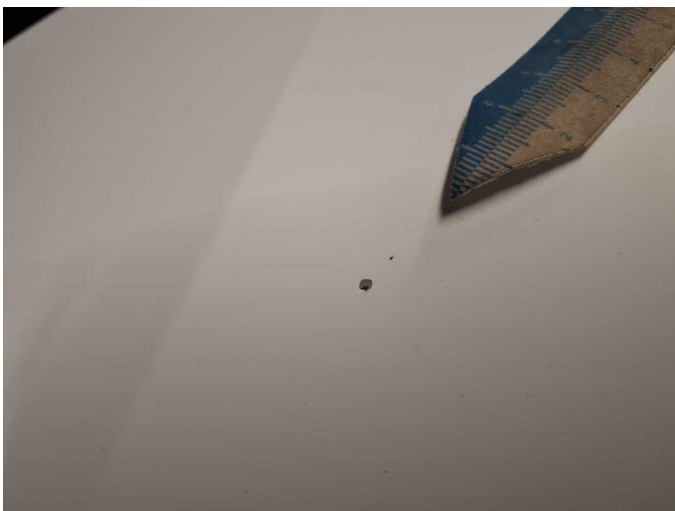
Damage 8: Bonnet: Bonnet - Stone chips - Paint

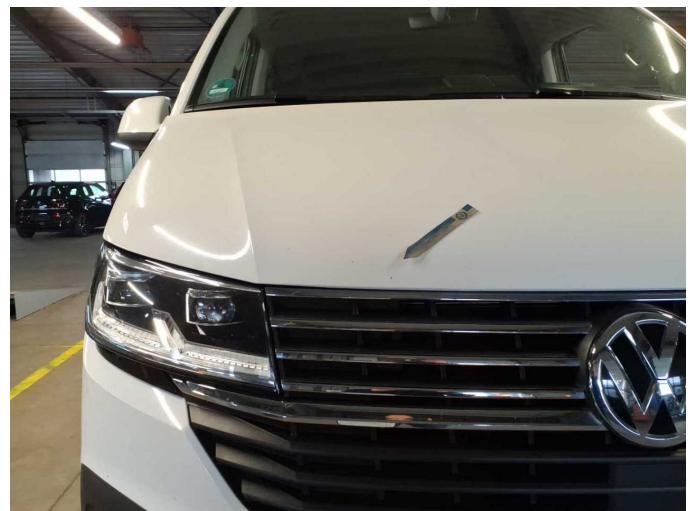
Damage 8: Bonnet: Bonnet - Stone chips - Paint

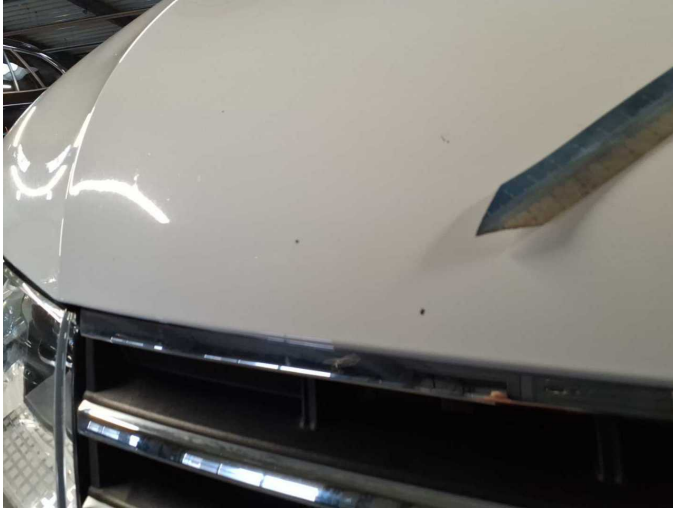
Damage 8: Bonnet: Bonnet - Stone chips - Paint

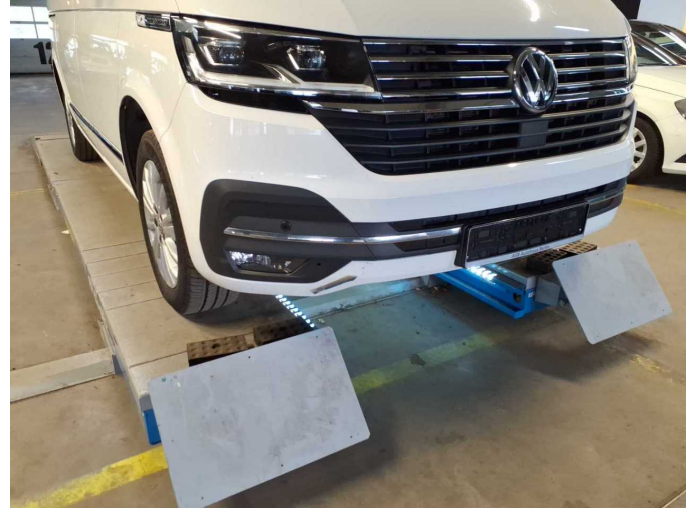
Damage 9: Front bumper: Front bumper (Steinschlag + Gitter V R erneuern) - Scratch(es) - Paint

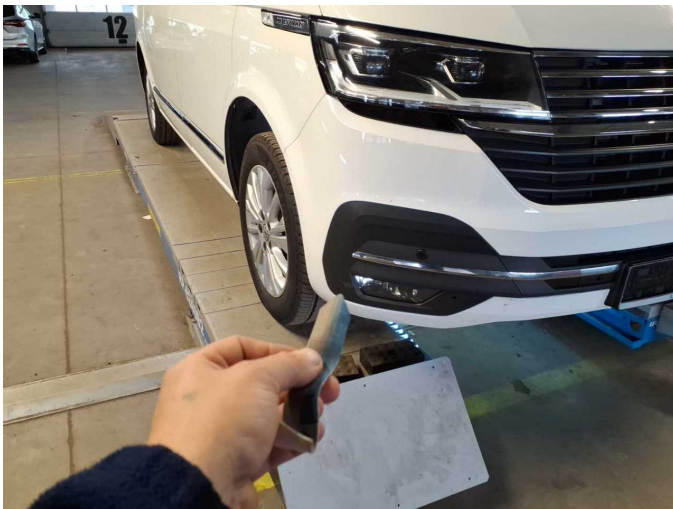
Damage 9: Front bumper: Front bumper (Steinschlag + Gitter V R erneuern) - Scratch(es) - Paint

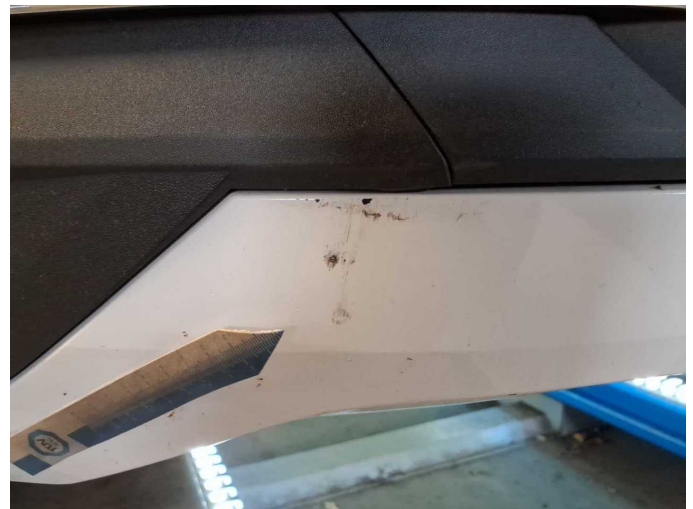
Damage 9: Front bumper: Front bumper (Steinschlag + Gitter V R erneuern) - Scratch(es) - Paint

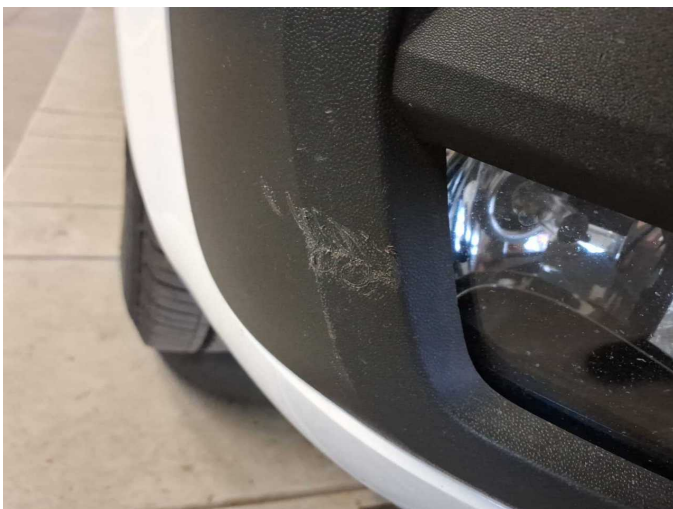
Damage 9: Front bumper: Front bumper (Steinschlag + Gitter V R erneuern) - Scratch(es) - Paint

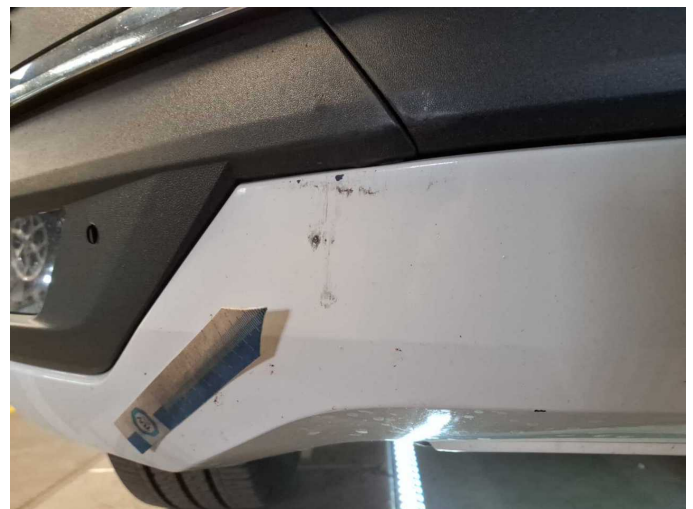
Damage 9: Front bumper: Front bumper (Steinschlag + Gitter V R erneuern) - Scratch(es) - Paint

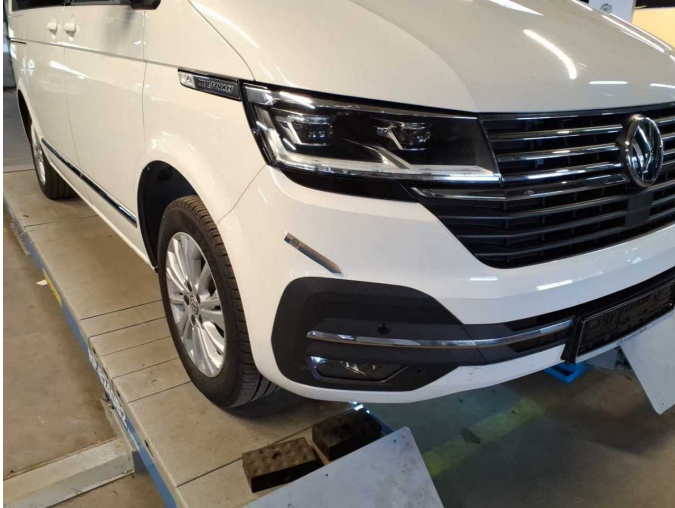
Damage 9: Front bumper: Front bumper (Steinschlag + Gitter V R erneuern) - Scratch(es) - Paint

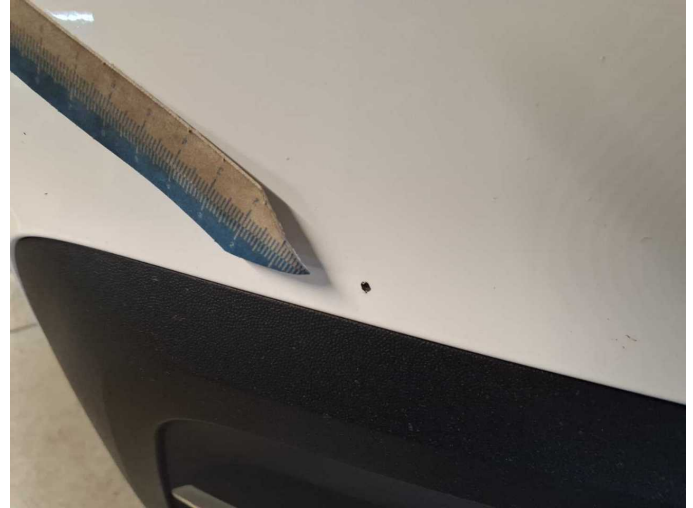
Damage 9: Front bumper: Front bumper (Steinschlag + Gitter V R erneuern) - Scratch(es) - Paint

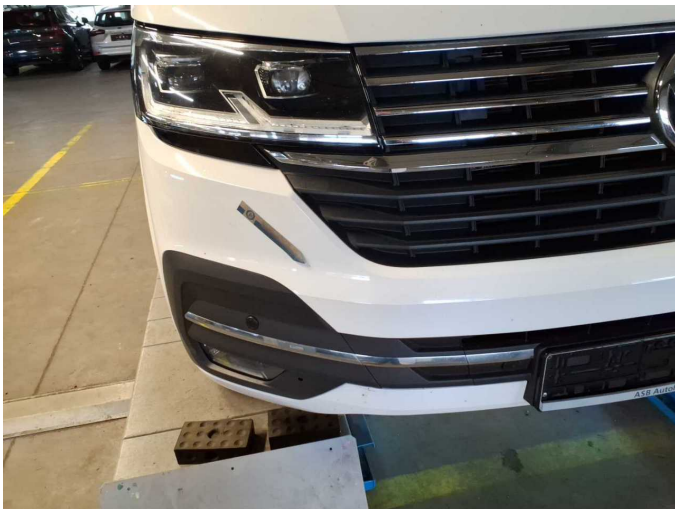
Damage 9: Front bumper: Front bumper (Steinschlag + Gitter V R erneuern) - Scratch(es) - Paint

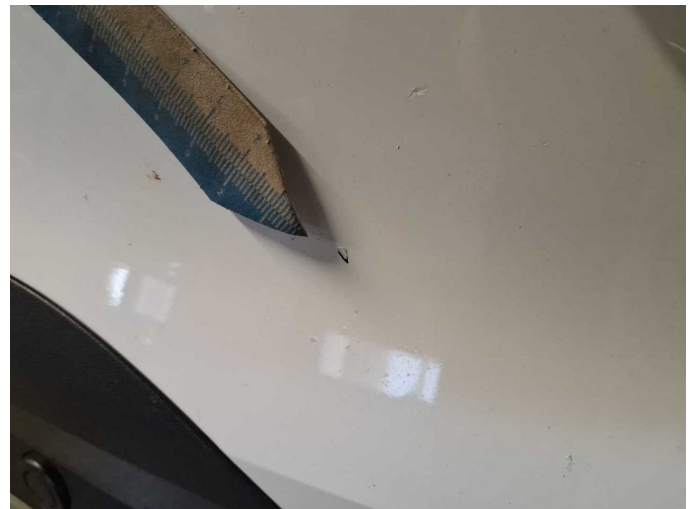
Damage 9: Front bumper: Front bumper (Steinschlag + Gitter V R erneuern) - Scratch(es) - Paint

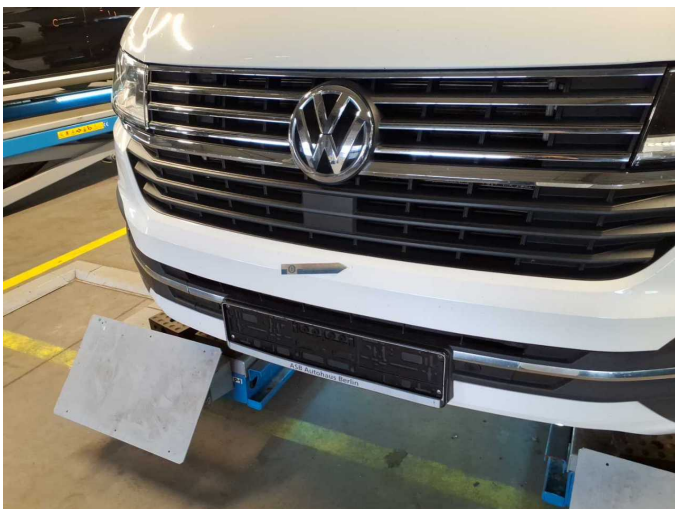
Damage 9: Front bumper: Front bumper (Steinschlag + Gitter V R erneuern) - Scratch(es) - Paint

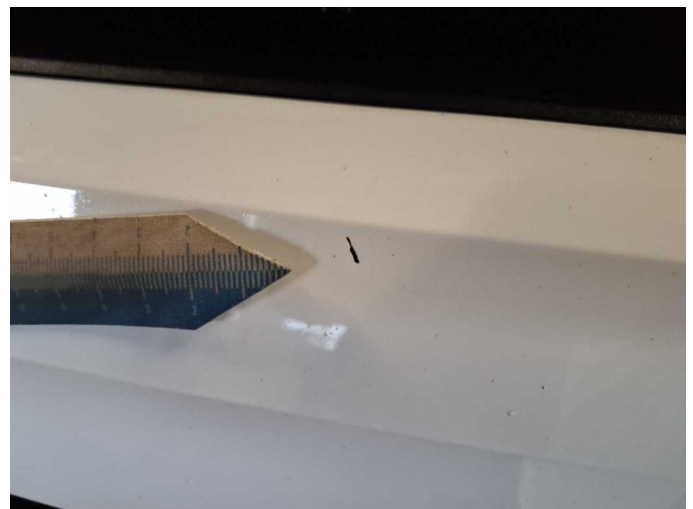
Damage 9: Front bumper: Front bumper (Steinschlag + Gitter V R erneuern) - Scratch(es) - Paint

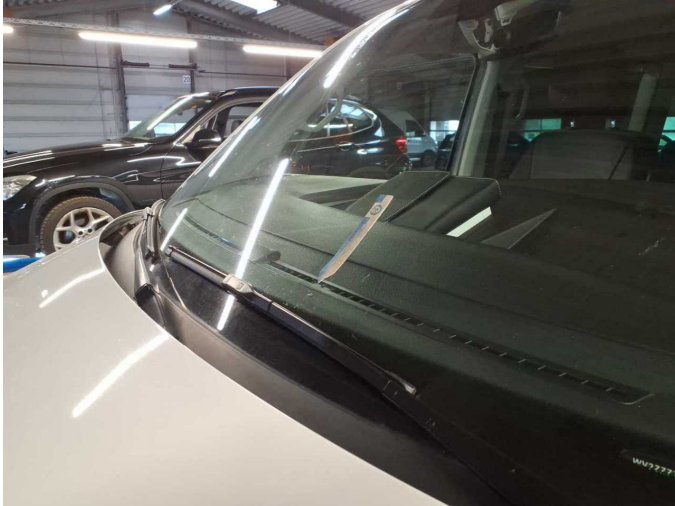
Damage 10: Vehicle glazing: Windscreen (Rissbildung) - Stone chips - Replace

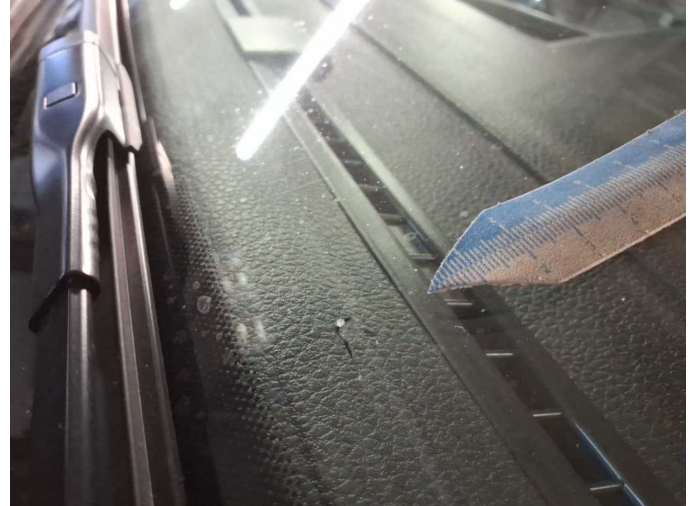
Damage 10: Vehicle glazing: Windscreen (Rissbildung) - Stone chips - Replace

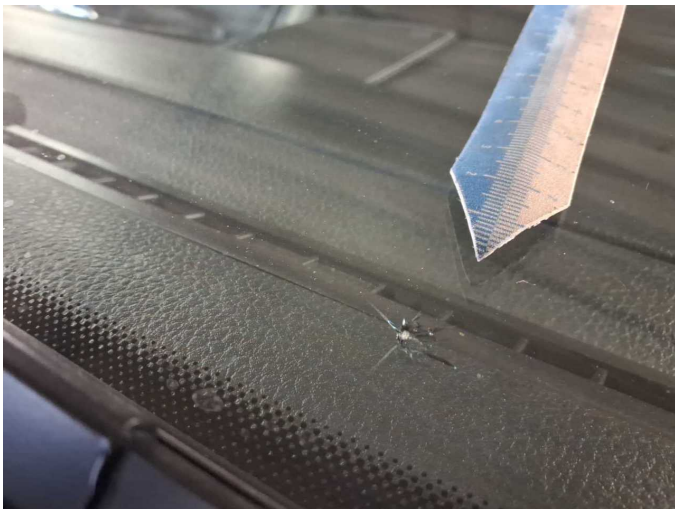
Damage 10: Vehicle glazing: Windscreen (Rissbildung) - Stone chips - Replace

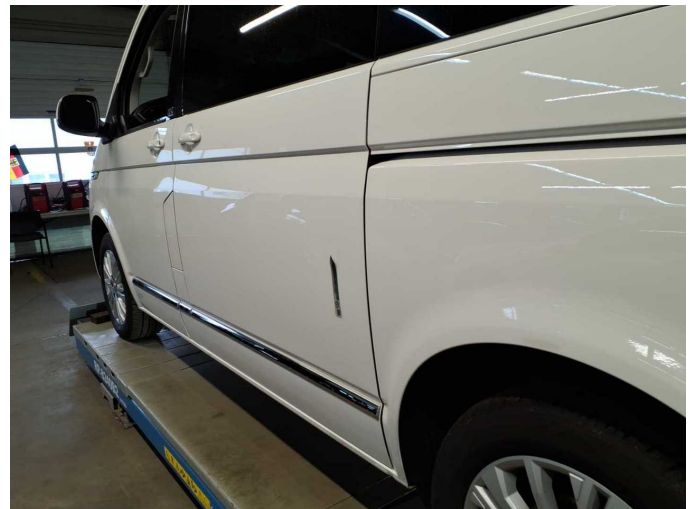
Wear and tear 3: Sliding door - left side: Sliding door with glass panel - dent(s) - No deduction

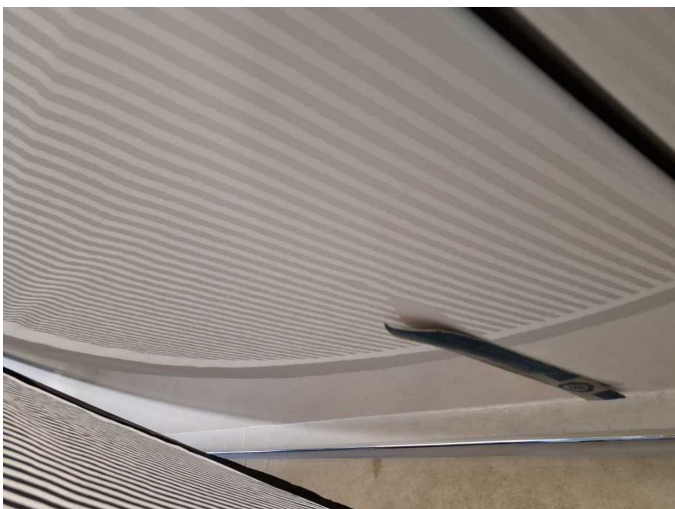
Wear and tear 3: Sliding door - left side: Sliding door with glass panel - dent(s) - No deduction

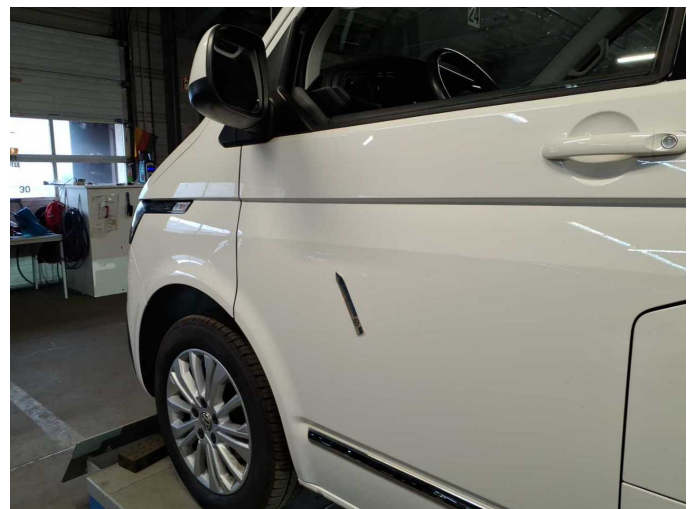
Wear and tear 4: Door - front left side: Door - dent(s) - No deduction

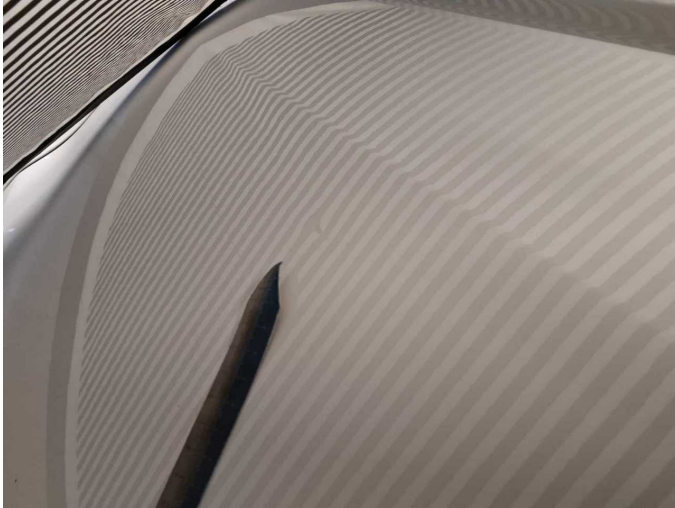
Wear and tear 4: Door - front left side: Door - dent(s) - No deduction
