## Expertise

Protocol number: 46250456  
Order No. / Reference: 26453339  
Inspection date: 30 Jun 2026

Model: Vito 114 CDI Kompakt HA Aut. BASE

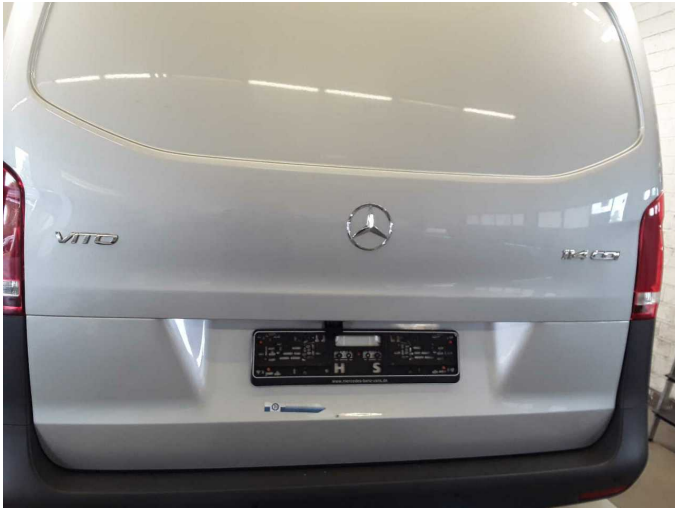
**Damage 3:** Boot lid / rear door: Boot lid - Scratched - Smart repair

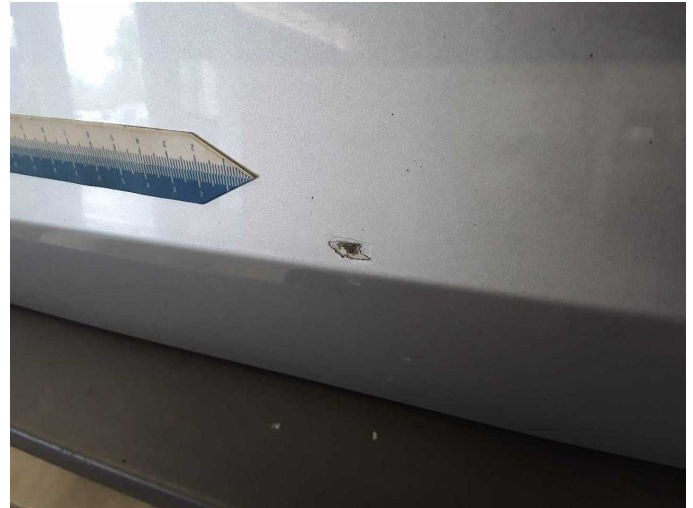
**Damage 3:** Boot lid / rear door: Boot lid - Scratched - Smart repair

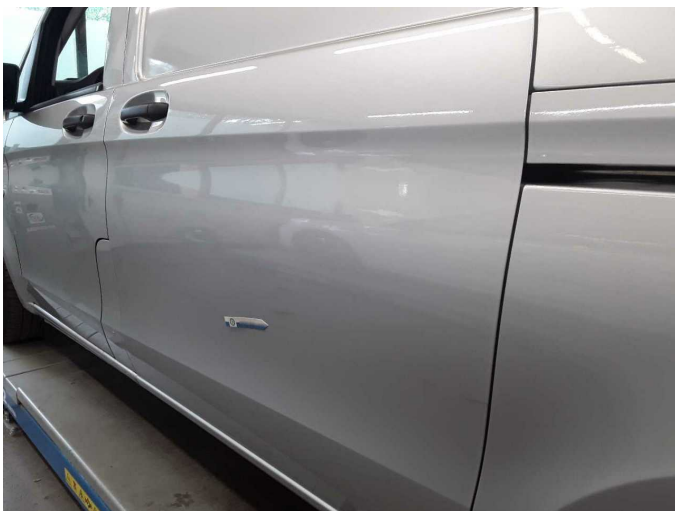
**Damage 4:** Sliding door - left side: Sliding door (Unterhalb nachlackiert) - Does not meet the leasing specifications - Paint

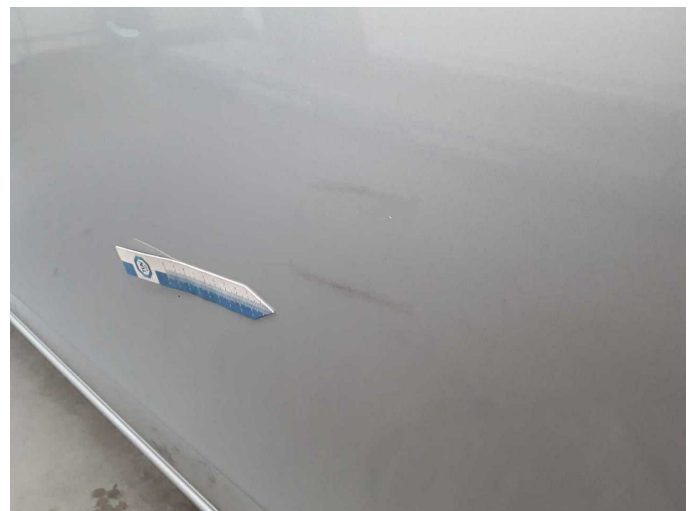
**Damage 4:** Sliding door - left side: Sliding door (Unterhalb nachlackiert) - Does not meet the leasing specifications - Paint

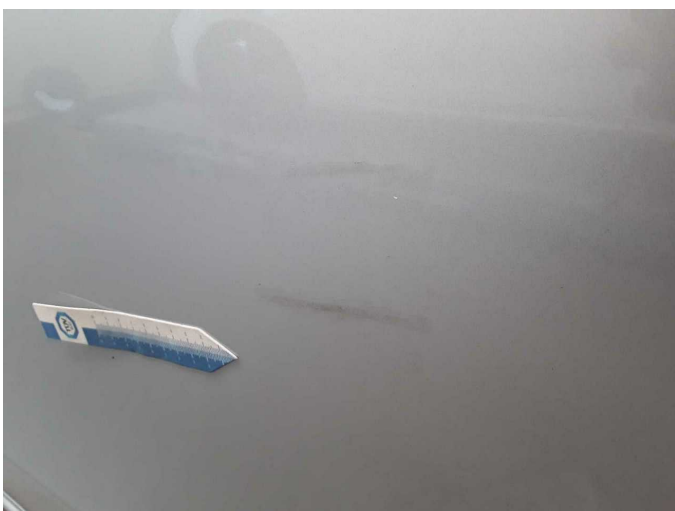
**Damage 4:** Sliding door - left side: Sliding door (Unterhalb nachlackiert) - Does not meet the leasing specifications - Paint

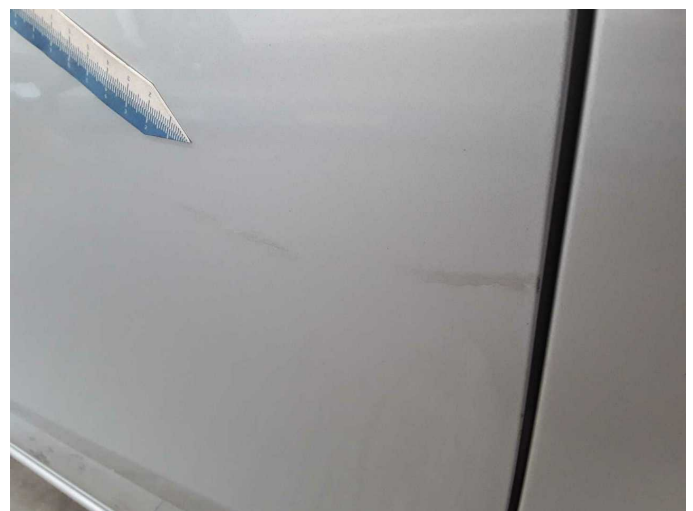
**Damage 4:** Sliding door - left side: Sliding door (Unterhalb nachlackiert) - Does not meet the leasing specifications - Paint

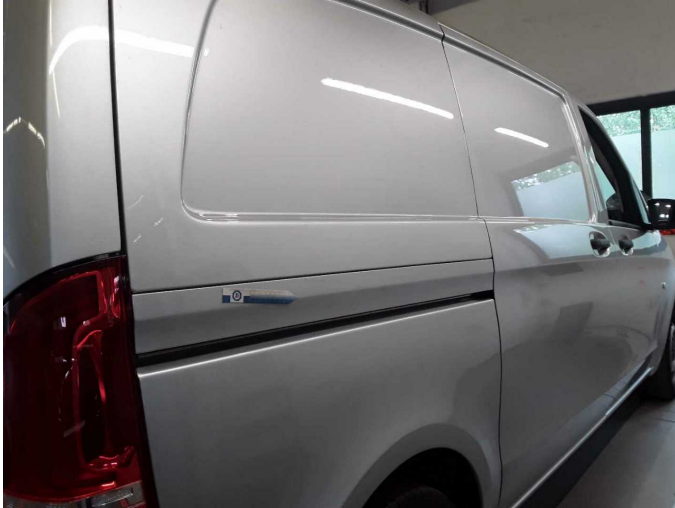
**Damage 5:** Side panel - rear right side: Side panel (Abdeckung) - Dent / paintcoat damage - Repair and paint

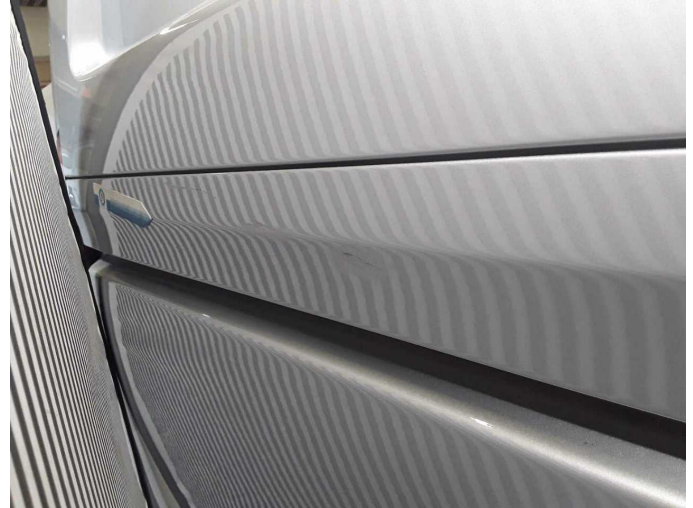
**Damage 5:** Side panel - rear right side: Side panel (Abdeckung) - Dent / paintcoat damage - Repair and paint

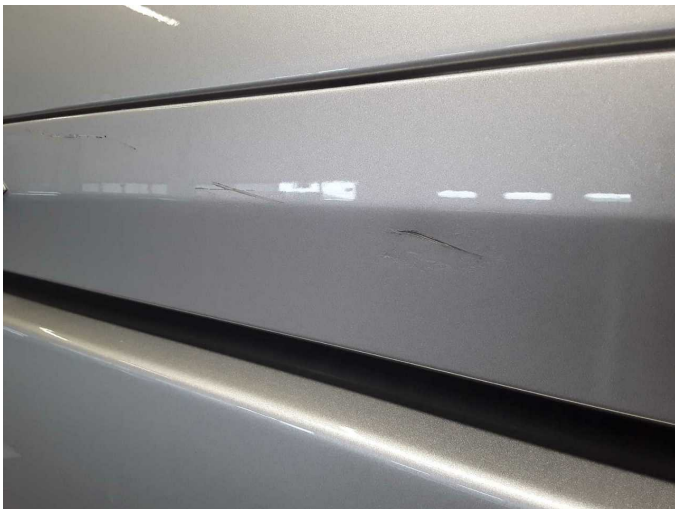
**Damage 5:** Side panel - rear right side: Side panel (Abdeckung) - Dent / paintcoat damage - Repair and paint

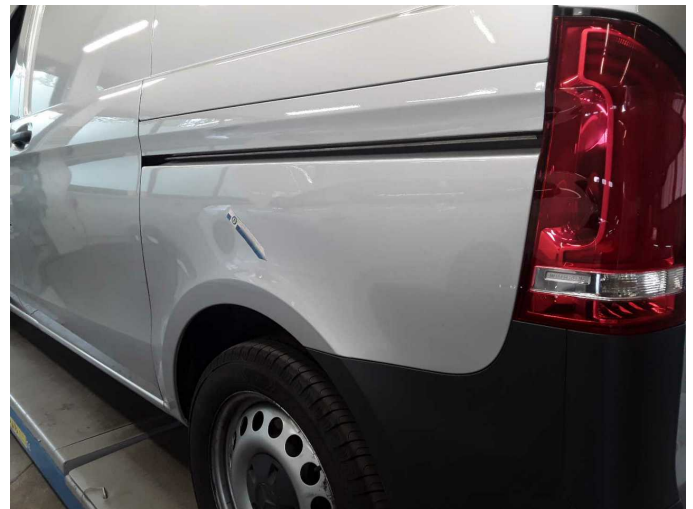
**Damage 6:** Side panel - rear left side: Side panel (Unterhalb nachlackiert) - Does not meet the leasing specifications - Paint

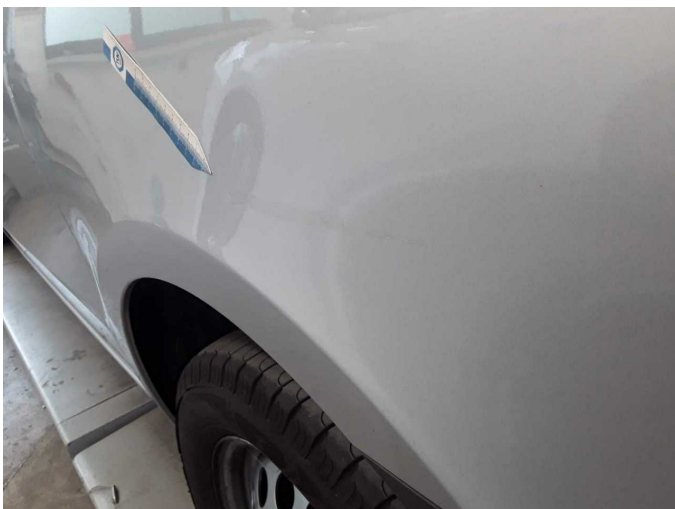
**Damage 6:** Side panel - rear left side: Side panel (Unterhalb nachlackiert) - Does not meet the leasing specifications - Paint

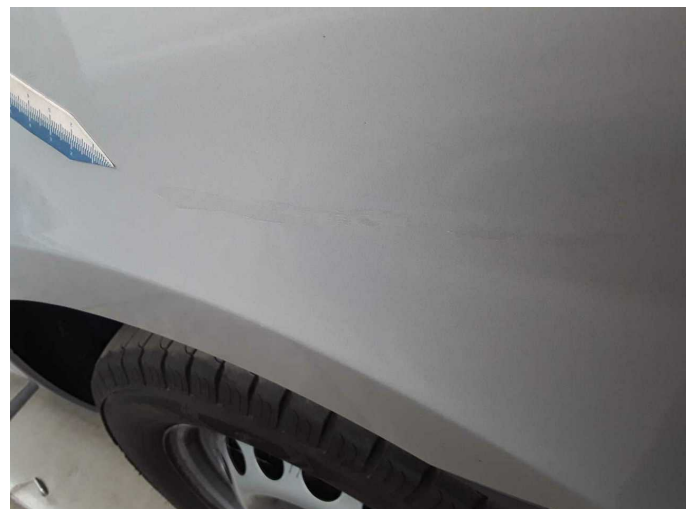
**Damage 6:** Side panel - rear left side: Side panel (Unterhalb nachlackiert) - Does not meet the leasing specifications - Paint

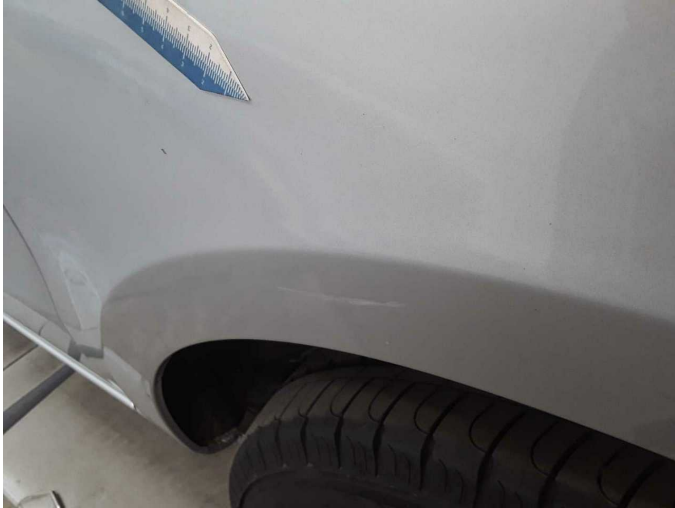
**Damage 6:** Side panel - rear left side: Side panel (Unterhalb nachlackiert)  
- Does not meet the leasing specifications - Paint

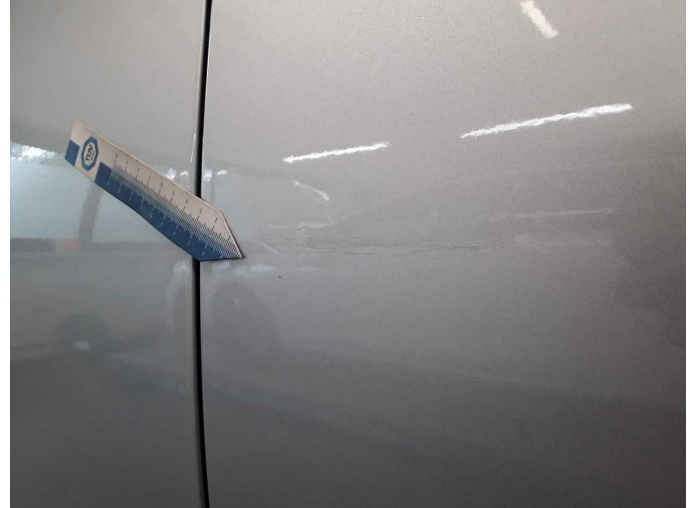
**Damage 6:** Side panel - rear left side: Side panel (Unterhalb nachlackiert)  
- Does not meet the leasing specifications - Paint

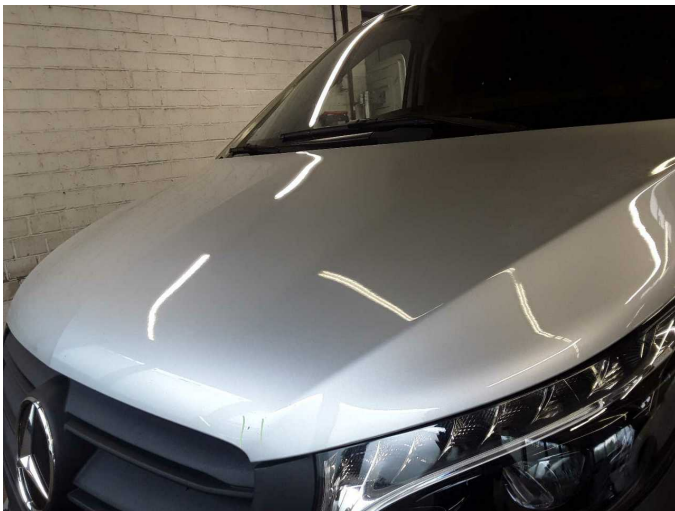
**Damage 7:** Bonnet: Bonnet - Dent / paintcoat damage - Repair and paint

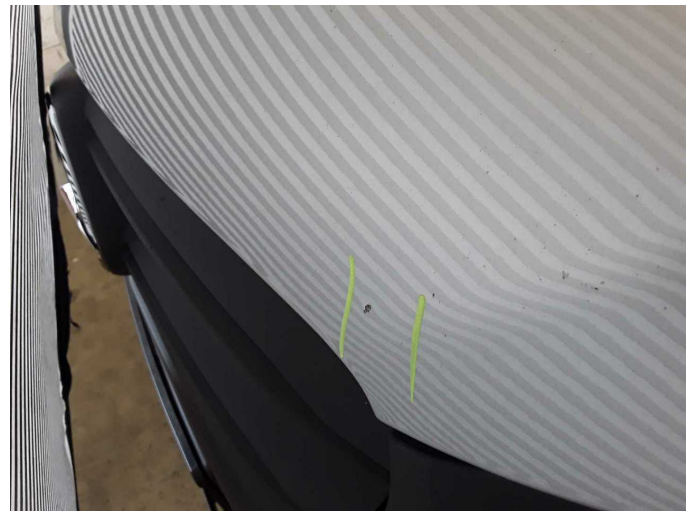
**Damage 7:** Bonnet: Bonnet - Dent / paintcoat damage - Repair and paint

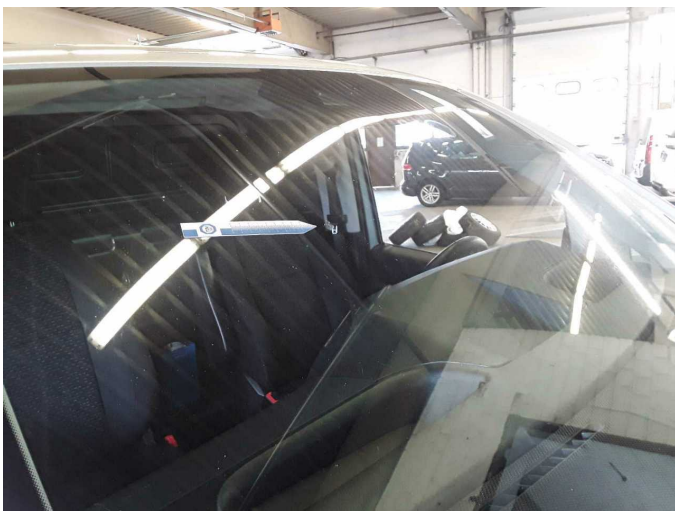
**Damage 8:** Vehicle glazing: Windscreen (Rissbildung) - Stone chips -  
repair according to calculation

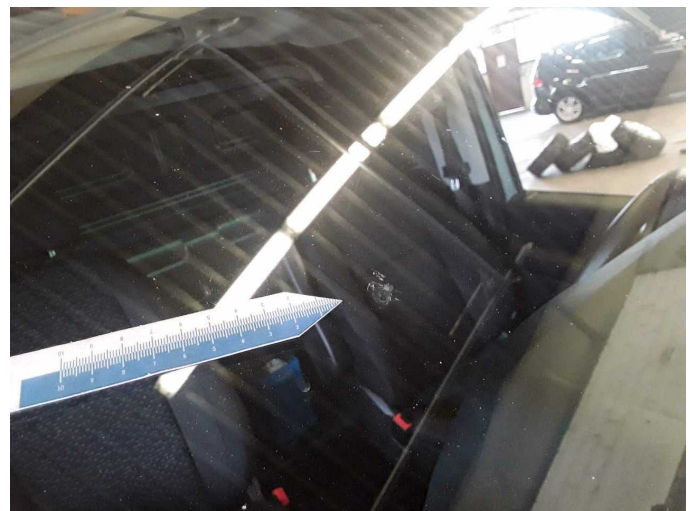
**Damage 8:** Vehicle glazing: Windscreen (Rissbildung) - Stone chips -  
repair according to calculation

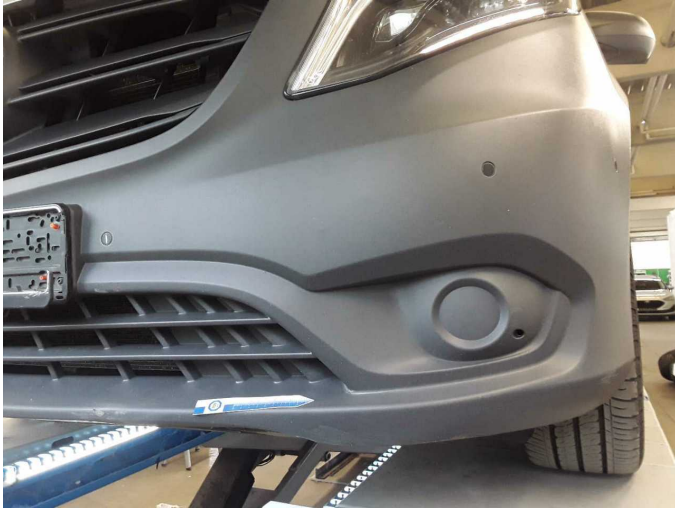
**Wear and tear 1:** Front bumper: Front bumper (unpainted) - Scratched - No deduction

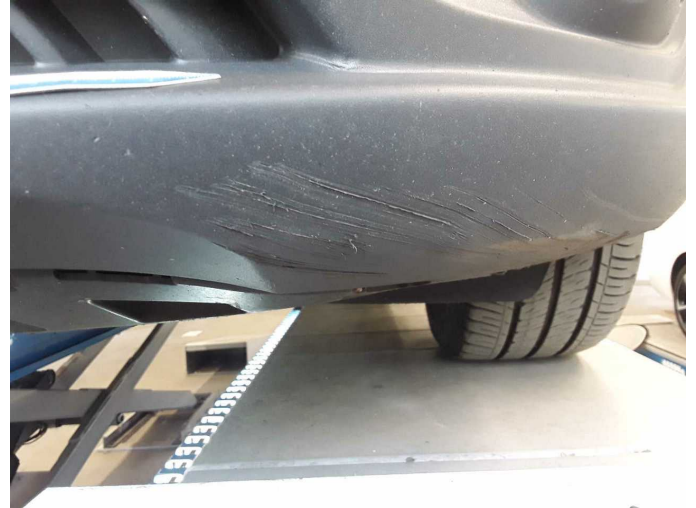
**Wear and tear 1:** Front bumper: Front bumper (unpainted) - Scratched - No deduction

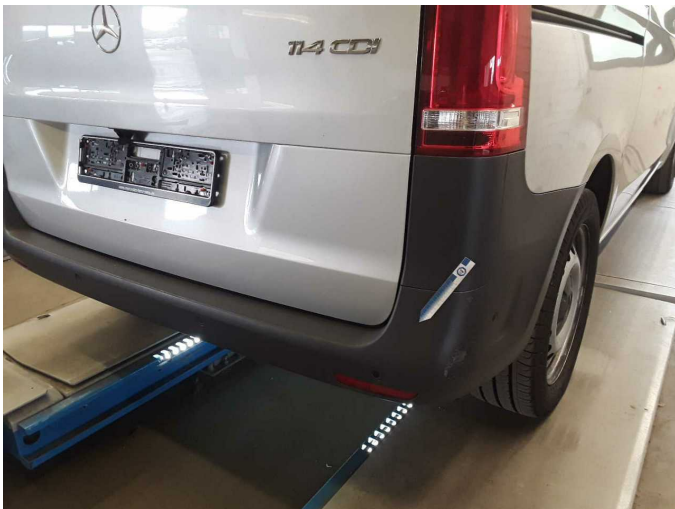
**Wear and tear 2:** Rear bumper: Rear bumper (unpainted) - Scratched - No deduction

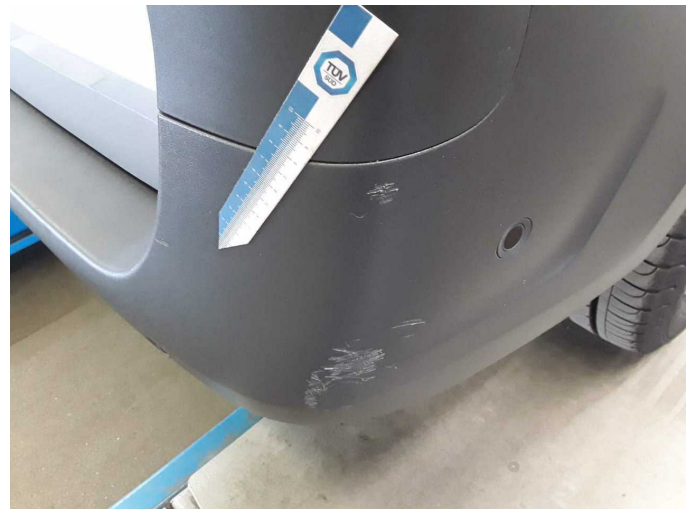
**Wear and tear 2:** Rear bumper: Rear bumper (unpainted) - Scratched - No deduction

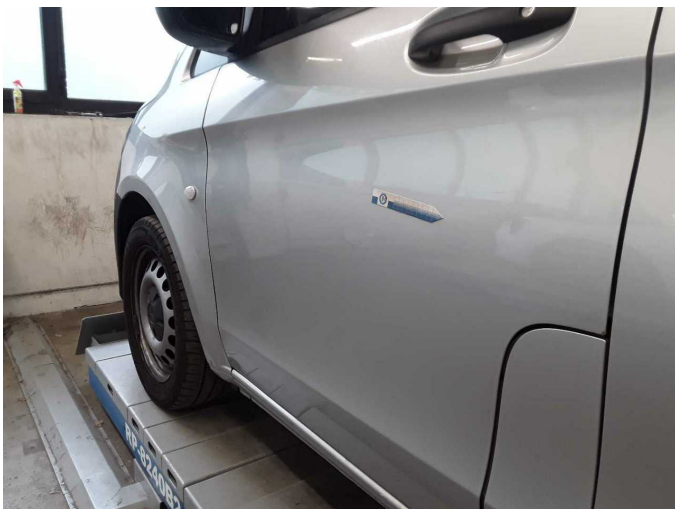
**Wear and tear 4:** Door - front left side: Door - Dent / paintcoat damage - No deduction

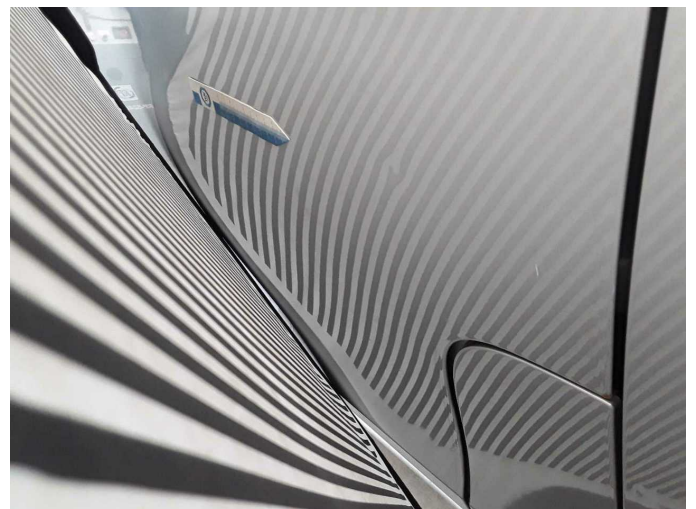
**Wear and tear 4:** Door - front left side: Door - Dent / paintcoat damage - No deduction

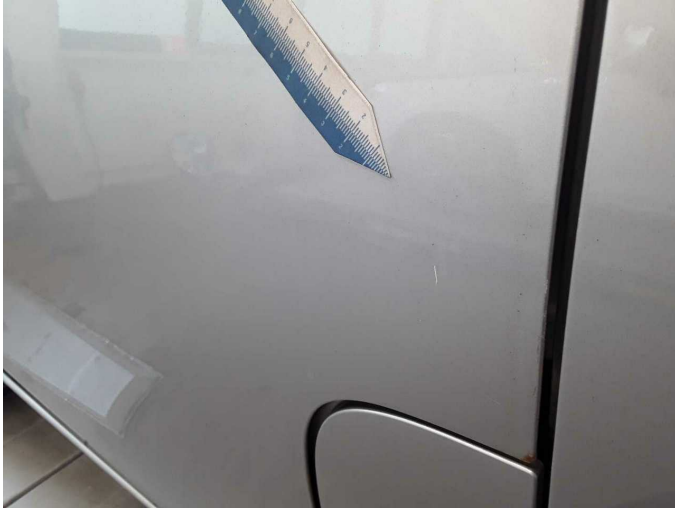
**Wear and tear 4:** Door - front left side: Door - Dent / paintcoat damage - No deduction

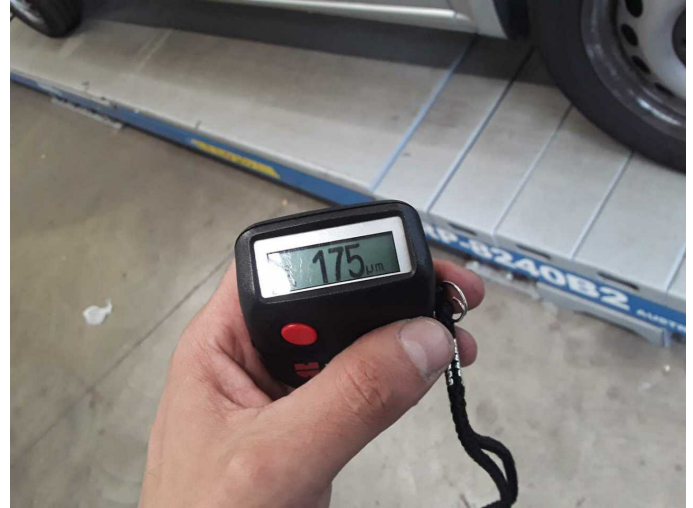
**Repainting 1:** Mudguard - right side, Side panel - rear right side, Door - front right side

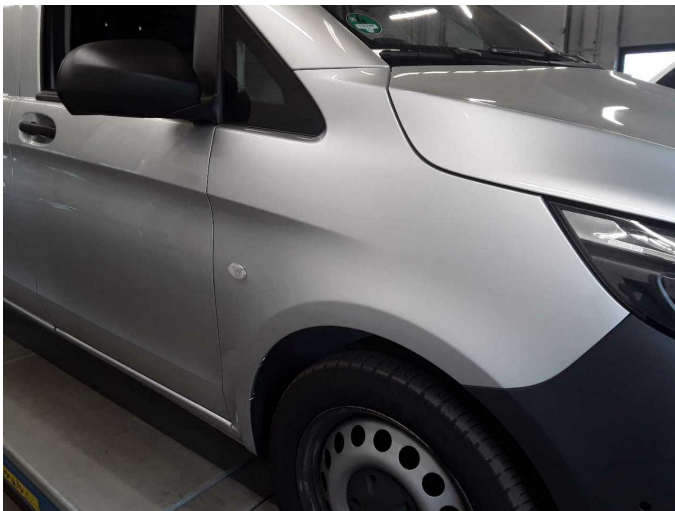
**Repainting 1:** Mudguard - right side, Side panel - rear right side, Door - front right side

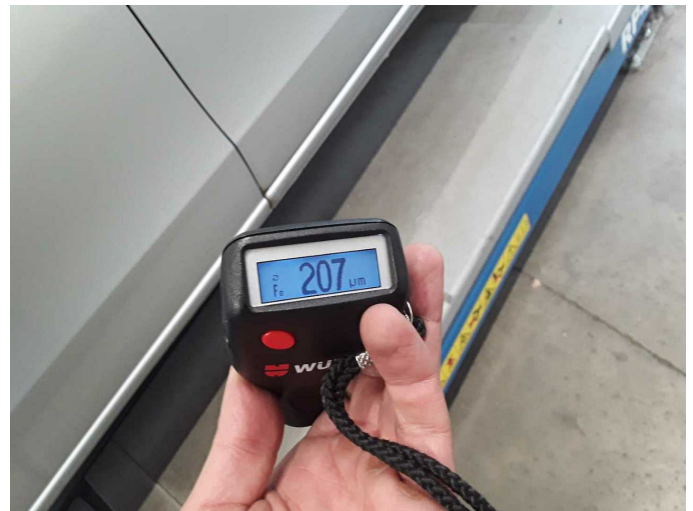
**Repainting 1:** Mudguard - right side, Side panel - rear right side, Door - front right side

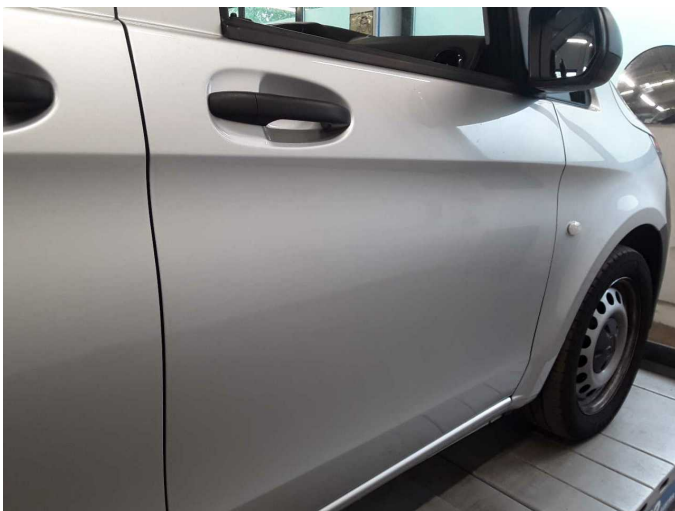
**Repainting 1:** Mudguard - right side, Side panel - rear right side, Door - front right side

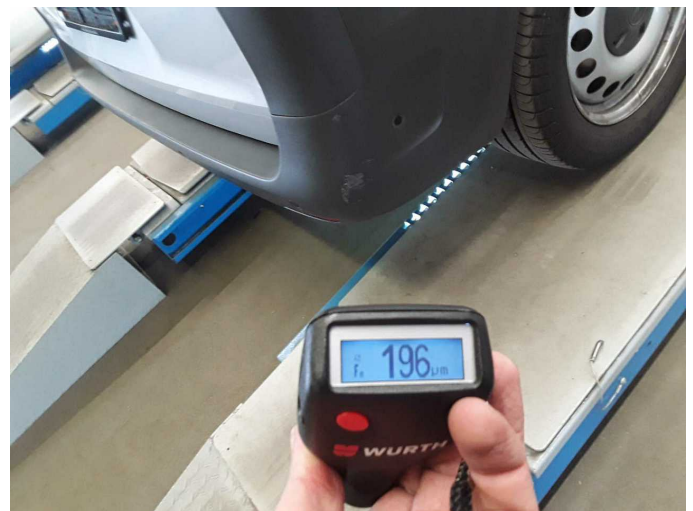
**Repainting 1:** Mudguard - right side, Side panel - rear right side, Door - front right side

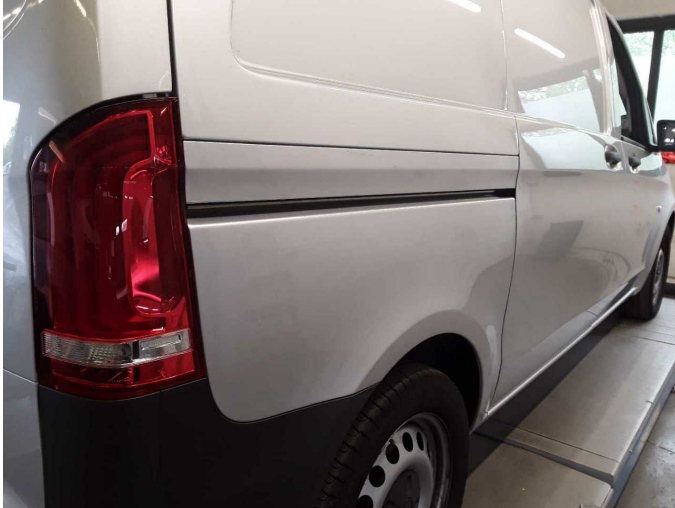
**Repainting 1:** Mudguard - right side, Side panel - rear right side, Door - front right side
