Expertise

Protocol number: 46474965  
Order No. / Reference: 26496486  
Inspection date: 9 Jul 2026

Manufacturer: Ford

Model: Transit Custom 280 L1H1 LKW VA Trend

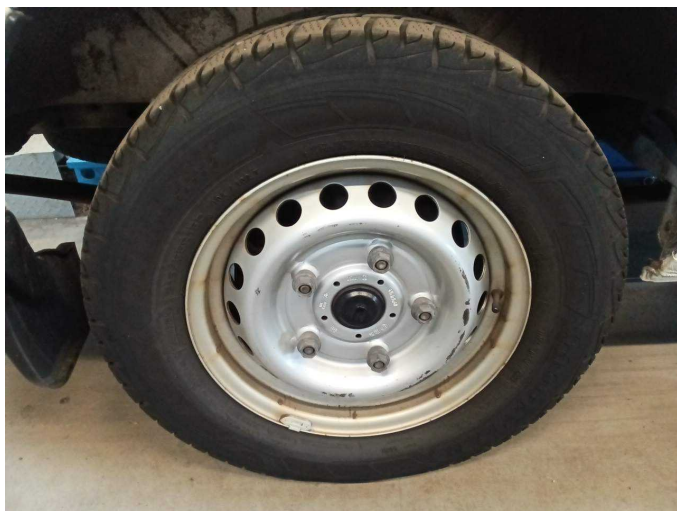
| No. | Component group | Description |
|---|---|---|
| 1 | Wheel / tyres | Wheel cover - rear right side - Missing - Replace |

**Damage 1:** Wheel / tyres: Wheel cover - rear right side - Missing - Replace

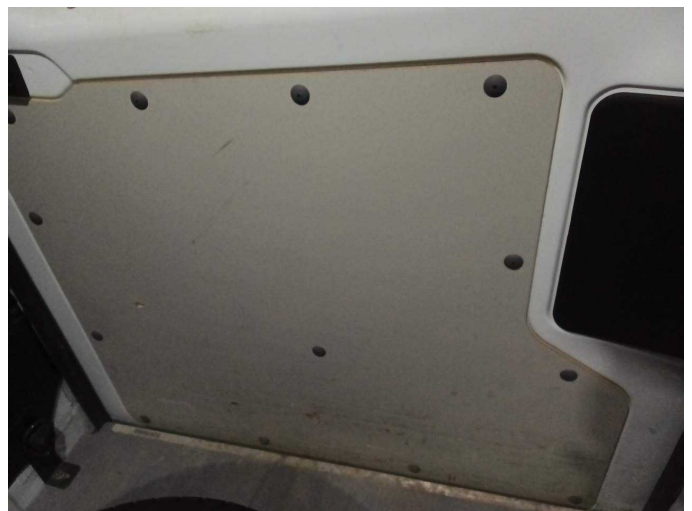
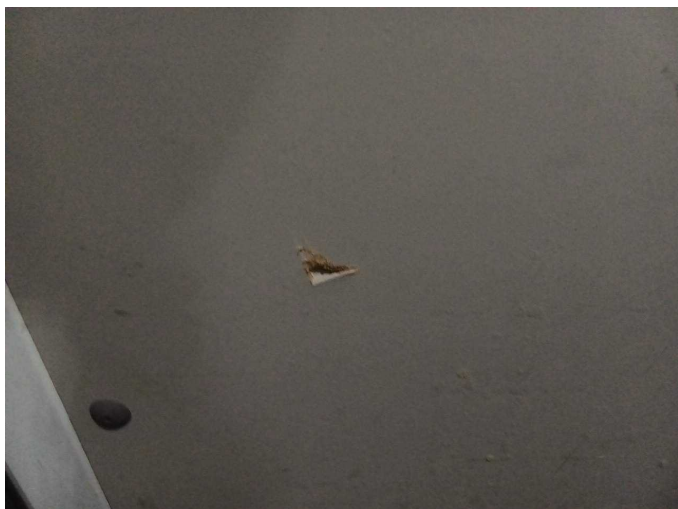
| No. | Component group | Description |
|---|---|---|
| 2 | Trim / covers | Door trim - rear right side - Holes - Replace |

**Damage 2:** Trim / covers: Door trim - rear right side - Holes - Replace

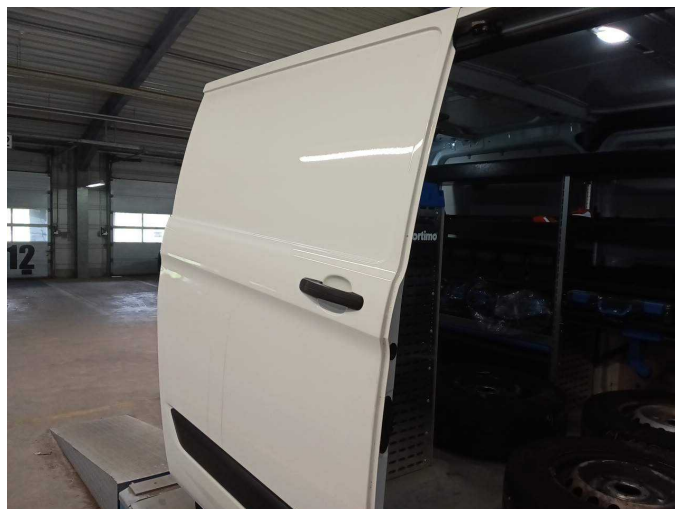
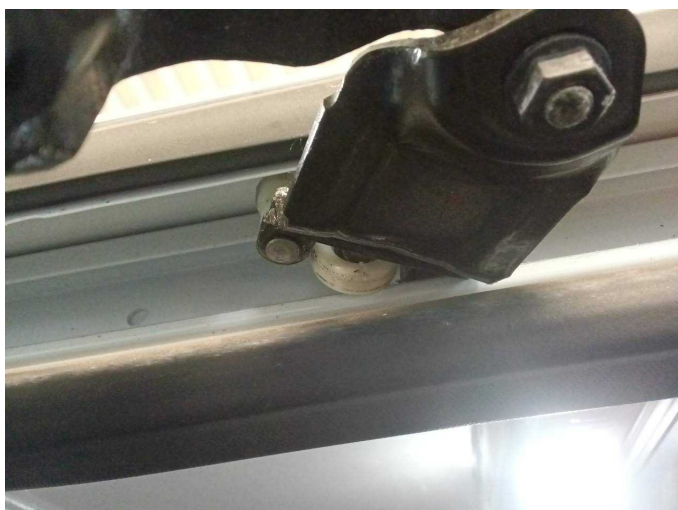
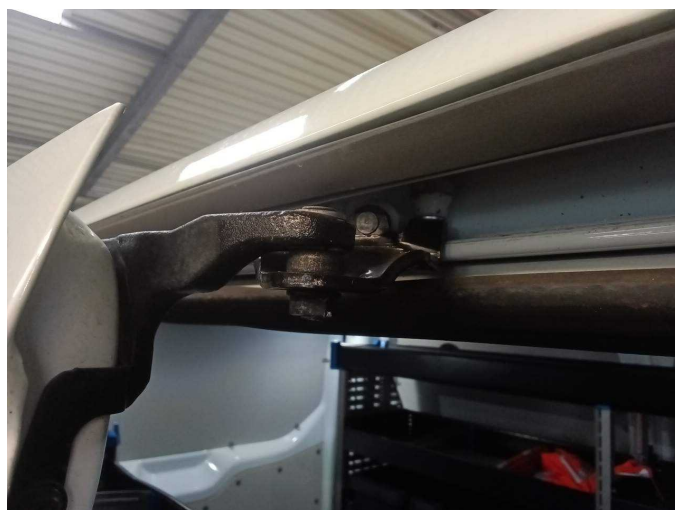
| No. | Component group | Description |
|---|---|---|
| 3 | Sliding door, right | Sliding door - Malposition - Set / adjust |

**Damage 3:** Sliding door, right: Sliding door - Malposition - Set / adjust

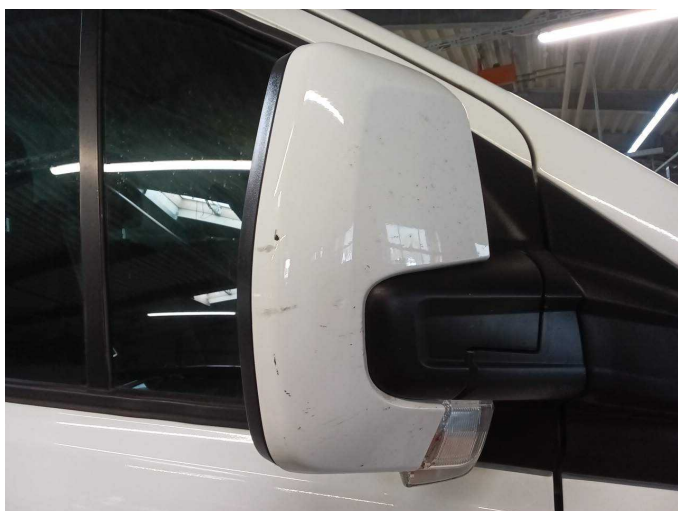
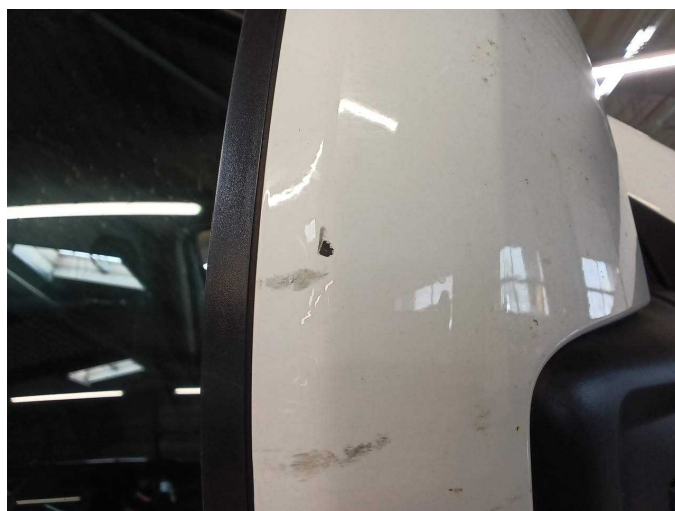
| No. | Component group | Description |
|---|---|---|
| 4 | Wing mirror - right side | Mirror housing - Scratch(es) - Smart repair |

**Damage 4:** Wing mirror - right side: Mirror housing - Scratch(es) - Smart repair

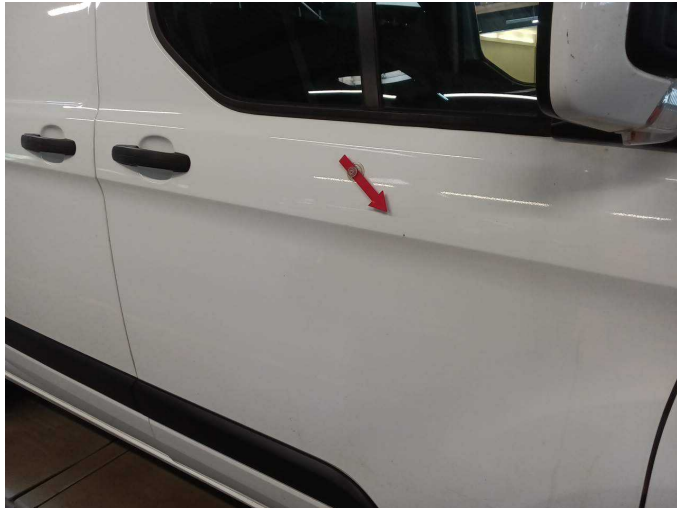
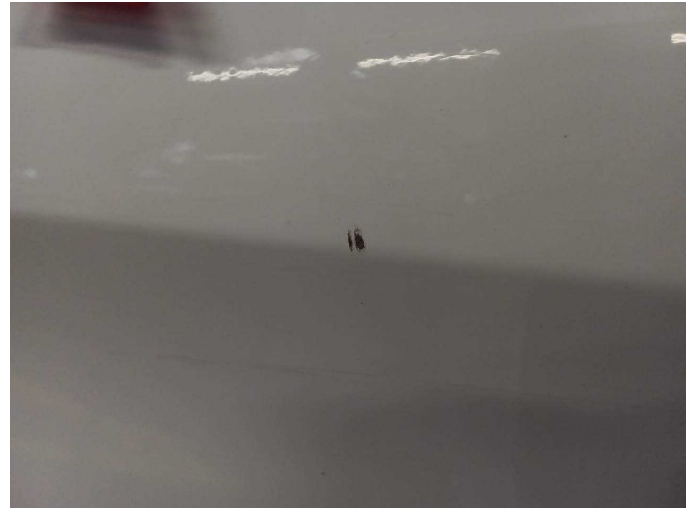
| No. | Component group | Description |
|---|---|---|
| 5 | Door - front right side | Door - Scratch(es) - Smart repair |

**Damage 5:** Door - front right side: Door - Scratch(es) - Smart repair

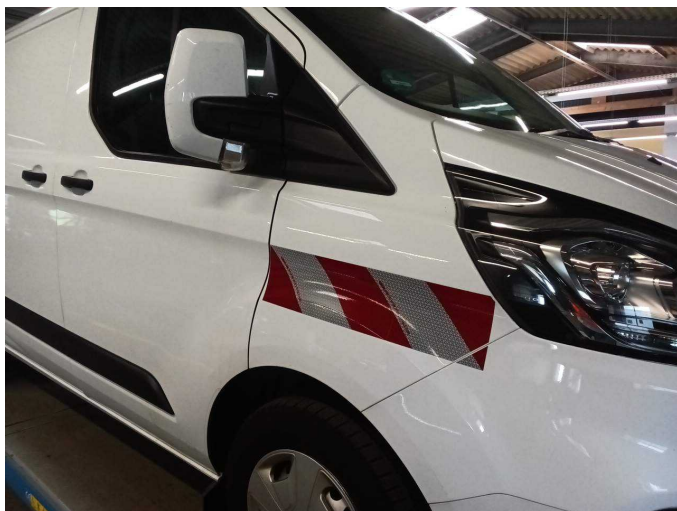
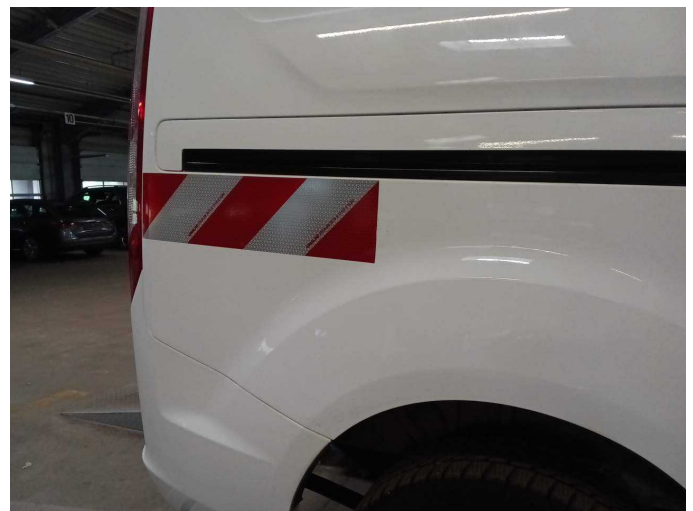
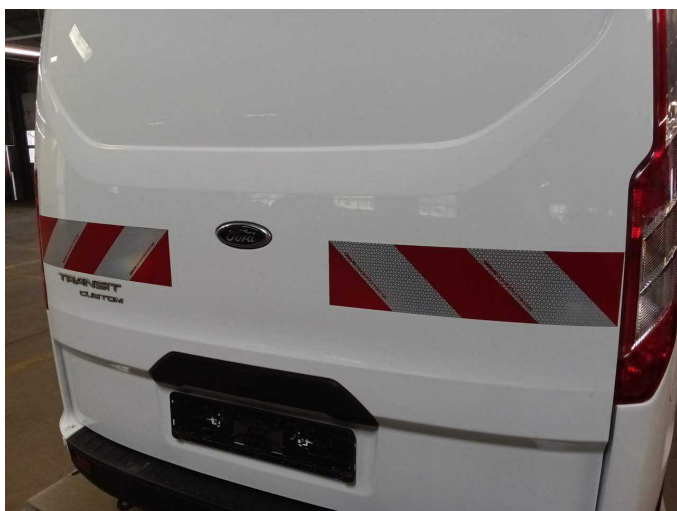
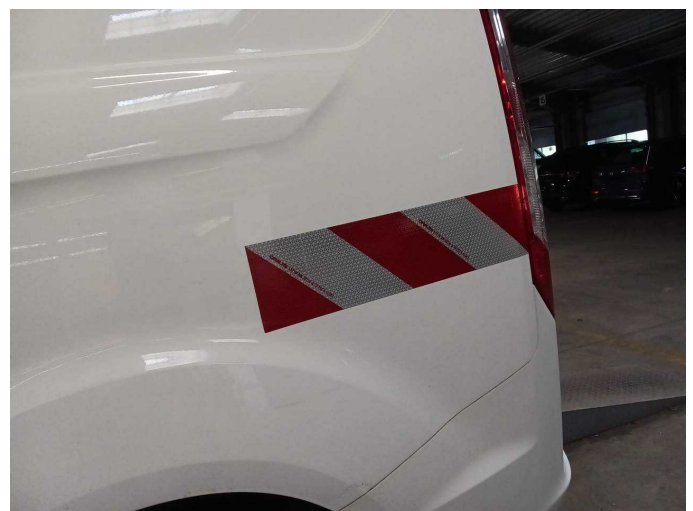
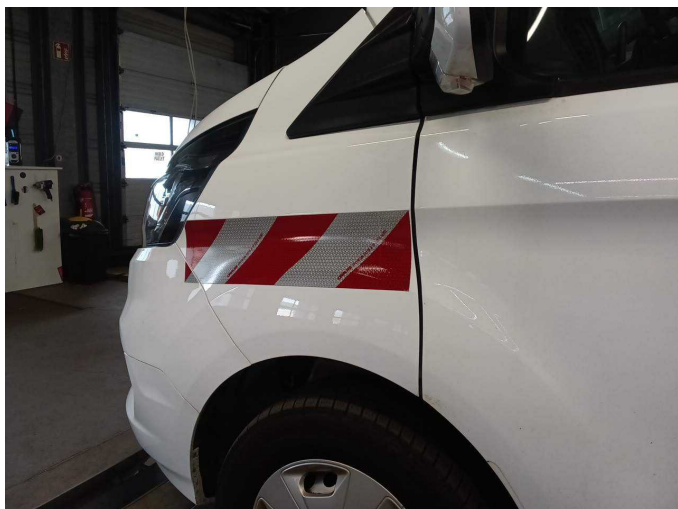
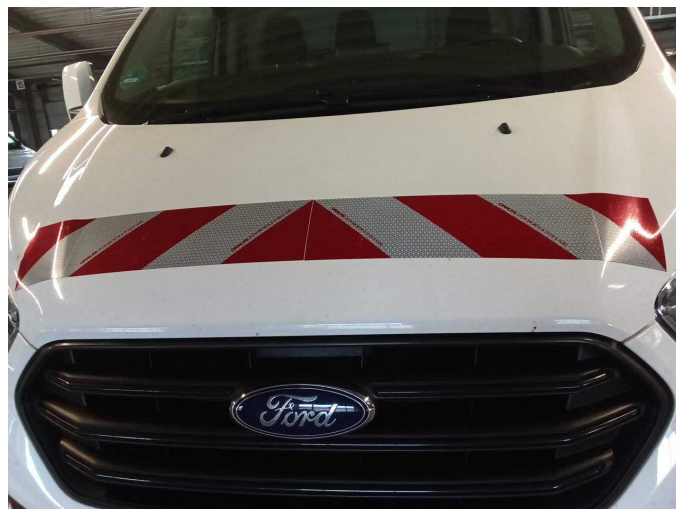
| No. | Component group | Description |
|---|---|---|
| 6 | Body | Body - Glued / labelled - Remove |

**Damage 6:** Body: Body - Glued / labelled - Remove

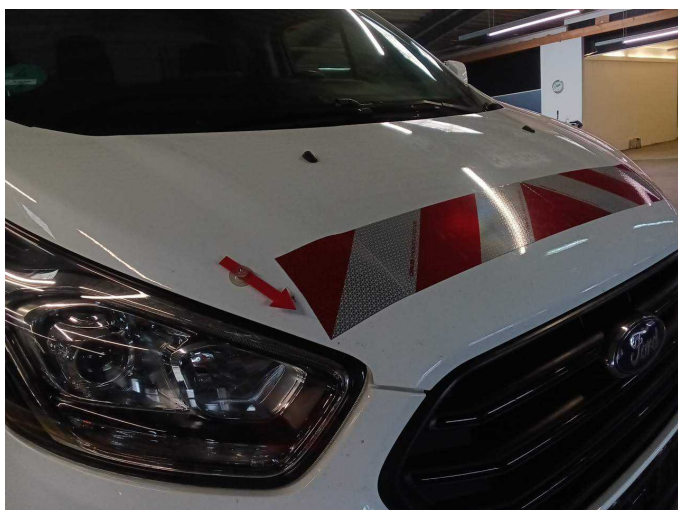
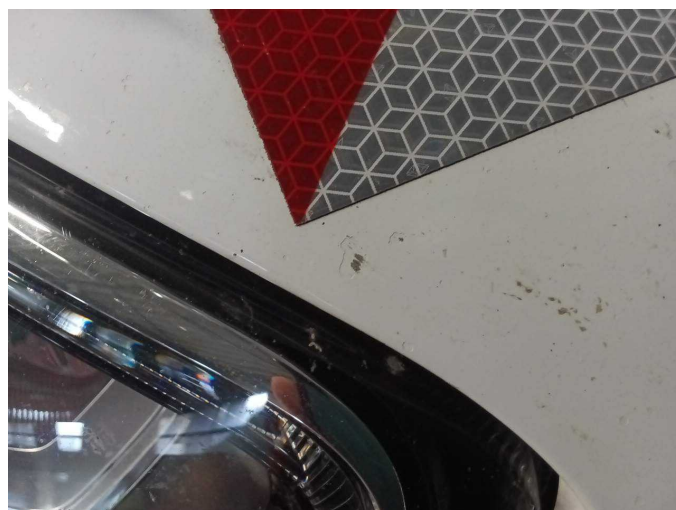
| No. | Component group | Description |
|---|---|---|
| 1 | Bonnet | Bonnet - Stone chips - No deduction |

**Wear and tear 1:** Bonnet: Bonnet - Stone chips - No deduction

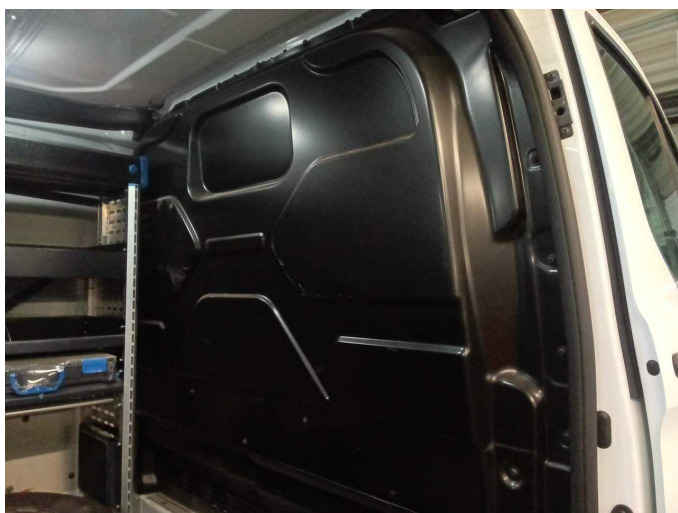
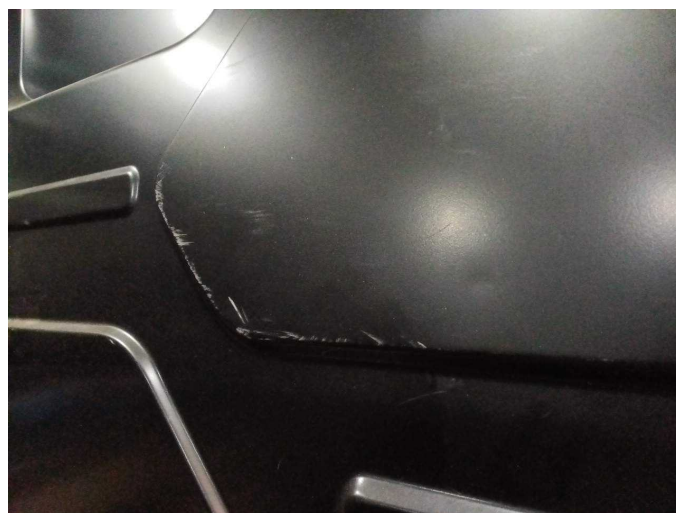
| No. | Component group | Description |
|---|---|---|
| 2 | Interior | Separation net - Scratch(es) - No deduction |

**Wear and tear 2:** Interior: Separation net - Scratch(es) - No deduction
