Expertise

Protocol number: 46833662  
Order No. / Reference: 26657709  
Inspection date: 30 Jul 2026

Manufacturer: Mazda

Model: 2 e-SKYACTIV G 90 M HYBRID Homura

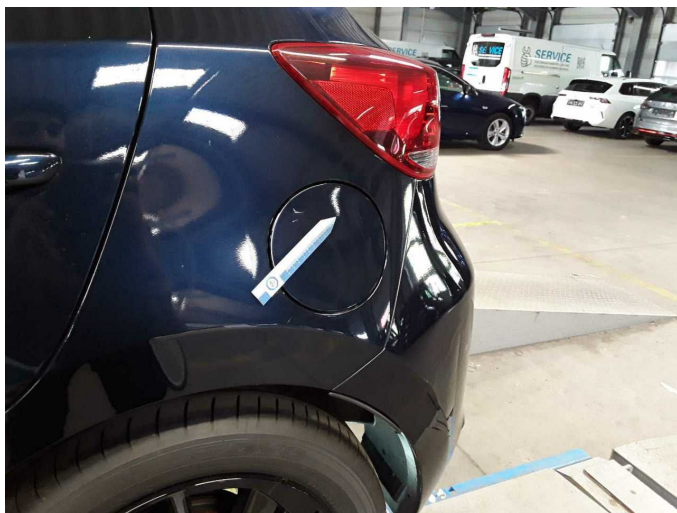
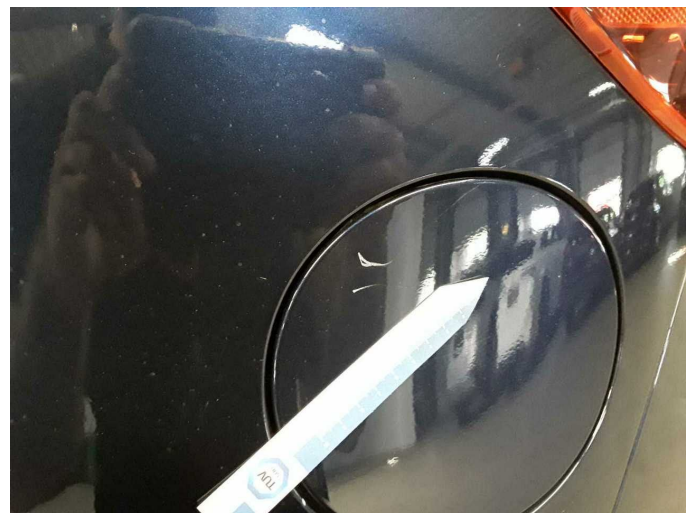
| No. | Component group | Description |
|---|---|---|
| 3 | Fuel system | Tank cap - Scratch(es) - Smart repair |

Damage 3: Fuel system: Tank cap - Scratch(es) - Smart repair

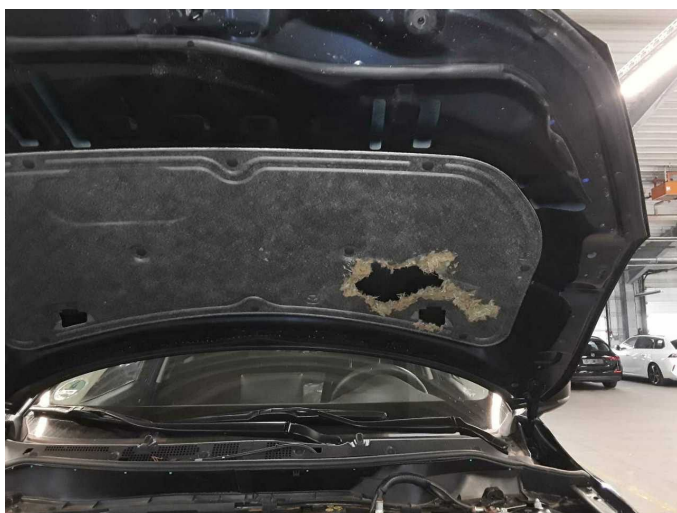
| No. | Component group | Description |
|---|---|---|
| 4 | Bonnet | Insulation lining - Damage caused by marten / rodent - Replace |

Damage 4: Bonnet: Insulation lining - Damage caused by marten / rodent - Replace

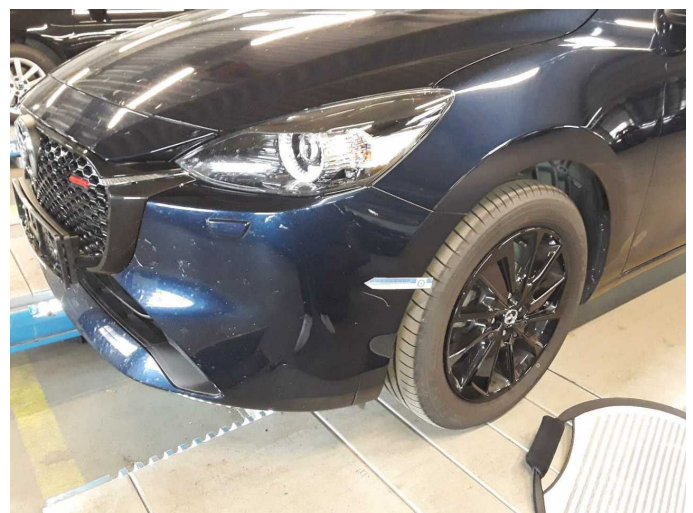
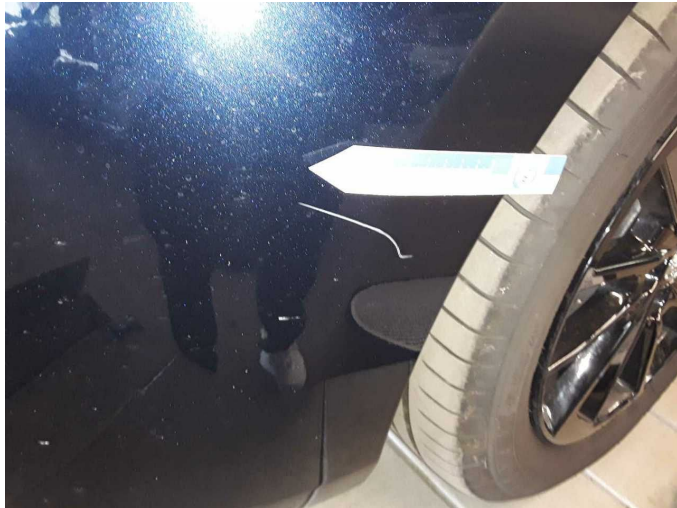
| No. | Component group | Description |
|---|---|---|
| 5 | Front bumper | Front bumper - Scratch(es) - Paint |

Damage 5: Front bumper: Front bumper - Scratch(es) - Paint

**Damage 5:** Front bumper: Front bumper - Scratch(es) - Paint

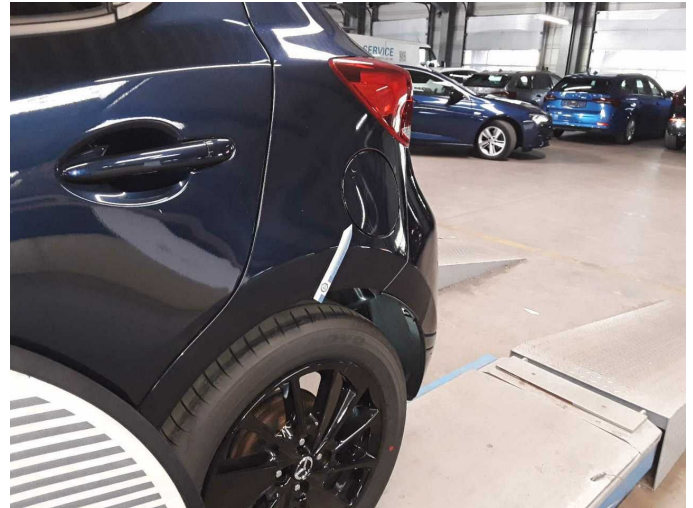
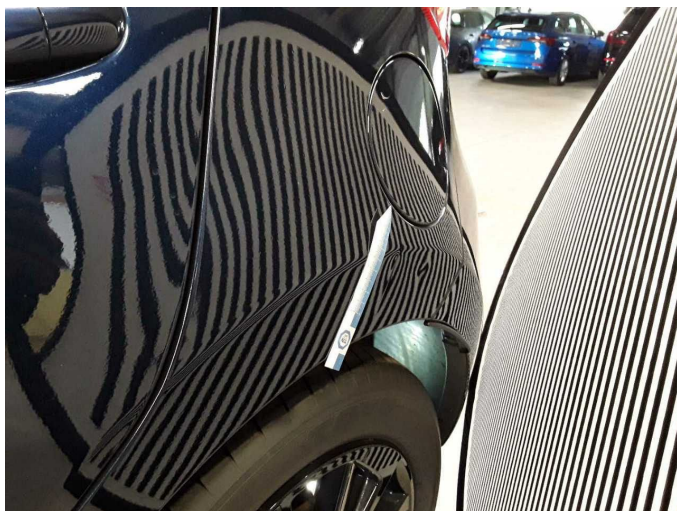
| No. | Component group | Description |
|---|---|---|
| 6 | Side panel - rear left side | Side panel - Dent / paintcoat damage - Repair and paint |

**Damage 6:** Side panel - rear left side: Side panel - Dent / paintcoat damage - Repair and paint
