Expertise

Protocol number: 45865917
Order No. / Reference: 26449950
Inspection date: 9 Jun 2026

Manufacturer: Opel

Model: Astra 1.5 D Start/Stop Sports Tourer Automatik Edition

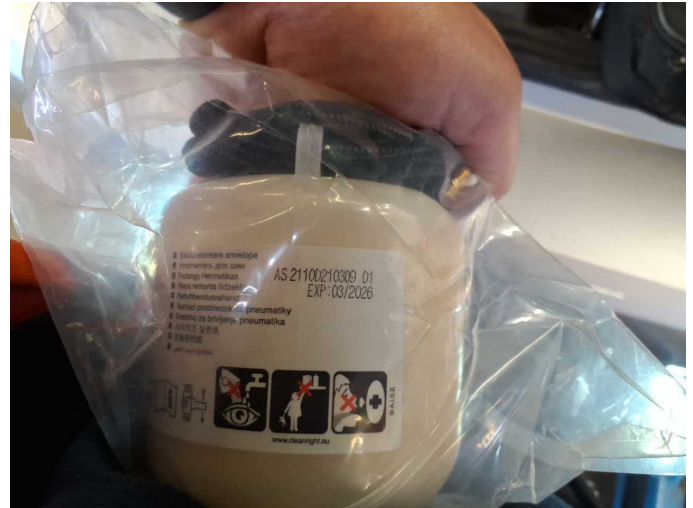
Damage 1: Equipment: Tirefit filler - Expired - Replace

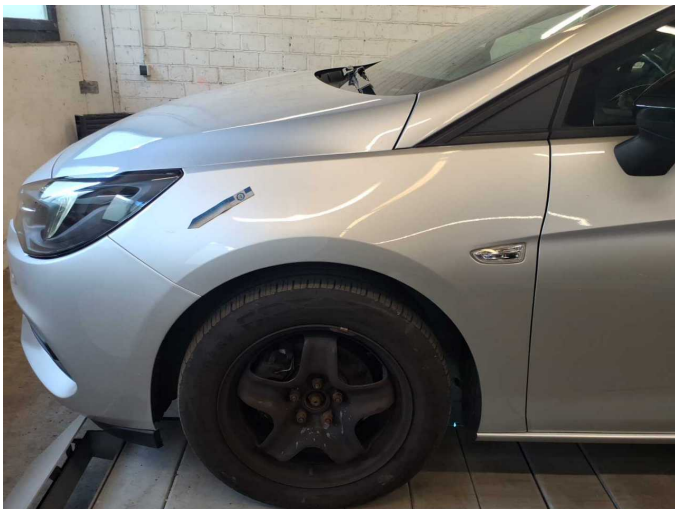
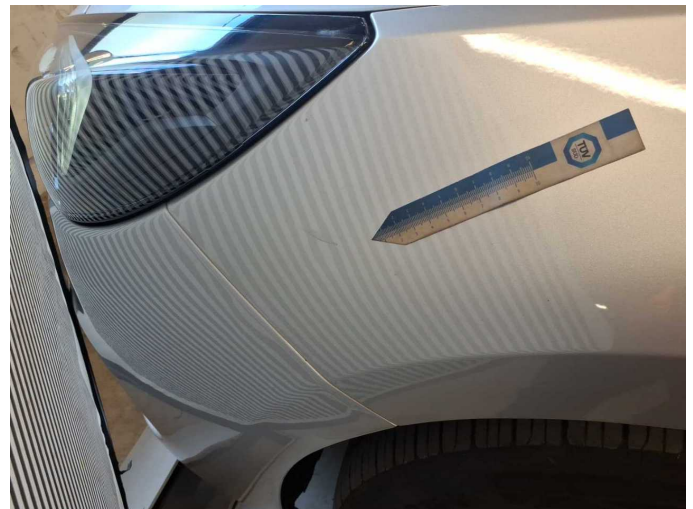
Damage 2: Mudguard - left side: Mudguard - left side - Dent / paintcoat damage - Smart repair

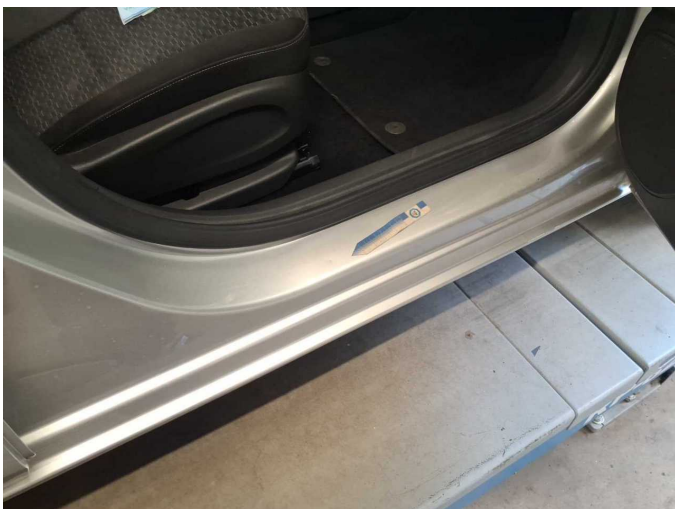
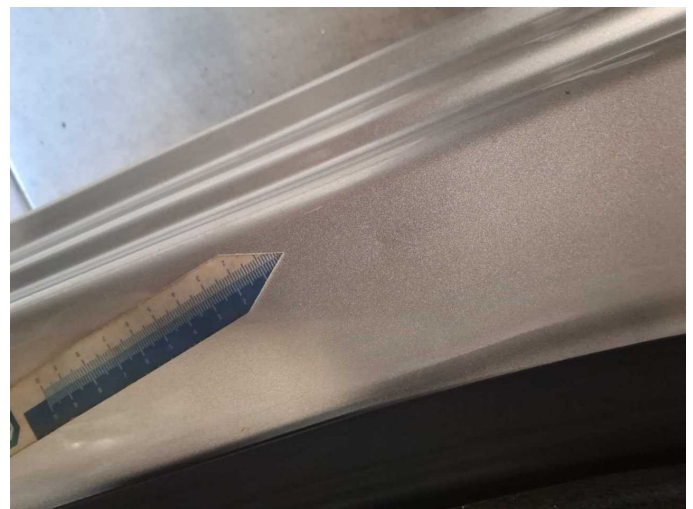
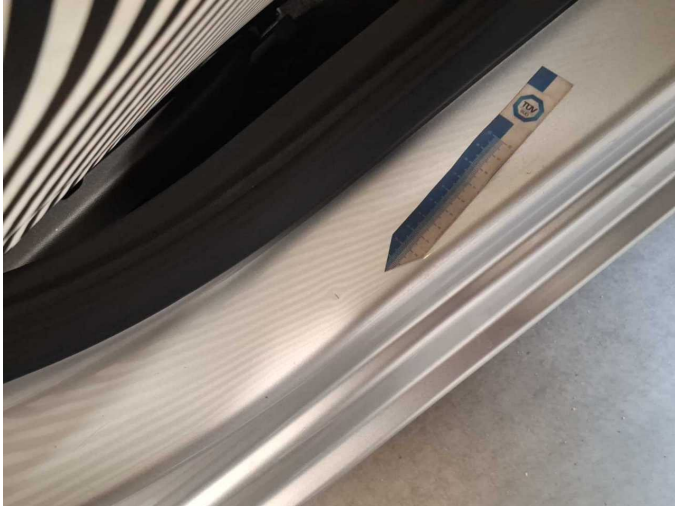
Damage 3: Sill - right side: Sill - Dent / paintcoat damage - Smart repair

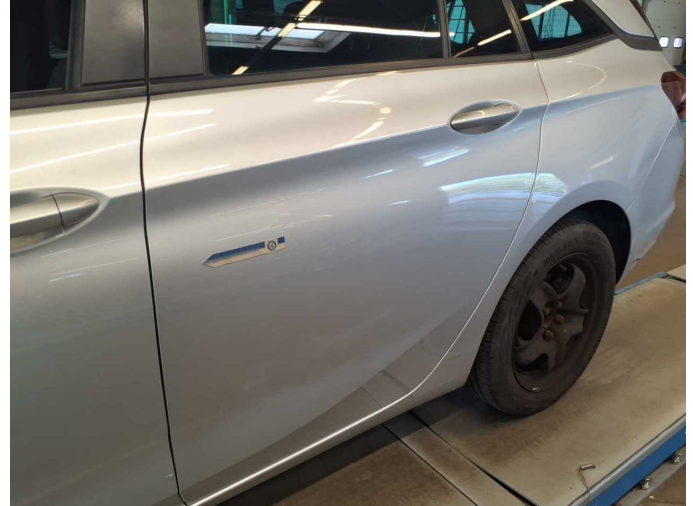
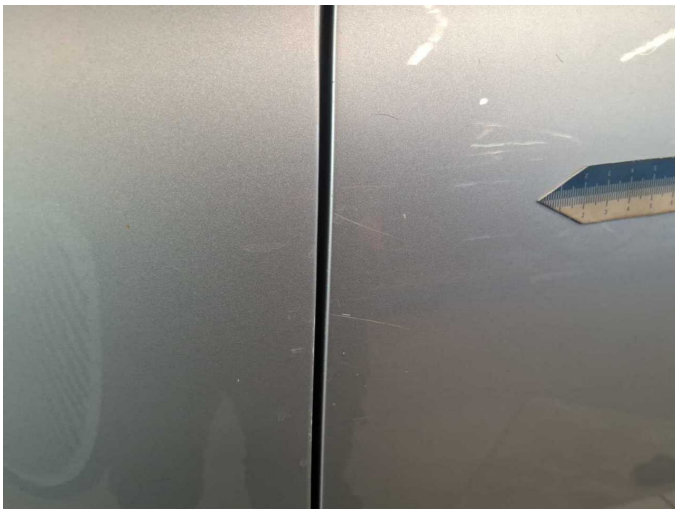
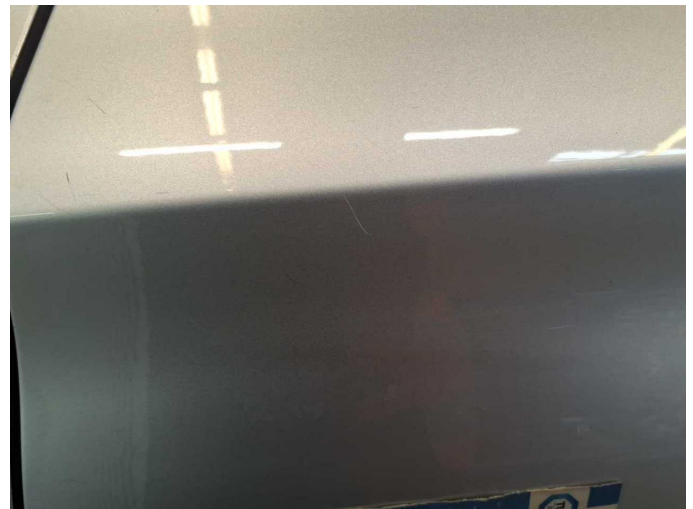
Damage 4: Door - rear left side: Door - Scratch(es) - Paint

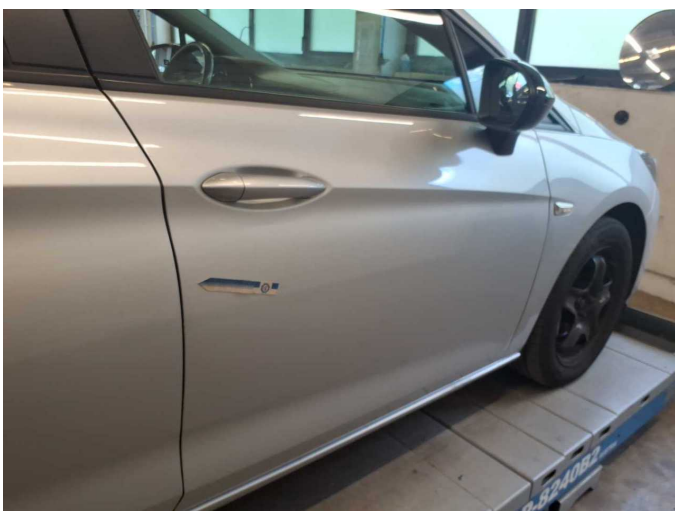
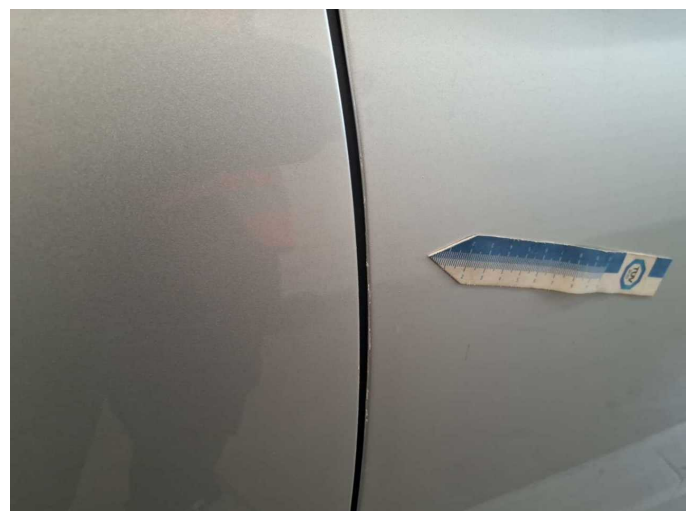
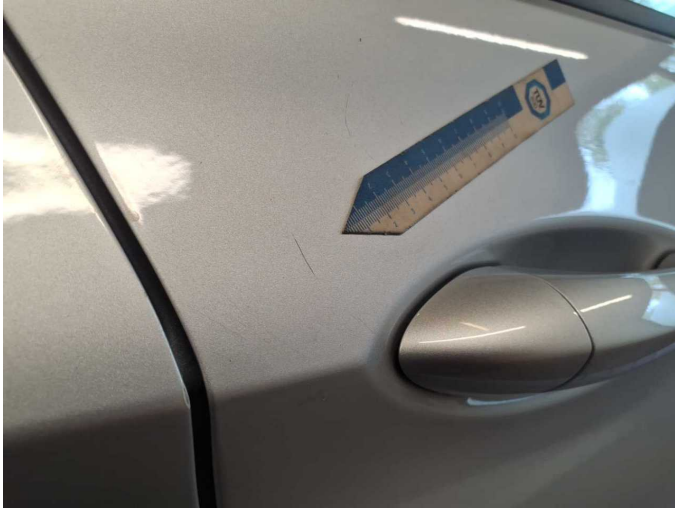
Damage 5: Door - front right side: Door - Scratch(es) - Paint

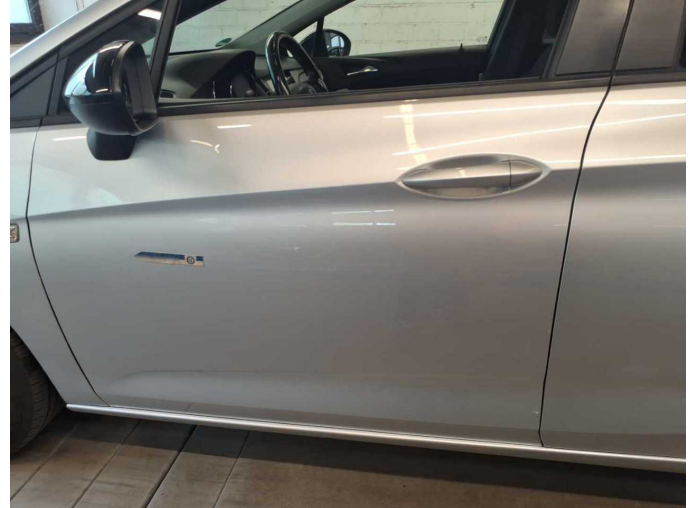
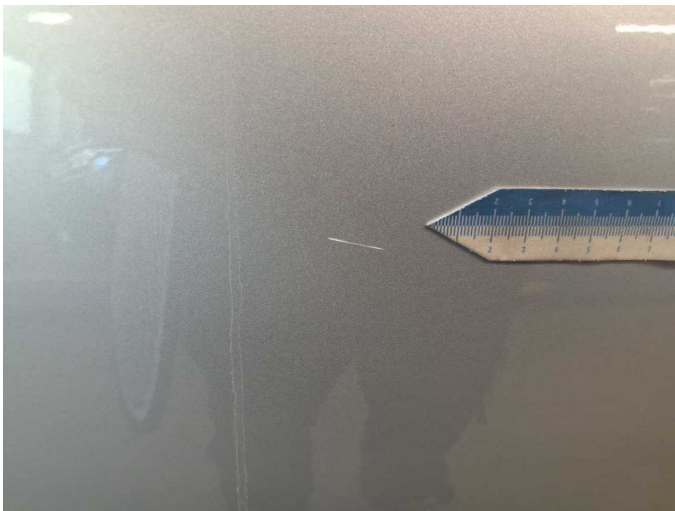
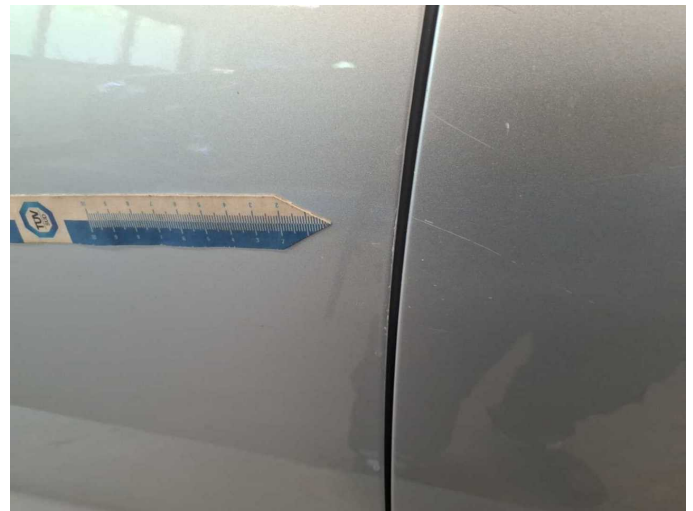
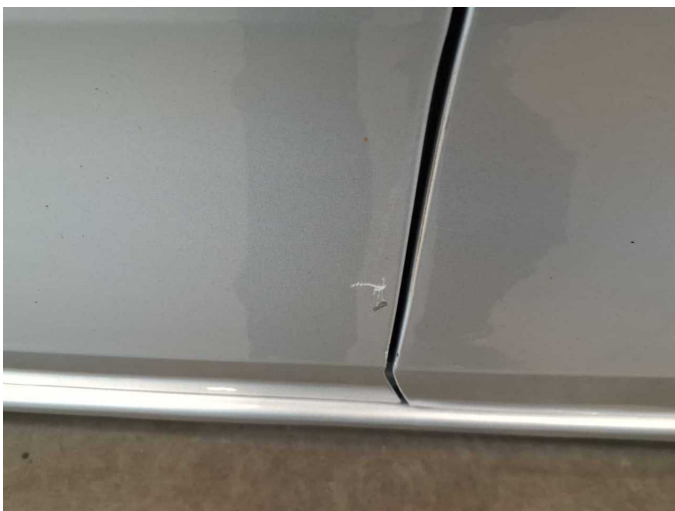
Damage 6: Door - front left side: Door - Scratch(es) - Paint

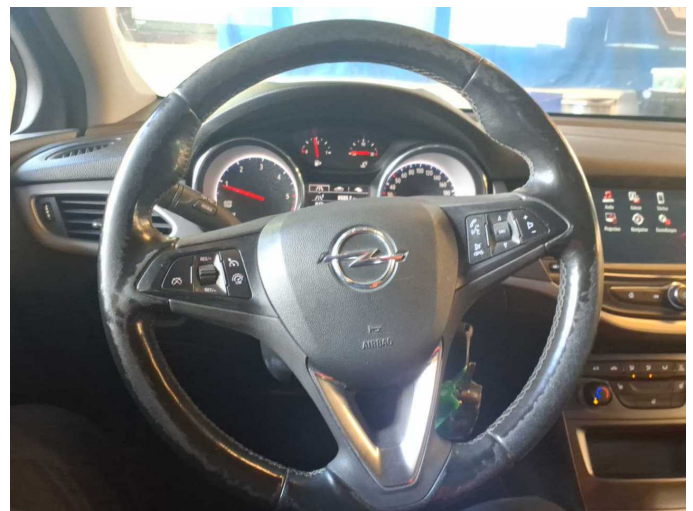
Wear and tear 1: Steering system: Steering wheel sheath - Scratched - No deduction

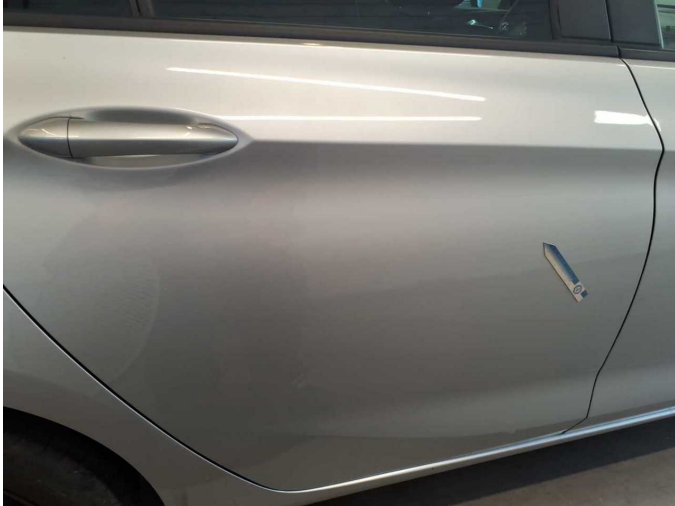
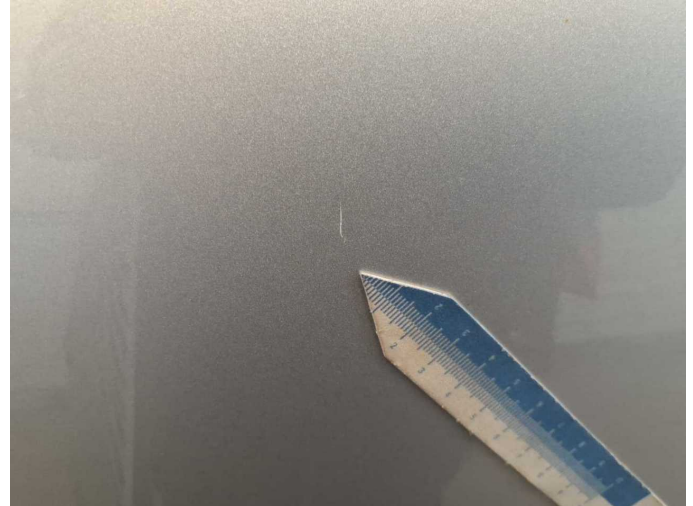
Wear and tear 2: Door - rear right side: Door - Scratch(es) - No deduction

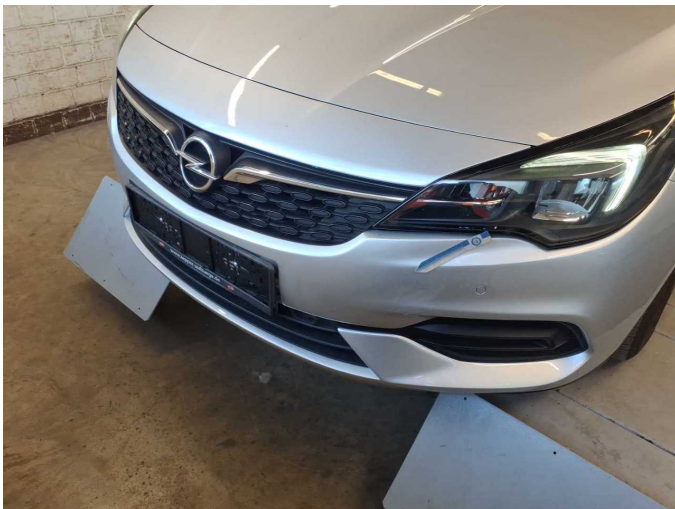
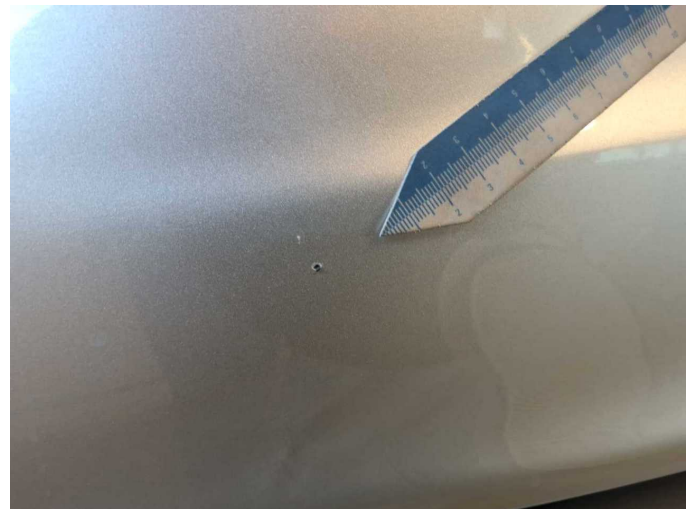
Wear and tear 3: Front bumper: Front bumper - Stone chips - No deduction

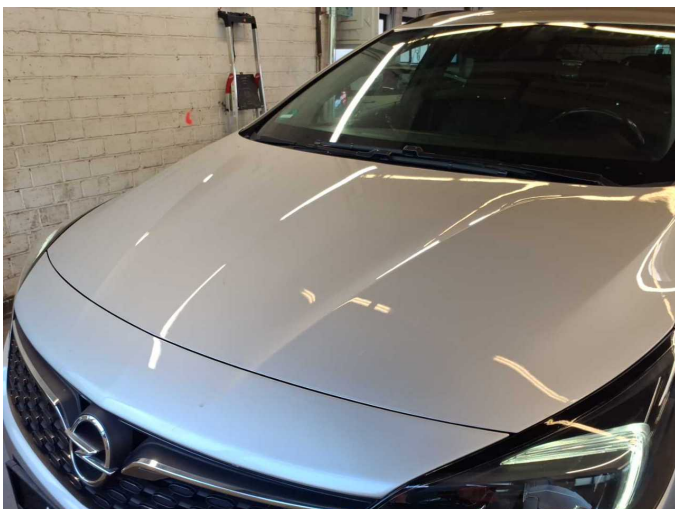
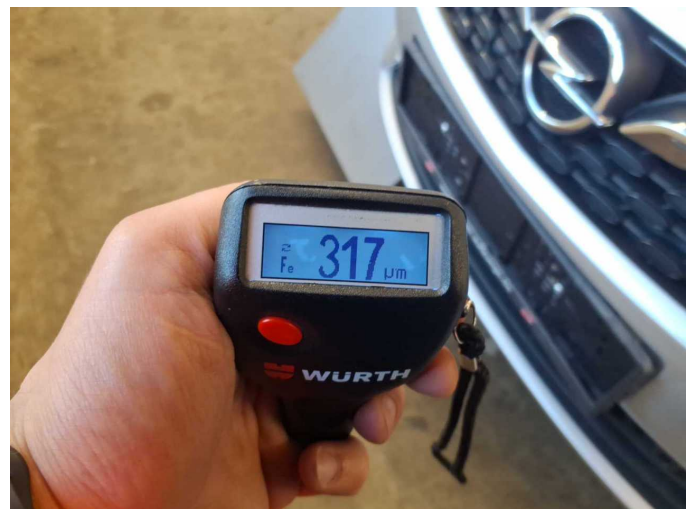
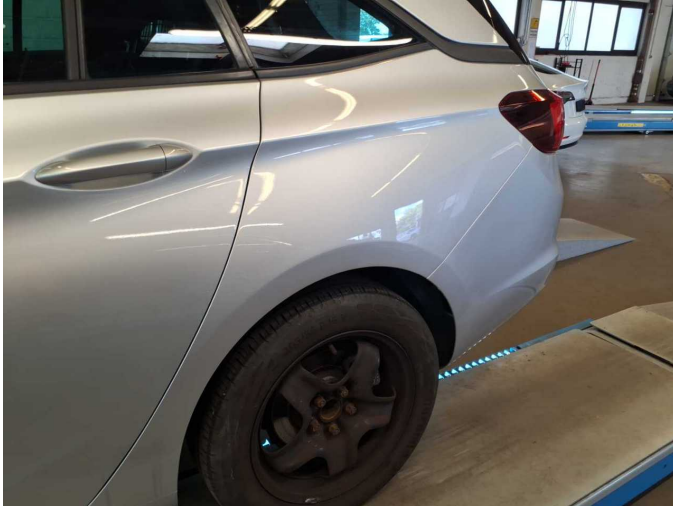
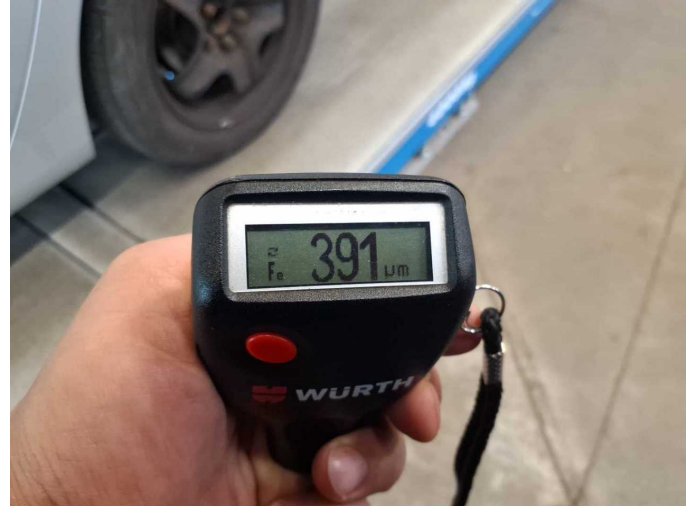
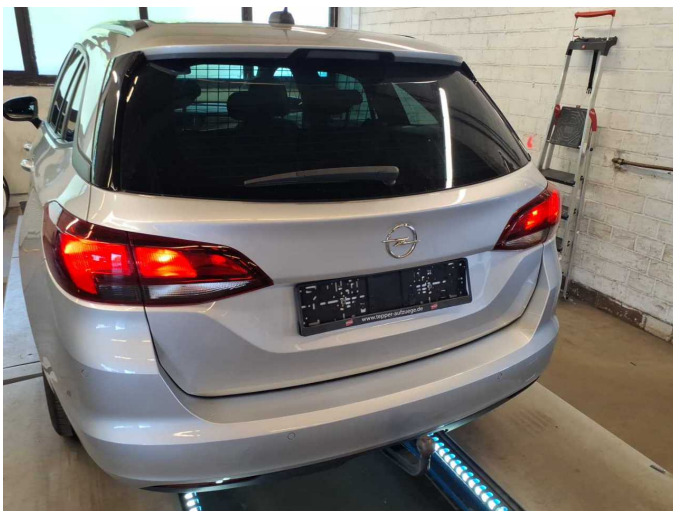
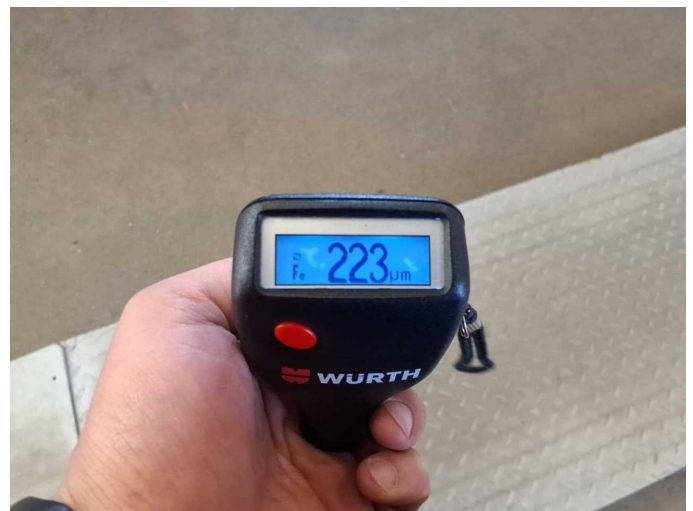
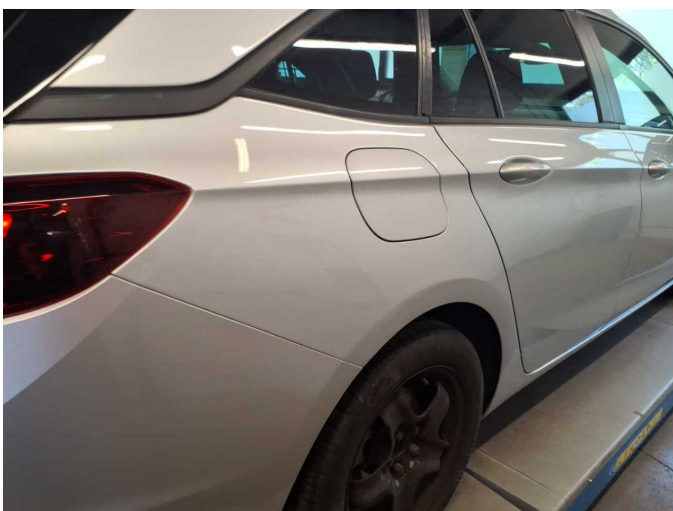
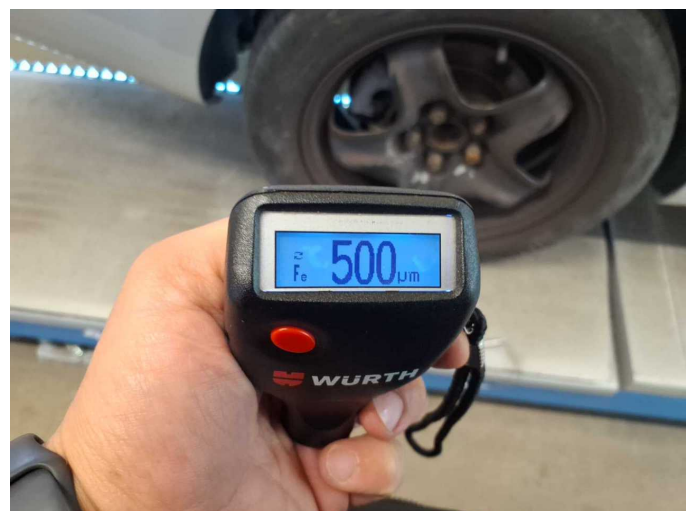
1	Boot lid / rear door, Bonnet, Side panel - rear left side, Side panel - rear right side, Professionally carried out, Invoice of repair done Non-existent
---	--

Boot lid / rear door	235 µm	Bonnet	268 µm
Side panel - rear left side	299 µm	Side panel - rear right side	513 µm

Repainting 1: Boot lid / rear door, Bonnet, Side panel - rear left side, Side panel - rear right side
