Expertise

Protocol number: 46320929
Order No. / Reference: 26530458
Inspection date: 3 Jul 2026

Manufacturer: Opel

Model: Zafira Life 2.0 D L Selection

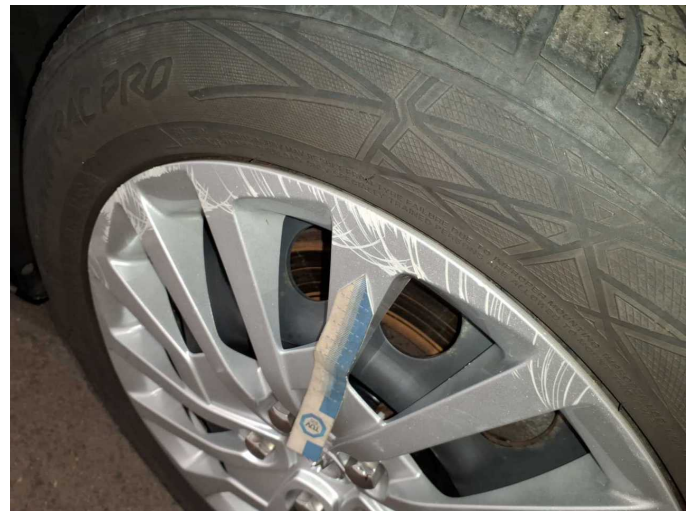
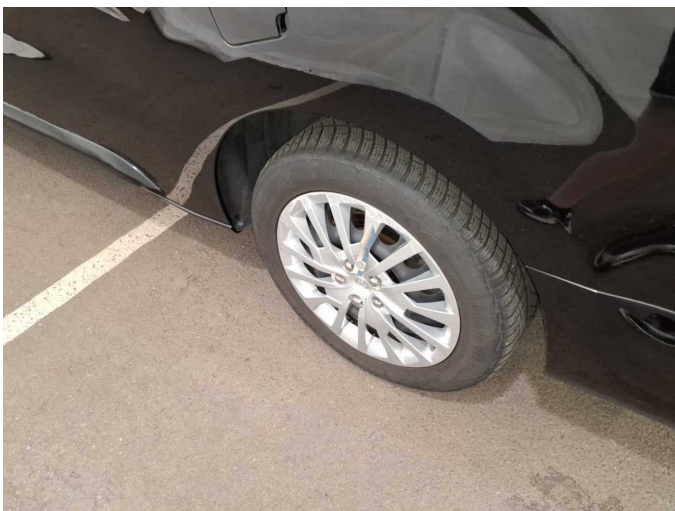
Damage 1: Wheel / tyres: Wheel cover - rear left side - Scratched - Replace

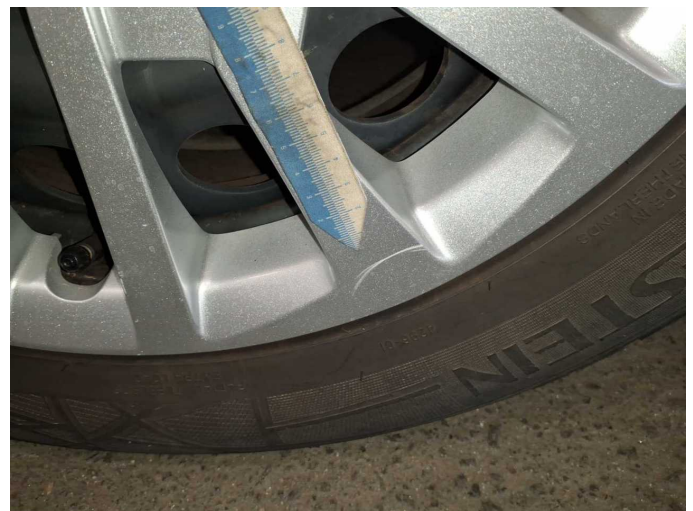
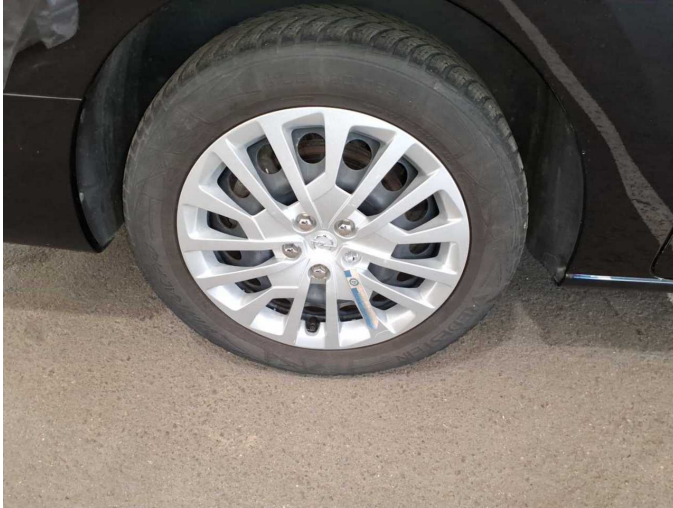
Damage 2: Wheel / tyres: Wheel cover - rear right side - Scratch(es) - Replace

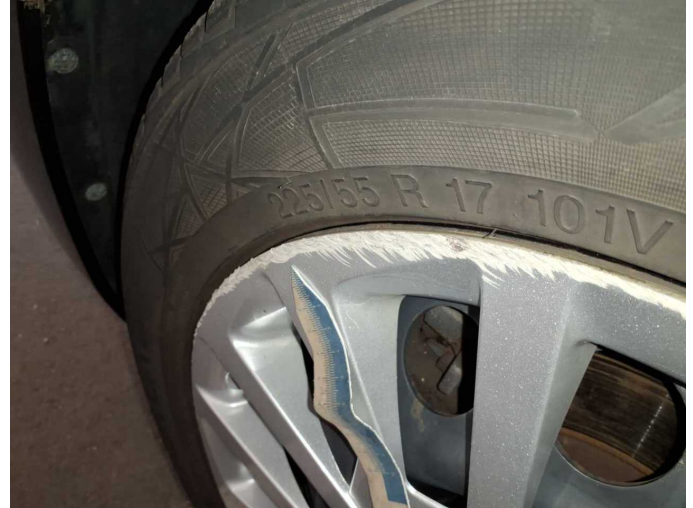
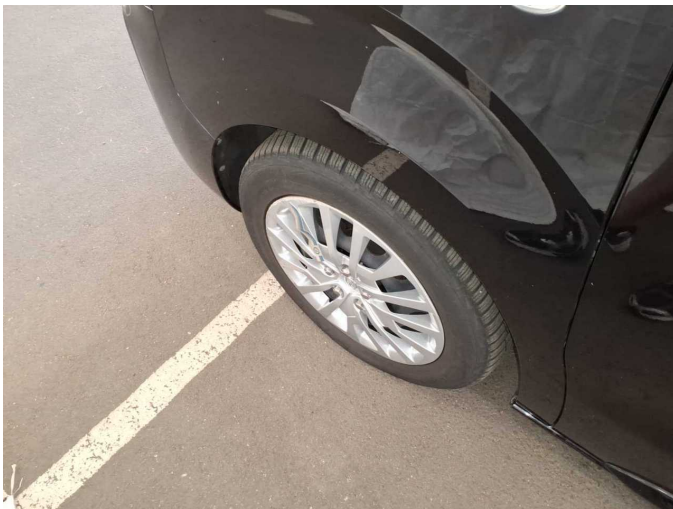
Damage 3: Wheel / tyres: Wheel cover - front left side - Scratch(es) - Replace

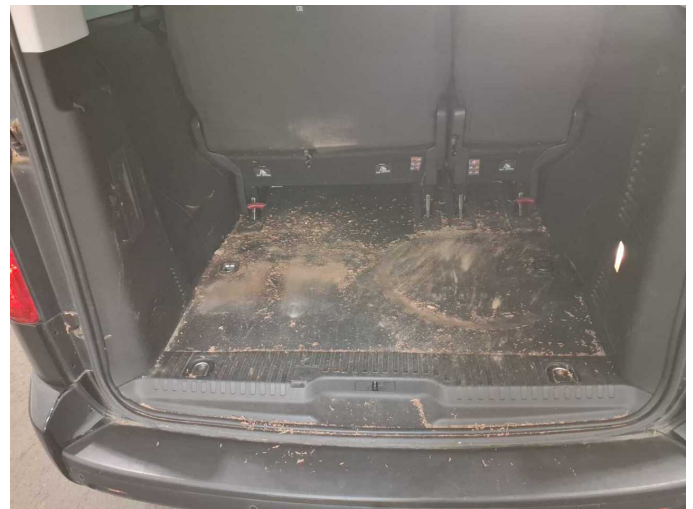
Damage 4: Interior: Cargo area floor - Soiled - Conditioning

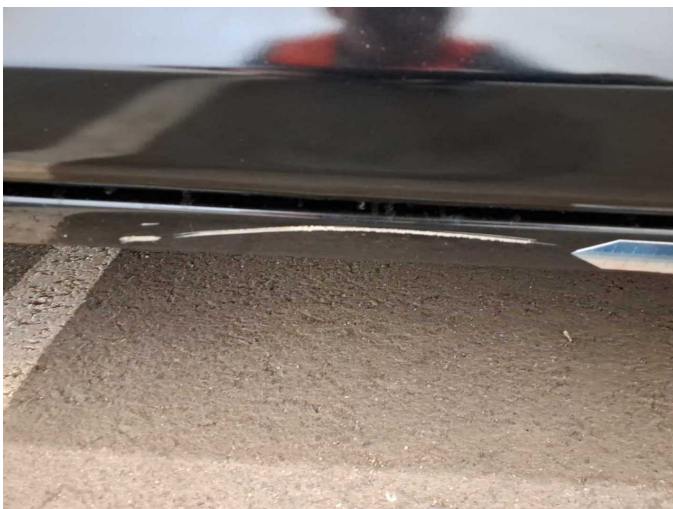
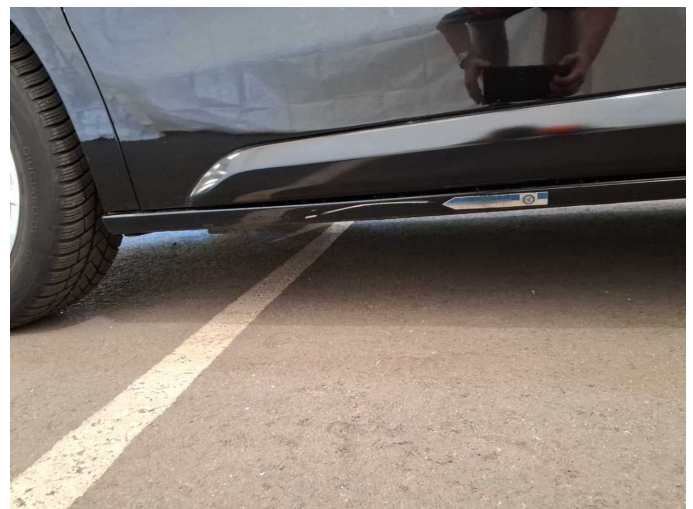
Damage 5: Sill - left side: Sill - Scratch(es) - Smart repair

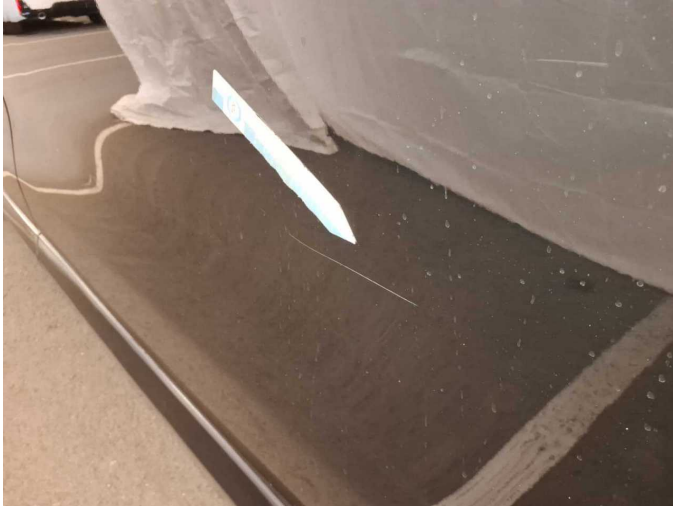
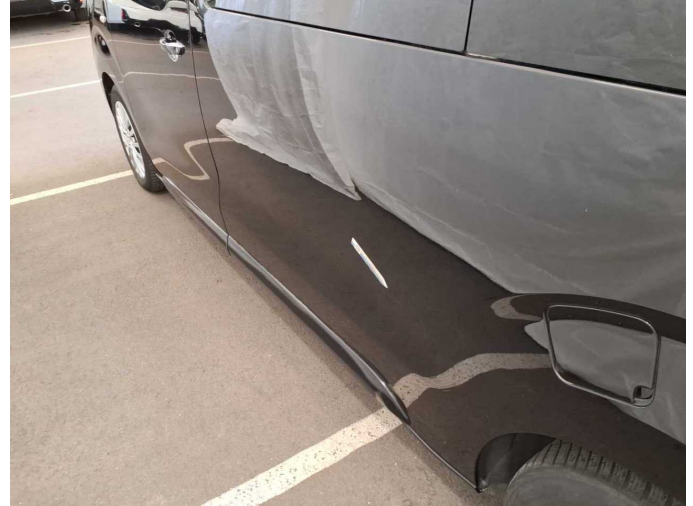
Damage 6: Side panel - rear left side: Side panel - Scratch(es) - Smart repair

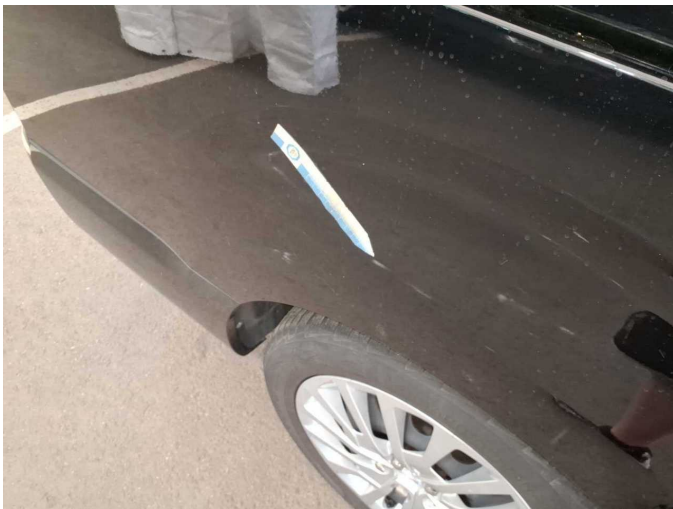
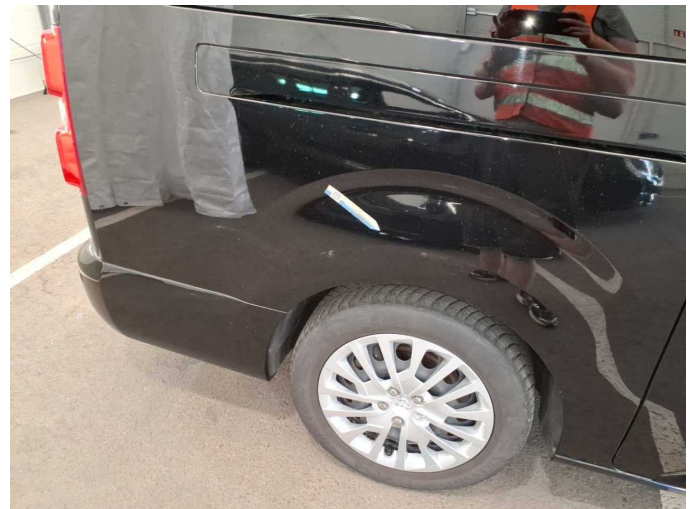
Damage 7: Side panel - rear right side: Side panel - Scratch(es) - Smart repair

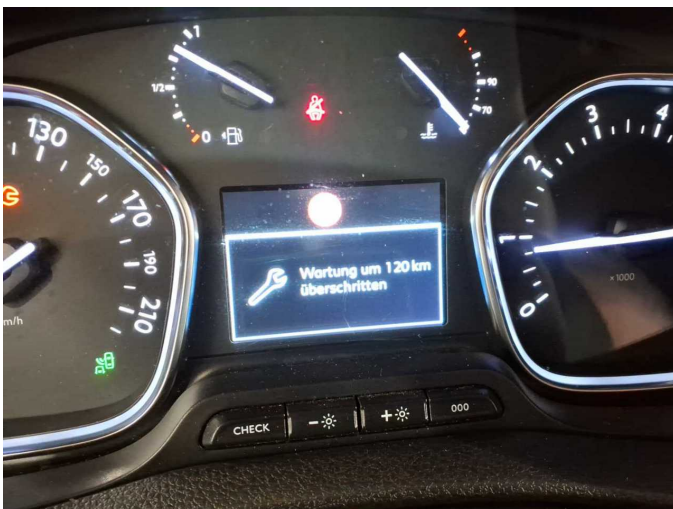
Damage 8: Misc.: Inspection / maintenance - Expired - Perform

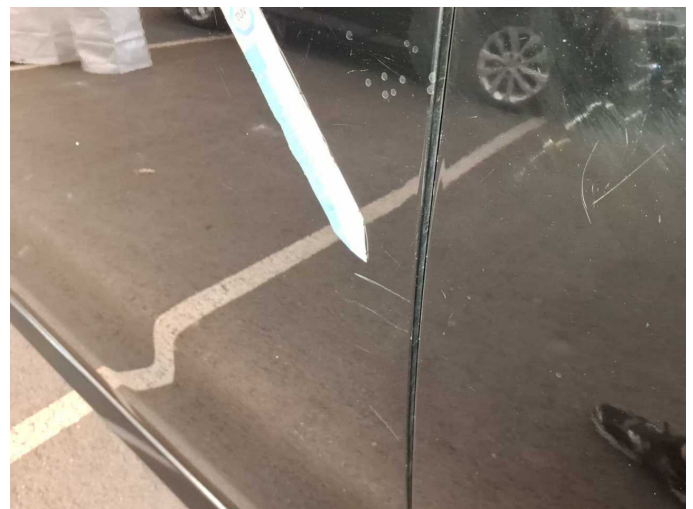
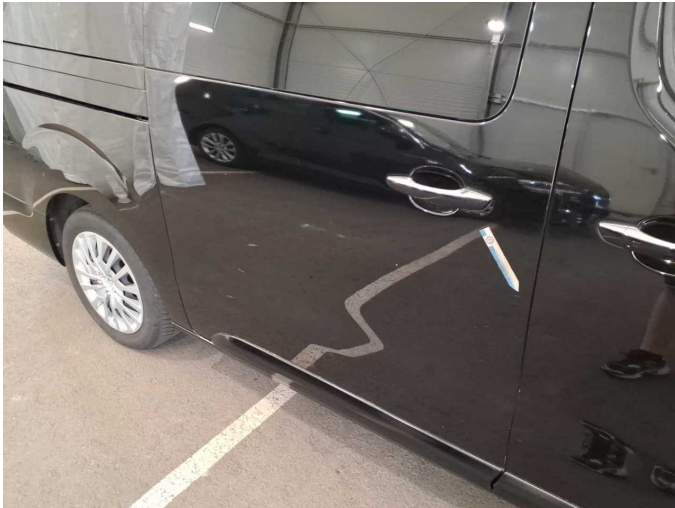
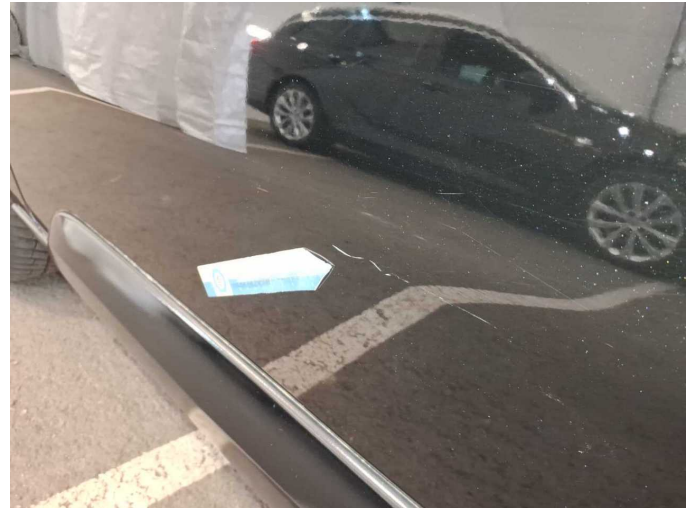
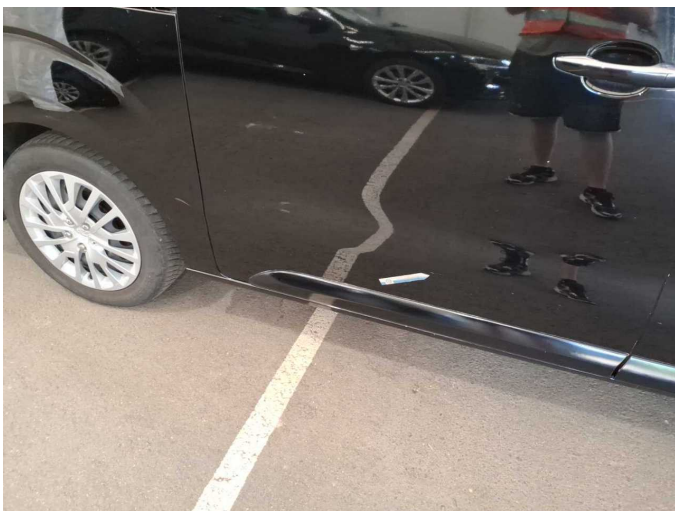
Damage 9: Door - rear right side: Door - Scratch(es) - Paint

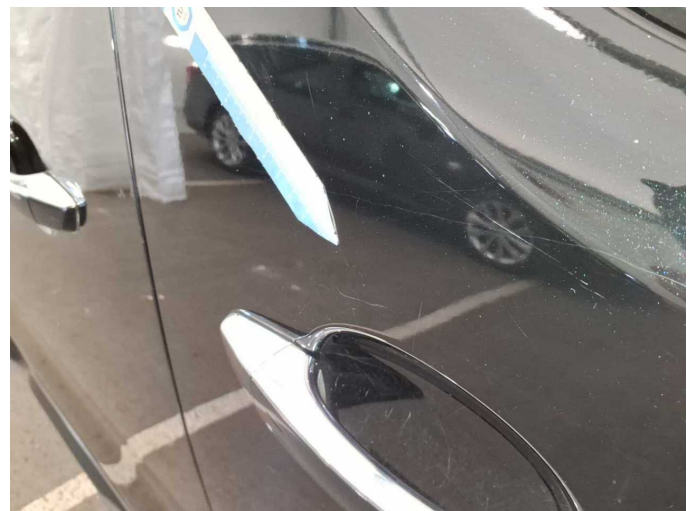
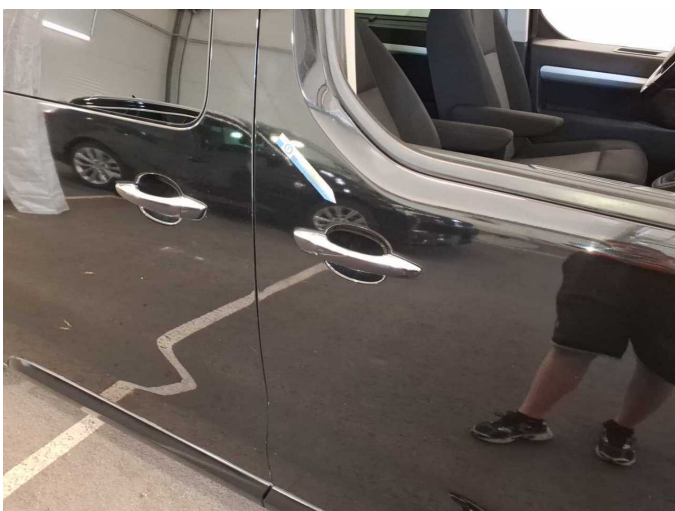
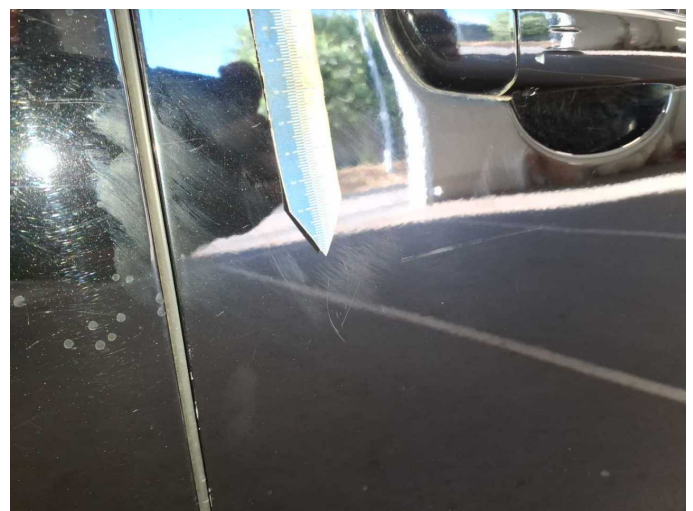
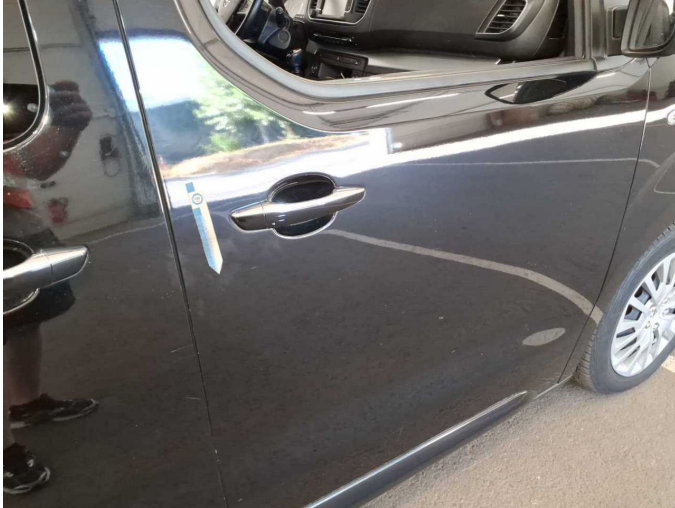
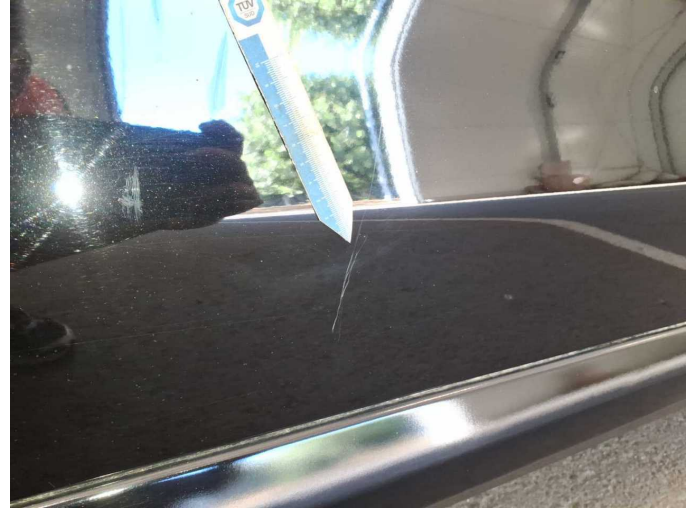
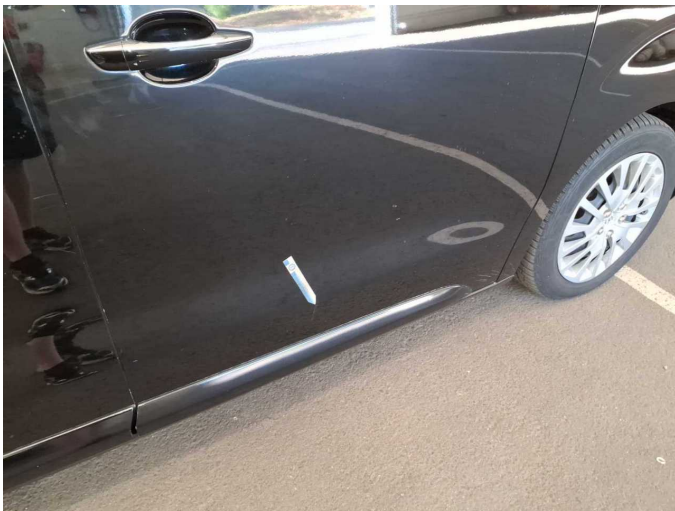
Damage 10: Door - front right side: Door - Scratch(es) - Paint

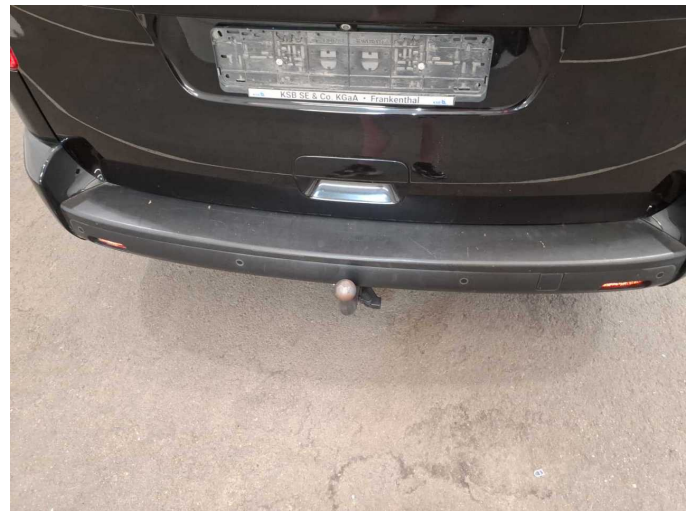
Wear and tear 2: Rear bumper: Rear bumper (unpainted) - Scratch(es) - No deduction

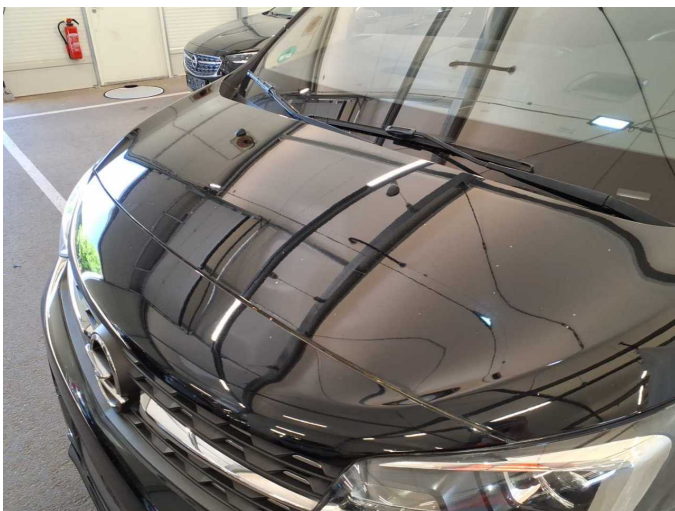
Wear and tear 3: Bonnet: Bonnet - Stone chips - No deduction

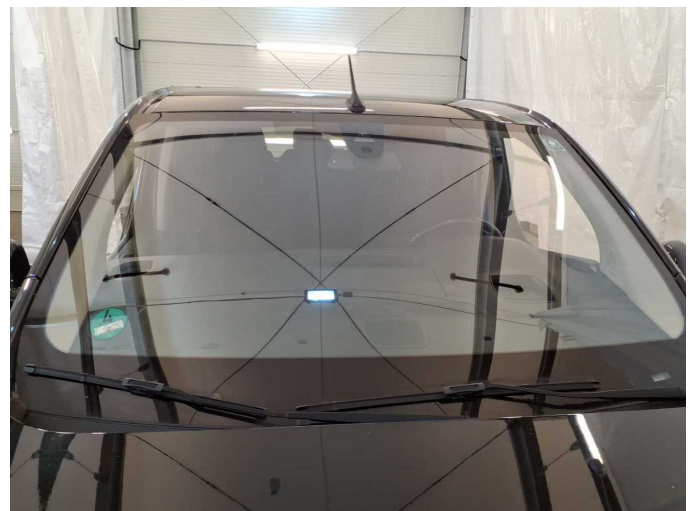
Wear and tear 4: Vehicle glazing: Windscreen - Stone chips - No deduction

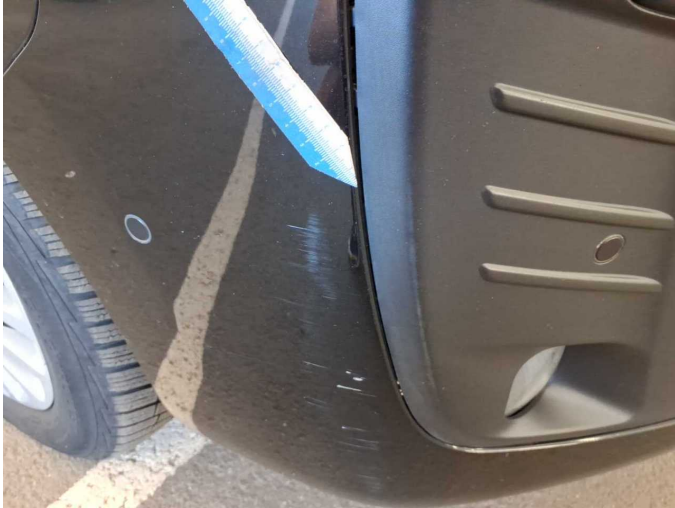
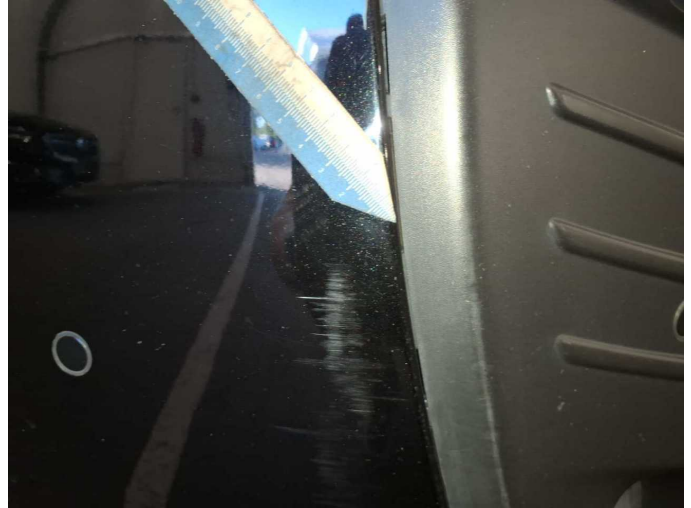
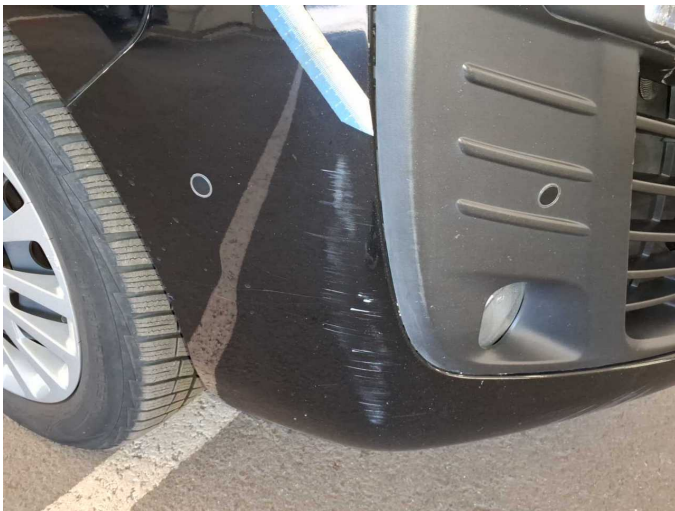
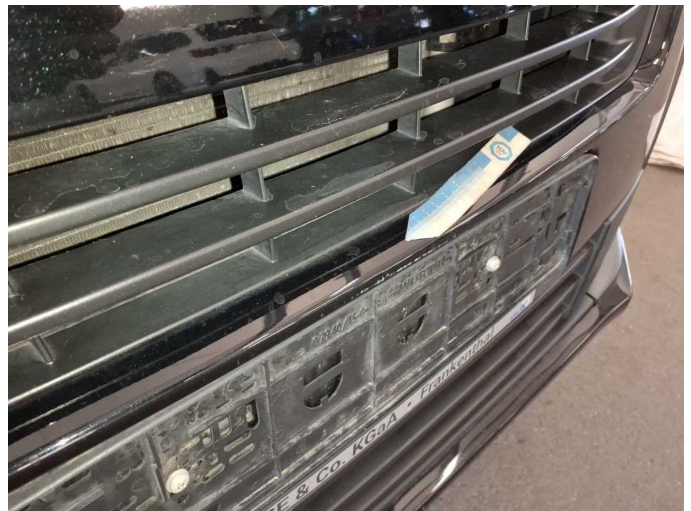
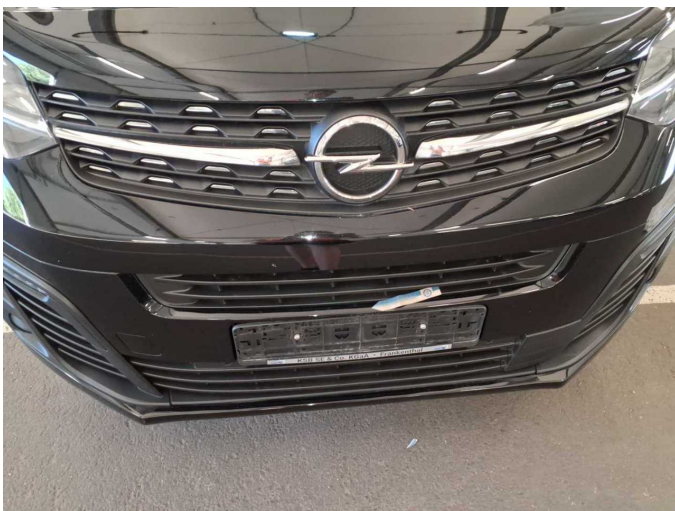
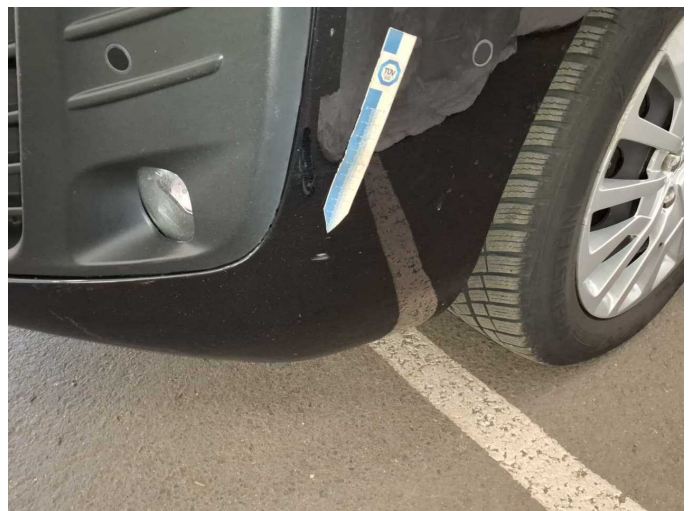
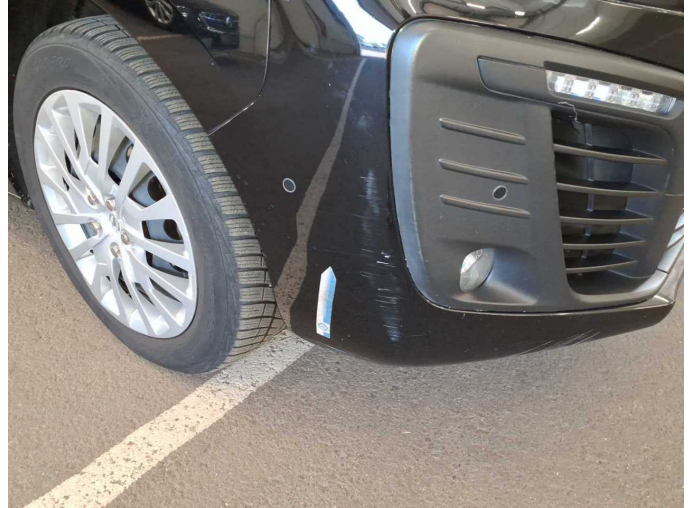
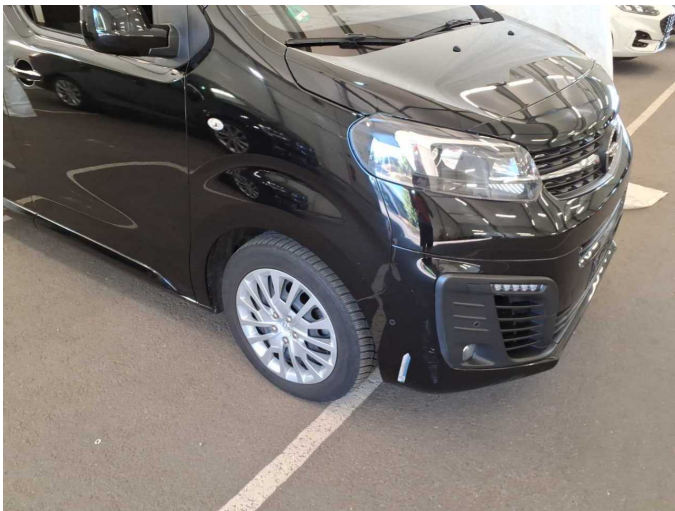
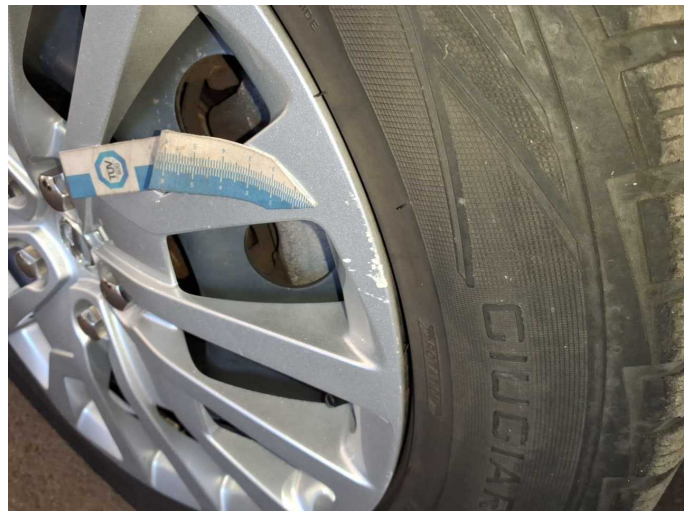
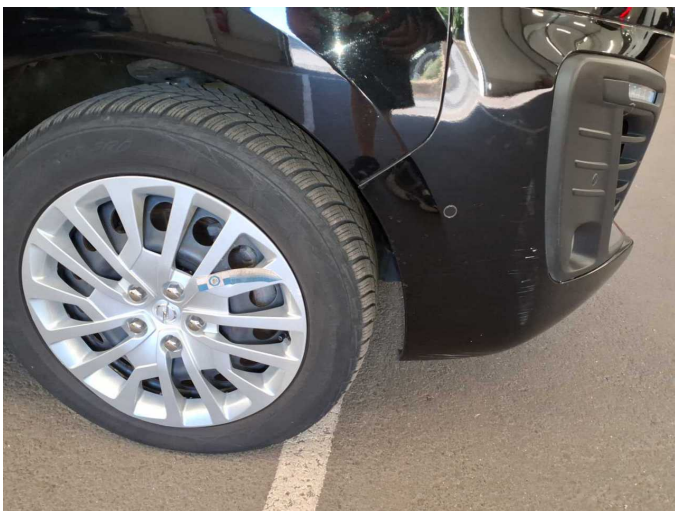
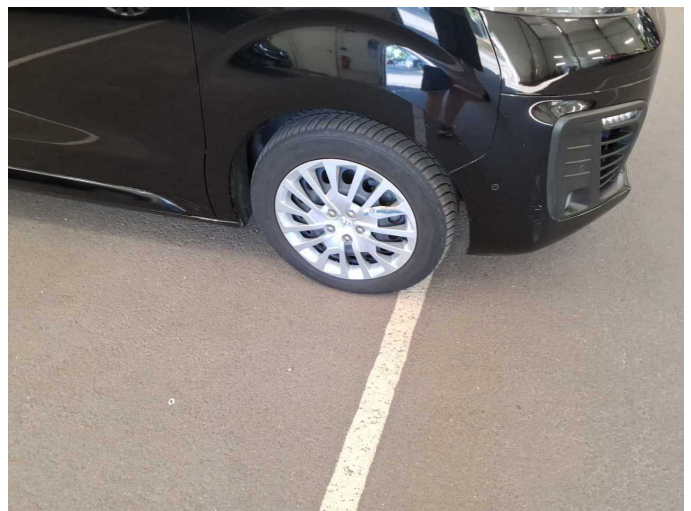
Non-repaired previous damages were found at the vehicle. The necessary repair costs are listed in the expert report or if necessary, are listed in detail in a separately enclosed repair cost calculation.

Accident 1: Front
