Expertise

Protocol number: 46741259  
Order No. / Reference: 26674429  
Inspection date: 28 Jul 2026

Manufacturer: Mazda

Model: 2 e-SKYACTIV G 90 M HYBRID Homura

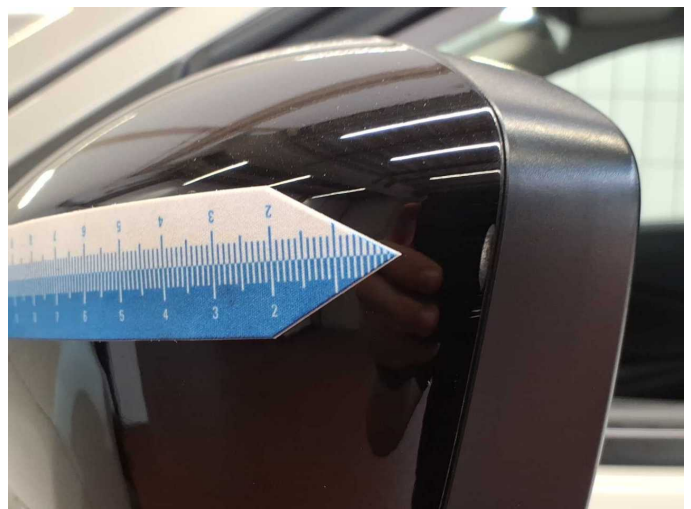
| No. | Component group | Description |
|---|---|---|
| 1 | Wing mirror - left side | Cap - Scratch(es) - Smart repair |

Damage 1: Wing mirror - left side: Cap - Scratch(es) - Smart repair

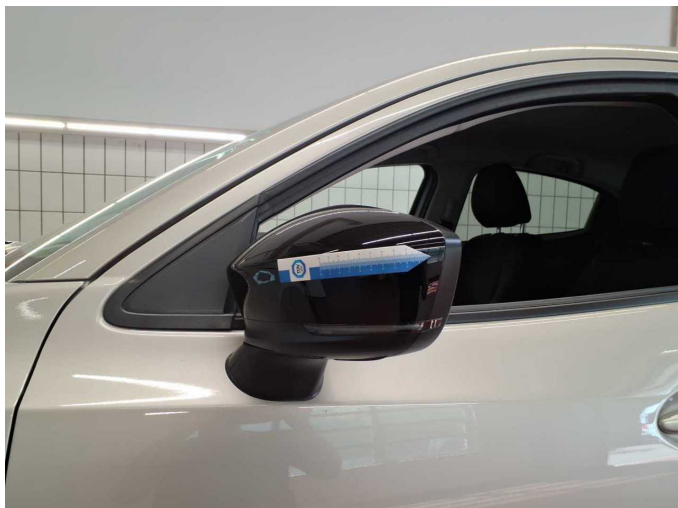
**Damage 1:** Wing mirror - left side: Cap - Scratch(es) - Smart repair

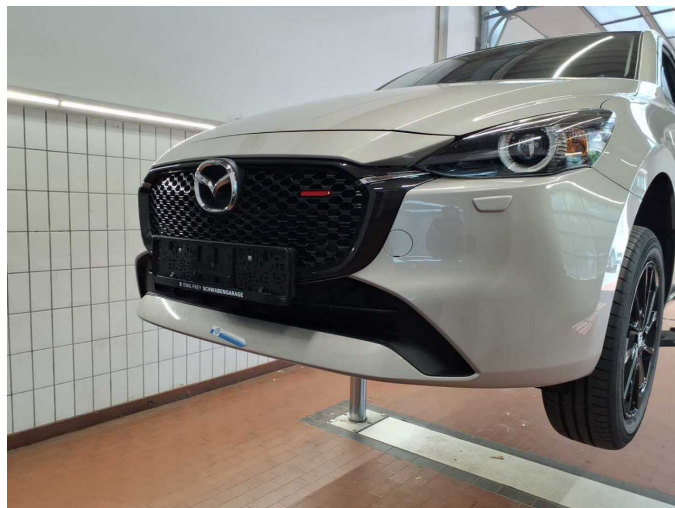
| No. | Component group | Description |
|---|---|---|
| 2 | Front bumper | Front bumper - Stone chips - Smart repair |

**Damage 2:** Front bumper: Front bumper - Stone chips - Smart repair

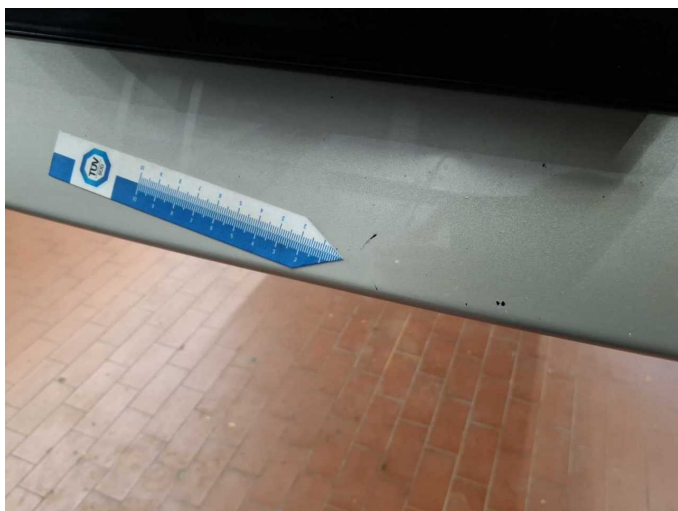
**Damage 2:** Front bumper: Front bumper - Stone chips - Smart repair

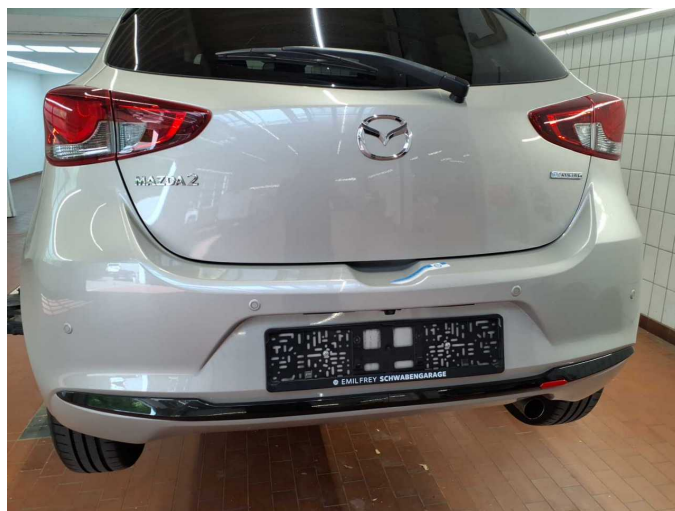
| No. | Component group | Description |
|---|---|---|
| 3 | Rear bumper | Rear bumper - Scratch(es) - Smart repair |

**Damage 3:** Rear bumper: Rear bumper - Scratch(es) - Smart repair

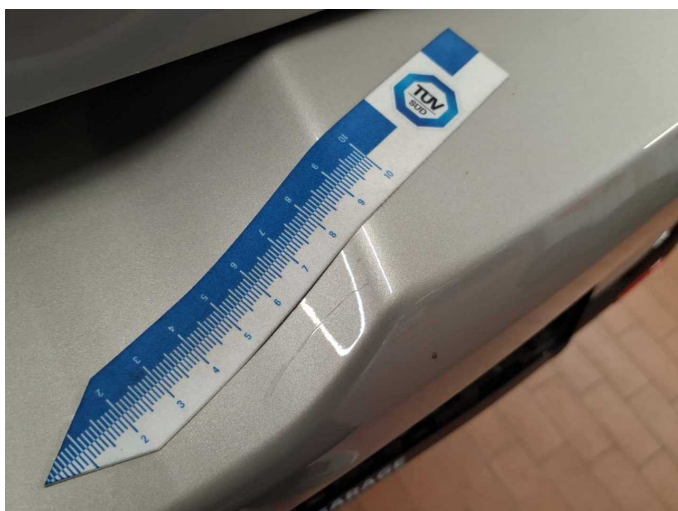
**Damage 3:** Rear bumper: Rear bumper - Scratch(es) - Smart repair

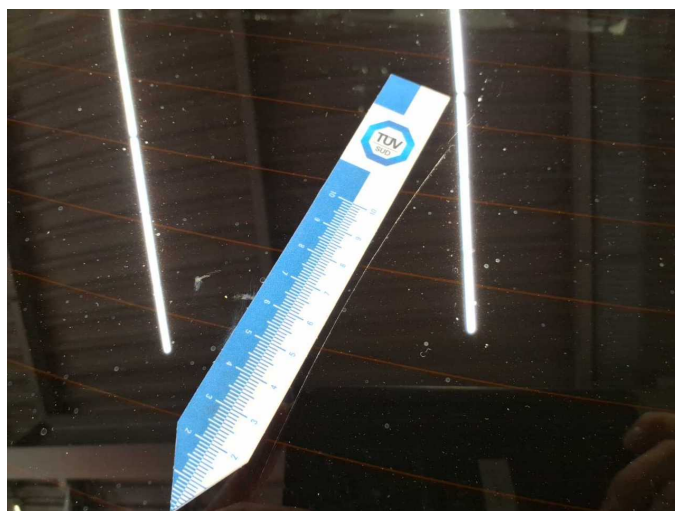
| No. | Component group | Description |
|---|---|---|
| 1 | Vehicle glazing | Rear window - Scratch(es) - No deduction |

**Wear and tear 1:** Vehicle glazing: Rear window - Scratch(es) - No deduction

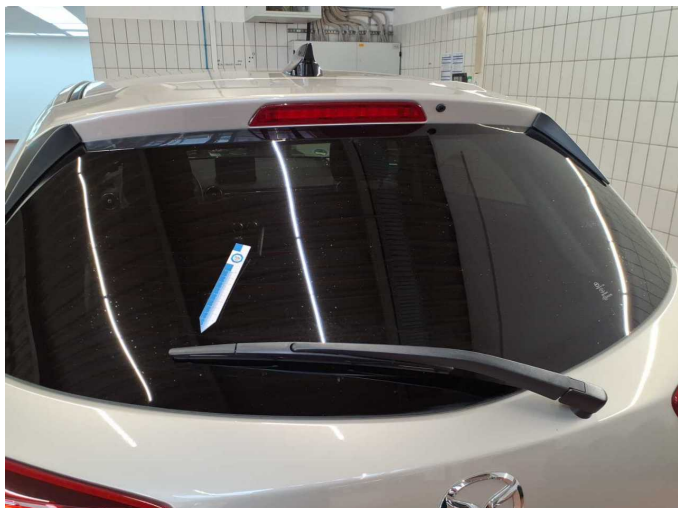
**Wear and tear 1:** Vehicle glazing: Rear window - Scratch(es) - No deduction

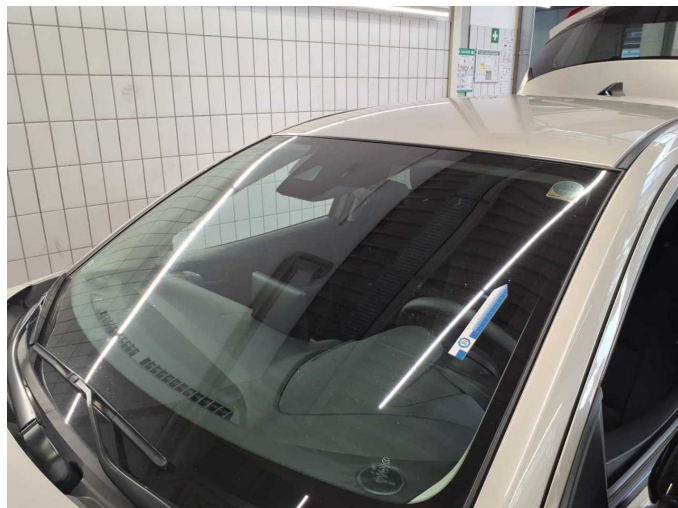
| No. | Component group | Description |
|---|---|---|
| 2 | Vehicle glazing | Windscreen - Stone chips - No deduction |

**Wear and tear 2:** Vehicle glazing: Windscreen - Stone chips - No deduction

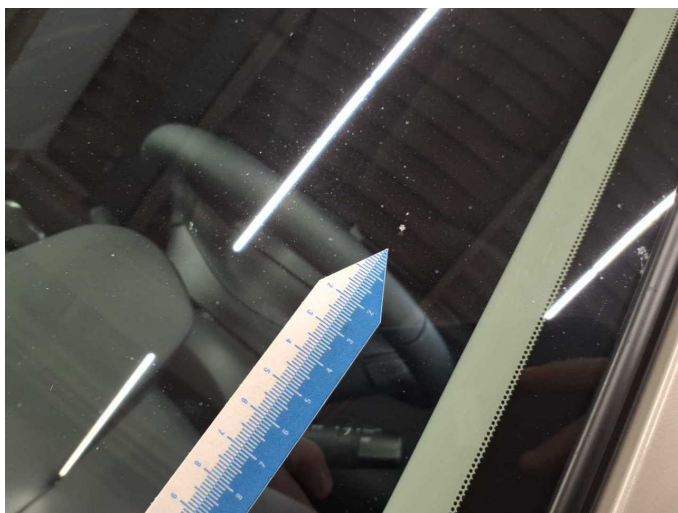
**Wear and tear 2:** Vehicle glazing: Windscreen - Stone chips - No deduction
