## Expertise

Protocol number: 45868148  
Order No. / Reference: 26260934  
Inspection date: 9 Jun 2026

Manufacturer: Mercedes-Benz

Model: 315 CDI Sprinter Standard HA

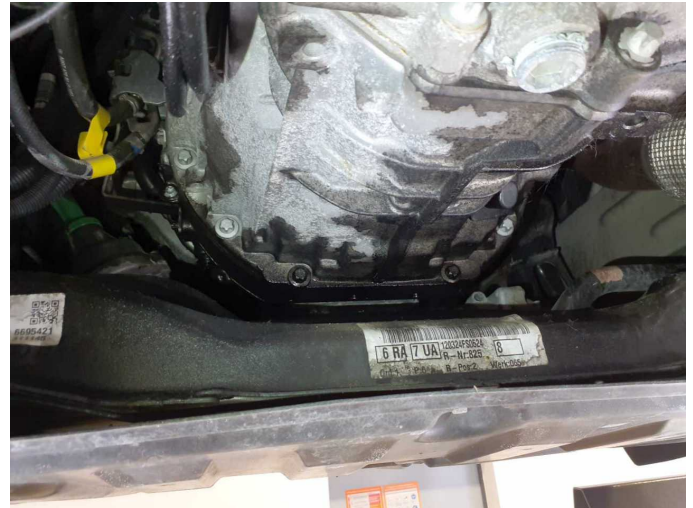
Damage 3: Gearbox: Gearbox - Leaking - Perform diagnosis

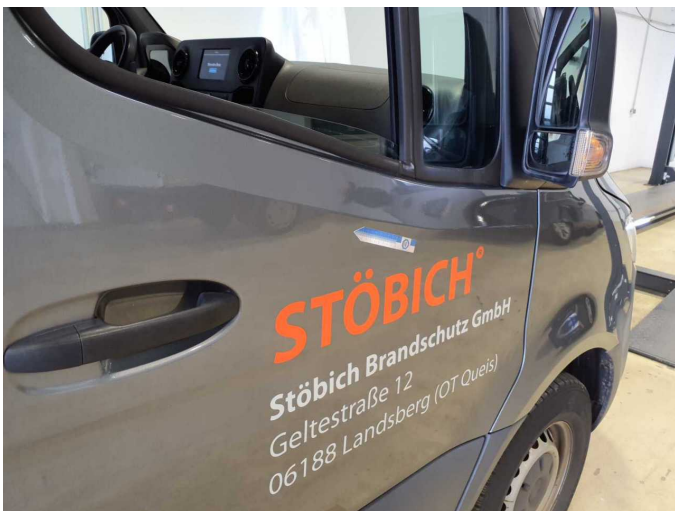
Damage 4: Door - front right side: Door - dent(s) - Smooth repair work

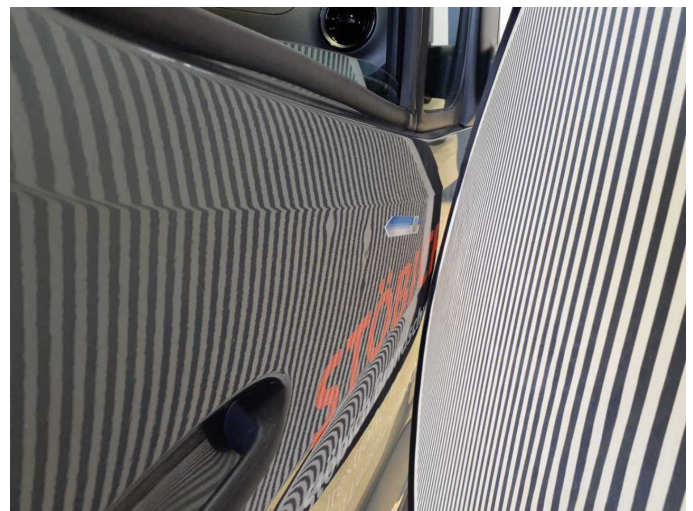
Damage 4: Door - front right side: Door - dent(s) - Smooth repair work

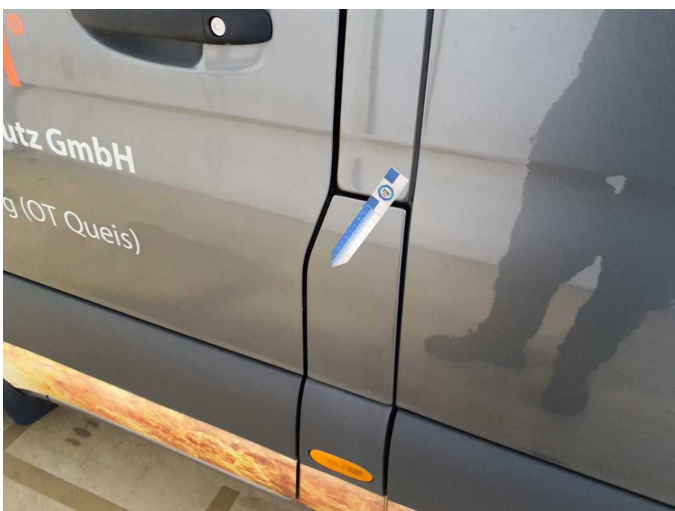
Damage 5: Fuel system: Tank flap - Scratch(es) - Smart repair

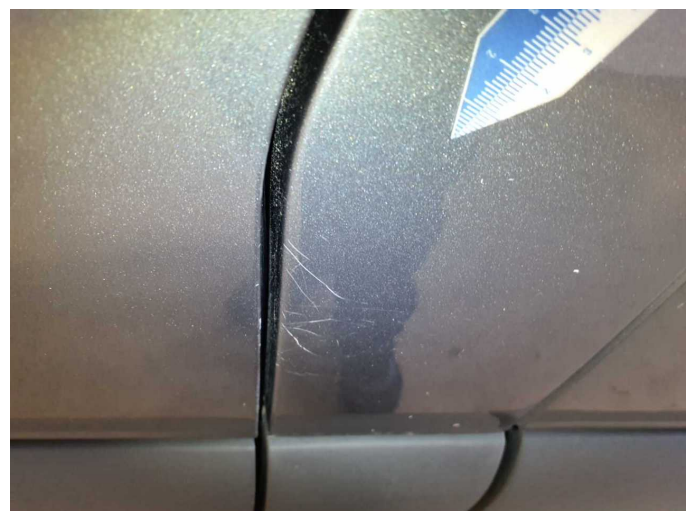
Damage 5: Fuel system: Tank flap - Scratch(es) - Smart repair

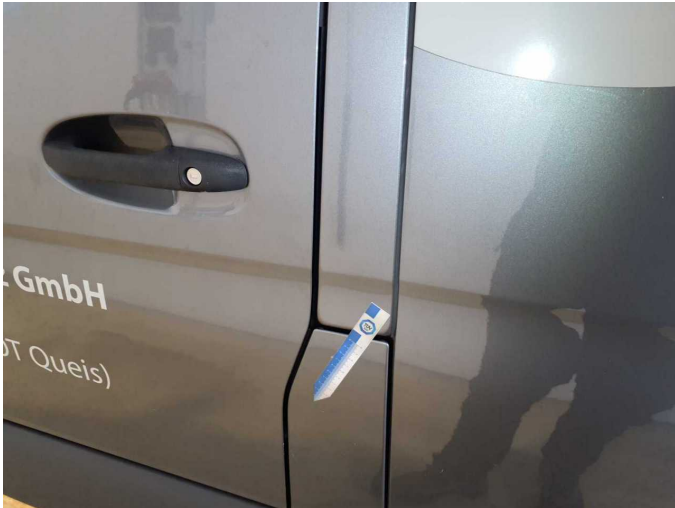
**Damage 6:** Body: B-pillar - left side - Scratch(es) - Smart repair

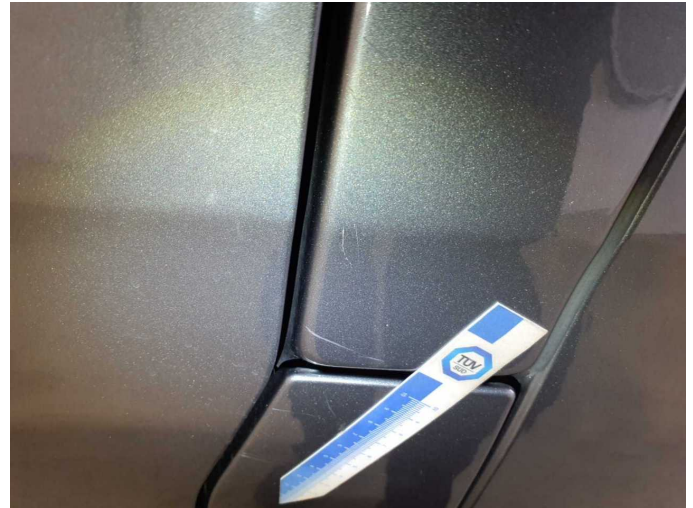
**Damage 6:** Body: B-pillar - left side - Scratch(es) - Smart repair

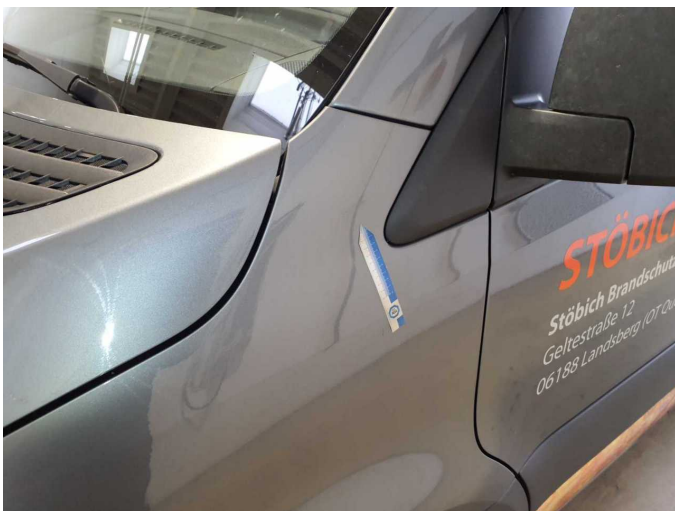
**Damage 7:** Mudguard - left side: Mudguard - left side - Scratch(es) - Smart repair

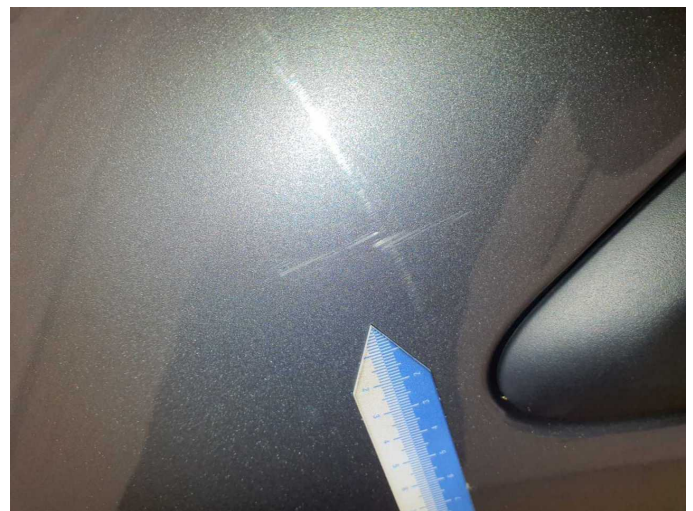
**Damage 7:** Mudguard - left side: Mudguard - left side - Scratch(es) - Smart repair

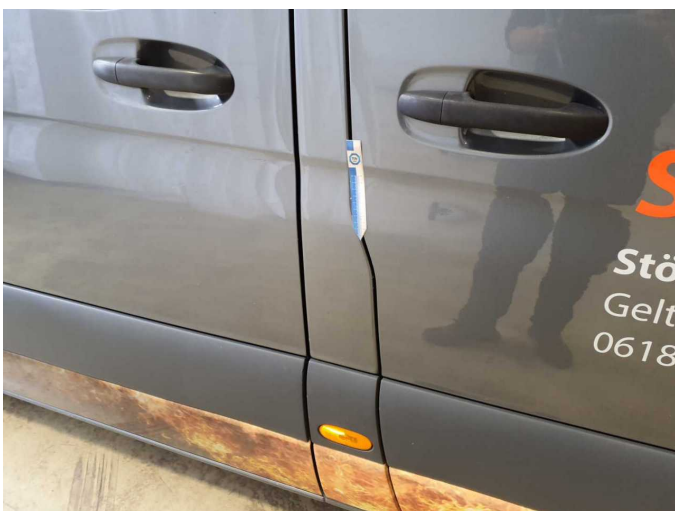
**Damage 8:** Body: B-pillar - right side - Scratch(es) - Smart repair

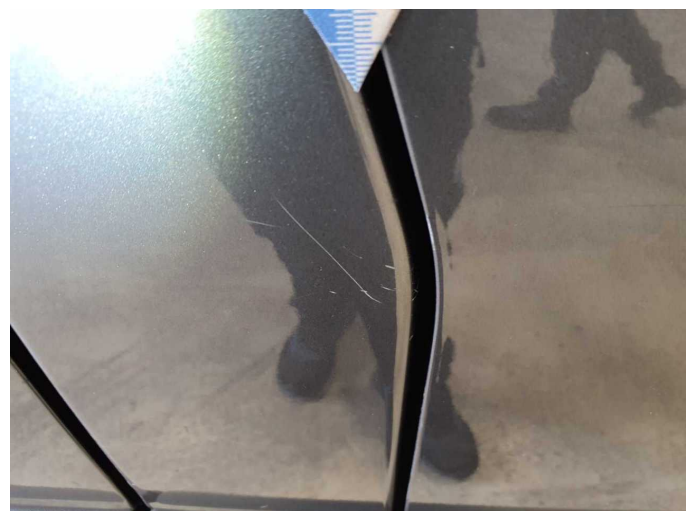
**Damage 8:** Body: B-pillar - right side - Scratch(es) - Smart repair

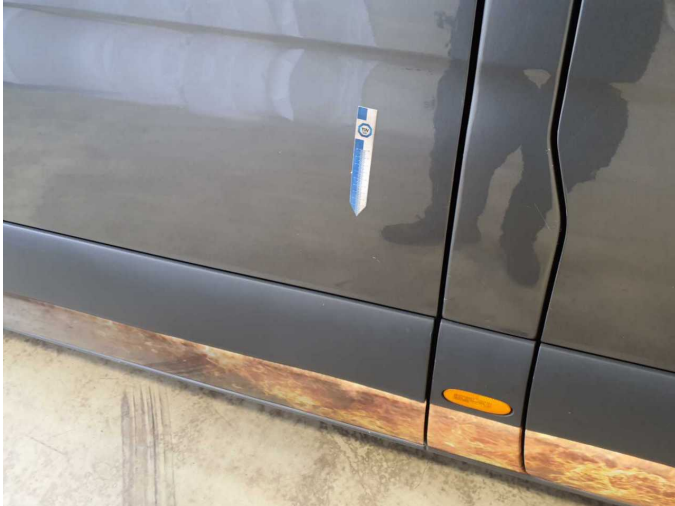
**Damage 9:** Sliding door, right: Sliding door - Scratch(es) - Smart repair

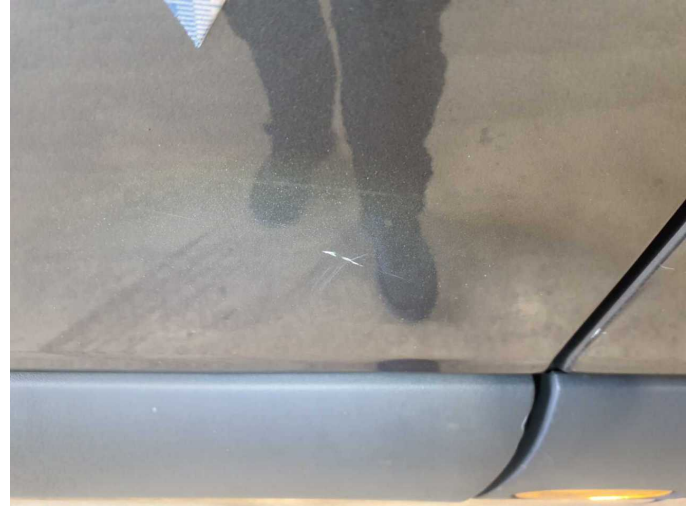
**Damage 9:** Sliding door, right: Sliding door - Scratch(es) - Smart repair

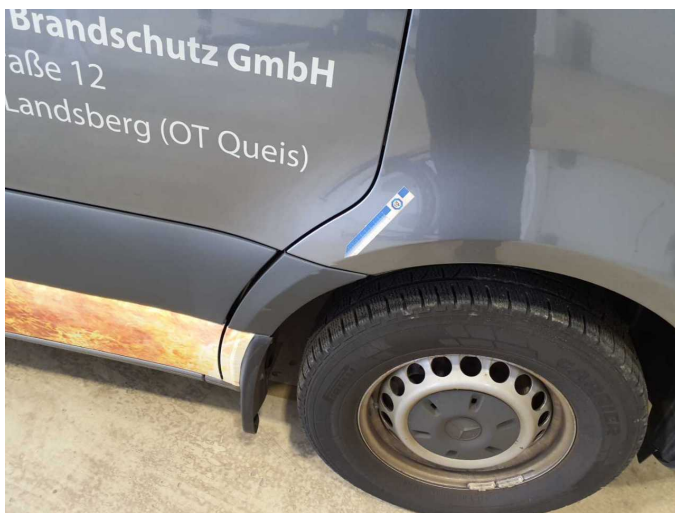
**Damage 10:** Mudguard - right side: Mudguard - right side - Scratch(es) - Smart repair

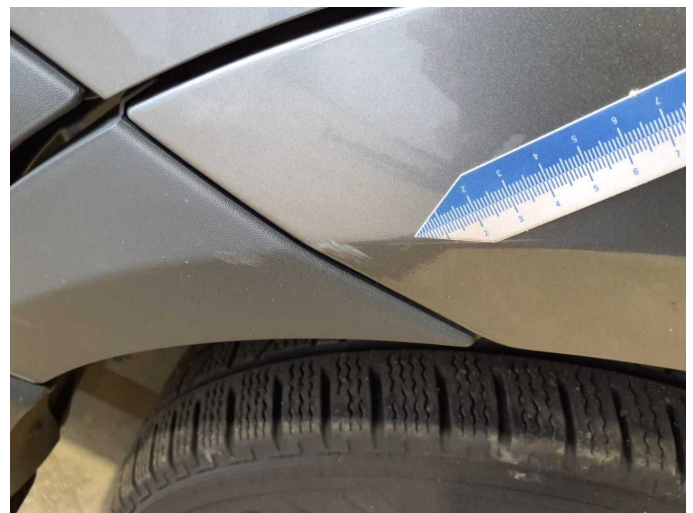
**Damage 10:** Mudguard - right side: Mudguard - right side - Scratch(es) - Smart repair

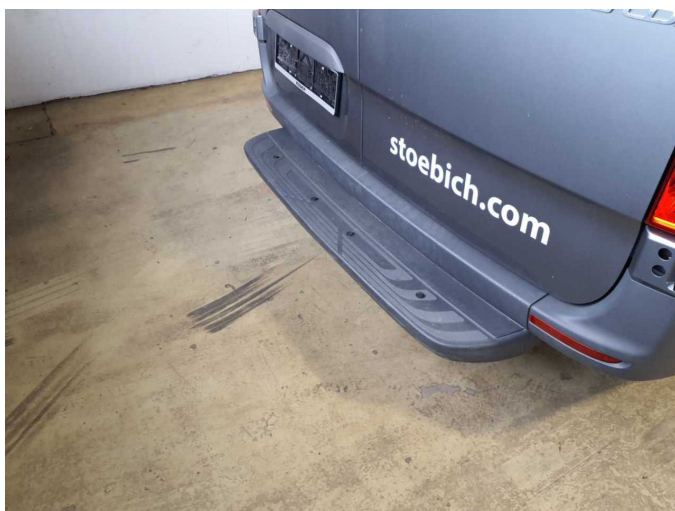
**Damage 11:** Rear of vehicle: Foot plate - Scratch(es) - Loss in value

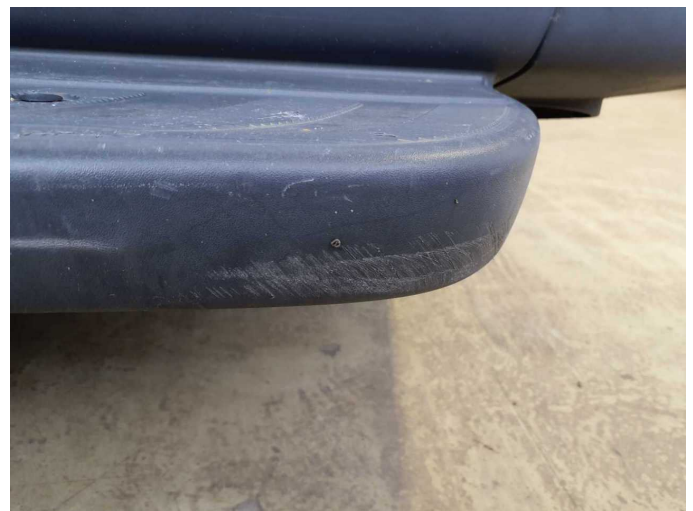
**Damage 11:** Rear of vehicle: Foot plate - Scratch(es) - Loss in value

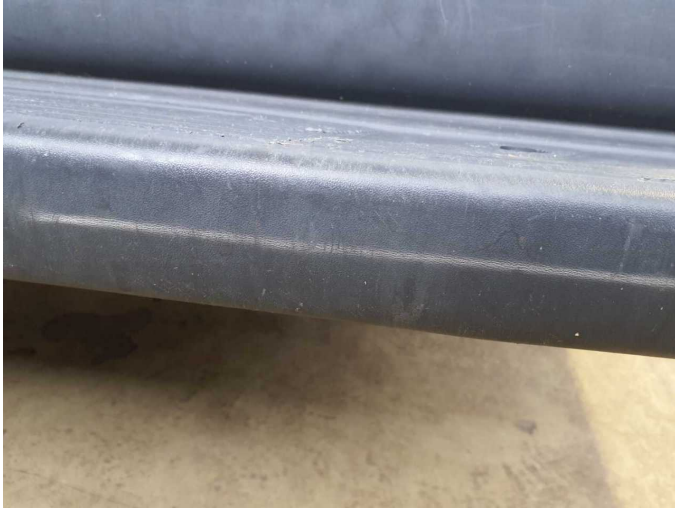
**Damage 11:** Rear of vehicle: Foot plate - Scratch(es) - Loss in value

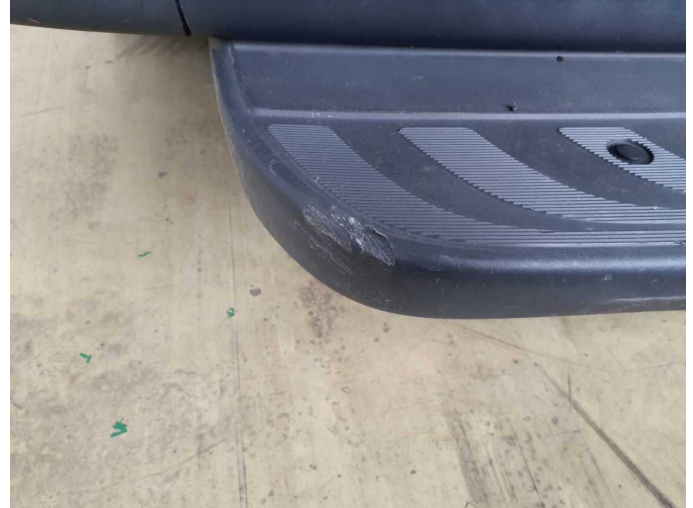
**Damage 11:** Rear of vehicle: Foot plate - Scratch(es) - Loss in value

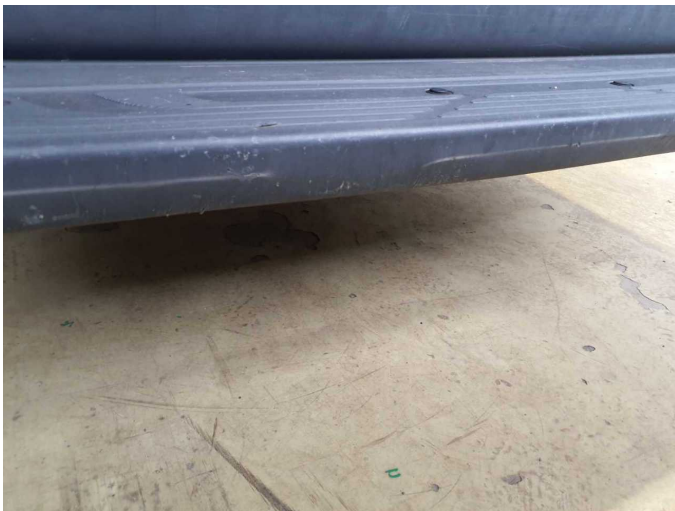
**Damage 11:** Rear of vehicle: Foot plate - Scratch(es) - Loss in value

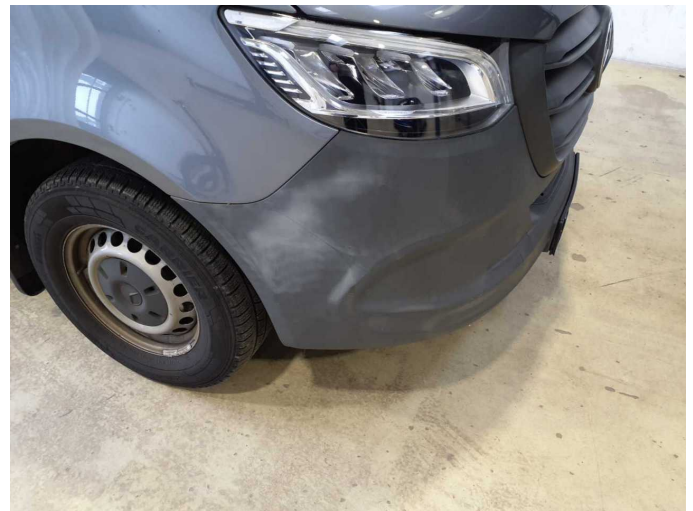
**Damage 12:** Front bumper: Front bumper - Worn - Loss in value

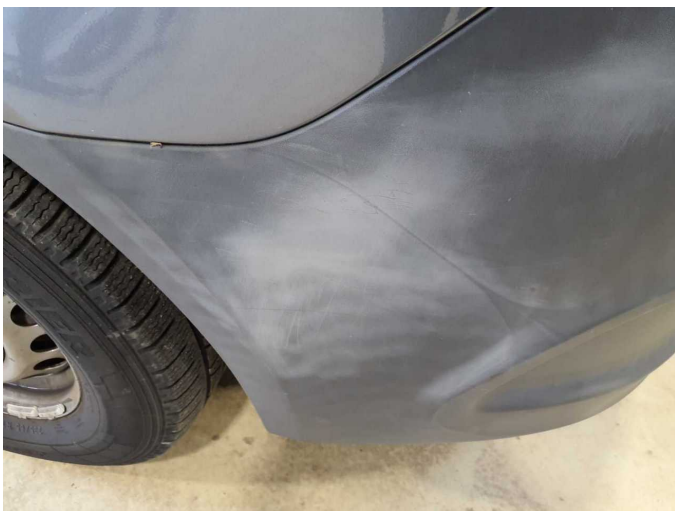
**Damage 12:** Front bumper: Front bumper - Worn - Loss in value

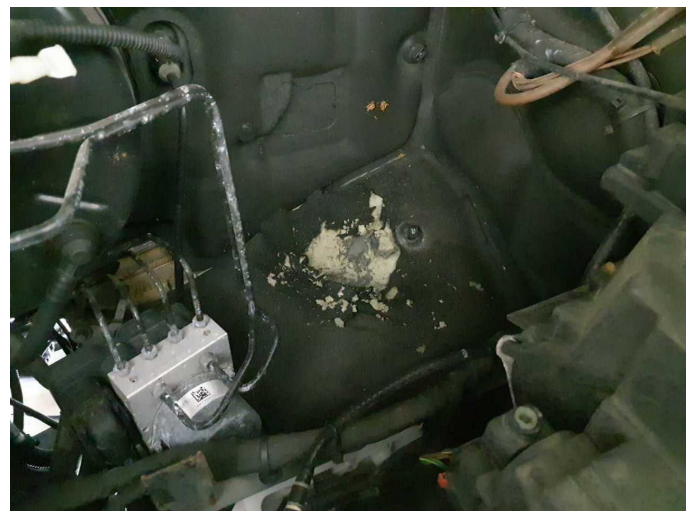
**Damage 13:** Cab: Insulation lining - Broken / torn - Replace

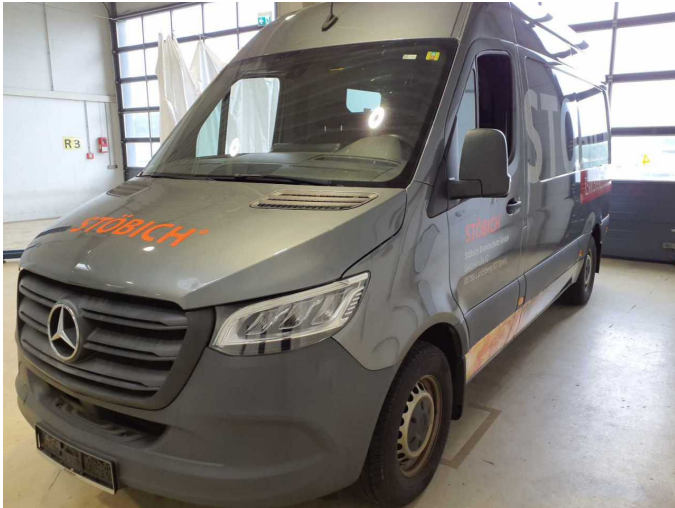
**Damage 14:** Body: Body - Glued / labelled - De-glue / neutralise

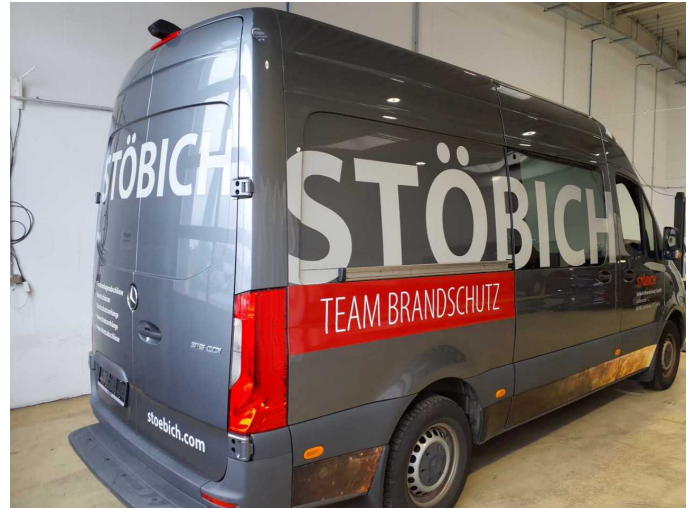
**Damage 14:** Body: Body - Glued / labelled - De-glue / neutralise

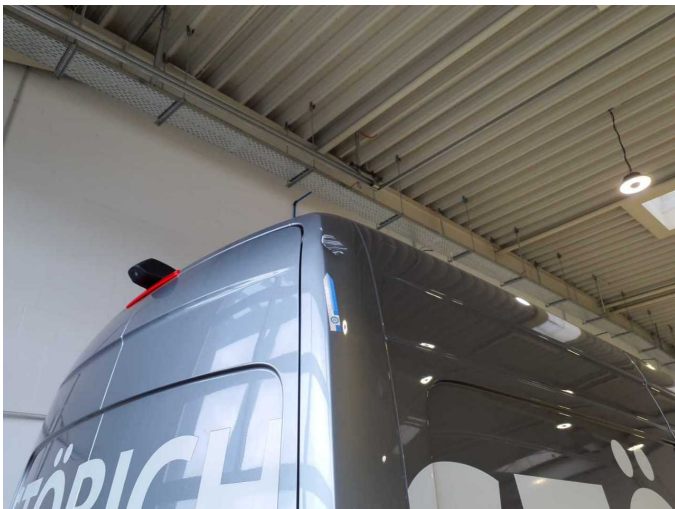
**Damage 15:** Body: C-pillar - right side - Dent / paintcoat damage - Repair and paint

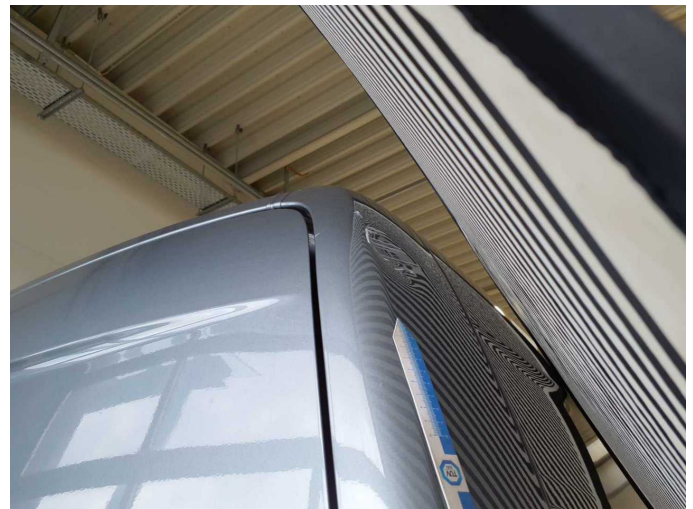
**Damage 15:** Body: C-pillar - right side - Dent / paintcoat damage - Repair and paint

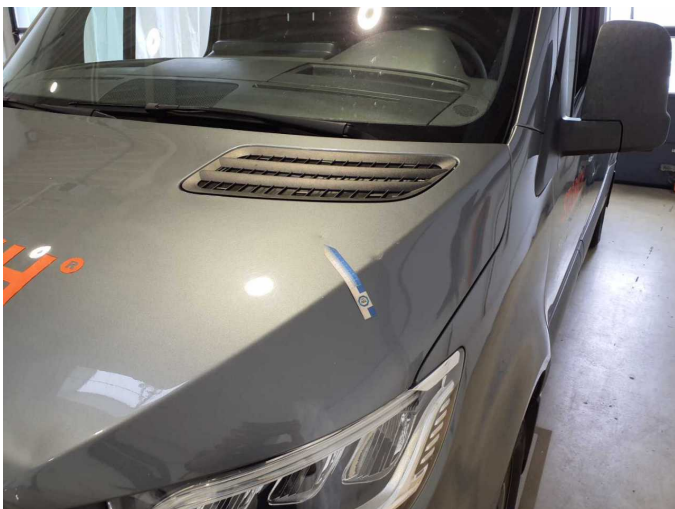
16	Bonnet	Bonnet - Dent / paintcoat damage - Repair and paint
17	Vehicle glazing	Windscreen - Stone chips - repair according to calculation
18	Boot lid / rear door	Rear door - left side - Broken / torn - repair according to calculation

**Damage 16:** Bonnet: Bonnet - Dent / paintcoat damage - Repair and paint

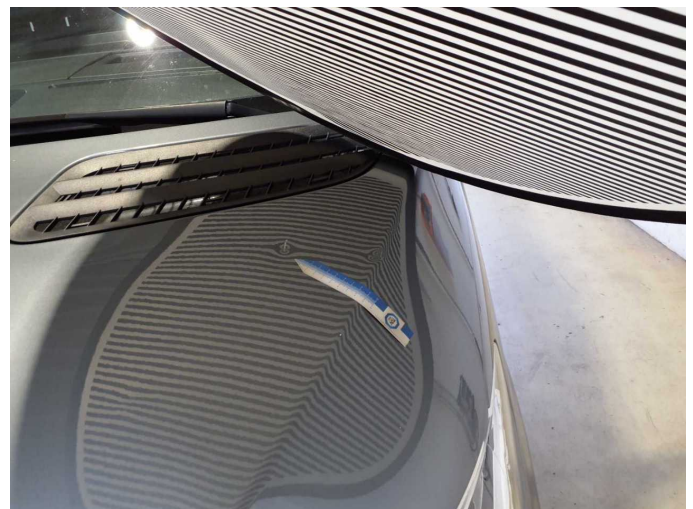
**Damage 16:** Bonnet: Bonnet - Dent / paintcoat damage - Repair and paint

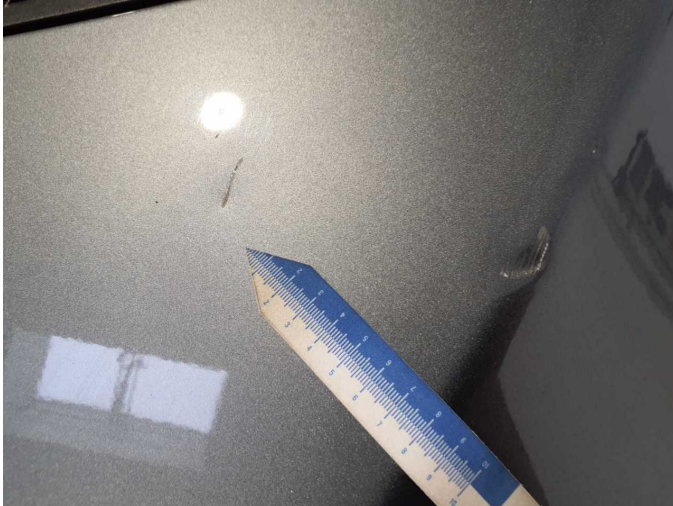
**Damage 16:** Bonnet: Bonnet - Dent / paintcoat damage - Repair and paint

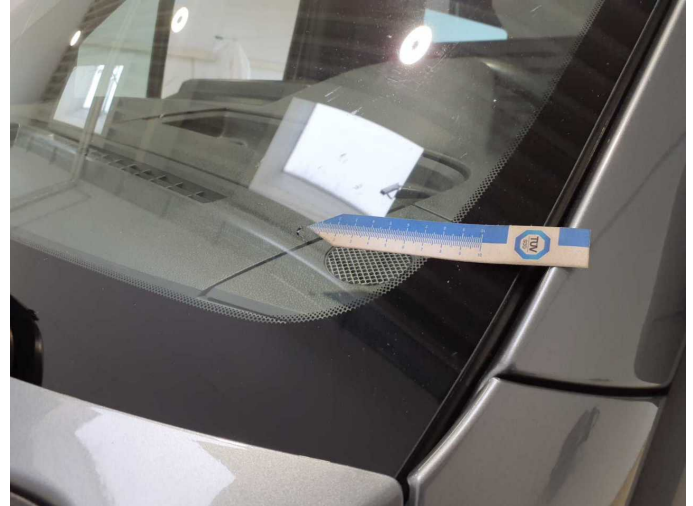
**Damage 17:** Vehicle glazing: Windscreen - Stone chips - repair according to calculation

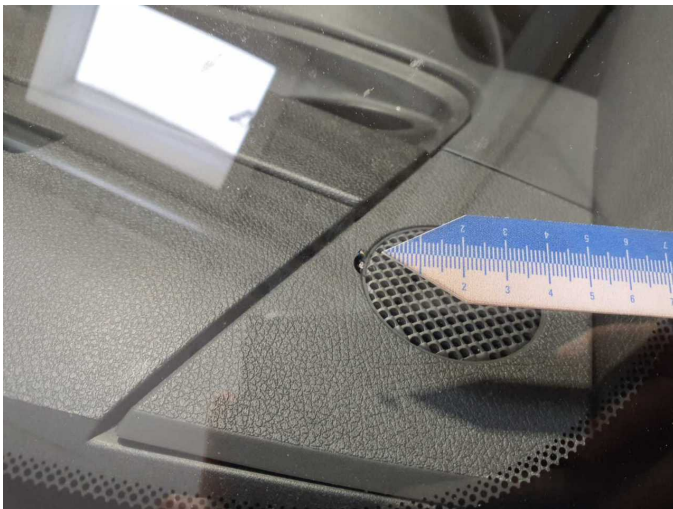
**Damage 17:** Vehicle glazing: Windscreen - Stone chips - repair according to calculation

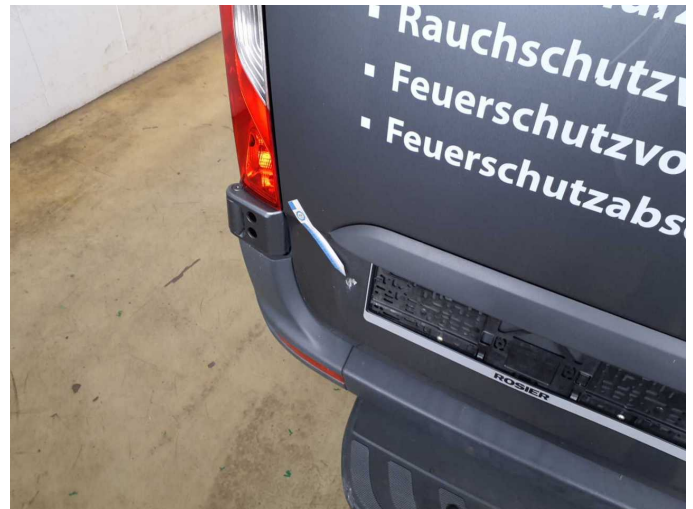
**Damage 18:** Boot lid / rear door: Rear door - left side - Broken / torn - repair according to calculation

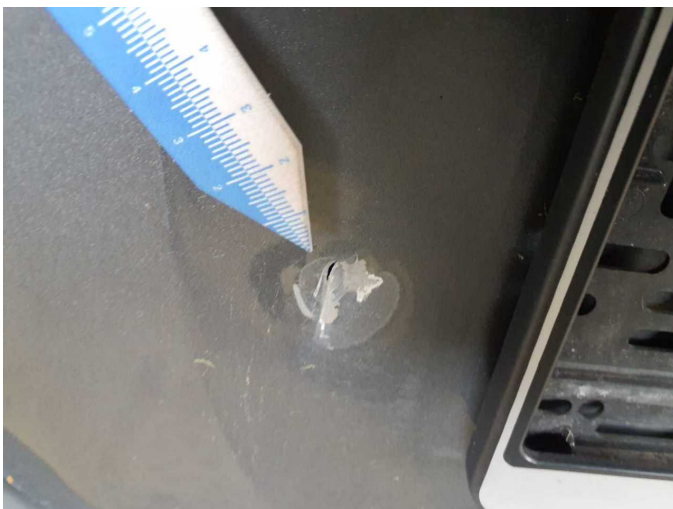
**Damage 18:** Boot lid / rear door: Rear door - left side - Broken / torn - repair according to calculation

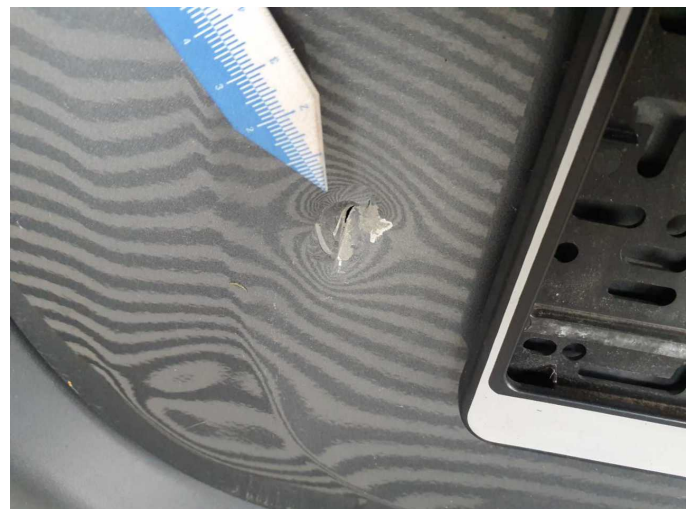
**Damage 18:** Boot lid / rear door: Rear door - left side - Broken / torn - repair according to calculation
