## Expertise

Protocol number: 46237484  
Order No. / Reference: 26529837  
Inspection date: 29 Jun 2026

Model: Tiguan Allspace 2.0 TDI SCR DSG Life

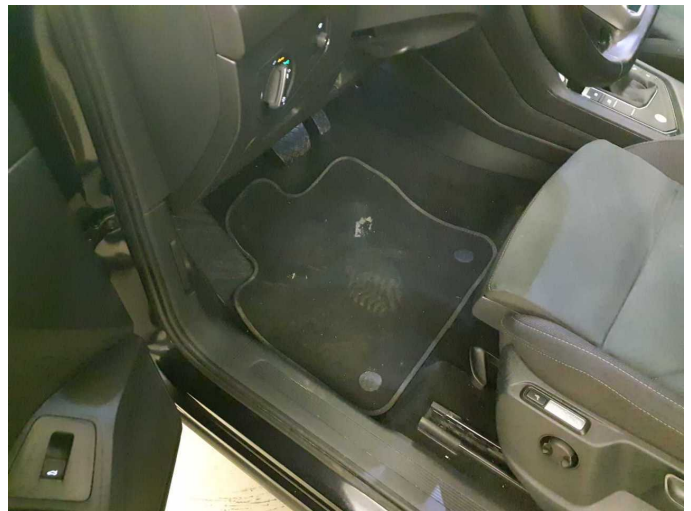
Damage 1: Trim / covers: Floor mats - Holes - Replace

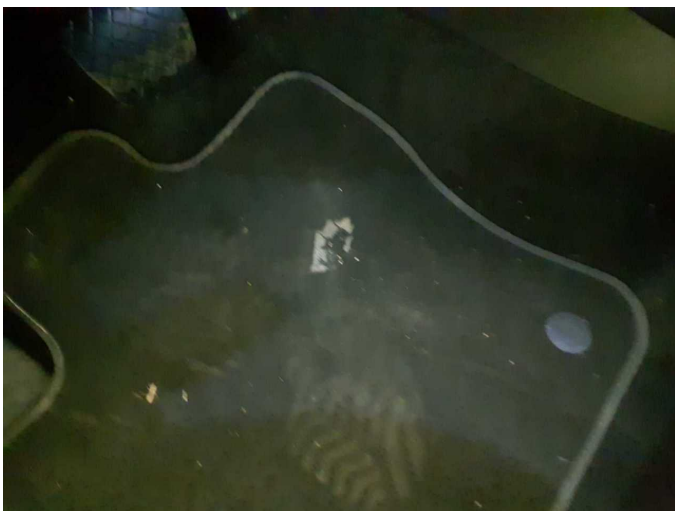
Damage 1: Trim / covers: Floor mats - Holes - Replace

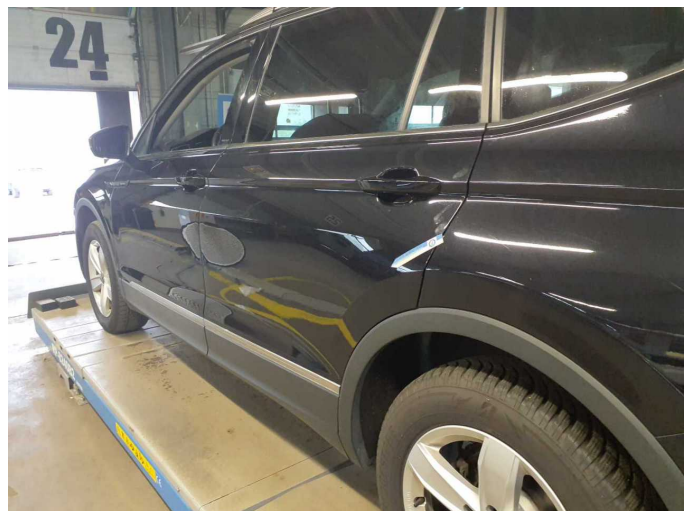
Damage 2: Door - rear left side: Door - dent(s) - Smooth repair work

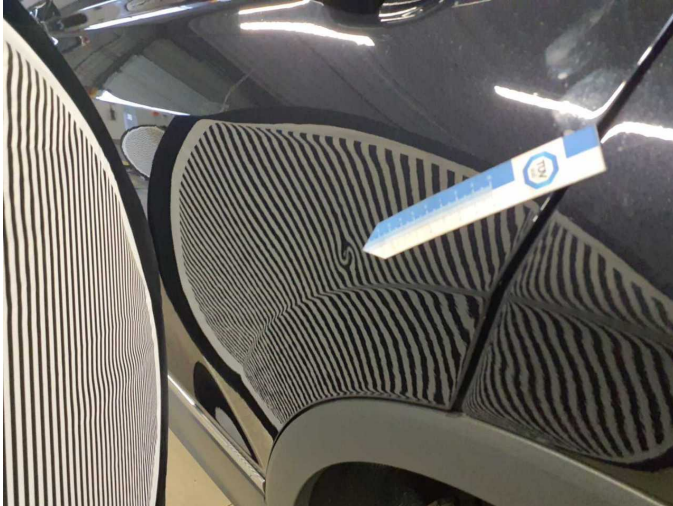
**Damage 2:** Door - rear left side: Door - dent(s) - Smooth repair work

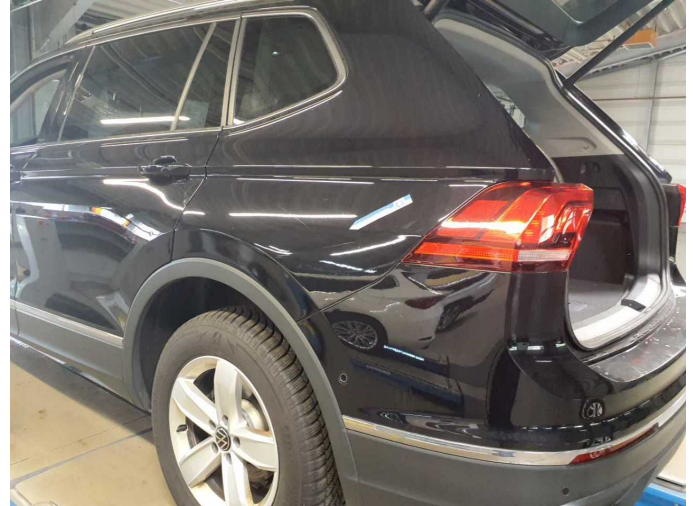
**Damage 3:** Side panel - rear left side: Side panel - Dent / paintcoat damage - Repair and paint

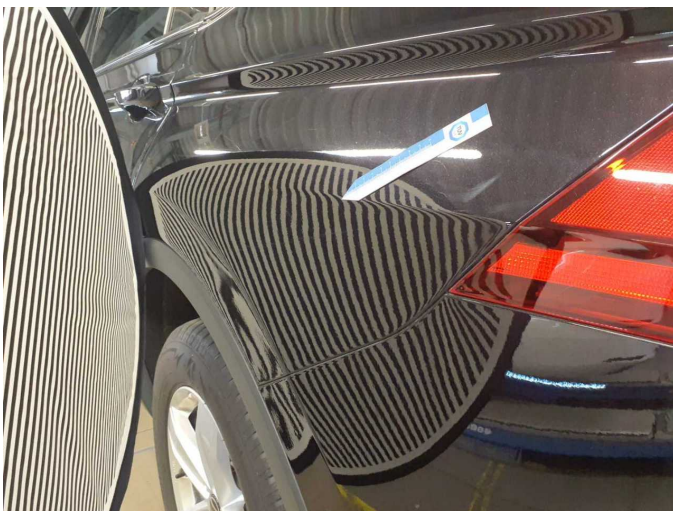
**Damage 3:** Side panel - rear left side: Side panel - Dent / paintcoat damage - Repair and paint

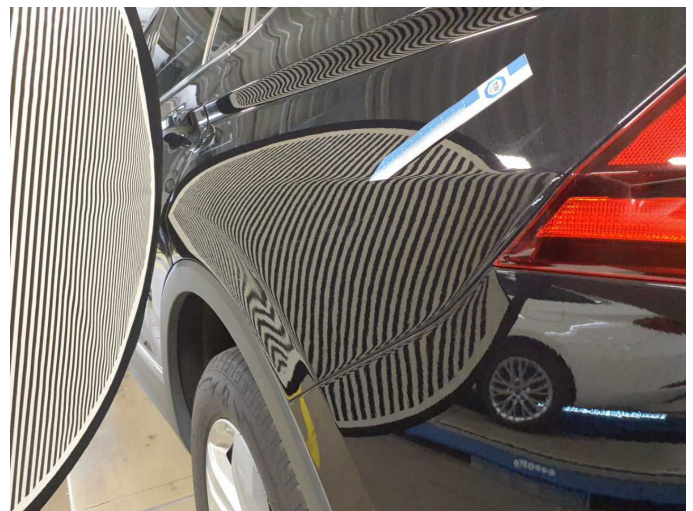
**Damage 3:** Side panel - rear left side: Side panel - Dent / paintcoat damage - Repair and paint

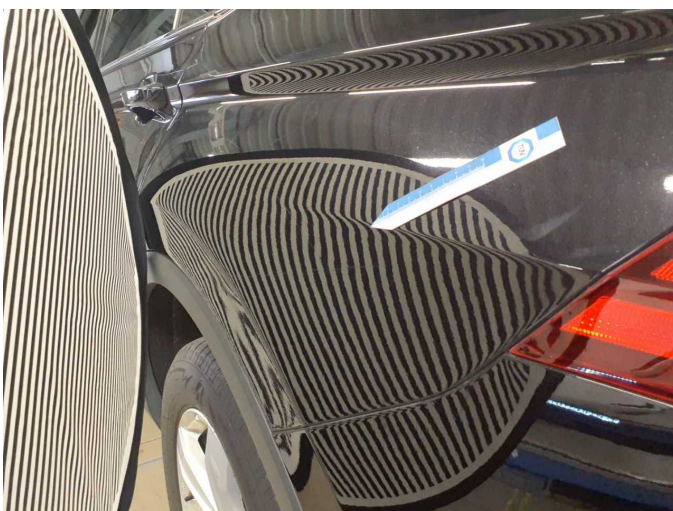
**Damage 3:** Side panel - rear left side: Side panel - Dent / paintcoat damage - Repair and paint

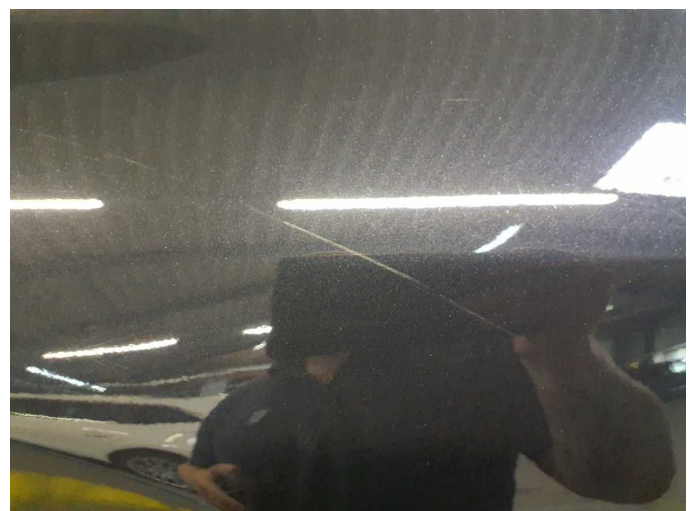
**Damage 3:** Side panel - rear left side: Side panel - Dent / paintcoat damage - Repair and paint

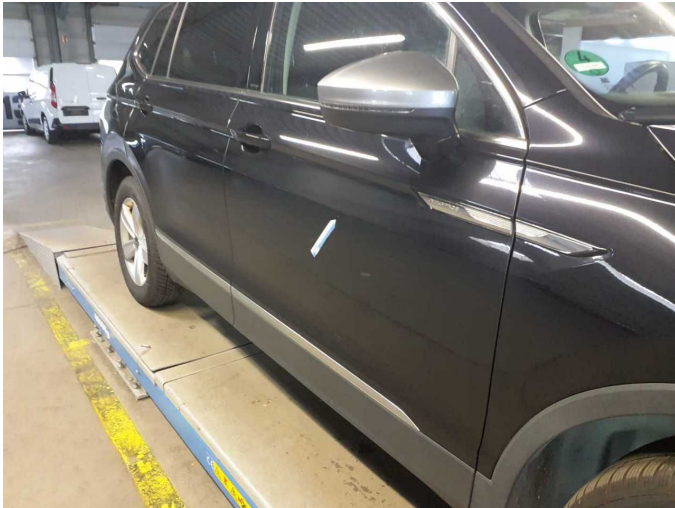
**Damage 4:** Door - front right side: Door - Scratched - Paint

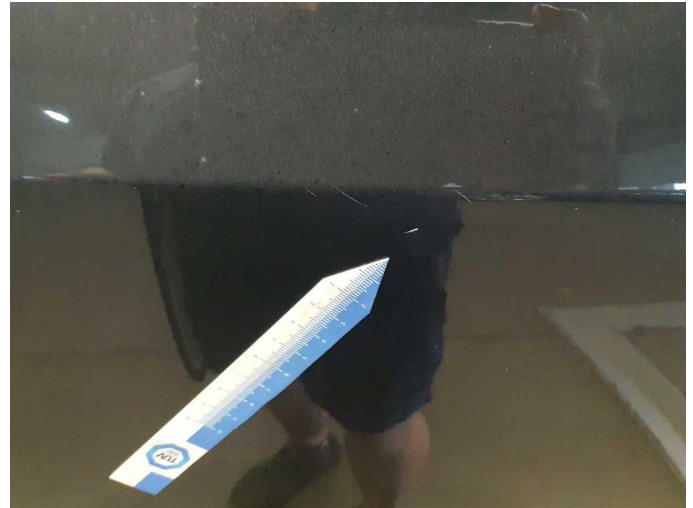
**Damage 4:** Door - front right side: Door - Scratched - Paint

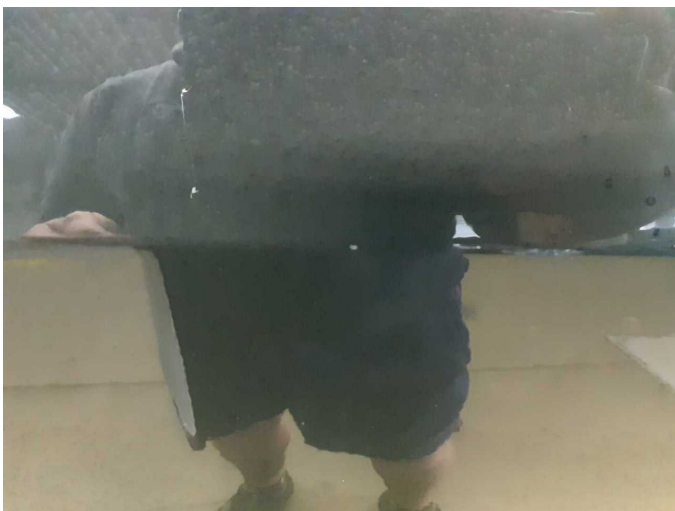
**Damage 4:** Door - front right side: Door - Scratched - Paint

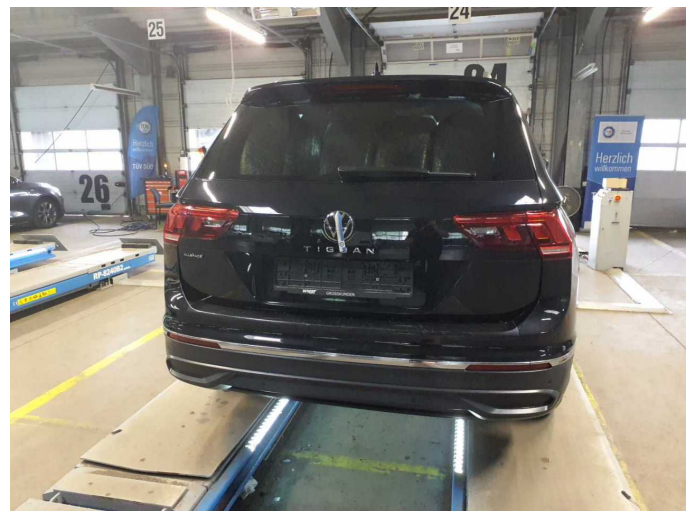
**Damage 5:** Boot lid / rear door: Boot lid - Deformed - Repair and paint

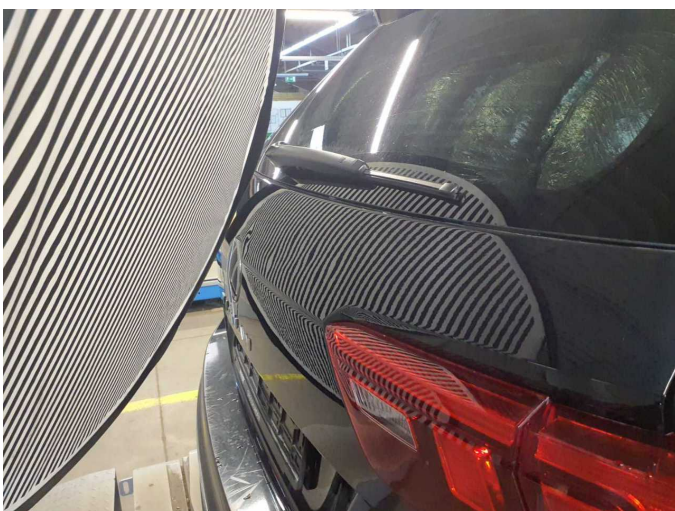
**Damage 5:** Boot lid / rear door: Boot lid - Deformed - Repair and paint

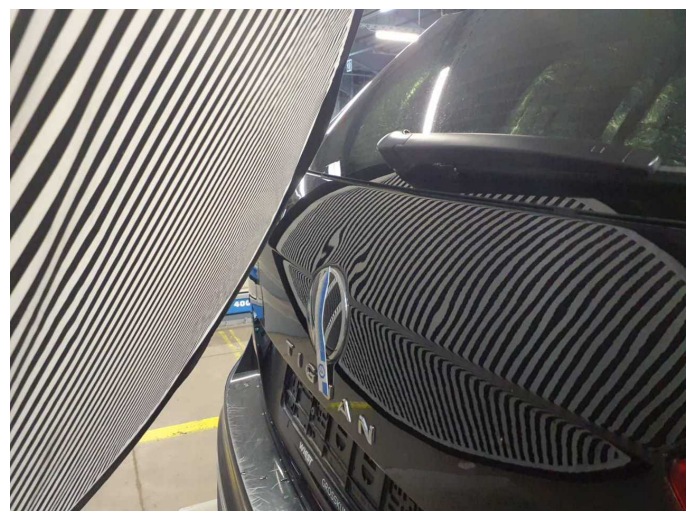
**Damage 5:** Boot lid / rear door: Boot lid - Deformed - Repair and paint

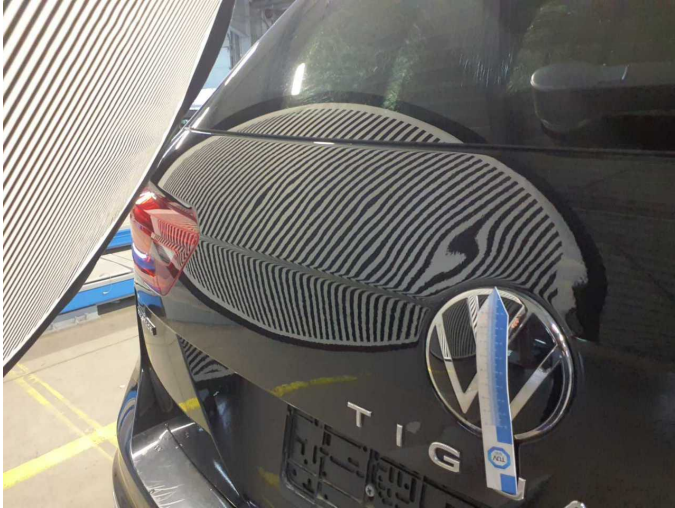
**Damage 5:** Boot lid / rear door: Boot lid - Deformed - Repair and paint

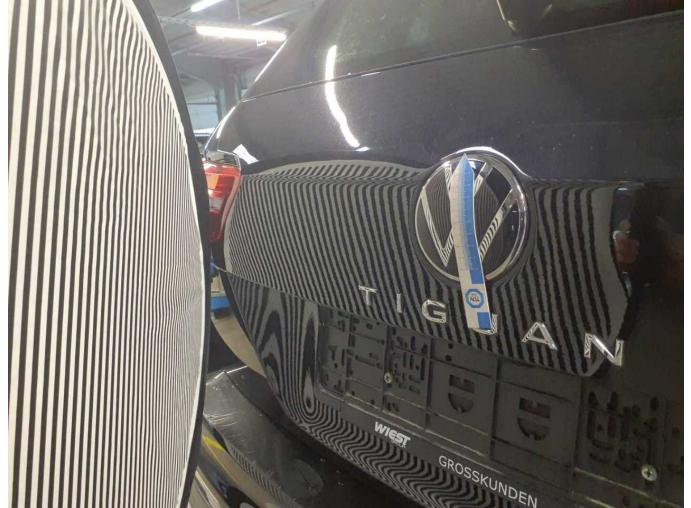
**Damage 5:** Boot lid / rear door: Boot lid - Deformed - Repair and paint

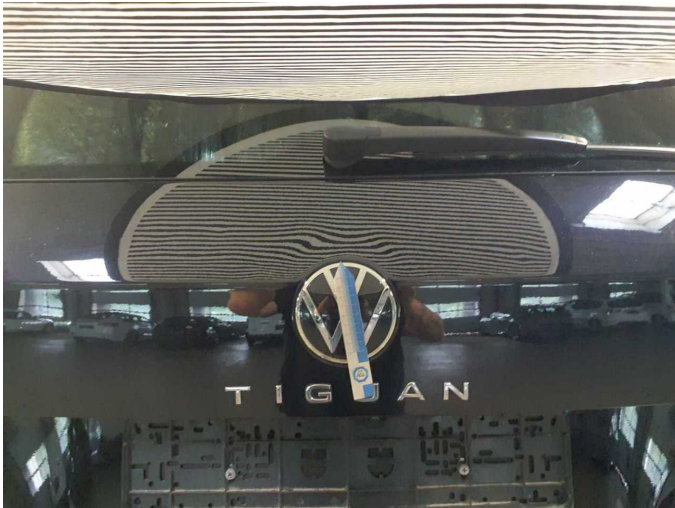
**Damage 5:** Boot lid / rear door: Boot lid - Deformed - Repair and paint

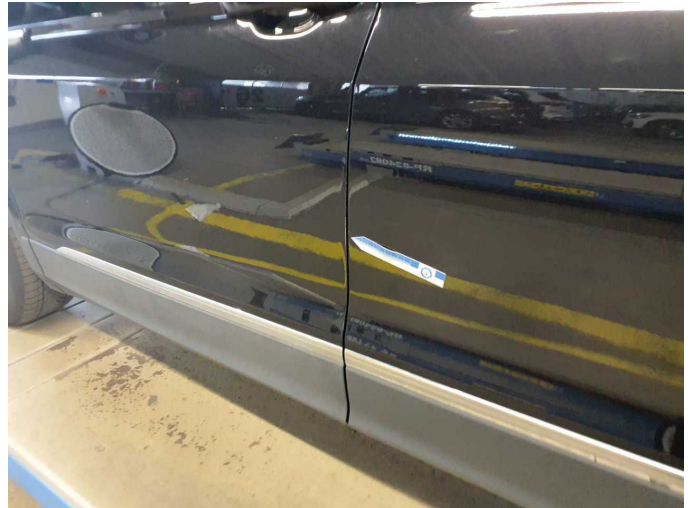
**Damage 6:** Door - front left side: Door - Dent / paintcoat damage - Repair and paint

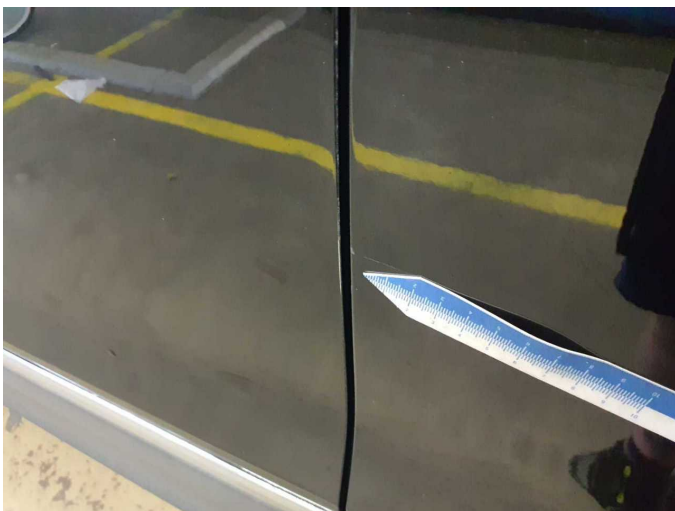
**Damage 6:** Door - front left side: Door - Dent / paintcoat damage - Repair and paint

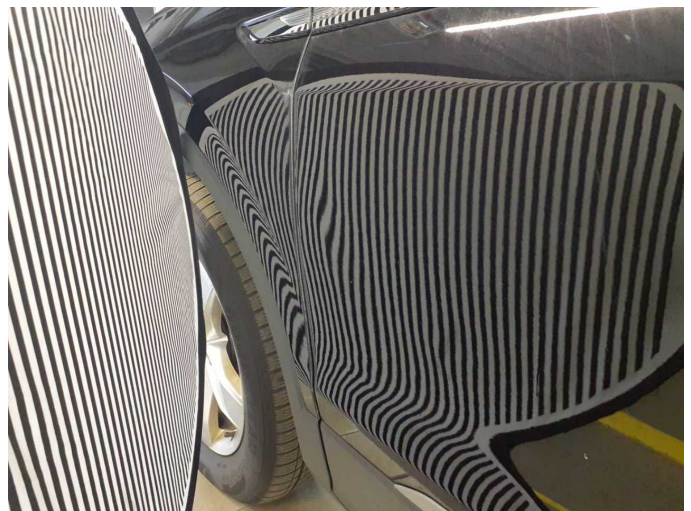
**Damage 6:** Door - front left side: Door - Dent / paintcoat damage - Repair and paint

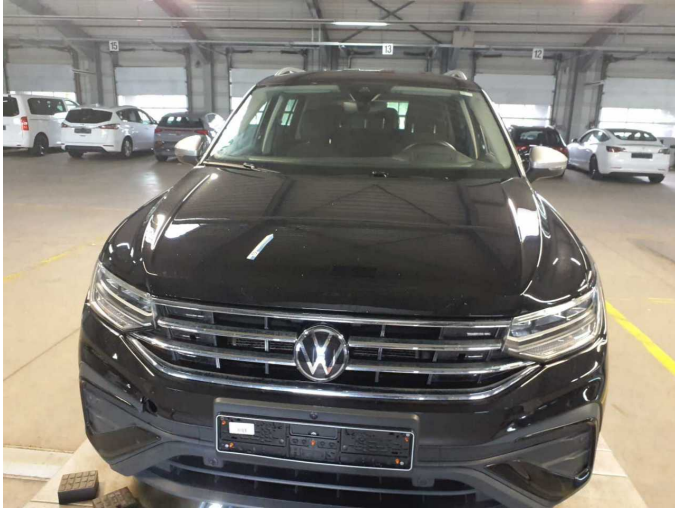
**Damage 7:** Bonnet: Bonnet - Stone chips - Paint

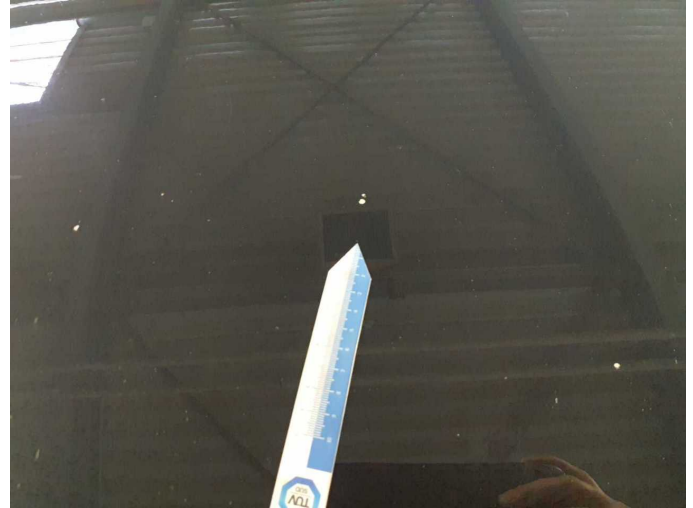
**Damage 7:** Bonnet: Bonnet - Stone chips - Paint

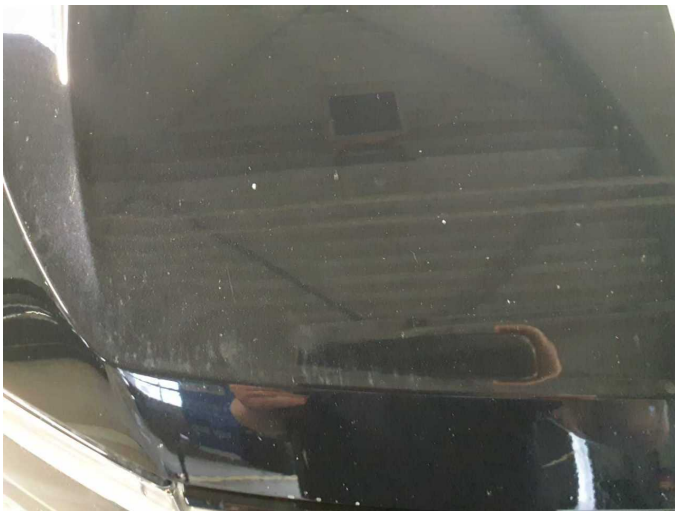
**Damage 7:** Bonnet: Bonnet - Stone chips - Paint

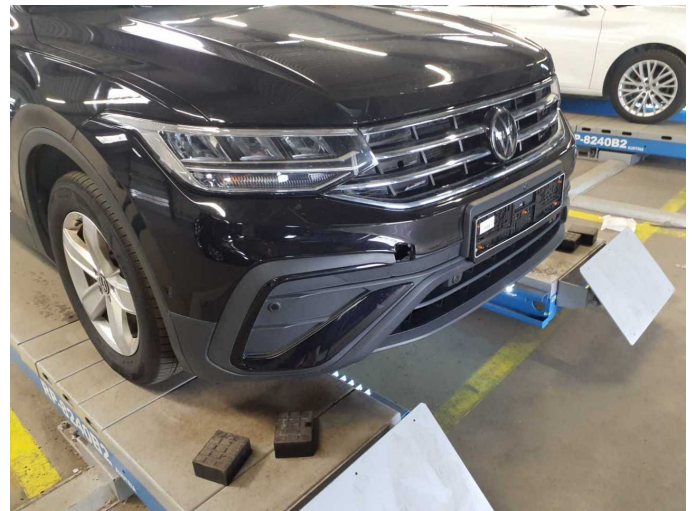
**Missing part 1:** Equipment: Towing eye (Abdeckung) - Missing - Replace

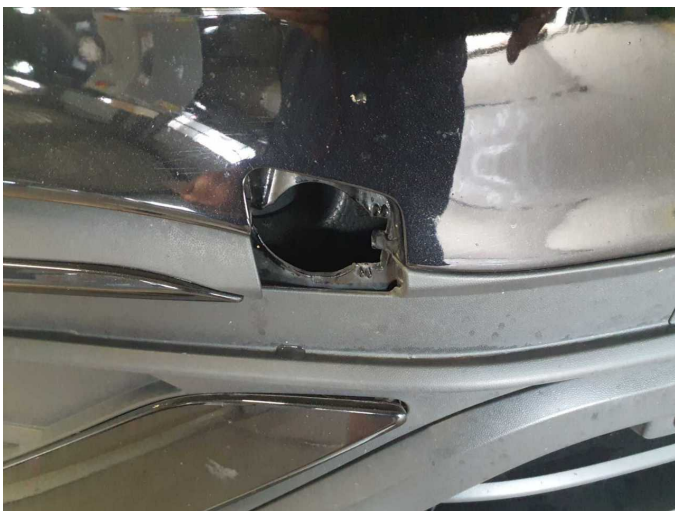
**Missing part 1:** Equipment: Towing eye (Abdeckung) - Missing - Replace

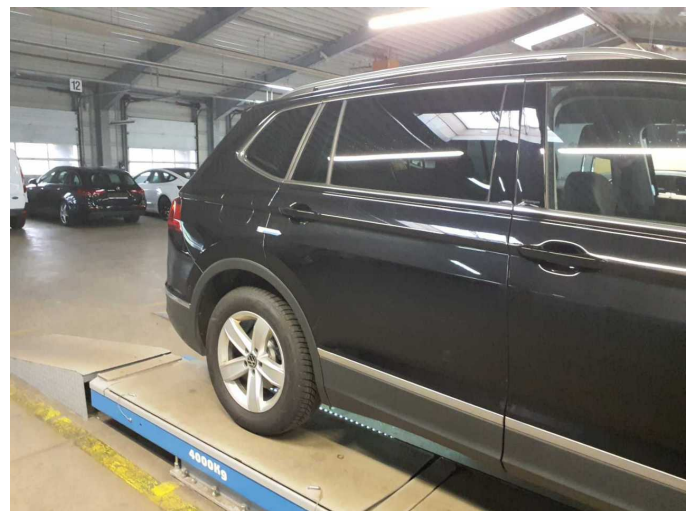
**Accident 1:** Side right

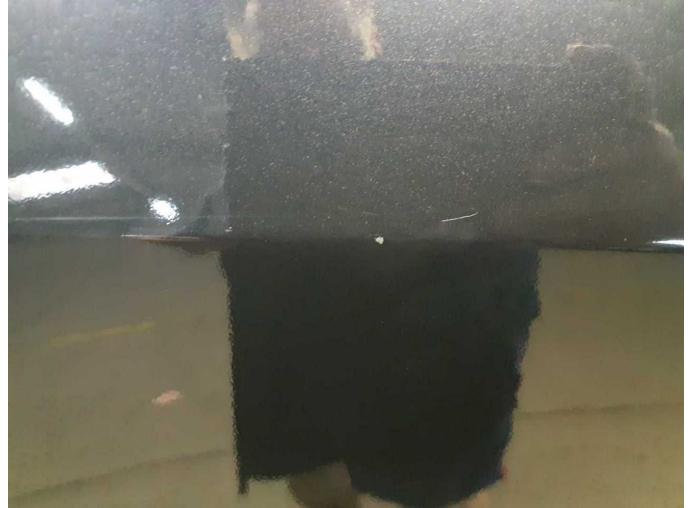
Accident 1: Side right

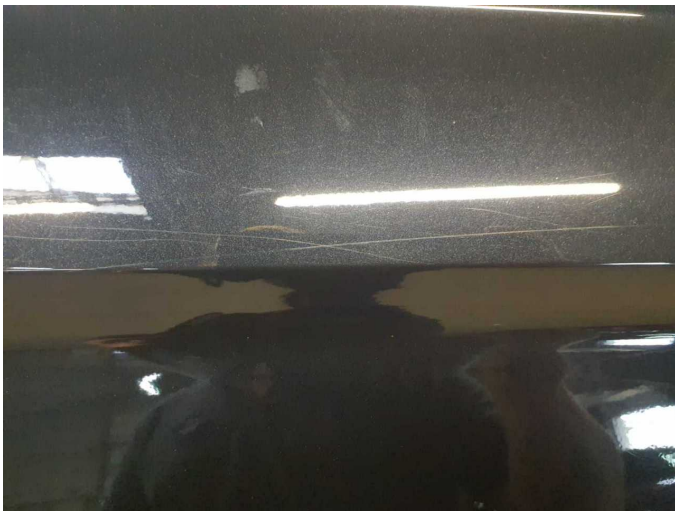
Accident 1: Side right

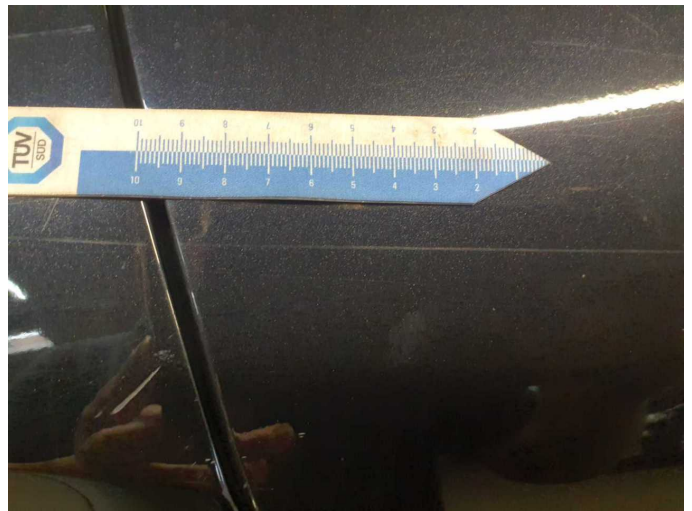
Accident 1: Side right

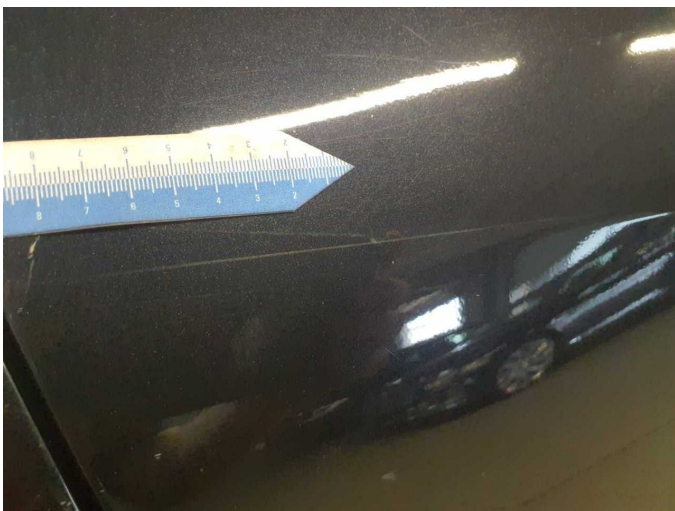
Accident 1: Side right

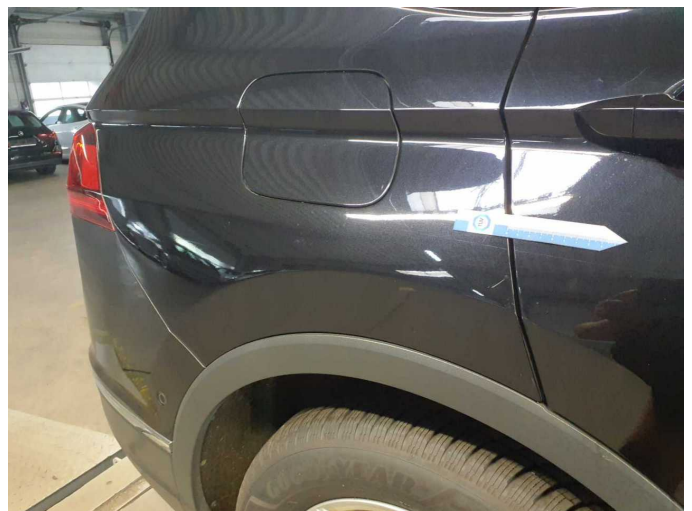
Accident 1: Side right

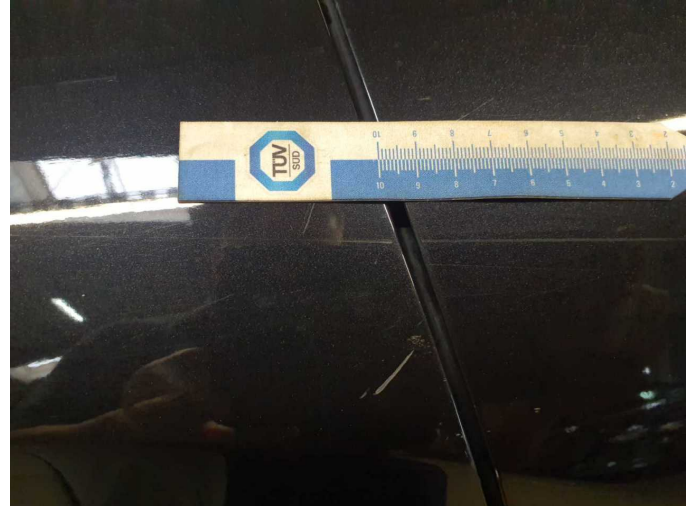
**Accident 1: Side right**

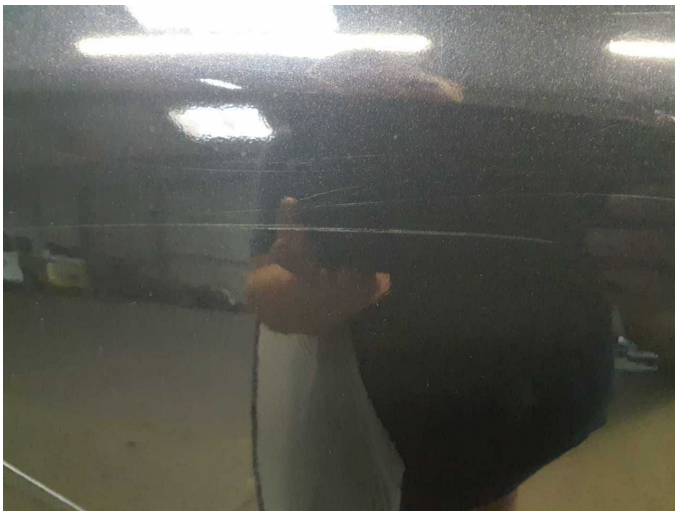
**Accident 1: Side right**

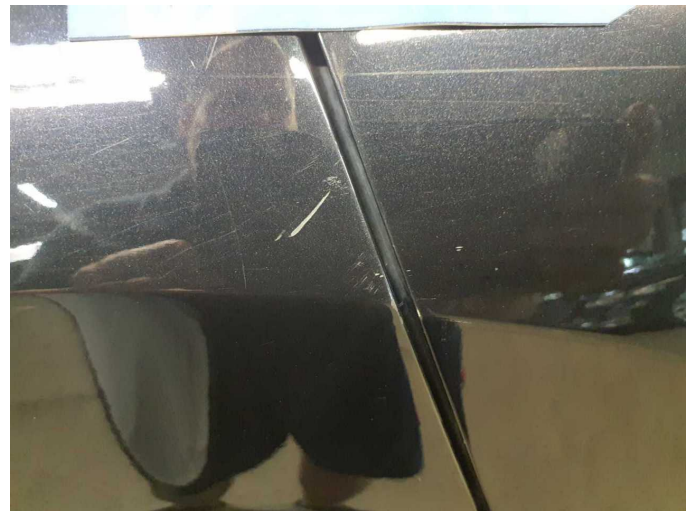
**Accident 1: Side right**

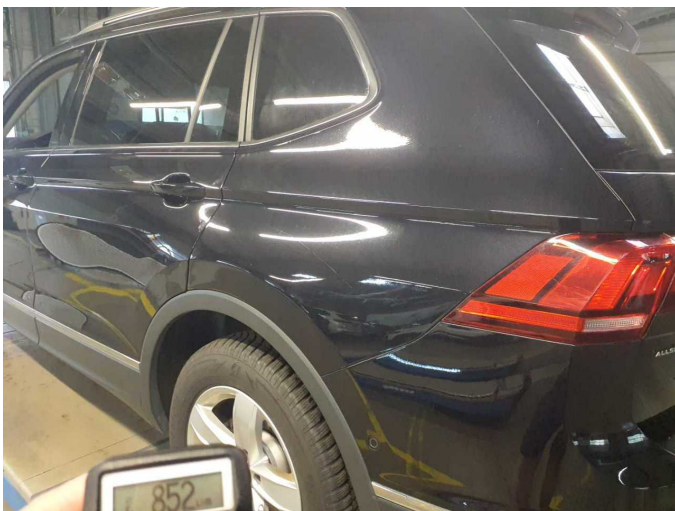
Side panel - rear left side	852 µm	Side panel - rear right side	1,080 µm
Door - rear left side	269 µm	Door - front left side	419 µm

**Repainting 1: Side panel - rear left side**

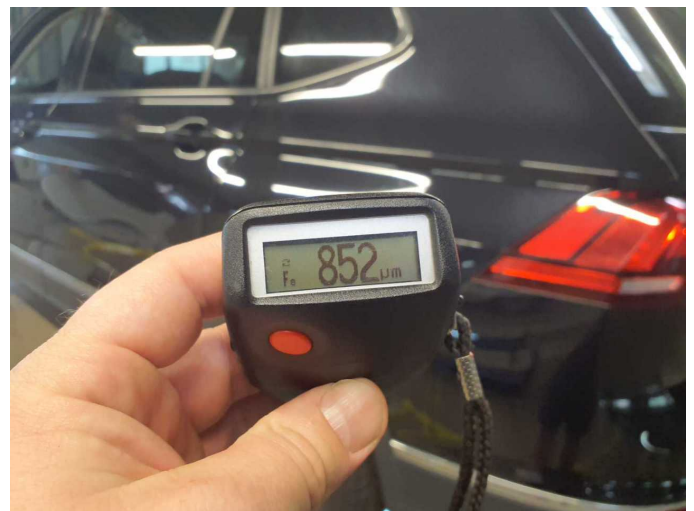
**Repainting 1: Side panel - rear left side**

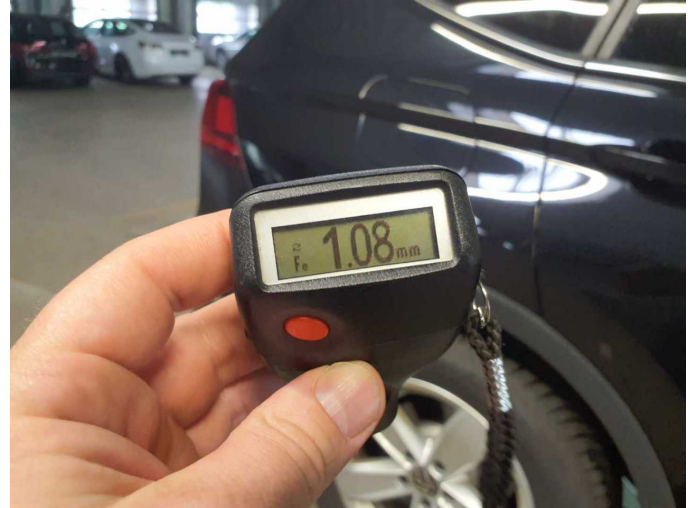
**Repainting 2:** Side panel - rear right side

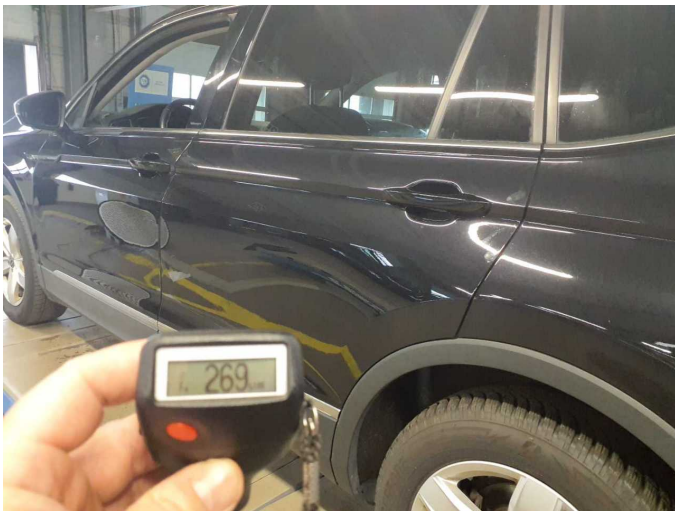
**Repainting 3:** Door - rear left side

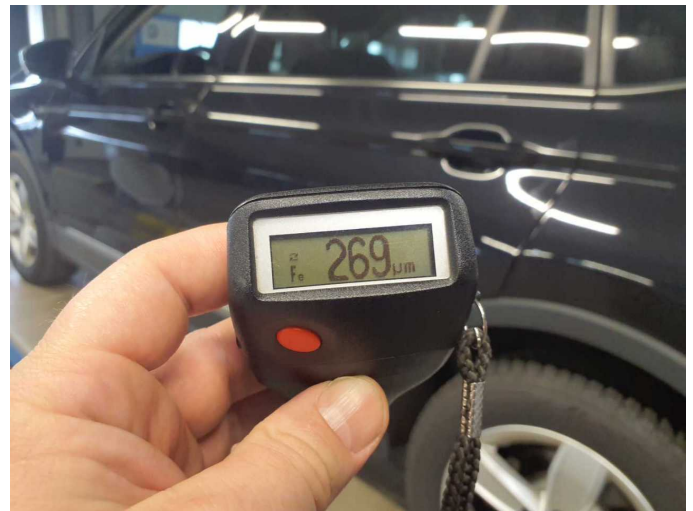
**Repainting 3:** Door - rear left side

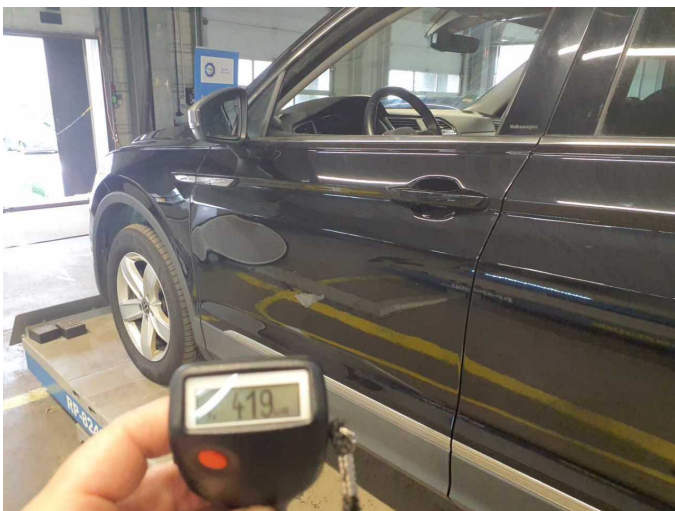
**Repainting 4:** Door - front left side

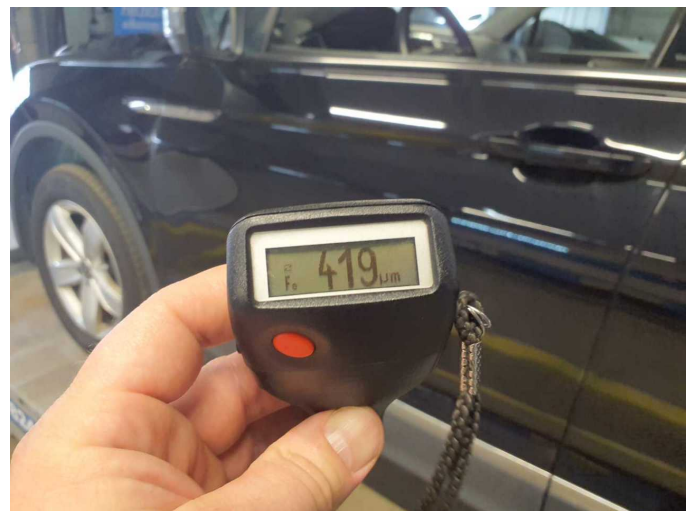
**Repainting 4:** Door - front left side
