## Expertise

Protocol number: 46287936  
Order No. / Reference: 26521120  
Inspection date: 1 Jul 2026

Manufacturer: Peugeot

Model: 5008 PureTech 180 EAT8 Stop & Start GT Pack

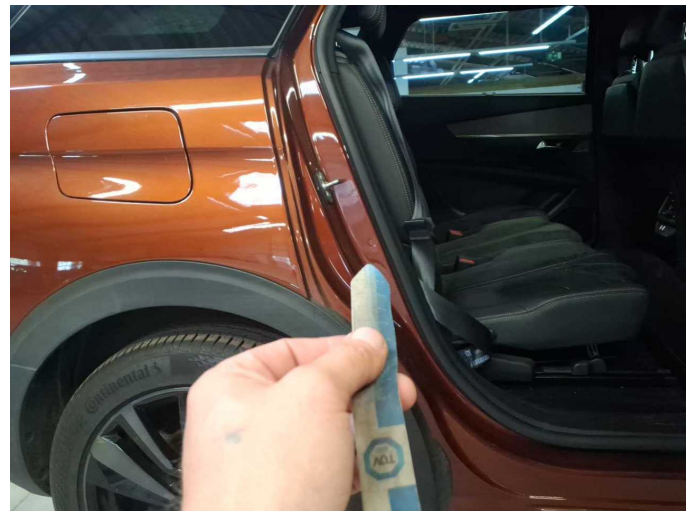
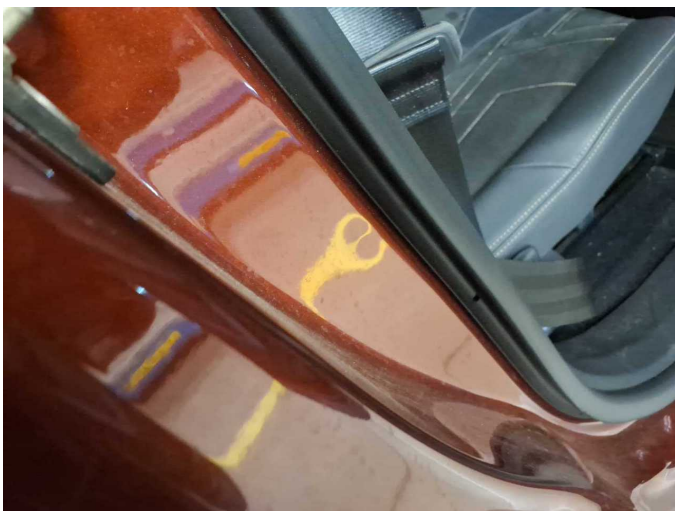
| No. | Component group | Description |
|---|---|--|
| 2 | Side panel - rear right side | Sill - dent(s) - Smooth repair work |

Damage 2: Side panel - rear right side: Sill - dent(s) - Smooth repair work

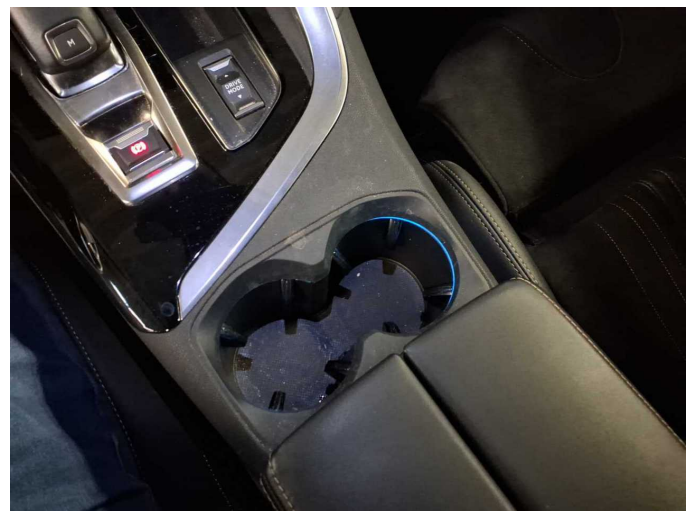
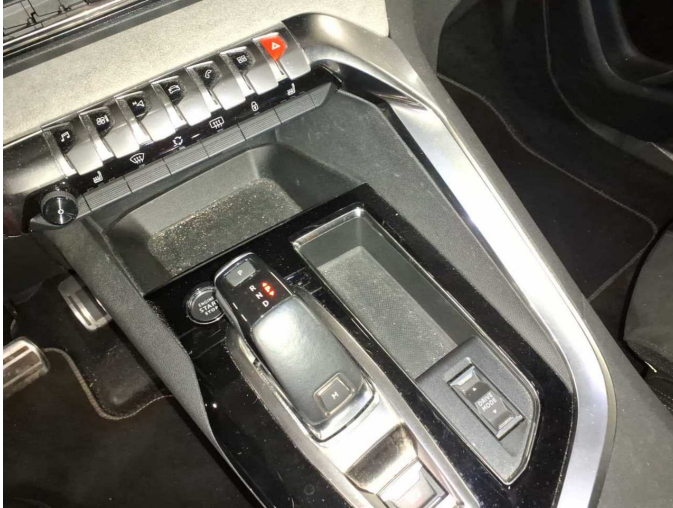
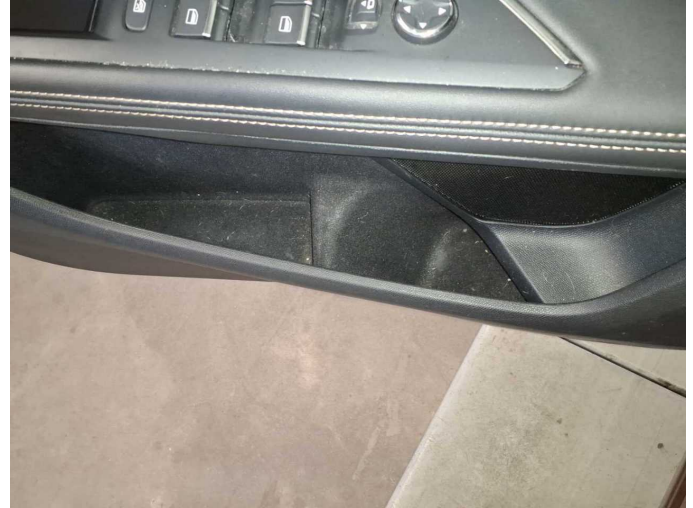
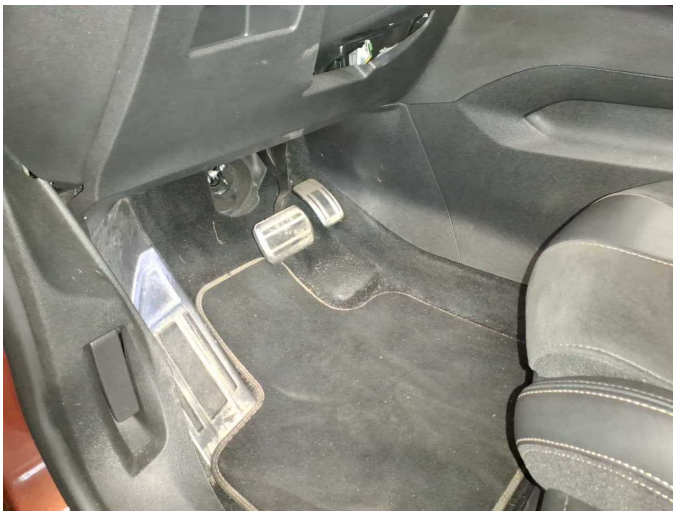
| No. | Component group | Description |
|---|---|--|
| 3 | Interior | Interior - Soiled - Clean |

Damage 3: Interior: Interior - Soiled - Clean

**Damage 3:** Interior: Interior - Soiled - Clean

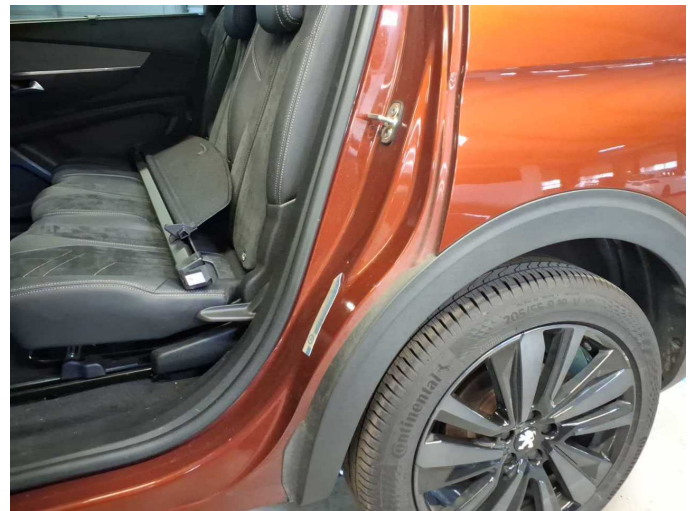
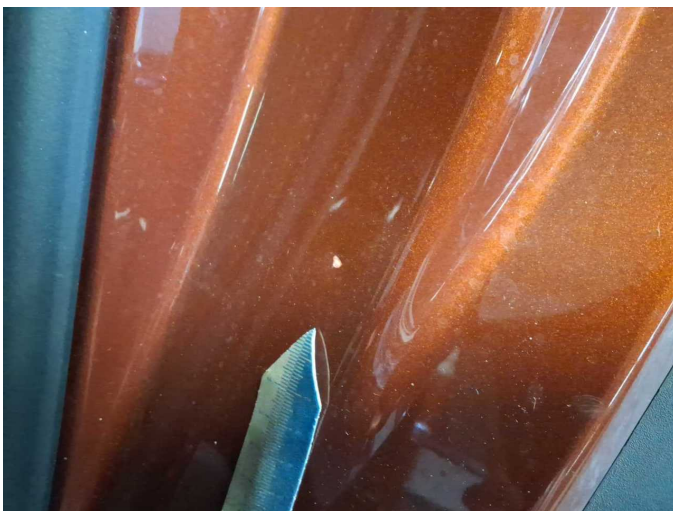
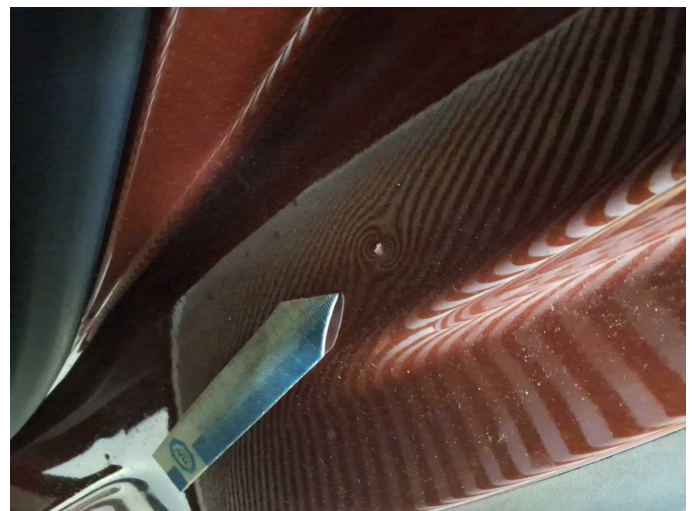
| No. | Component group | Description |
|---|---|--|
| 4 | Side panel - rear left side | Sill - Dent / paintcoat damage - Smart repair |

**Damage 4:** Side panel - rear left side: Sill - Dent / paintcoat damage - Smart repair

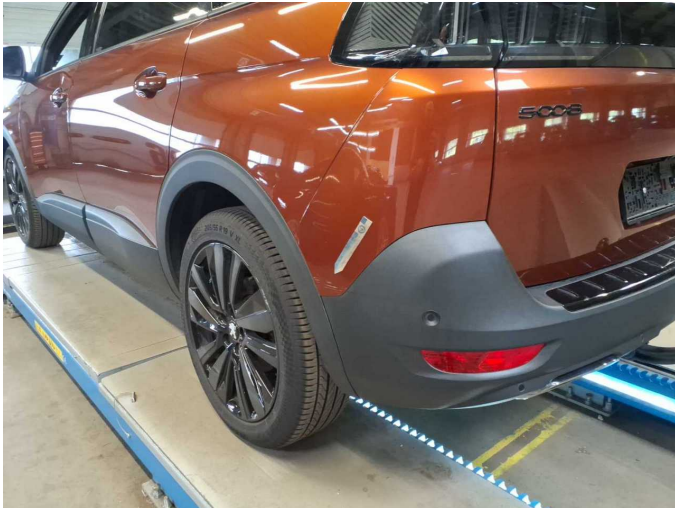
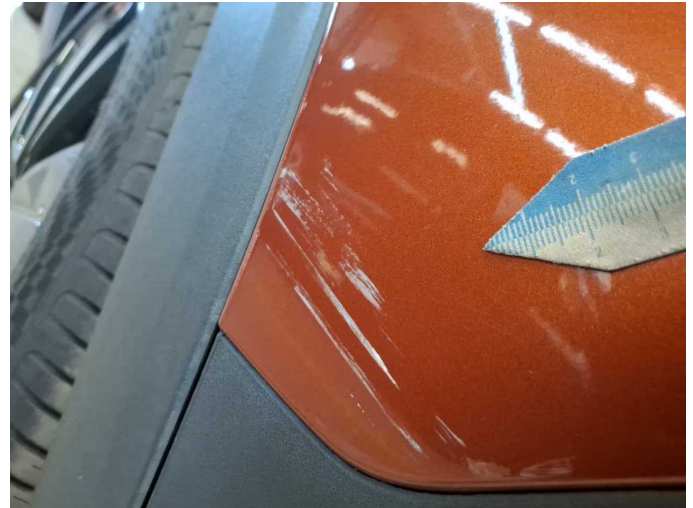
| No. | Component group | Description |
|---|---|--|
| 5 | Rear bumper | Bumper - rear left side - Scratch(es) - Smart repair |

**Damage 5:** Rear bumper: Bumper - rear left side - Scratch(es) - Smart repair

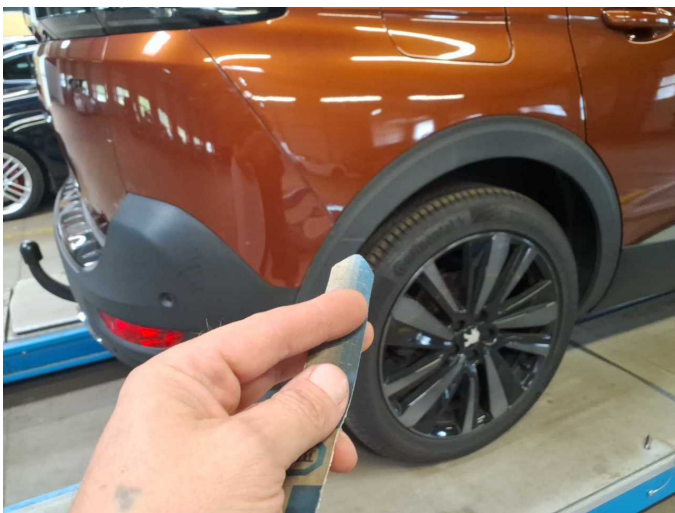
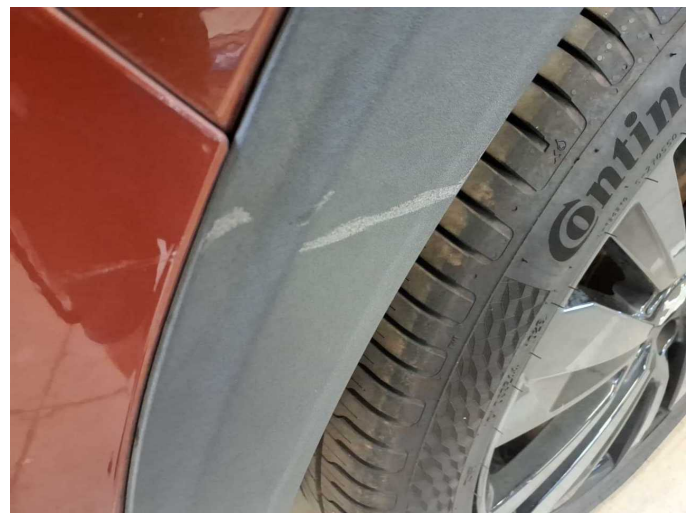
| No. | Component group | Description |
|---|---|--|
| 6 | Side panel - rear right side | Wheel well extension - Scratched - Replace |

**Damage 6:** Side panel - rear right side: Wheel well extension - Scratched - Replace

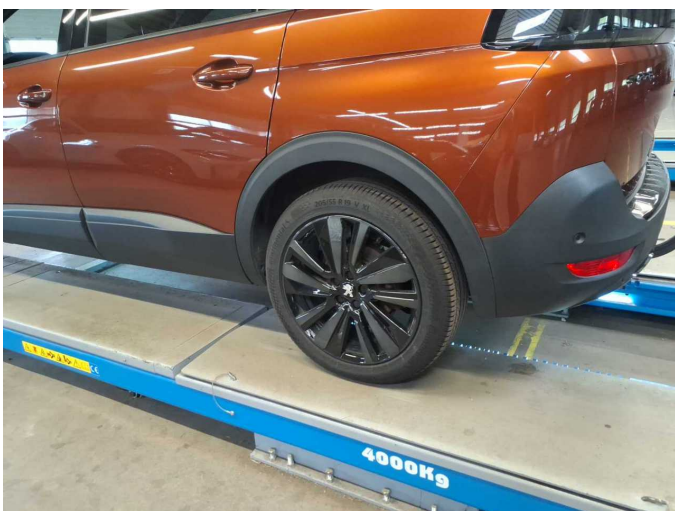
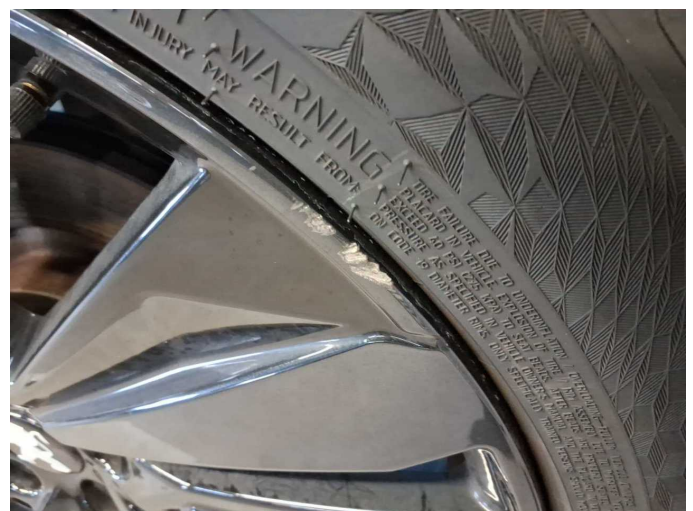
| No. | Component group | Description |
|---|---|--|
| 7 | Wheel / tyres | Alloy rim - rear left side - Scratch(es) - Loss in value |

**Damage 7:** Wheel / tyres: Alloy rim - rear left side - Scratch(es) - Loss in value

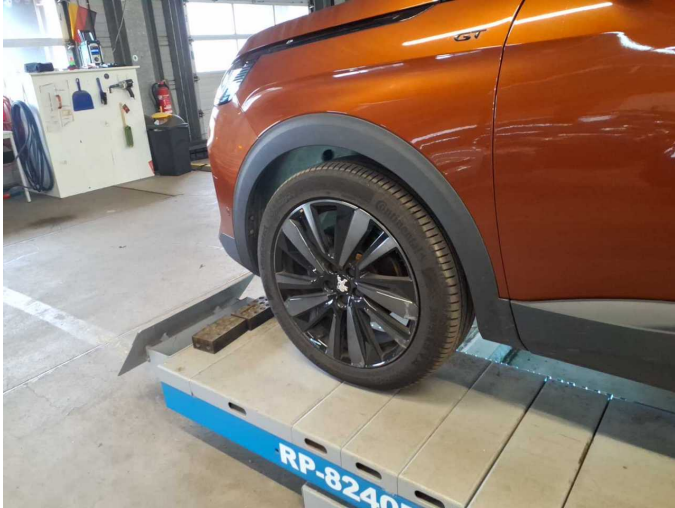
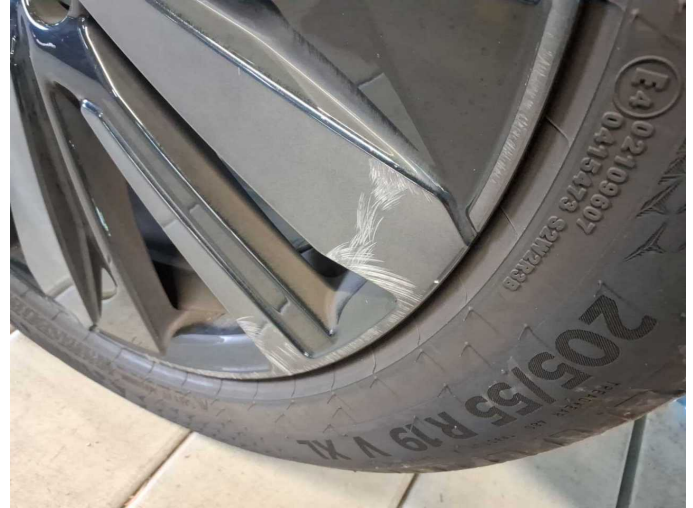
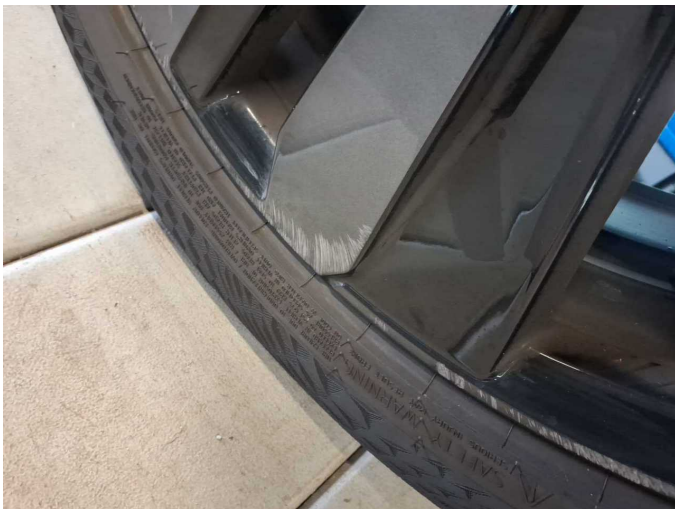
| No. | Component group | Description |
|---|---|--|
| 8 | Wheel / tyres | Alloy rim - front left side - Scratched - Loss in value |

**Damage 8:** Wheel / tyres: Alloy rim - front left side - Scratched - Loss in value

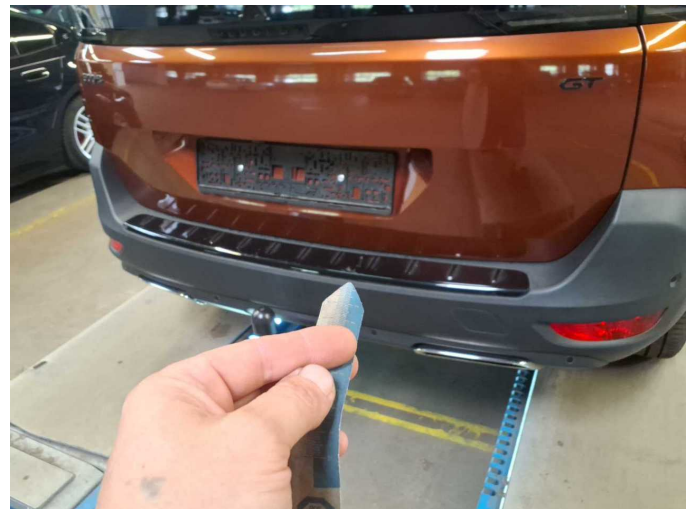
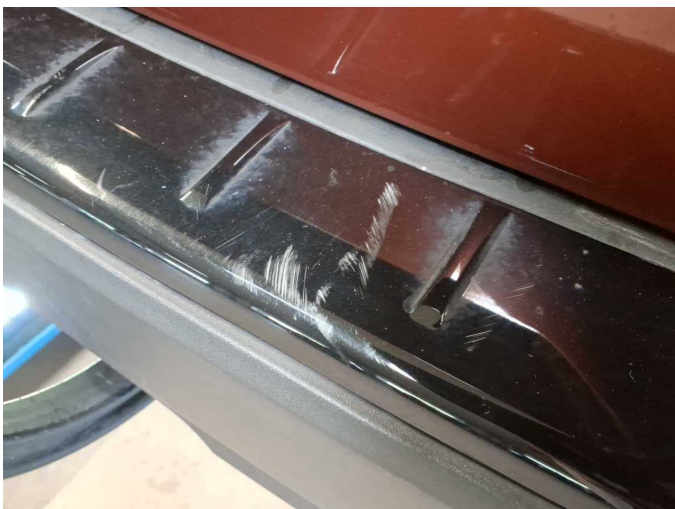
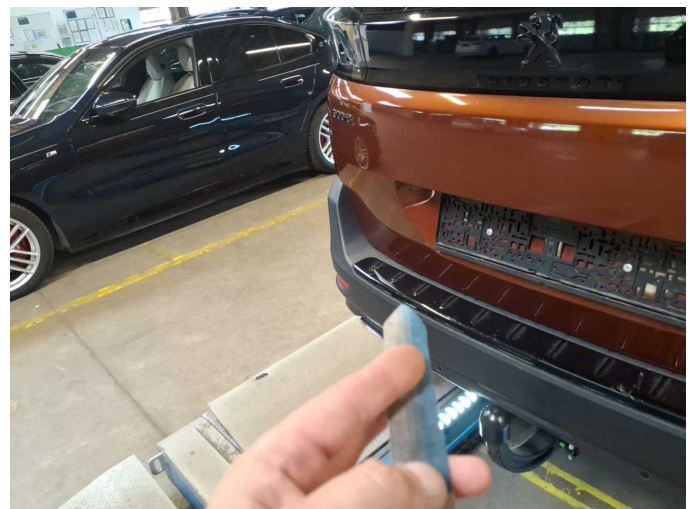
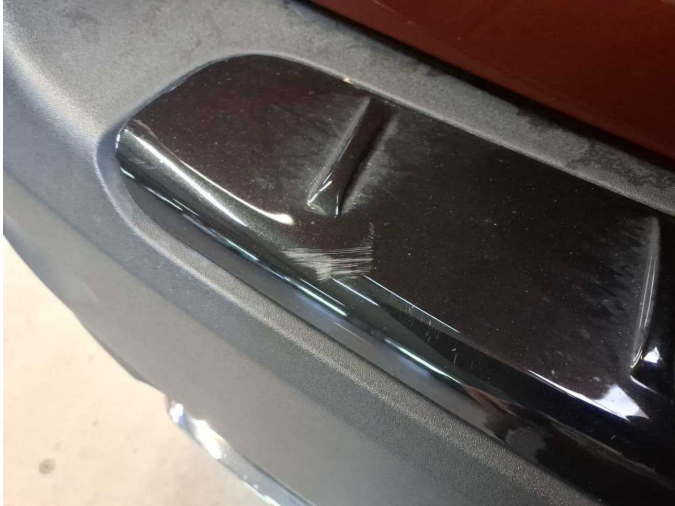
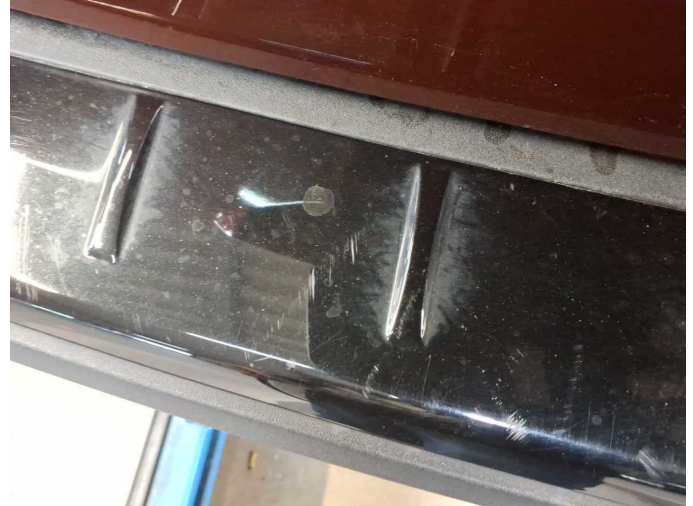
| No. | Component group | Description |
|---|---|--|
| 9 | Rear bumper | Protection strip - centre - Scratched - Replace |

**Damage 9:** Rear bumper: Protection strip - centre - Scratched - Replace

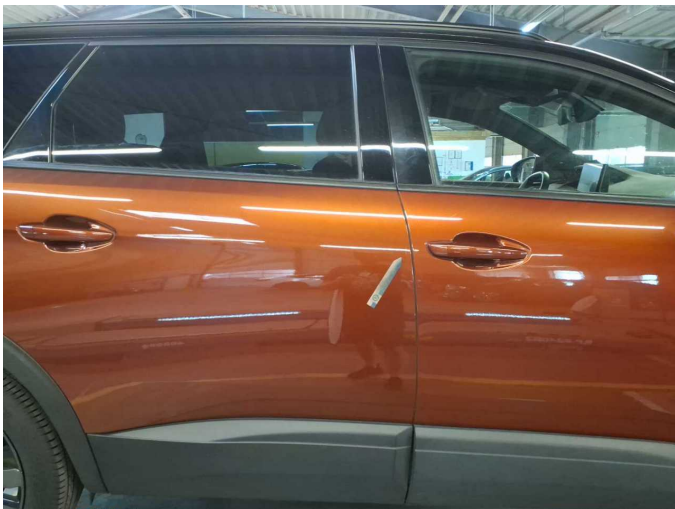
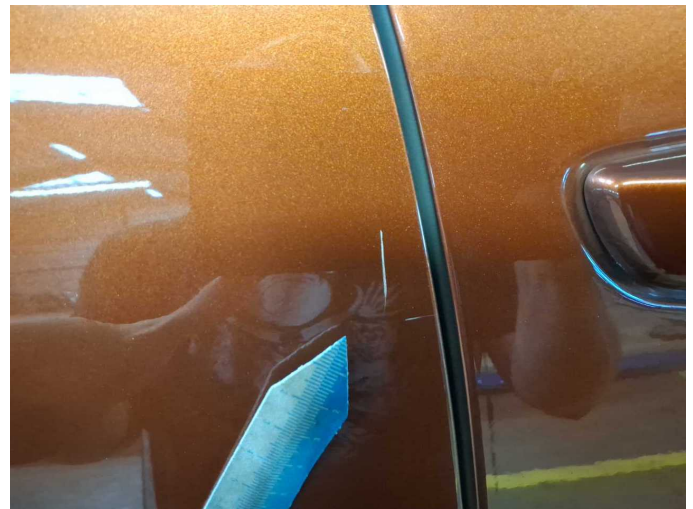
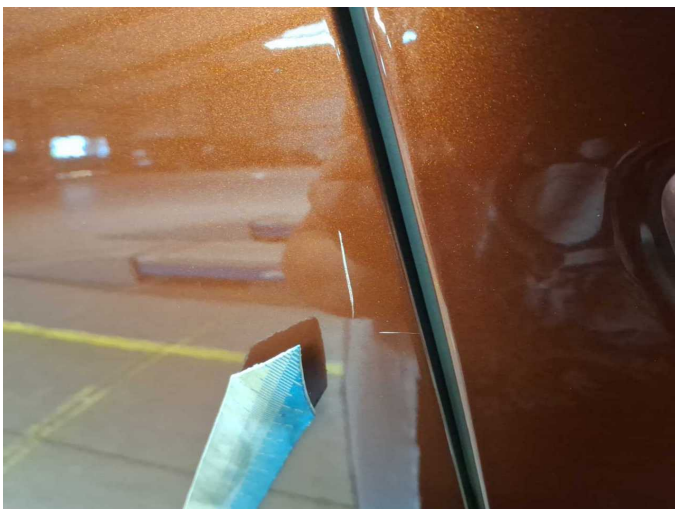
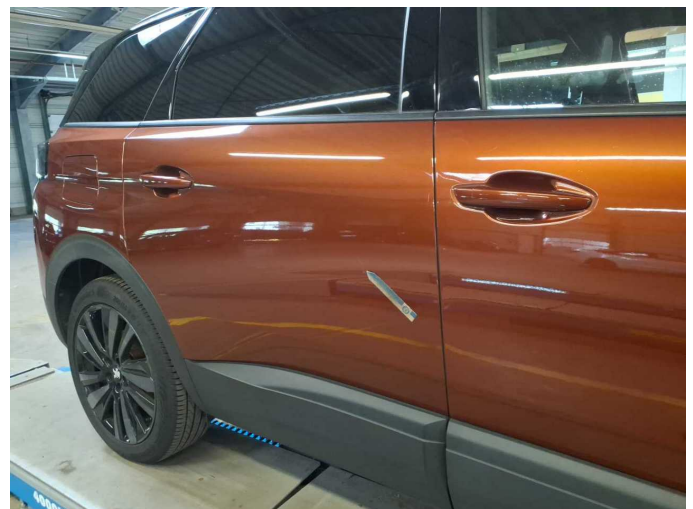
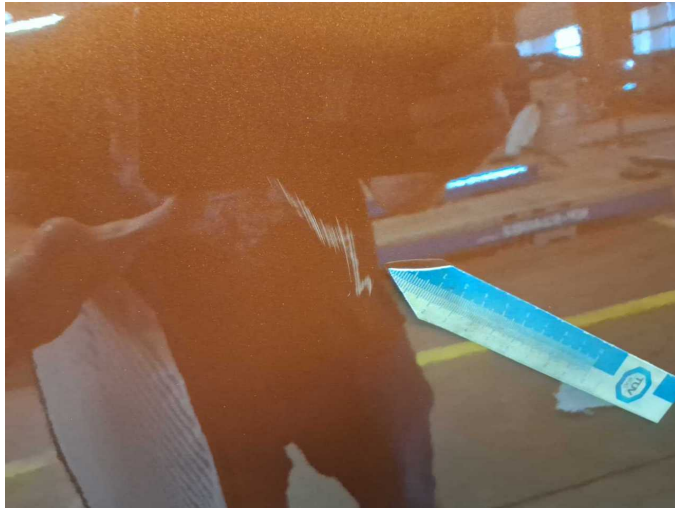
| No. | Component group | Description |
|---|---|--|
| 10 | Door - rear right side | Door - Scratch(es) - Paint |

**Damage 10:** Door - rear right side: Door - Scratch(es) - Paint

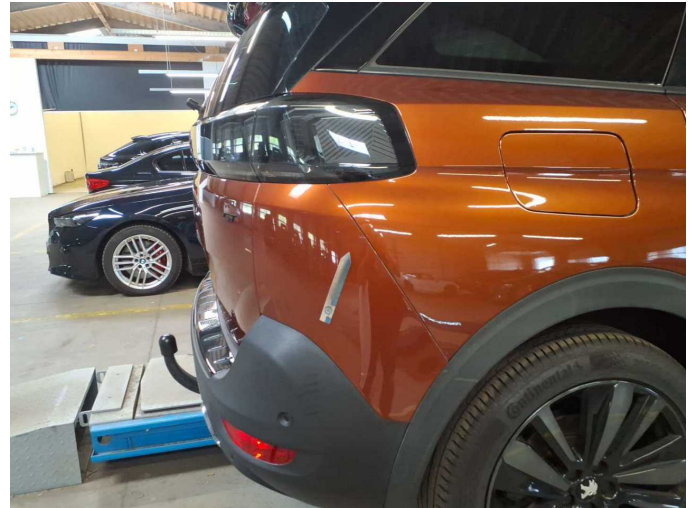
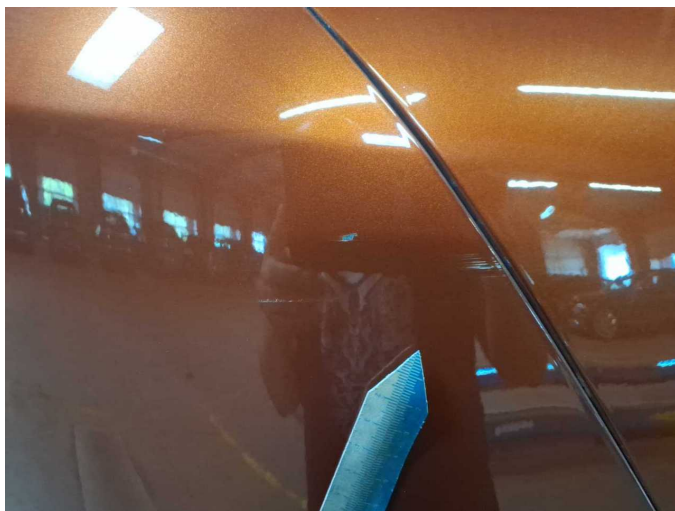
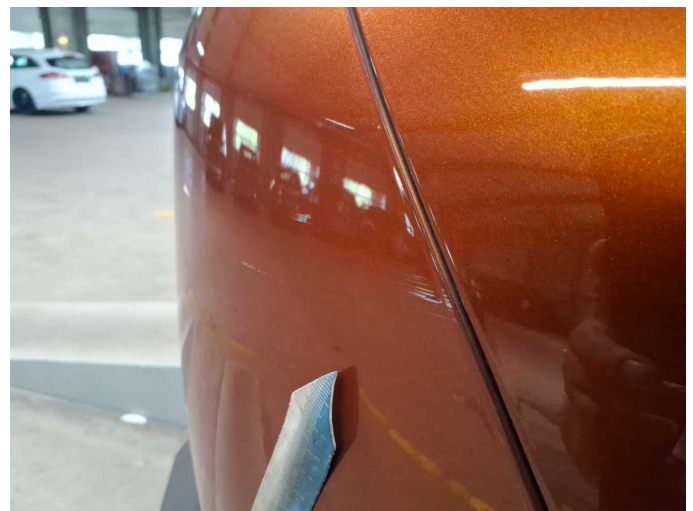
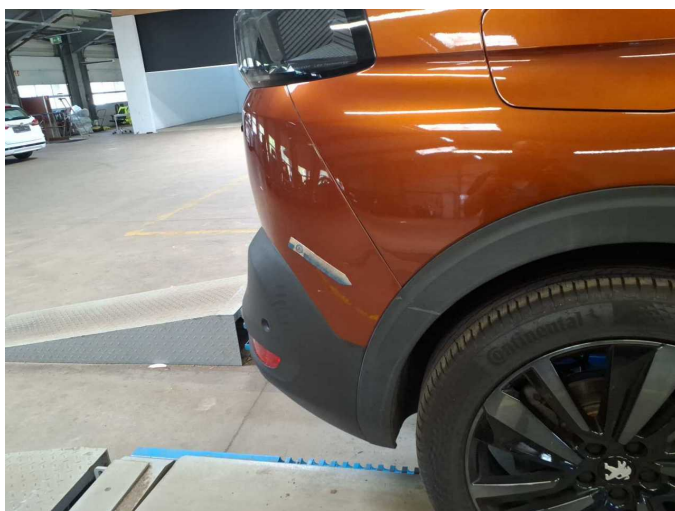
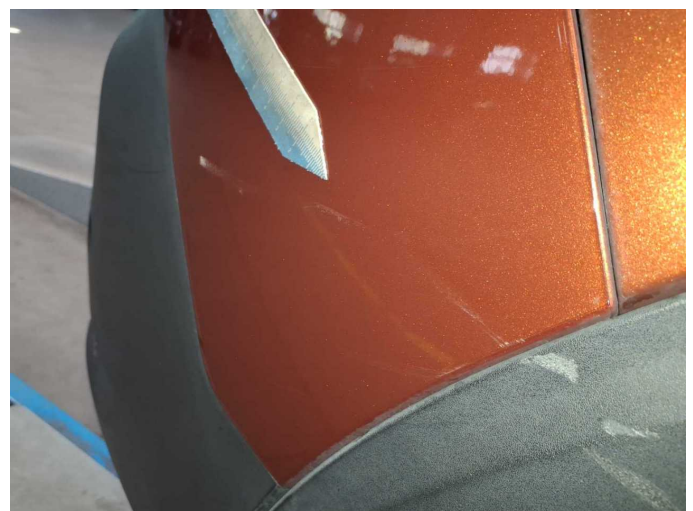
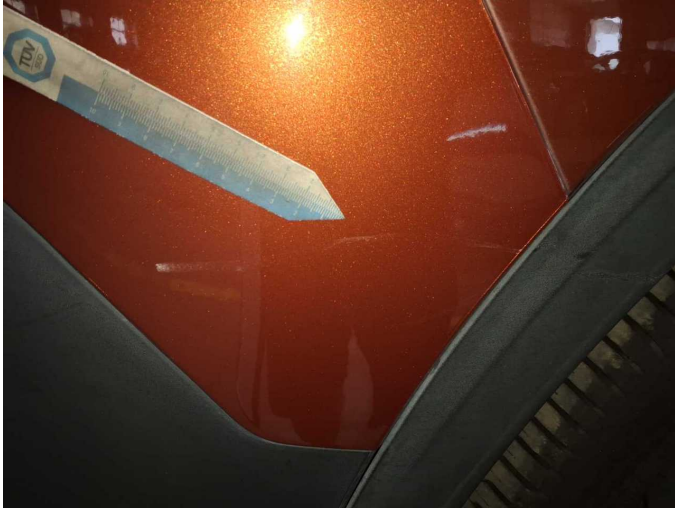
| No. | Component group | Description |
|---|---|--|
| 11 | Rear bumper | Bumper - rear right side - Scratched - Paint |

**Damage 11:** Rear bumper: Bumper - rear right side - Scratched - Paint

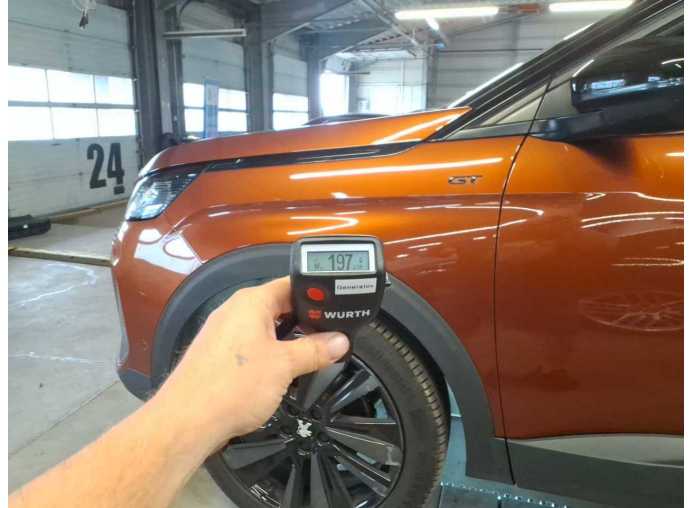
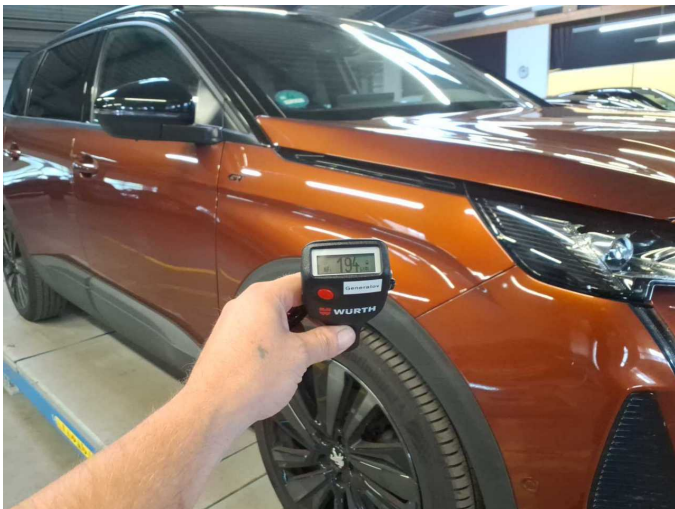
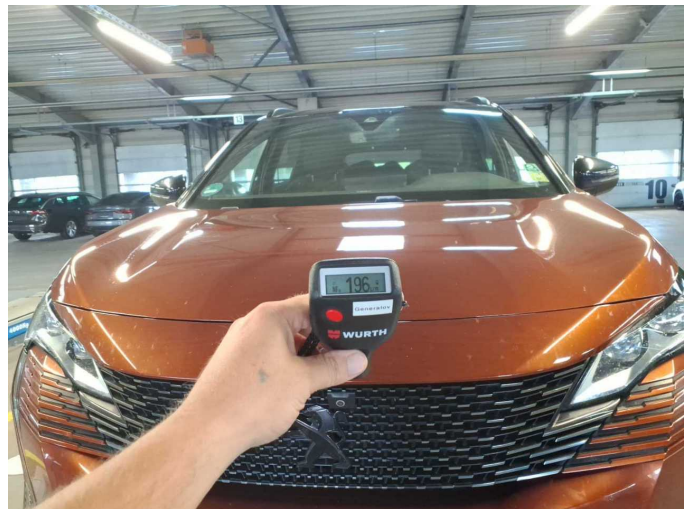
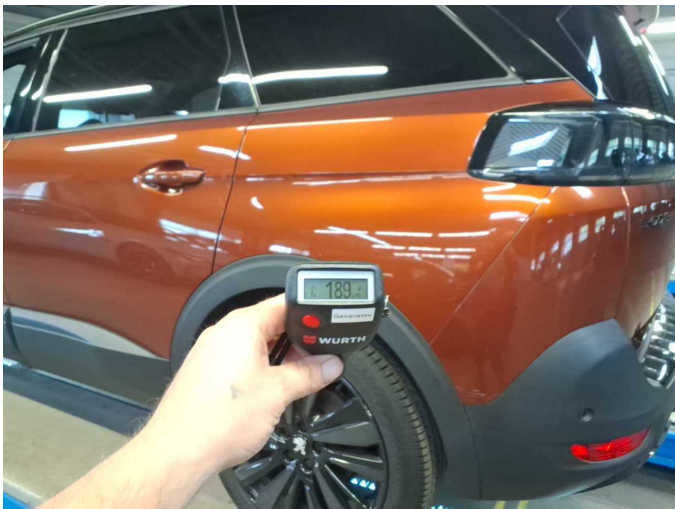
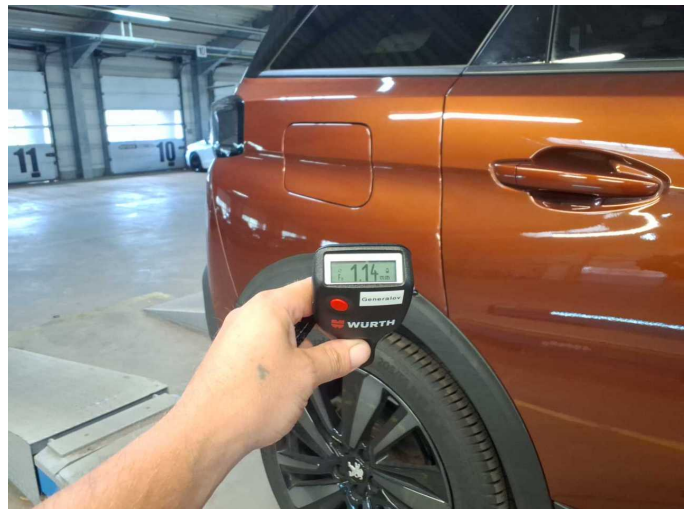
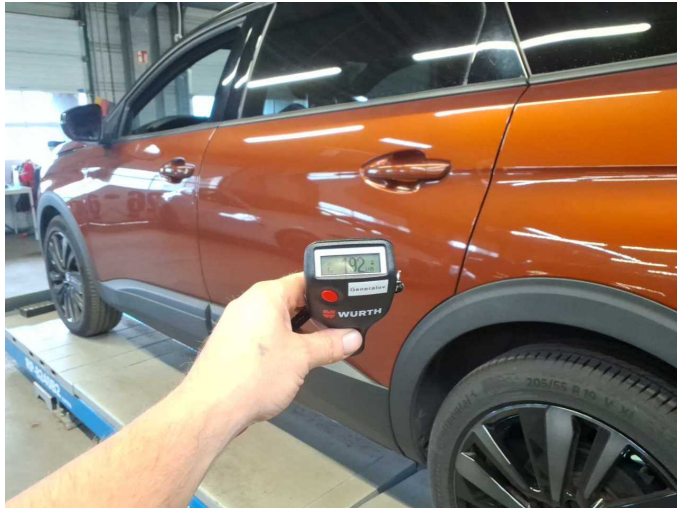
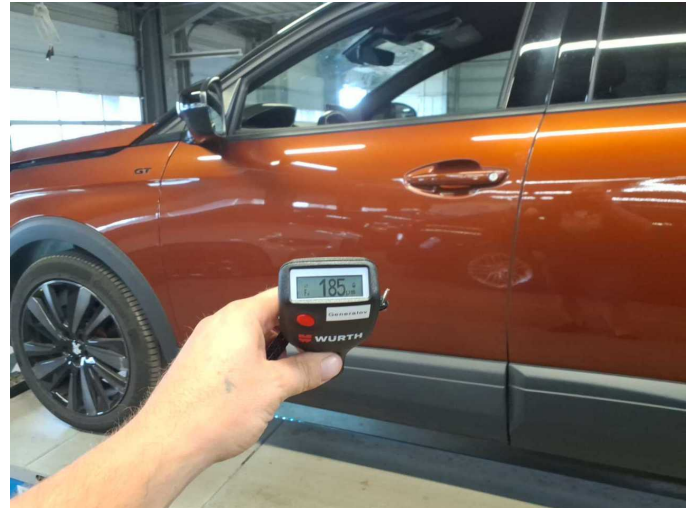
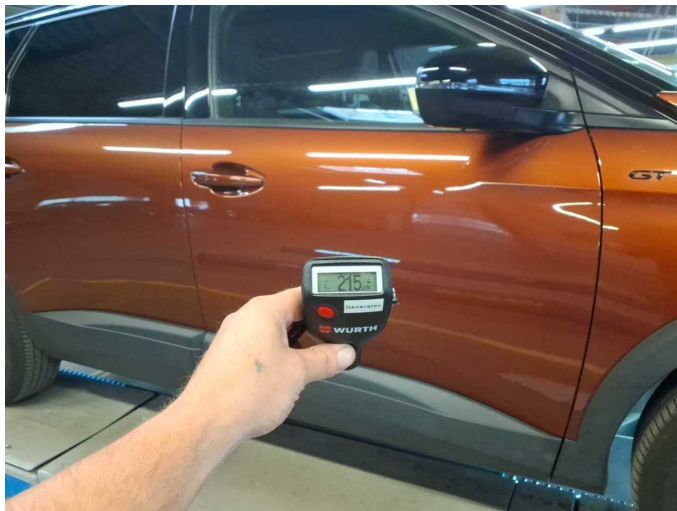
| No. | Repainting |
|---|---|
| 1 | Mudguard - left side, Mudguard - right side, Bonnet, Side panel - rear left side, Side panel - rear right side, Door - rear left side, Door - front left side, Door - front right side, Professionally carried out, Invoice of repair done Non-existent |

**Repainting 1:** Mudguard - left side, Mudguard - right side, Bonnet, Side panel - rear left side, Side panel - rear right side, Door - rear left side, Door - front left side, Door - front right side
