Expertise

Protocol number: 45828116
Order No. / Reference: 26403127
Inspection date: 27 May 2026

Manufacturer: Peugeot

Model: 5008 BlueHDi 180 EAT8 GT

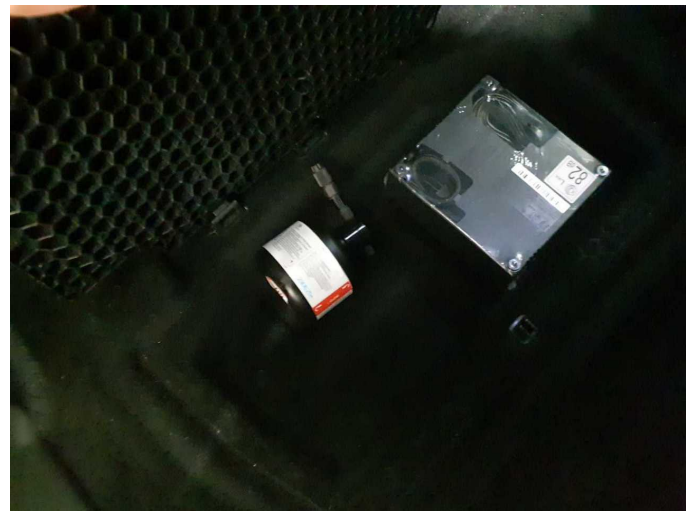
Damage 1: Equipment: Tirefit filler - Expired - Replace

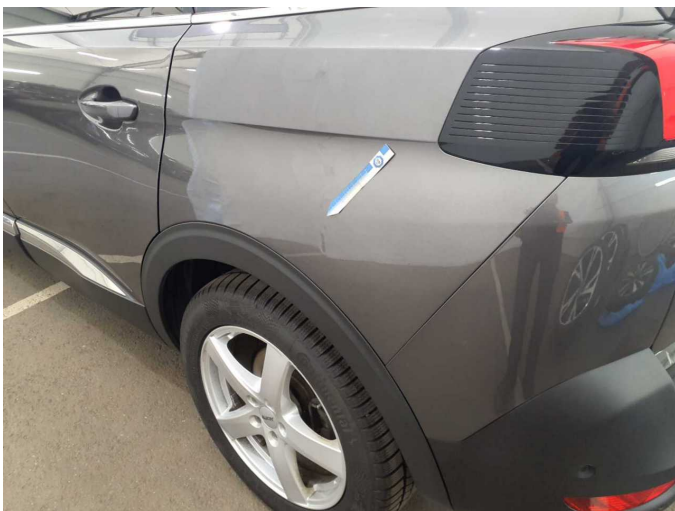
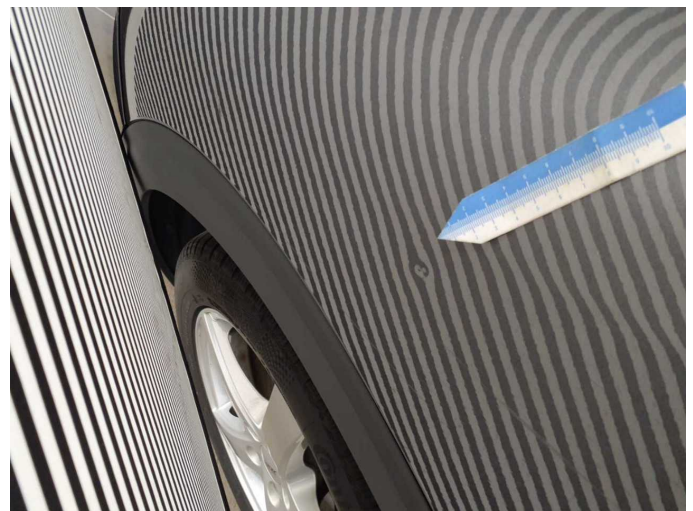
Damage 2: Side panel - rear left side: Side panel - dent(s) - Smooth repair work

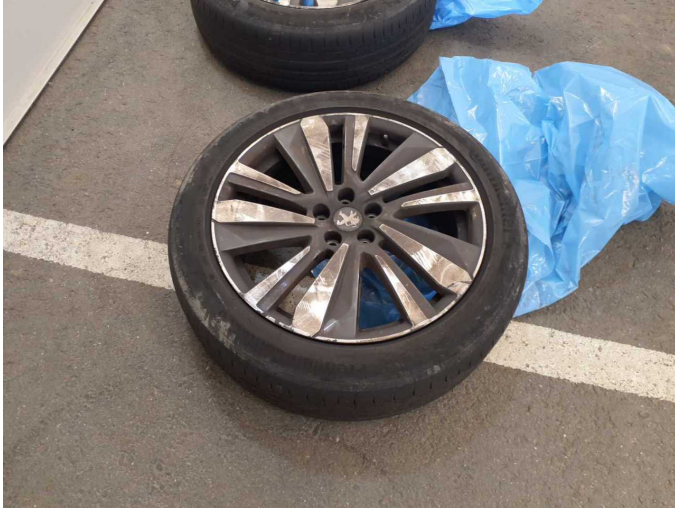
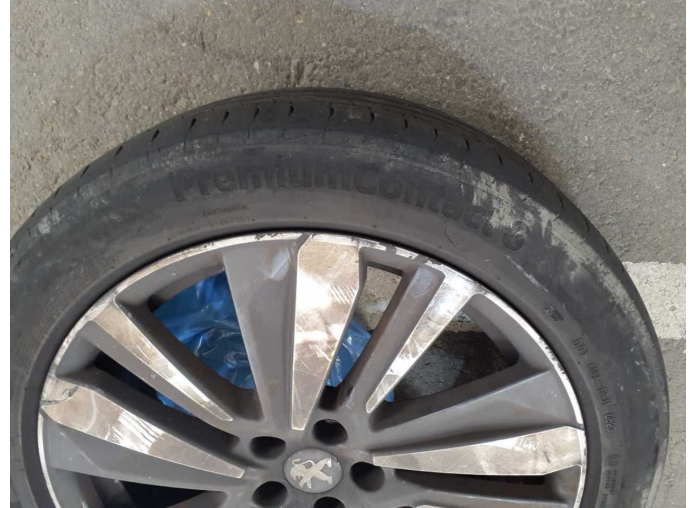
Damage 3: 2nd wheel set: 1 tyre (Flankenbeschädigung) - Damaged - Replace

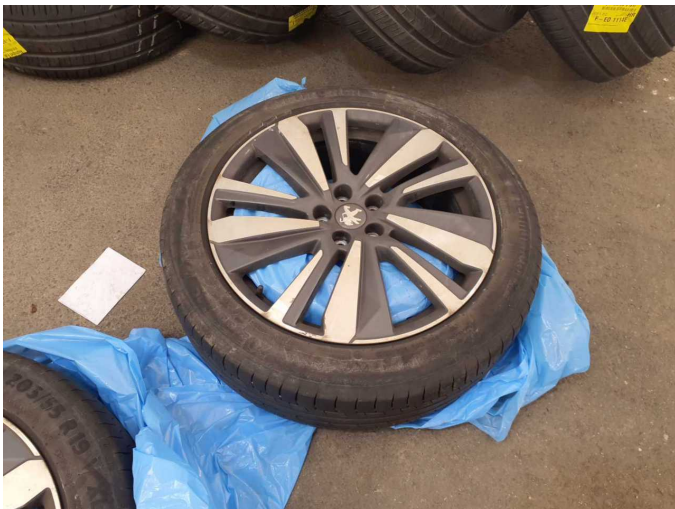
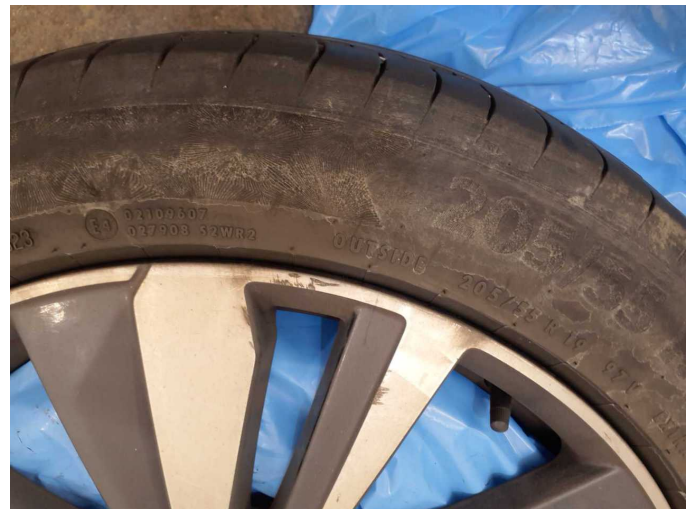
Damage 4: 2nd wheel set: 1 alloy rim - Scratched - Loss in value

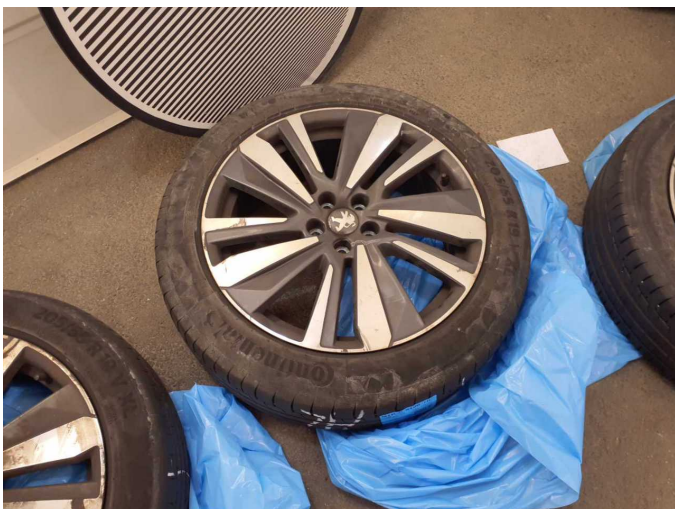
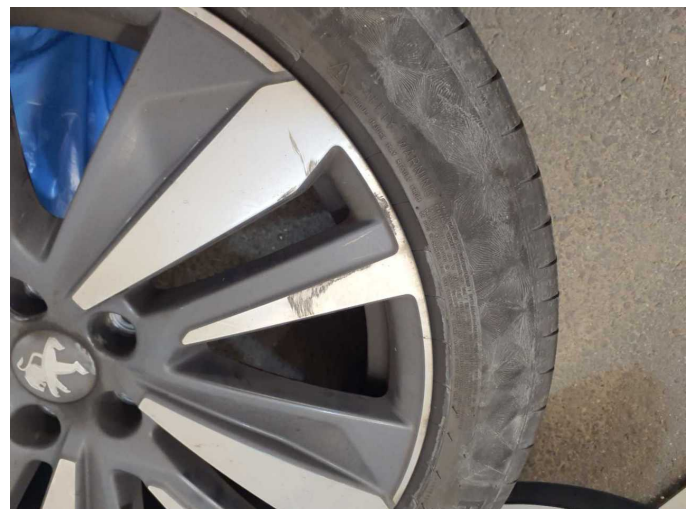
Damage 5: 2nd wheel set: 1 alloy rim - Scratched - Loss in value

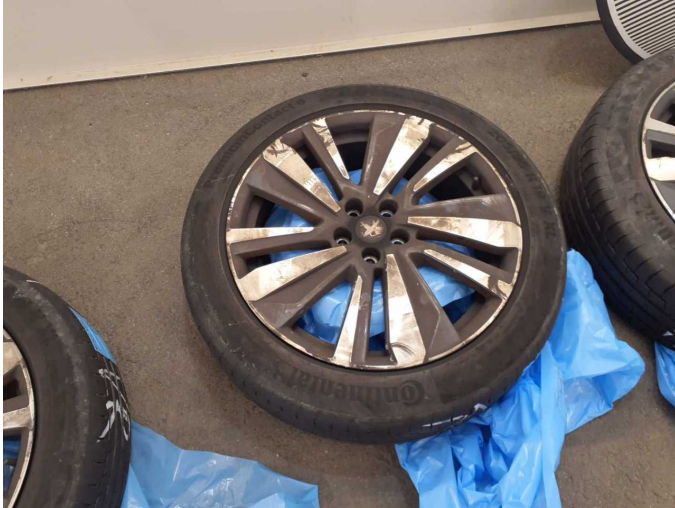
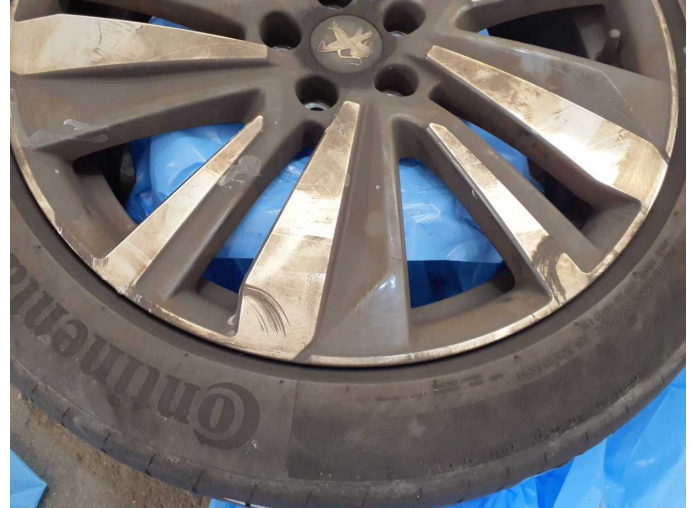
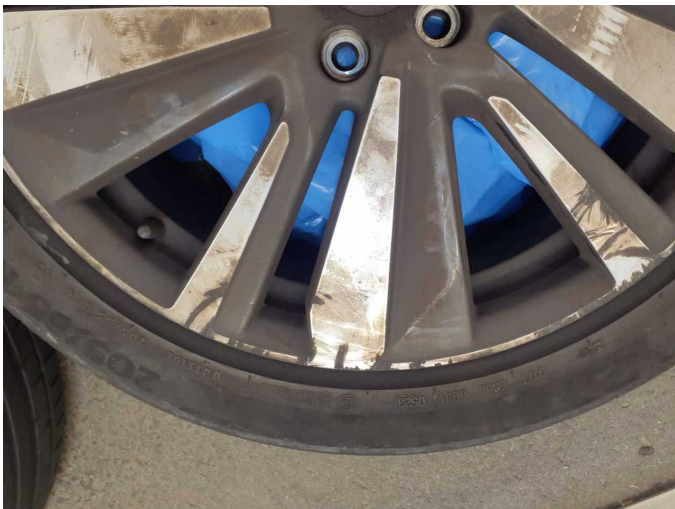
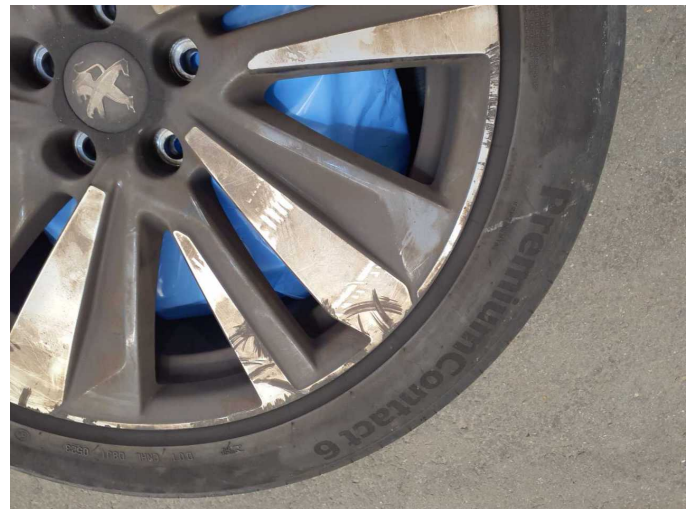
Damage 6: 2nd wheel set: 1 alloy rim (Großflächig verkratzt) - Scratched - Replace

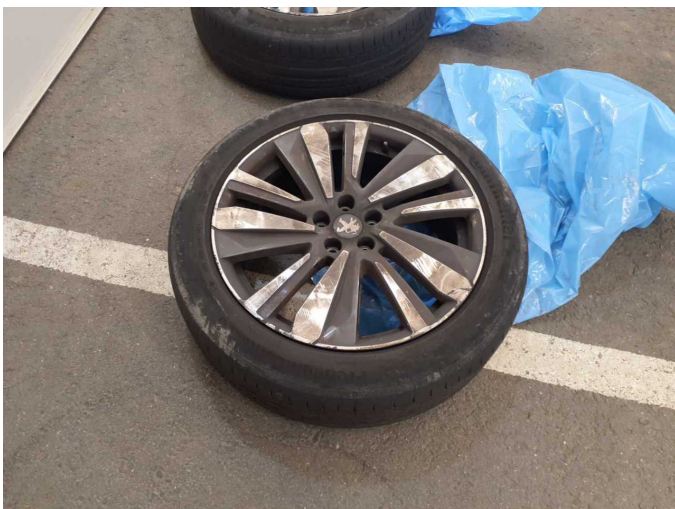
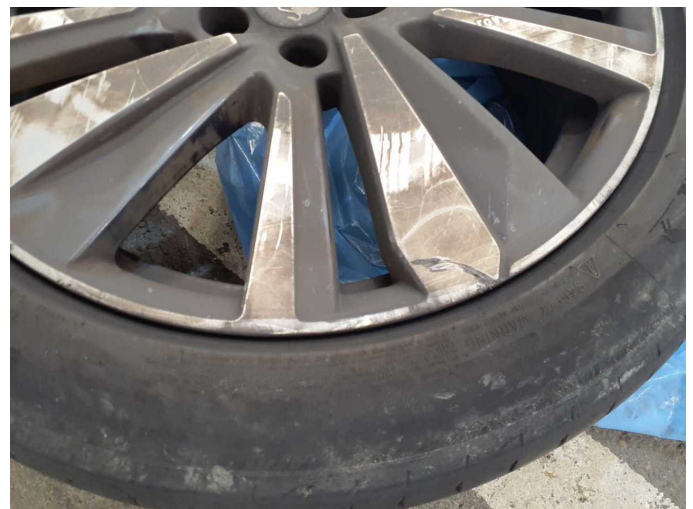
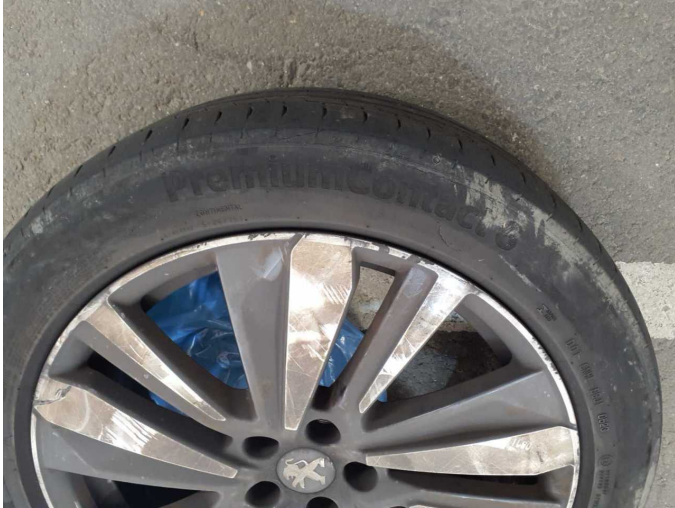
Damage 7: 2nd wheel set: 1 alloy rim (Großflächig verkratzt / mit Materialabtrag) - Scratched - Replace

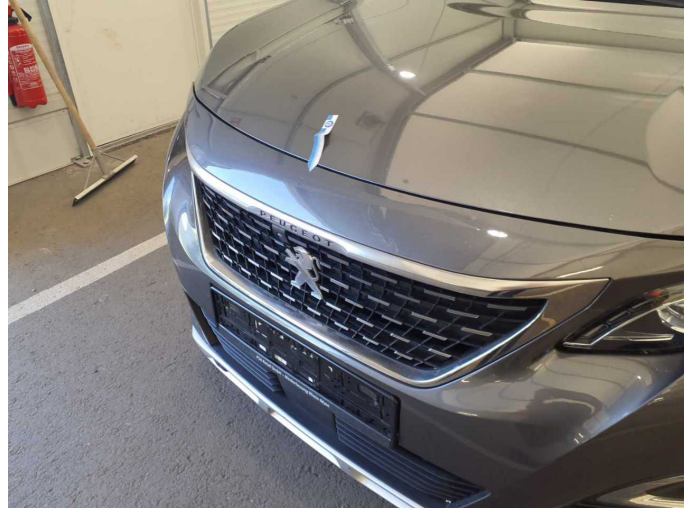
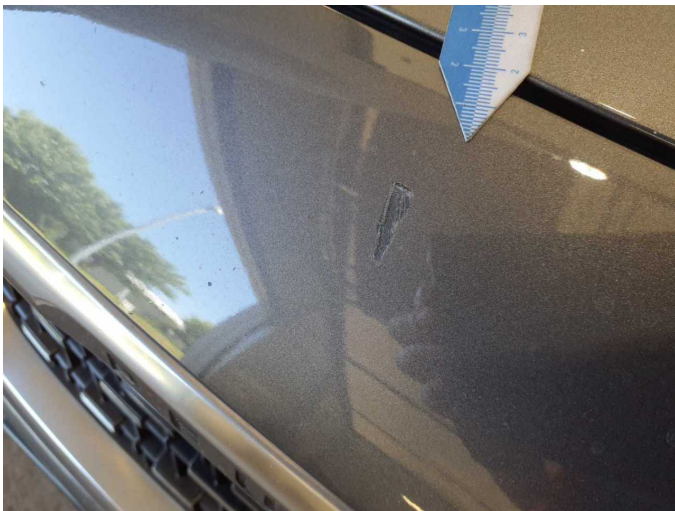
Damage 8: Front bumper: Front bumper - Scratched - Paint

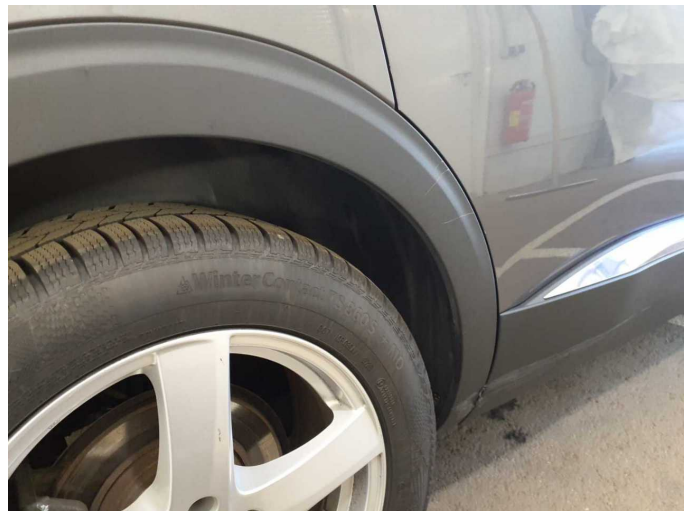
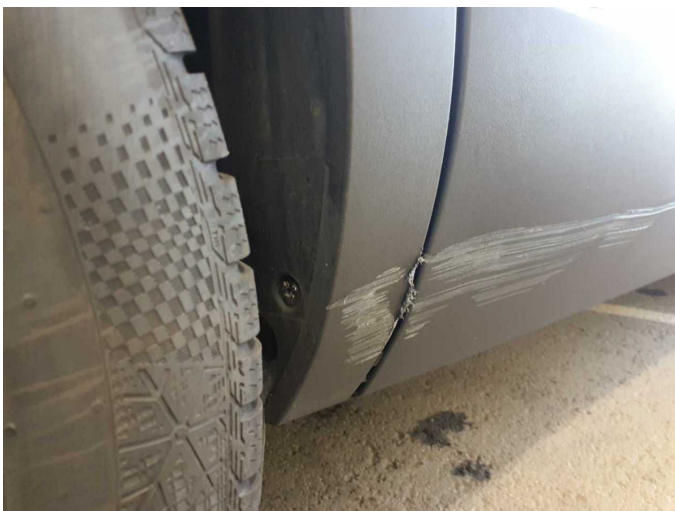
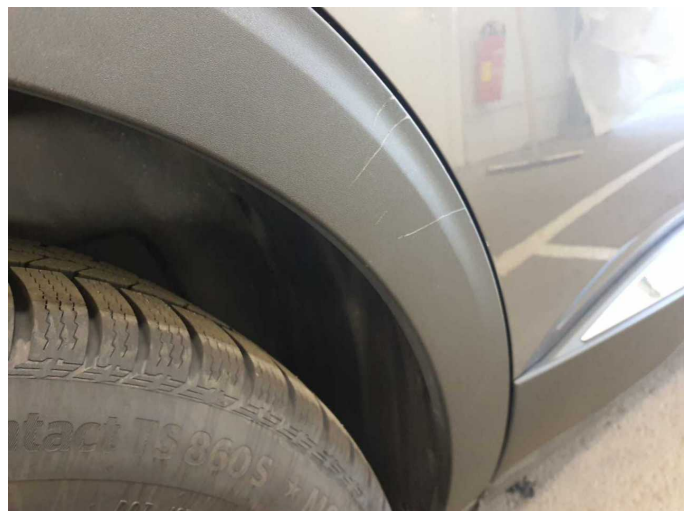
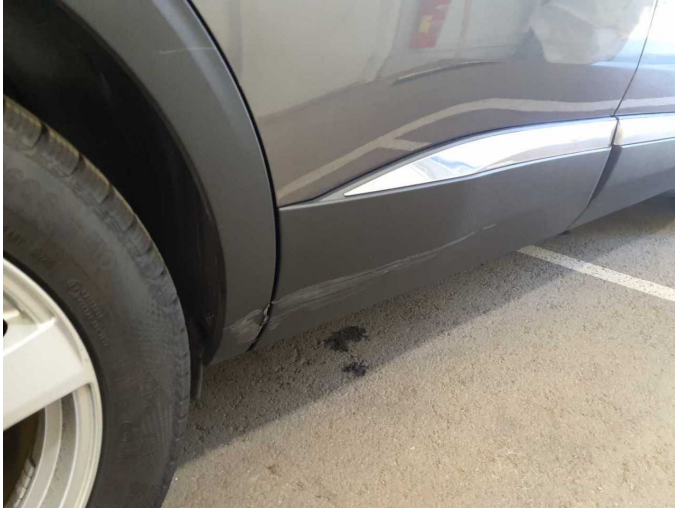
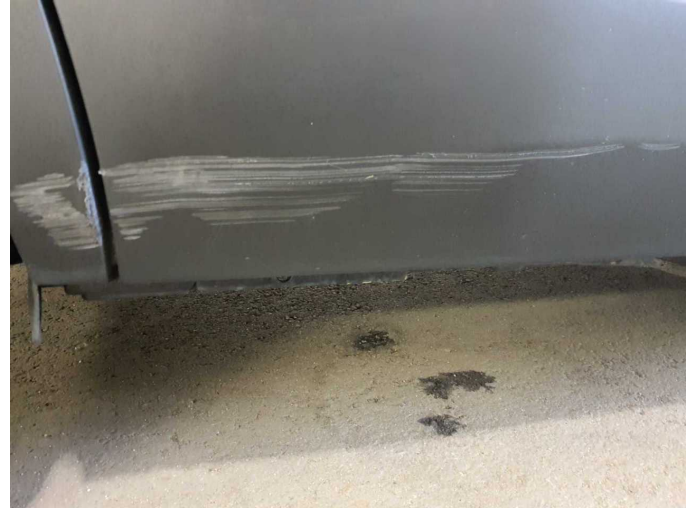
Accident 1: Side right
